**AVO7829**
**Rev. F**
**Subject:**
**A/C 0852 RH Horizontal Stabilizer Damage Assessment**
**Issue Date:**
**07/25/2019**
**Issued by:**
**M. Nguyen**
**Aircraft/Component: N57852**
**Disposition:**

Ground damage event on aircraft 0852 via inadvertent contact with an American Airlines aircraft, causing damage to the RH Horizontal Stabilizer, including the following damages: Right-hand elevator outboard section was broken off at second attach fitting. Right-hand horizontal Stab has scratches and dents and possible cracks on right hand side lower skin. Scratches and dents on lower skin extending 24-30 inches from outboard end. Right-hand horizontal stab end cap damage and punctured.

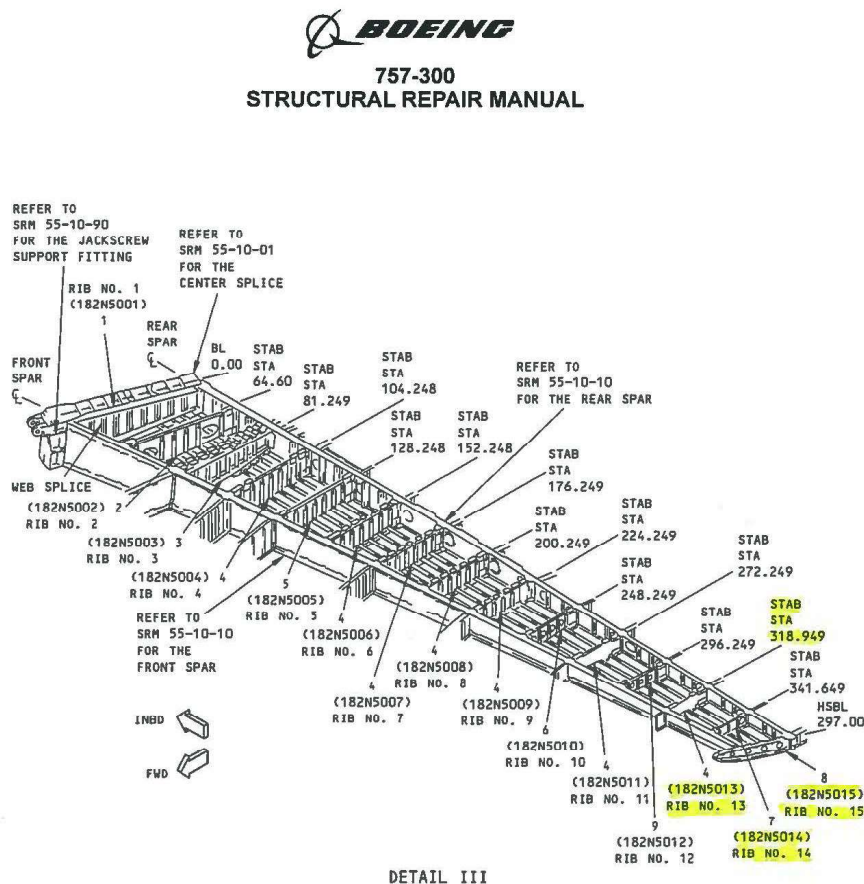
Figure 4

4. Once access is available, accomplish a detailed visual inspection of the following internal structures for any signs of distortion, buckles, dents, cracked or pulled/loose/missing fasteners/rivets, see attached Figures 4 thru 7 for details.
  - a. Internal skin area from Stab Sta 318. - HSBL 297.00 and between front spar to rear spar.

- b. Stringers S-1 thru S-3 from Stab Sta 318. - HSBL 297.00.
- c. Ribs 13 thru 15.
- d. Elevator Control Fittings.
- e. Stabilizer Pivot Support Fitting.
- f. Horizontal Stabilizer Jackscrew Support Fitting.
- 5. For any internal structure parts that have signs of distortion, buckles and dents, accomplish HFEC surface inspections per 757 NDT Part 6, Chapter 51-00-19 for cracks.

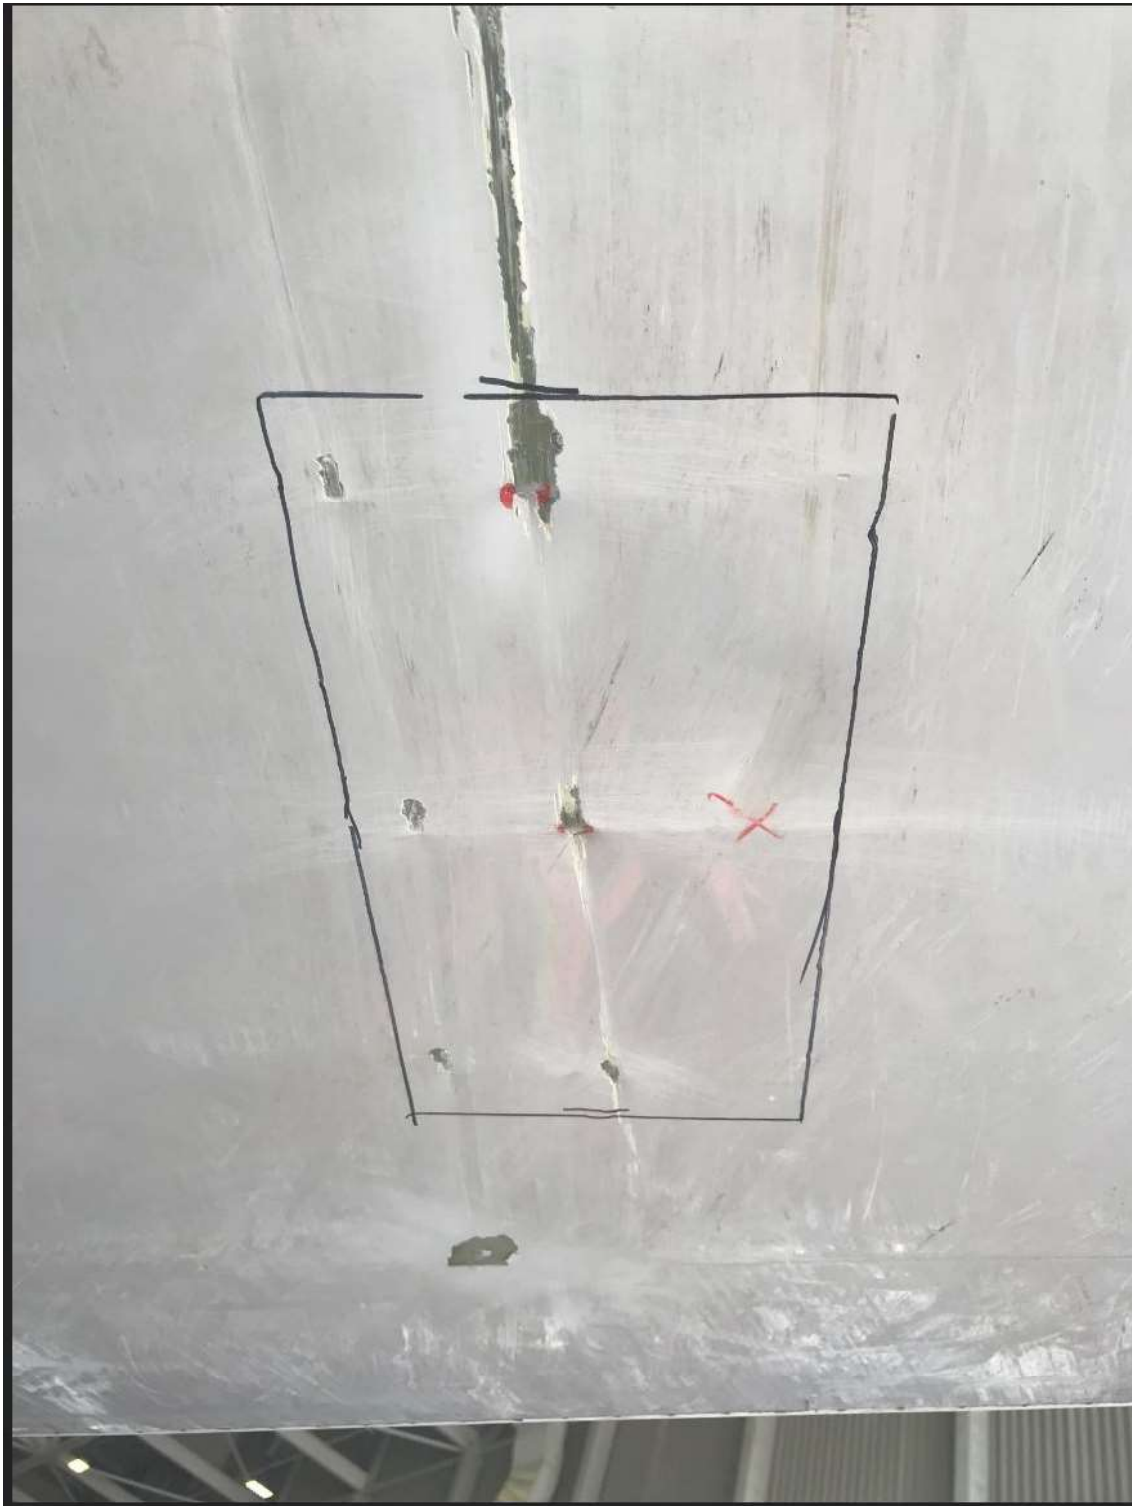
Figure 8

- c. At damage skin section with two cracks and a gouge:
    - i. Carefully cut out the minimal amount of fuselage skin, approximately 6.0" x 12" area, to remove the two cracks and the gouge area as shown in Figure 8.

- ii. Ensure the shape of the cutout is rectangular with the sides parallel or perpendicular to the stringer or rib.
    - iii. Maintain a minimum 2D+0.040" edge margin at all fastener locations.

- iv. Ensure the corner radii of the cut a minimum of 0.50 inch.
    - v. Accomplish a high frequency eddy current inspection (HFEC) of the skin cut out edge to ensure no cracks. Refer to 757 NDT Part 6, 51-00-01 or 51-00-19.

- vi. Enlarge cut out 0.040 inch as an insurance cut.
  - d. At other blend out areas, accomplish an ultrasound thickness test per 757 NDT Manual Part 4, Chapter 51-00-00 or equivalent to determine the remaining skin thickness. At any locations with blend out areas beyond 757 SRM 55-10-01 Allowable Damage 1, use a .25" grid system, record the remaining skin thickness and provide all dimensions to Engineering. Map out the damage location, provide size of affected area and distance to adjacent structure.
