**PARTY SUBMISSION OF  
SOUTHWEST AIRLINES PILOTS' ASSOCIATION  
TO THE NATIONAL TRANSPORTATION SAFETY BOARD**

**SOUTHWEST FLIGHT 278  
KBUR - Burbank, California  
06 December 2018**

**NTSB DCA19IA036**

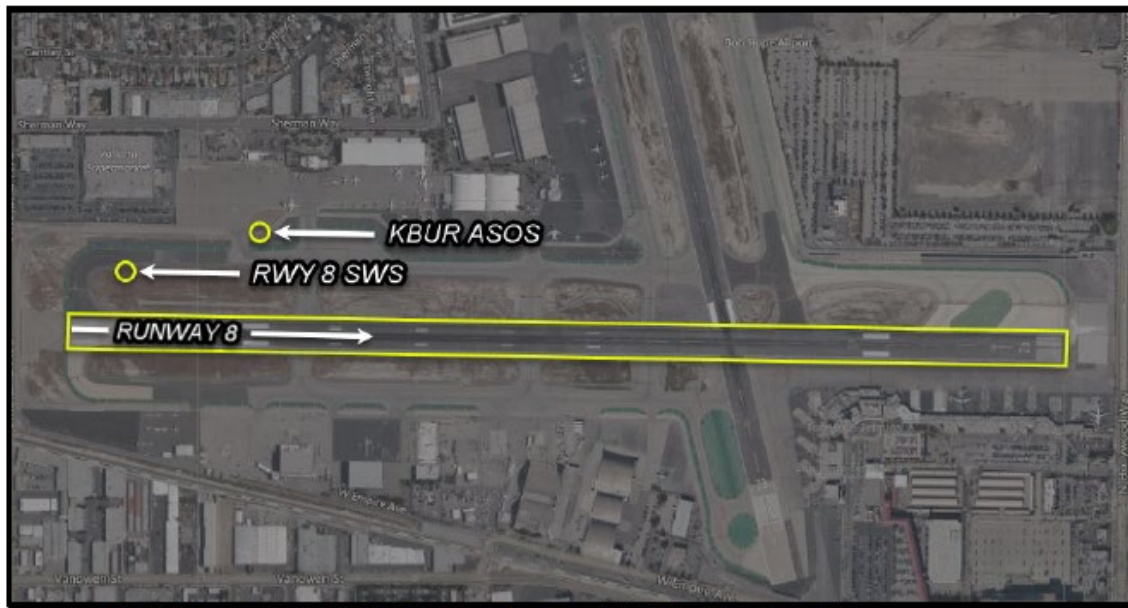
The wind readouts provided to the crew by the controller were from the Surface Weather System (SWS), and differed considerably from those recorded by the Automated Surface Observation System (ASOS), which includes the average 2-minute winds and is updated every 5 seconds. As depicted below, there is an 800’ difference in locations of the ASOS and the runway 08 SWS, with

the SWS located near the beginning of the runway and the ASOS located closer to the actual touchdown zone.<sup>7</sup>

KBUR Runway 8 with KBUR ASOS and runway 8 SWS locations depicted

There was a significant difference in wind values between these two independent wind measuring systems. The average 2-minute winds recorded by ASOS were 269/16 at 9:00 and 273/15 at 9:01. At the time of SWA 278's landing, the average 2-minute winds were 279/14 at 9:02 and 282/14 at 9:03, equating to approximately a 14-knot tailwind component.

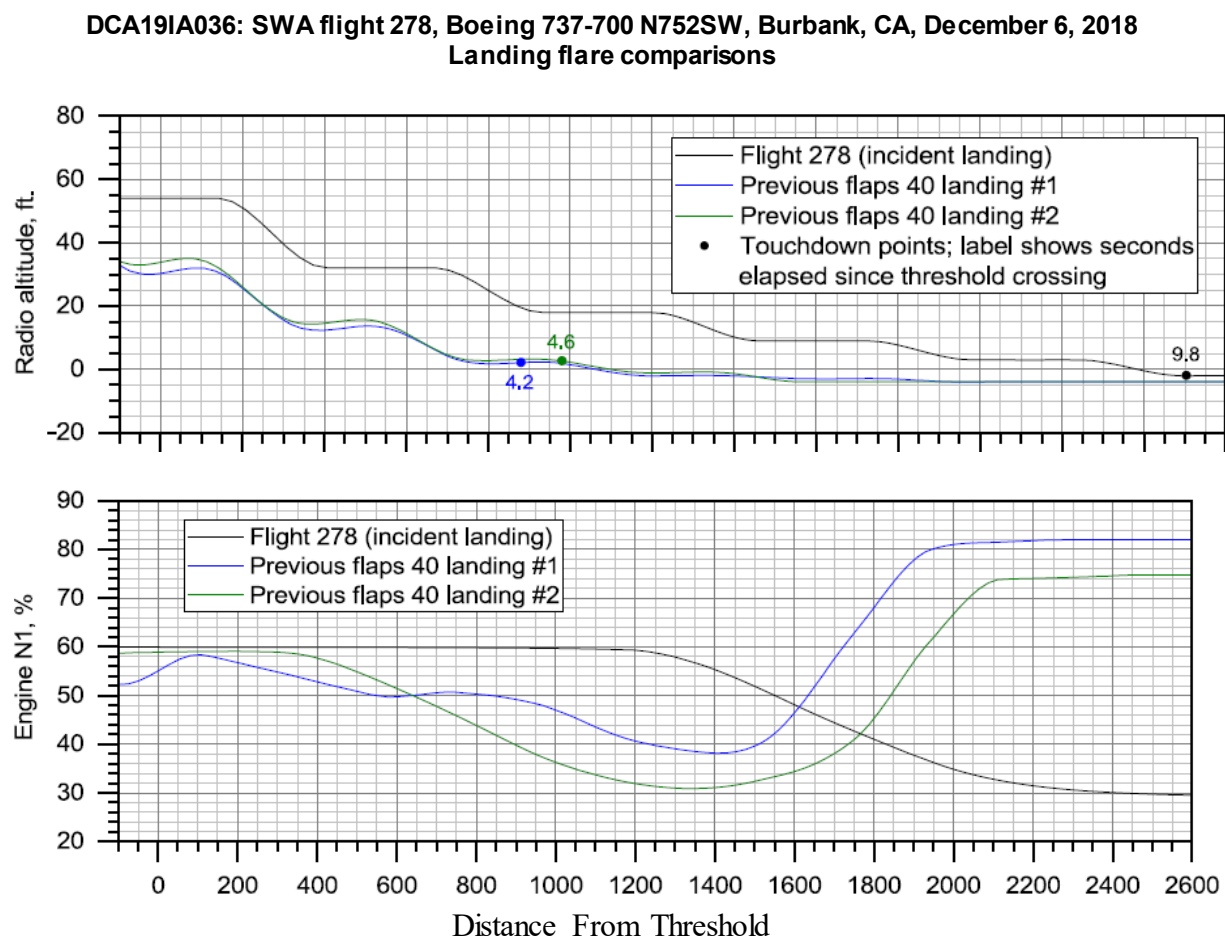
The following two graphs are taken from the Performance Study Figure 19 (page 93). To simplify our point, we have reduced the four graphs to two for ease of comparison of “Radio Altimeter,” “N1” and “Distance From Threshold.”

In its analysis of N1 reduction, the Study does not account for the fact that there is no flight deck instrument that alerts the pilots to the distance traveled beyond the threshold, exact threshold crossing height, or time since threshold passage. Pilots do not fly the aircraft based on those parameters; they fly the aircraft based on the parameters they have access to – height above ground, indicated airspeed, sink rate, and thrust. Power is reduced in the flare based on these parameters, not distance or time in seconds from the threshold. A closer review of Figure 19 shows that all crews reduced power at approximately 20 feet. It was the excessive tailwind, unknown/unreported to the crew that caused the late touchdown, not pilot technique or airmanship.

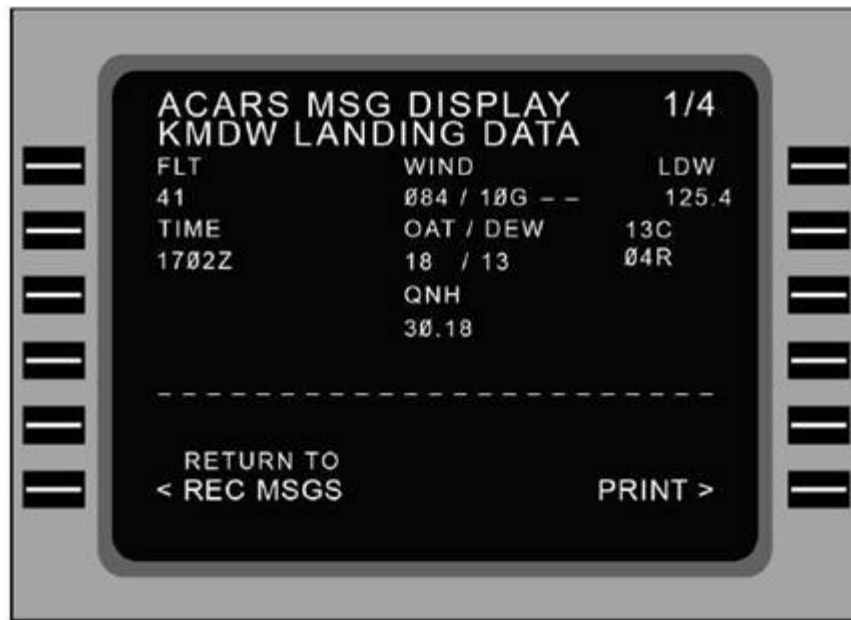
This aircraft also did not have an ACARS printer, although some SWA aircraft are equipped with printers. As can be seen in the figure below, the ACARS installed on the aircraft have a prompt at 6R to print the information on the screen but there is no printer installed on most aircraft.

PWB System Landing Data page 1. Source: SWA

An ACARS printer can also reduce workload, as the crew does not have to copy down the information for later review. A printed weather report also reduces the possibility for errors in transcription.

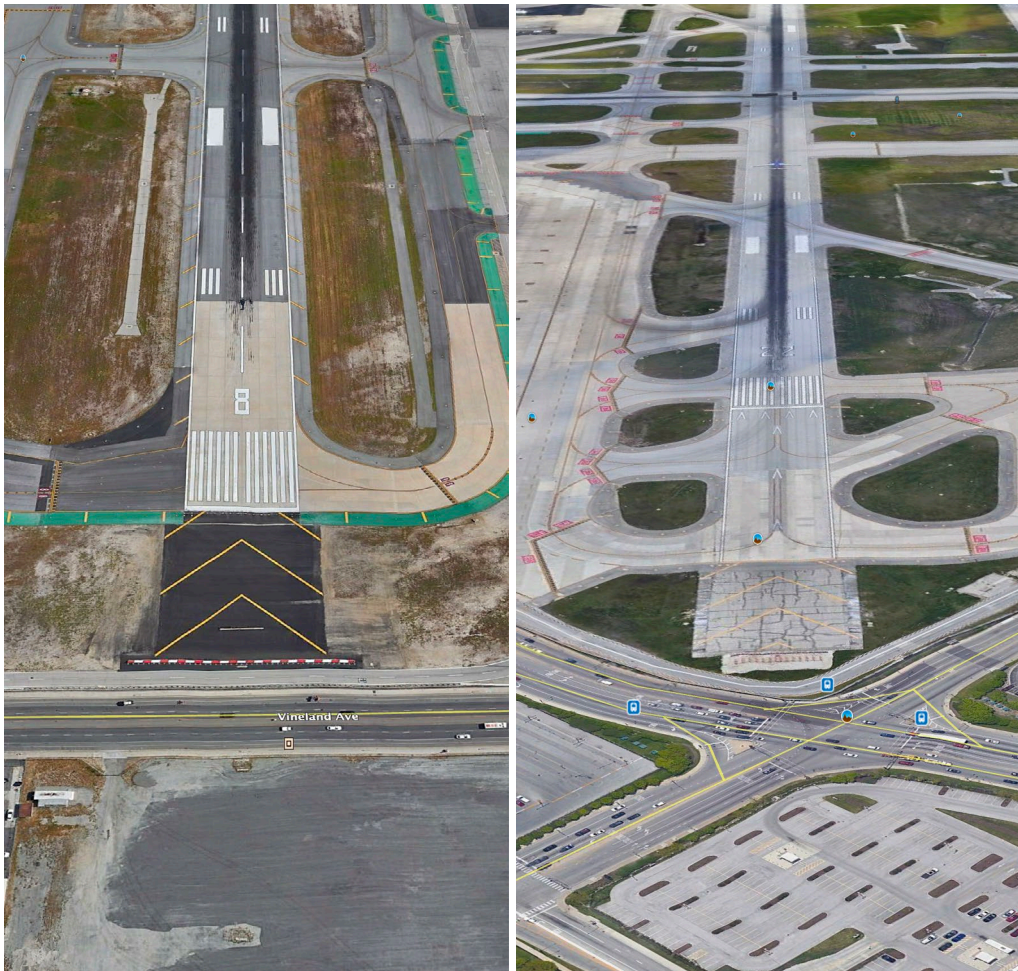
### **KBUR Runway 08**

The combination of two different runway materials, literally black and white, so close the threshold of Runway 08 could be mistaken by pilots for a displaced threshold, especially in conditions of reduced visibility and high ground speeds. These factors, in combination with the higher than normal TCHs of the ILS and the VGSI at BUR and distinctly different from the similar runway at MDW, deserve more study to determine if they contribute to the tendency to land long at BUR.
