**NATIONAL TRANSPORTATION SAFETY BOARD**  
Vehicle Recorder Division

## **Sound Spectrum Study**

**Group Chairman's Factual Report**  
**By Sean Payne**

Location: Baytown, Texas  
Date: February 23, 2019  
Aircraft: Boeing 767-375BCF, Registration N1217A  
Operator: Atlas Air Cargo, Flight 3591  
NTSB Number: DCA19MA086

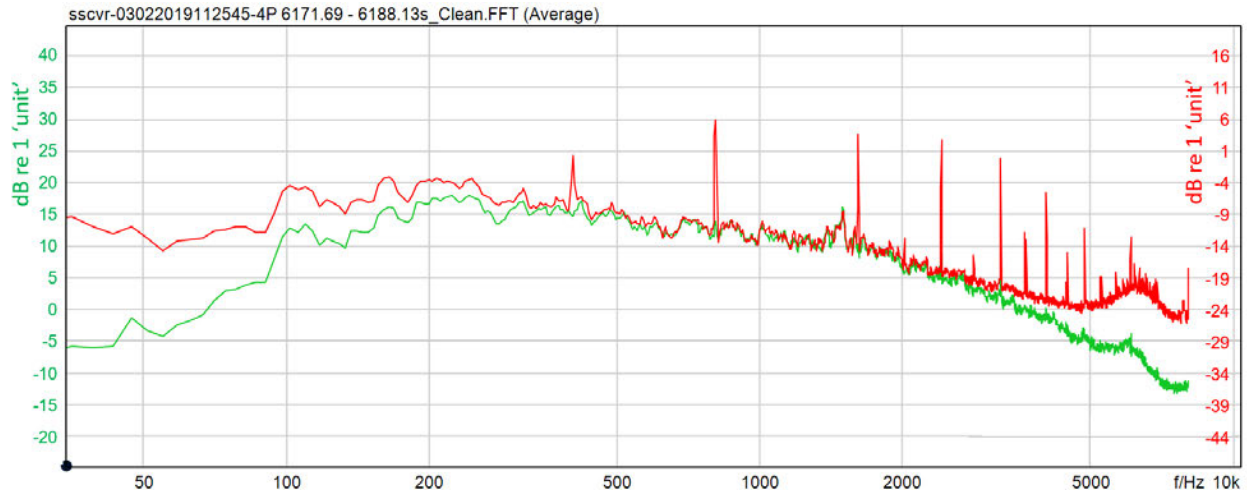
**Figure 2. A FFT of 17 seconds prior to the audio level change (Channel 1 in green) and a FFT of 17 seconds post the audio level change (Channel 2 in red). The curves were plotted together to show that the background level is the same within the range of 500 Hz to 2000 Hz. However, there is a 24 dB shift between the curves. The red curve shows noise floor influence below 500 Hz and above 2000 Hz.**

In figure 2, channel 2 is shown (red) as having frequency values at 400 Hz, 800 Hz, 1600 Hz and repeating at higher frequency levels. Channel 1 (green) shows a “cleaner” signal with limited frequency values than those observed in channel 2.

Additionally, a root mean square (RMS) value was measured for a time interval 10 seconds before and a time interval 10 seconds after the signal change. The RMS value was 22.2 dB higher prior to the signal change than the RMS measured after the signal change.

As a result of this change in decibel level, dynamic range is lost, resulting in the loss of some audio data.
