Subject: Boeing Submission for Atlas Air 767-300BCF N1217A Accident near  
Houston, Texas, 23 Feb 2019

**Atlas Air 767-300BCF N1217A  
Flight 3591 Accident  
Trinity Bay, TX  
23 February 2019**

**The Boeing Company  
07 February 2020**

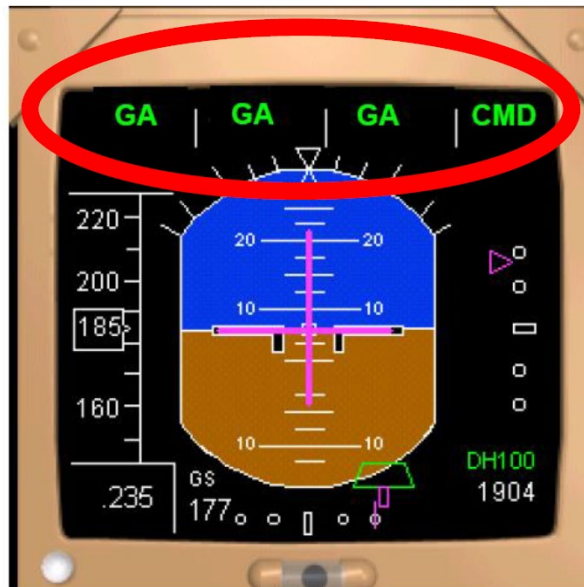
mode. The airplane began to climb at this time. About 6 seconds after the commanded increase in thrust the speedbrakes were manually retracted and the engines reached the commanded go around thrust. About 3 seconds later, the control column was deflected forward for 10 seconds in opposition to the autopilot commands resulting in annunciation of the AUTOPILOT Caution EICAS message (aural beeper, autopilot light, master caution light, and message on EICAS status display). This is expected when a single channel autopilot is overridden by motion of the control column. The CA continued normal ATC communications at this time and there was no discussion regarding a command or callout for go around, AFDS mode annunciation change, stowing of speedbrakes, or acknowledgment of the AUTOPILOT Caution noted on the CVR recording.

Figure 1 – Go Around AFDS mode annunciations on the EADI FMA<sup>14</sup>
