**PARTY SUBMISSION OF  
THE INTERNATIONAL BROTHERHOOD OF TEAMSTERS LOCAL 2750  
TO THE NATIONAL TRANSPORTATION SAFETY BOARD**

**ATLAS AIR FLIGHT 3591**

Trinity Bay  
Anahuac, TX, USA  
23 February 2019

**NTSB DCA19MA086**

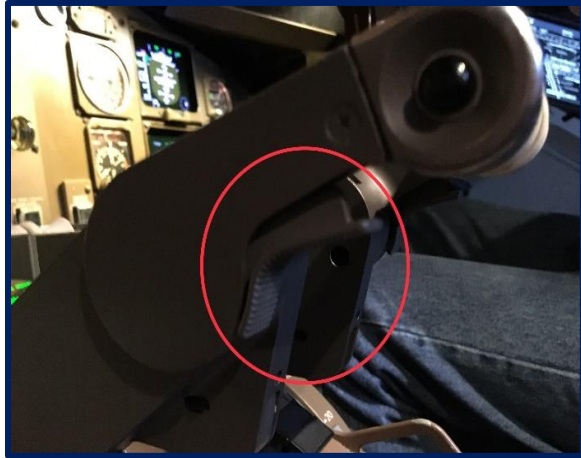
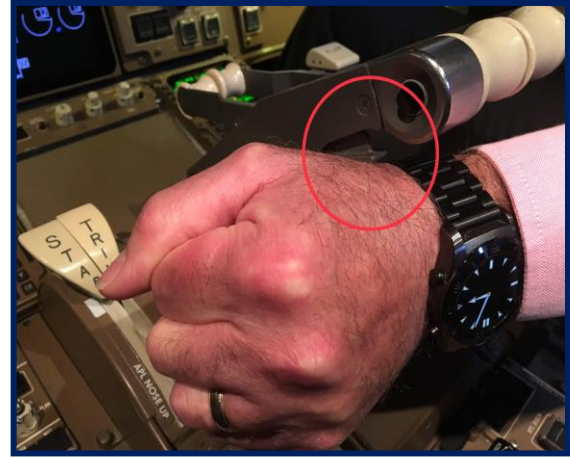
Figure 7 B767-300 Go Around Switches side view.

The B767-400ER TO/GA switches are better “masked” than the B767-300 accident aircraft as shown in Figures 8 above and 9 below. The -300 switches actuate in an upward direction whereas the -400 aft switches actuate forward. The switch action on the -400 design would inherently be less prone to inadvertent activation.

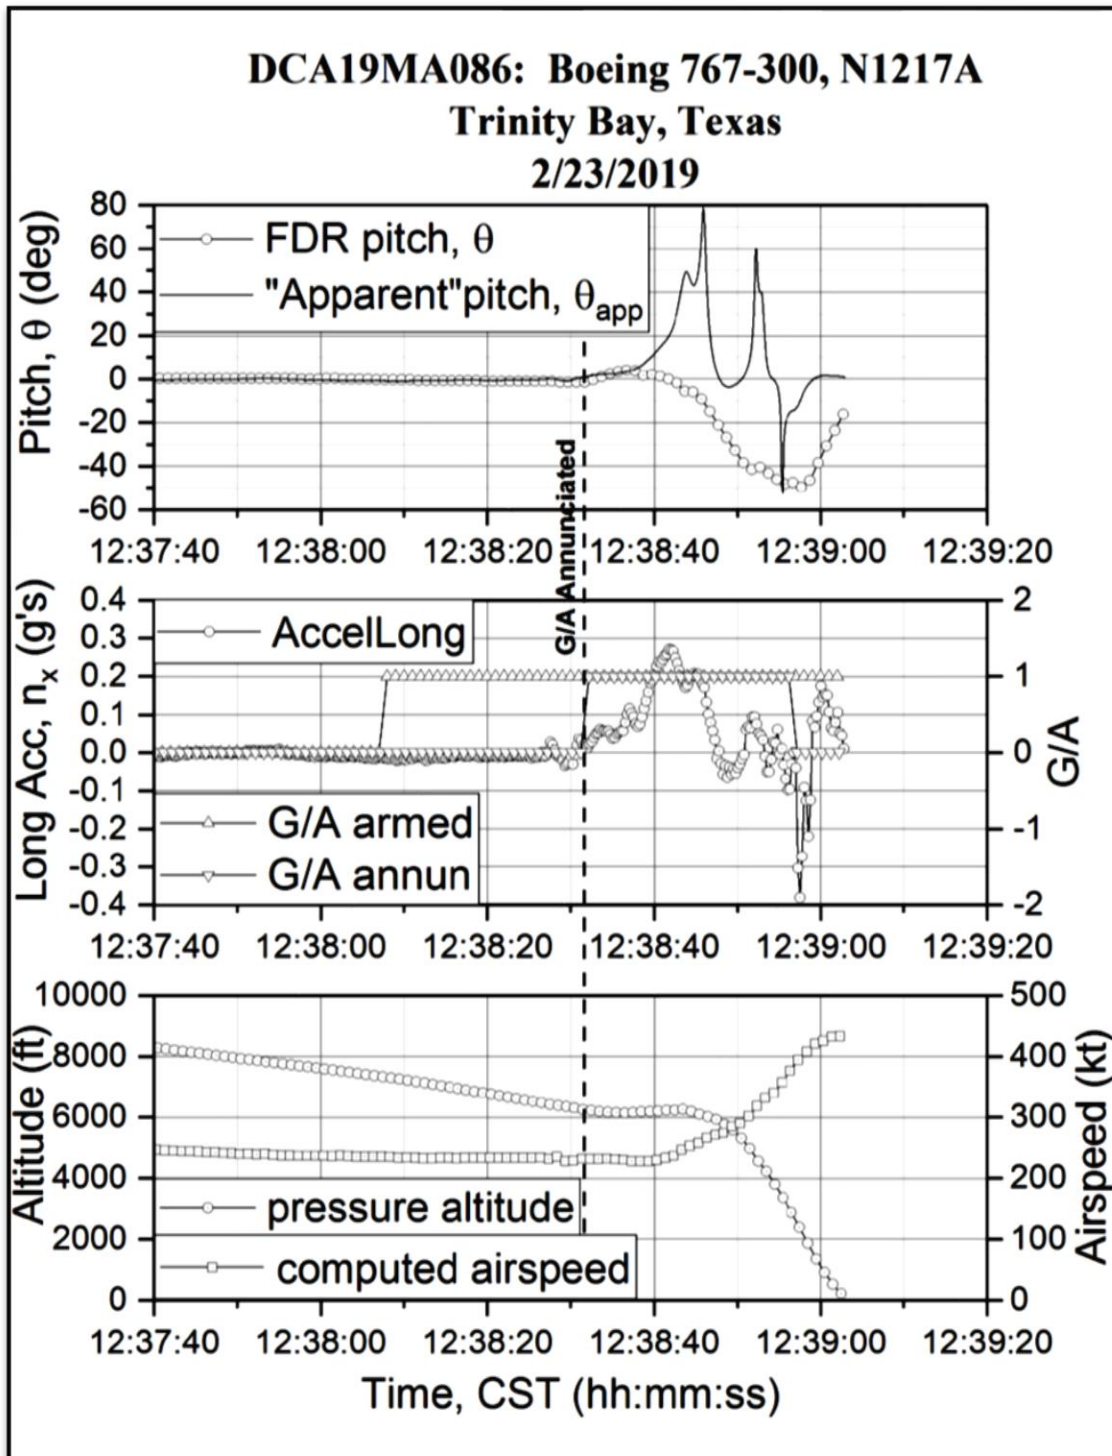
Figure 10

The longitudinal acceleration was caused by the application of full thrust and was calculated to produce up to a perceived +80 degree pitch up. This perceived pitch up caused by the longitudinal acceleration should have been countered by use of the flight instruments. However, as discussed previously, it appears the First Officer may have also been experiencing cognitive lockup and was unable to process the information displayed by the aircraft instruments. A less than 1 g flight regime has been found to be disorienting to pilots, and the issue of negative g disorientation has been cited in cases such as the recent crash of a USAF F15 from Kadena Air Force Base.<sup>74</sup>

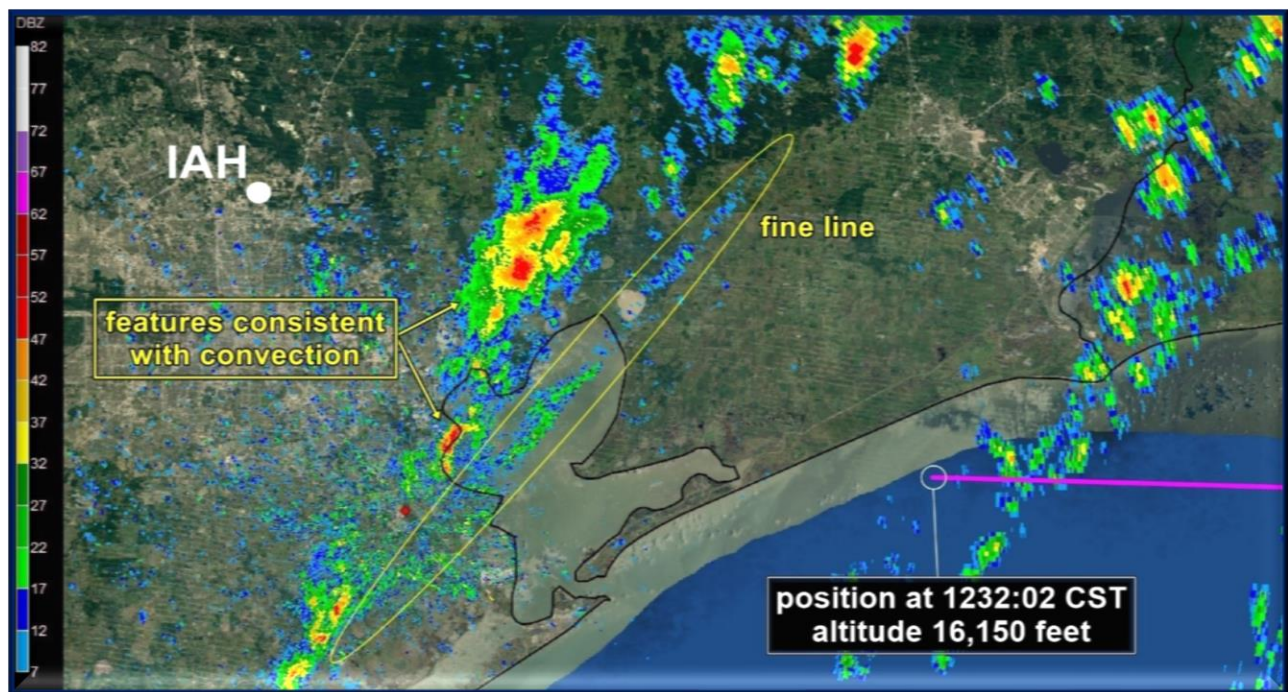
Figure 11 NEXRAD Radar Depiction from NTSB Meteorology Factual Report

The image in Figure 11 shows the areas of convection and the initial approach path of the aircraft as it arrived from Miami. The “Fine Line” is in front of the line of convection and indicates an outflow boundary of cold air pushing out in front of the convective weather. The Fine Line is small birds and bugs that are being lifted and pushed out by the gust front that the radar detects

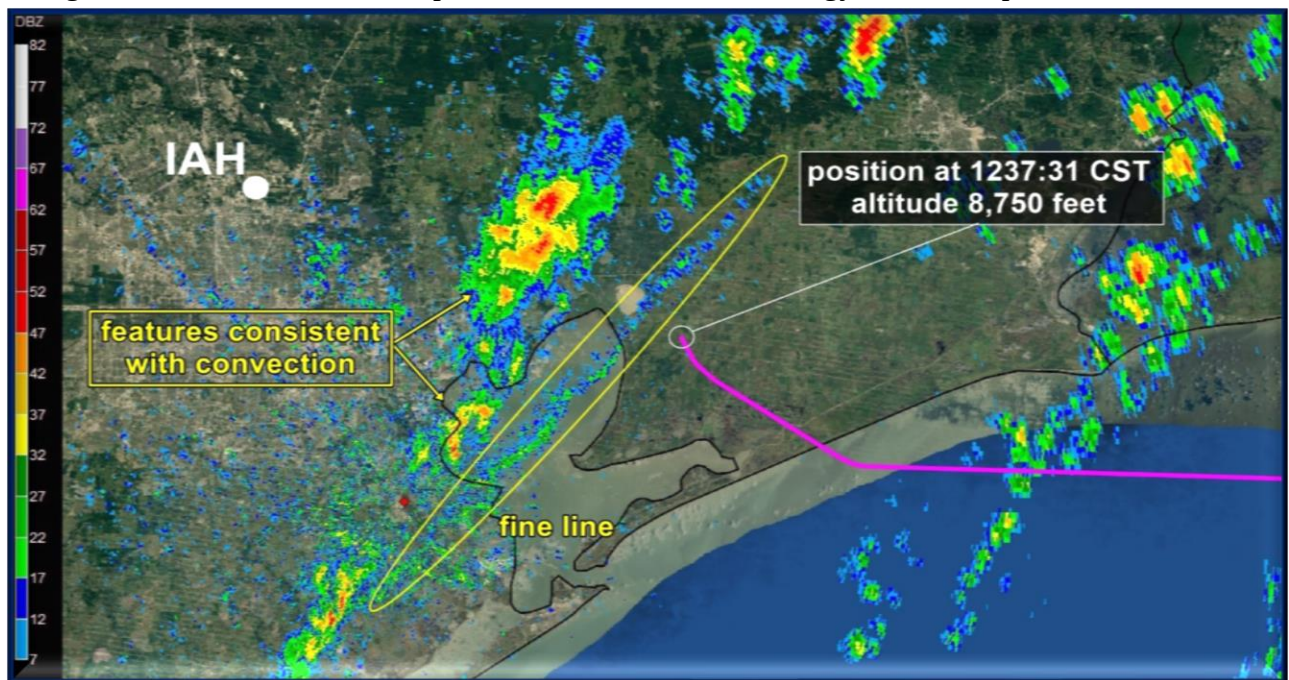
Figure 12 Depiction of NEXRAD with flight track in vicinity of crash site from Meteorology Factual Report.

Houston Approach vectored the aircraft on a 270 degree heading to fly between the two areas of weather depicted in Figure 12. The gap appears to be large enough to allow the aircraft to pass through, and other traffic departing KIAH eastbound flew through this same gap. Statements and FDR data collected from other aircraft do not indicate that weather hazards would have been a significant factor for Giant 3591.
