We have received an updated damage assessment from our engineering services group regarding the 757 Tail Strike on 21 March 2020 in LAS.

Brent Curlee |Sr. Air Safety Investigator | American Airlines, Inc.

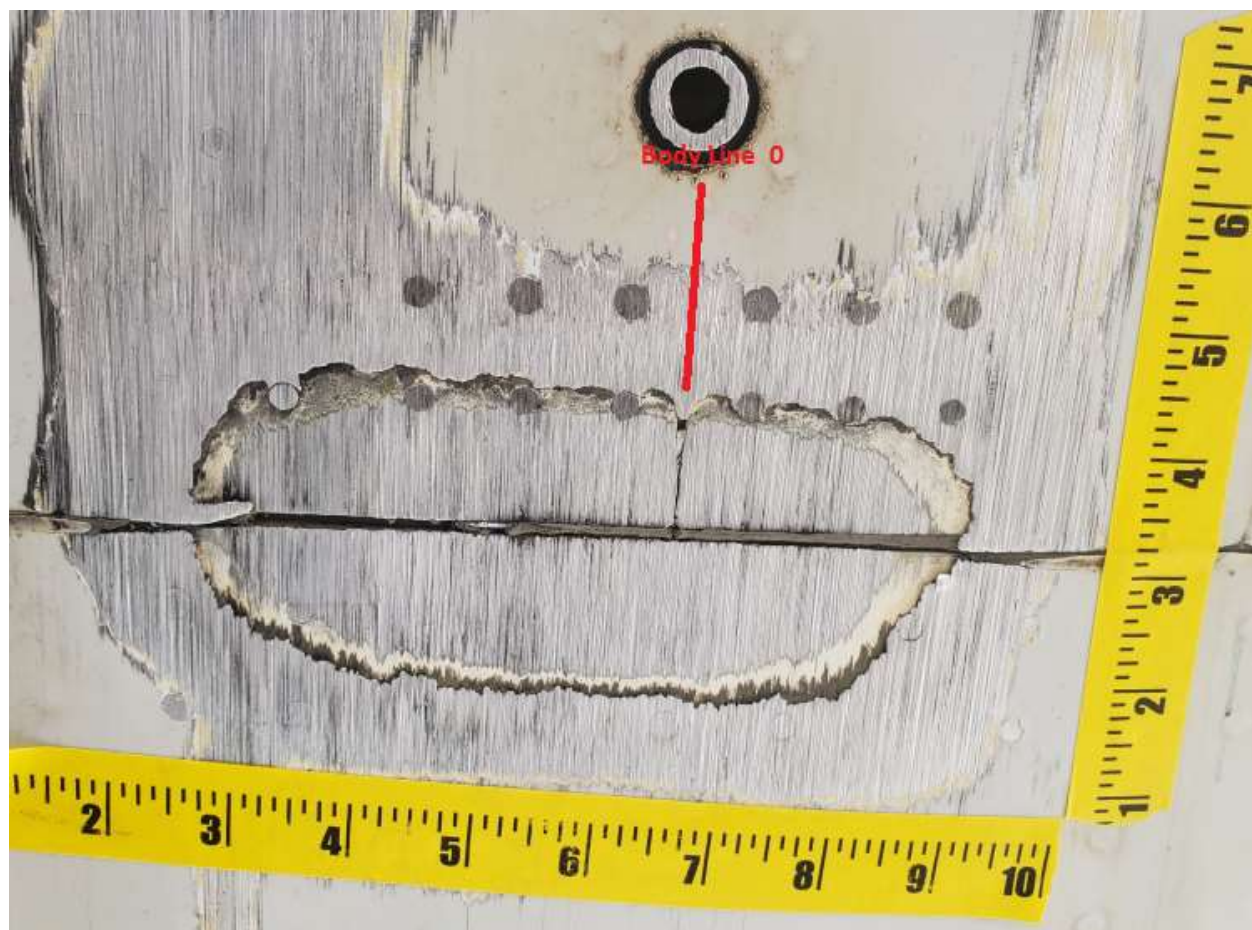
- What was initially identified as a 'crack' by several engineering technicians was determined to be a butt joint where the L/H lower brake ring and the R/H lower break ring meet at the bottom of the fuselage

- The butt joint was exposed due to that specific area of the fuselage having slightly more material ground off during the tail strike (see Images 1 & 2)

- Normally, the butt line where the brake rings meet would look much cleaner, however, damage from the tail strike ground off some material, making it easy to mistake as a crack

- If you look at the very forward edge where the red mark is (see Image 1) you can see it's a perfect gap which is what the full length of the break ring butt line usually looks like

- The brake ring thickness starts at 0.170 and tapers to 0.100, and our engineering services group agreed that based off the amount of material that was ground off, the pressure bulkhead was not damaged

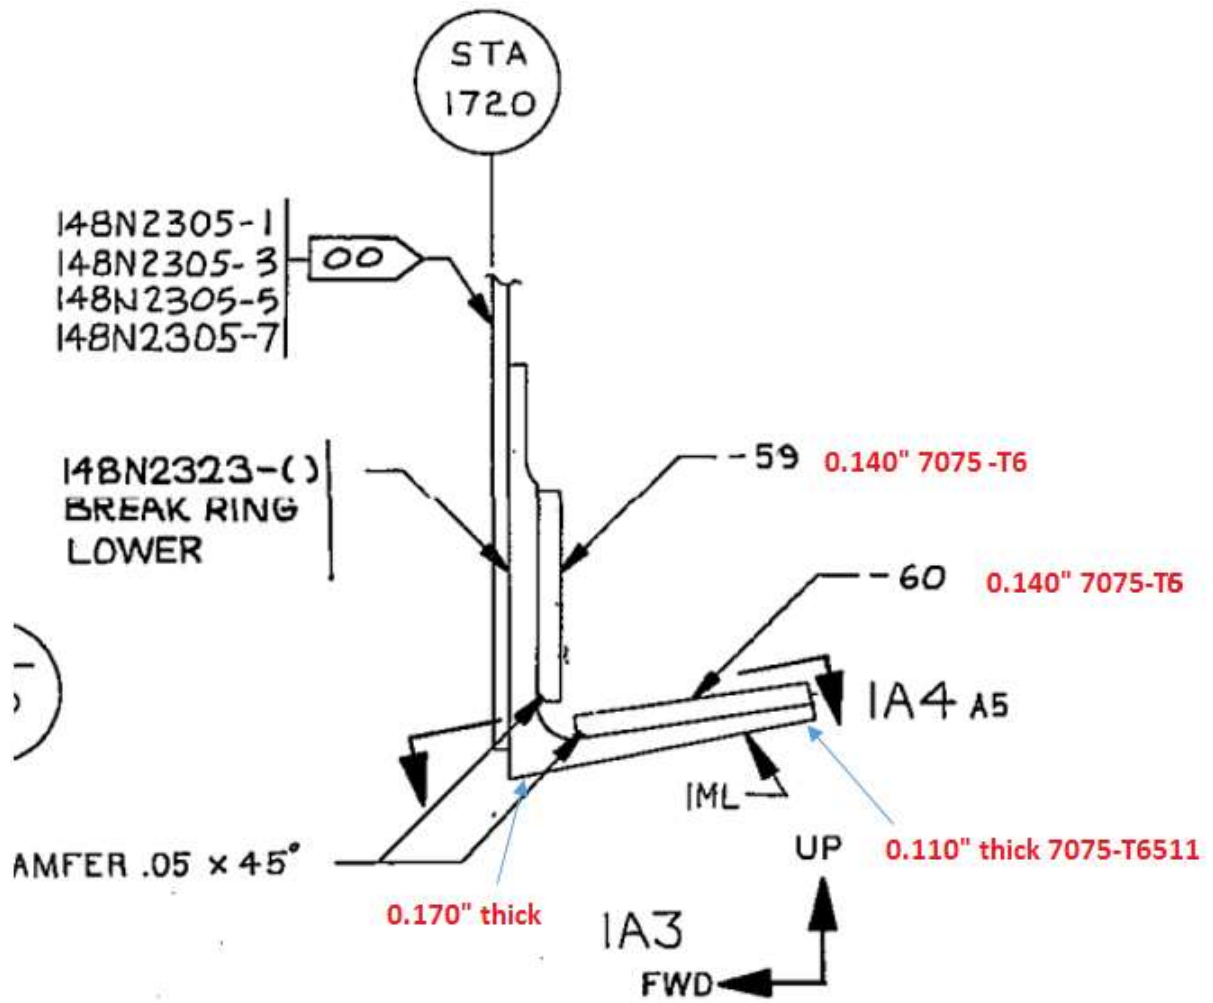
Based on this information, **the pressure bulkhead was intact and not compromised as a result of the tail strike**. I've also attached two engineering diagrams (see Diagram 1 & Diagram 2) that illustrate the area damaged in more detail. This revised damage assessment was just provided to us today, I apologize for the lateness in delivering this information. Please do not hesitate to call or email if you have any questions.
