**NATIONAL TRANSPORTATION SAFETY BOARD  
Office of Aviation Safety  
Washington, D.C.**

**SYSTEMS SPECIALIST REPORT – DAMAGED WIRES EXAMINATION**

DCA20IA014

| Aircraft: | Embraer ERJ 170-200LR, N117HQ |

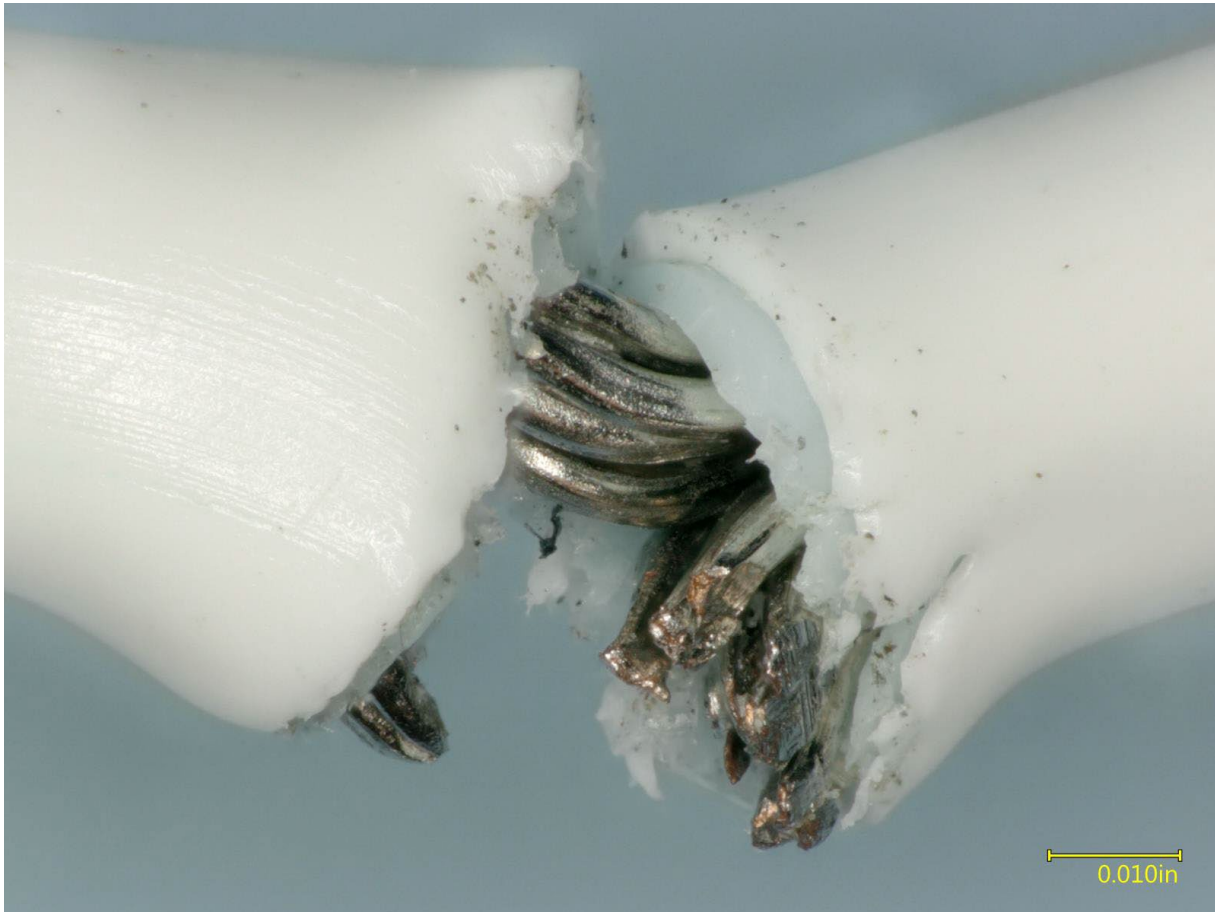
### **B.1 W251-00013-24 (Captain Quick Disconnect Switch)**

Wire W251-00013-24 (Captain Quick Disconnect Switch) – Damage was located approximately 6 <sup>3</sup>/<sub>4</sub> inch from the base of the gold-colored connector pin. The insulation was broken 360 degrees around the wire. Several wire strands were broken. Mechanical scraping damage was observed on some of the wires. Continuity using a Fluke multimeter was observed from the damaged area to the gold-colored wire connector pin. No definitive signs of arcing were observed. (See Figure 1).

Figure 1: Damage to Wire W251-00013-24 (150x magnification)

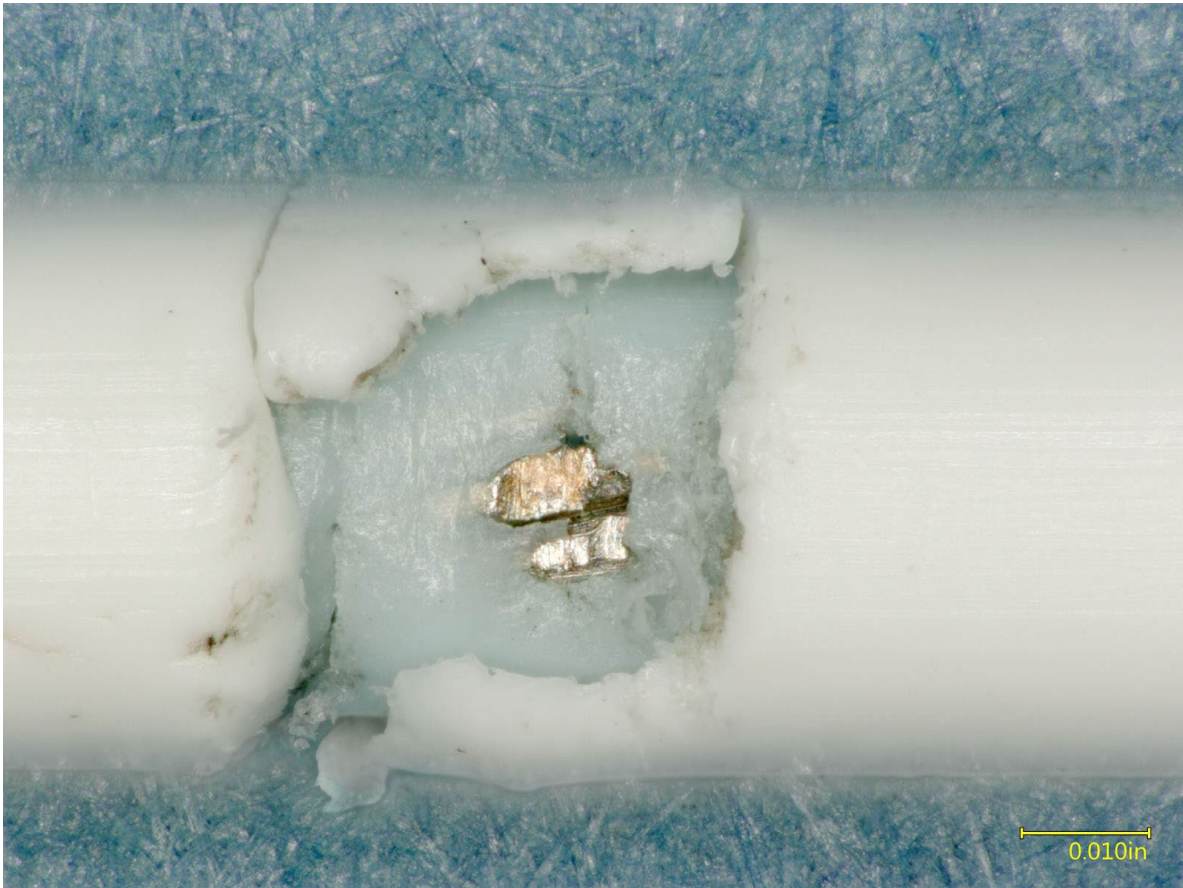
## **B.2 W251-00060-22 (Captain Nose Up Trim A)**

Wire W251-00060-22 (Captain Nose Up Trim A) – Damage was located approximately 5  $\frac{3}{4}$  inch from the base of the gold-colored connector pin. The insulation was chaffed and broken exposing the conducting wire. Mechanical scraping damage was observed on the exposed wire. Continuity using a Fluke multimeter was observed from the damaged area to the gold-colored wire connector pin. No definitive signs of arching were observed. (See Figure 2).

Figure 2: Damage to Wire W251-00060-22 (150x magnification)

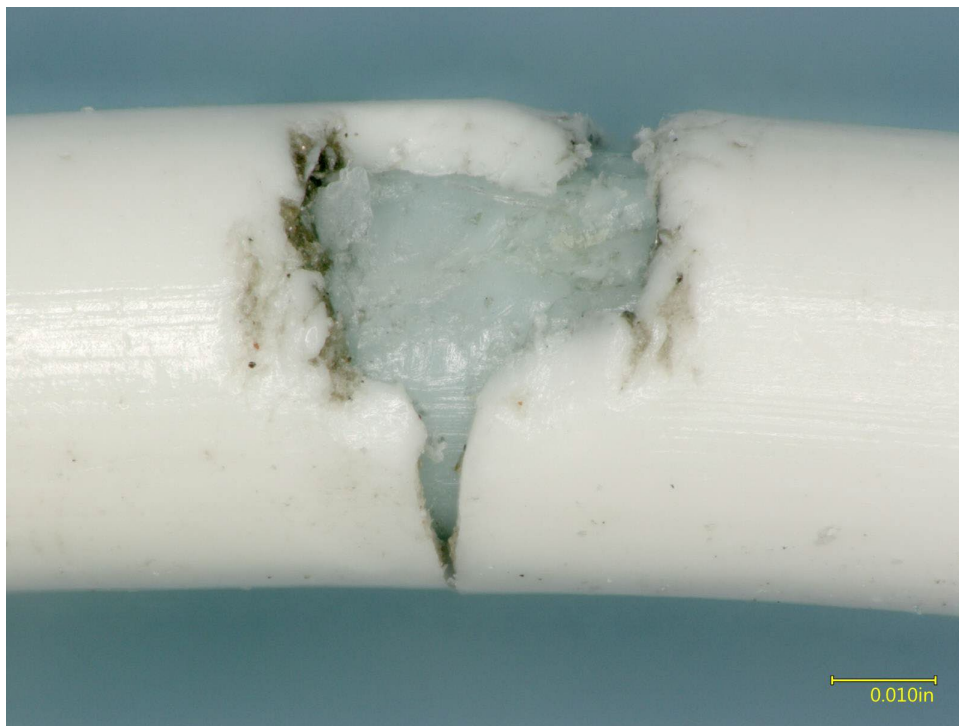
### **B.3 Wire W251-00059-22 (Captain Nose Up Trim B)**

Wire W251-00059-22 (Captain Nose Up Trim B) – Damage was located approximately 5  $\frac{3}{4}$  inch from the base of the gold-colored connector pin. The outer layer of insulation was chaffed and broken. Mechanical scraping damage was observed on the insulation. Continuity from the damaged section of wire insulation to the gold-colored wire connector pin was first observed by connecting a small cotton swab soaked with soapy water to the multimeter lead, and then pressing the swab against the damaged area. Following this test, continuity was then checked by using the standard multimeter probe pressed against the damaged insulation, and continuity was not observed in this case. Finally, a small piece of cut safety wire was attached to the multimeter lead and lightly pressed against the damaged insulation, and continuity was again observed. No definitive signs of arching were observed. (See Figure 3).

Figure 3: Damage to Wire W251-00059-22 (150x magnification)
