**NATIONAL TRANSPORTATION SAFETY BOARD**

**SYSTEMS GROUP CHAIRMAN'S FACTUAL REPORT**

DCA20IA014

| Aircraft: | Embraer ERJ 170-200LR, N117HQ |

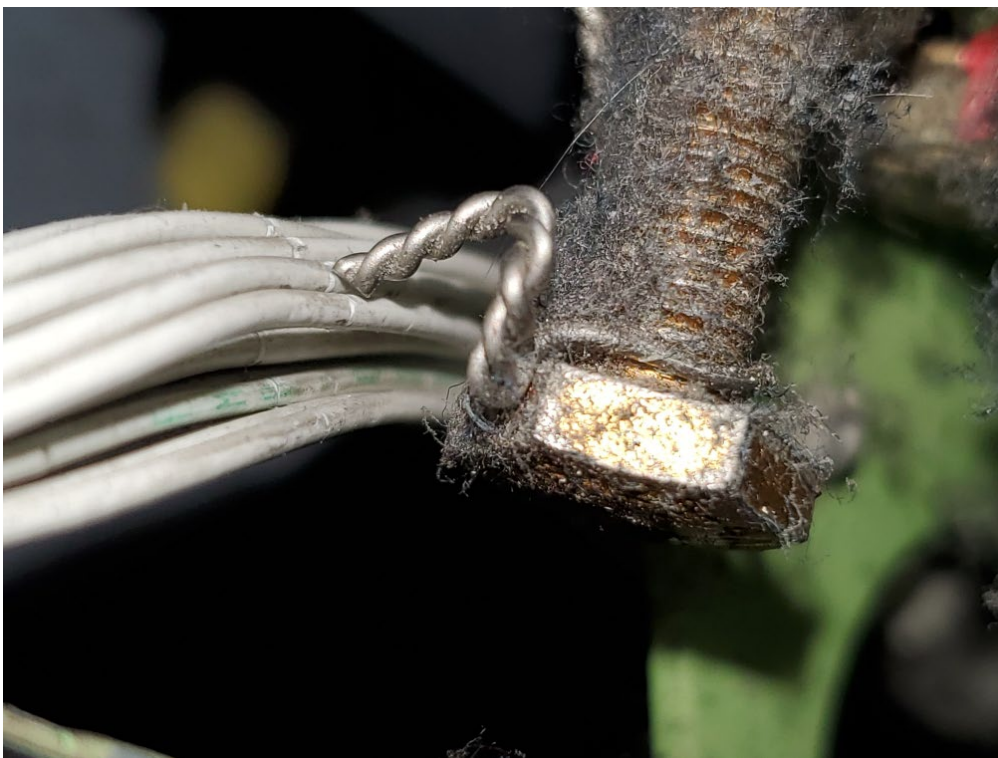
The ferry flight to Indianapolis occurred on 11/9/2021 with no anomalies noted. Once in Indianapolis, the Republic Airways maintenance crew performed wire inspections and identified damaged wiring at the base of the captain's control column. Six wires were identified as chaffed and damaged due to contact with an incorrectly tucked pigtail from the safety wire retaining the captain's control column forward mechanical stop bolt (part number: NAS428H4A12). See Figure 3. Subsequent laboratory testing revealed that the insulation for wires W251-00013-24 (Captain Quick Disconnect Switch), W251-00060-22 (Captain Trim Switch - Nose Up Trim A), and W251-00059-22 (Captain Trim Switch - Nose Up Trim B) were damaged such that continuity to the internal wire strands could be achieved. The Captain Quick Disconnect switch wire insulation was damaged completely around the wire strands and multiple exposed wire

strands were severed. The Captain Trim Switch – Nose Up Trim A wire insulation was chaffed exposing a small section of the conducting wire which showed signs of mechanical scraping. The Captain Trim Switch – Nose Up Trim B wire insulation was chaffed and damaged, but the conducting wire strands were not definitively visible. Continuity to the conducting wire could not be made with the multimeter leads alone; however, continuity was achieved by using both a cotton swab soaked in soapy water placed on the damage area, as well as by using a sample piece of cut safety wire pressed lightly on the damaged area. No definitive signs of arcing were identified on any wire. Wires W251-00061-22 (Captain Trim Switch - Nose Down Trim A), W251-00058-22 (Captain Trim Switch - Nose Down Trim B), and W251-00057-22 (Captain Trim Switch Ground) also demonstrated varying degrees of damage to the insulation; however, the damage was not severe enough to allow for continuity to the internal wire. According to Republic, there were no problems identified with the routing of these damaged wires.

Figure 3: Incorrectly Tucked Safety Wire Contacting Electrical Wires

A test flight was performed on 11/10/2019 after the damaged wires were repaired. The test flight was aborted during climb out due to a perceived trim anomaly by the crew. The aircraft returned to base and further troubleshooting was performed but no additional problems were identified. It was theorized that the perceived trim anomaly that occurred during the test flight was either caused by unintended physical activation, or that it was actually normal behavior of the auto-trim function that is active even when autopilot is not engaged. The HS-ACE was removed and replaced, and then two additional test flights were flown on 11/13/2019 using only the first officer's and backup pitch trim control switches. The captain's pitch trim control switch was then replaced, followed by a third test flight on 11/14/2019 in which the replaced captain's pitch trim control switch was operated. There were no anomalies identified in the final three test flights. Embraer specialists arrived on 11/13/2019, after the captain's pitch trim control switch had

The task did not call out AMM Task 20-10-02-910-801-A “Typical Safetying Methods - Maintenance Practices”. This task states that a typical safetying method when using safety wire is to “Bend the wire end to the part to prevent injury to the hands and not to permit the wire to catch on moving parts.” Although this bending technique is common practice, Embraer added this reference to Task 27-31-01-820-801-A in October of 2020 for additional emphasis regarding this maintenance action.<sup>3</sup>

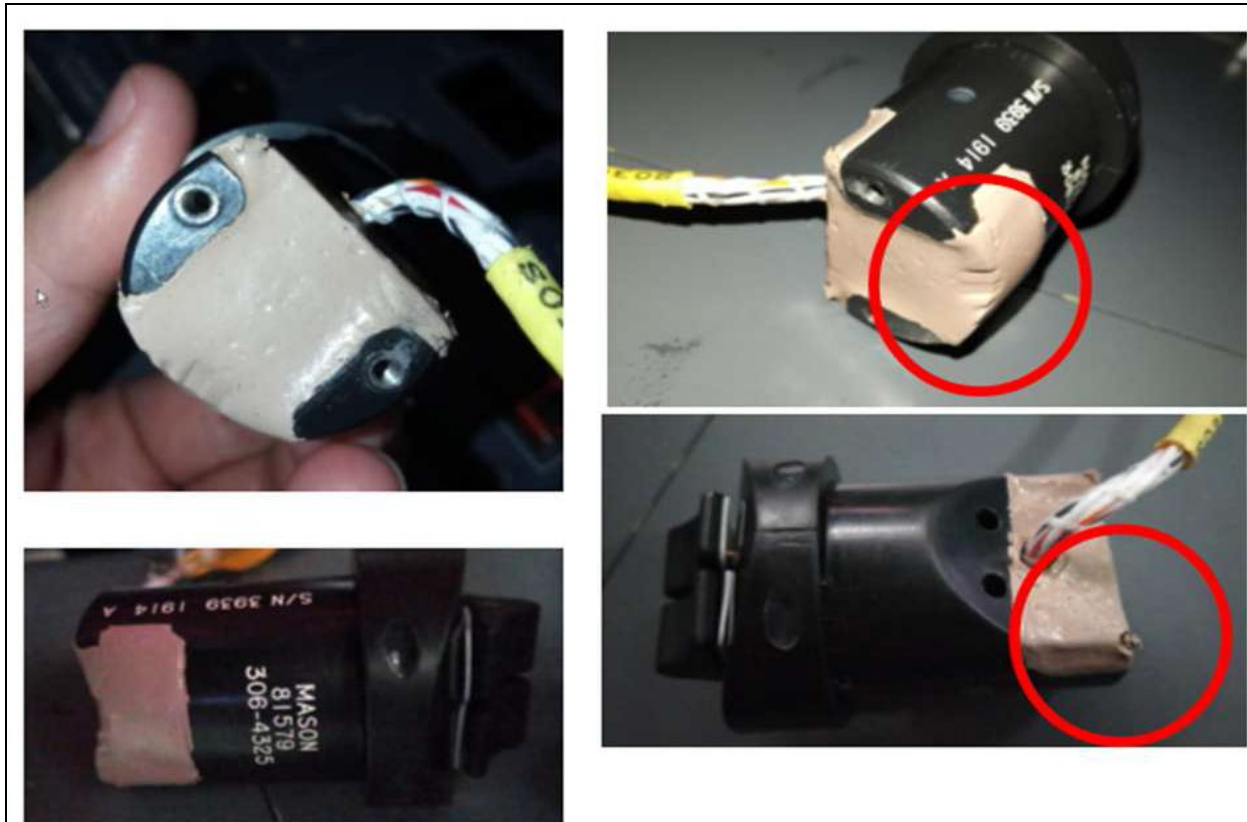
already been replaced. Embraer inspection of the removed pitch trim control switch on 11/14/2019 revealed an imprint mark in the silicone area on the back of the switch (see Figure 4). According to Embraer, this mark is caused by contact against a spring and is consistent with the switch being installed inverted at some point in time. Embraer released Service Bulletin 170-27-0051, with an original release date of February 27, 2015, to alert the fleet of the possibility that the switch could be installed inverted and to recommend the installation of a support in the control yoke to prevent future incorrect installation of the pitch trim control switch. The compliance time of the bulletin was 7,500 hours or 36 months, whichever occurred first. SB 170-27-0051 had not been incorporated on the incident airplane at the time of the event.

Figure 4: Imprint on Back of Captain's Pitch Trim Control Switch
