# NATIONAL TRANSPORTATION SAFETY BOARD

## MATERIALS LABORATORY ADDENDUM REPORT

Report No. 20-014B

Place : Denver, Colorado  
Date : December 22, 2019  
Vehicle : Boeing 737-800, N87513  
NTSB No. : DCA20LA047  
Investigator : Dan Bower, AS-10

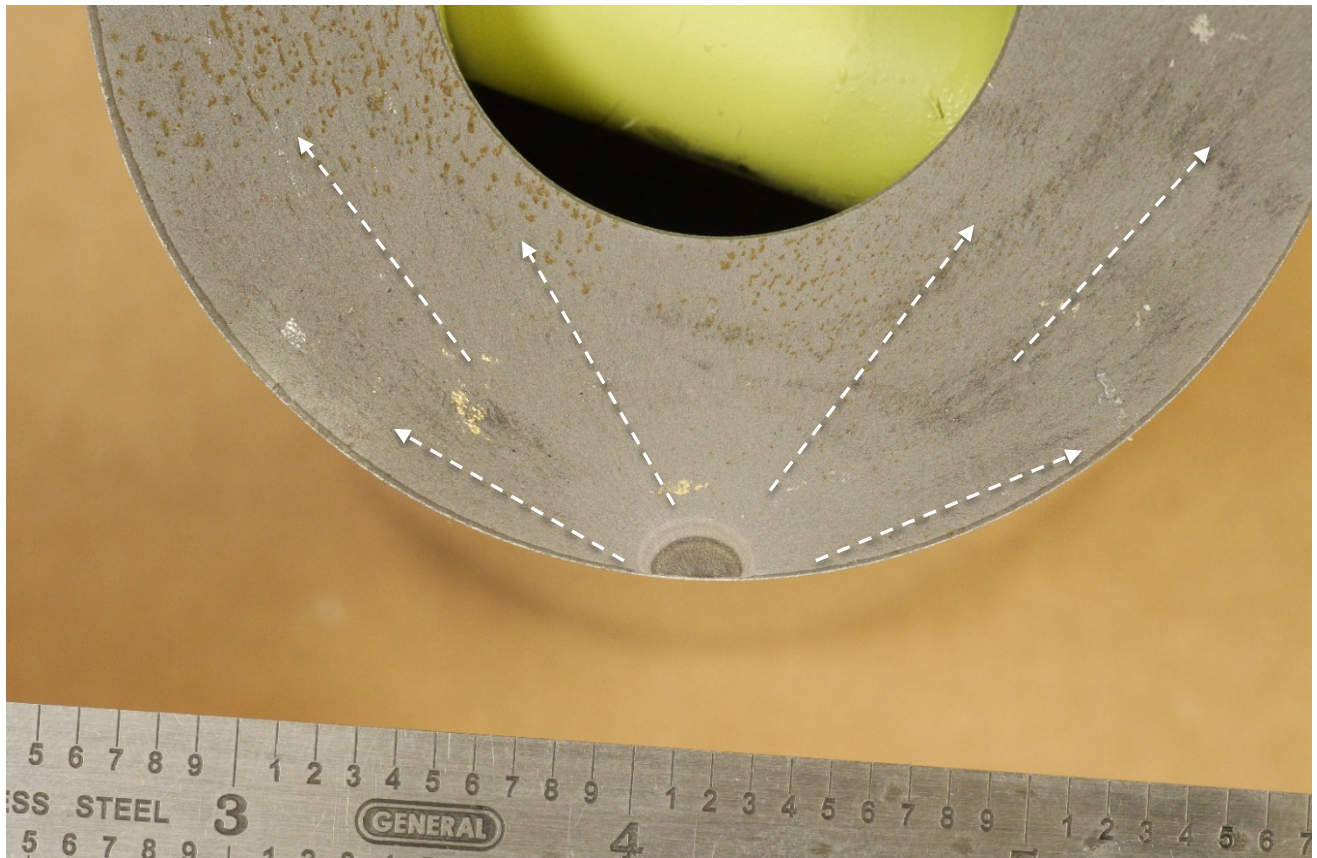
On December 22, 2019, a Boeing 737-800 collapsed during a landing in Denver, CO. After examination, the left main landing gear assembly was found to have failed, and the left hand main landing gear aft trunnion pin was found fractured. The trunnion pin, P/N 161A1192-13 and S/N 65780-0066, exhibited a small thumbnail crack at the approximately 12 o'clock position (see Figure 1).

Figure 1 – Fracture surface of the forward pin fracture surface, showing a thumbnail crack at the 12 o'clock position. White dashed arrows denote the fracture direction from the thumbnail.

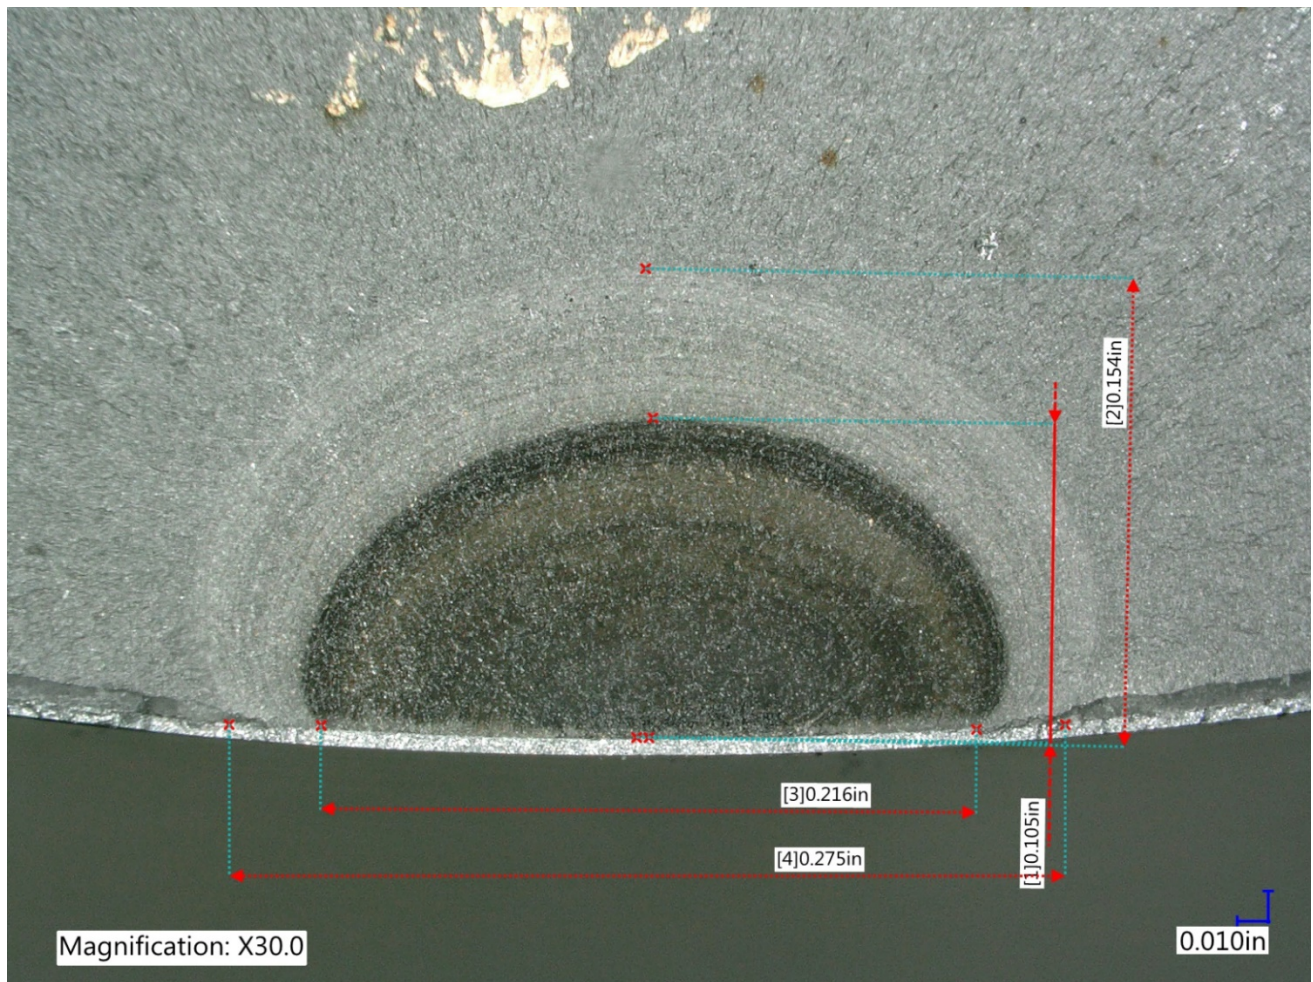
The thumbnail crack exhibited distinct regions, which were measured as annotated in Figure 2. As detailed in the Materials Laboratory Factual Report (20-014), the thumbnail crack mostly exhibited striations, consistent with fatigue crack propagation. This fatigue cracking occurred prior to the accident, and its total depth was 0.154 inch (3.91 mm). The initial 0.0164 inch (415  $\mu\text{m}$ ) portion of the crack consisted of the outer 0.006 inch (152  $\mu\text{m}$ ) chromium electroplated layer and an internal region of intergranular fracture. The 0.105 inch (2.67 mm) portion of the crack exhibited fatigue striations, but exhibited a darker color visually. The remainder of crack exhibited fatigue striations (with isolated overstress bands typified by dimpled rupture) but was not discolored.

Figure 2 – Microscopic view of the thumbnail crack in Figure 1, annotated to show various dimensions.

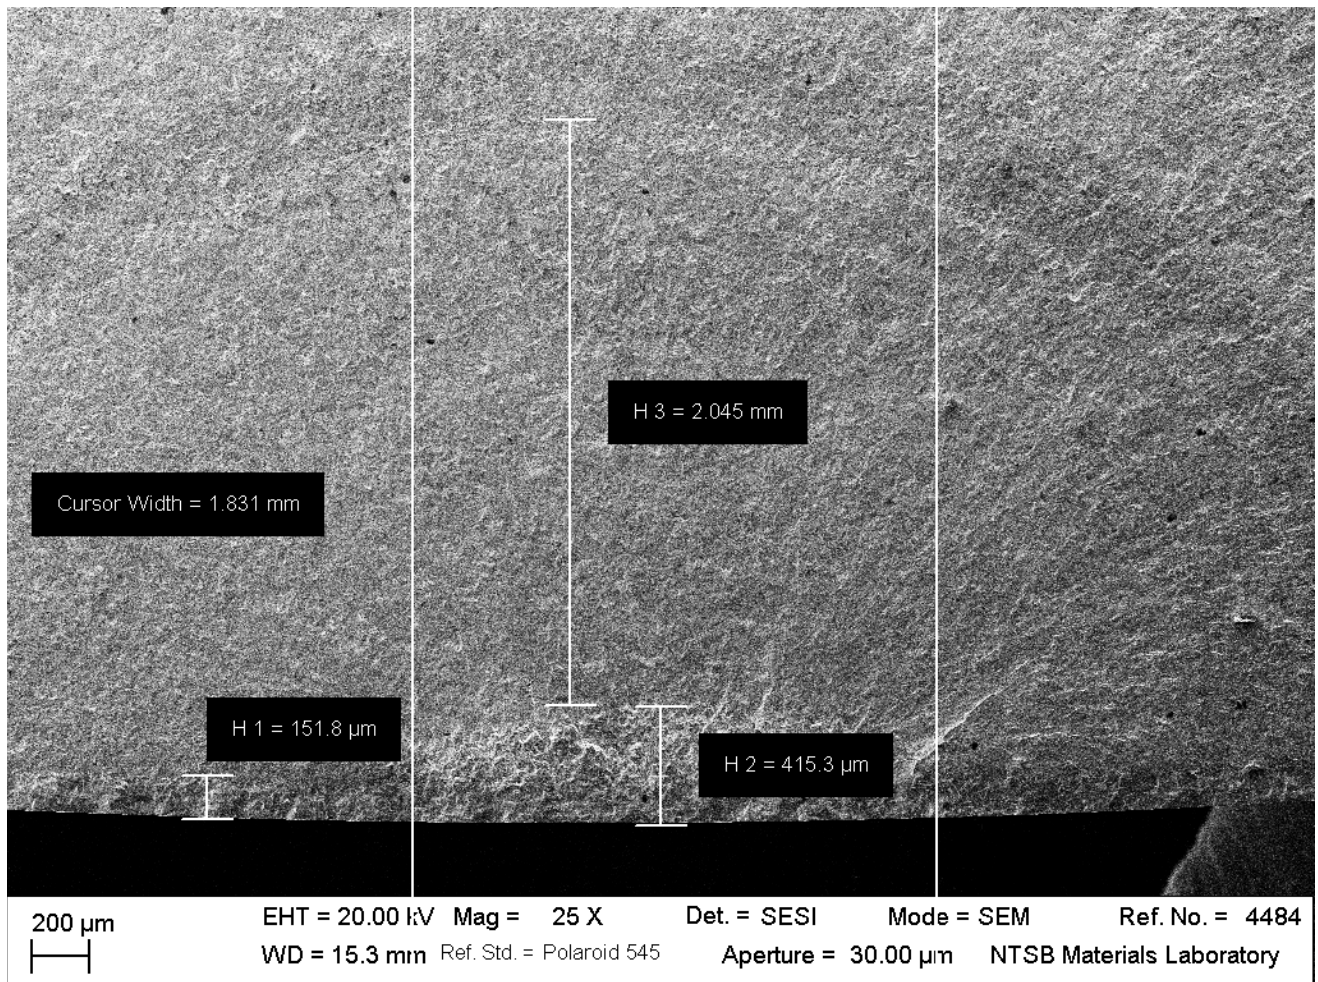
Figure 3 – Secondary electron (SE) micrograph of the overall view of the thumbnail crack, annotated to show various measurements.

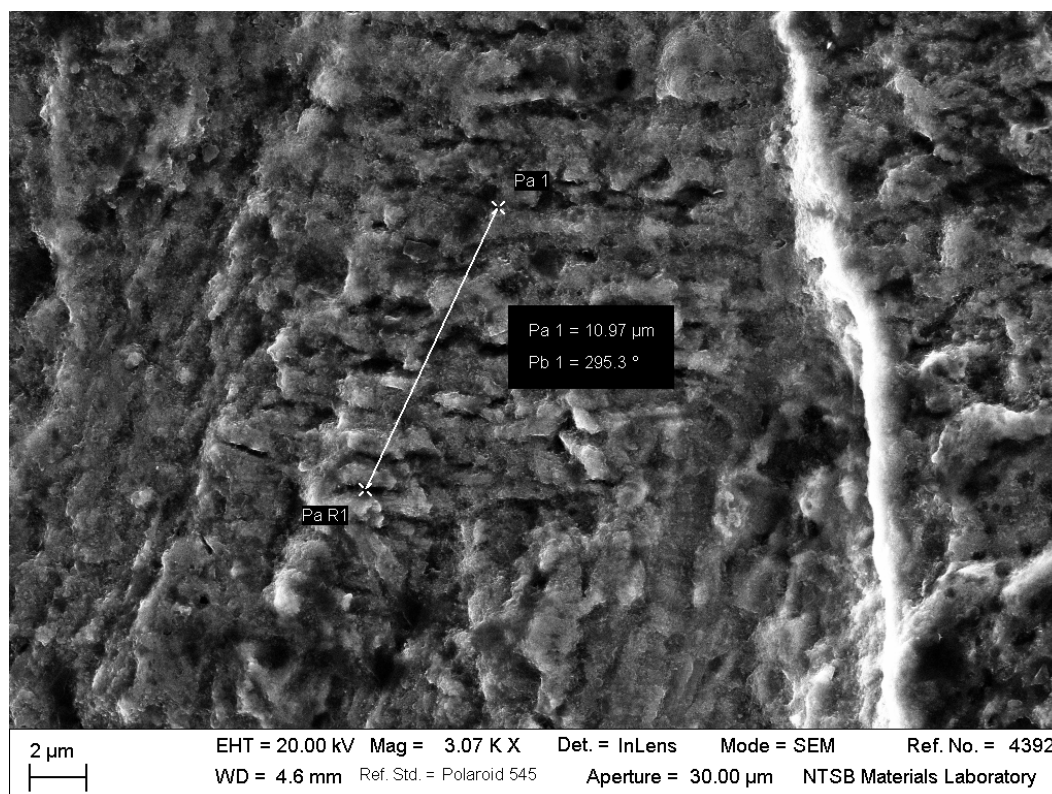
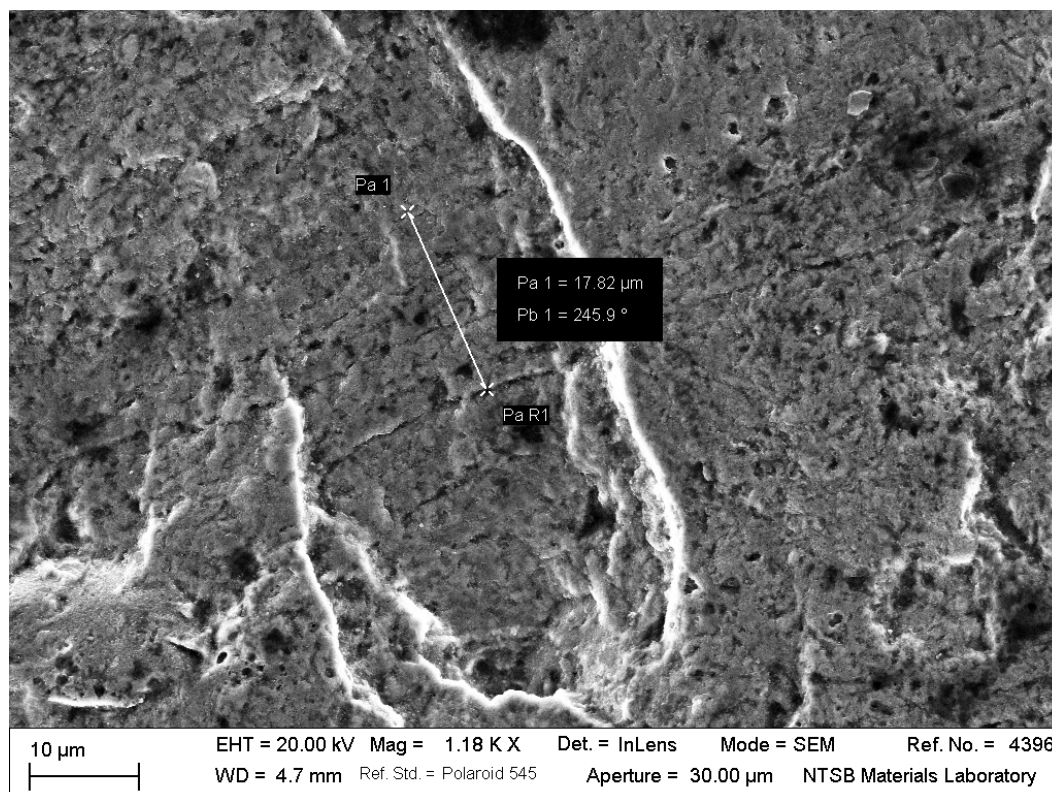
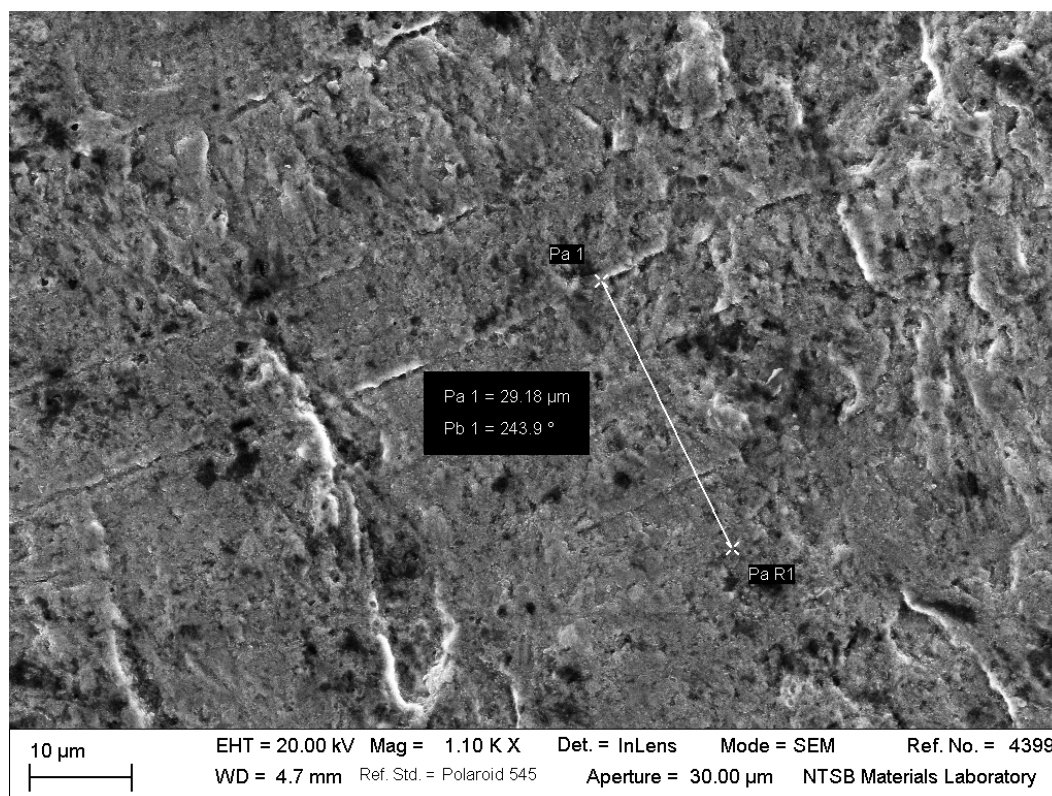
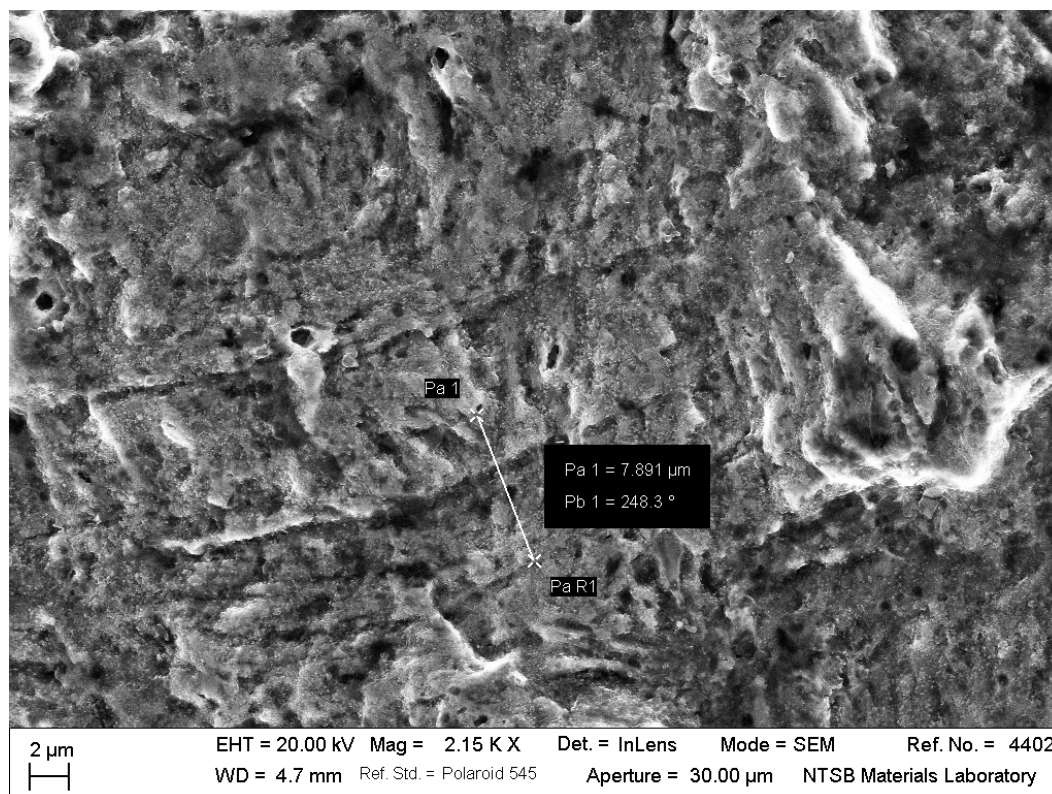
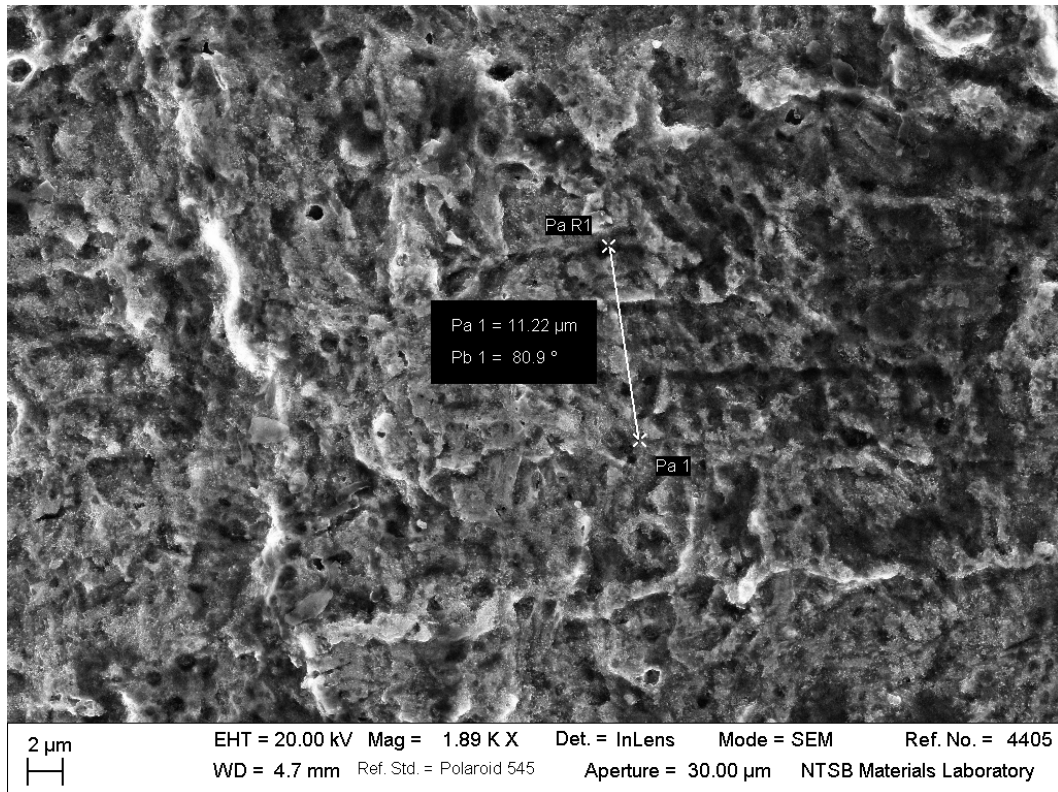
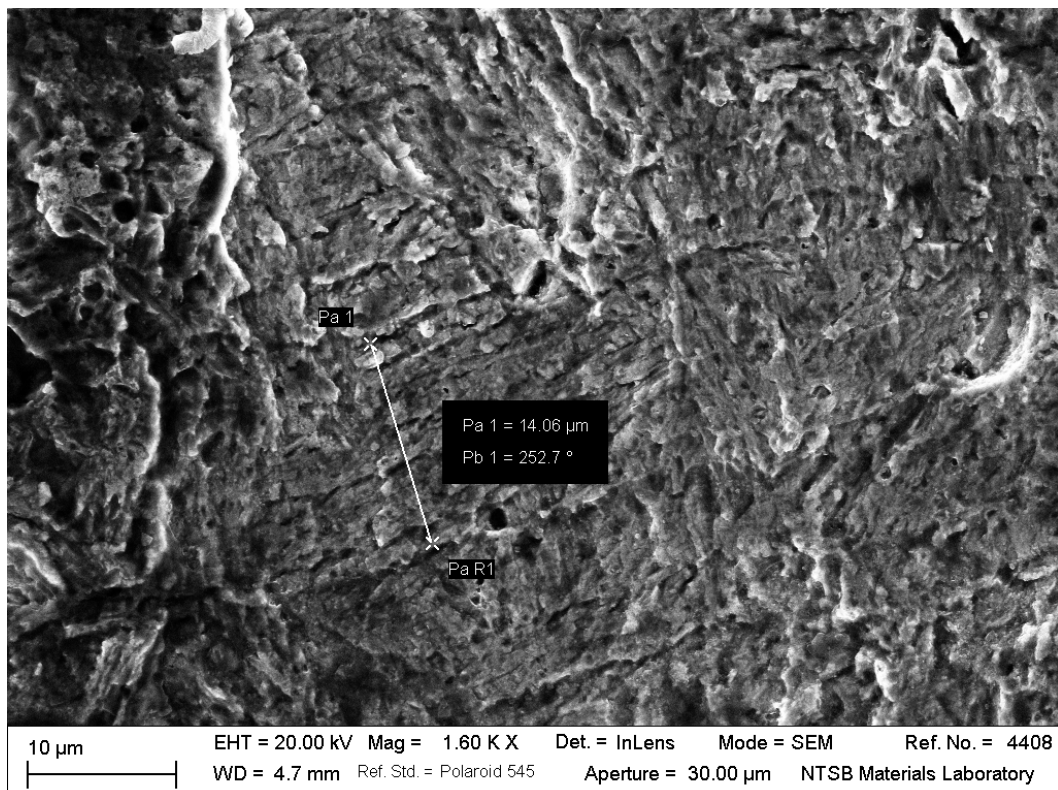
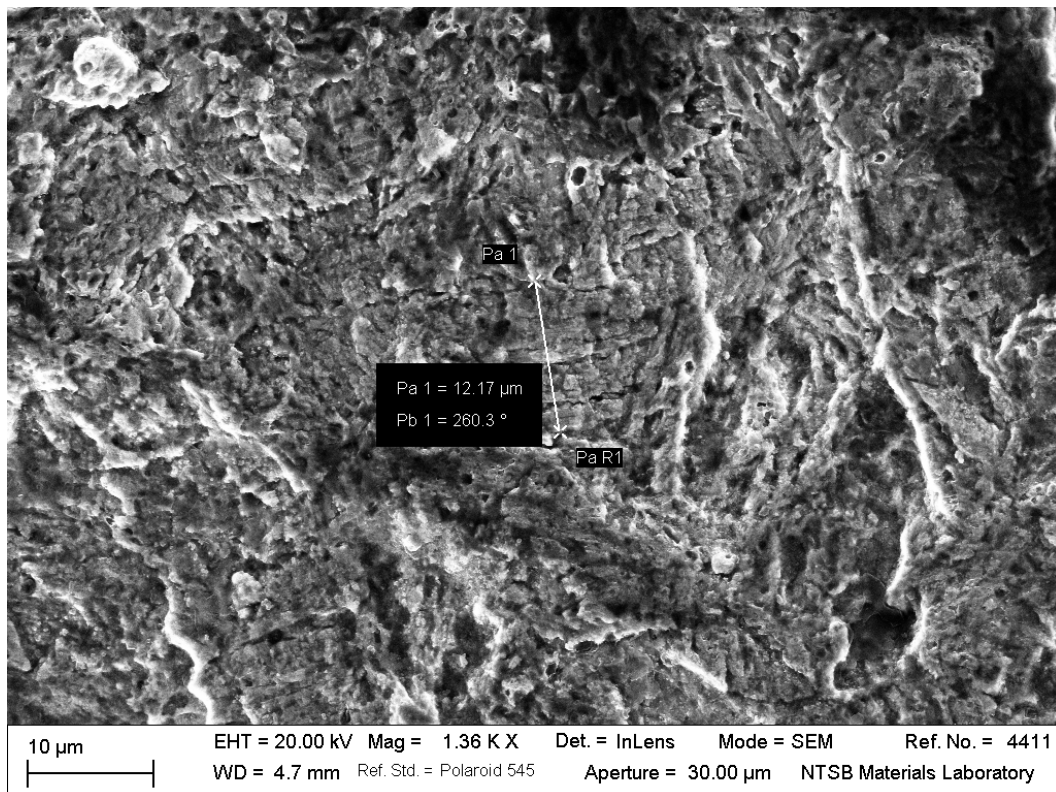
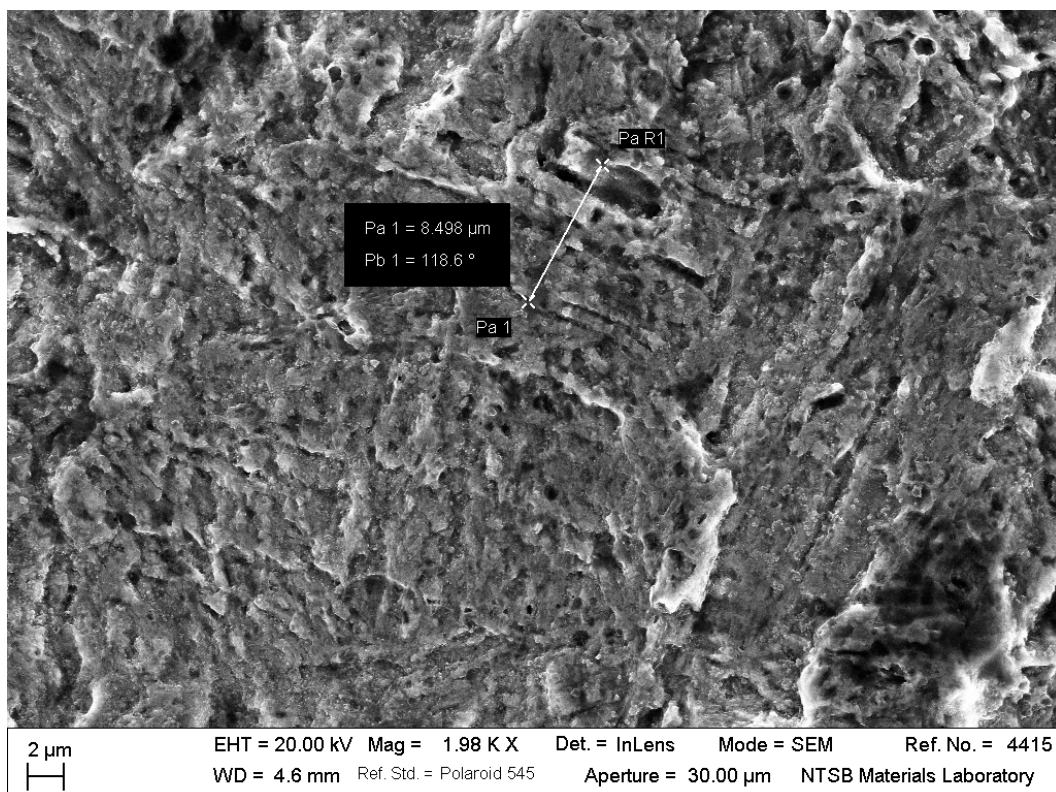
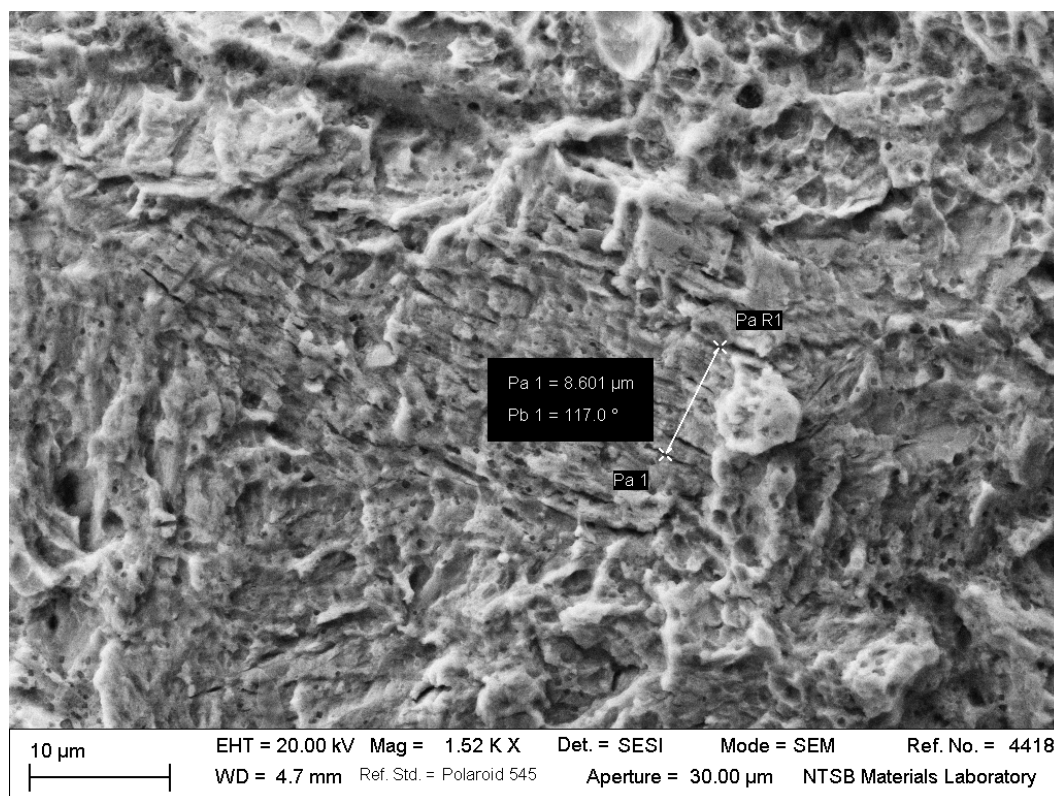
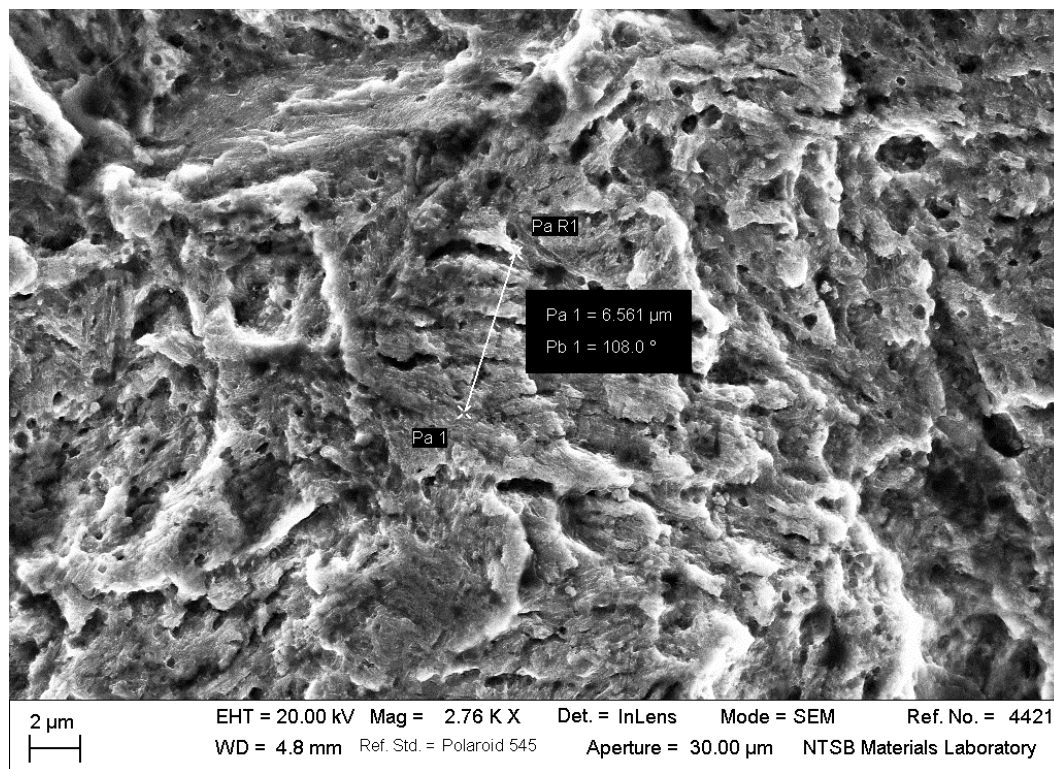
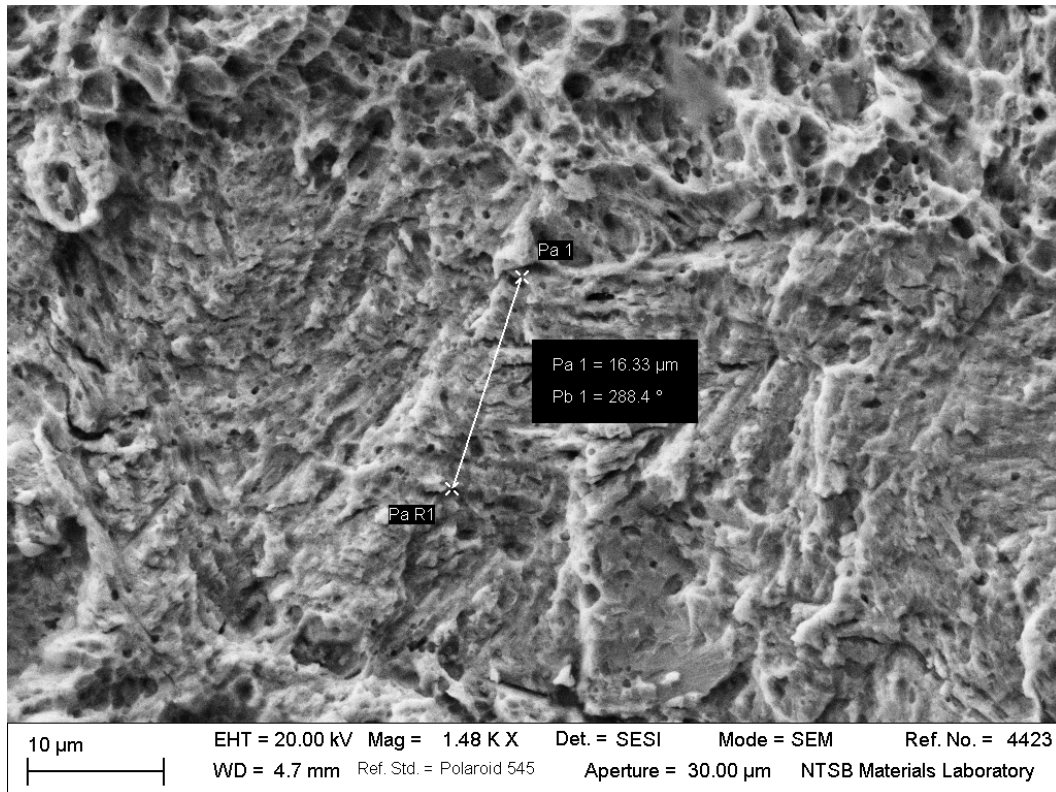
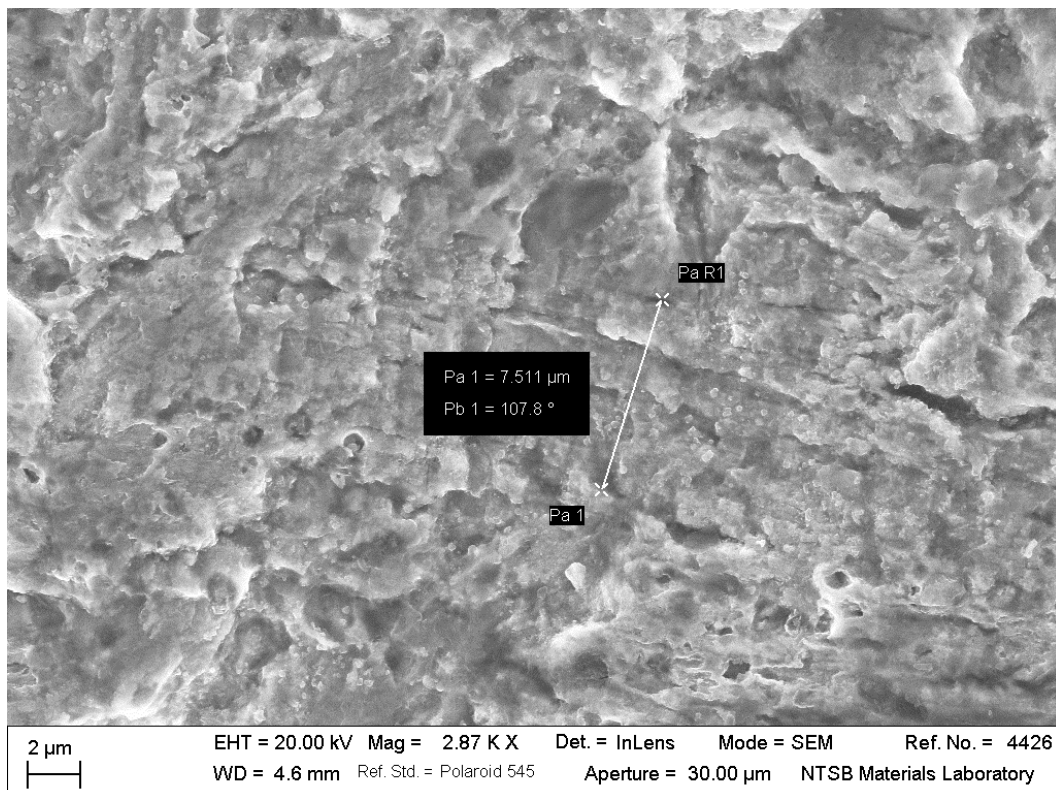
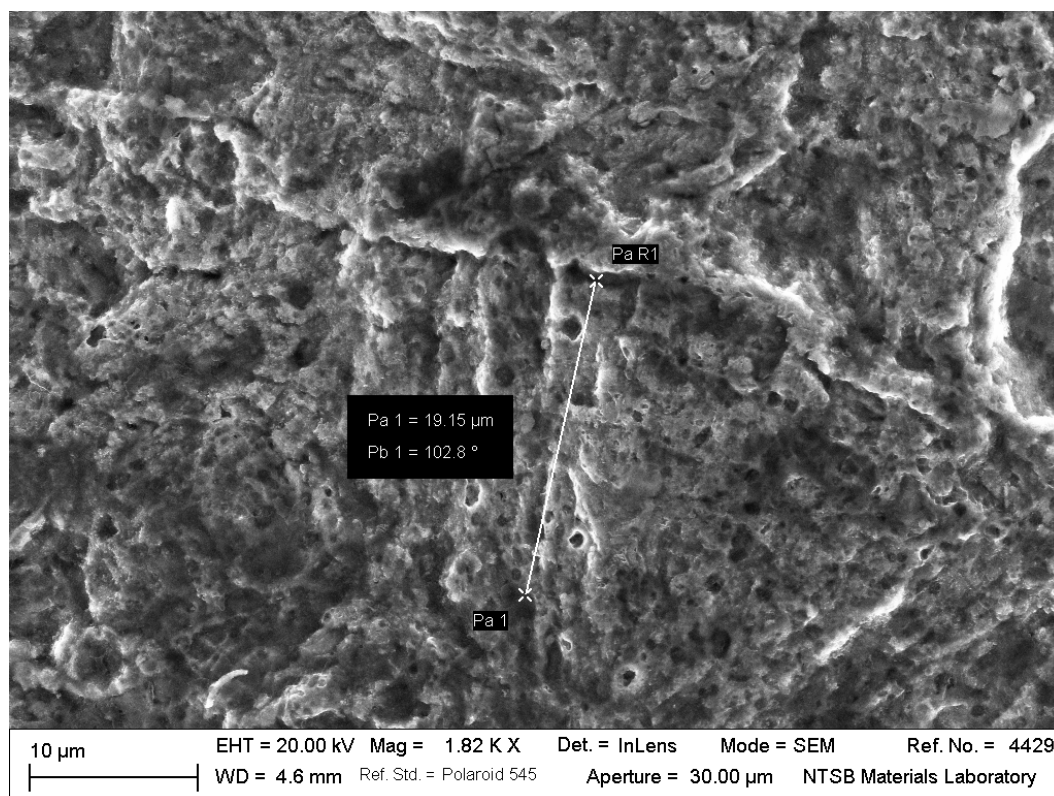
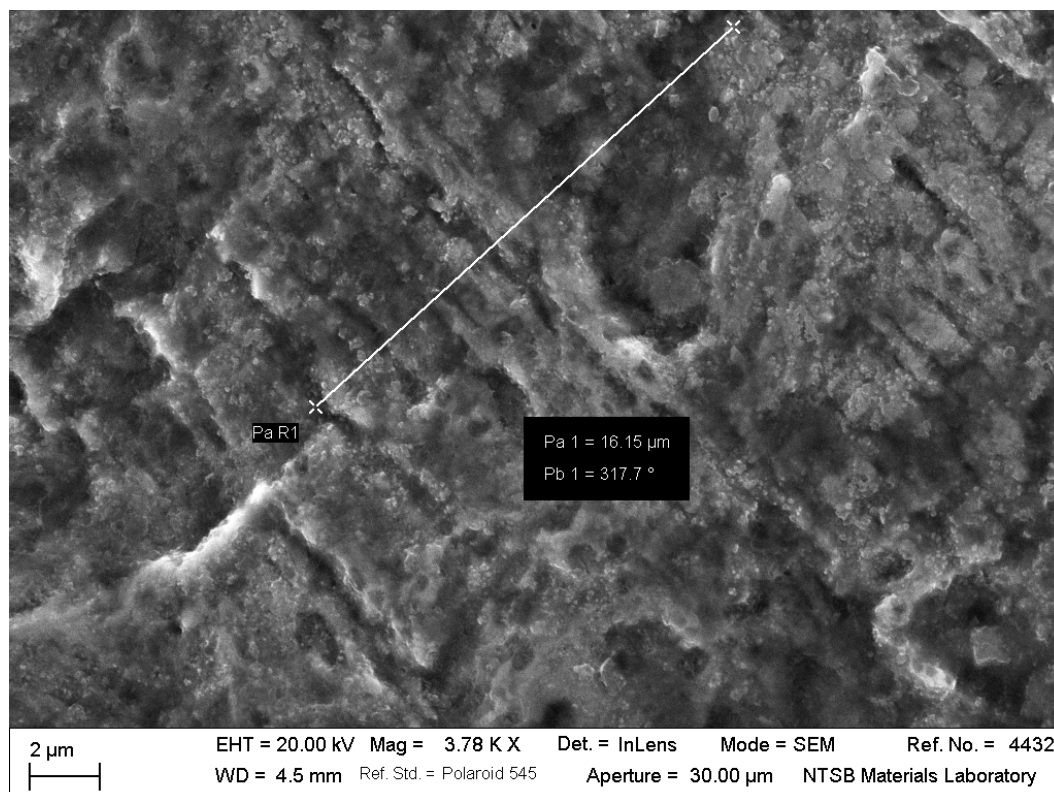
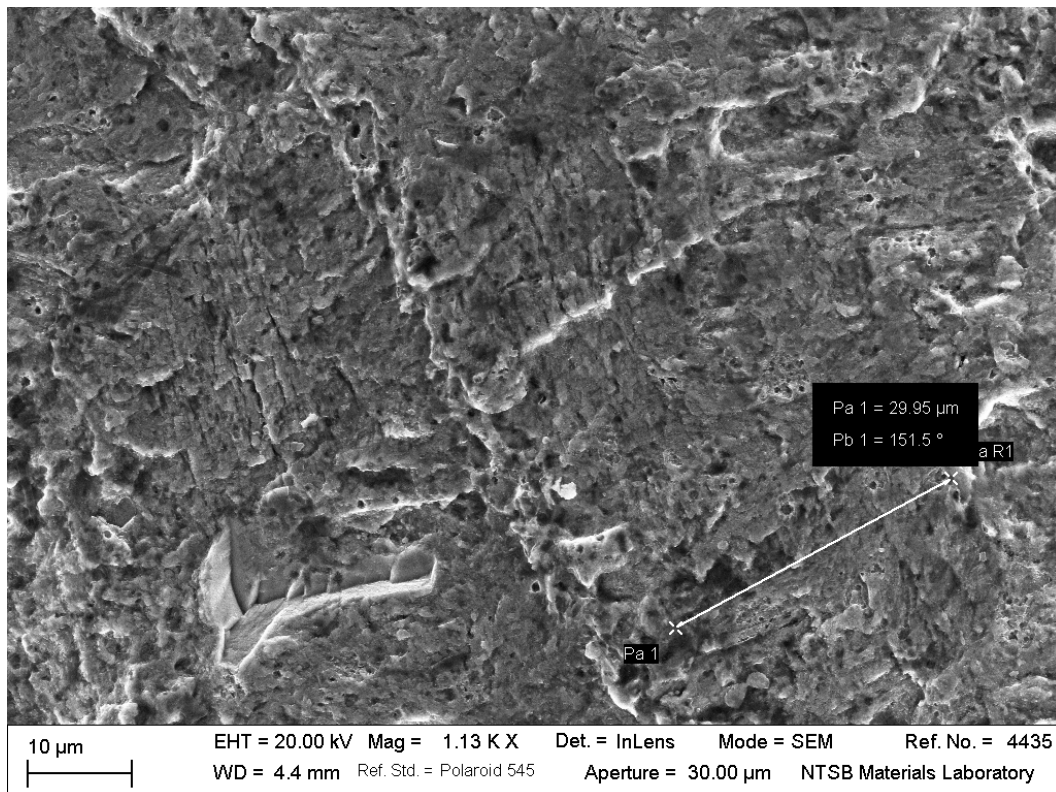
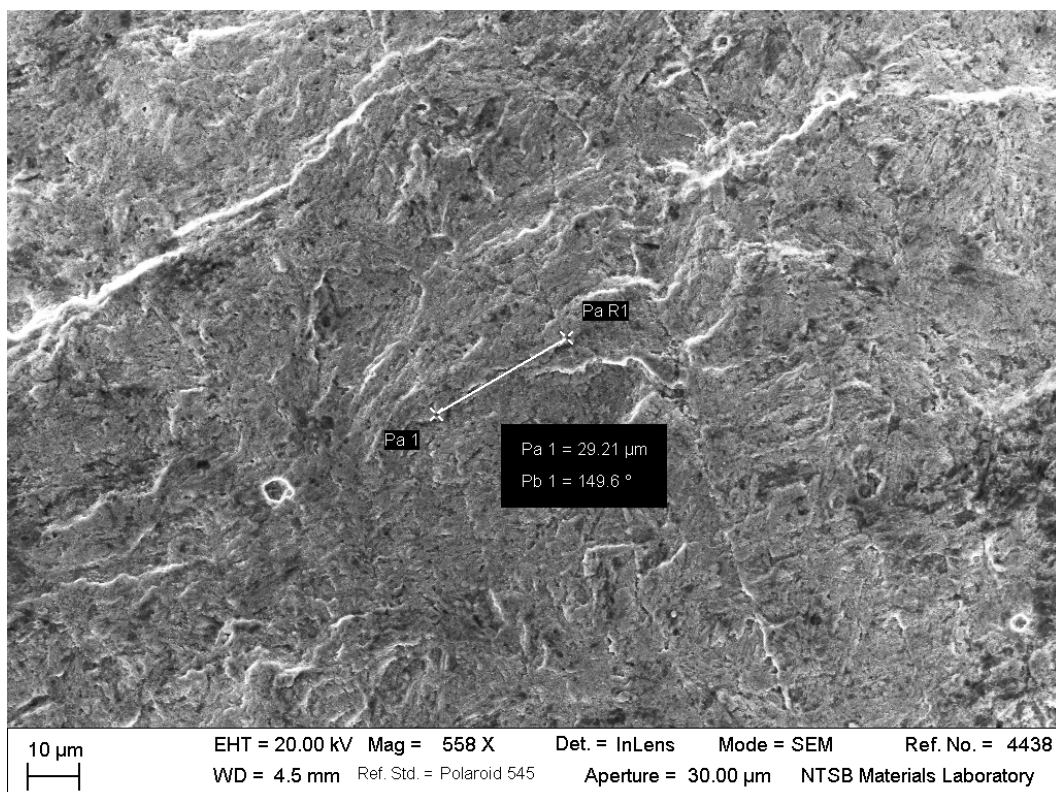
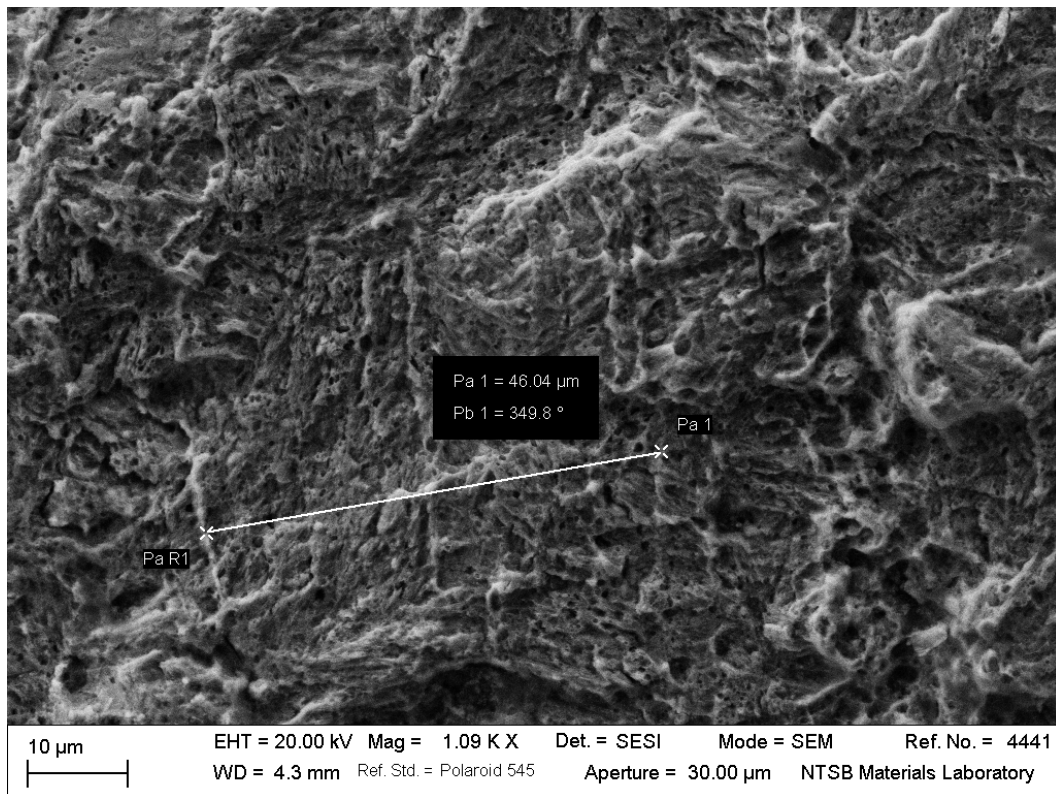
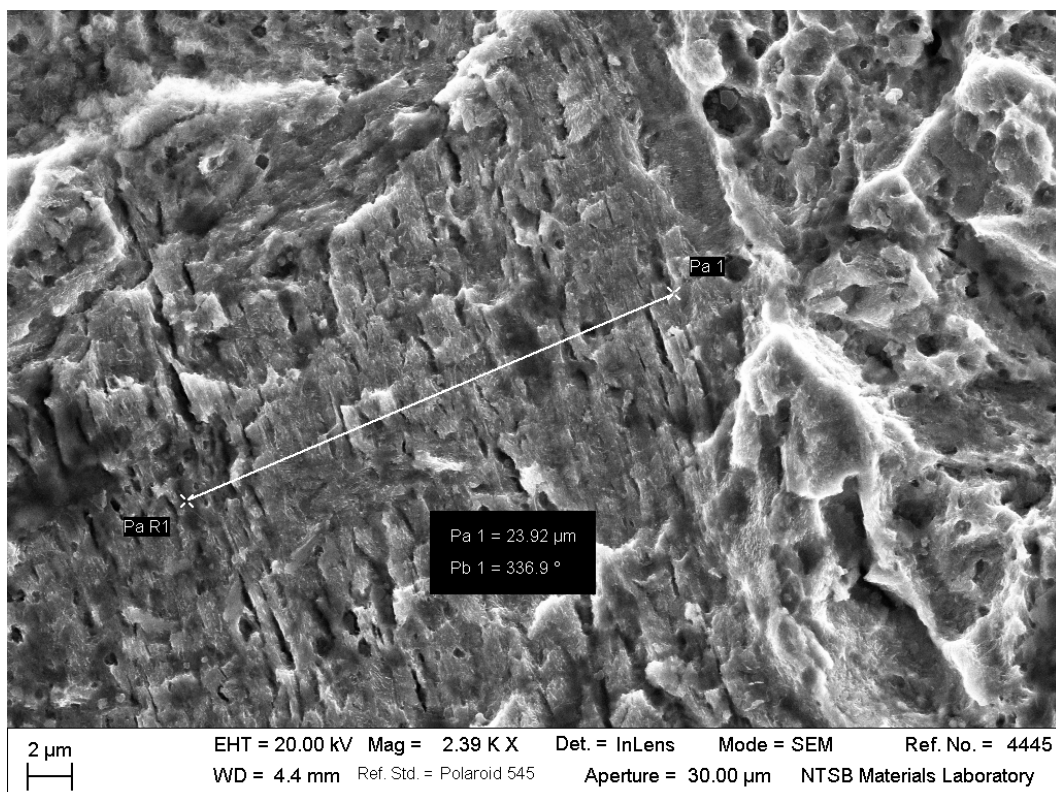
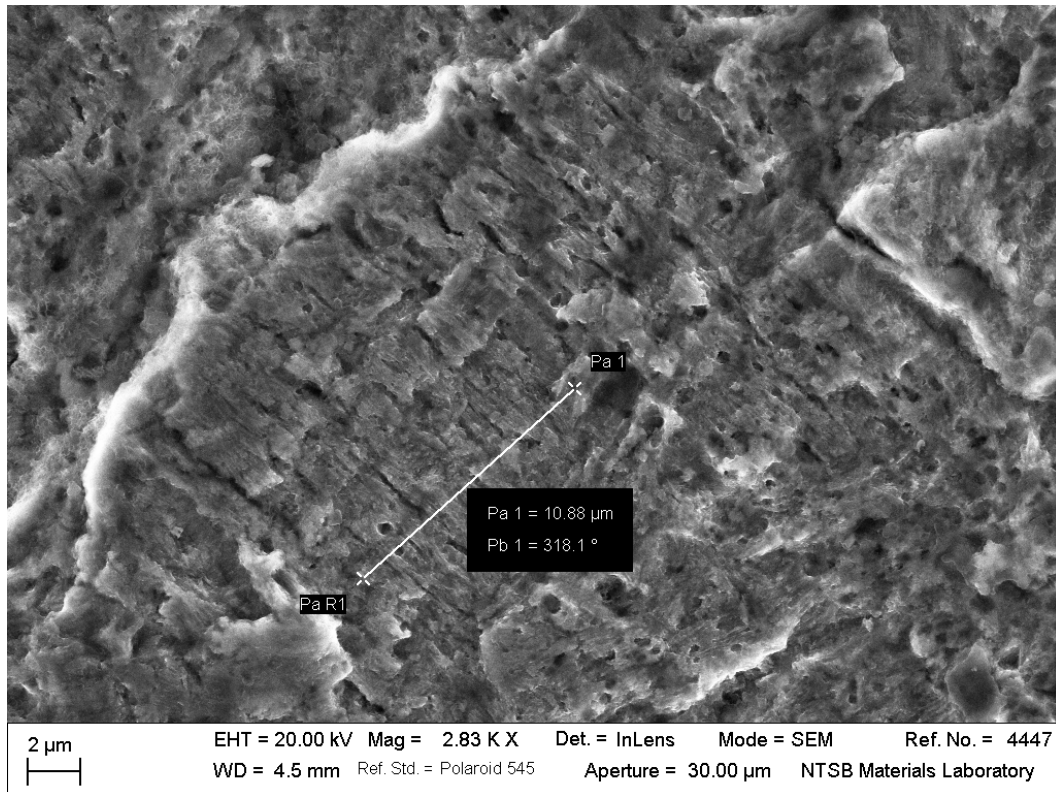
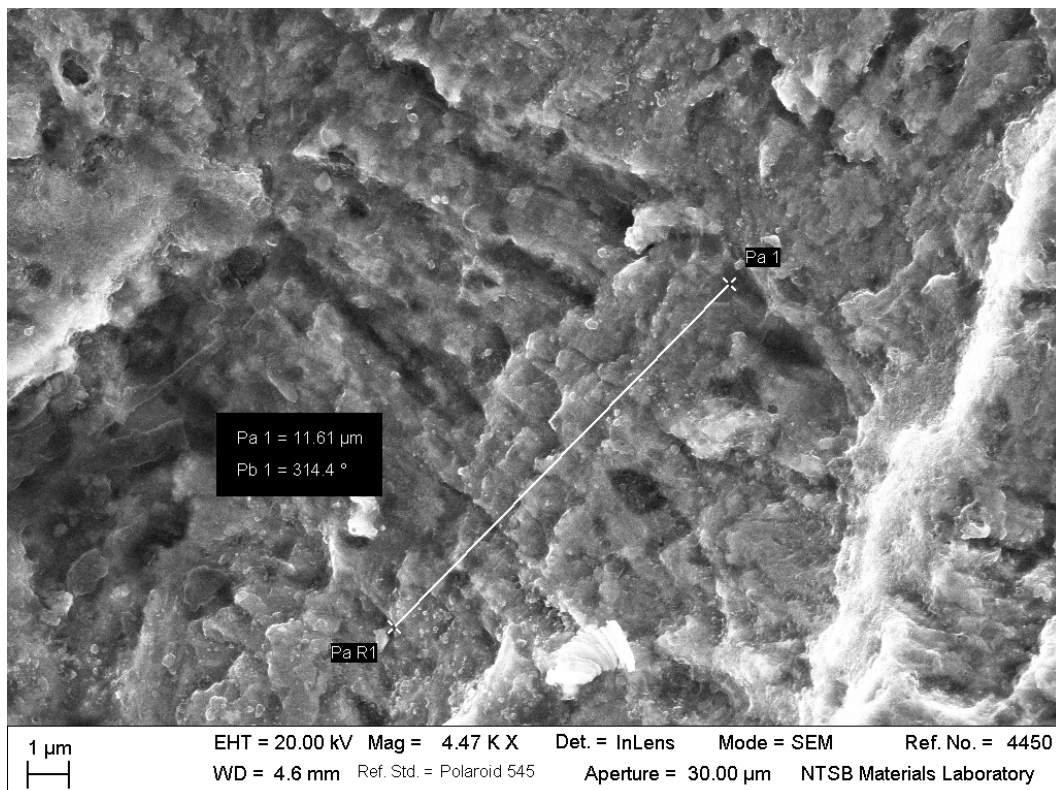
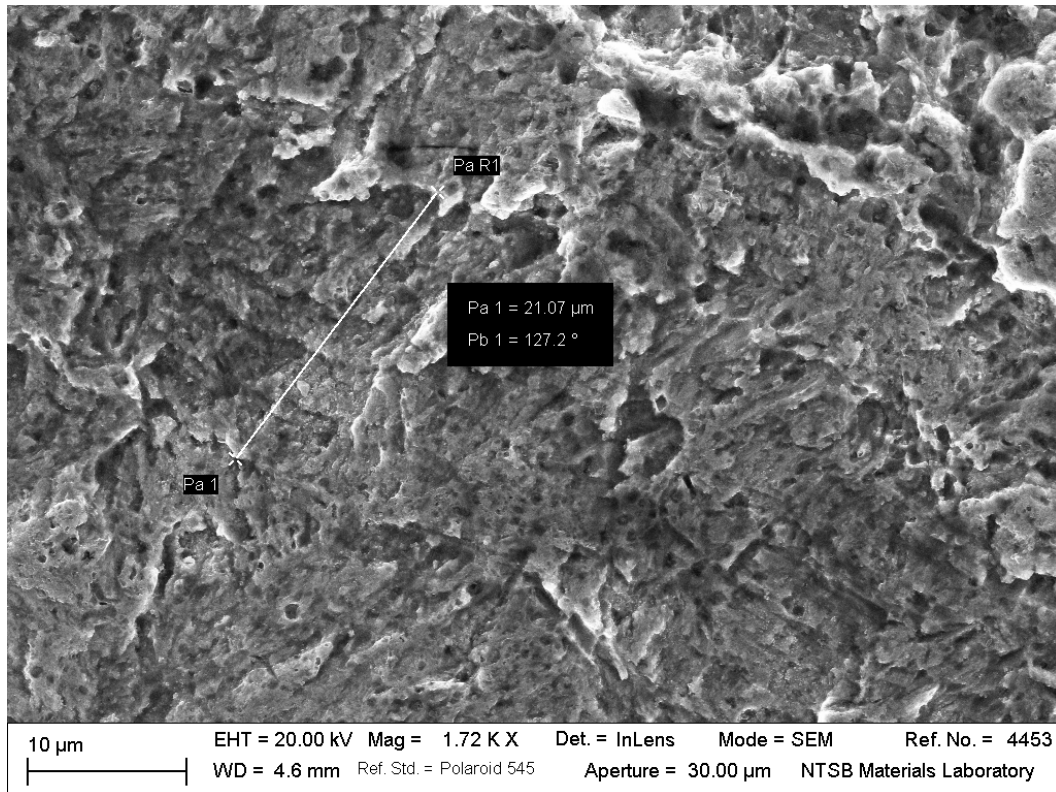
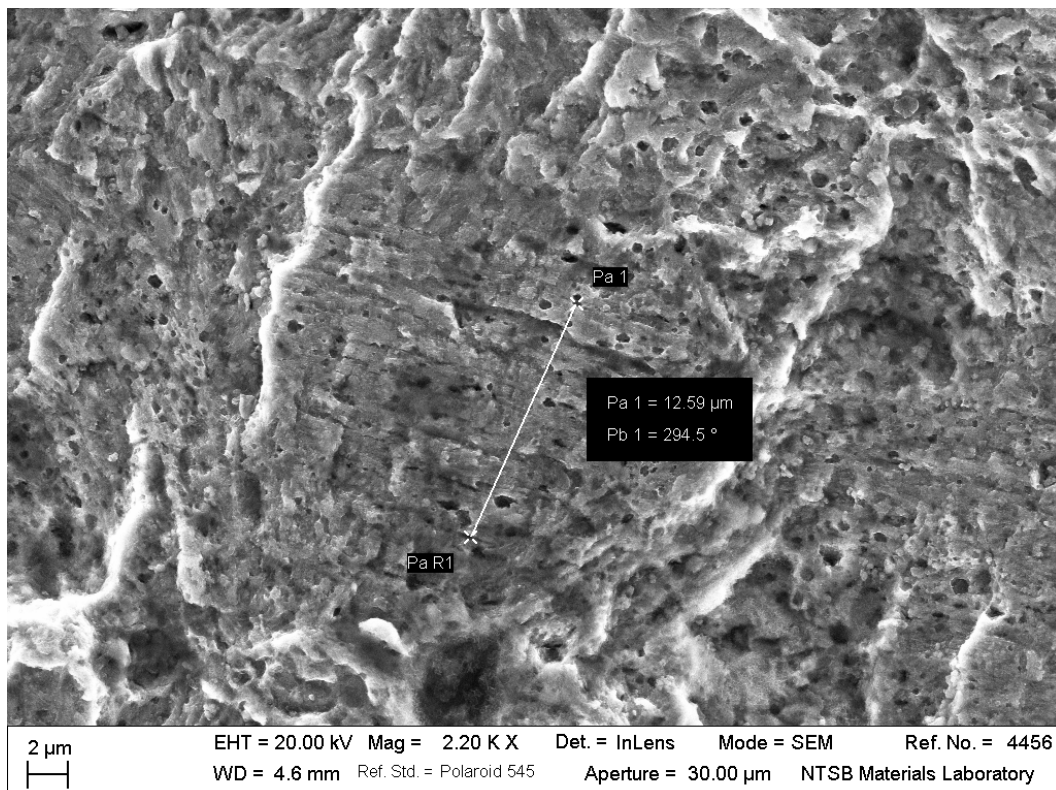
In order to better understand how long the fatigue crack had been present, a fatigue crack growth rate analysis was performed by counting striations at intervals along the crack depth. The fatigue striation counts were taken at over 30 random, unique, and non-duplicated places on the fracture surface, with the distances from the initiation site recorded. The initiation site was labeled from its location on the specimen stage, 49.932 mm in the X-direction and 61.903 mm in the Y-direction. The distances were measured via a calibrated stage on a field emission scanning electron microscope (FESEM). These

locations and the measurements are shown in Figure 4 through Figure 33. No measurements were taken in any overstress regions.

Using a FESEM, multiple areas exhibiting striations were counted, and the distance of the counted striations was measured. This analysis assumed that each counted striation (a feature consistent with crack growth) correlated directly to a landing cycle with no other comparable stresses (such as from braking or vibrations). The analysis also assumed that sampled regions were representative regions of fatigue crack growth at each particular crack depth, the fracture surface was flat, and that the fatigue striation spacing increased with crack depth. The summary of the results is tabulated in Table 1.
