# NATIONAL TRANSPORTATION SAFETY BOARD

## MATERIALS LABORATORY FACTUAL REPORT

Report No. 20-014

Place : Denver, Colorado  
Date : December 22, 2019  
Vehicle : Boeing 737-800, N87513  
NTSB No. : DCA20LA047  
Investigator : Dan Bower, AS-10

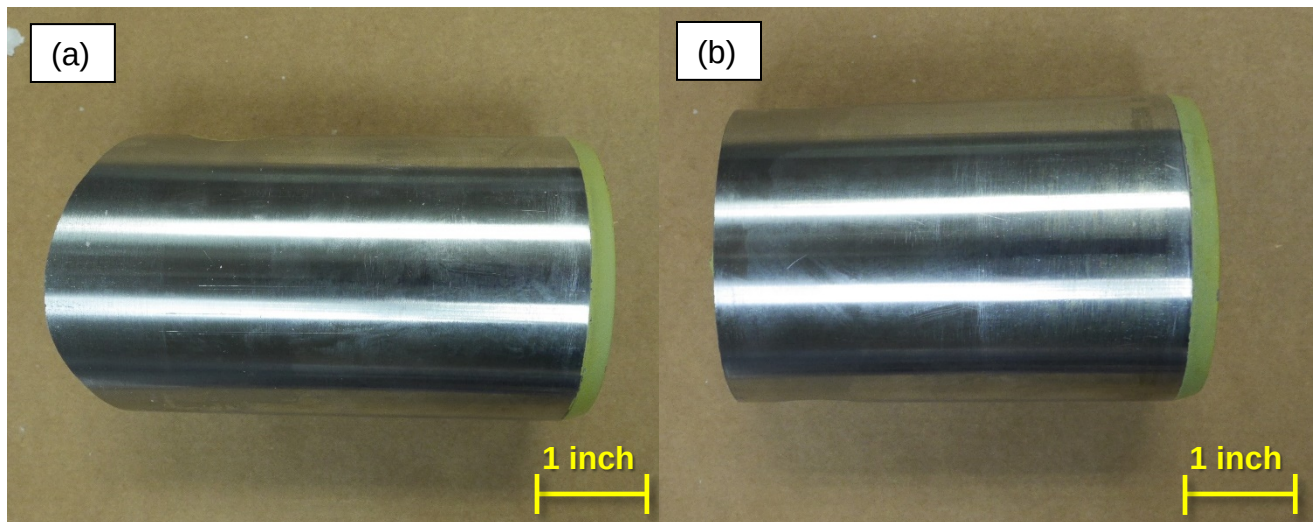
The trunnion pin had fractured into two pieces, as shown in Figure 1 and Figure 2. The pin had fractured approximately perpendicular to the length of the pin at midspan. The separated aft piece of the pin contained remnants of white paint on the beveled bottom of the pin opposite the fracture surface (Figure 2). The forward piece of the pin that was found inside the trunnion had green enamel primer on the beveled face opposite the fracture surface (Figure 1).

Figure 1 – The forward fractured section of the trunnion pin, as received, viewed from (a) the approximately 6 o'clock position and (b) the approximately 12 o'clock position.

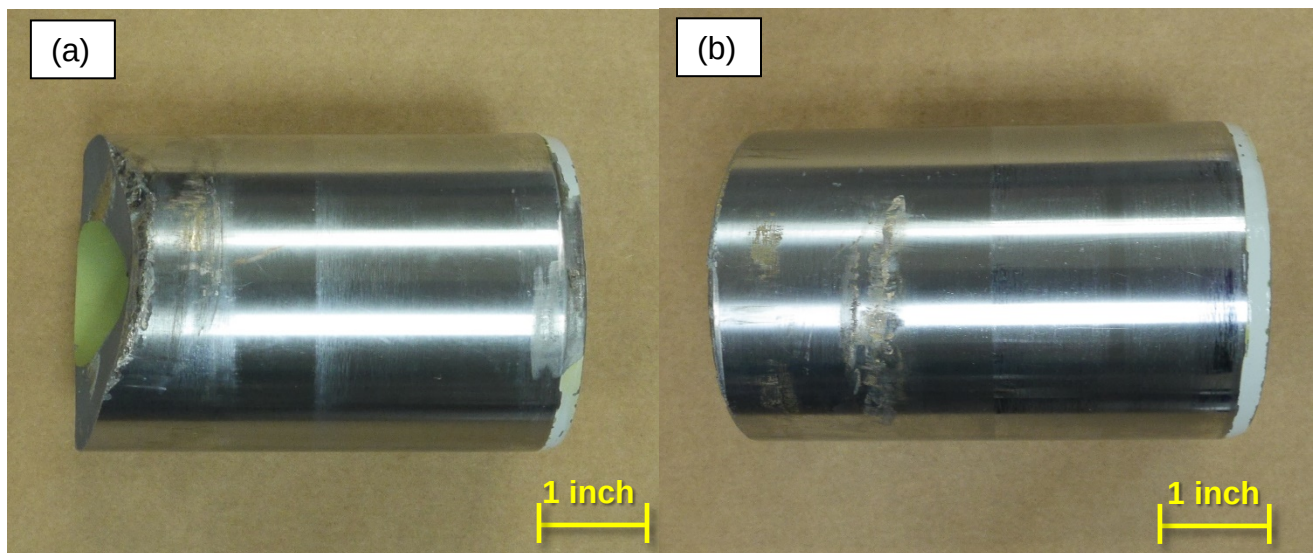
Figure 2 – The aft fractured section of the trunnion pin, as received, viewed from (a) the approximately 6 o'clock position and (b) the approximately 12 o'clock position.

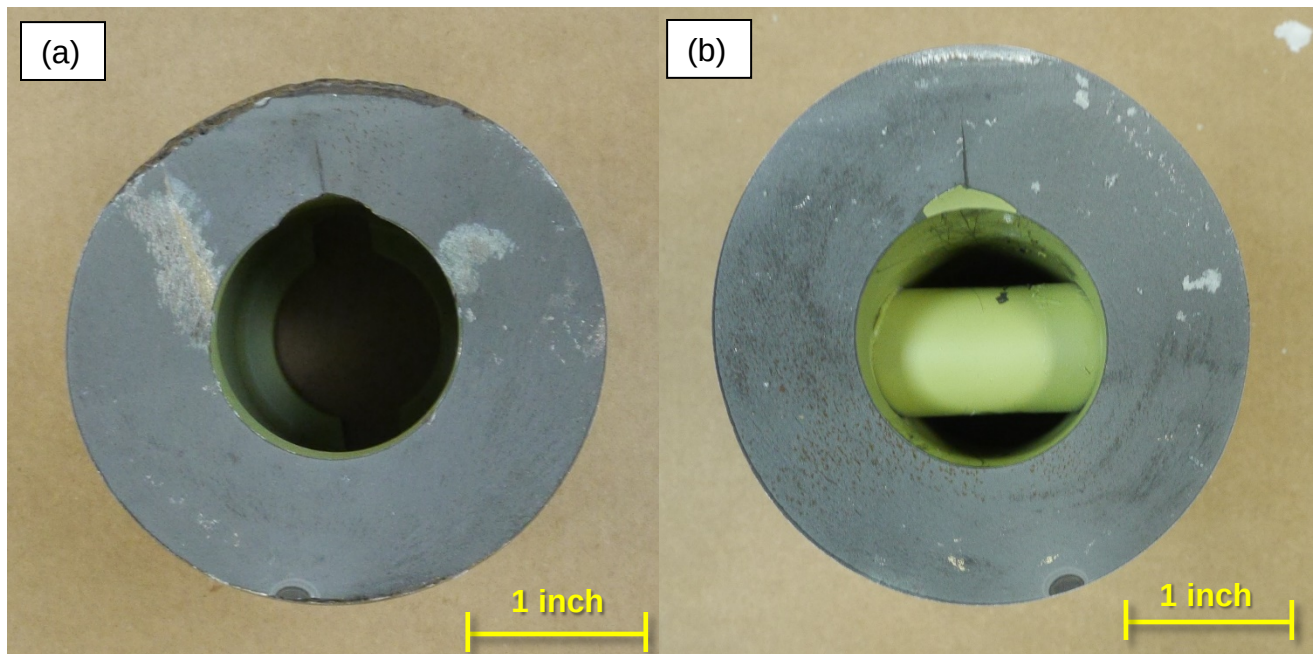
The mating fracture surfaces are shown in Figure 3. The majority of the mating pin fracture faces exhibited a rough, fibrous surface with a dull gray luster. This surface exhibited flow lines consistent with fracture of the part from the bottom of the fracture in Figure 3 around the pin cavity upward. The flow lines emanated from a small thumbnail crack, approximately located at the 12 o'clock (upward-facing) position of the pin (shown on the bottom of Figure 3a and Figure 3b).

Figure 3 – The mating fracture surfaces of the trunnion pin from (a) the aft and (b) forward sides.

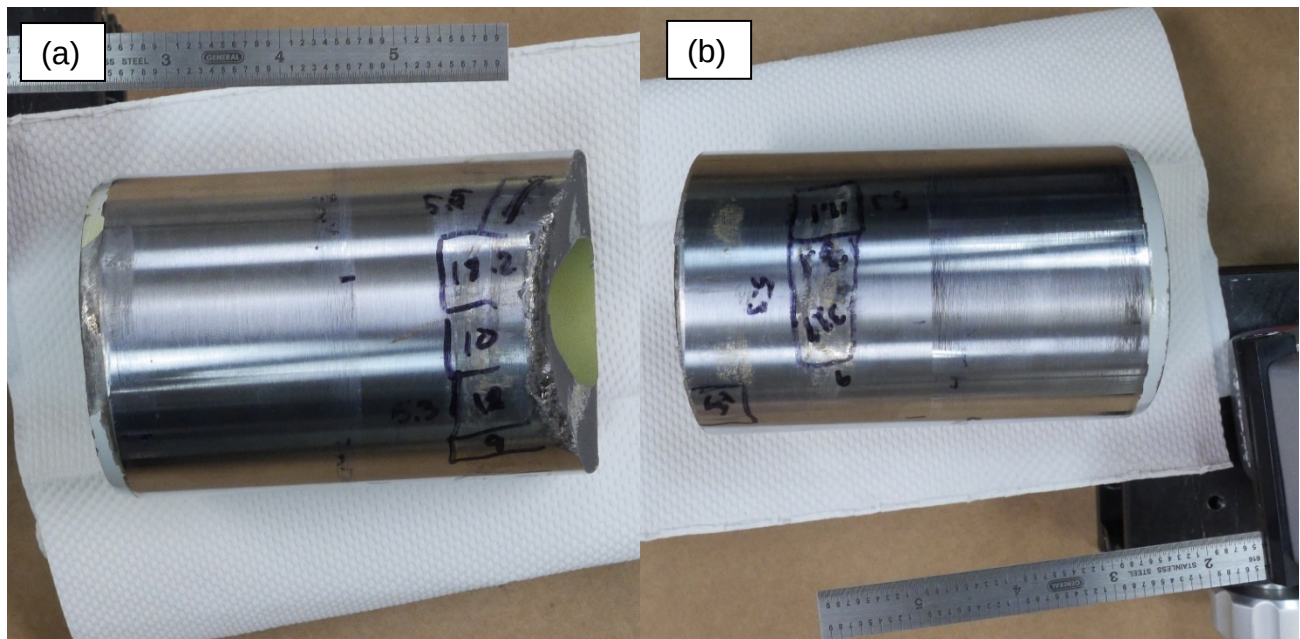
The BNI readings were taken on the outer surface of both pin pieces (see Figure 4 and Figure 5). The data showed readings above the calculated baseline near the fracture surface of both halves—this was concentrated near the fracture origin on the forward pin piece (Figure 5a and Figure 5b) and 180° opposite on the aft pin piece (Figure 4a). In addition, the aft piece exhibited elevated readings above the calculated baseline about 1 inch below the fracture surface origin (Figure 4b). This area was approximately 2 inches along the circumferential direction and 0.5 inch in the longitudinal direction.

The stripped aft section of the pin was examined using MPI (illustrated in Figure 24). This nondestructive inspection revealed longitudinal ladder cracks, located in the area of material transfer and elevated Barkhausen noise indications, shown in Figure 4b. This cracking pattern was consistent with those observed from a subsequent FPI inspection, as illustrated in Figure 25.

Figure 4 – The aft trunnion pin remnant, from (a) the 6 o'clock and (b) and 12 o'clock positions, after examination using Barkhausen noise inspection.

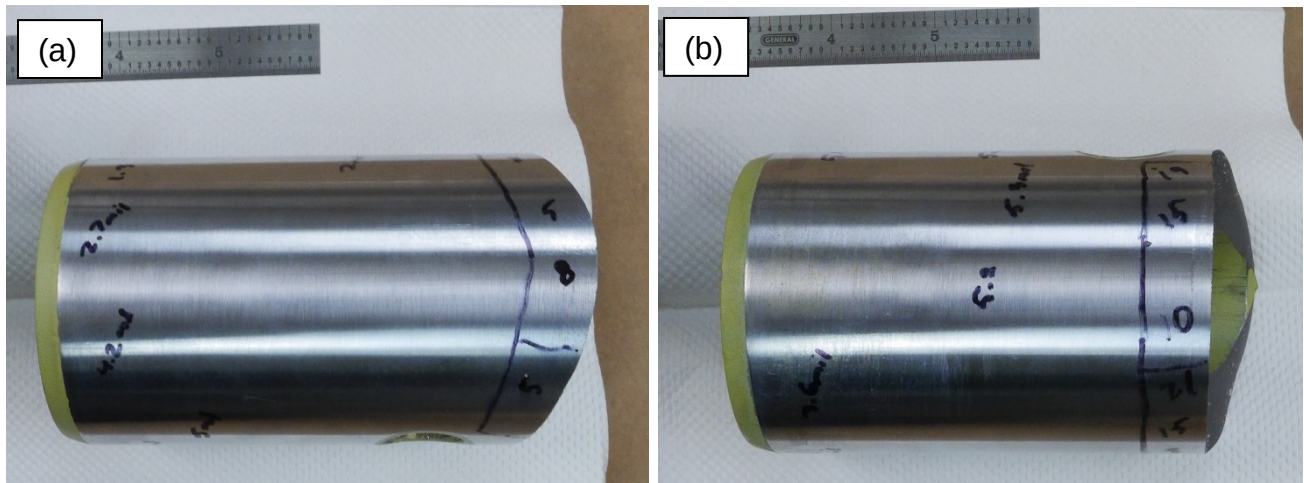
Figure 5 – The forward trunnion pin remnant, from (a) the 6 o'clock and (b) and 12 o'clock positions, after examination using Barkhausen noise inspection.

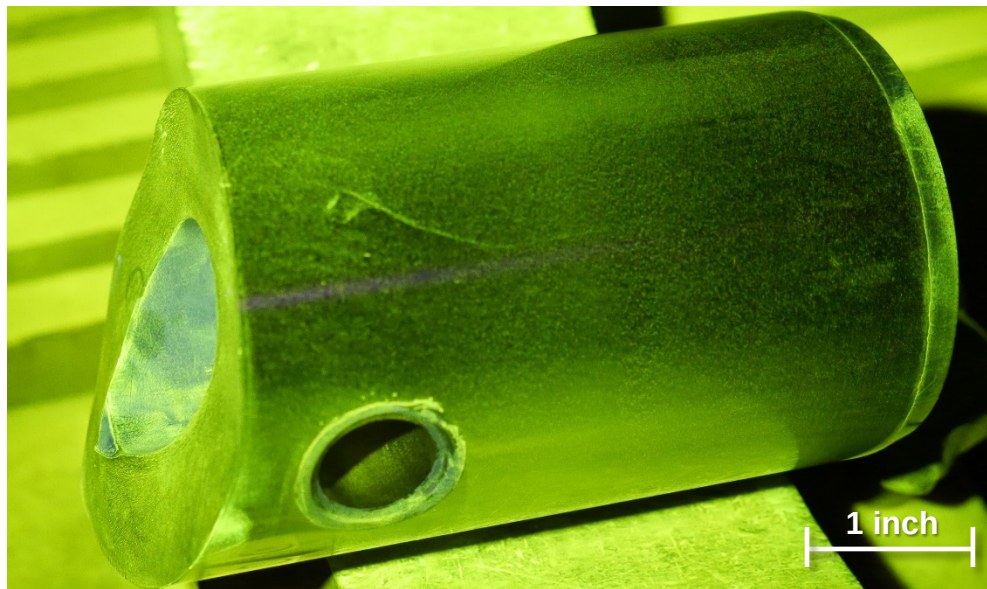
The parts were then inspected using MPI and FPI. MPI was able to be performed in the coil and head shot directions for the aft piece, but could only be performed in the coil direction for the forward piece. In both cases, the coil shot direction would be able to detect circumferential/transverse crack indications. Neither MPI orientation revealed any indications of cracks (as typified in Figure 6).

Figure 6 – View of the forward trunnion pin piece under UV light after MPI. The indication observed was consistent with a post-fracture scratch.

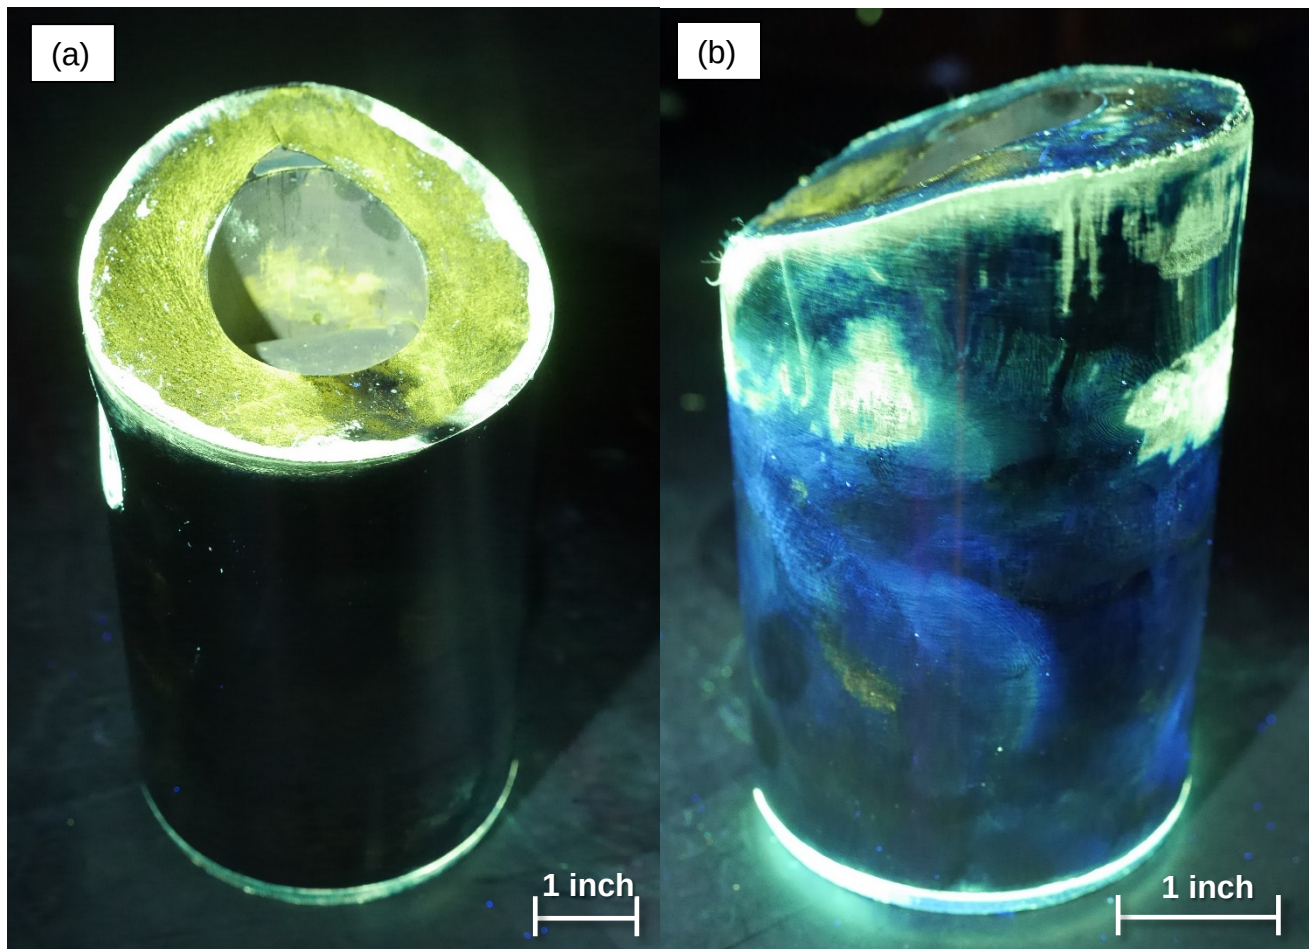
FPI inspection was performed on both pieces (see Figure 7). From this inspection, no indications of an abnormal network of cracks, (such as “chicken wire” or “ladder” cracks) were observed on the surfaces of the parts. Small cracks parallel and adjacent to the fracture surface were found in the chromium electroplated layer. These cracks were not observed near

the fracture origins. These cracks were consistent with cracks in the chromium electroplated layer that would form as the pin separated at the time of the accident.

Figure 7 – View of the (a) forward and (b) aft trunnion pieces viewed under UV light during FPI.

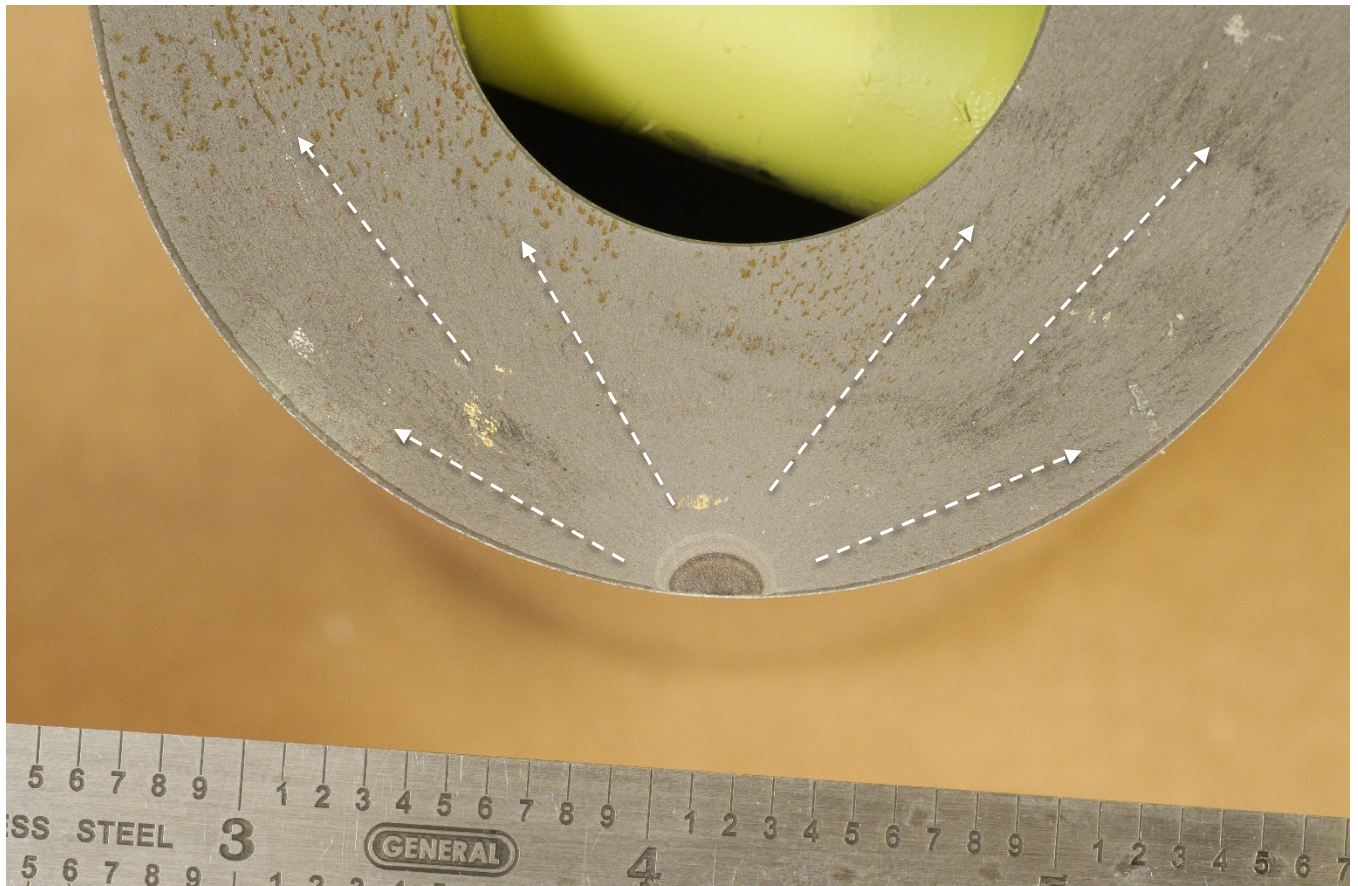
The fracture surface was examined and documented. A small thumbnail crack was present on the approximate 12 o'clock position of the forward pin piece fracture surface. This thumbnail crack exhibited diverse colors visually, along with crack arrest marks (see Figure 8). These features were consistent with pre-existing progressive cracking in this section of the pin. The majority of the rest of the fracture surface exhibited river patterns and chevron marks, which flowed from the small thumbnail crack. Some limited shear lips were observed in the upper half of the fracture, along the outer diameter surface. These features were consistent with subsequent overstress fracture during the accident landing event.

Figure 8 – Fracture surface of the forward pin fracture surface, showing a thumbnail crack at the 12 o'clock position. White dashed arrows denote the fracture direction from the thumbnail.

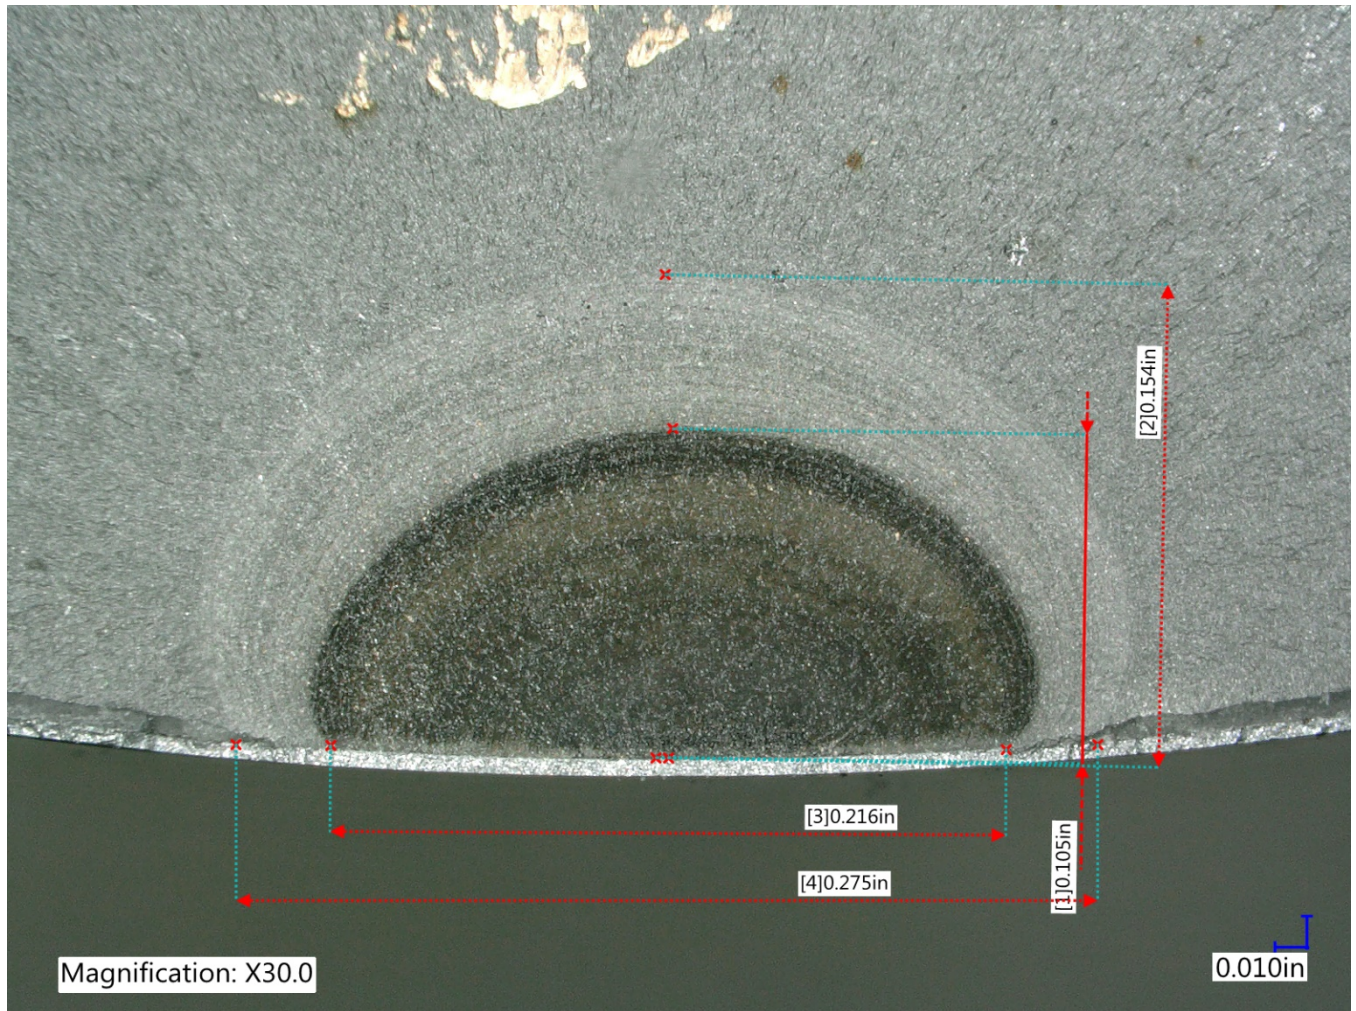
The thumbnail crack dimensions were measured with a digital optical microscope, as annotated in Figure 9. The crack measured 0.154 inches deep, with a linear length on the outer diameter (OD) of 0.275 inches. There was a discolored region that measured 0.105 inches deep by 0.216 inches long inside the thumbnail crack (see Figure 9). There was an adherent shiny external layer, and a subsurface darker, faceted region (see Figure 10). These different regions of the fracture surface will be detailed further below.

Figure 9 – Microscopic view of the thumbnail crack in Figure 8, annotated to show various dimensions.

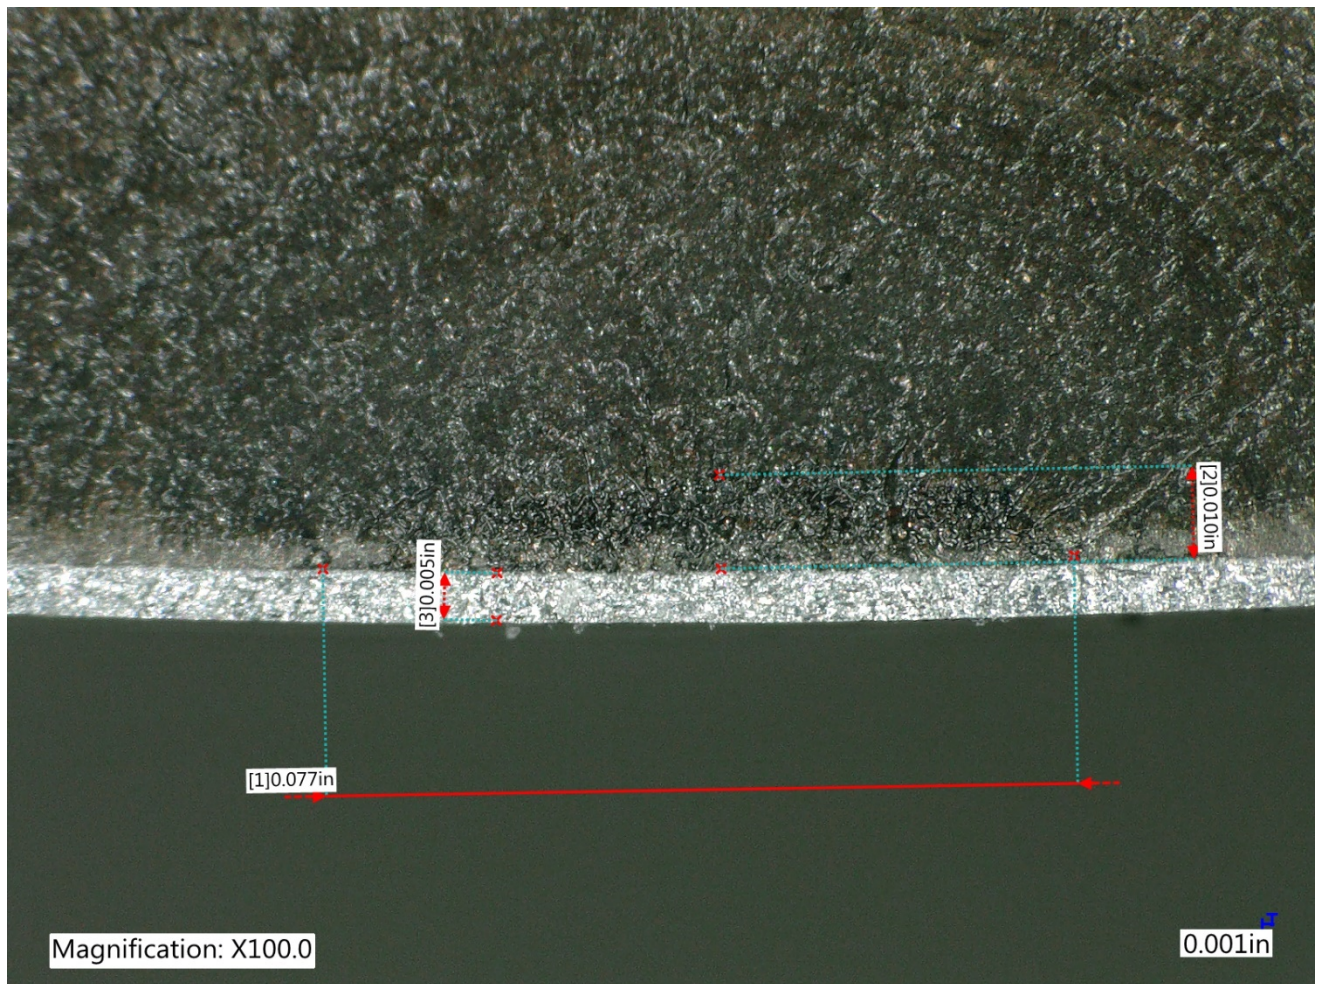
Figure 10 – Closer view of the initiation region of the thumbnail crack in Figure 9, with annotated measurements of the intergranular region (dark) and the outer chromium electroplating layer (light).

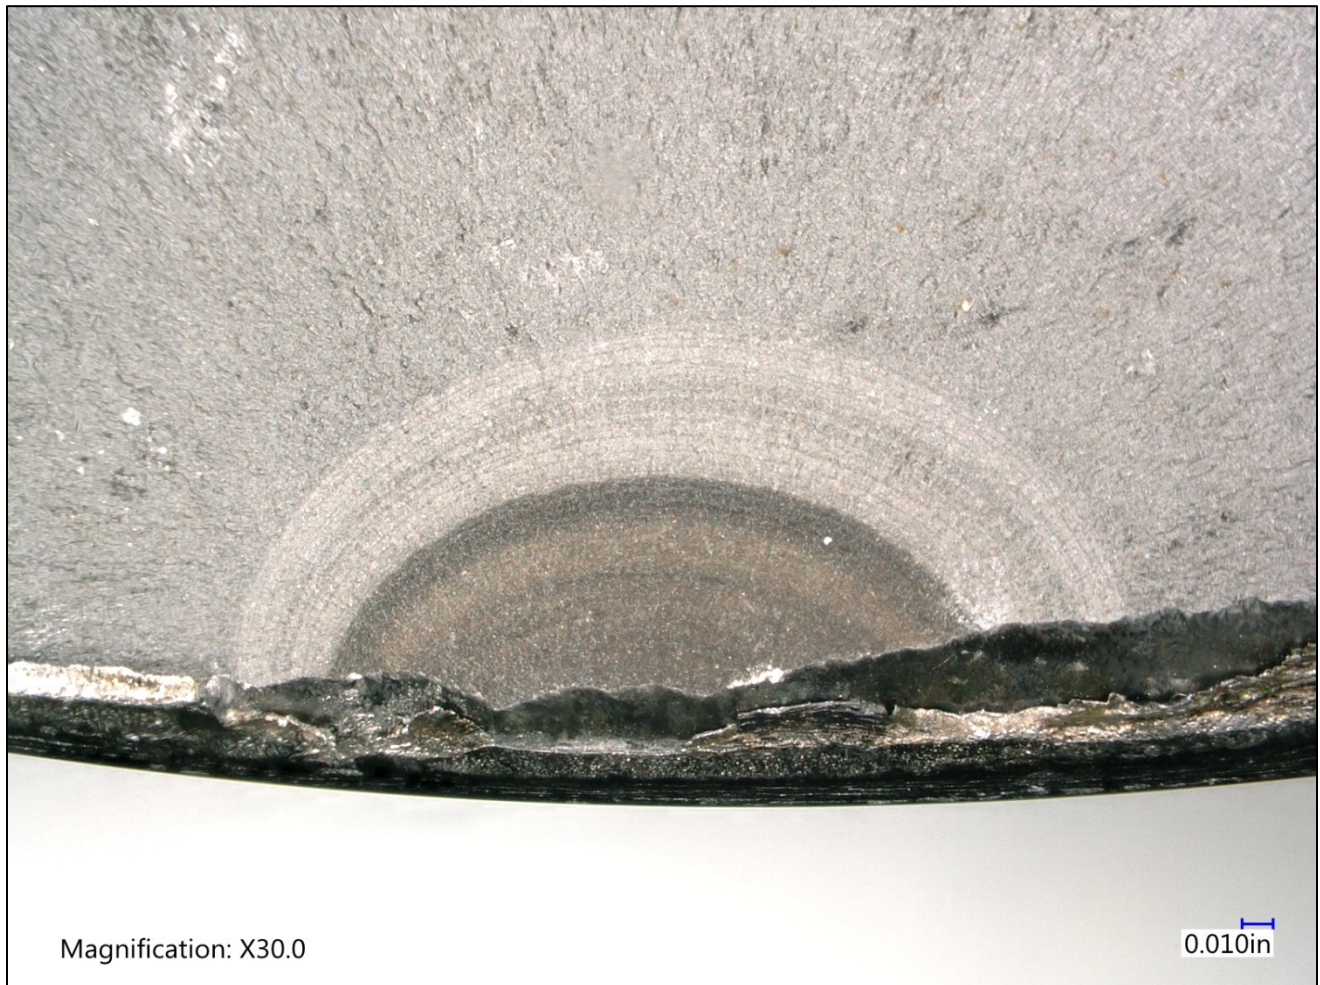
The thumbnail crack on the aft side had been damaged along the edge, consistent with post-fracture impact damage with another component (see Figure 11). The mating forward fracture surface was relatively undamaged, and it was selected for further microscopic examination. The aft fracture surface was used for metallographic examination, along with a temper etchant inspection.

Figure 11 – View of the thumbnail crack on the aft fracture surface, showing the post fracture damage to the edge.

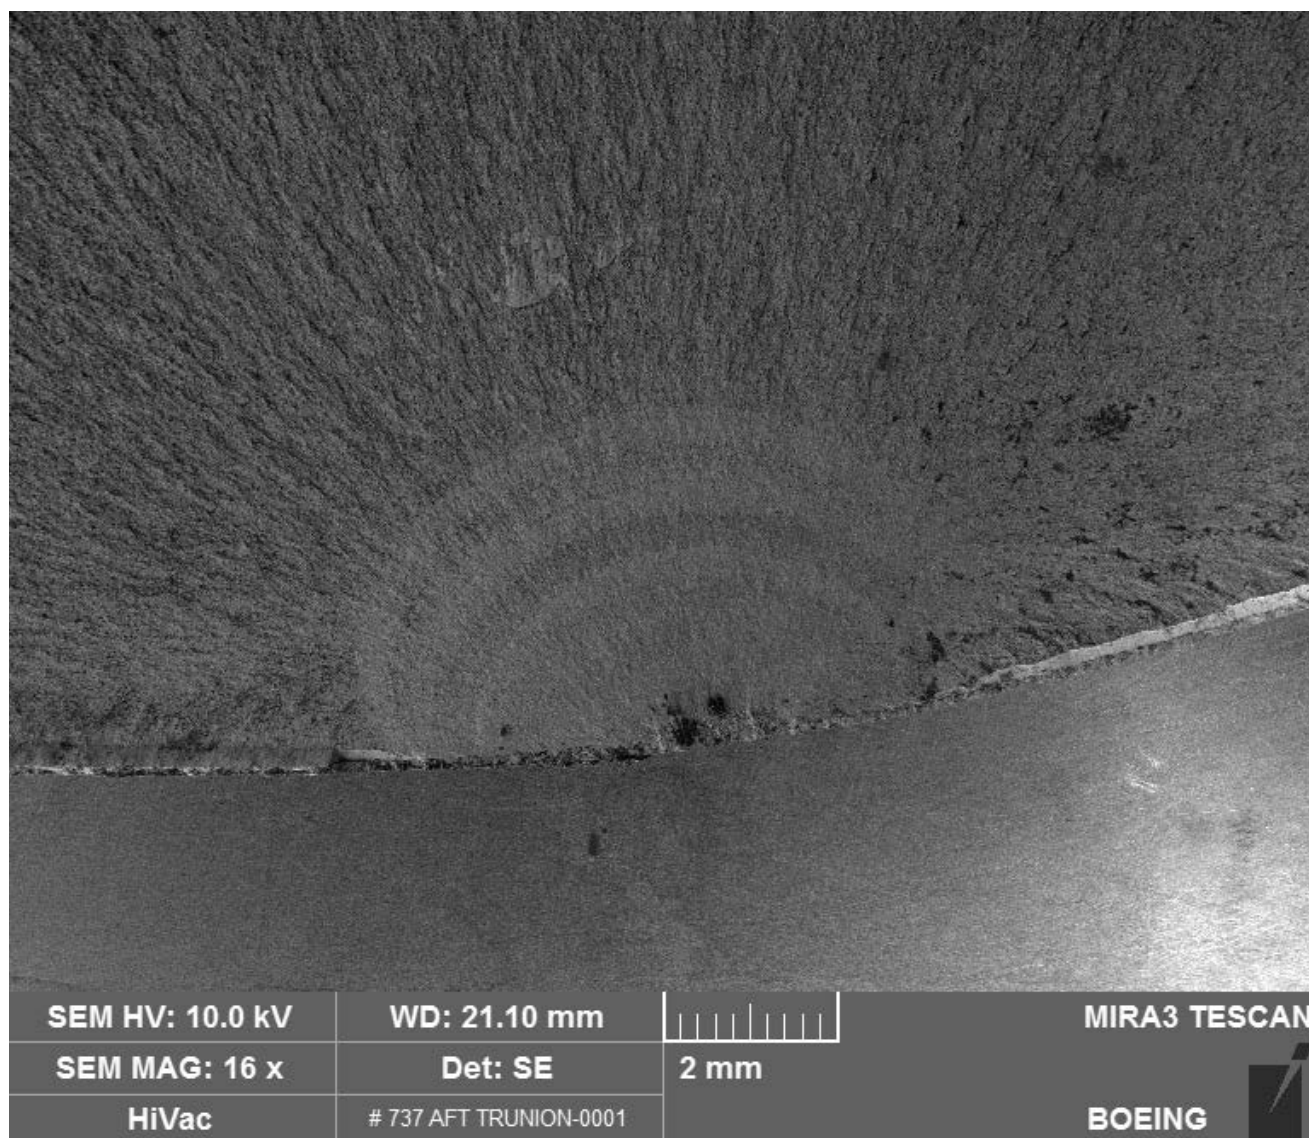
A section encompassing the forward piece thumbnail crack was examined in a scanning electron microscope (SEM), as shown in Figure 12. This crack was examined after MPI and FPI, and again after using successive cleaning with acetone, cellulose acetate tape, and Alconox.<sup>3</sup> Examination using the SEM found an outer adherent chromium electroplated layer, approximately 0.005 inches in thickness, upwards of 0.006 inches thick at the crack initiation site (Figure 13). The chromium electroplated layer was generally adherent, with no indications of corrosion or pitting. The chromium electroplated area along the fracture surface exhibited faceted fracture features (Figure 14).

Figure 12 – Secondary electron (SE) micrograph of the forward side thumbnail crack.

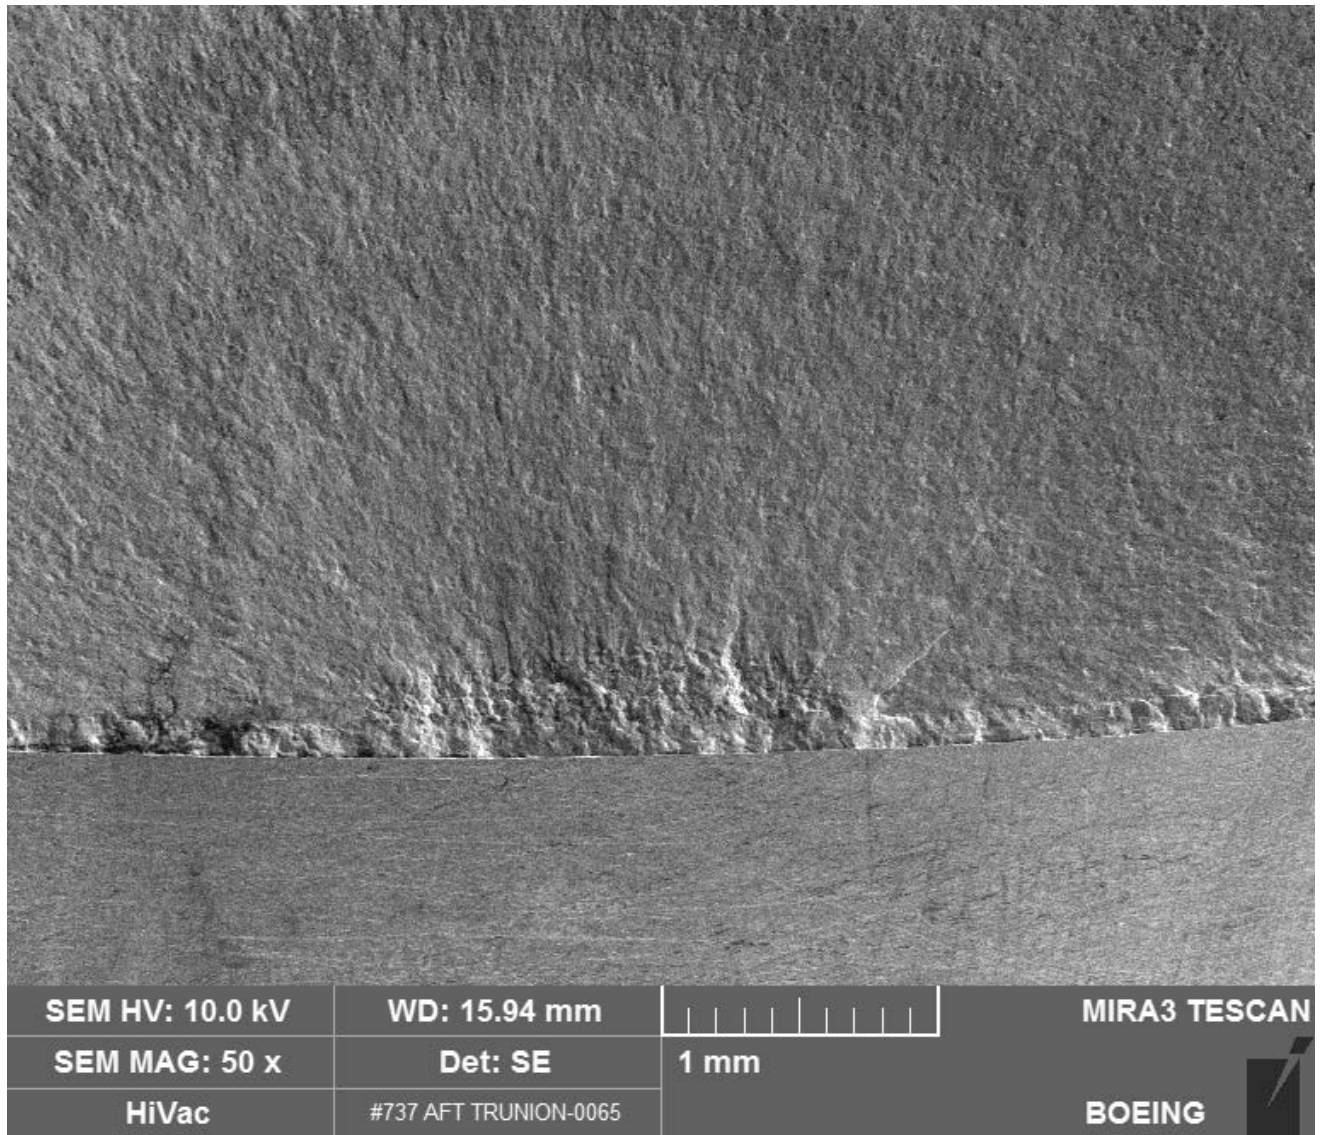
Figure 13 – SE micrograph of a closer view of the initiation site, angled to show the edge with the outer surface.

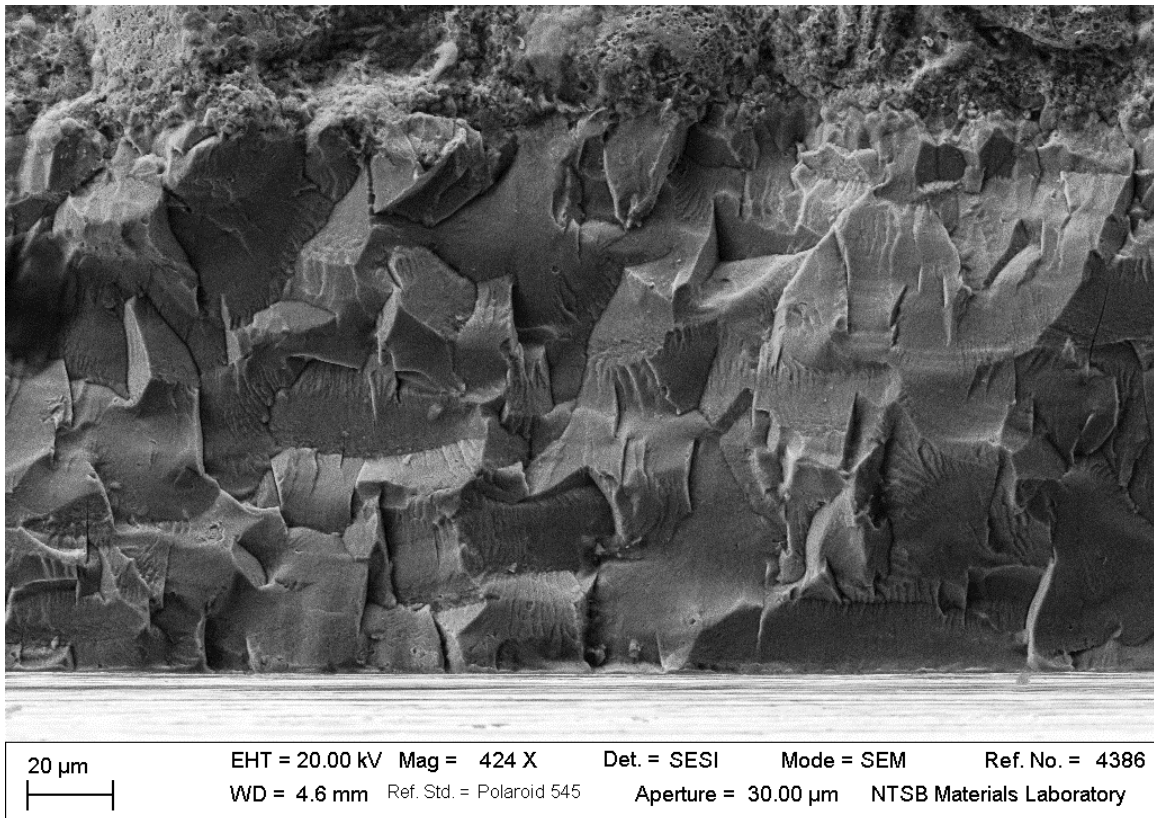
Figure 14 – SE micrograph showing a closer view of the faceted fracture features in the chromium electroplating layer.

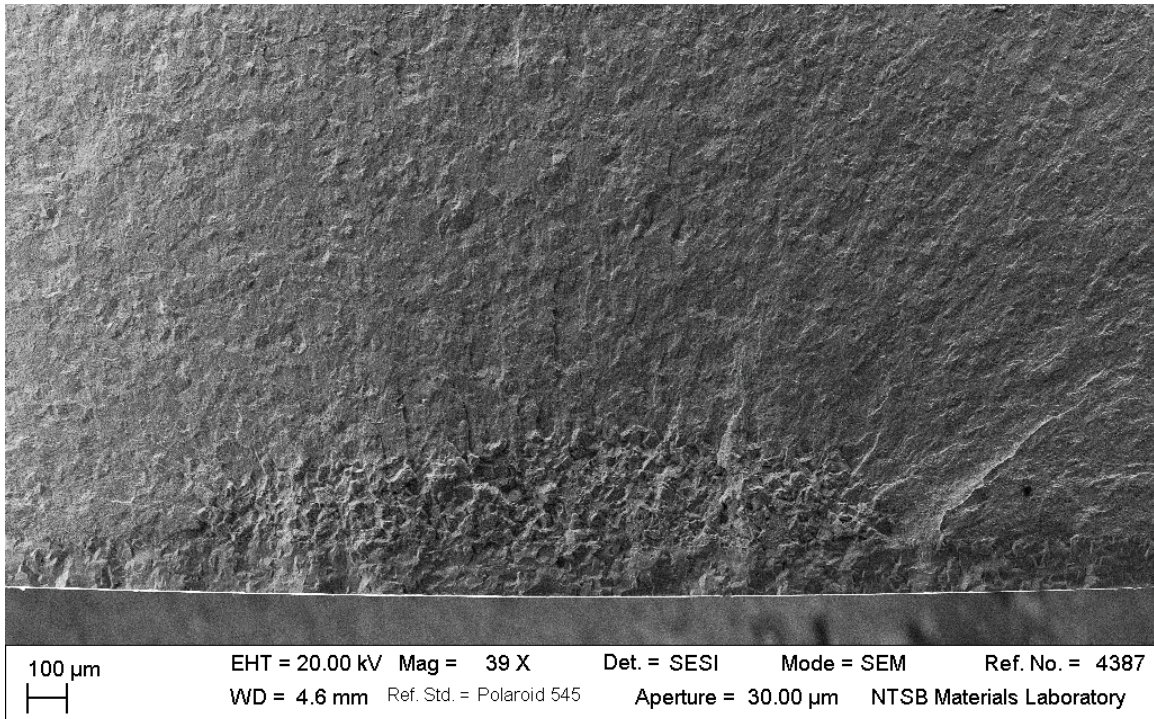
A thin layer of intergranular cracking was present below the chromium electroplating layer (see Figure 15). This intergranular cracking area was consistent with the location of the origin of the thumbnail crack (Figure 16). Internal to this intergranular region was a series of small ratchet marks, consistent with multiple small cracks coalescing as they propagated inward. The intergranular region measured approximately 0.011 inches deep and was approximately 0.074 inches in width.

Figure 15 – SE micrograph showing the intergranular initiation region in Figure 13.

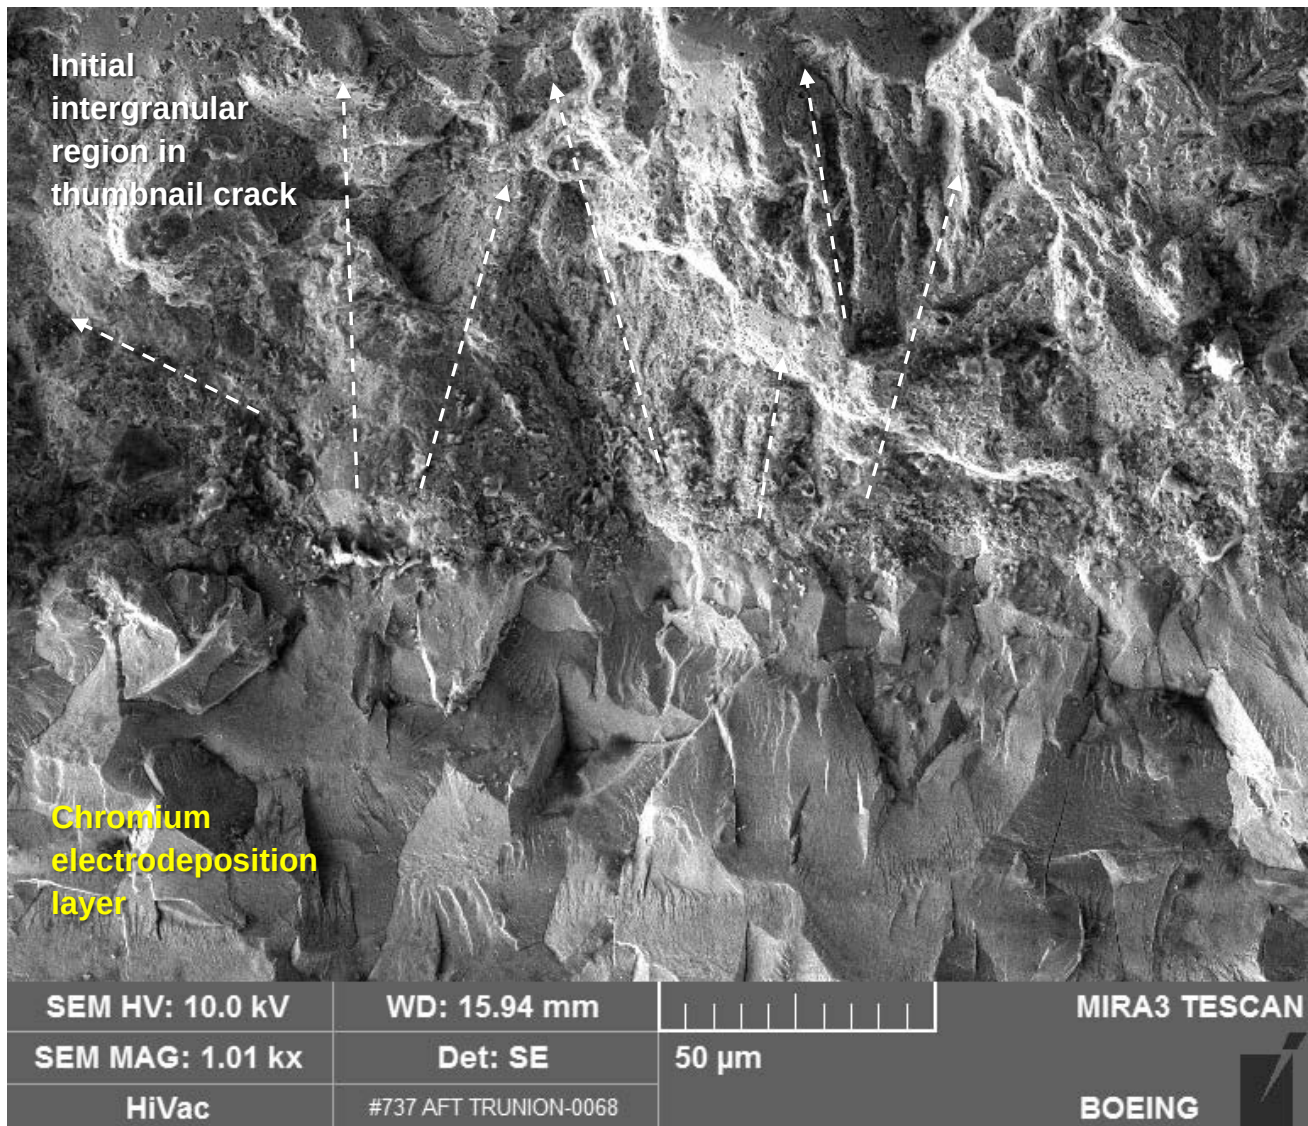
Figure 16 – SE micrograph of the transition between the faceted fracture in the chromium electrodeposition plating (lower) and intergranular region of the pin substrate (upper) in the thumbnail crack initiation area from the forward pin fracture surface, after two cleaning procedures. The white dashed arrows denote general fatigue crack propagation directions in this area.

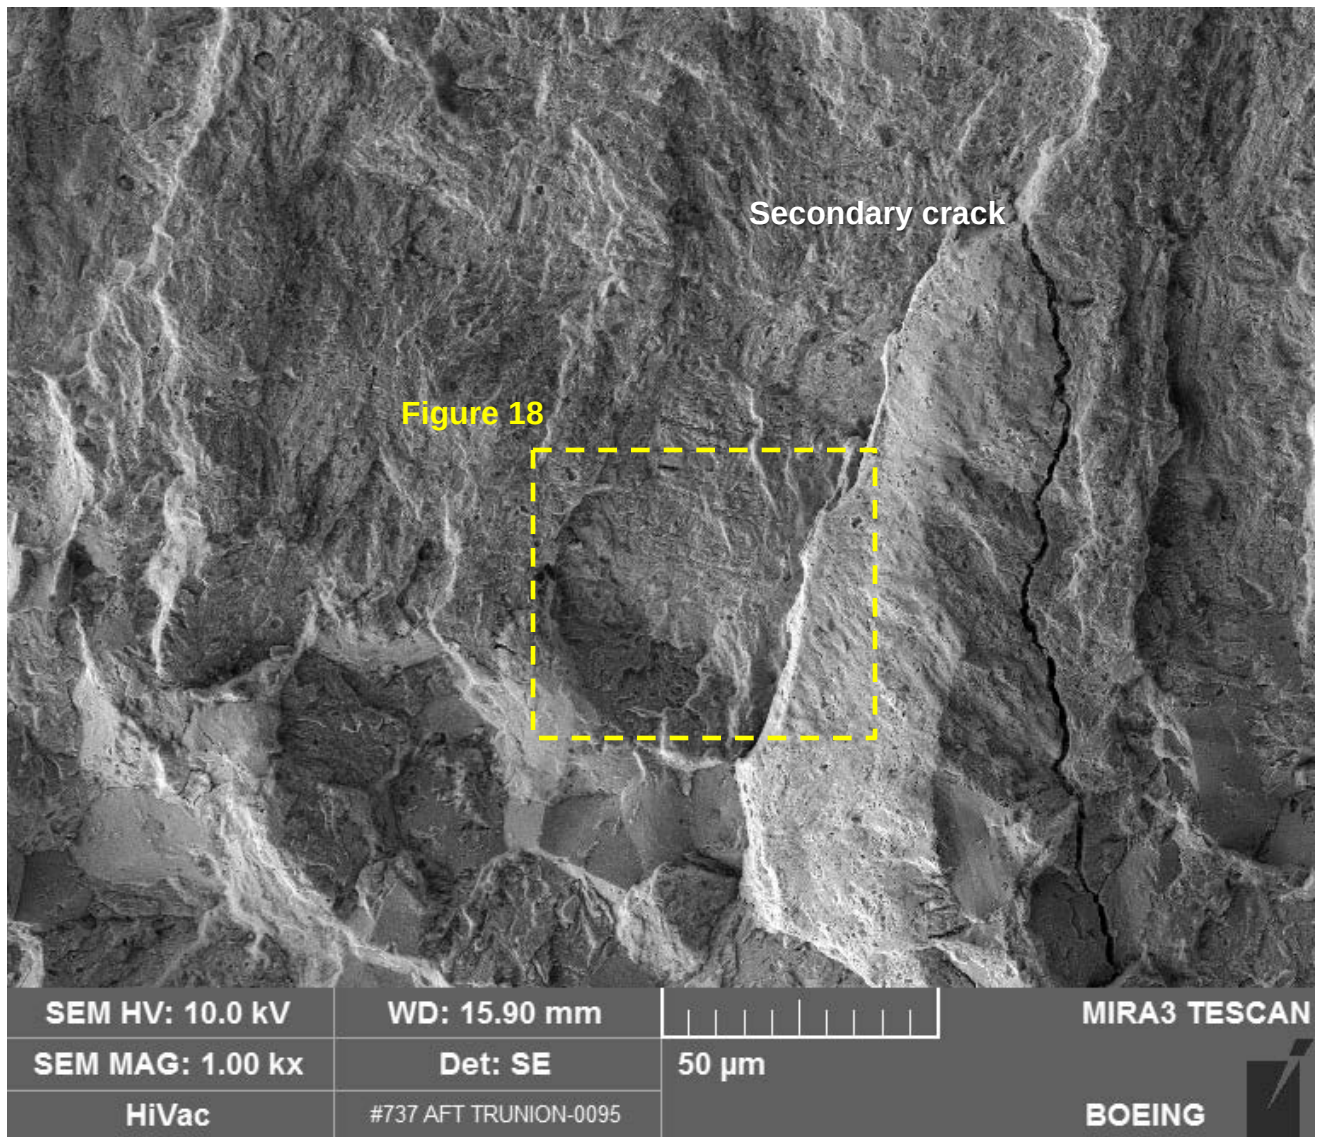
Figure 17 shows a closer view of one of the facets in the intergranular region. This area exhibited a secondary crack, which was a crack that had propagated perpendicular to the fracture surface. Just above the middle facet highlighted in Figure 17 was the transition to

Figure 17 – SE micrograph showing an area of the edge of the intergranular region, with a secondary crack on one of the facets. The boxed area is shown in Figure 18.

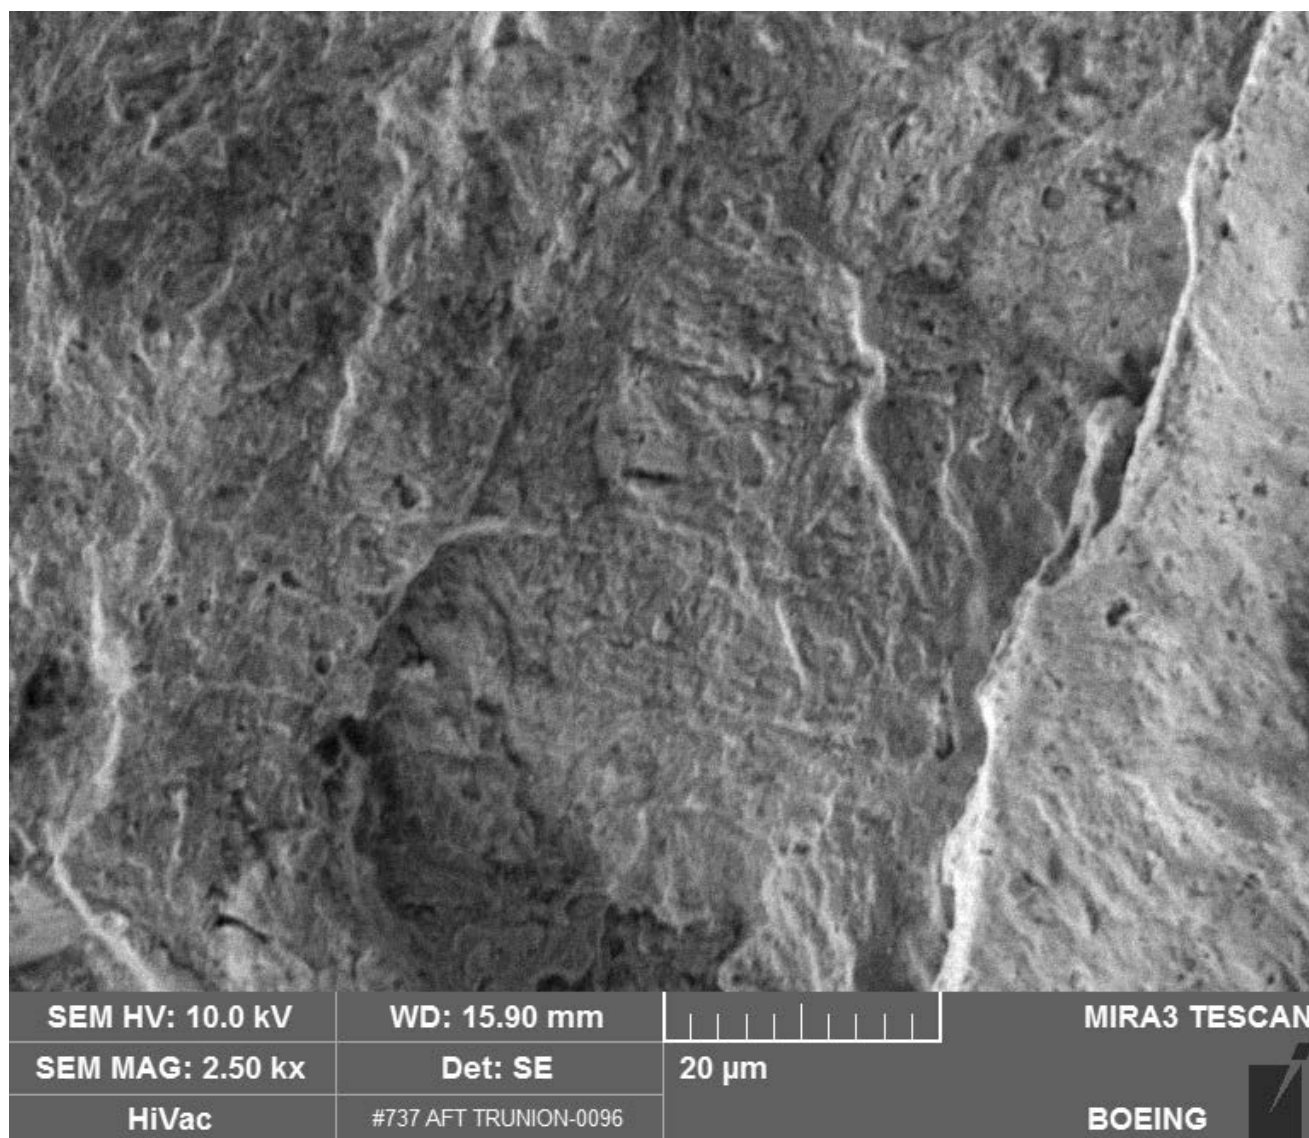
different fracture features. As highlighted in Figure 18, these features were sequential bands parallel to the intergranular facet, consistent with fatigue striations.

Figure 18 – SE micrograph of the boxed area in Figure 17, showing fatigue striations, propagating from lower left to upper middle in the figure.
