# NATIONAL TRANSPORTATION SAFETY BOARD

## MATERIALS LABORATORY FACTUAL REPORT

Report No. 20-014

Place : Denver, Colorado  
Date : December 22, 2019  
Vehicle : Boeing 737-800, N87513  
NTSB No. : DCA20LA047  
Investigator : Dan Bower, AS-10

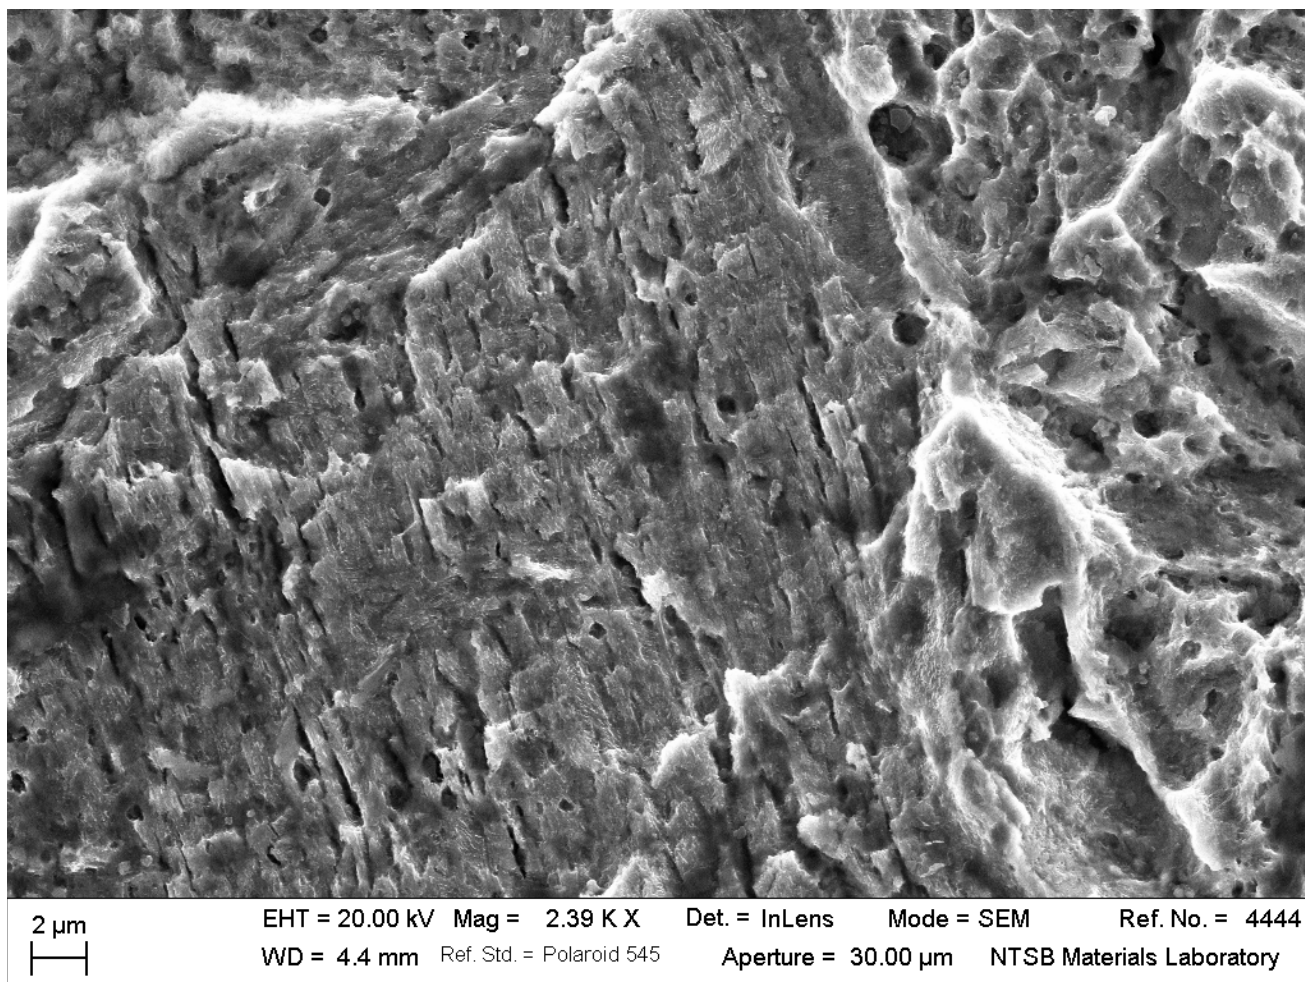
The remainder of the thumbnail crack exhibited fatigue striations, consistent with fatigue crack propagation (Figure 19). There was no indication of mixed mode features, such as dimpled rupture or intergranular cracking within the fatigue regions of the darker portions of the thumbnail crack. In the outer areas of the thumbnail crack (those not discolored visually), some bands of dimpled rupture were observed among fatigue striations.

Figure 19 – SE micrograph of fatigue striations from the end of the fatigue thumbnail crack on the forward pin remnants fracture surface, after two cleaning procedures.

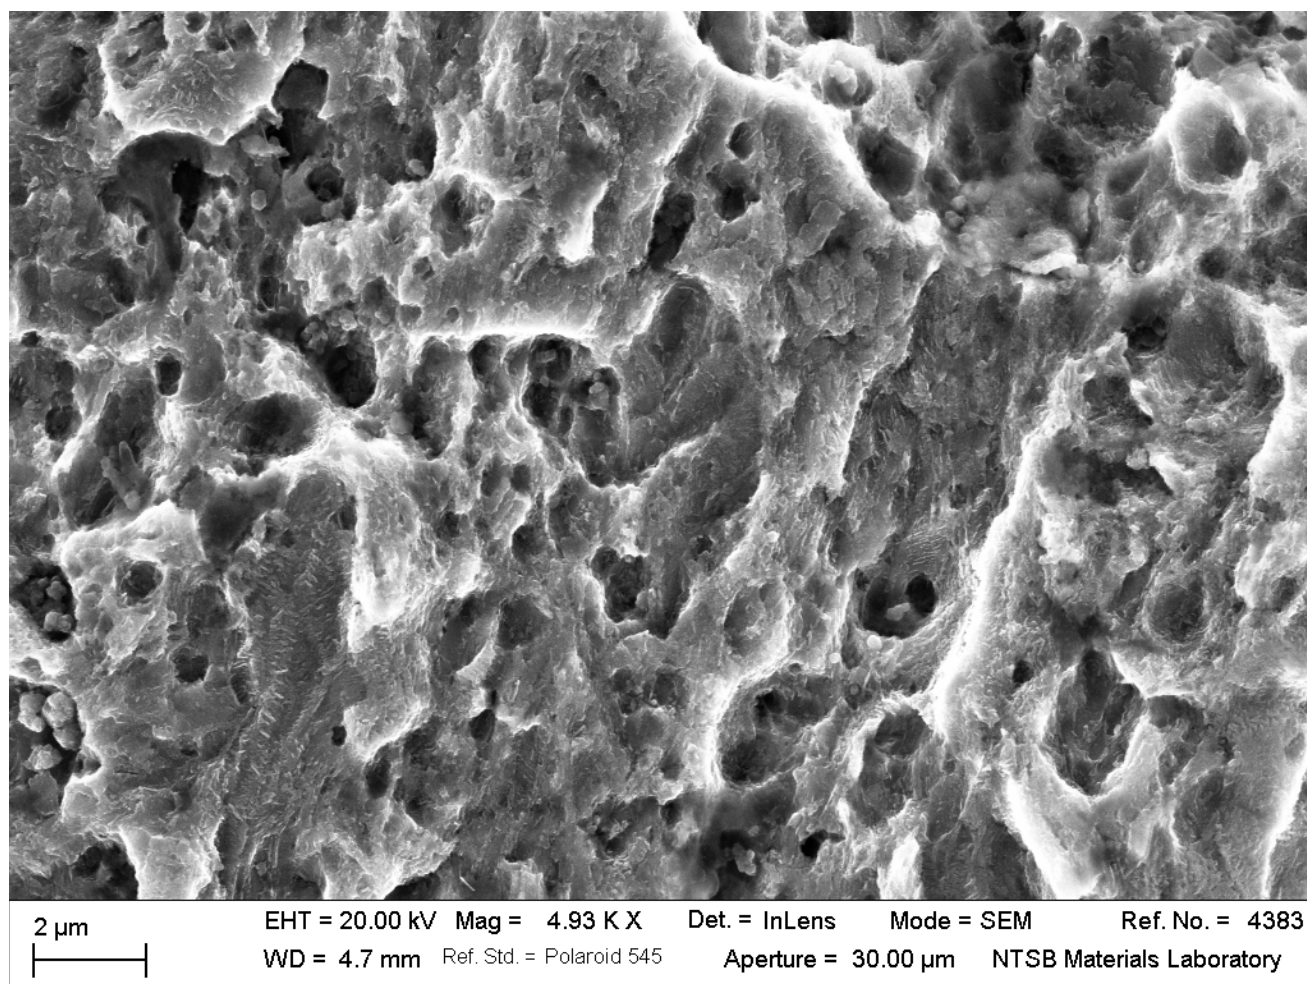
Outside of the thumbnail crack, dimpled rupture was observed—these features were consistent with subsequent overstress fracture that occurred during the final fracture upon the accident landing event (Figure 20). Along the edge of the fracture surface, the thumbnail crack bowed, consistent with lateral as well as depth-wise crack propagation (see Figure 21). These areas also exhibited fatigue striations. There were indications of striations along the chromium electroplated layer, as shown in Figure 21.

Figure 20 – SE micrograph of a typical area outside the fatigue thumbnail crack in Figure 9, showing dimpled rupture.

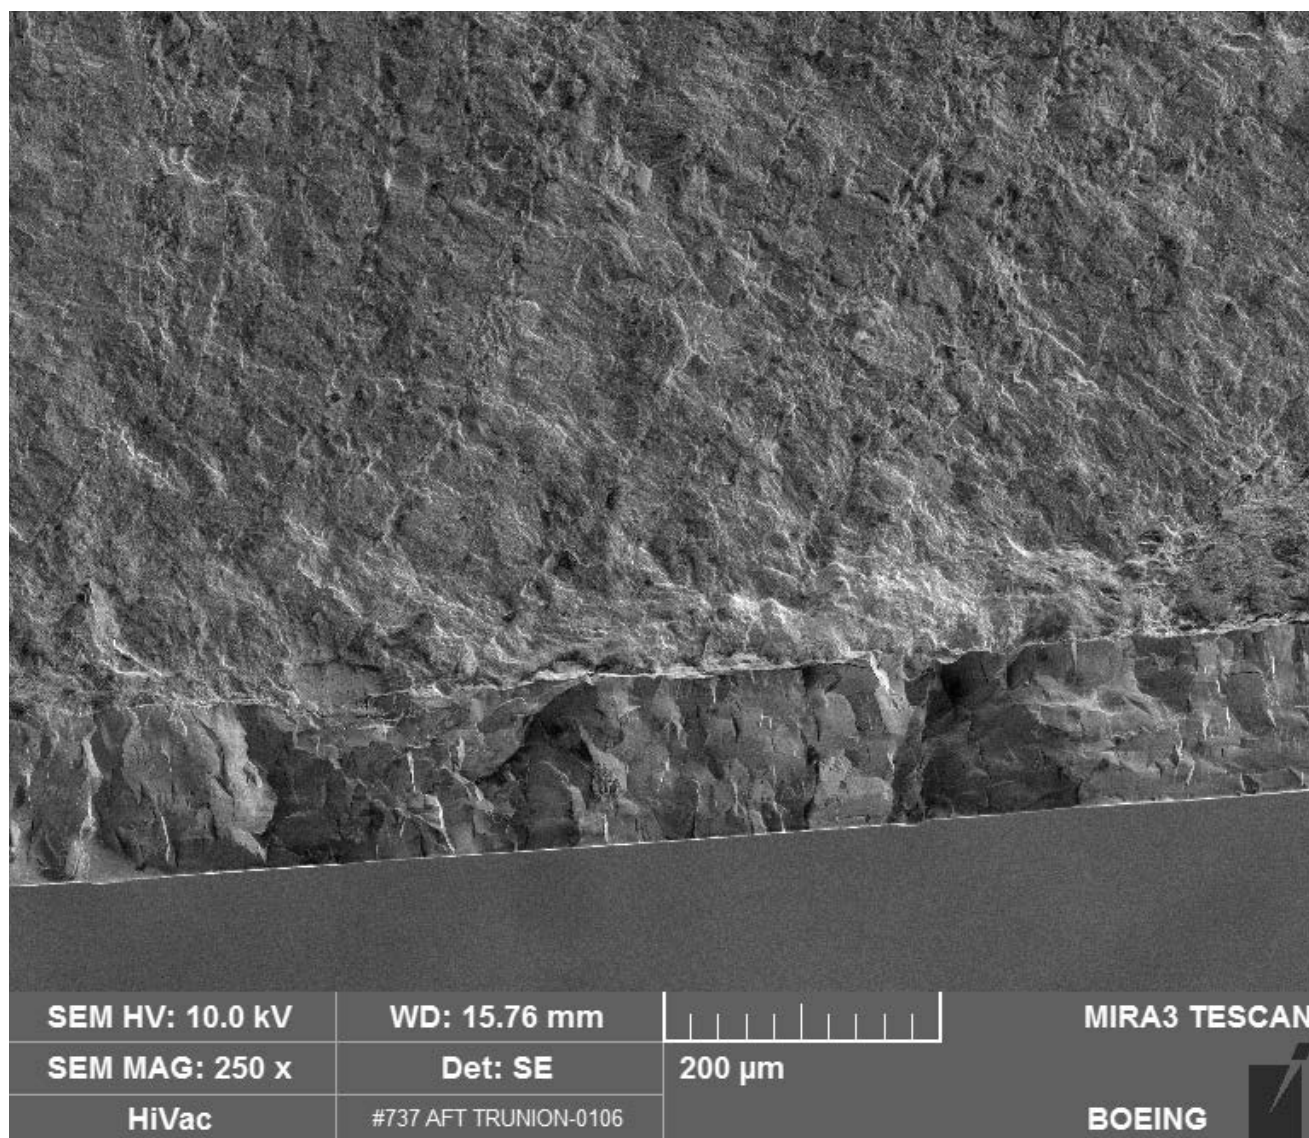
Figure 21 – SE micrograph of the end of the thumbnail crack along the edge, located right of the crack initiation region shown in Figure 15, showing the fracture features in the chromium electroplating layer.

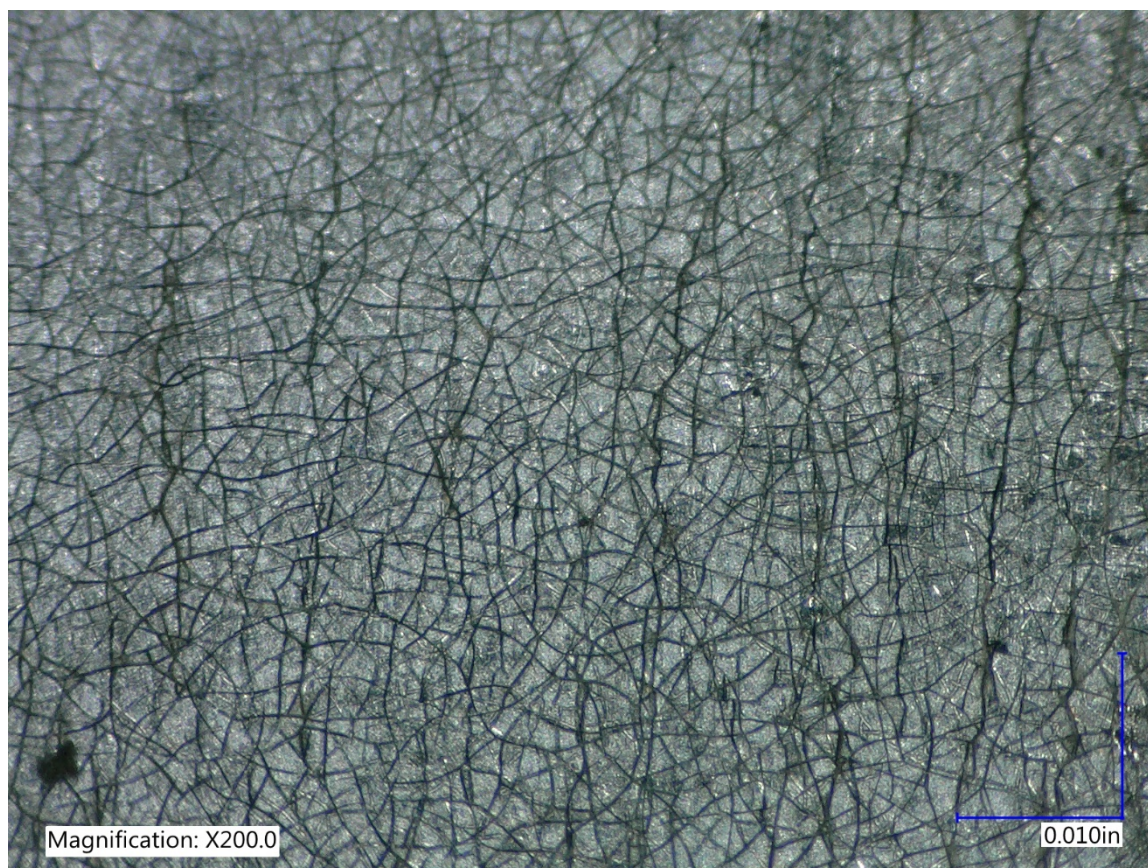
Figure 23 – View of the partially-stripped chromium electroplated layer from the aft pin remnant.

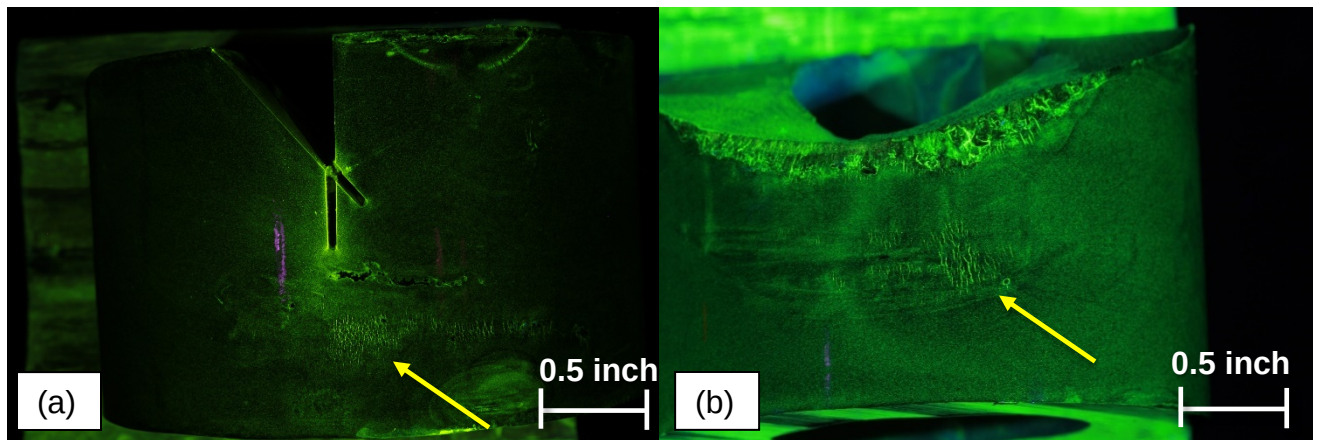
The stripped aft section of the pin was examined using MPI (illustrated in Figure 24). This nondestructive inspection revealed longitudinal ladder cracks, located in the area of material transfer and elevated Barkhausen noise indications, shown in Figure 4b. This cracking pattern was consistent with those observed from a subsequent FPI inspection, as illustrated in Figure 25.

Figure 24 – The (a) 12 o'clock and (b) 6 o'clock faces of the aft trunnion piece, after sectioning in Figure 22, exposed to UV light after MPI, showing longitudinal cracking (arrows).

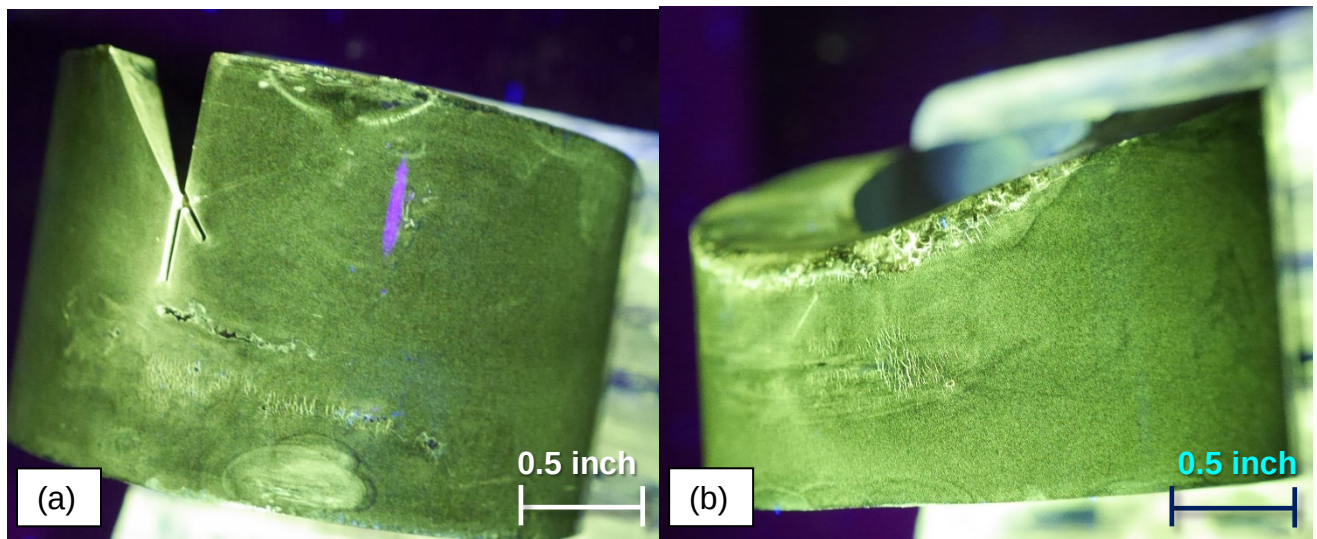
Figure 25 – The (a) 12 o'clock and (b) 6 o'clock faces of the aft trunnion piece, after sectioning in Figure 22, exposed to UV light after FPI, showing ladder cracking (arrows).

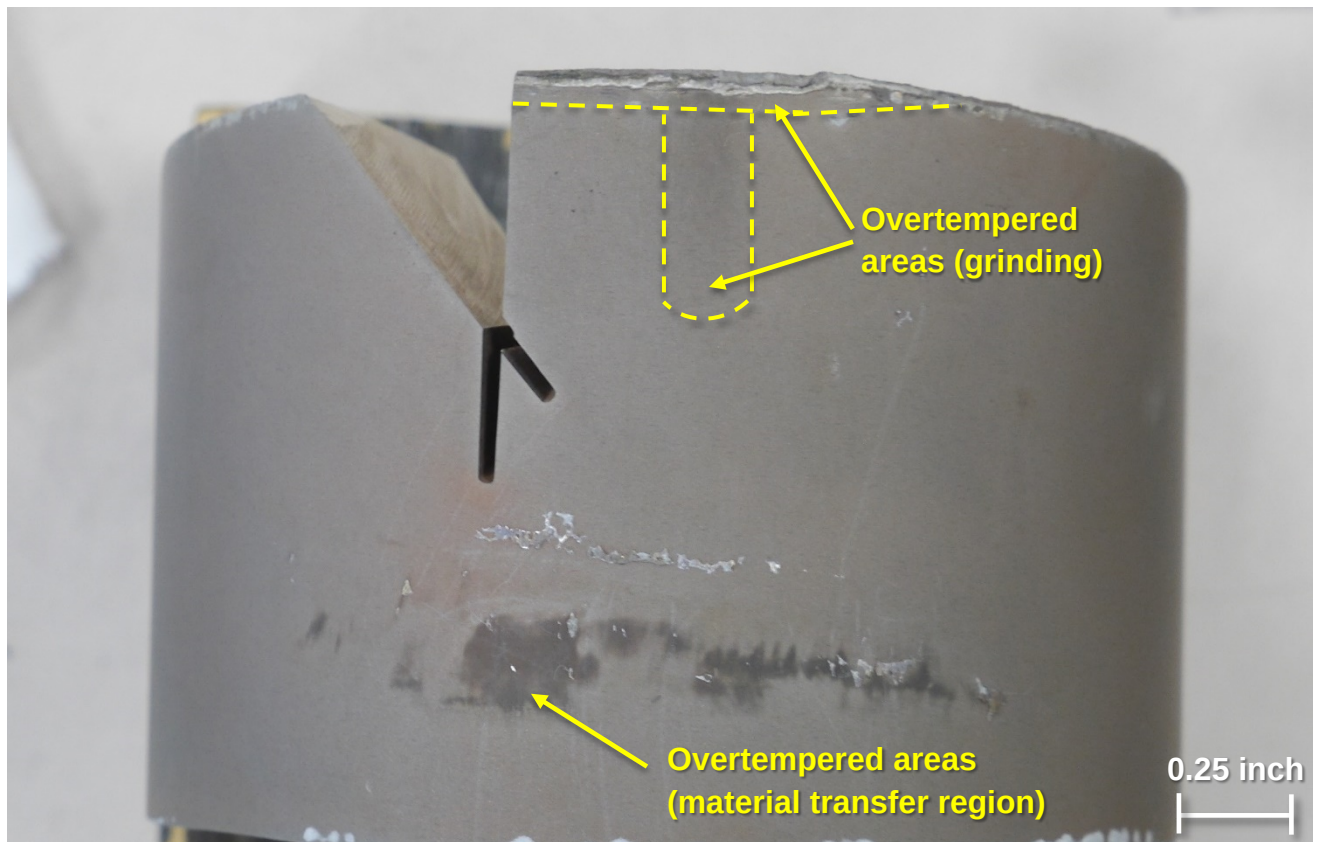
The stripped surfaces were then etched in a 2% Nital bath. As shown in Figure 26, there were two areas exhibiting darker contrast on the surface, consistent with localized elevated iron carbide content, indicative of localized overtempering. There was an area approximately 0.5 inches from the fracture origin, and an area noted adjacent to the fracture surface. These marks were consistent with heat exposure, typical of a previous grinding operation. The stripped material transfer area also exhibited more pronounced darker regions, consistent with overtempering (Figure 27). This area was consistent with the location of the ladder cracks identified by MPI.

Figure 26 – The 12 o'clock face of the aft pin remnant, after temper etch using 2% Nital etch. The areas of noted overtempering are annotated.

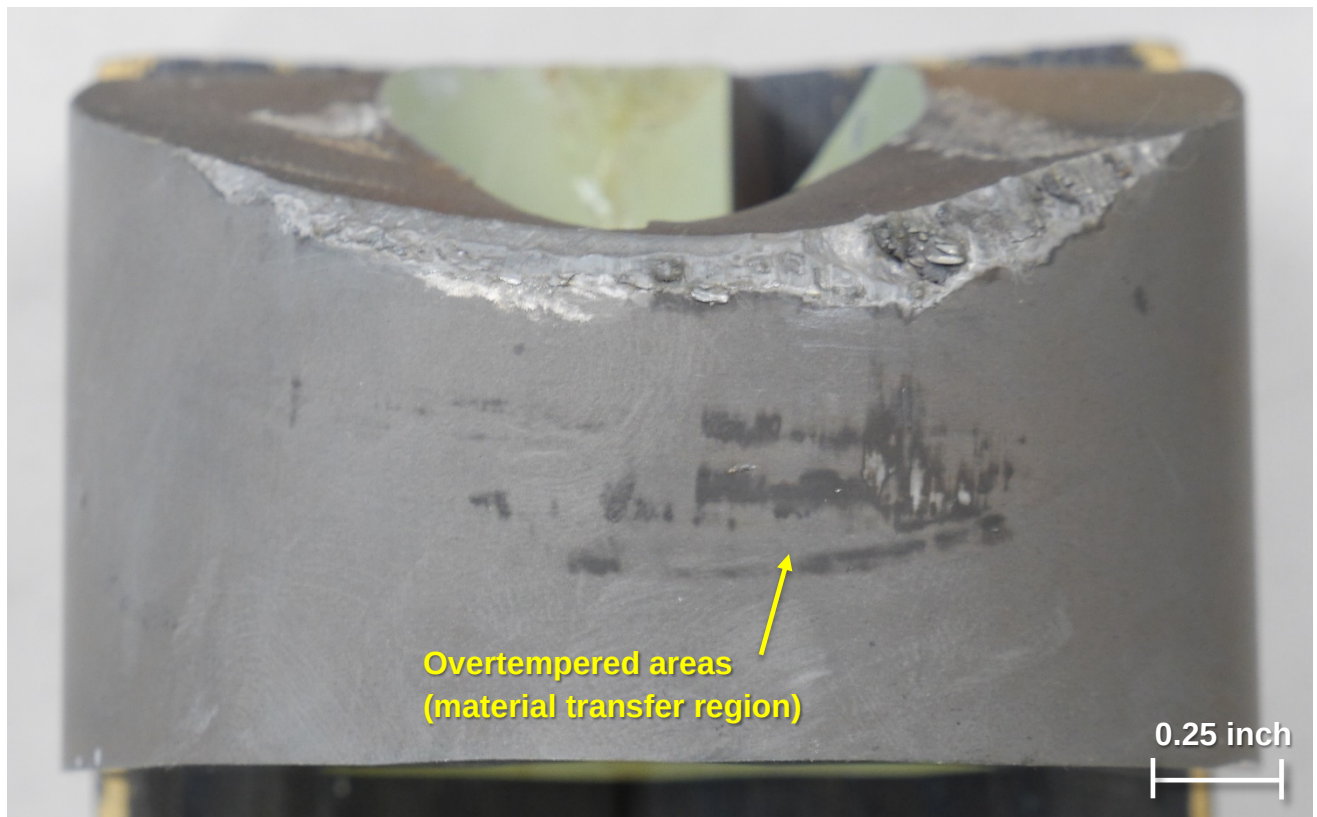
Figure 27 – The 6 o'clock face of the aft pin remnant, after temper etch using 2% Nital etch. The areas of noted overtempering are annotated.

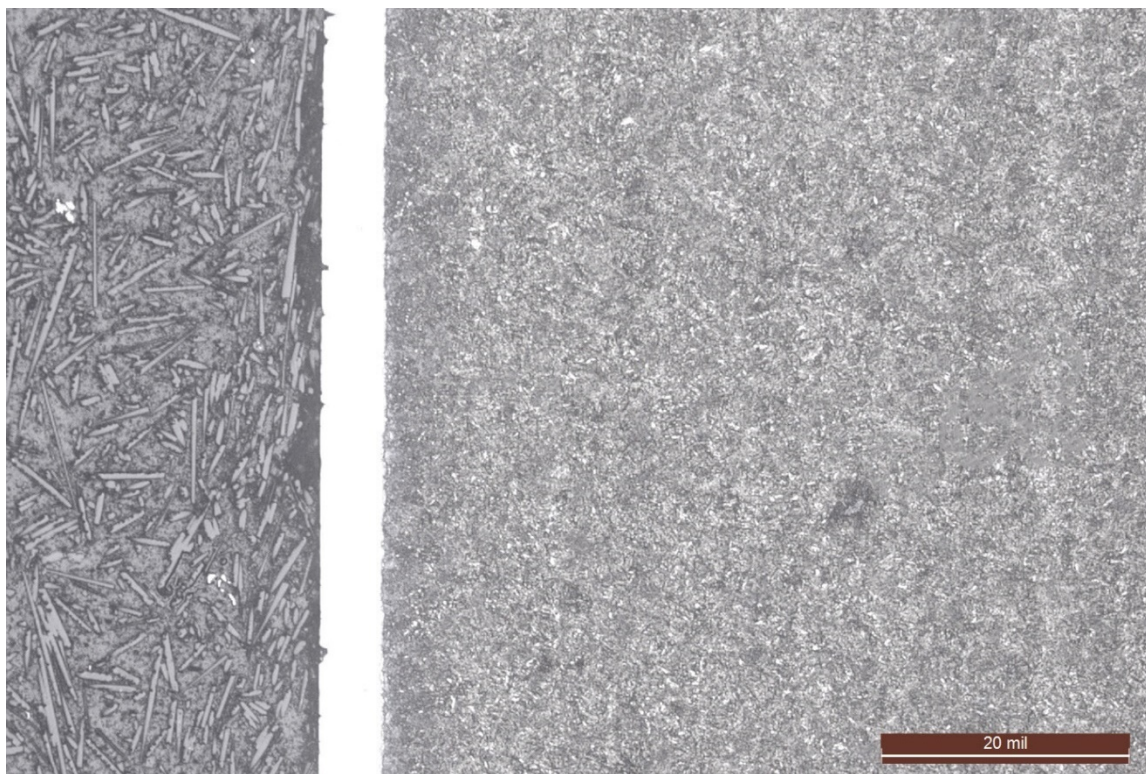
Overall, the microstructure of the aft thumbnail cross section was consistent with tempered martensite. The area of the underlying etched steel microstructure exhibited a darker color in response to the etch underneath the chromium electroplated layer (left side of Figure 29). A closer view of this subsurface darker region is highlighted in Figure 35.

Figure 29 – BF optical micrograph of an etched version of Figure 28, showing the a darker etch response adjacent to the chromium electroplated layer (~50X, etched 2% Nital).

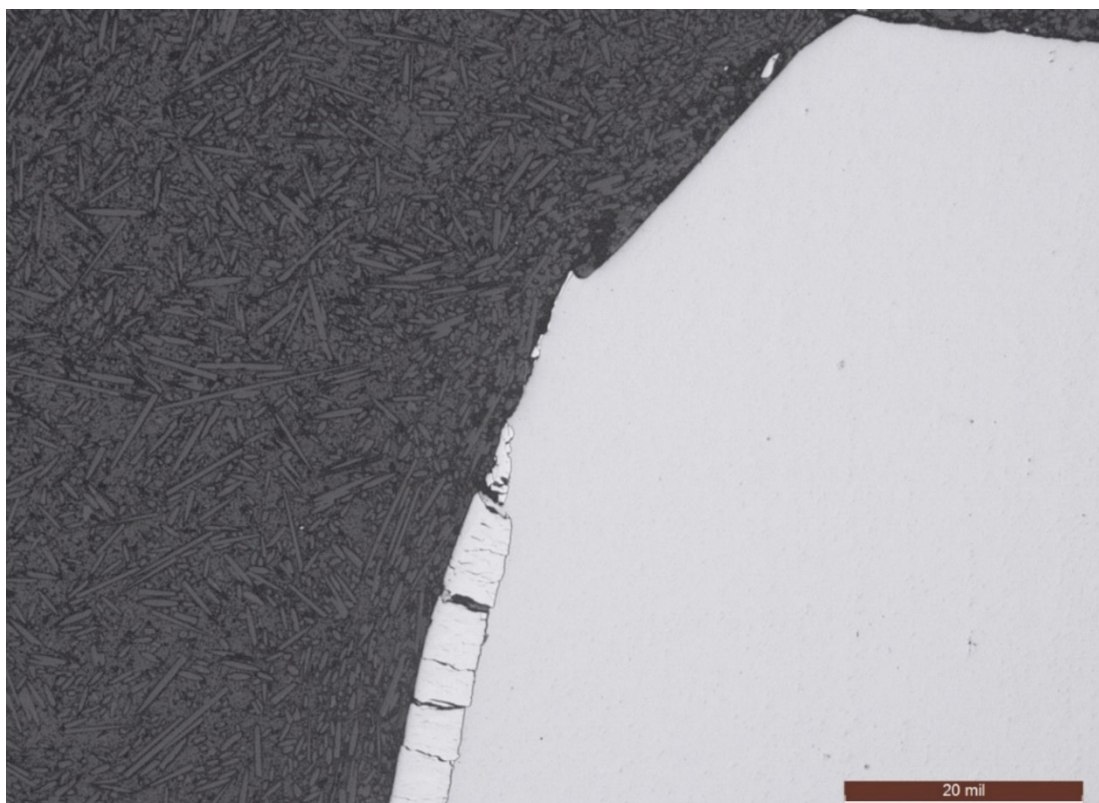
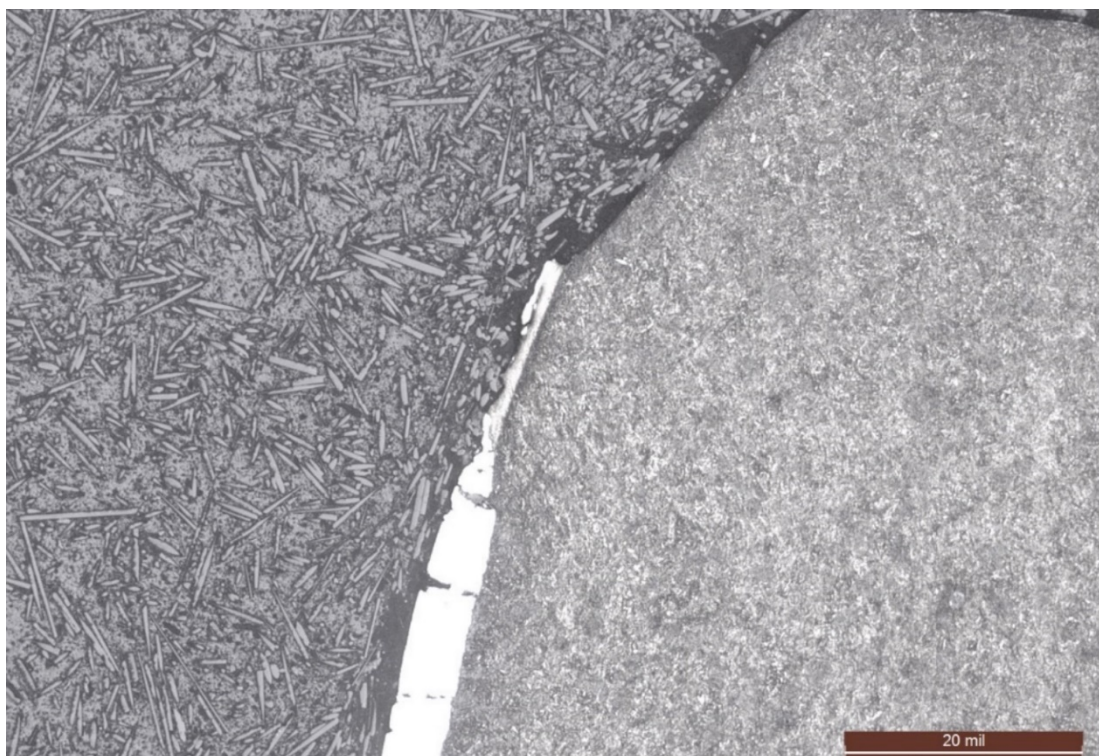
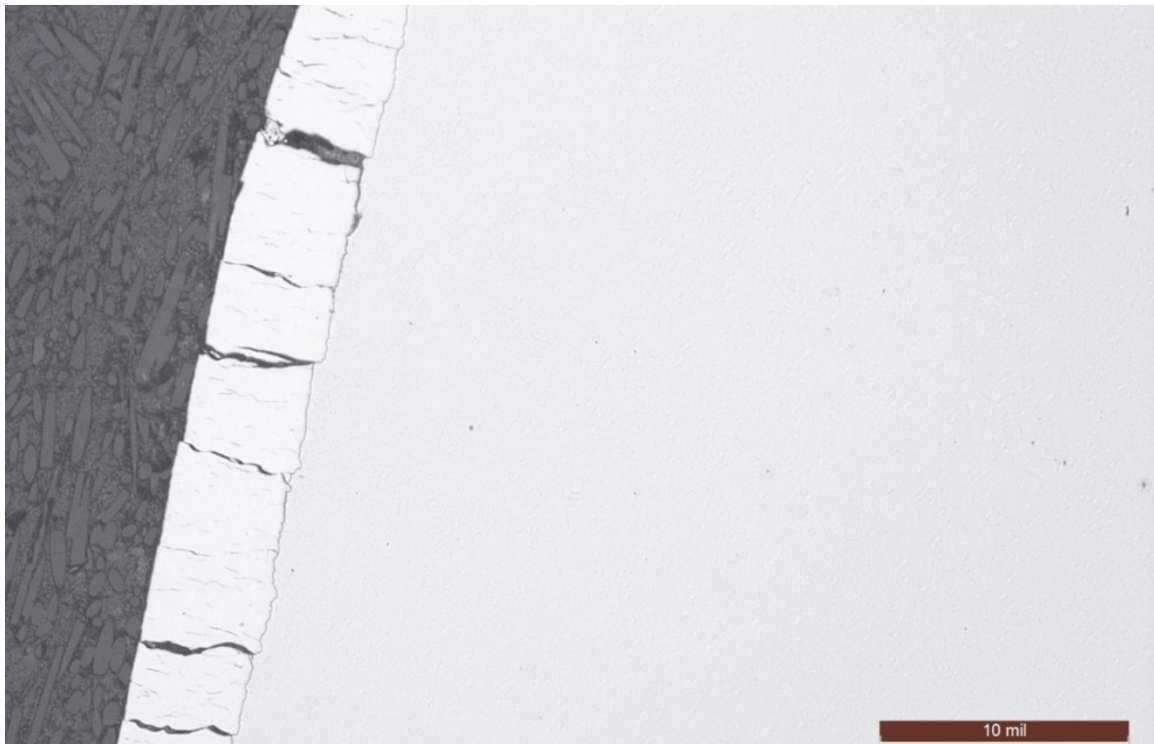
The chromium electroplated layer adjacent to the beveled edge of the thumbnail crack exhibited through cracking (Figure 30 through Figure 32). This cracking was present only in the areas consistent with post fracture impact damage. No indications of secondary cracking were found emanating from either the fracture surface or the outer diameter (plated) surface of the cross section (compare with Figure 28). The beveled area closest to the fracture surface was absent chromium electroplated layer and exhibited a localized area of a lighter-etching microstructure, consistent with untempered martensite (Figure 33). This damage mirrored that observed macroscopically on the mating aft pin remnant (shown in Figure 34 after chromium electroplated layer stripping and acid etching).

Figure 30 – Bright field (BF) optical micrograph of the cross section through the thumbnail crack on the aft fracture surface (~50X, as-polished).

Figure 31 – BF optical micrograph of the location in Figure 30, after etching (~50X, etched 2% Nital).

Figure 32 – BF optical micrograph of a closer view of the cracking in the chromium electroplated layer near the edge with the fracture surface (~100X, as-polished).

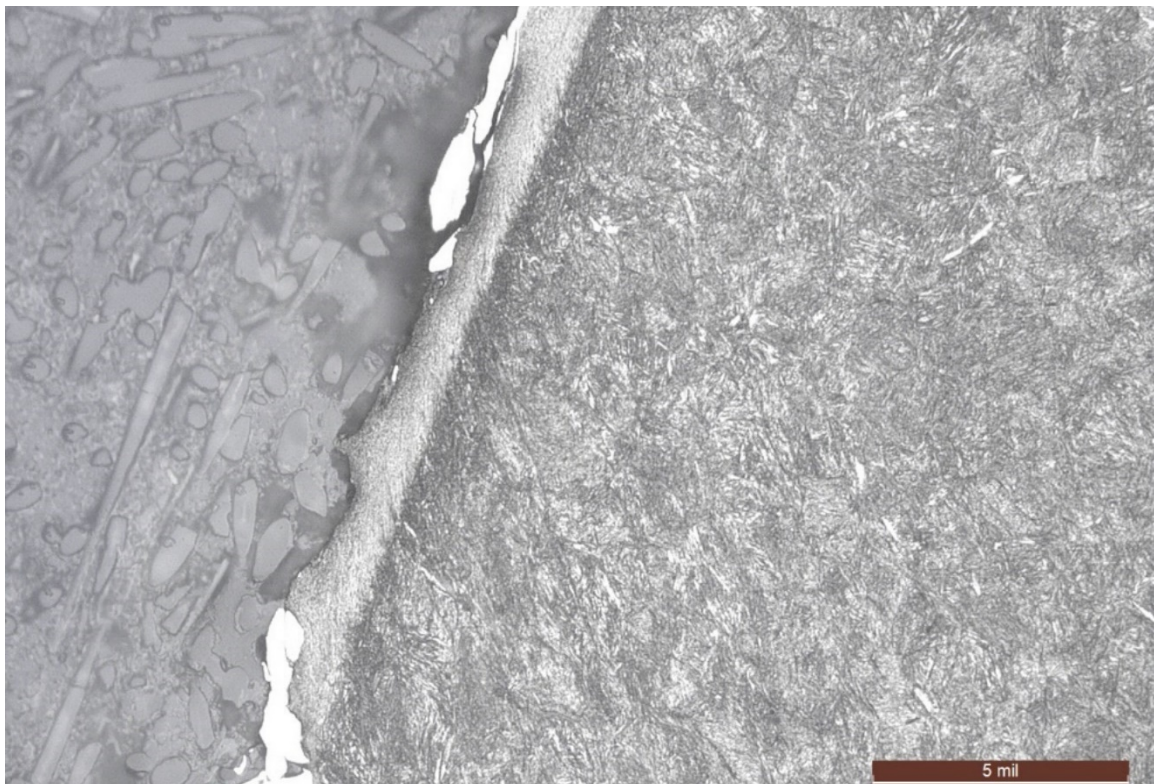
Figure 33 – BF optical micrograph of an area adjacent the impacted fracture surface edge, showing a lack of chromium electroplated layer and a distressed surface region (~200X, etched 2% Nital).

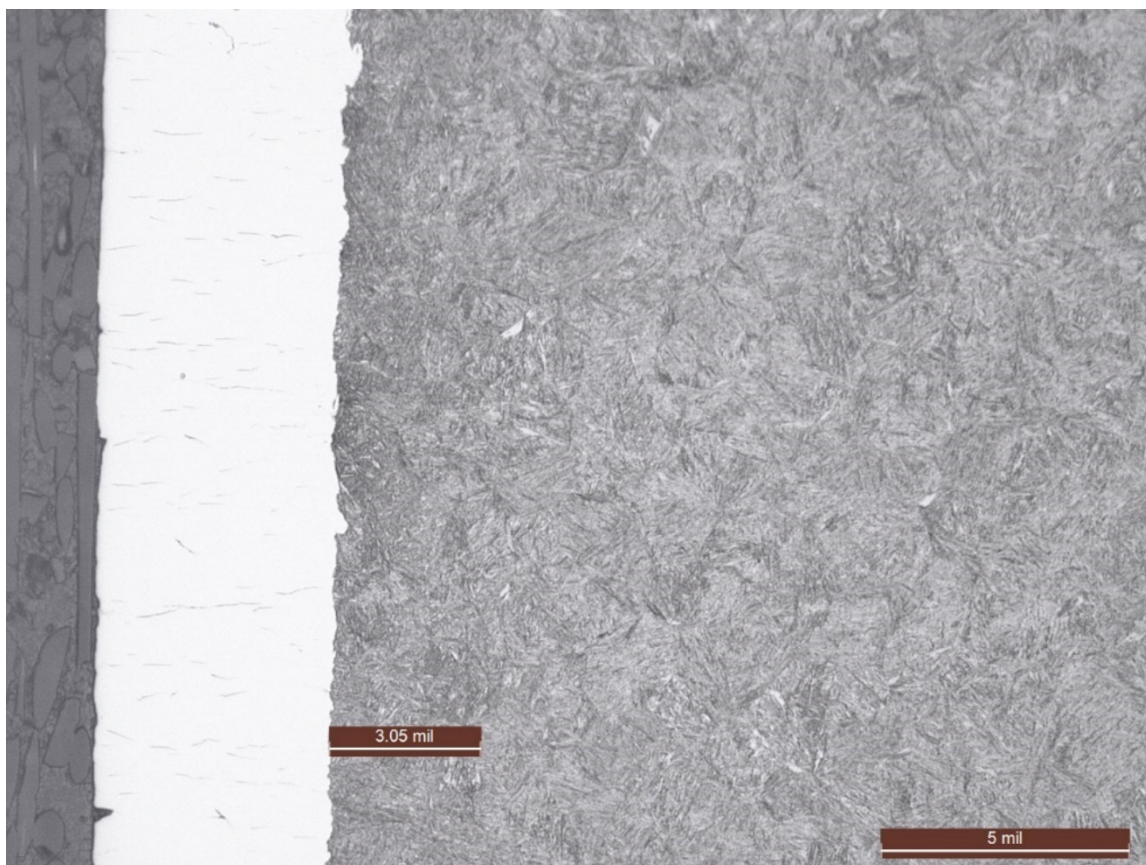
The regions just under the chromium electroplated layer exhibited a darker color, consistent with a different etching response than the rest of the pin steel. This darker region was consistent with an area of higher iron carbide content, indicative of localized overtempering.

Figure 35 – BF optical micrograph of a closer view of the pin surface, showing the relative depth of the darker subsurface area (~500X, etched 2% Nital).

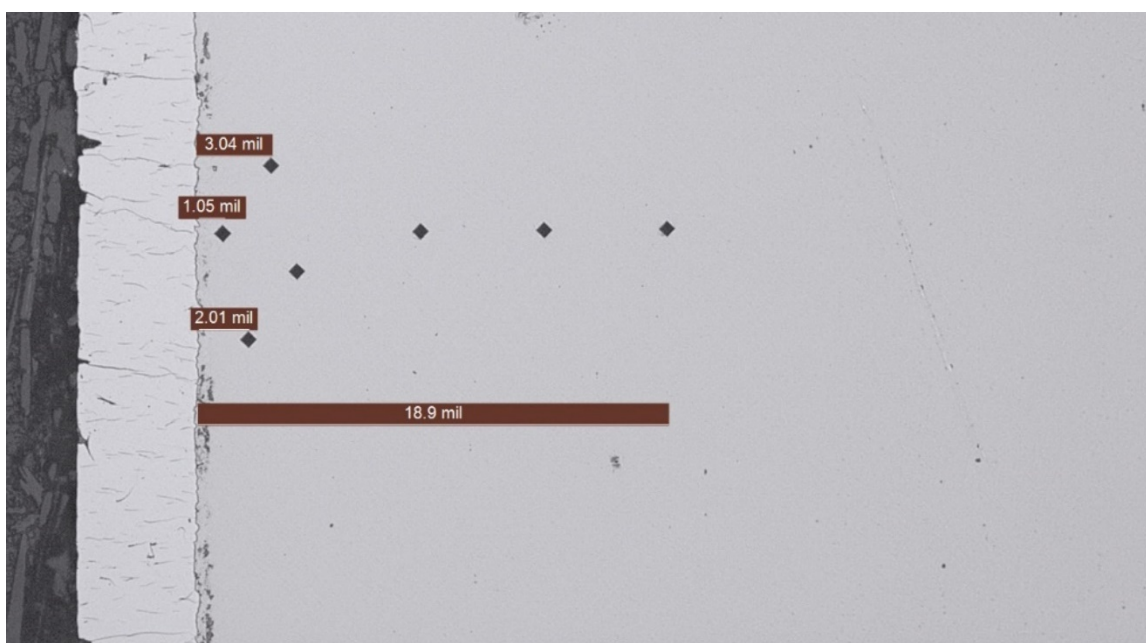
The hardness was examined using a microindentation hardness method using a 100 gram load for Vickers hardness ( $HV_{100}$ ), consistent with ASTM E384.<sup>5</sup> The data were converted per ASTM E140.<sup>6</sup> The hardness in the core averaged 55 to 56 HRC (595 to 613  $HK_{100}$ ). The hardness of the core material adjacent to the chromium electroplated layer measured 52 HRC (540  $HK_{100}$ ).

Figure 36 – BF optical micrograph of a closer view of the pin surface, showing the location of microindentation hardness indents (~200X, as-polished).

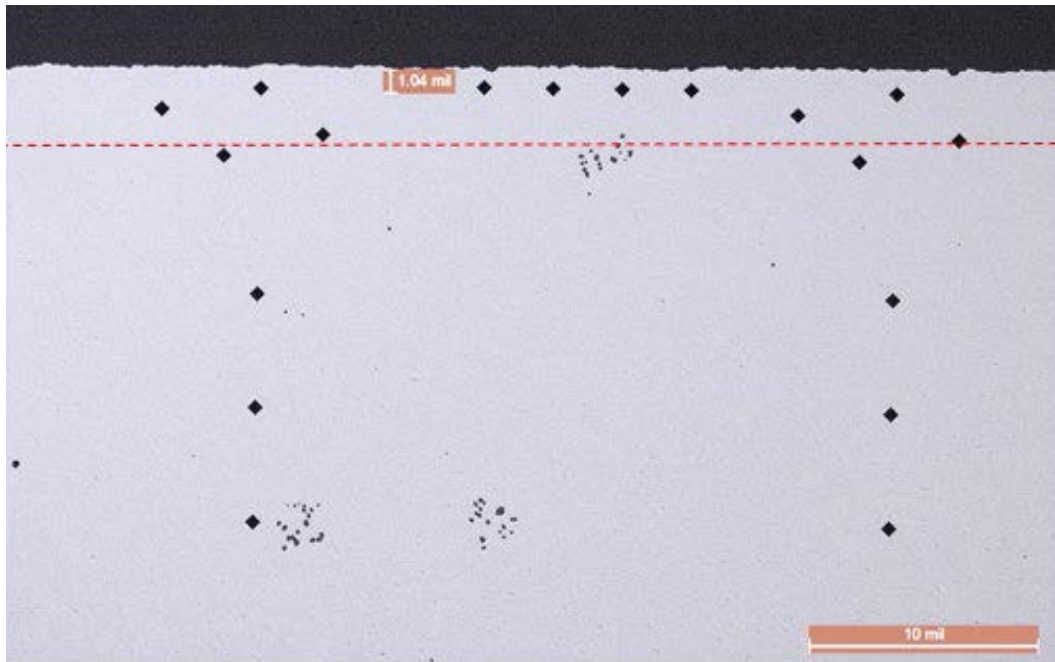
A similar cross section was taken through the darker colored region in the etch aft pin outer diameter surface region, highlighted in Figure 26. Figure 37 shows the microindentation hardness indents in this cross section. Whereas the core regions (away from the outer

diameter surface) exhibited an average hardness between 55 to 56 HRC, the areas closest to the surface exhibited a lower hardness of 53 HRC (556 HK<sub>100</sub>).

Figure 37 – BF optical micrograph of a cross section through the darker area in Figure 26, showing the series of microindentation hardness indents approaching and along the surface (~200X, as-polished).
