**NATIONAL TRANSPORTATION SAFETY BOARD**  
Office of Aviation Safety

**STRUCTURES GROUP CHAIRMAN'S FACTUAL REPORT**

**DCA20LA107**

Operator: Swift Air, Flight 3518  
Location: Victorville, California  
Date: May 19, 2020  
Time: 1500 Pacific Daylight Time (PDT)  
Aircraft: Boeing 737-8Q8  
Registration: N820TJ

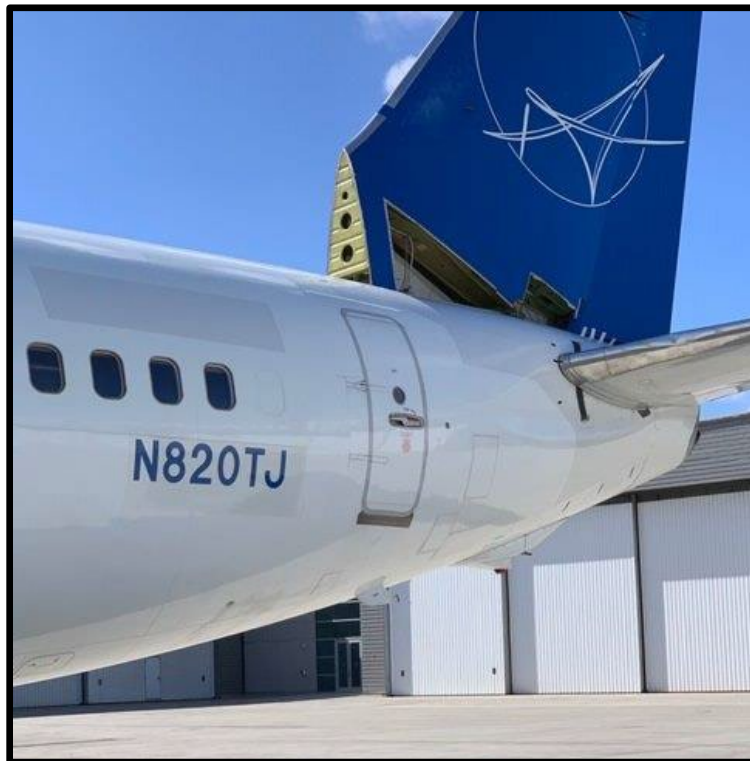
Post-flight inspection of the aircraft found that the dorsal fin and three panels on the lower left side of the vertical stabilizer were missing (Figure 1). The missing panels and dorsal fin were not recovered. The fuselage crown skin, left horizontal stabilizer, and vertical stabilizer sustained damage. The upper fuselage crown skin was dented, punctured, and gouged at four locations between fuselage station (FS) 666 and FS 1005 and between stringer (S) S-2L and S-5L. The left horizontal stabilizer leading edge had multiple dents, gouges, and punctures along its length. The left horizontal stabilizer lower skin had multiple dents, gouges, and punctures from stabilizer station (SS) 267 outboard to the tip. The left horizontal stabilizer upper skin had multiple dents, gouges, and punctures from SS 75 to the tip. The left horizontal stabilizer front spar upper chord was fractured between SS 263 and SS 278, the lower chord was deformed between SS 298 and SS 301, and the web was gouged at SS 226 and SS 264.5. The panel attach structure on the lower left side of the vertical stabilizer was fractured and deformed in several places.

*Figure 1-N820TJ missing dorsal fin and vertical stabilizer panels.*

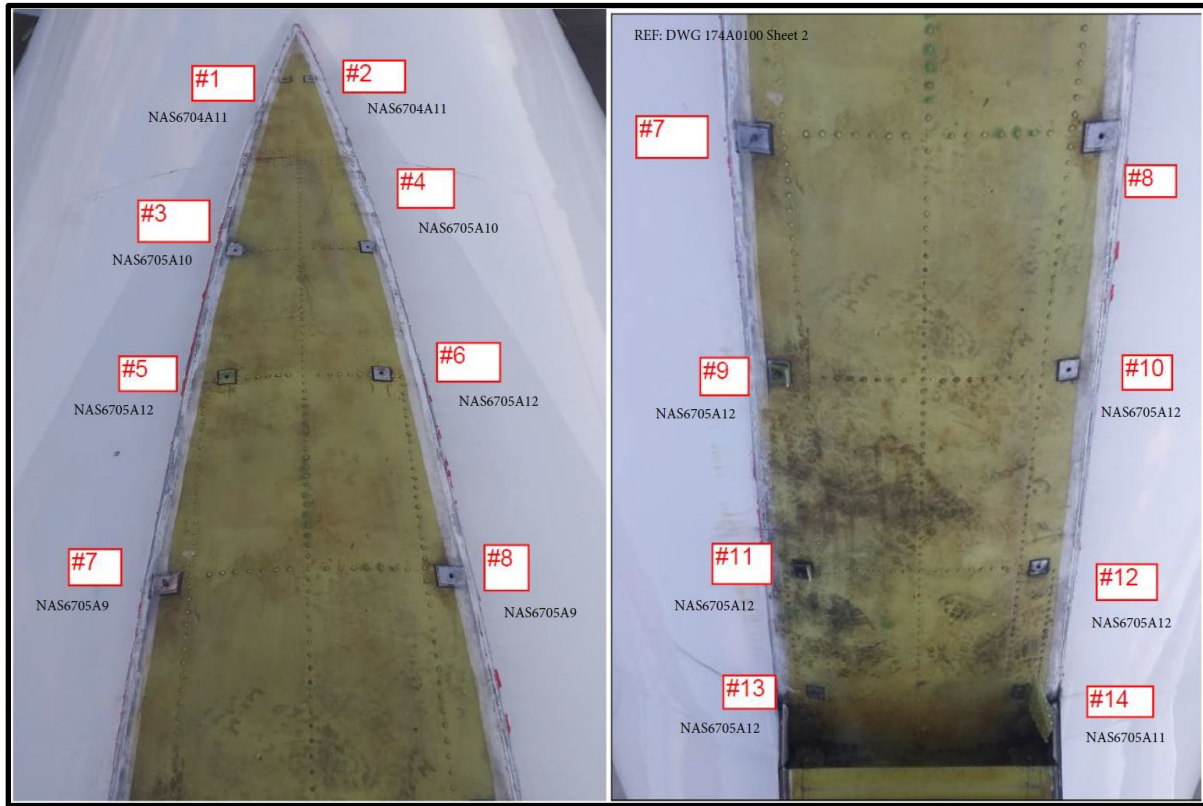
The dorsal fin is normally attached to the upper fuselage at 14 locations. Figure 2 is a photo of the attach points on the accident airplane after the accident with the holes numbered for identification and the required fastener (bolt) part numbers.

Figure 2-N820TJ Dorsal Fin attach points and required fasteners.

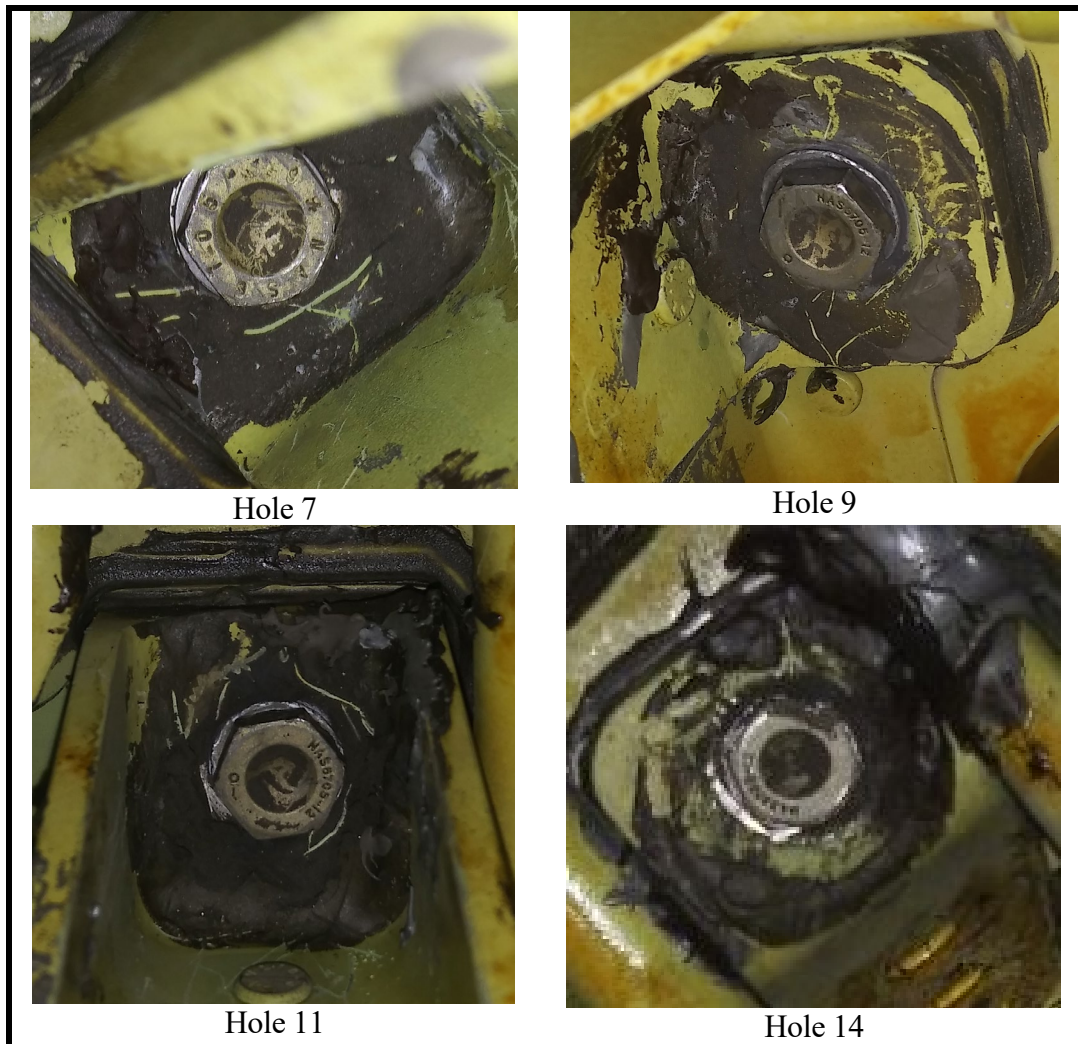
There were no bolts found in holes 1-6, 8, 10, 12, and 13. Bolts remained in holes 7, 9, 11, and 14. Pieces of the dorsal fin rib structures remained attached to the bolts in holes 9, 11, and 14. Three loose bolts were recovered on the interior ceiling panels beneath the dorsal fin location. Photographs of the 4 installed bolts prior to removal were supplied to the investigation by the operator as shown in Figure 3. The bolt installed in hole 7 was marked NAS6705-9, the bolt in hole 9 was marked NAS6705-12, the bolt in hole 11 was marked NAS6705-12, and the bolt in hole 14 was marked NAS6705-12. One of the three loose bolts was marked NAS6705-9, one was marked NAS6705-12, and the marking on the third was partially unreadable but contained an 8, 3, 0 1M, and S (Figure 4).

Figure 3-Bolts remaining at locations 7, 9, 11, and 14.

The photos showed that there was evidence of old sealant material around the installed bolt locations and remnants on the heads of the bolts but no sealant covering the bolt heads. The hole

locations where there were no bolts exhibited a similar lack of sealant. The dorsal fin rib sections that were attached at locations 9, 11, and 14 all had an intact nut plate installed on the upper side that the bolts were threaded into.

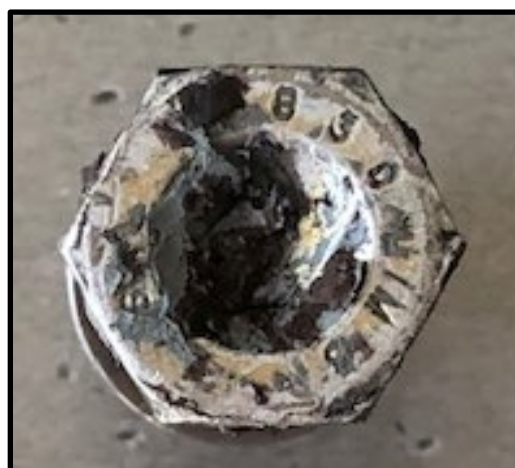
Figure 4-Loose bolt with partially unreadable markings.
