# NATIONAL TRANSPORTATION SAFETY BOARD

## MATERIALS LABORATORY FACTUAL REPORT

Report No. 20-040

Place : Victorville, California  
Date : 5/20/2020  
Vehicle : Boeing 737-8Q8 N820TJ  
NTSB No. : DCA20LA107  
Investigator : Clinton Crookshanks, AS-40

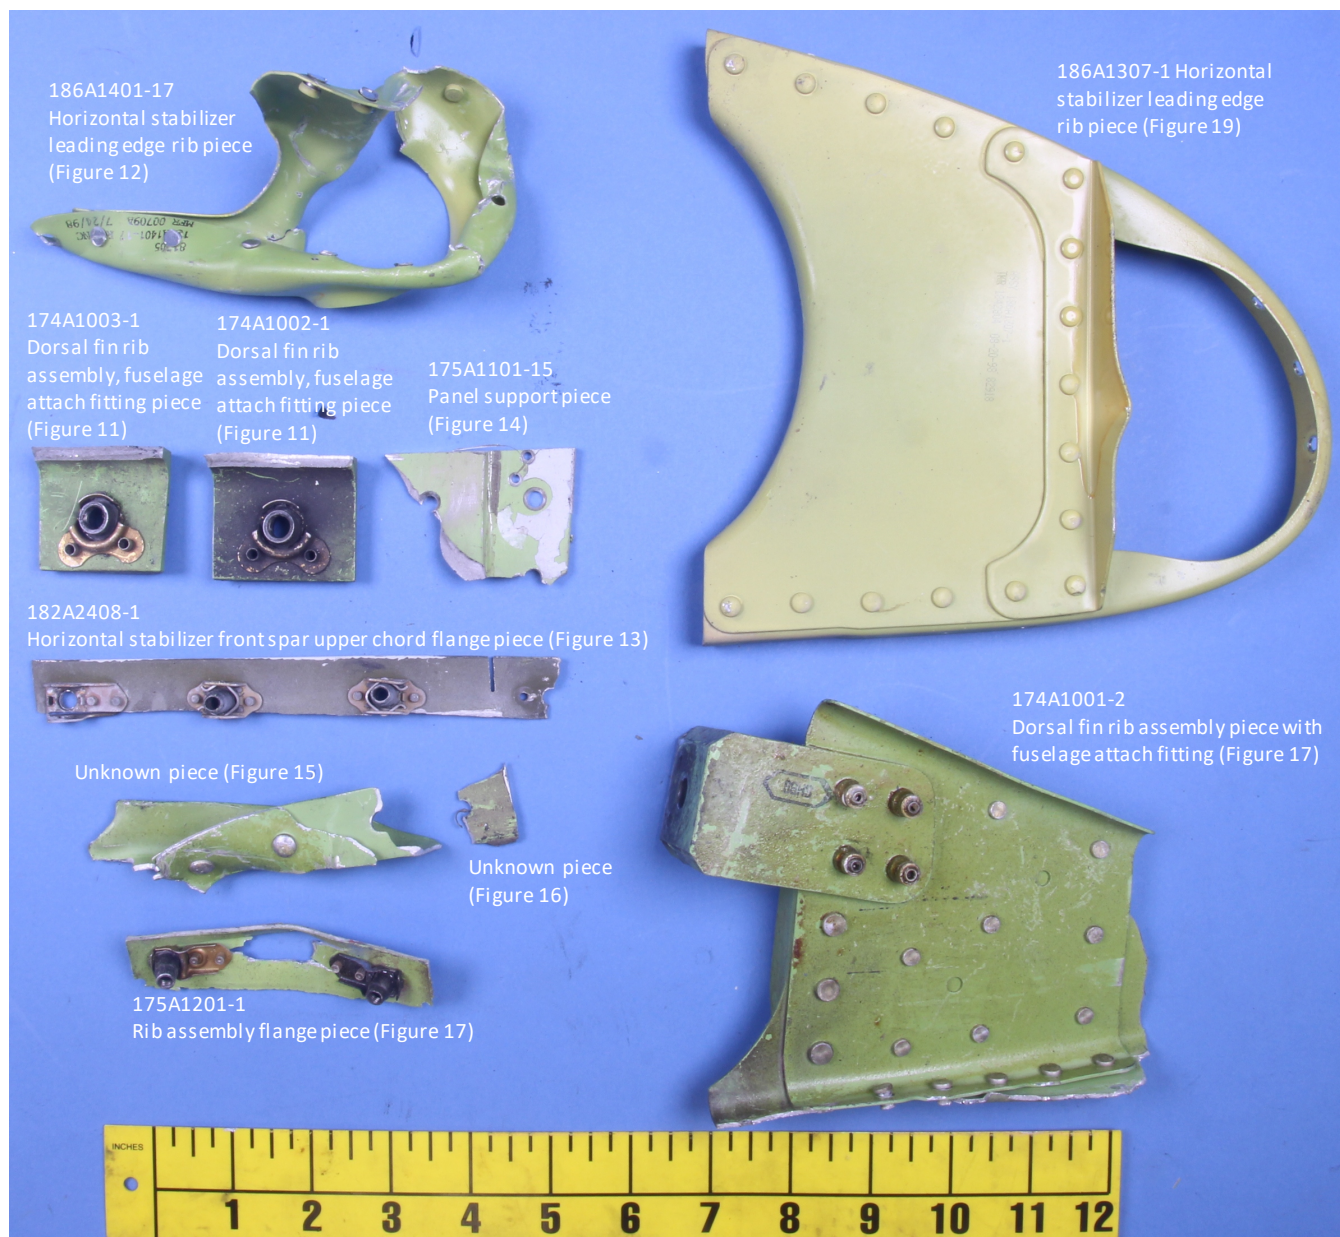
Figure 2 Image of the as-received structural pieces. Where known, Boeing part numbers are indicated.

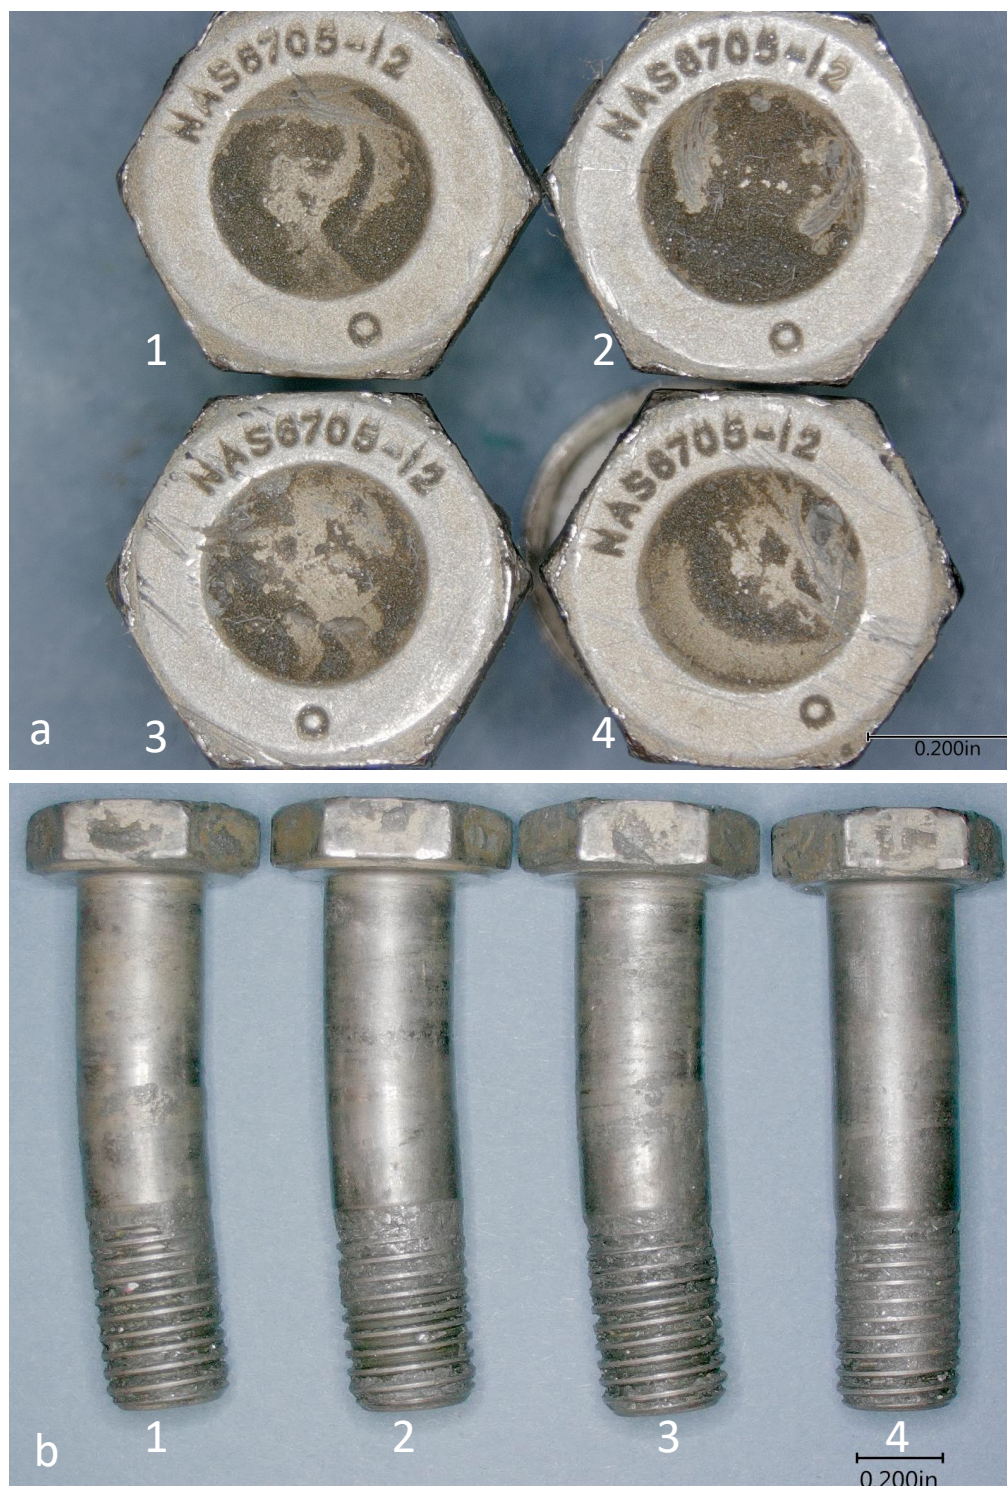
Closer views of the four NAS6705-12 bolts in the as-received and cleaned condition are shown in Figures 3-7. The bolts were arbitrarily numbered 1 through 4 for identification purposes. Bolts 1-3 were visibly bent to the unaided eye. Residual sealant was observed on the tops and hex flats of the bolt heads. The anti-seize compound in the as-received threads was dry and flakey. The bulk of the compound was removed using a wooden toothpick, the threads were subsequently cleaned using acetone and ultrasonic agitation. Higher magnification images of the threads are shown in Figures 5-7. In general, the threads were in serviceable condition, with a thread on bolt 3 exhibiting damage as indicated in Figure 7.

Figure 3 The NAS6705-12 bolts, as-received. The bolts were arbitrarily numbered for identification purposes. View (a) shows the bolt heads with markings. The dark deposits in the center of the heads is residual sealant. View (b) shows the longitudinal view of the bolts. Bolts 1,2, and 3, exhibited pronounced bending deformation. The threads are filled with anti-seize compound.

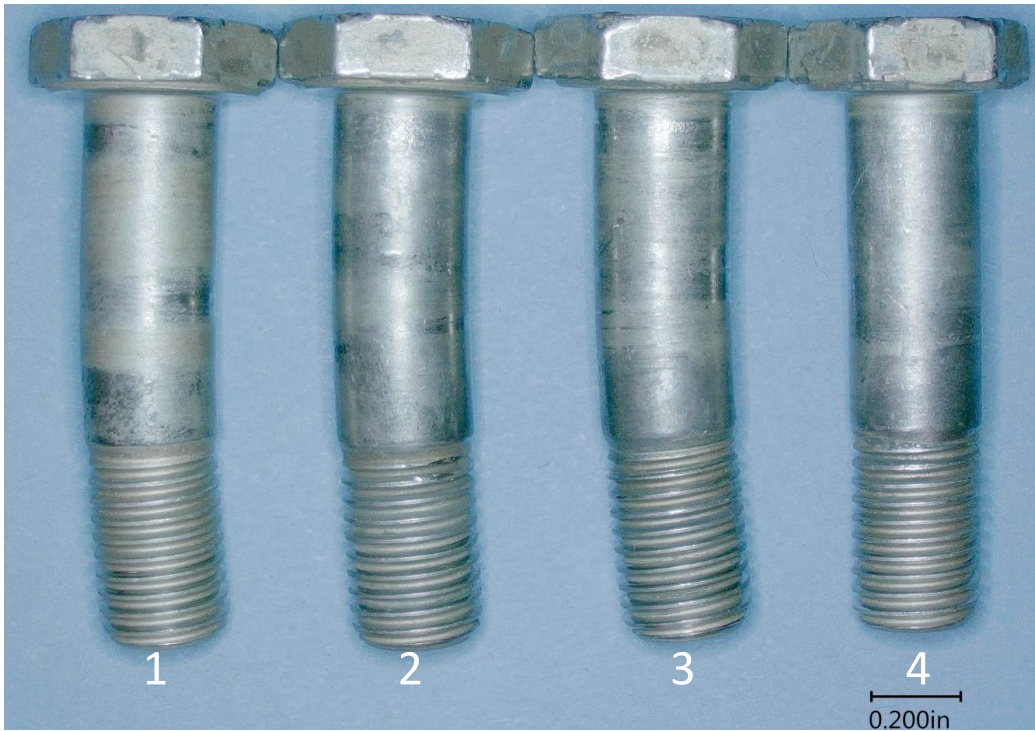
Figure 4 The NAS6705-12 bolts, after ultrasonic cleaning in acetone. Longitudinal view of the bolts. Bolts 1,2, and 3, exhibited pronounced bending deformation. The shanks exhibit isolated, semi-circumferential polishing wear scars.

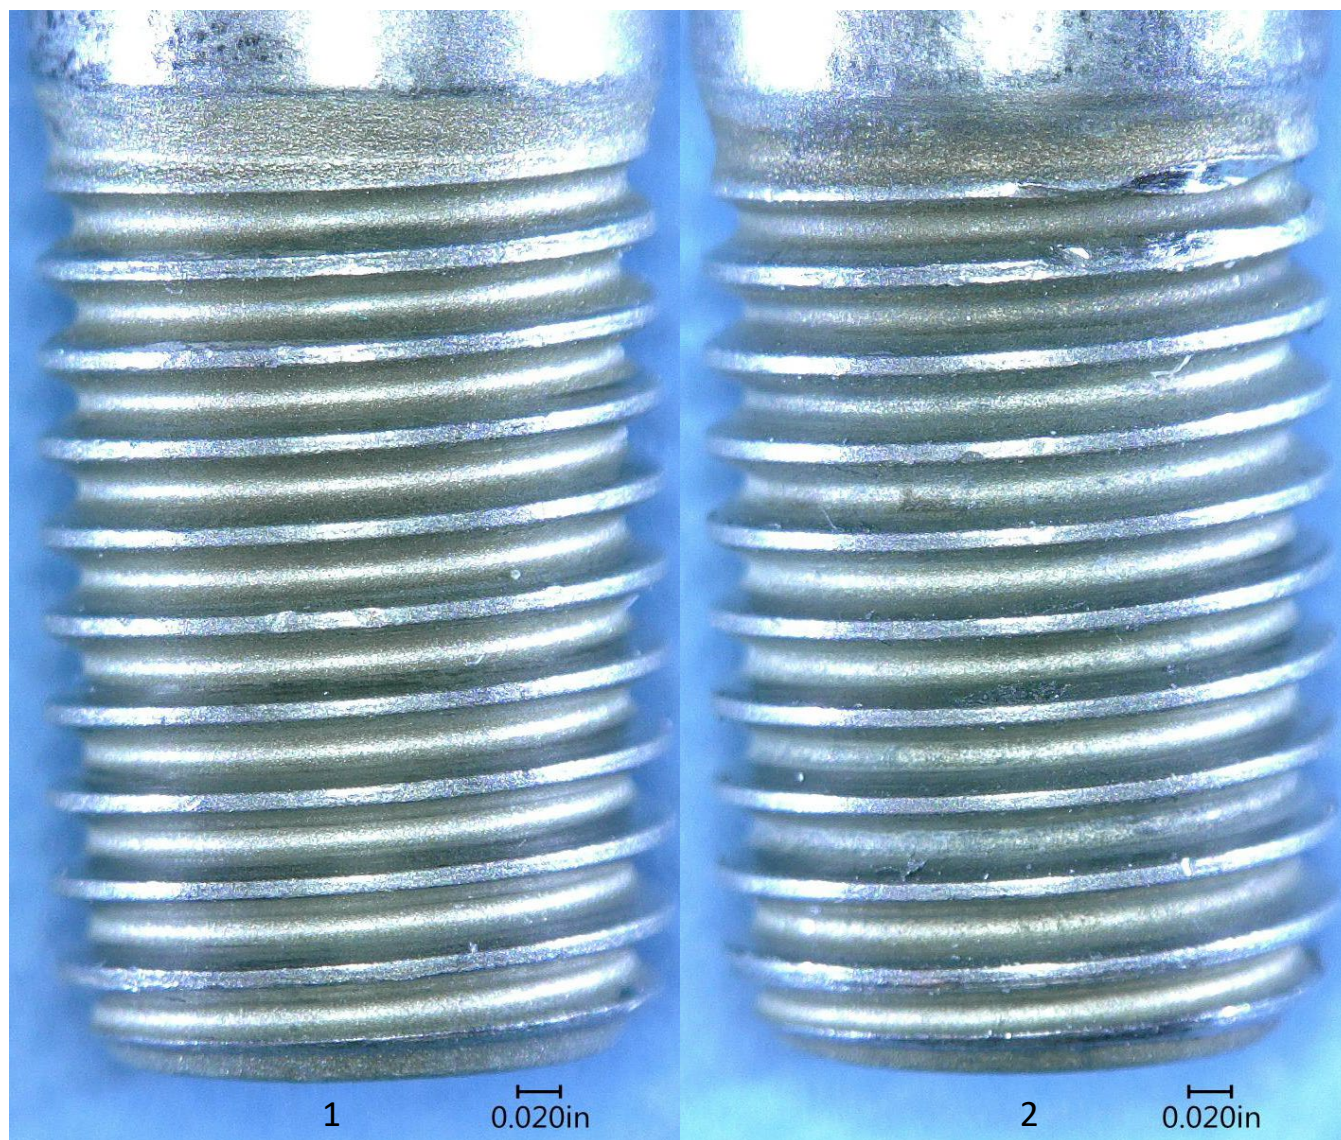
Figure 5 Close view of the threads from NAS6705-12 bolts 1 and 2 shown in Figure 4. Bolt 2 exhibited minor thread tip damage near the start of the grip.

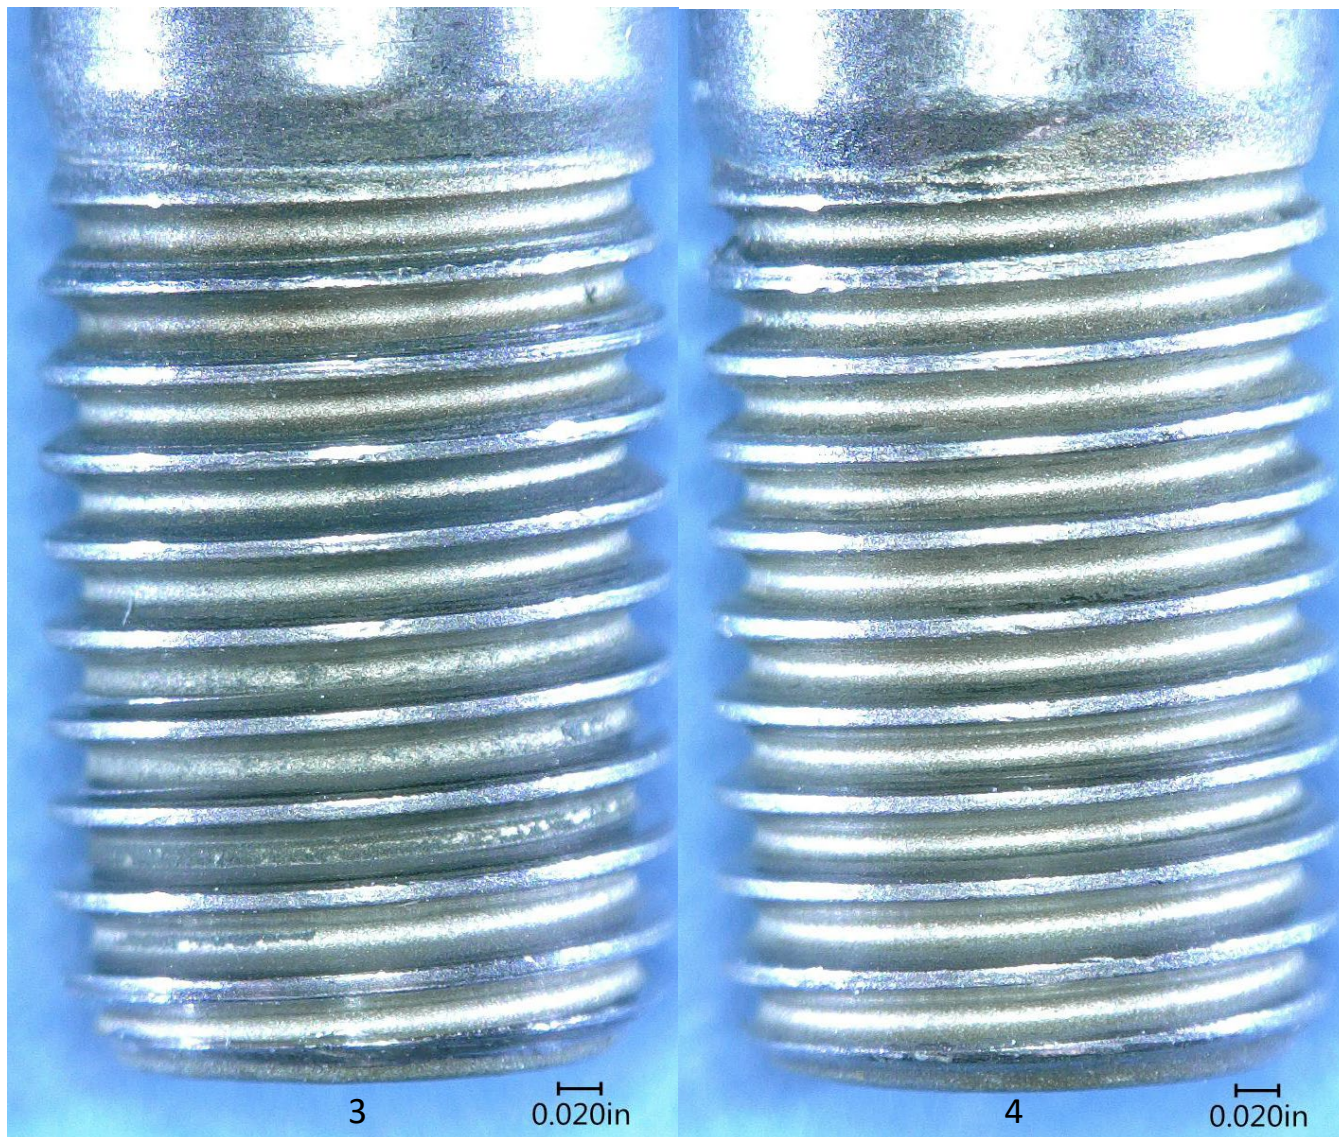
Figure 6 Close view of the threads from NAS6705-12 bolts 3 and 4 shown in Figure 4. Bolt 3 exhibited thread tip damage near the start of the grip as indicated in Figure 7.

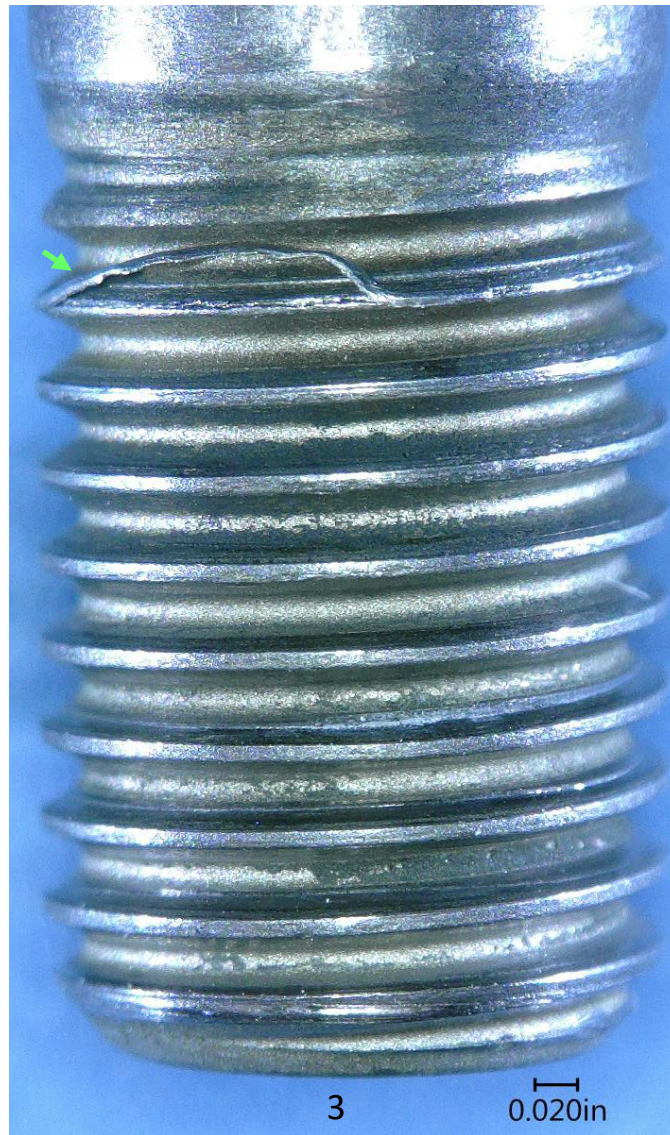
Figure 7 Close view of the threads from NAS6705-12 bolt 3 shown in Figure 4. The thread exhibited thread tip damage near the start of the grip (see green arrow).

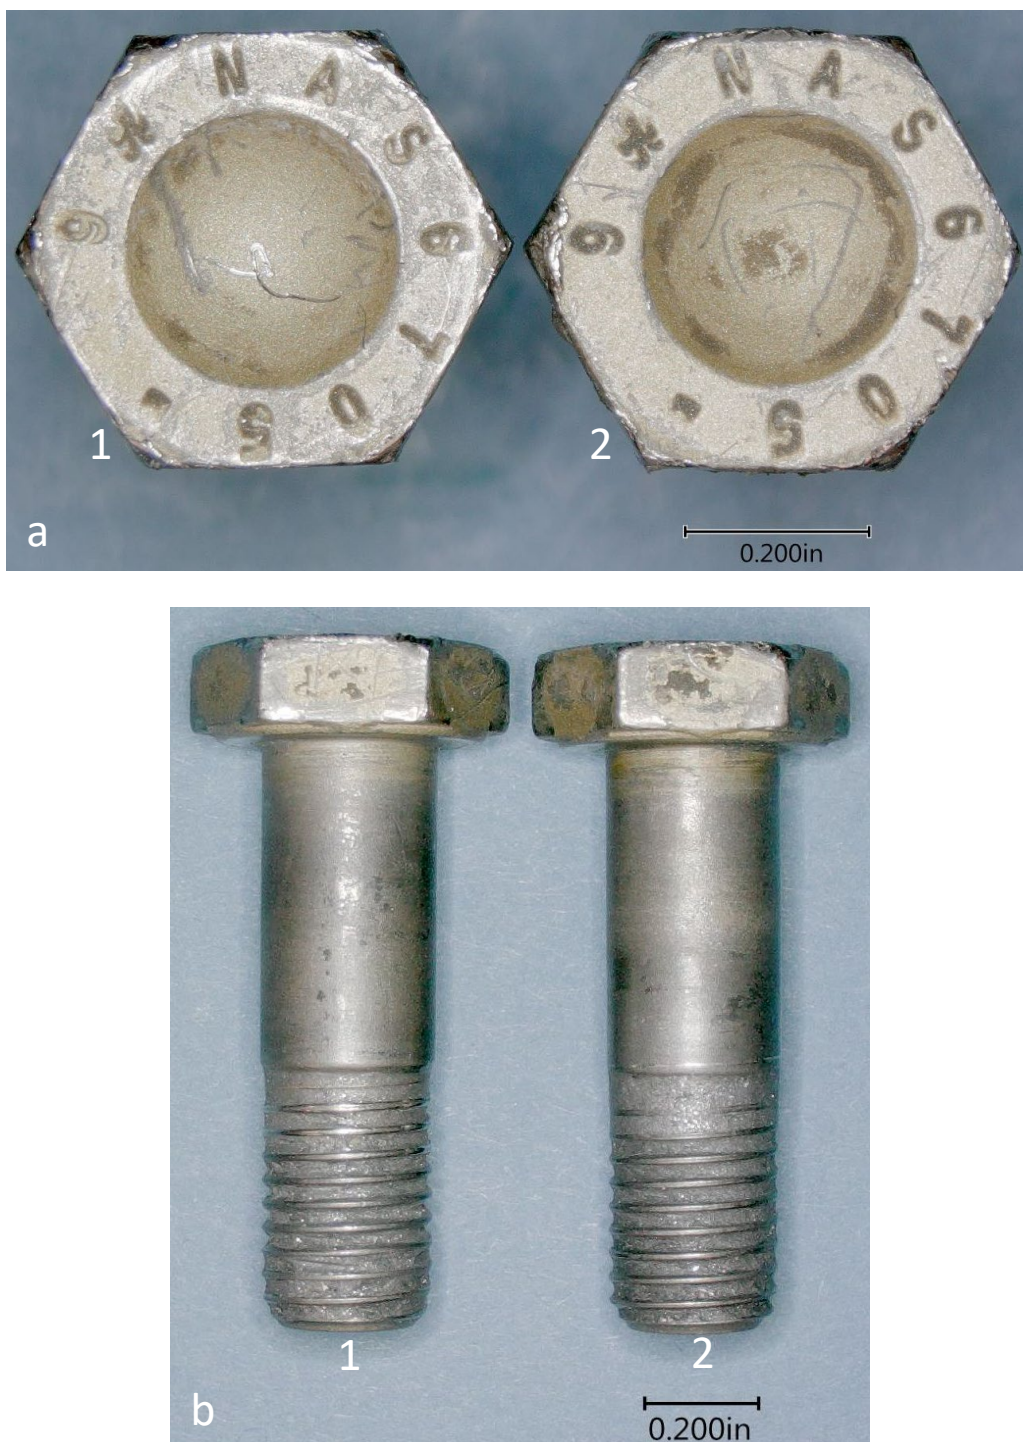
Closer views of the four NAS6705-9 bolts in the as-received and cleaned condition are shown in Figures 8-10. The bolts were arbitrarily numbered 1 and 2 for identification purposes. Residual sealant was observed on the tops and flats of the bolt heads. The anti-seize compound in the as-received threads was dry and flakey. The bulk of the compound was removed using a wooden toothpick, the threads were subsequently cleaned using acetone and ultrasonic agitation. Higher magnification images of the

Figure 8 The NAS6705-09 bolts, as-received. The bolts were arbitrarily numbered for identification purposes. View (a) shows the bolt heads with markings. View (b) shows the longitudinal view of the bolts. The threads are filled with anti-seize compound.

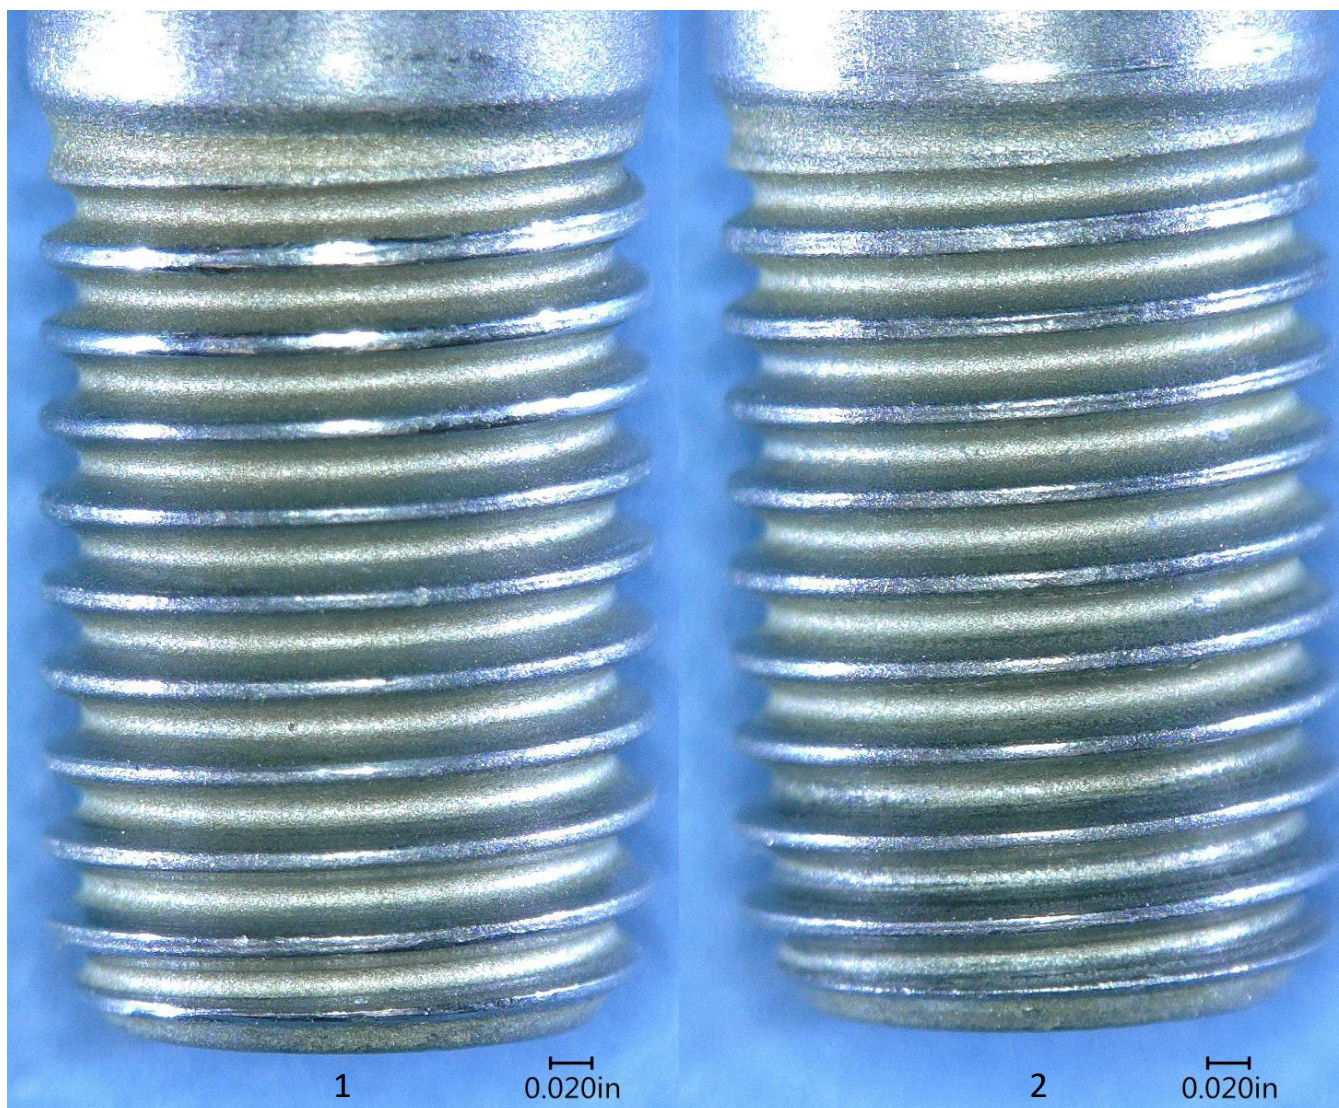
threads are shown in Figure 10. In general, the threads were in serviceable condition, with no notable issues.

Figure 10 Close view of the threads from NAS6705-09 bolts 1 and 2 shown in Figure 9

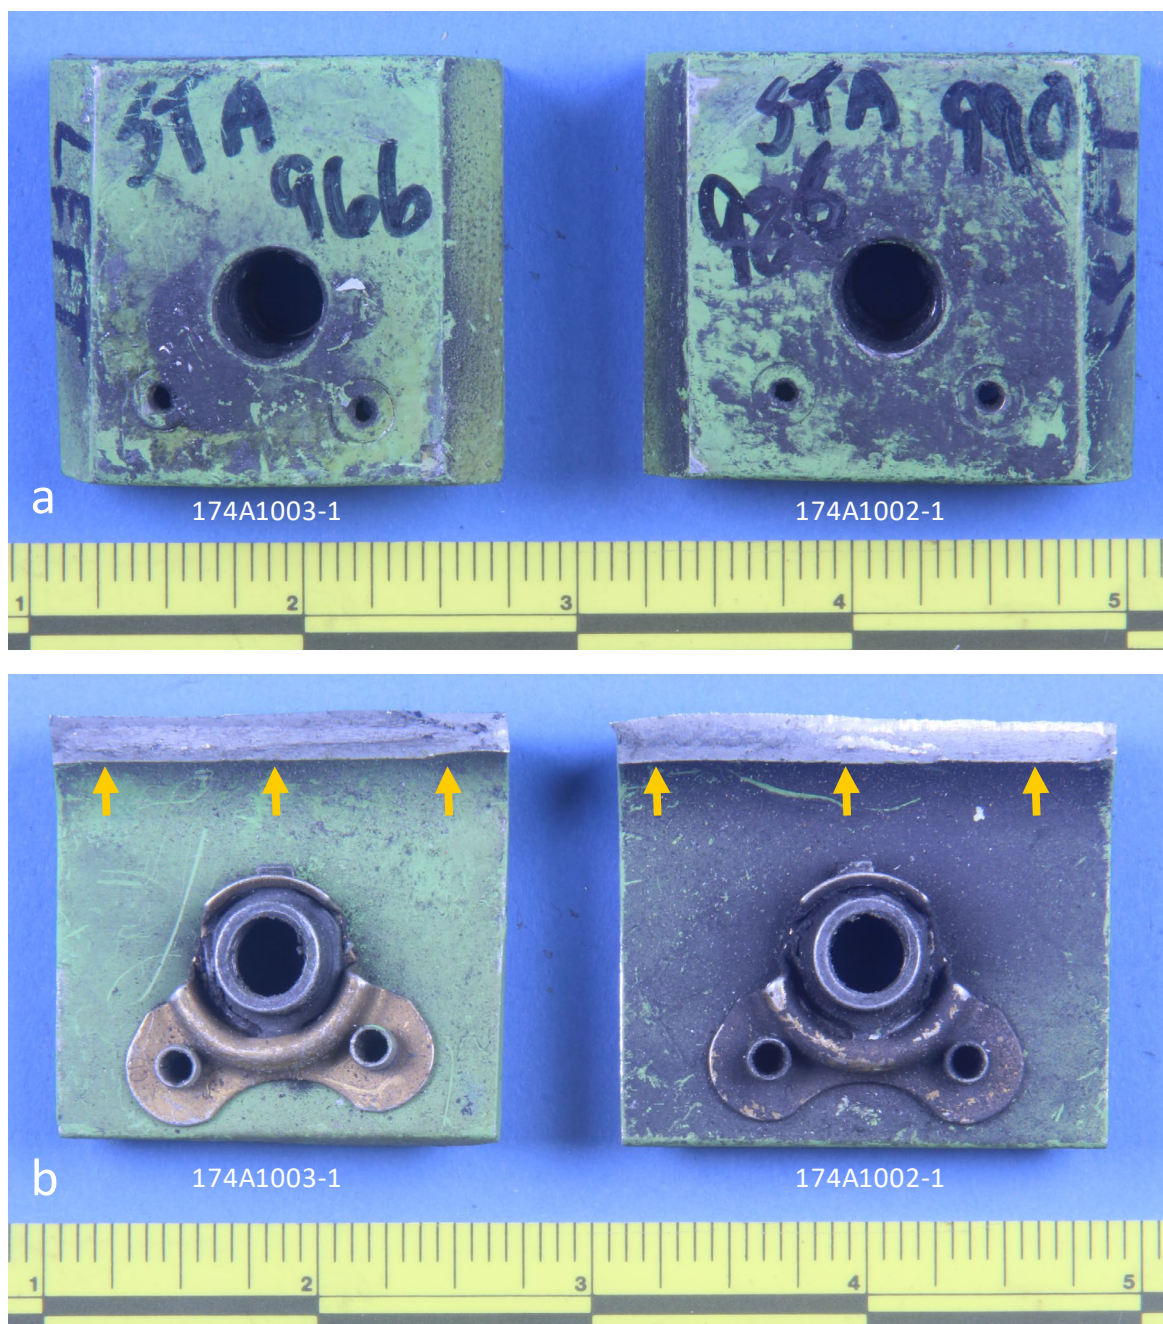
Figure 11 Dorsal fin rib assembly, fuselage attach fitting pieces (174A1003-1, 174A1002-1 ), station locations identified as marked on the pieces. View (a) is the lower face and view (b) is the upper face. The orange arrows in view (b) indicate general areas of monotonic overstress fracture. The fractures occurred due to combined twisting and bending forces. The nut threads are serviceable, with no indications of stripping.

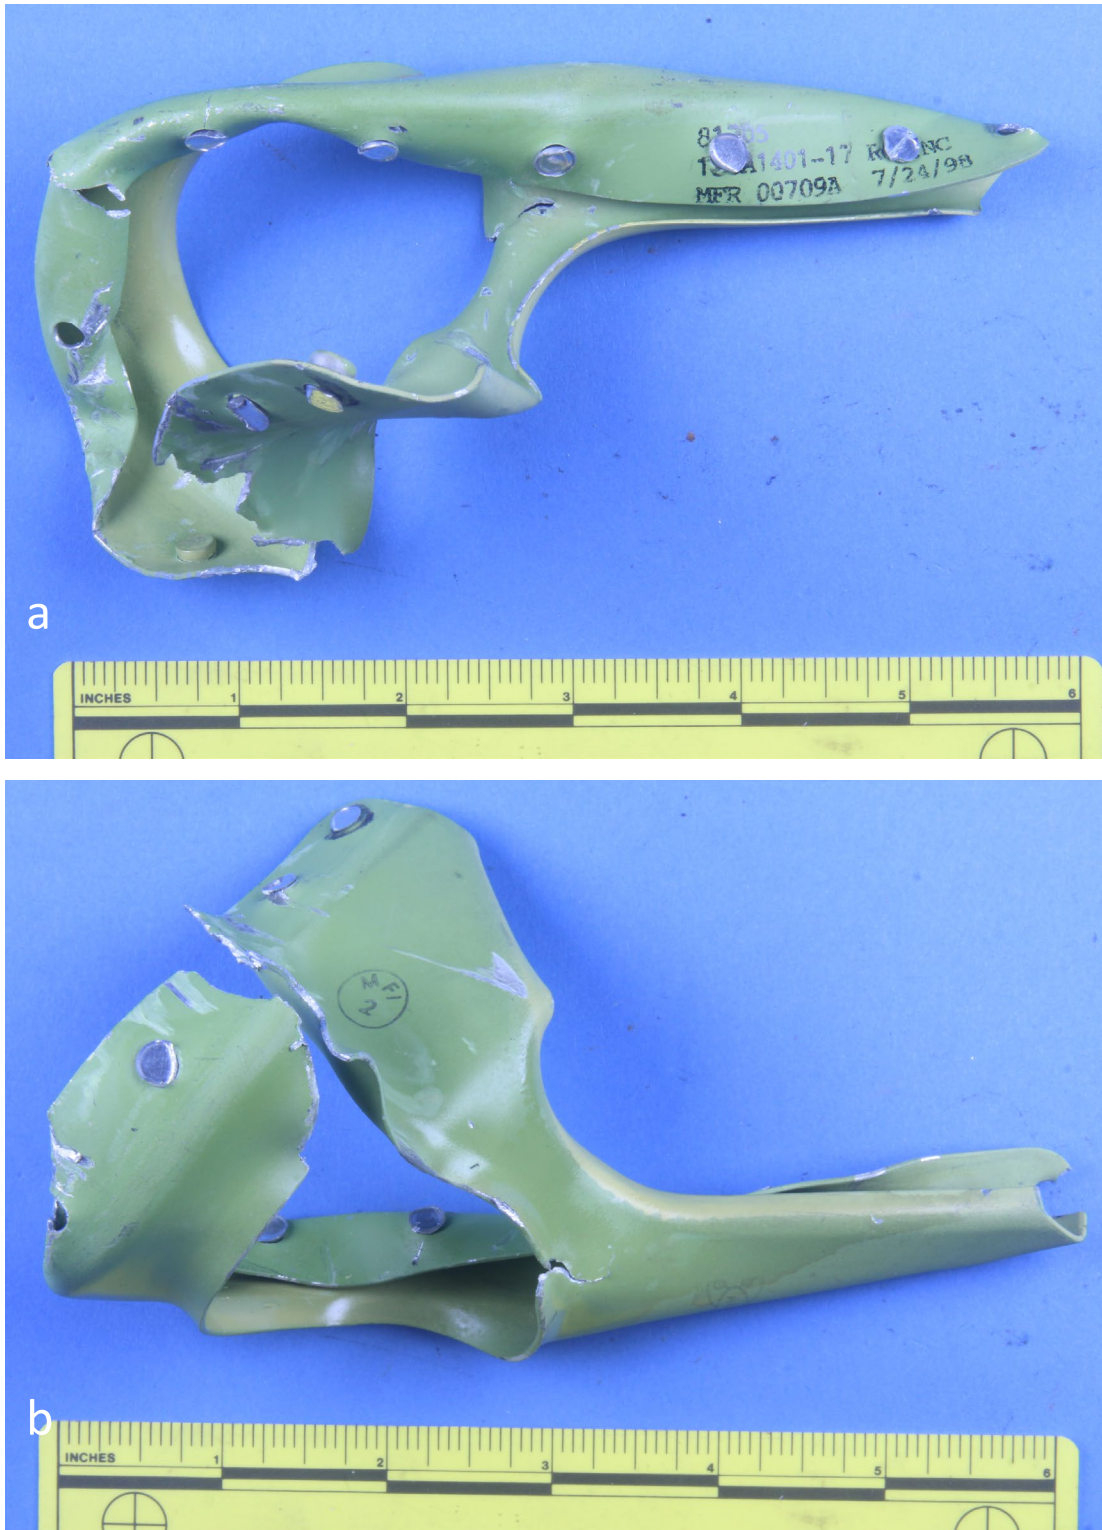
Figure 12 Horizontal stabilizer leading edge rib piece (186A1401-17) exhibiting bending distortion, overstress fractures, and rivet pullout.

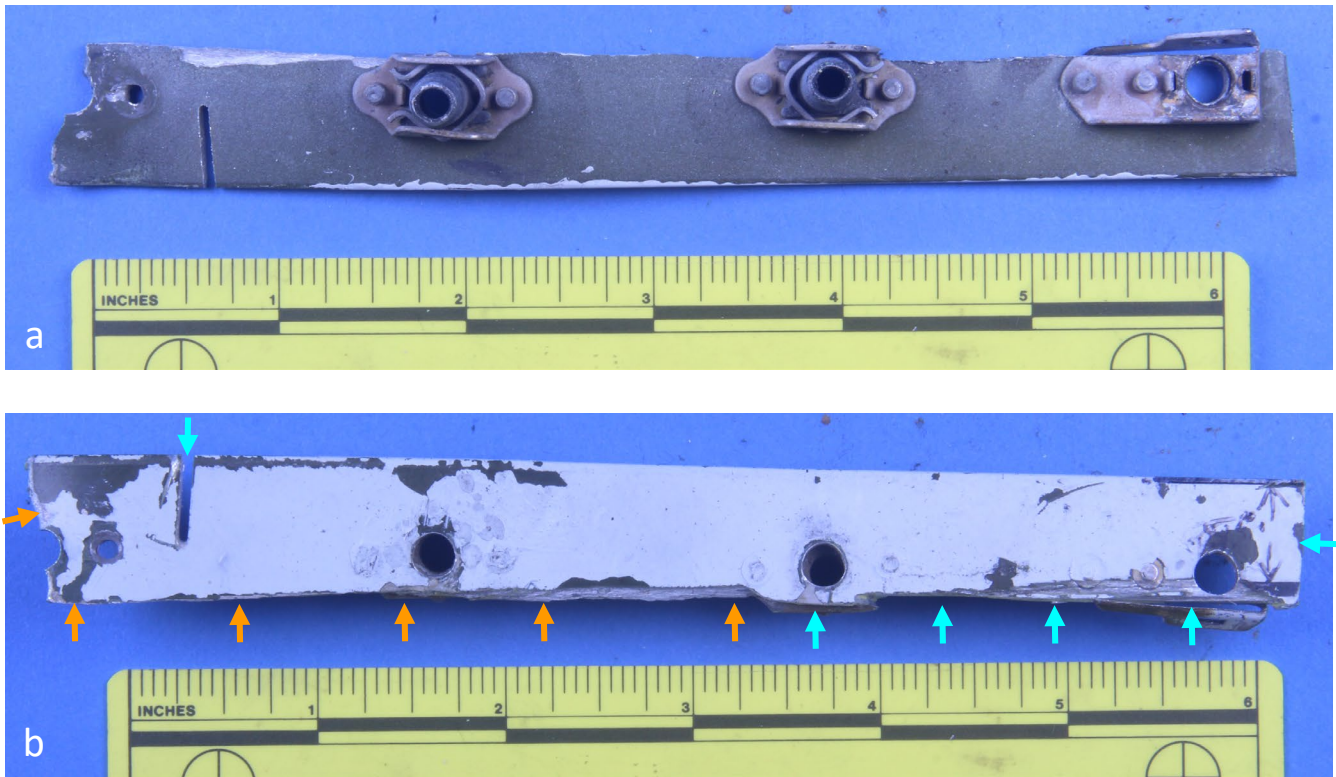
Figure 13 Horizontal stabilizer front spar upper chord flange piece (182A2408-1). The orange arrows in view (b) indicate general areas of monotonic overstress fracture and the blue arrows indicate areas that have been saw-cut. The nut threads are serviceable, with no indications of stripping.

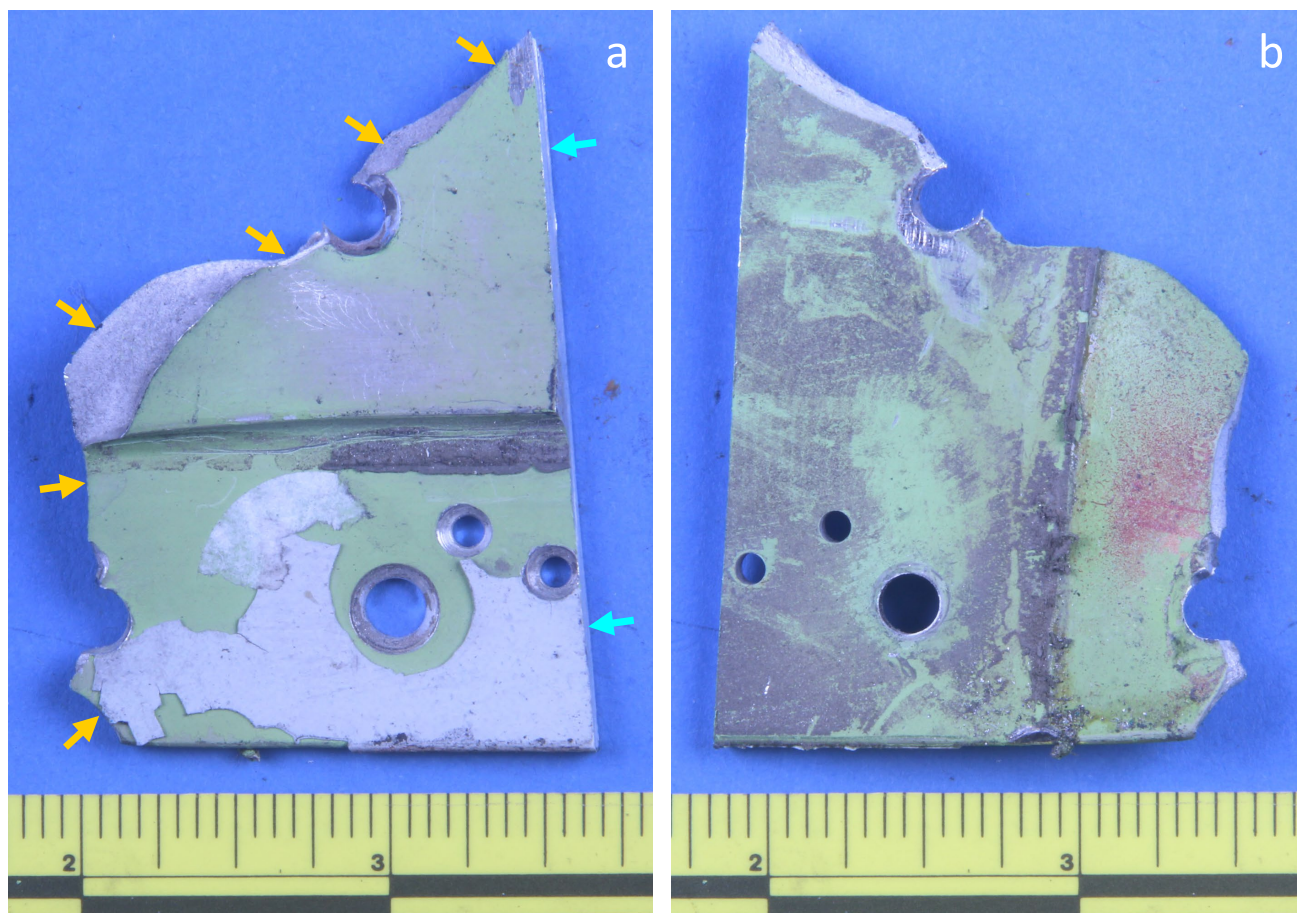
Figure 14 Panel support piece (175A1101-15). The orange arrows in view (a) indicate general areas of monotonic overstress fracture and the blue arrows indicate areas that have been saw-cut.

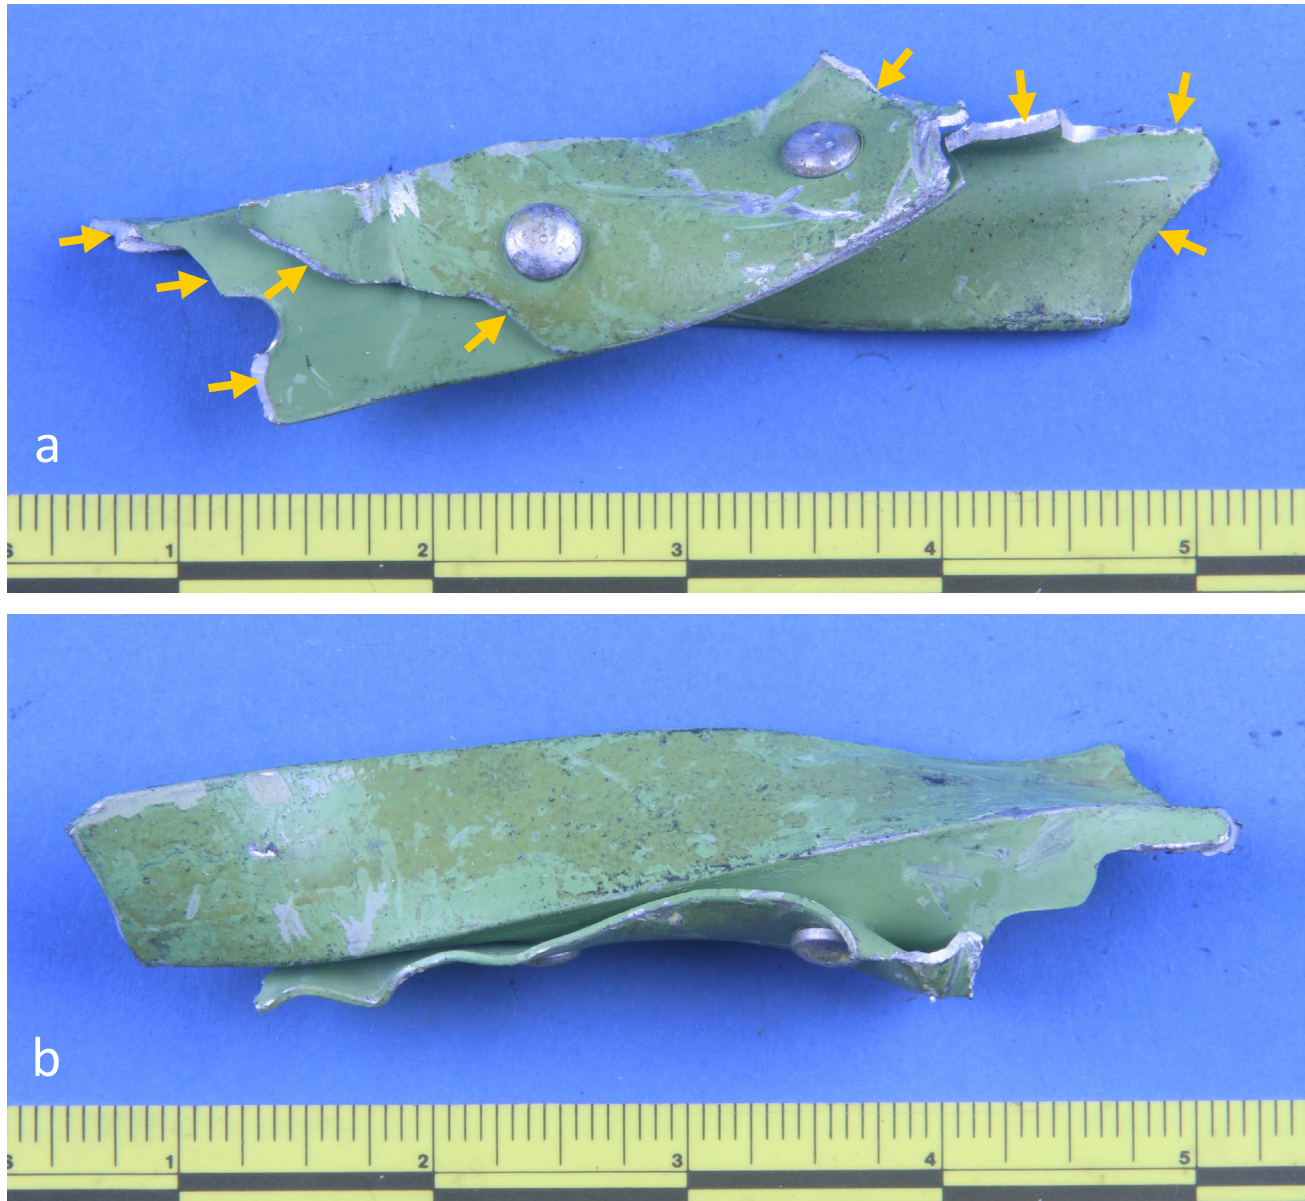
Figure 15 Unknown structural remnant. The orange arrows in view (a) indicate general areas of monotonic overstress fracture.

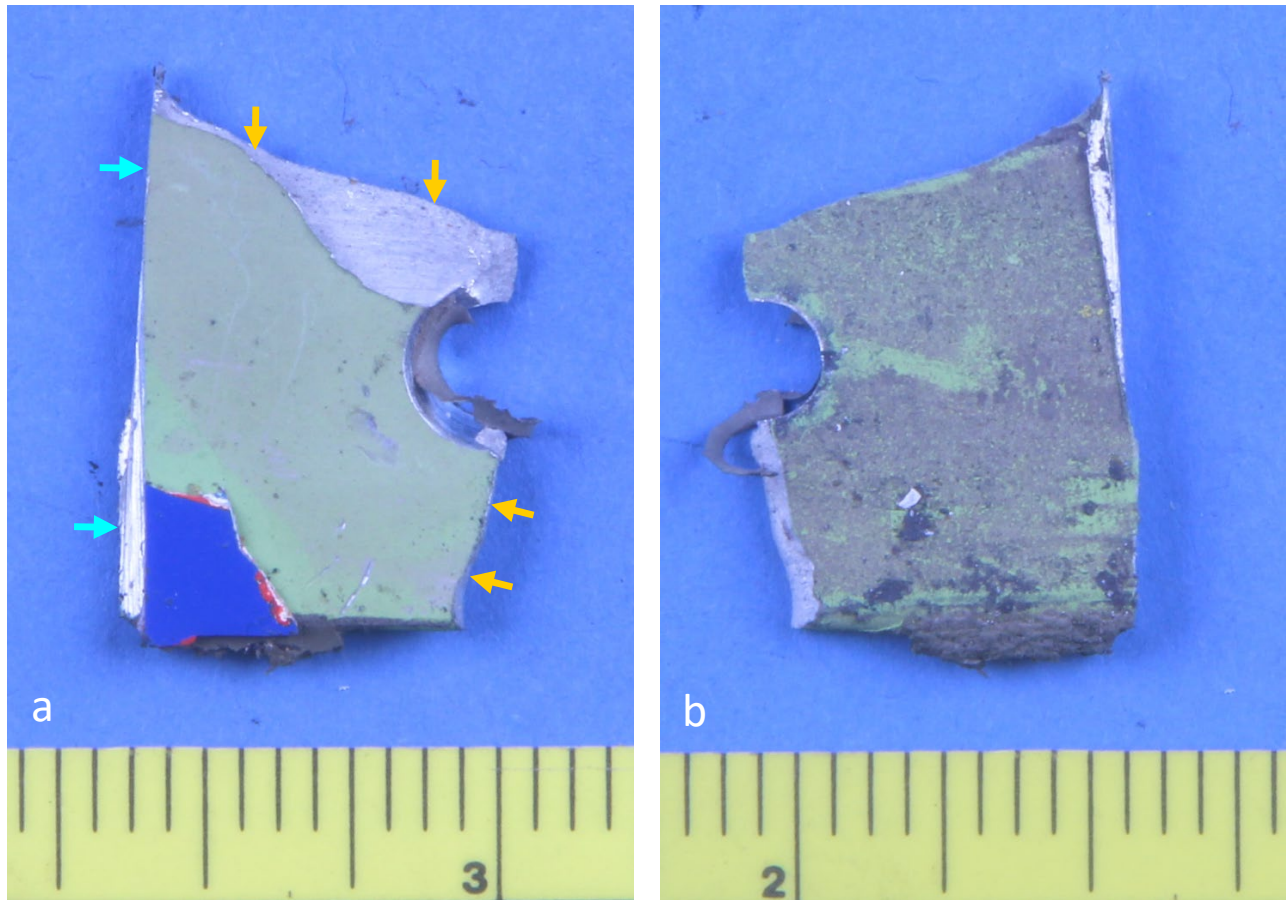
Figure 16 Unknown structural remnant. The orange arrows in view (a) indicate general areas of monotonic overstress fracture and the blue arrows indicate areas that have been saw-cut.

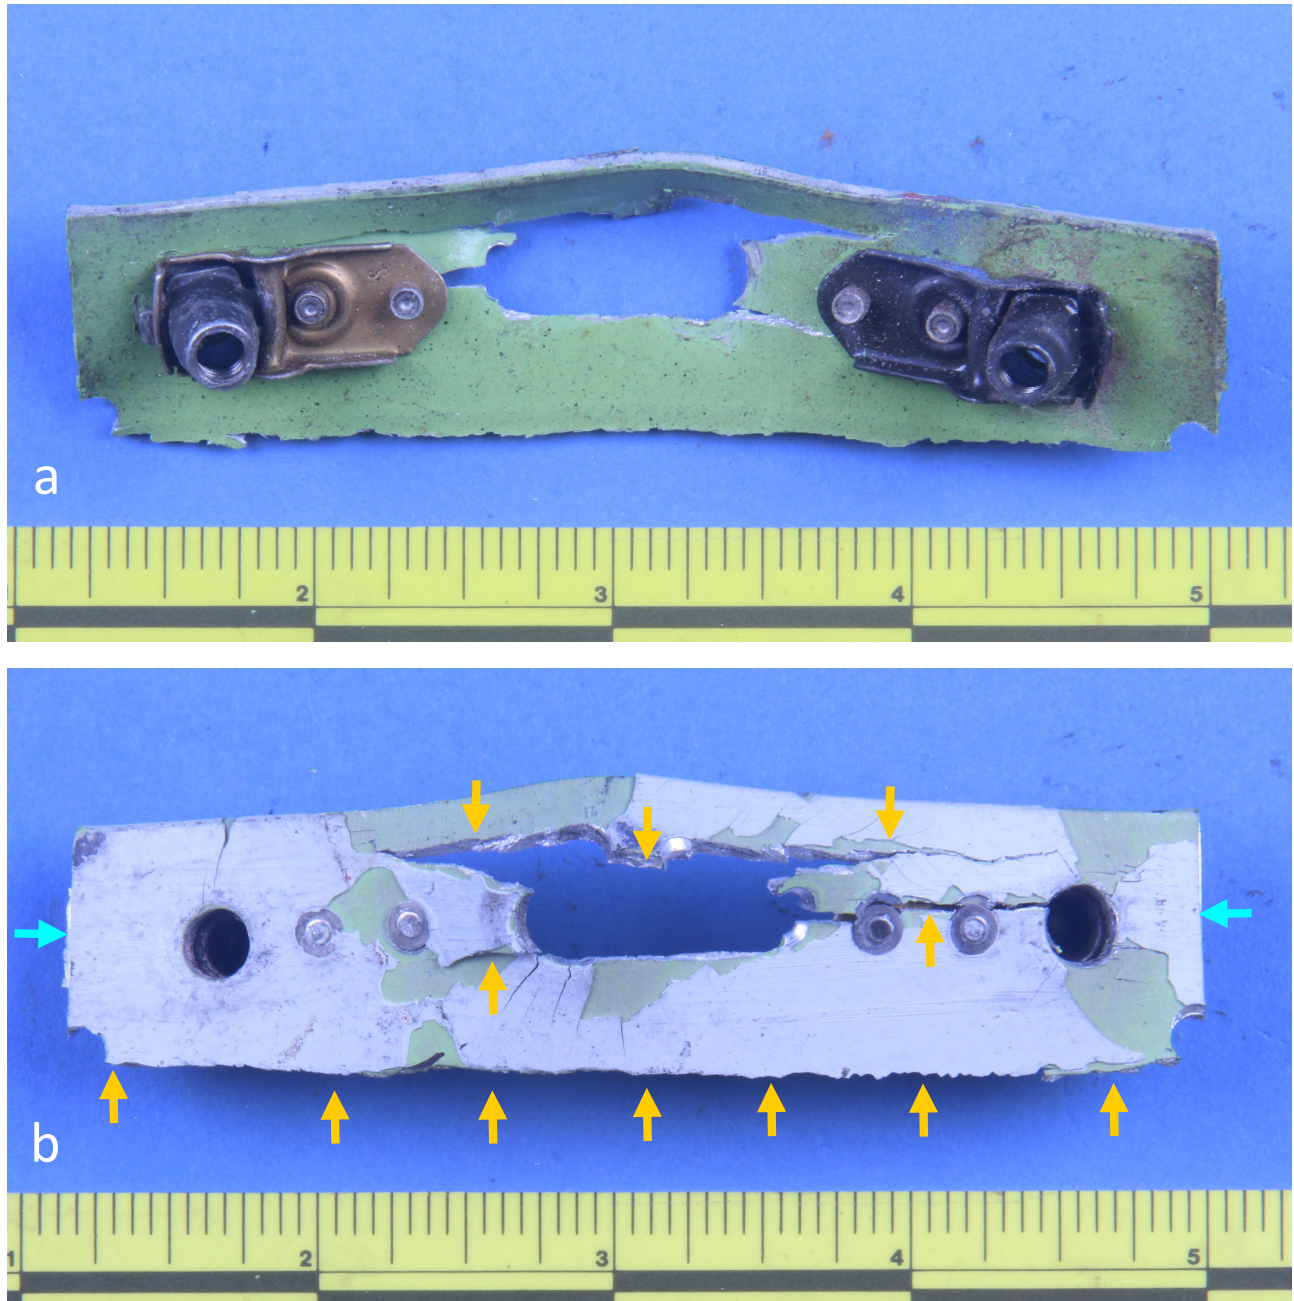
Figure 17 Rib assembly flange piece (175A1201-1). The orange arrows in view (b) indicate general areas of monotonic overstress fracture and the blue arrows indicate areas that have been saw-cut. The nut threads are serviceable, with no indications of stripping.

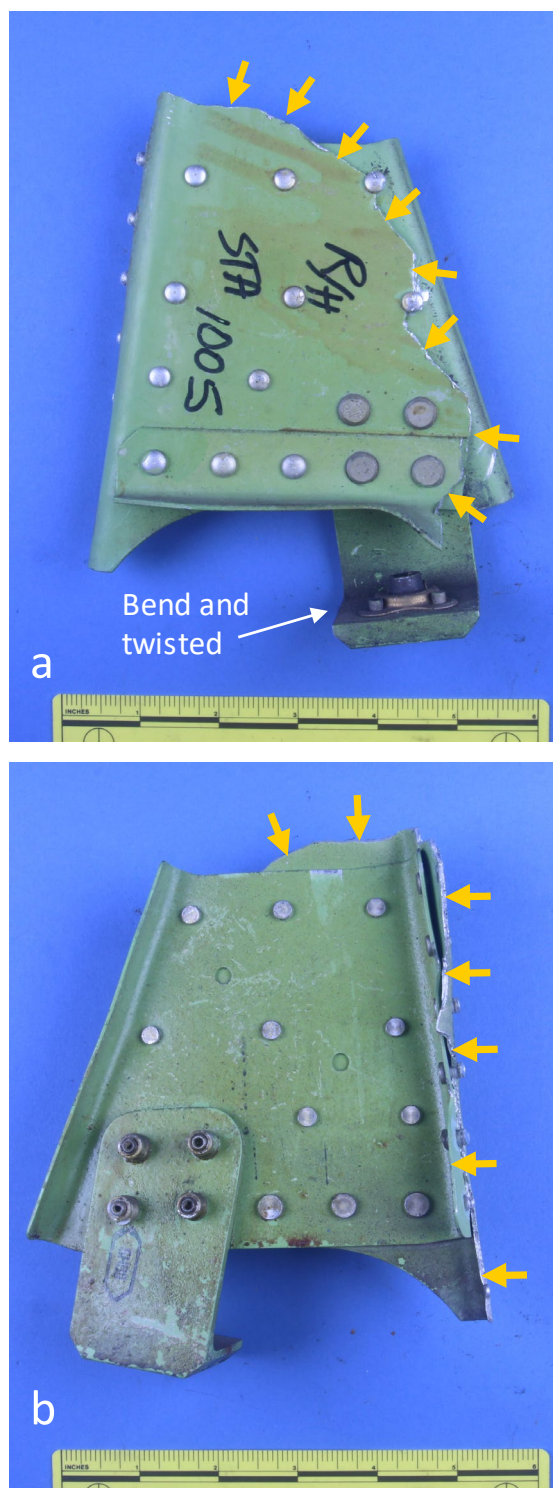
Figure 18 Dorsal fin rib assembly piece with fuselage attach fitting (174A1001-2). The orange arrows in views (a) and (b) indicate general areas of monotonic overstress fracture. The station location is marked on the piece. The nut threads are serviceable, with no indications of stripping.
