# NATIONAL TRANSPORTATION SAFETY BOARD

## MATERIALS LABORATORY FACTUAL REPORT

Report No. 20-040

Place : Victorville, California  
Date : 5/20/2020  
Vehicle : Boeing 737-8Q8 N820TJ  
NTSB No. : DCA20LA107  
Investigator : Clinton Crookshanks, AS-40

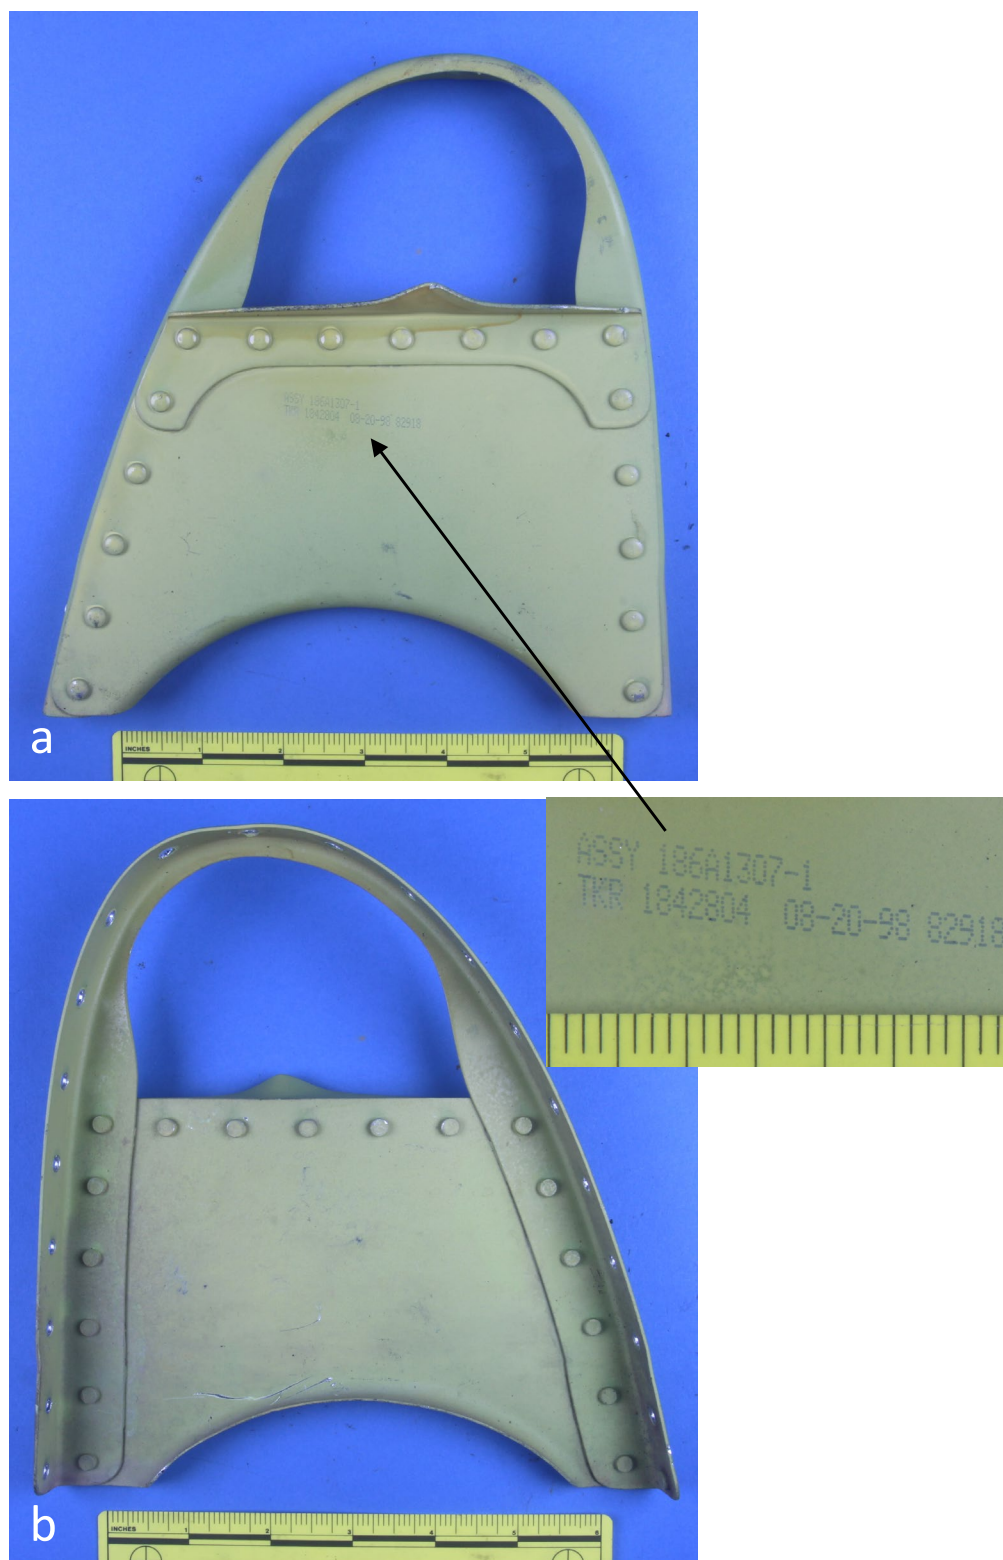
Figure 19 Horizontal stabilizer leading edge rib piece (186A1307-1). The piece exhibits bending distortion and evidence that the rivets have been drilled out.
