October 27, 2019

## Aircraft Performance Crash Site Factual

NTSB Number: DCA20MA002  
Location: Thomas Madsen Airport (DUT), Unalaska, Alaska  
Date: October 17, 2019  
Time: 1740 Alaska Daylight Time  
Aircraft: Saab 2000, N686PA  
Operator: Peninsula Aviation Services, Incorporated d.b.a. PenAir

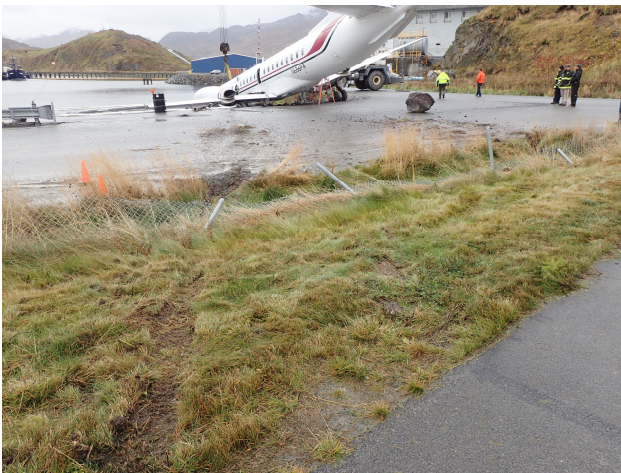
Aircraft performance evidence gathering began mid-day on October 19th with photographic documentation of the airplane in situ where it came to rest. Witness mark evidence from main gear wheels on improved runway surfaces indicated that the airplane had traveled off the departure end of runway 13, across the 300-ft declared distance runway safety area (RSA), and then on a curving path across the blast pad, to the right of the extended runway centerline. It then traversed a 15- to 30-foot section of grass and rolled over/through a 4-foot high, chain link, airport perimeter fence. Nonuniform curled and twisted wires were found along the top 8 inches of the perimeter fence in the travel path of the left engine propeller and left main landing gear. Each main landing gear wheel path was aligned with a vertical fence post support that was bent toward the ground in the direction of airplane travel, as documented by the photographs shown in Figures 1(a) and 1(b).

Figure 1(a): Left main gear wheel path exiting the blast pad surface, traveling across the grass, over the fence, across a ditch, and up on the roadway.

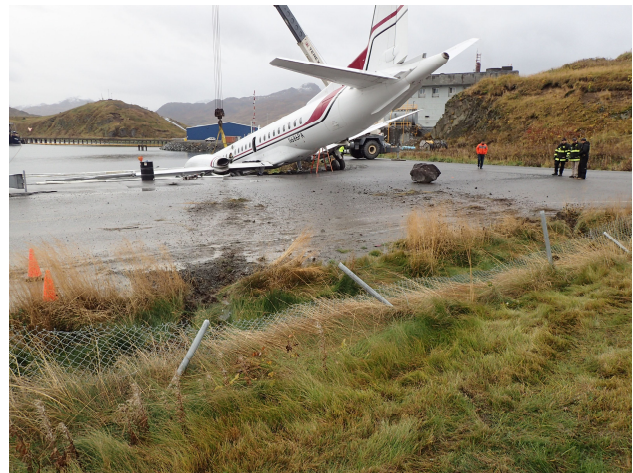
Figure 1(b): Airport perimeter fence, post and fence directional damage, displaced large rock and soil path across public roadway.

As the airplane entered and crossed a public road (with one travel lane in each direction), a large rock positioned between the airport perimeter fence and the road near the intersection of Ballyhoo Road and Airport Beach Road was displaced from the shoulder to the center of the roadway. The left wing or left engine propeller then struck a 4- to 6-foot vertical signal post on the opposite road shoulder. The left engine propeller subsequently struck a 6- to 8-foot high, yellow, diamond-shaped road sign (that displayed a warning regarding low flying aircraft) mounted on a metal post on the road shoulder. The yellow sign, metal post, and anchoring concrete monument were uprooted by the airplane. The Fuel Tank video image evidence documented in Section 2.4.1 indicates that the left engine shed propeller blade fragments and at least one propeller blade during this airplane/left engine propeller/road sign contact event.

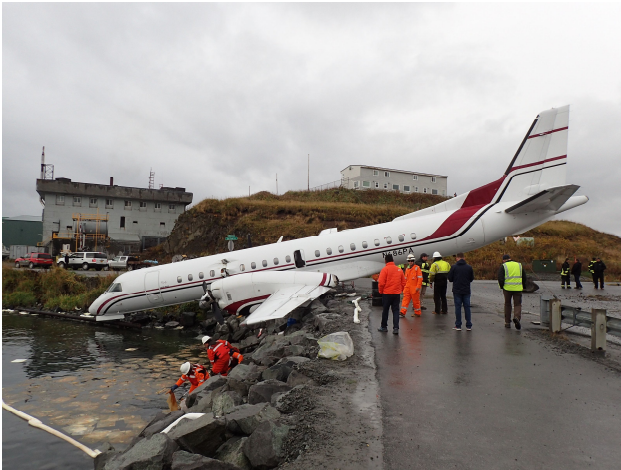
The airplane then pivoted counterclockwise (with 12 o'clock viewed toward the departure end of runway 13) around the damaged left main landing gear and came to rest with the airplane pitched airplane nose down. At the airplane final rest position shown in Figures 2(a) and 2(b), the nose landing gear wheels came to rest in shallow water at the edge of Dutch Harbor, the left main landing gear was embedded in rocks just below the edge of the Ballyhoo Road shoulder, and the right main landing gear remained on the dirt/grass shoulder at the intersection of East Point Road and Ballyhoo Road.

Figure 2(a): View parallel to public road at the end of runway 13, airplane nose pointed toward the extended runway 13 centerline, nose wheels in the waters of Dutch Harbor.

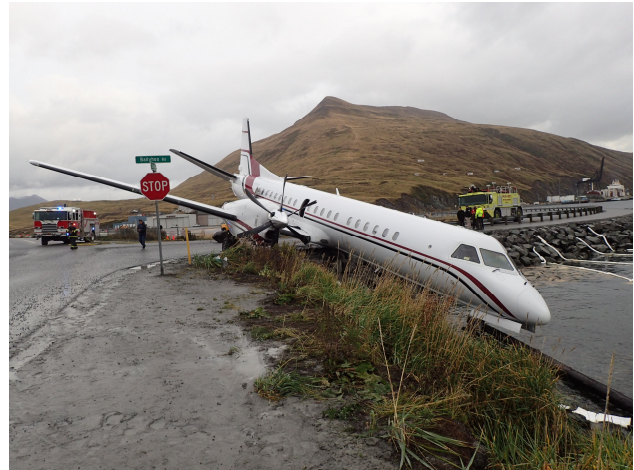
Figure 2(b): View of East Point Road (left) intersection with Ballyhoo Road (right) and Airport Beach Road (beyond the stop sign on the left), looking generally toward the approach end of runway 13.

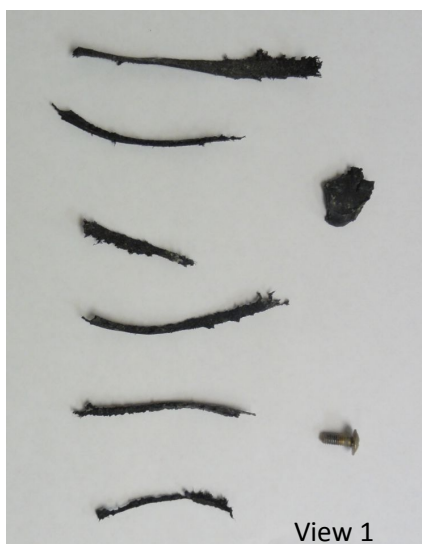
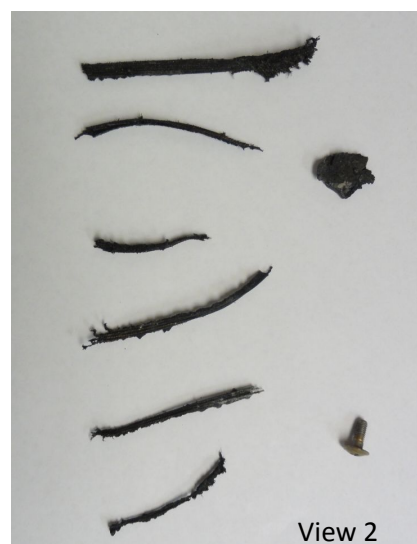
The visual search progressed full length down the left side of runway 31 and then back full length down the left side of runway 13. Two 2- to 3-inch strips of tacky rubber were recovered, together with a small screw and a quarter-sized, polygonal piece of non-tacky rubber. This evidence was added to four 3- to 5-inch strips of tacky rubber that were previously recovered during vehicle-based surveys of the runway by Airport Operations staff and the NTSB regional investigator. Photos of the items recovered are shown in Figure 3.

Figure 3: Tacky rubber strips, rubber piece, and screw (3/4 inch) recovered during runway 13 visual surveys

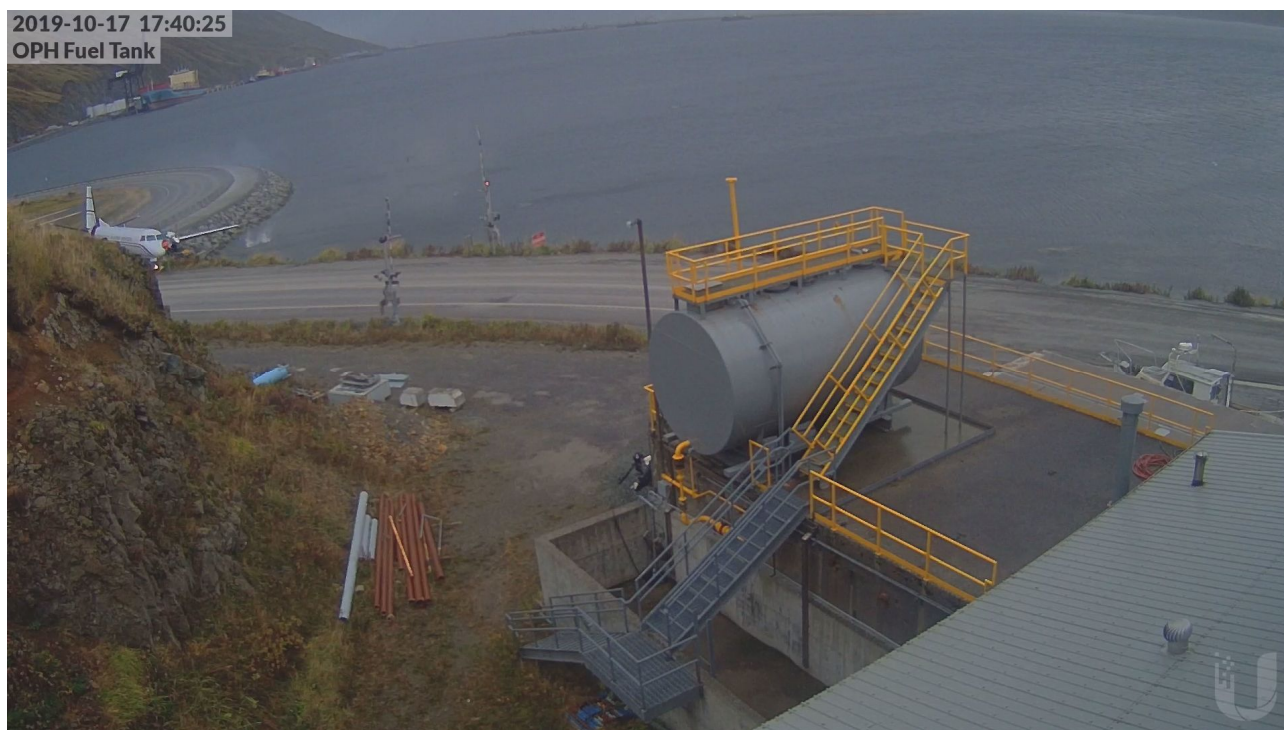
The video footage labeled “OPH Fuel Tank” documented N686PA landing rollout events during roughly the last 10 seconds of airplane motion toward its final rest position. An exemplar uncropped image is shown in Figure 4. See Attachments 2–3 for the corresponding cropped image sequence. The “Fuel Tank” label in this video refers to a fixed structure as opposed to an airplane fuel tank.

Figure 4: Exemplar frame from OPH Fuel Tank video. N686PA is shown in upper left.

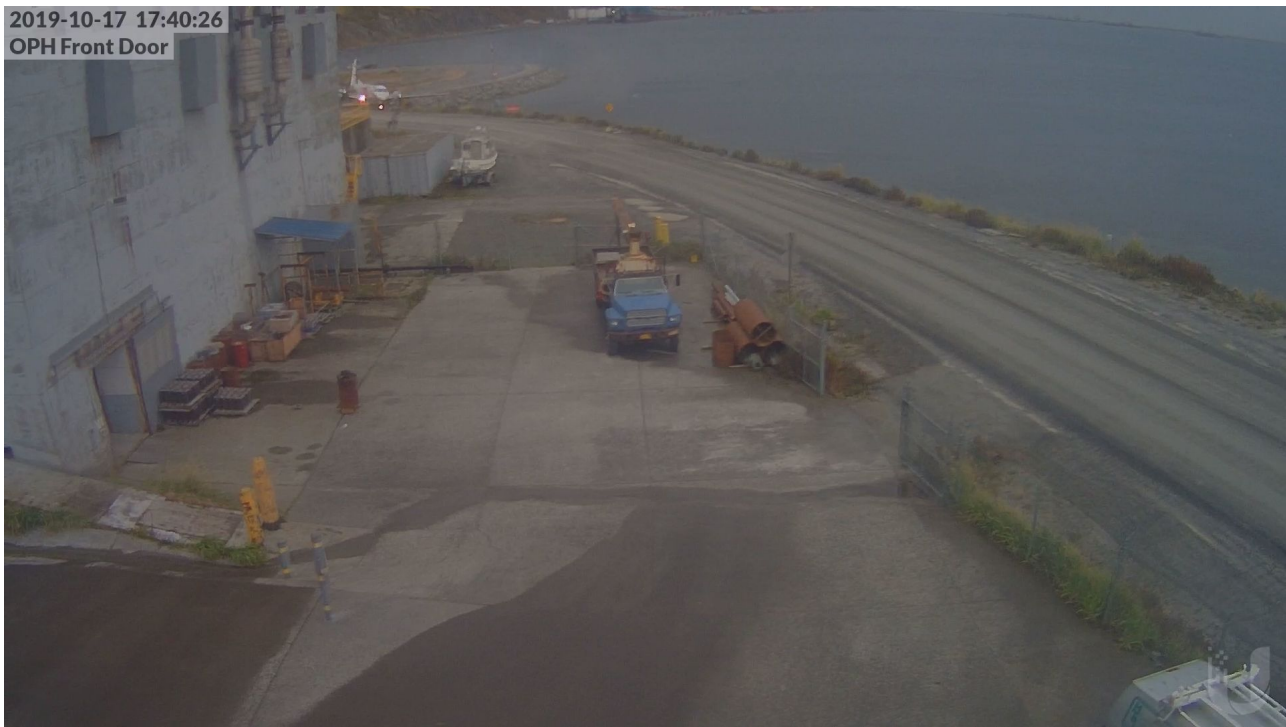
The video footage labeled “OPH Front Door” also recorded N686PA landing rollout events during roughly the last 10 seconds of airplane motion toward its final rest position. However, these images appear to be blurred due to wind-induced oscillation of the camera and/or the camera mounting system. An exemplar uncropped image is shown in Figure 5. Attachments 4–5 contain the corresponding cropped image sequences. The “Front Door” label in this video refers to a fixed structure as opposed to an airplane door.

Figure 5: Exemplar frame from OPH Front Door video. N686PA is shown in upper left.

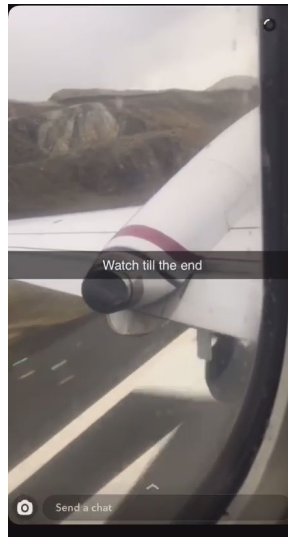
A passenger video was made available to the investigation on October 20 and reviewed by the NTSB Team. The same storyboard construction technique used for the OPH Fuel Tank and OPH Front Door videos was applied to develop the image sequence summary for the first passenger video. The image contents show intermittent views of the left wing, left engine cowling, left main gear (LMG) strut, LMG inboard and out-board wheels, the left side of runway 13, and related runway paint markings during the N686PA short final approach, touchdown and initial landing rollout. A smoke event near the LMG is visible during the rollout. An exemplar cropped image is shown in Figure 6. See Attachment 6 for the corresponding cropped image sequence.

Figure 6: Exemplar frame from first passenger video

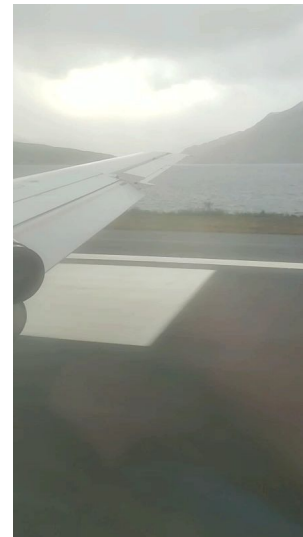
Figure 7: Exemplar frame, second passenger video

A second passenger video was made available to the investigation and reviewed by the NTSB Team. The image contents show views of the right wing, right engine cowling, the right side of runway 13, and related runway paint markings during the N686PA short final approach, touchdown, and initial landing rollout. An exemplar cropped image is shown in Figure 7. Attachment 7 contains the corresponding cropped image sequence.

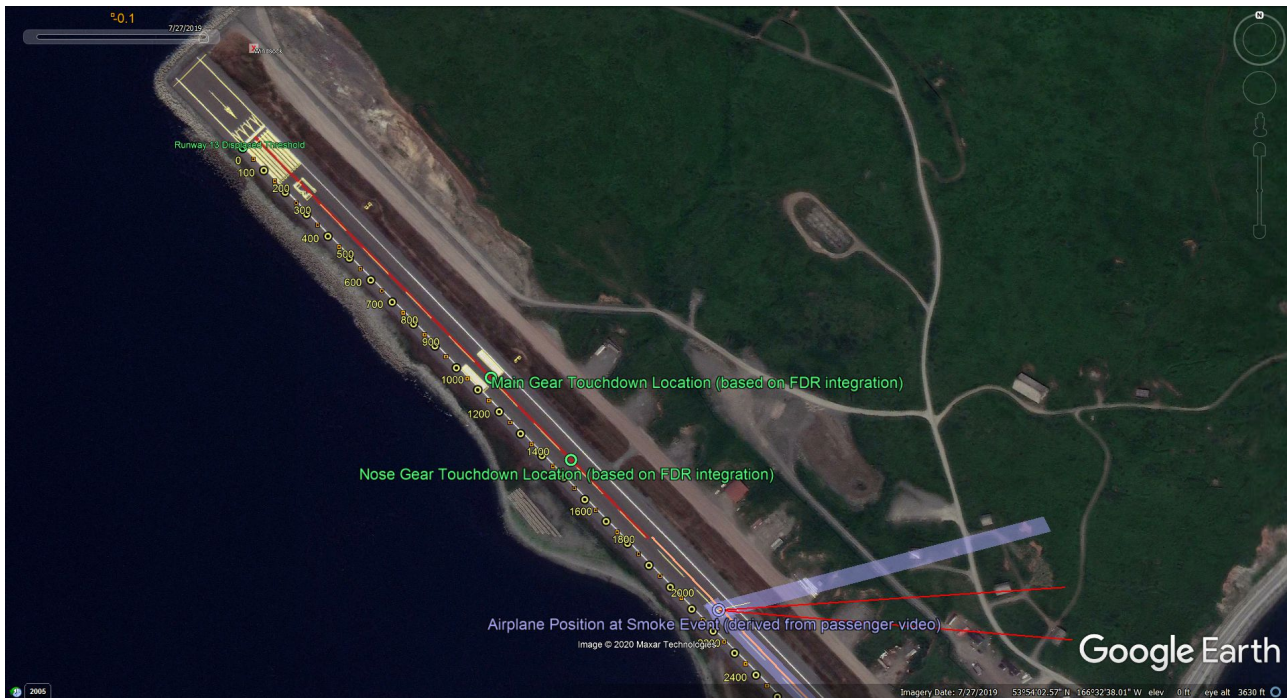
The calculated main gear touchdown point based on integrating FDR accelerometer data (see Section 2.8) is about 1,100 feet beyond the runway 13 threshold, as indicated by the green text label. Witness marks associated with the LMG outboard wheel path are depicted by the solid orange line, and begin about 1,835 feet downrange of the runway 13 threshold. The characteristics of the witness marks from the LMG outboard wheel vary from an initial, deep, dark, full width, contact patch to only thin inboard and outboard contact patch marks, to short, full-width patches of dark deposits, to long stretches of lighter deposits, to stretches free of discernible witness marks. The LMG outboard wheel path began on the left side of the runway centerline, crossed over to the right side of centerline, returned to the left side, and finally crossed over again to the right side before the airplane overran the blast pad surface (see Figures 9 and 10 for more detail).

The estimated position of a smoke event external to the airplane fuselage that was recorded in the first passenger video is identified by the blue text and corresponding camera orientation angle, at about 2,200 feet beyond the runway 13 threshold in Figures 8 and 9. Additional wheel path witness marks associated with the LMG inboard wheel and the right main gear (RMG) inboard and outboard wheels (beginning at about 4,030 feet downrange of the runway 13 threshold, near the midpoint of the 300-foot declared distance RSA) are shown by the respective solid orange lines in Figures 9 and 10.

Figure 8: Google Earth model showing N686PA calculated gear touchdown points and GPS survey of ground rollout path on DUT runway 13. Witness marks associated with the LMG outboard wheel are highlighted in orange (beginning about 1,835 feet on the distance scale). True North is toward the top of the page.

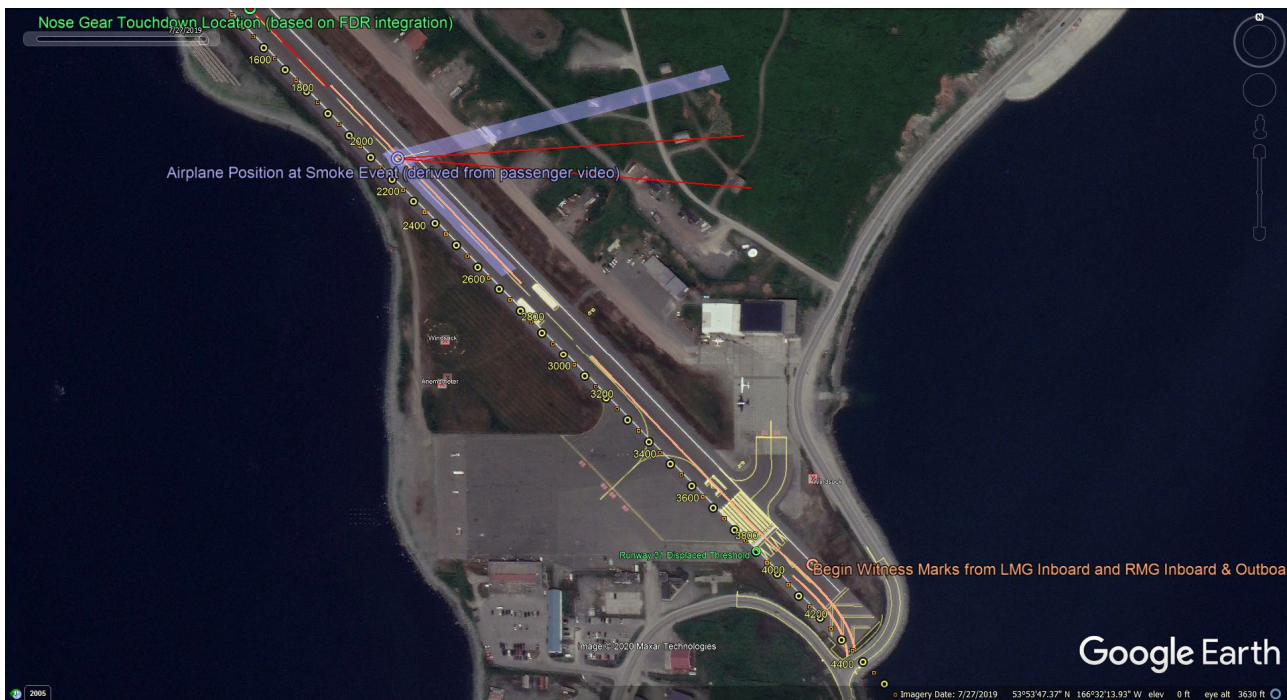
Figure 9: Google Earth model showing N686PA main gear wheel paths on DUT runway 13 based on GPS survey of witness mark evidence. Witness marks associated with the LMG inboard wheel and the RMG inboard and outboard wheels begin near the midpoint of the 300-foot declared distance RSA, as indicated by the respective solid orange lines. True North is toward the top of the page.

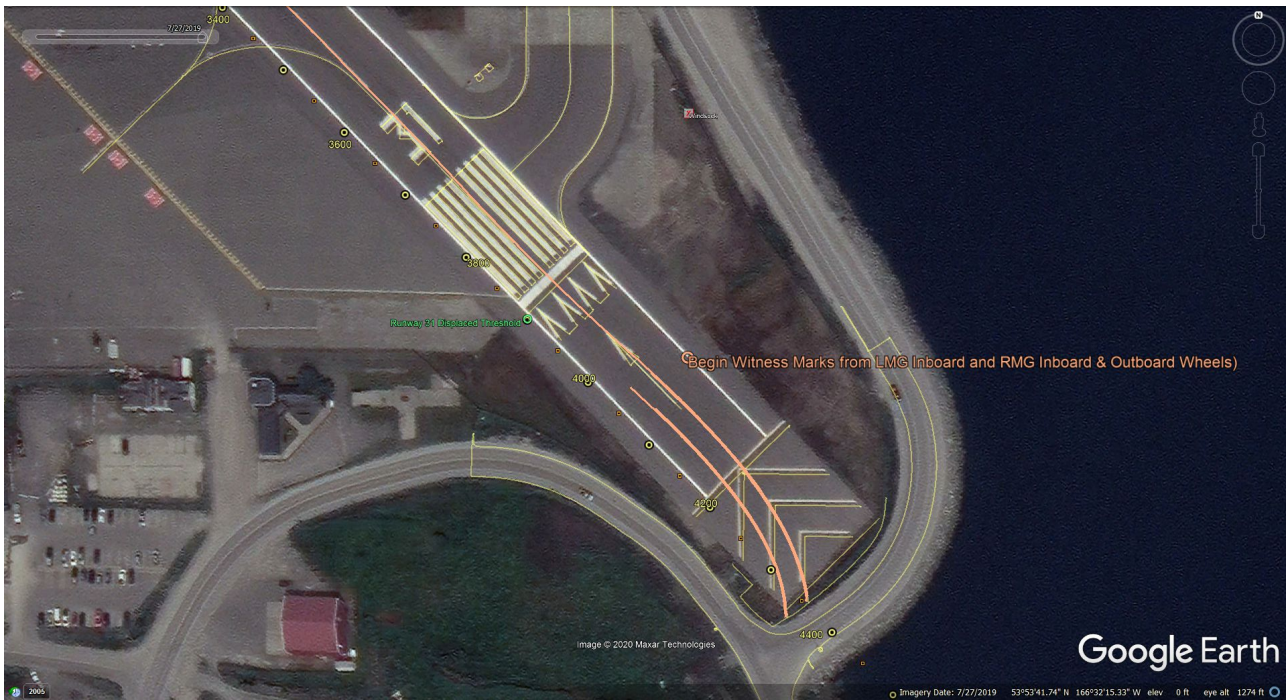
Figure 10: Google Earth model showing zoomed-in view of N686PA witness marks associated with the LMG inboard and outboard wheels and the RMG inboard and outboard wheels, as indicated by the respective solid orange lines. True North is toward the top of the page.

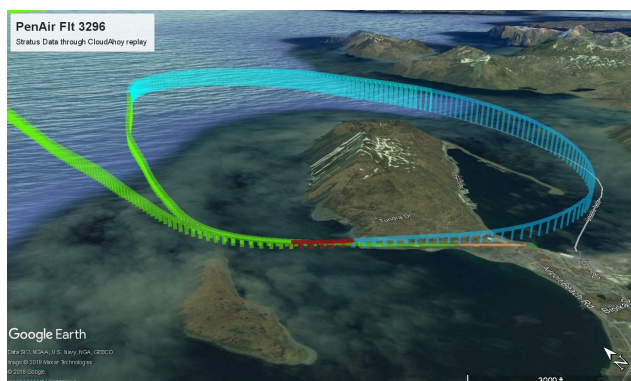
Figure 14(a): CloudAhoy reconstruction of N686PA flightpath during first approach, missed approach, second approach, landing, and rollout

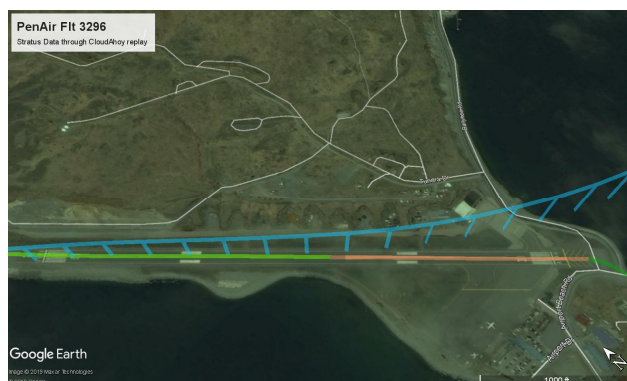
Figure 14(b): CloudAhoy reconstruction of N686PA flightpath during missed approach and landing rollout
