# NATIONAL TRANSPORTATION SAFETY BOARD

## MATERIALS LABORATORY FACTUAL REPORT

Report No. 20-043

| Vehicle | : | Sikorsky S76 helicopter |

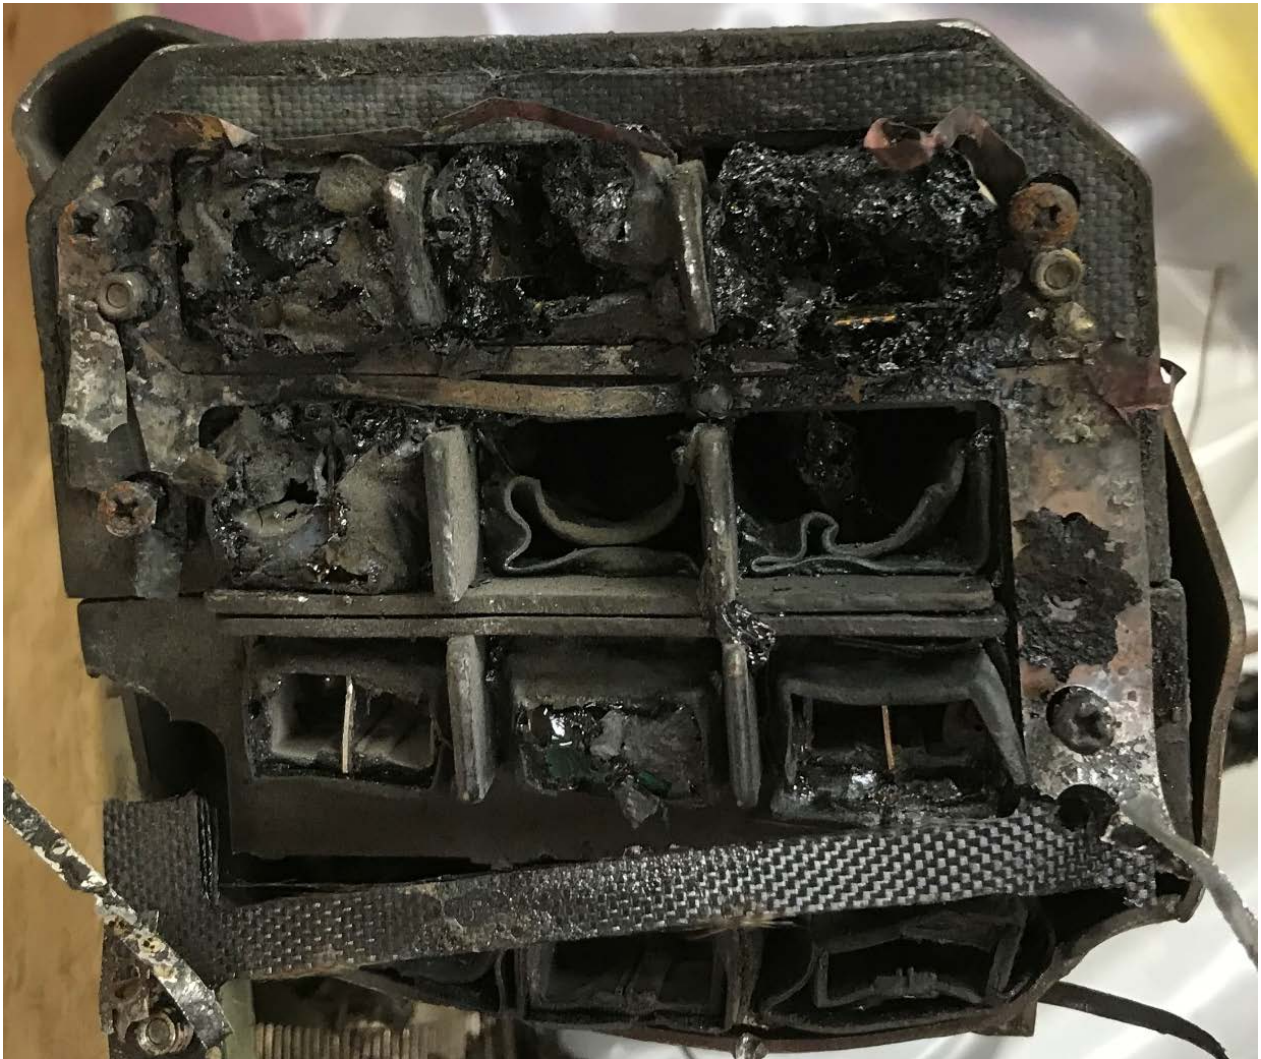
The Flight Director Mode Selector sustained significant impact and fire damage as shown in Figure 1. A layout drawing of the selector panel is shown in Figure 2. Most of the annunciator bulbs were missing or inaccessible due to damage<sup>1</sup>. Three annunciator lights in this panel had visible intact bulbs-ALT PRE ARM/CAP and VOR-APR ARM/CAP each had two intact bulbs and GA ON had one intact bulb. These annunciators were examined using a 5-50X zoom stereomicroscope. No hot filament stretching was observed in the any of the intact bulbs.

**Figure 1. Flight Director Mode Selector.**

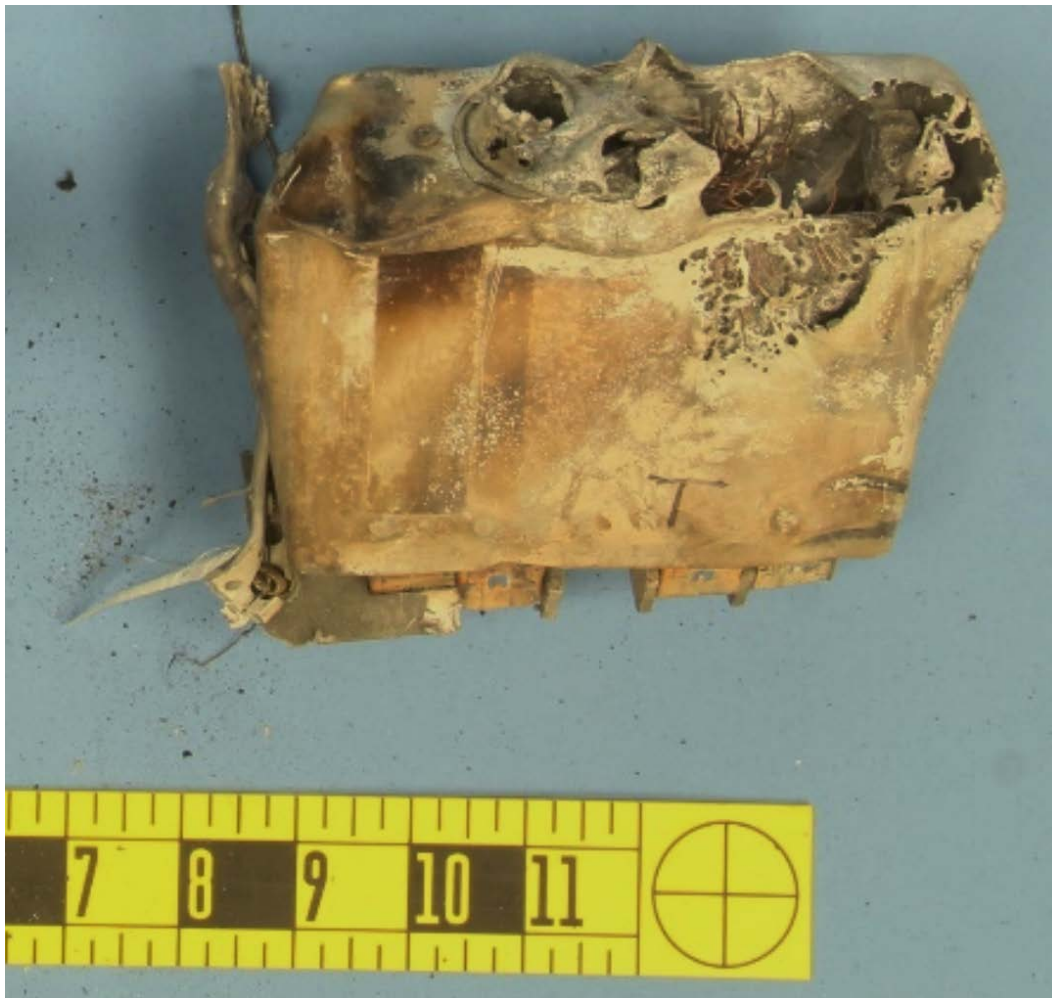
The Autopilot Controller sustained significant impact and fire damage as shown in Figure 3. A layout drawing of the selector panel is shown in Figure 4. No bulbs were found in the AP1 ON, AP2 ON, COLL RAD, FD2 and SAS/ATT annunciators. The remaining annunciators had at least one bulb intact. The intact bulbs were x-rayed to visualize the filaments within the individual annunciators. The findings are summarized in the table below. Radiographs of the intact annunciator bulbs are shown in Figures 5-9.

Figure 3. Autopilot controller.

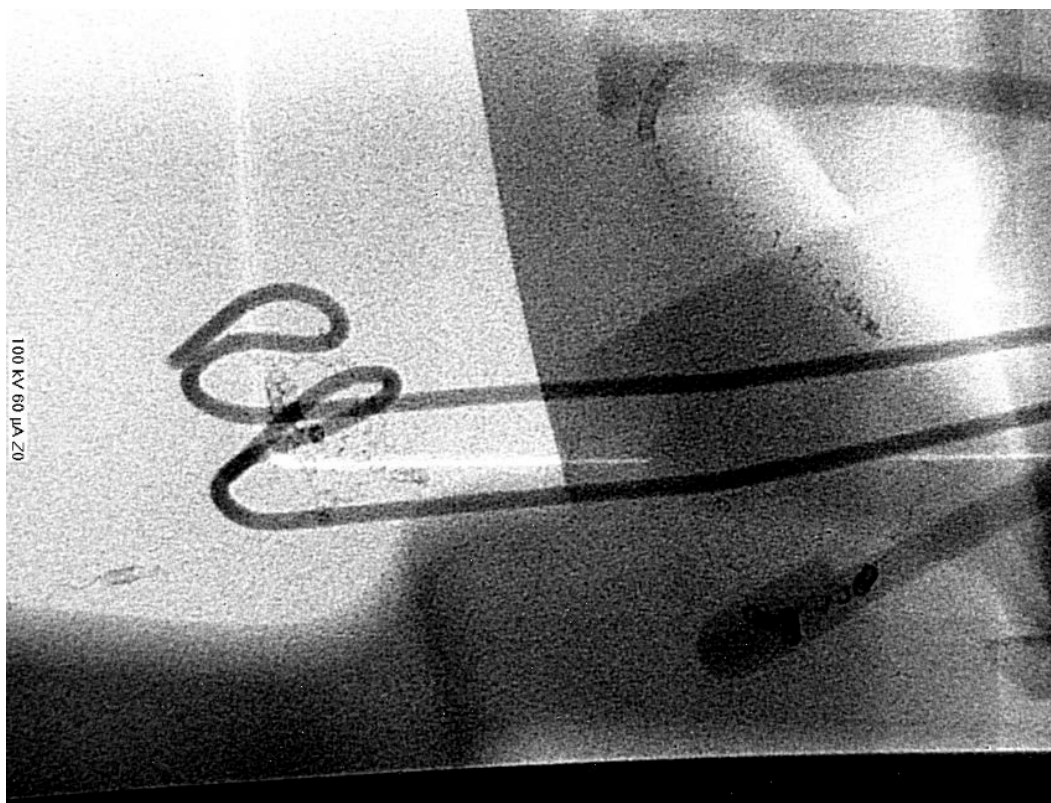
| <b>Annunciator</b> | <b>Bulb #1</b> | <b>Bulb #2</b> |
|---|---|---|
| TEST ON | Missing | Broken, stretched* |

\*The globe of this bulb was broken. Therefore, the filament condition is possibly a result of mechanical damage due to the bulb globe and not necessarily an indication of annunciator status at time of impact.

Figure 5. Radiograph of TEST ON bulb filament.

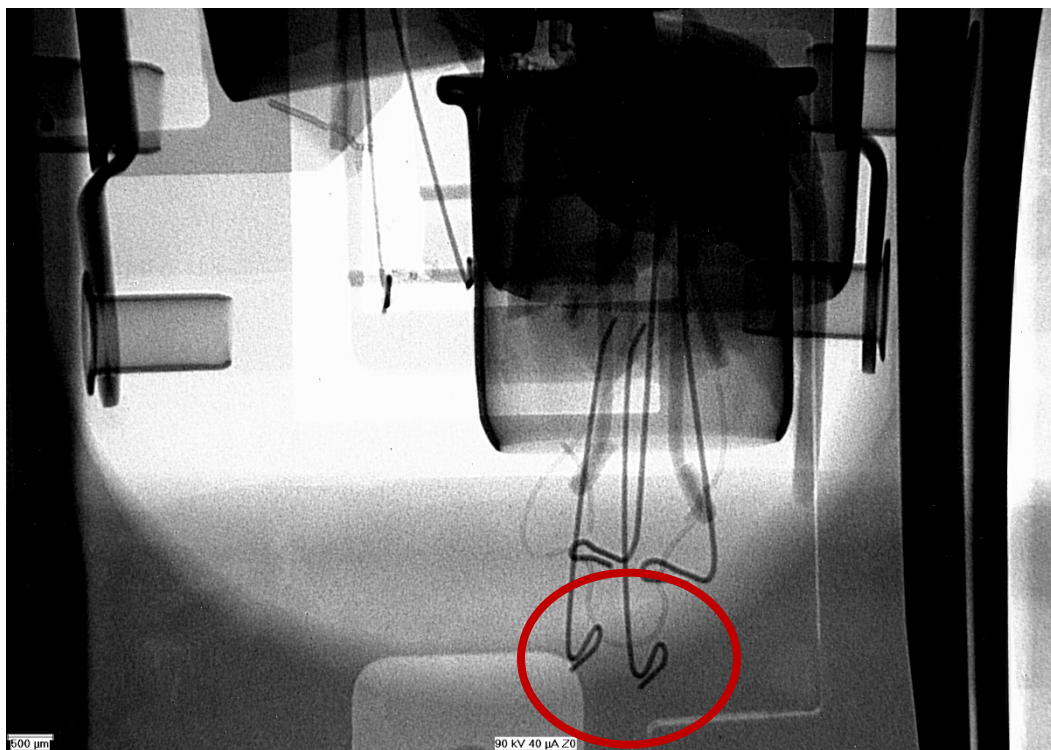
| <b>Annunciator</b> | <b>Bulb #1</b> | <b>Bulb #2</b> |
|---|---|---|
| HOV ON | Missing | Intact, not stretched |

Figure 6. Radiograph of remaining HOV ON bulb filament (circle in red).

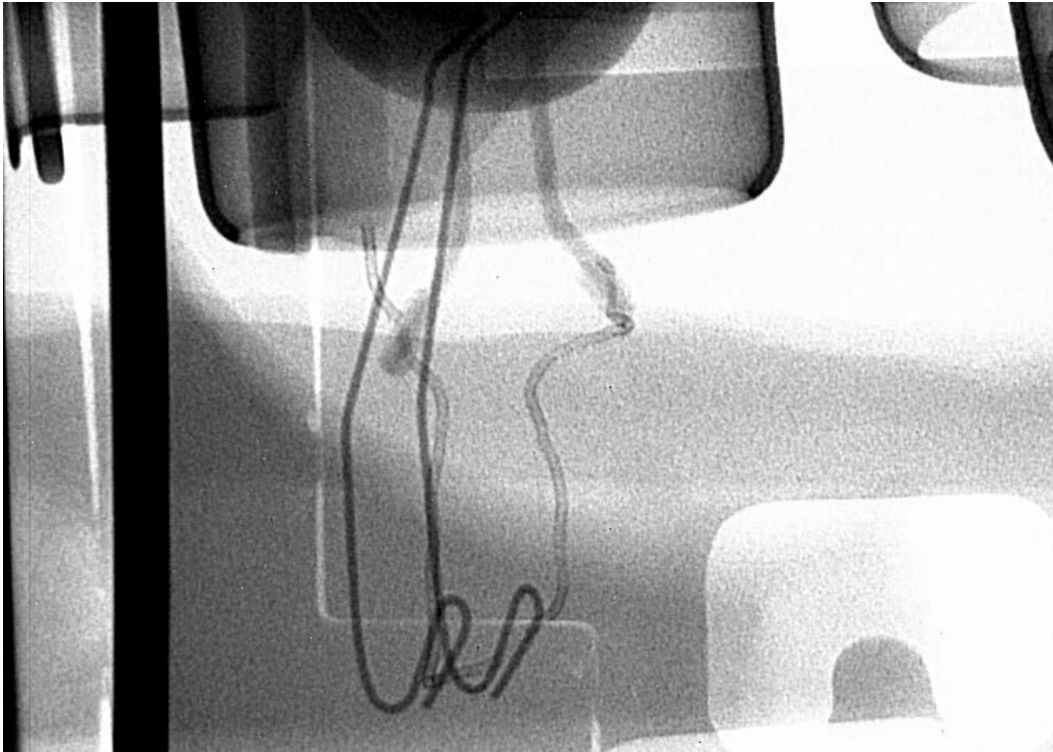
| <b>Annunciator</b> | <b>Bulb #1</b> | <b>Bulb #2</b> |
|---|---|---|
| FD 1 | Intact, Not Stretched | N/A |

**Figure 7. Radiograph of FD1.**

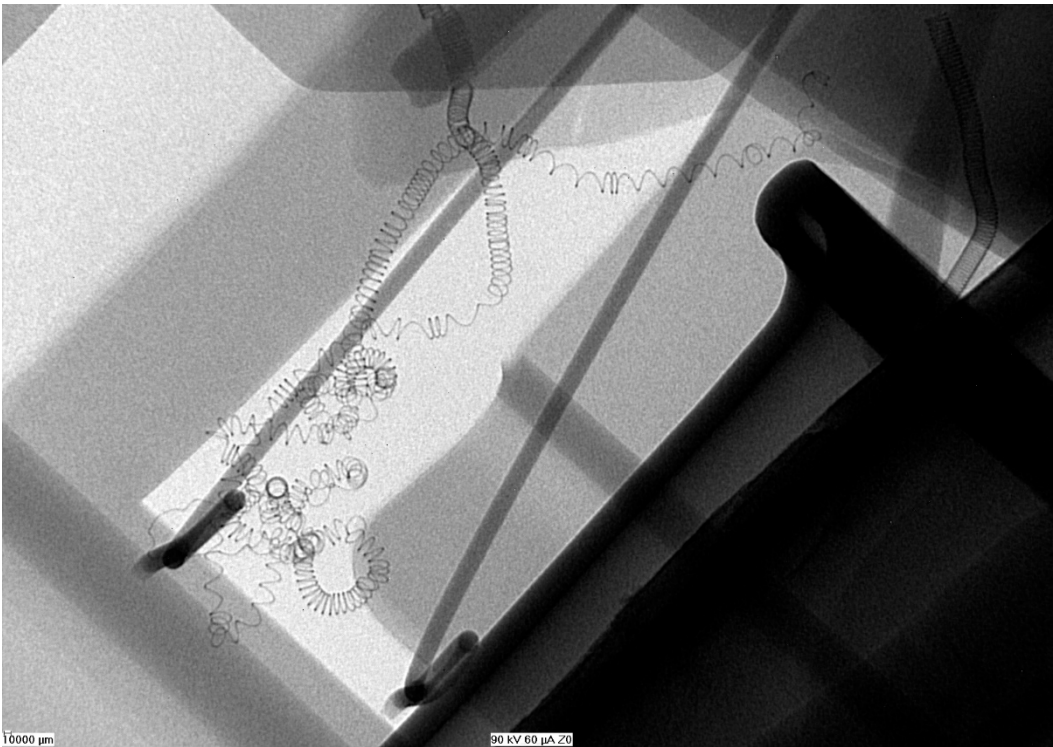
| <b>Annunciator</b> | <b>Bulb #1</b> | <b>Bulb #2</b> |
|---|---|---|
| COLL FD/RAD | Intact, stretched* | N/A |

**Figure 8. Radiograph of COLL FD bulb.**

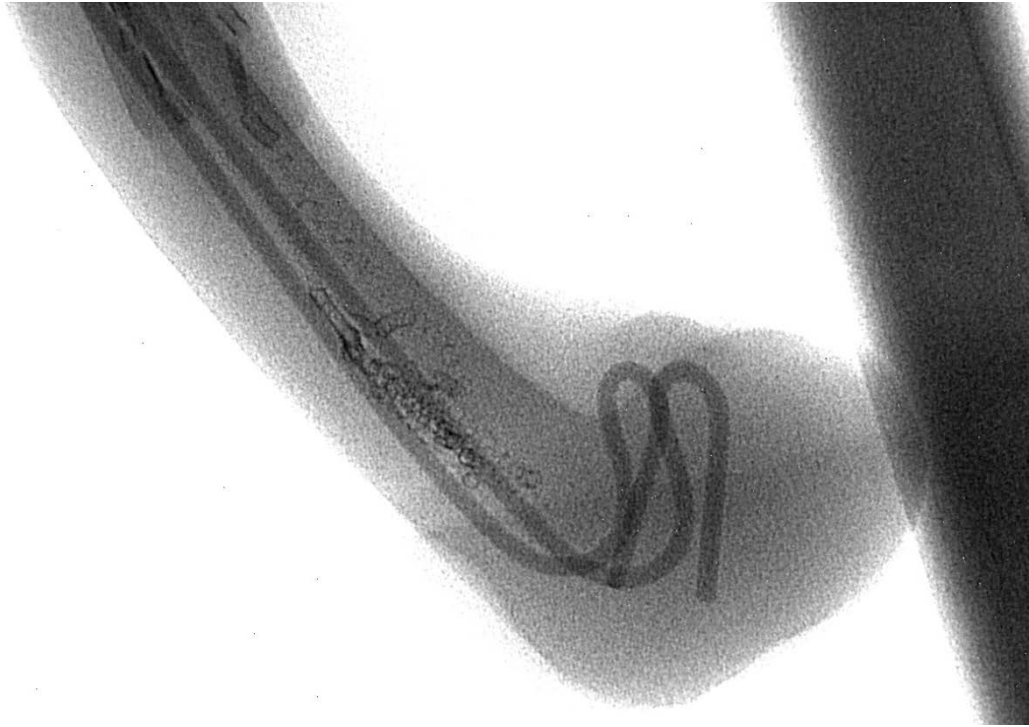
| <b>Annunciator</b> | <b>Bulb #1</b> | <b>Bulb #2</b> |
|---|---|---|
| CPL ON | N/A | Broken, stretch** |

\*\*The globe of this bulb exhibited significant thermal deformation. Therefore, the filament condition is possibly a result of the collapse of the bulb and not necessarily an indication of annunciator status at time of impact.

**Figure 9. Radiograph of CPL ON bulb.**

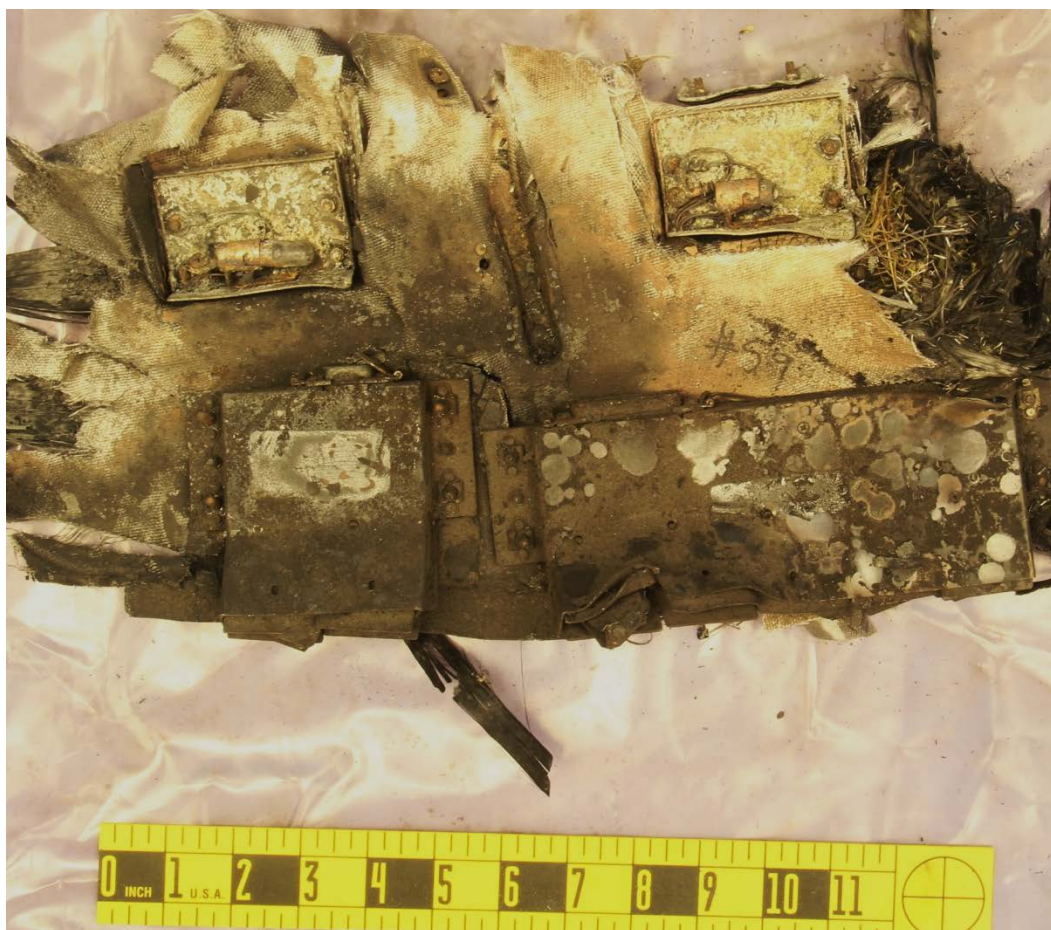
The pilot's side master warning annunciator panel sustained significant impact and fire damage as shown in Figure 10. A layout drawing of the selector panel is shown in Figure 11. The panel was x-rayed to visualize any annunciators with intact bulbs and/or filaments. The radiographs showed that only three of the annunciators had partially intact annunciators-#1 ENG MAN REV, #1 ENG FIRE and #2 ENG FIRE. However, none of the annunciators had two intact bulbs. #1 ENG MAN REV had one broken bulb with no filament and one intact bulb that had a broken, unstretched filament as shown in Figure 12. #1 ENG FIRE had had two broken bulbs and no recognizable filaments as shown in Figures 13 and 14. #2 ENG FIRE had one broken bulb with no filament and one intact bulb that had a broken, unstretched filament as shown in Figure 15.

Figure 10. Pilot's side master warning annunciator panel (underside of panel shown).

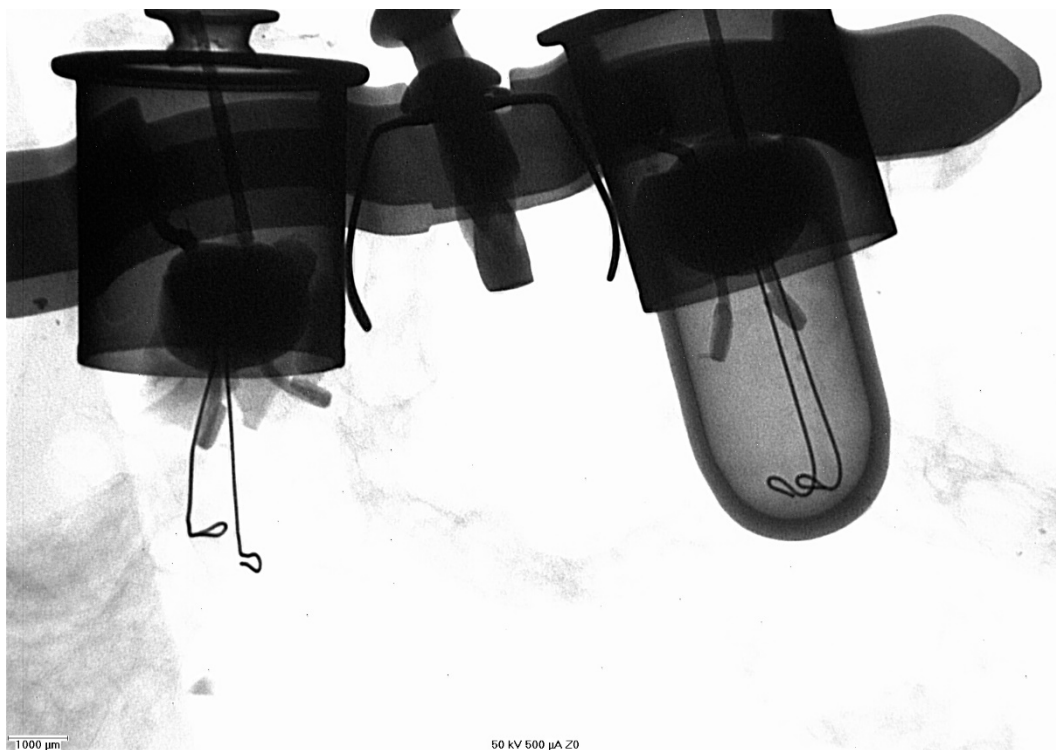
**Figure 15. Radiograph of #2 ENG FIRE annunciator**

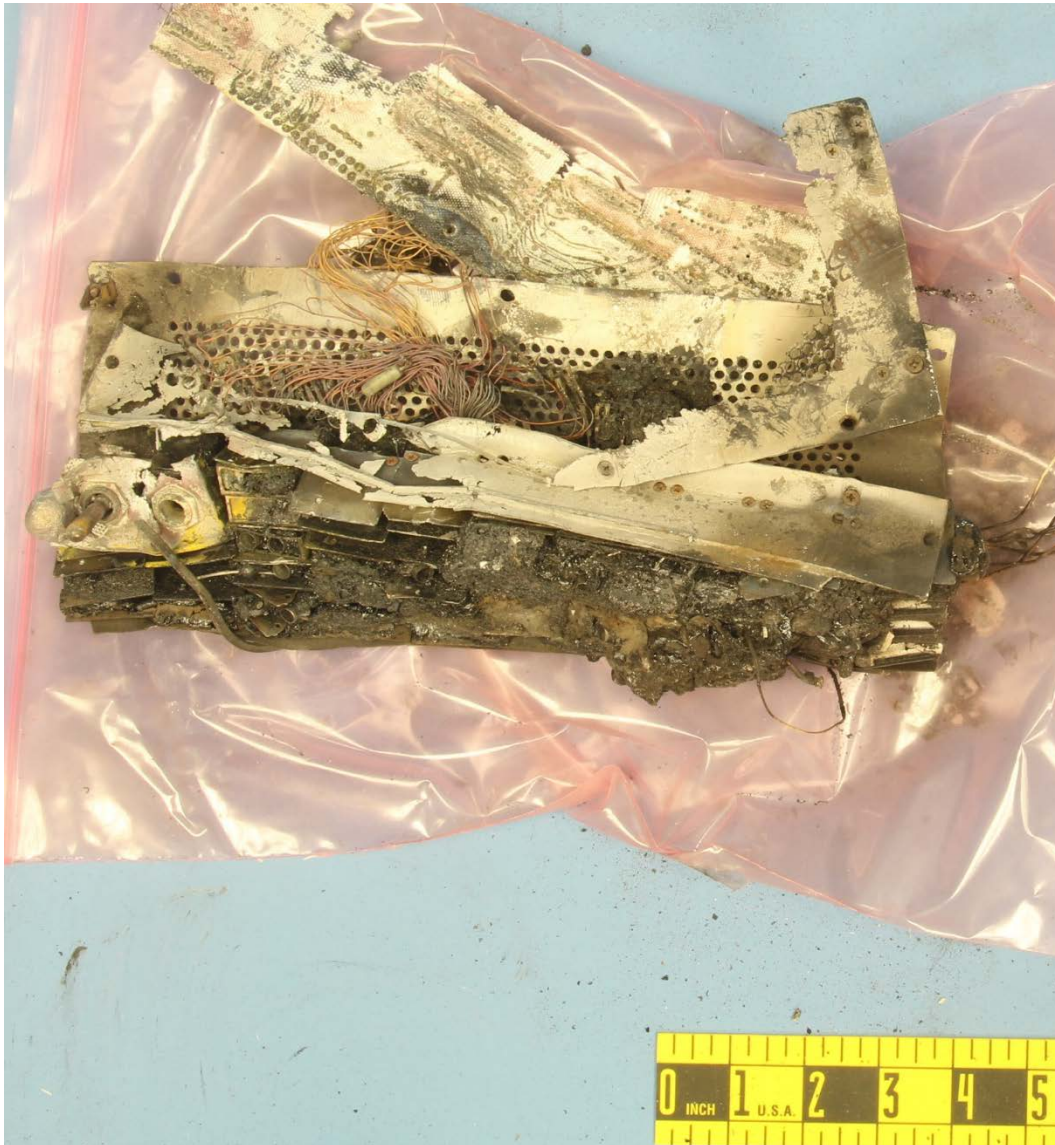
The caution panel sustained significant impact and fire damage as shown in Figure 16. A layout drawing of one layout option for the selector panel is shown in Figure 17. The actual layout for the accident aircraft could not be determined therefore the lights may have differed from the layout drawing. The intact bulbs were removed from the individual annunciators and x-rayed to visualize the filaments within each bulb. The

**Figure 16. Caution/advisory annunciator panel.**

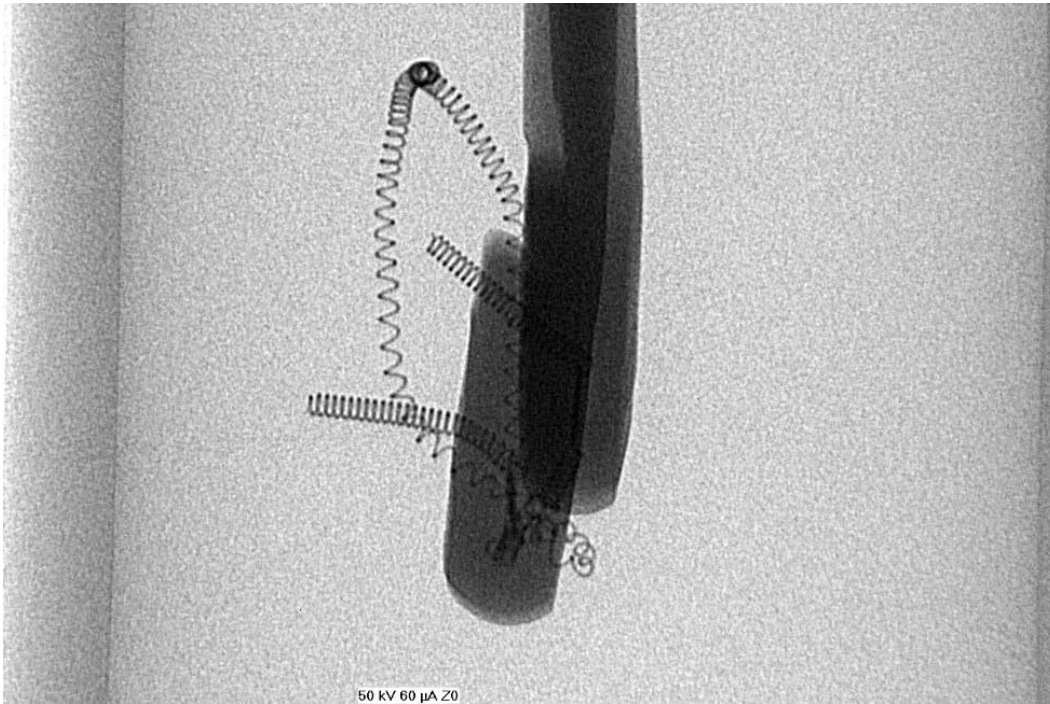
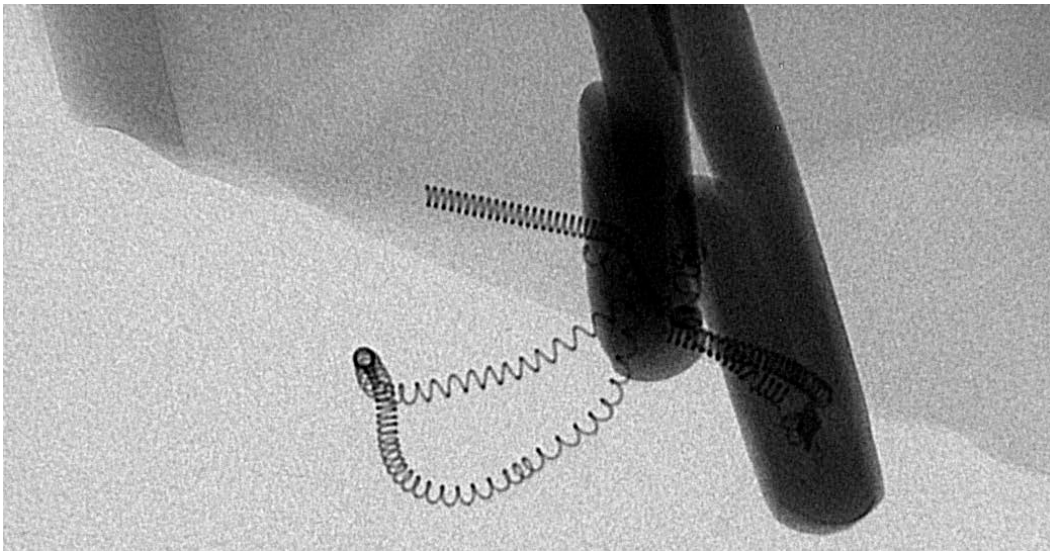
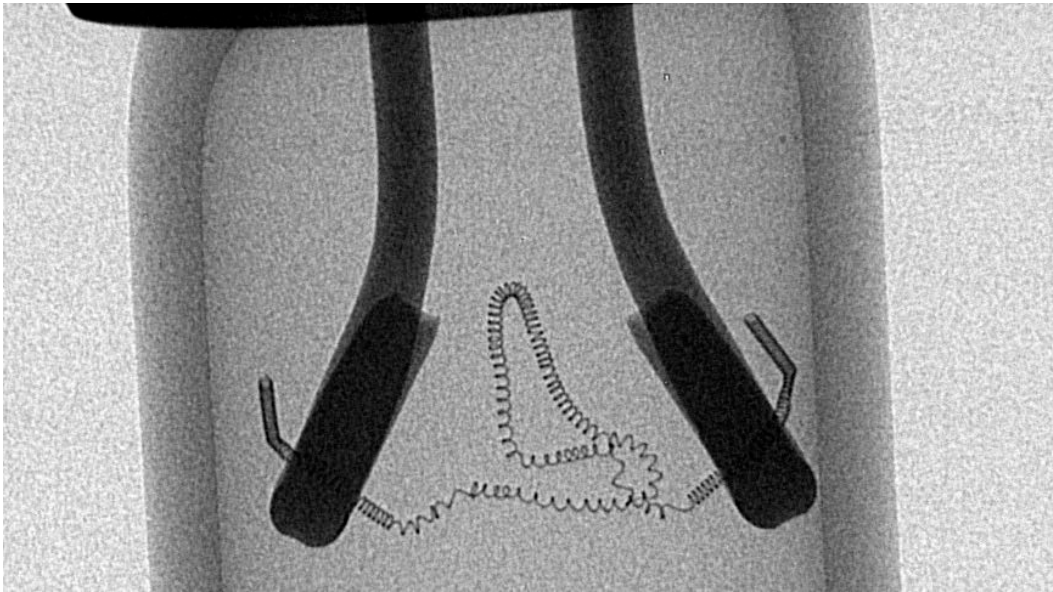
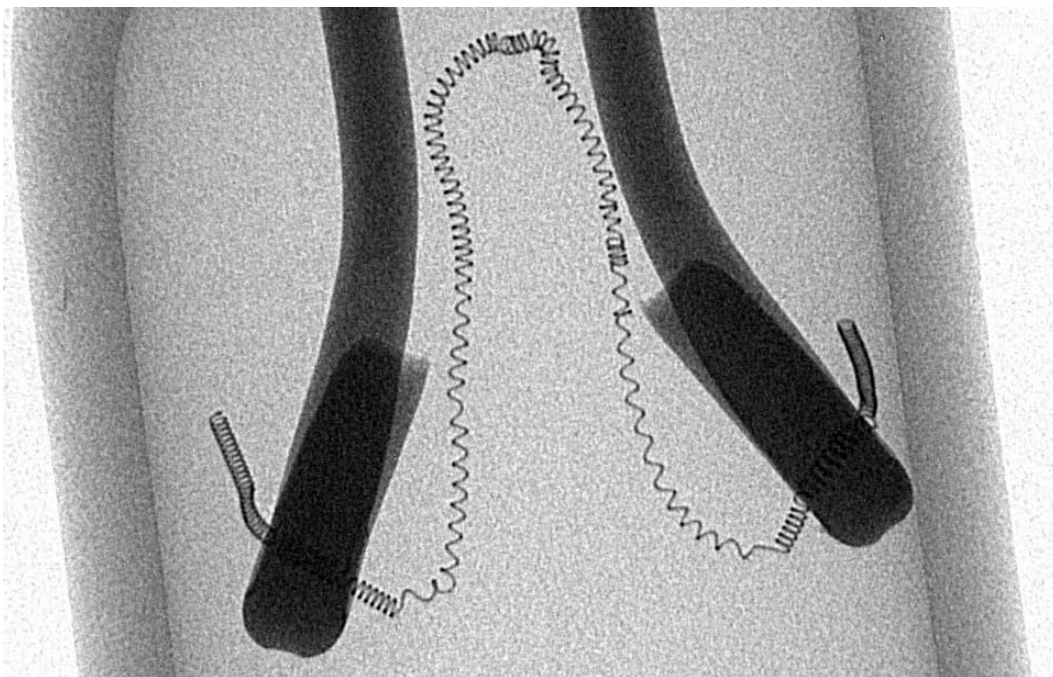
The bulbs in the Symbol Generator Reversionary (SG REV) push button switch all exhibited hot filament stretching as shown in Figures 36-39. By design, the bulbs for this push button were always on during helicopter operation.

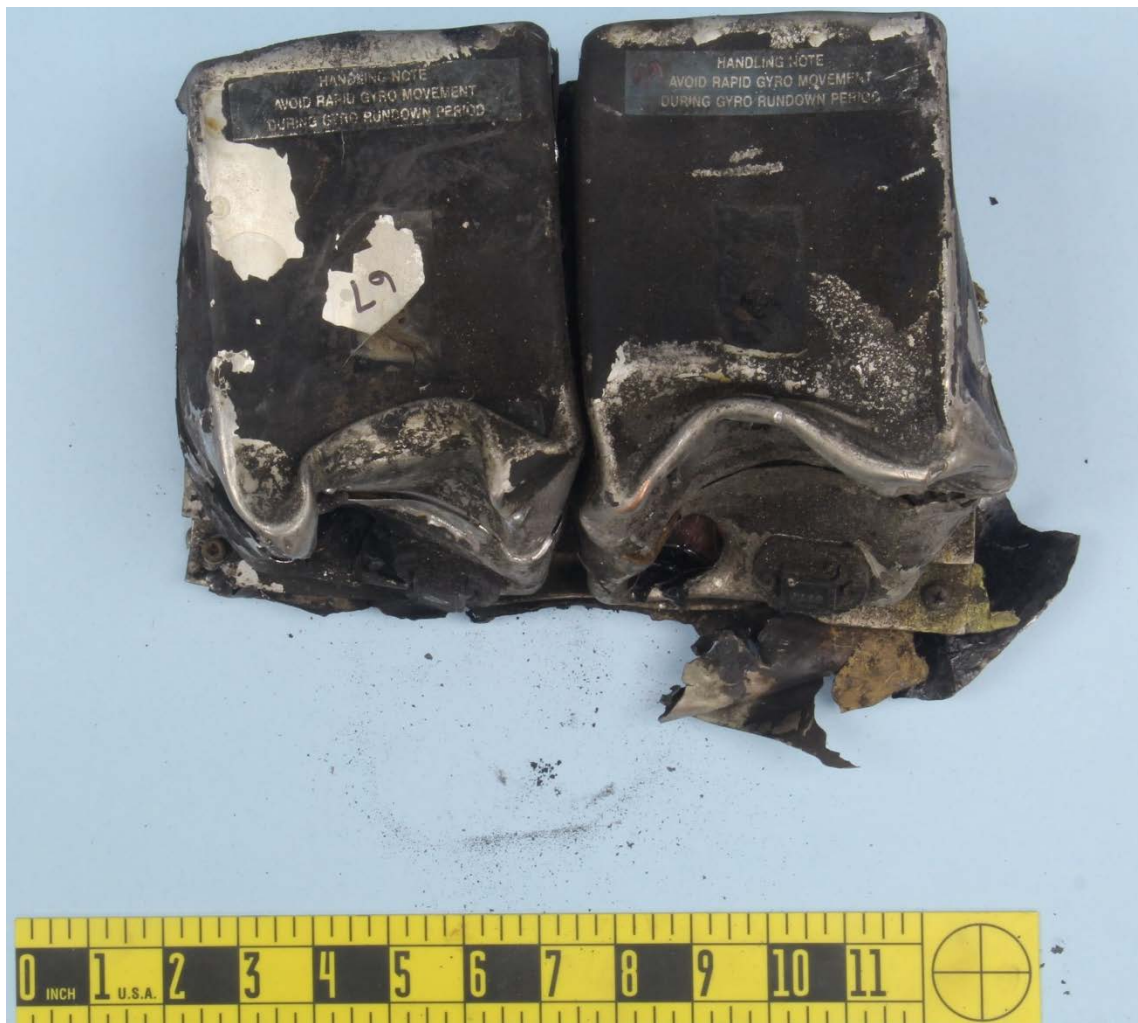
The vertical gyros sustained significant impact and fire damage as shown in Figure 40. The cases for both gyros were taken off and the individual gyros removed to assist with the examination. Both gyros appeared to freely rotate when manually turned indicating that there was no sustained contact between the masses and the structure around them. When the gyros were disassembled, light operational scoring was found on the rotational masses as shown in Figures 41 and 42. This scoring corresponded to the structure that surrounded the masses. The cases covered only the motors on the end of each gyro.

Figure 40. Vertical Gyros.

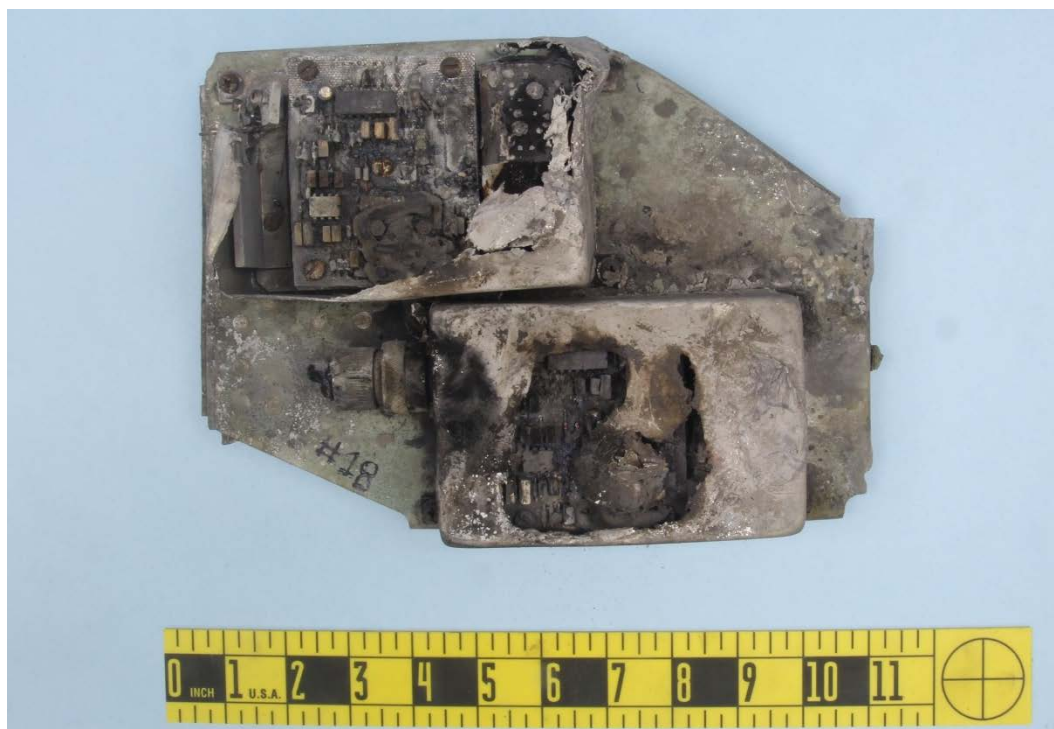
The rate gyros sustained significant impact and fire damage as shown in Figure 43. The cases for both gyros were taken off and the individual gyros removed to assist with the examination. Both gyros appeared to freely rotate when manually turned indicating that there was no sustained contact between the masses and the structure around the masses. When the cases around the gyros were removed, no operational scoring was found on the rotational masses, and the cases were unmarked. The rotational masses and exterior of the cases are shown in Figures 44 and 45.

Figure 43. Rate Gyros.

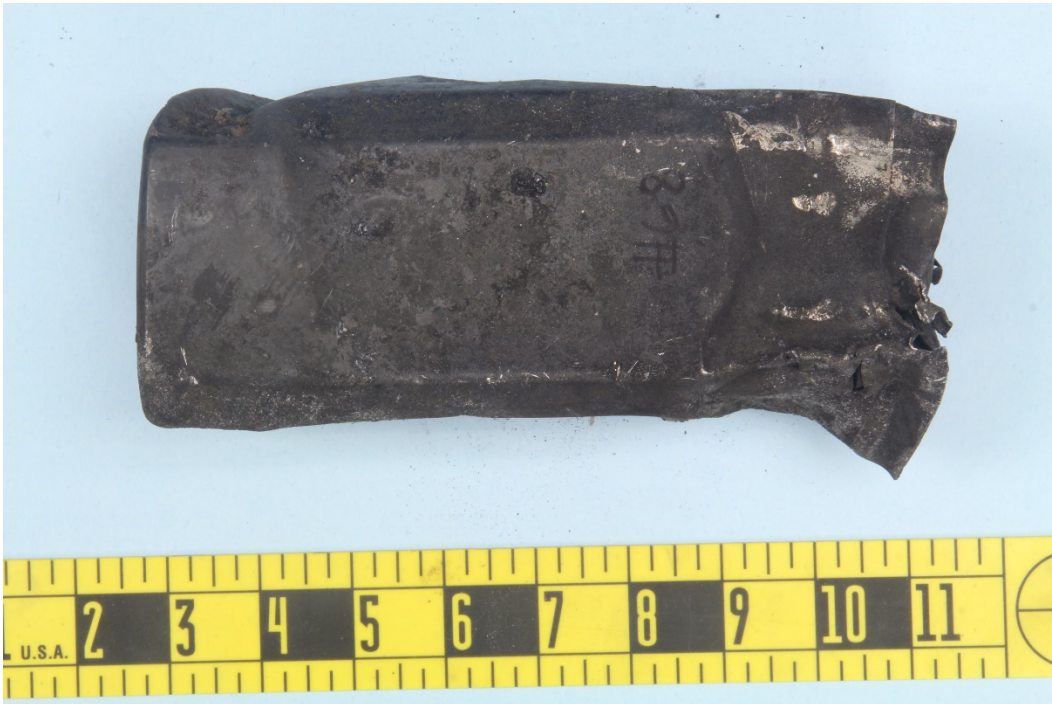
The standby attitude indicator sustained significant impact and fire damage as shown in Figure 46. The indicator faceplate sustained significant fire damage so any witness marks showing the position of the indicator could not be visualized. The case for the indicator was taken off and the gyro removed to assist with the examination. The gyro appeared to freely rotate when manually turned. When the gyro was disassembled, a small amount of operational scoring was found on the top of rotational mass as shown in Figure 47. The circumference of the mass and the top of the case had light scoring as shown in Figure 48. The scoring on the mass circumference corresponded to a machined ridge on the inside of the case.

**Figure 46. Standby Attitude Indicator.**

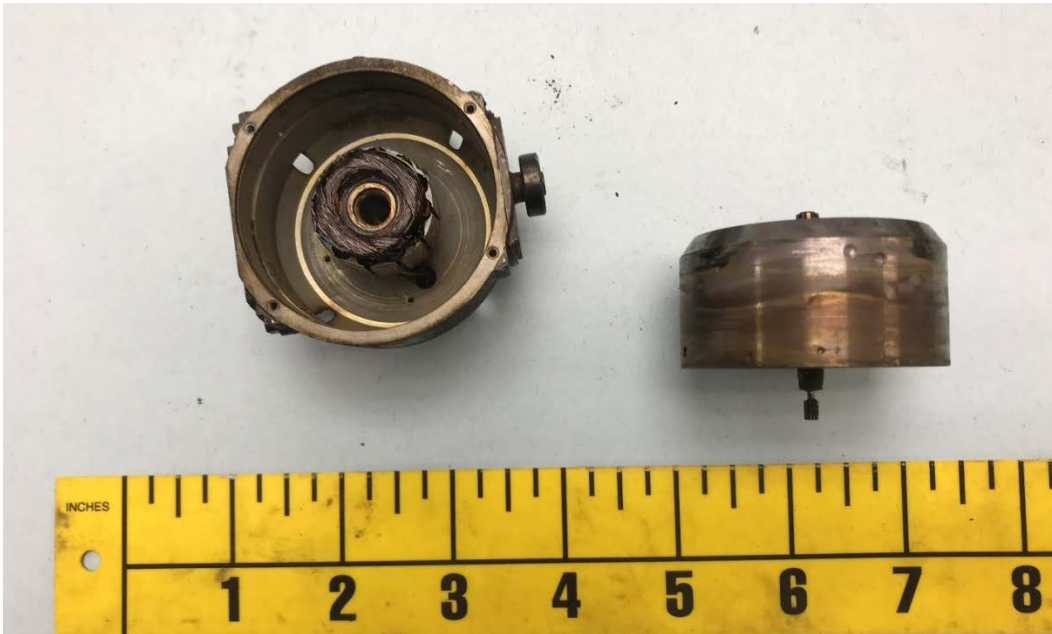
**Figure 48. Gyro (mass and case) from Standby Attitude Indicator.**
