# National Transportation Safety Board

## Performance Study

### Specialist Report

| Aircraft: | Sikorsky S-76B, N72EX |

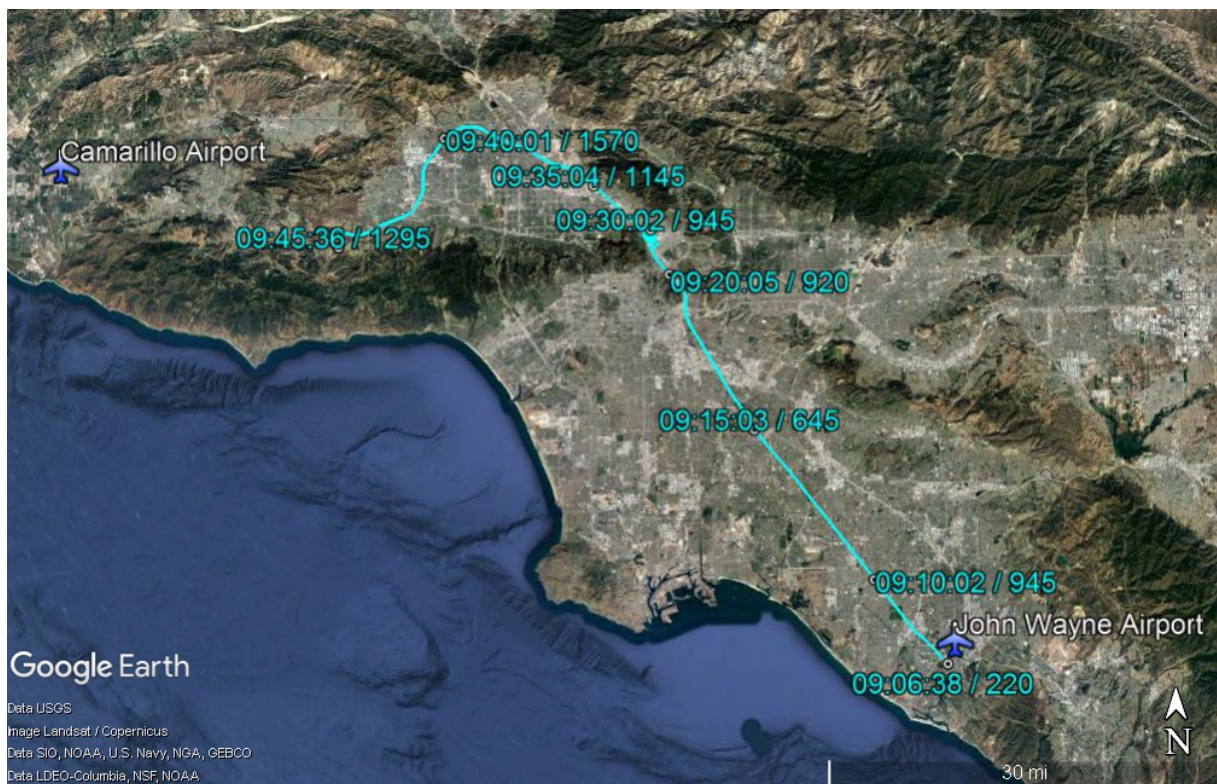
The helicopter departed John Wayne Airport at 09:07, after receiving a special visual flight rules (SVFR) departure from Long Beach Airport air traffic control tower (ATCT) (Figure 1). Its destination was Camarillo Airport which is shown west of the final ADS-B point. The helicopter flew northwest towards Glendale, where it held for 12 minutes, awaiting clearance from Burbank ATCT to continue. It then continued north along I-5 and around the Burbank and Van Nuys airports before turning south. At 09:42:45 the helicopter joined US 101 heading west towards Camarillo<sup>1</sup>. ADS-B data ended about three minutes later and the helicopter impacted terrain near Calabasas.

**Figure 1.** Accident flight path.

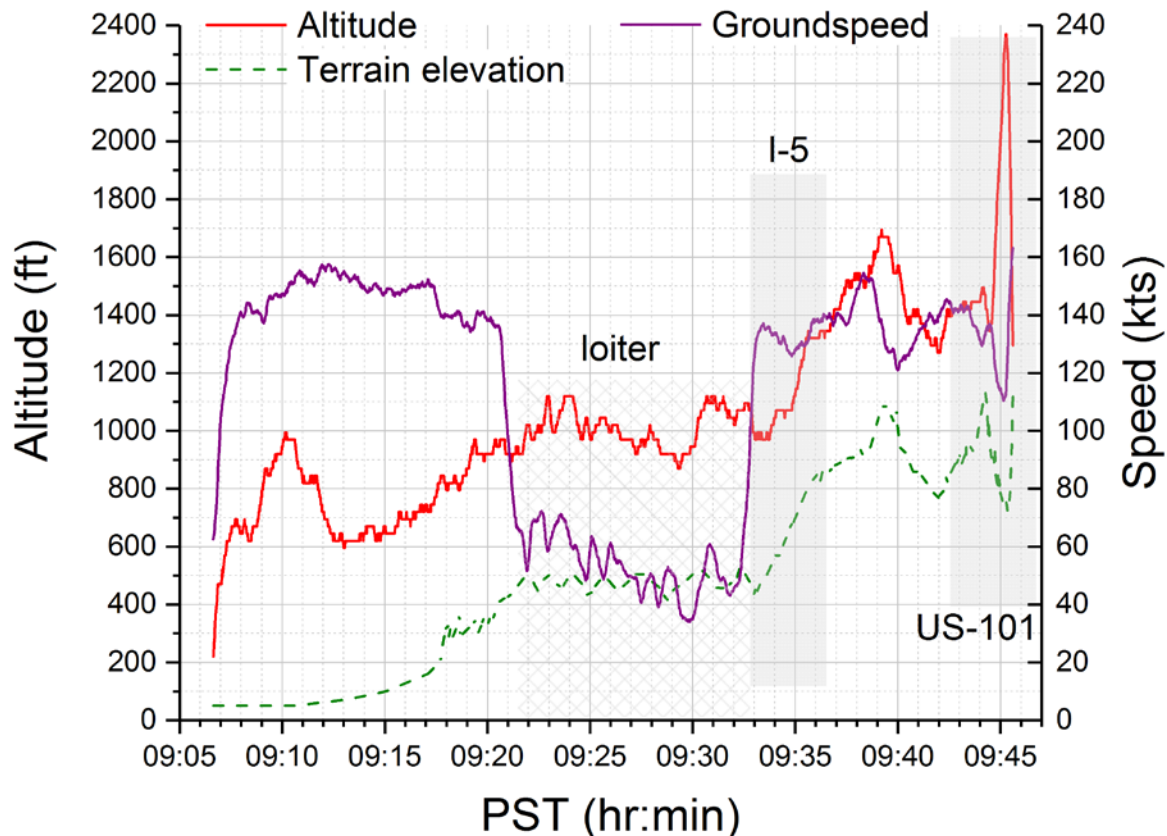
Figure 2 shows the corrected altitude, groundspeed, and terrain elevation. After departure, the helicopter headed northwest at about 150 kts. It climbed to 1,000 ft msl (mean sea level) before descending to 600 ft at about 09:13. From there, the helicopter stayed between 400 and 600 ft

**Figure 2.** Accident altitude, groundspeed, and terrain elevation.

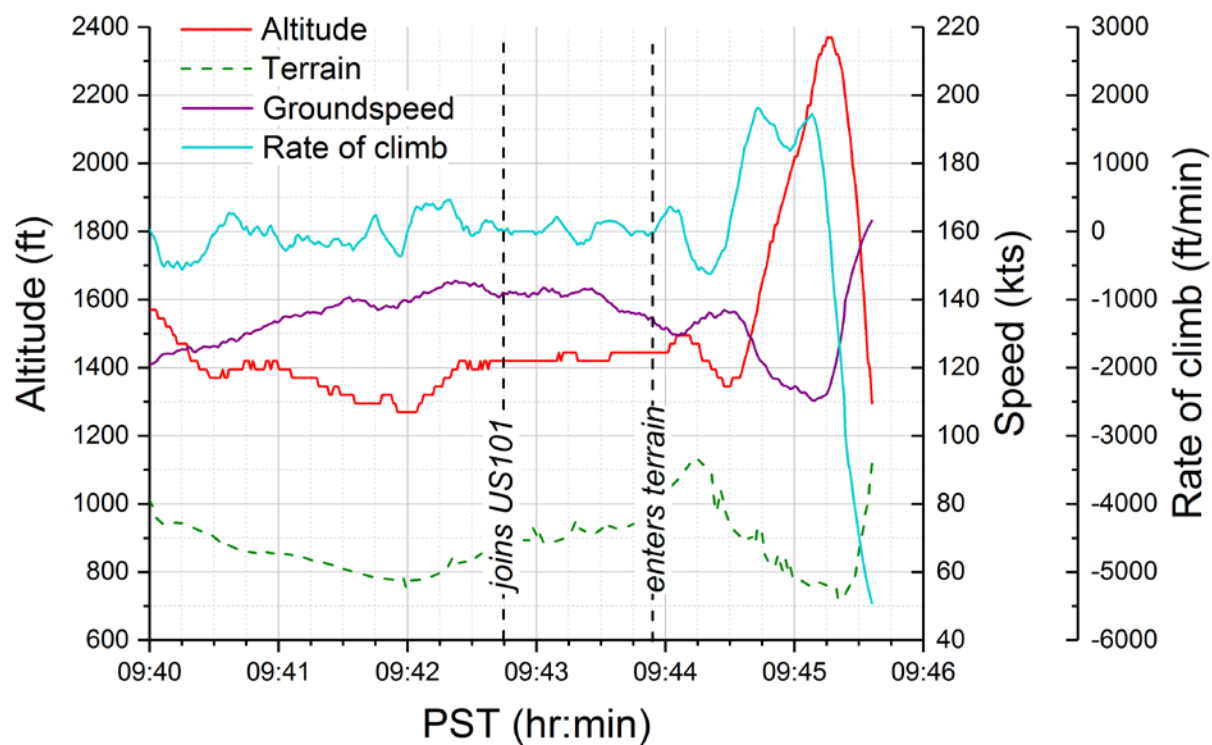
The helicopter joined US 101 at 09:42:45 at which point it was about 29 miles from its destination. Figure 3 shows the helicopter's altitude, groundspeed, and rate of climb at the end of flight. Figure 4 shows the flight path over a terrain map, Figure 5 shows the end of flightpath from an oblique angle, and Figure 6 from overhead. Just before 09:44, the helicopter entered more hilly terrain as US 101 followed a pass through local mountains (Figure 4). Visibility within this pass was limited and is discussed further in the Video-Based Visibility Study [3]. Just after 09:44:30, the helicopter started climbing at a rate of about 1,500 ft/min. About 09:45:10, the helicopter started a left turn away from US 101. The helicopter reached a maximum altitude just below 2,400 ft msl at 09:45:15, about 1,600 ft above the terrain below, when it began to descend rapidly while in a left turn.

**Figure 3.** Accident altitude and terrain elevation, groundspeed, and rate of climb and the end of flight.

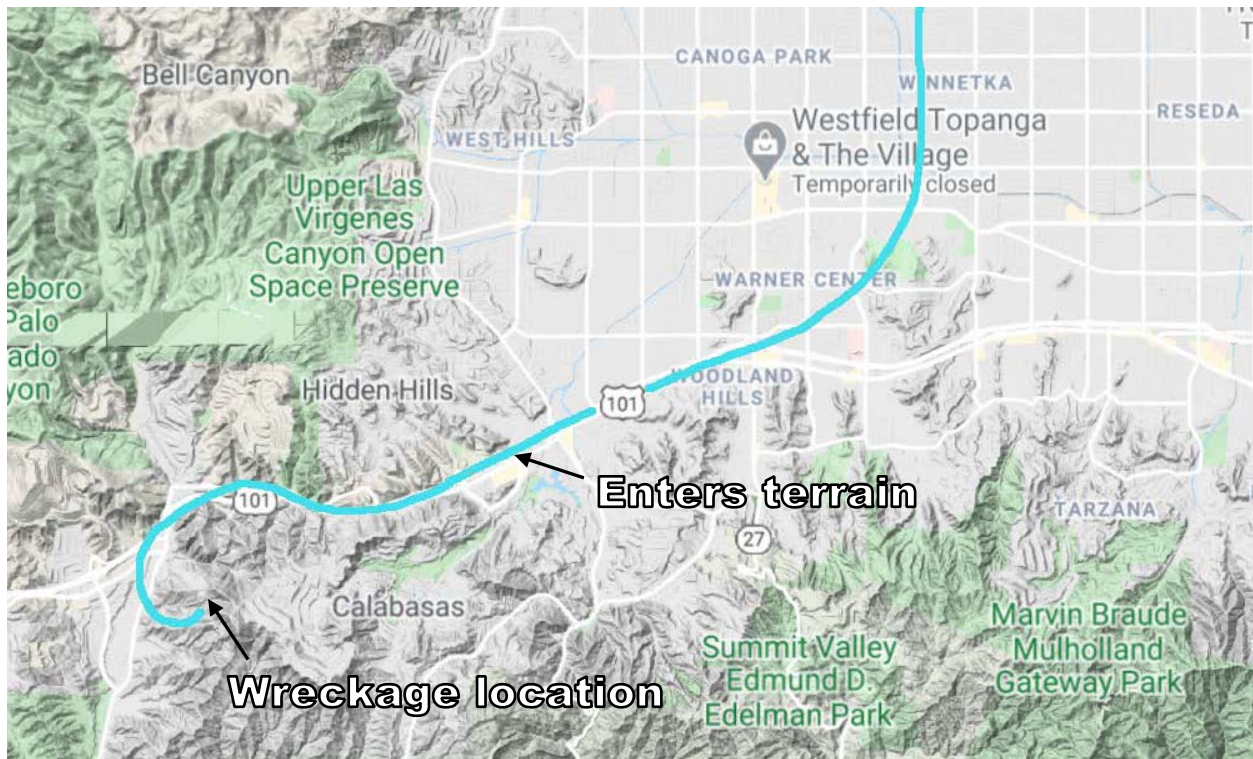
**Figure 4.** Accident flight path over terrain map.

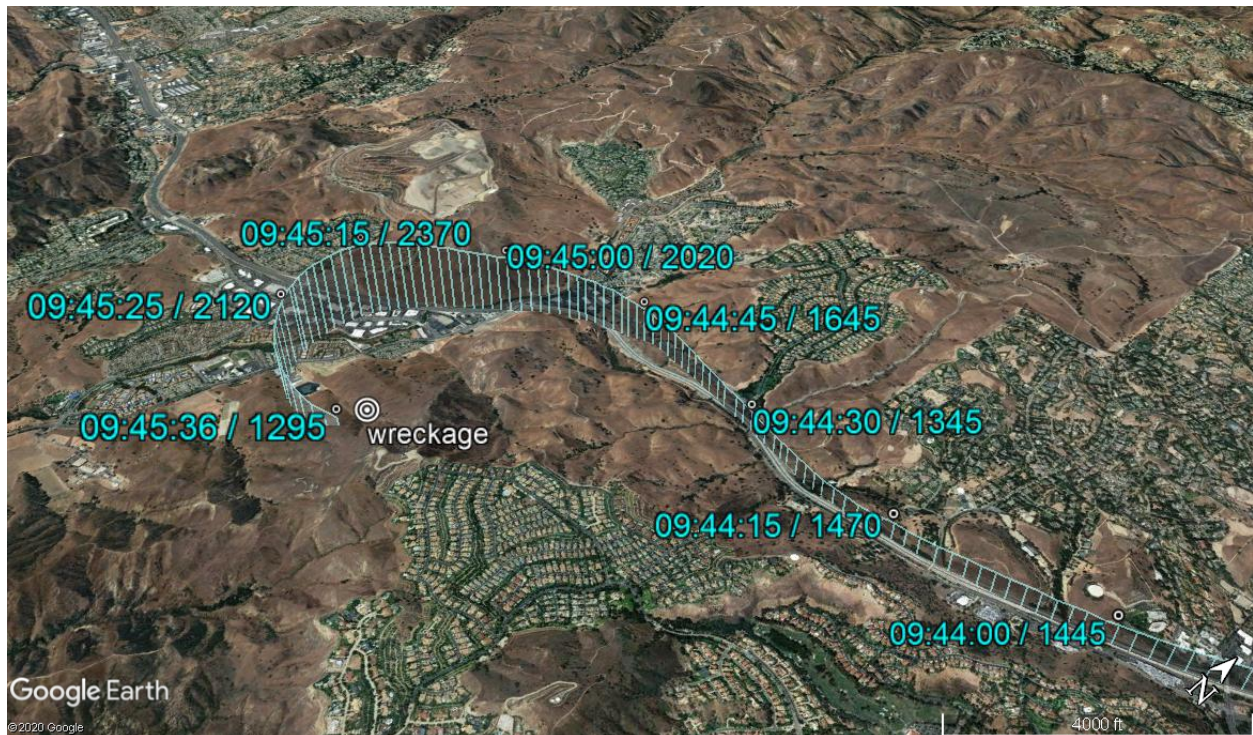
**Figure 5.** End of accident flight with time and altitudes noted.

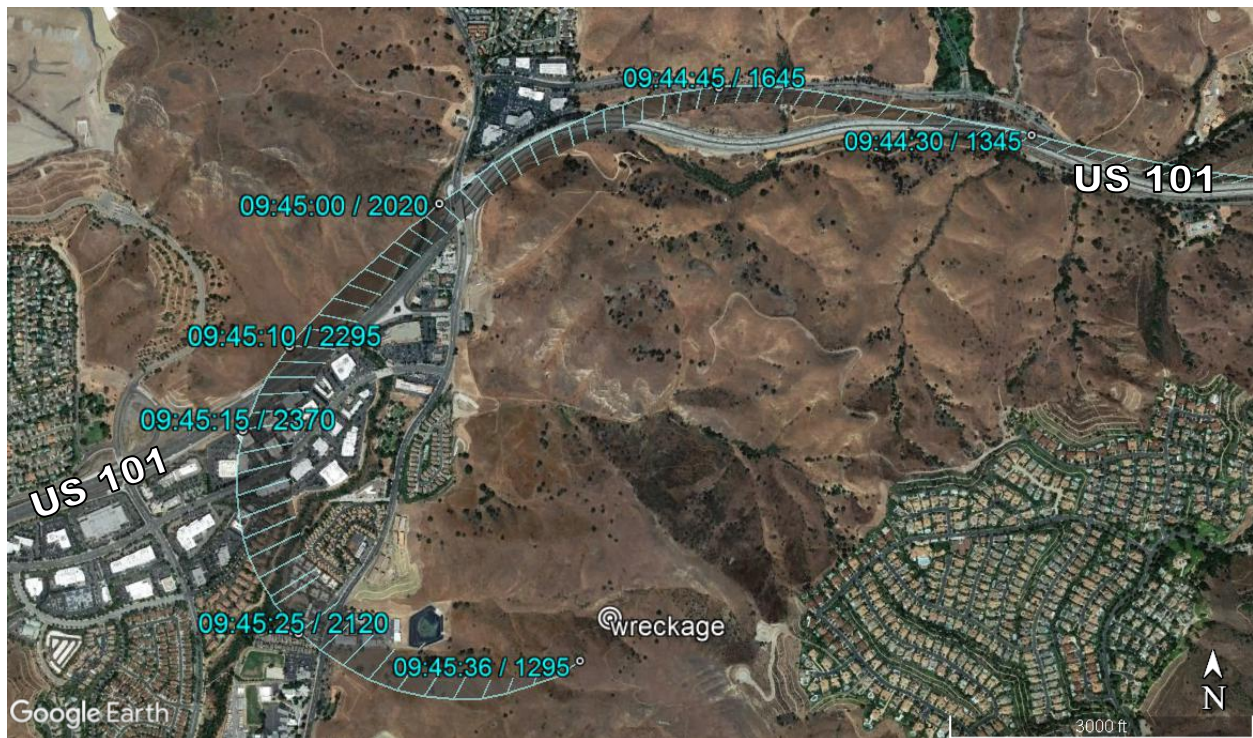
**Figure 6.** End of accident flight with time and altitudes noted.

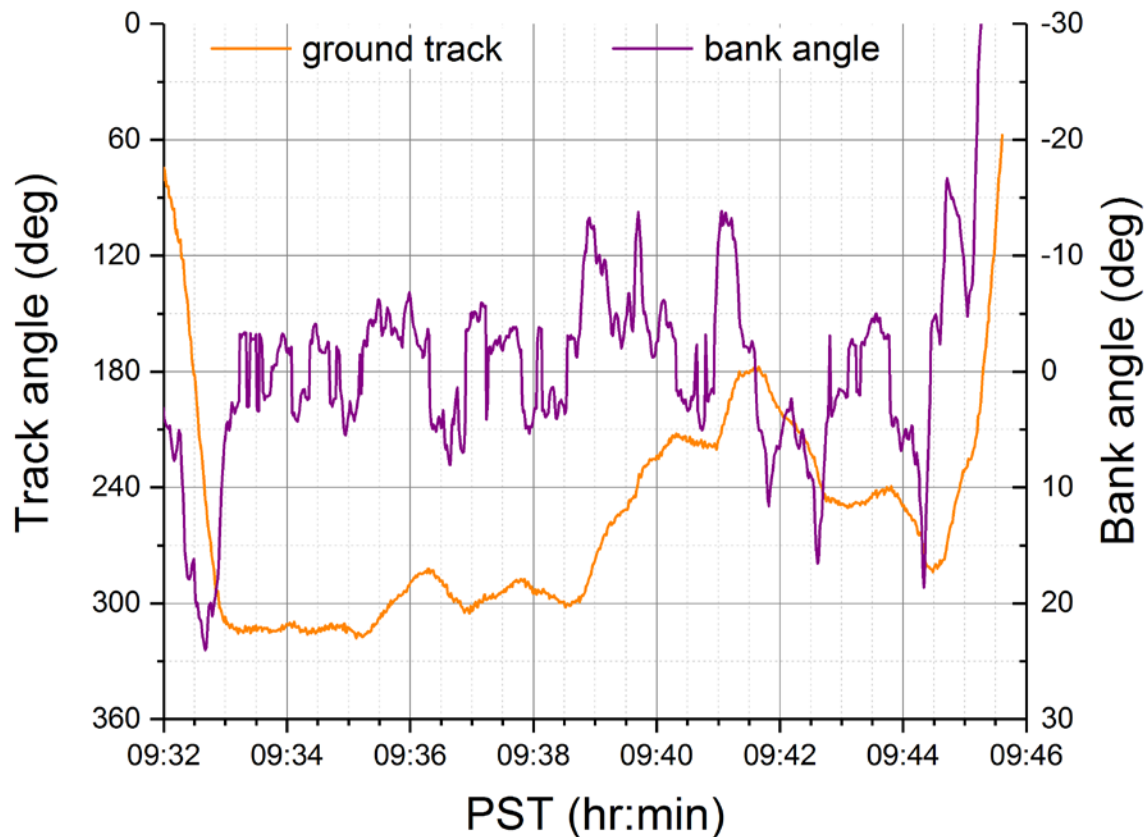
The radii of the turns were determined from the flight path. Figure 7 shows the resultant bank angle calculations from the method described above. A left-hand turn resulted in a negative bank angle. These calculations are estimates but are illustrative of trends in the data.

**Figure 7.** Accident track angle from ADS-B data and calculated bank angle. Negative bank angle indicates a left turn. The whole flight is not shown for clarity.

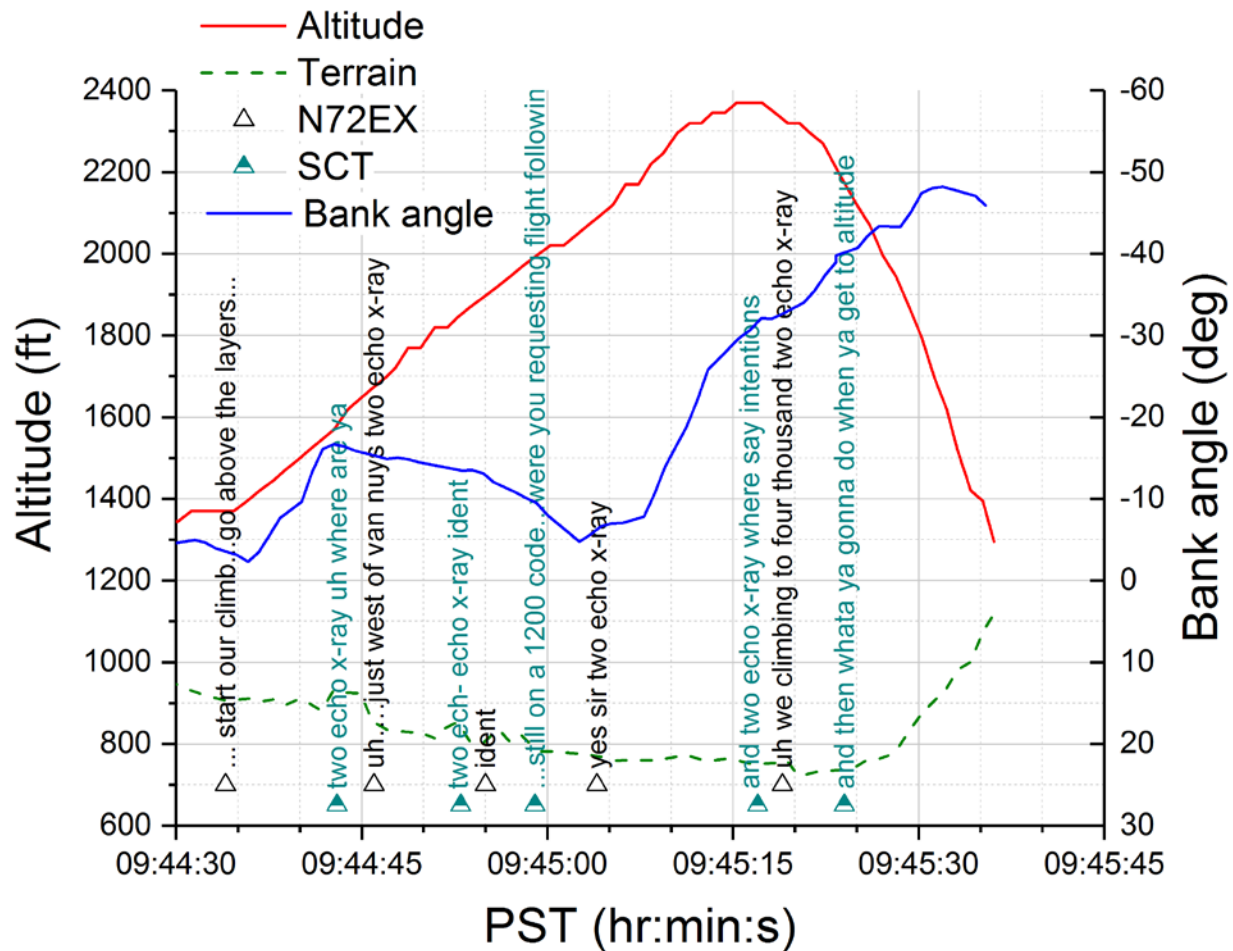
Figure 8 shows the altitude and bank angle of the last minute of flight overlaid with ATC communications. The pilot informed SCT at 09:44:34 that they were going to “start our climb to go above the ... layers” immediately after which the final climb began. The new controller at SCT asked where the accident helicopter was and discussed the helicopter’s transponder code. The helicopter’s left bank angle increased about 09:45:10 and as the helicopter reached its maximum altitude right as SCT asked for the pilot’s intentions. The pilot responded, “climbing to four thousand,” but the helicopter was descending, 17 seconds before the end of data. SCT asked for his intentions, but the pilot never responded.

**Figure 8.** End of flight altitude, terrain, and calculated bank angle. ATC communications between the accident helicopter (N72EX) and SCT are also show.

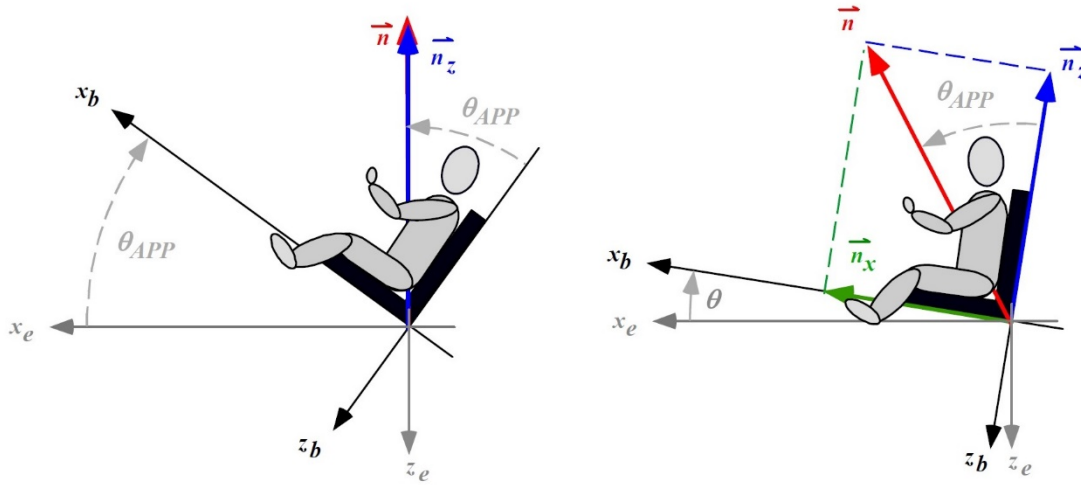
Figure 9 shows the orientation of the resultant load factor vector  $\vec{n}$  for two cases. In the left image, the aircraft is unaccelerated, and  $\vec{n}$  is aligned with the gravity vector  $\vec{g}$ , along the earth’s vertical axis ( $z_e$ ). In the right image, the aircraft is in accelerated flight, and  $\vec{n}$  has a component along the  $x_b$  axis ( $n_x$ ). In both cases, the angle of the vector  $\vec{n}$  relative to the aircraft’s vertical axis ( $z_b$ ) is the

**Figure 9.** Apparent angles in an unaccelerated (left) and accelerated (right) reference frame.

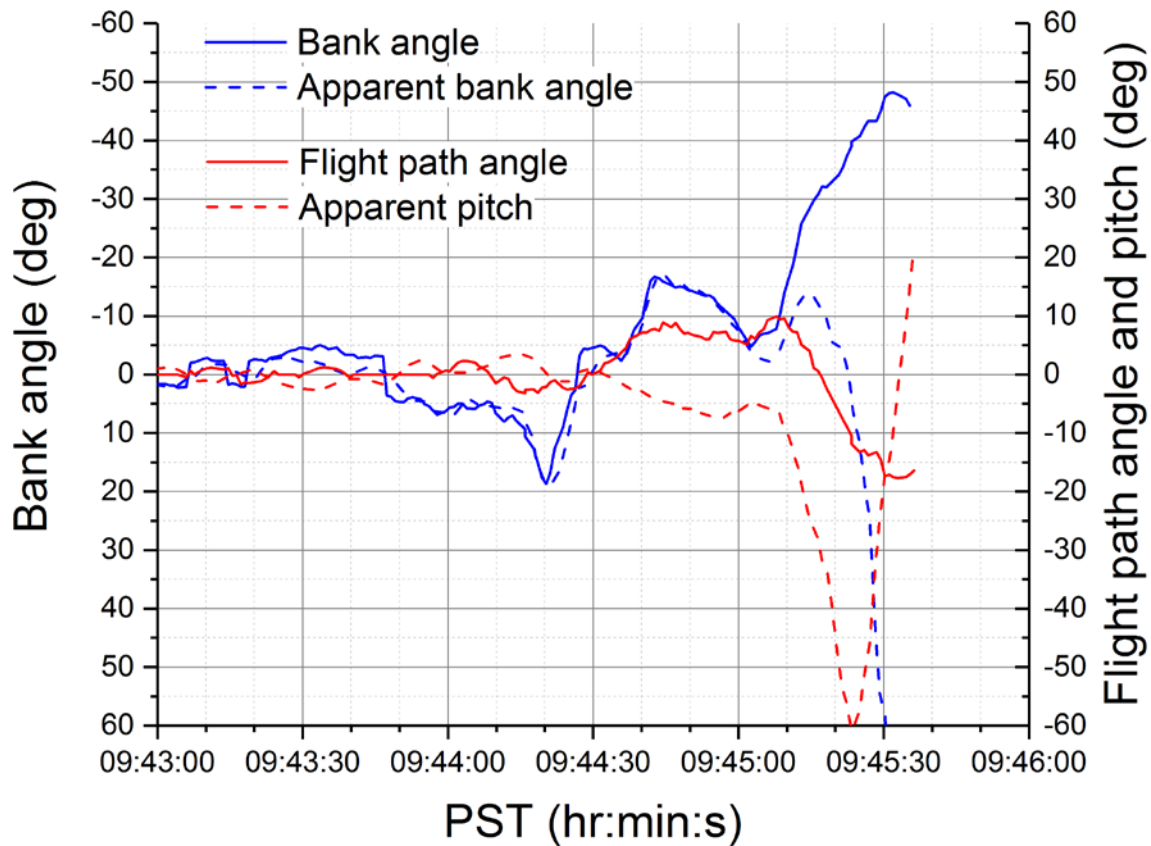
Since it did not have a data recorder, the helicopter's accelerations, which could be measured by onboard accelerometers, were not recorded. Therefore, ADS-B position data was twice differentiated to determine load factors. However, these calculations are not as accurate as measurements would be and required extensive smoothing of the data. Once  $n_x$ ,  $n_y$ , and  $n_z$  were determined,  $\theta_{APP}$  and  $\phi_{APP}$  were calculated and are shown below in Figure 10. Without outside references or attention to the helicopter's attitude display, the actual pitch and bank angles have the potential to be misperceived. The apparent angles were compared to the calculated bank angles discussed earlier and the helicopter's flight path angle, since pitch was not recorded.

**Figure 10.** Apparent bank and pitch angles as compared to calculated bank and flight path angles.

The helicopter's forward speed slowed beginning at 09:44:30 (refer to Figure 3), contributing to a negative apparent pitch angle despite the rapid climb to near 2,400 ft, followed by an increasing apparent pitch as the helicopter gained speed while descending. While the apparent and actual bank angles initially track each other, the apparent bank is to the right as the left turn tightens. Figure 11 overlays the final ATC communications with the helicopter attitude and apparent angles and shows that the pilot was communicating with ATC during the deviation of actual and apparent roll angles.

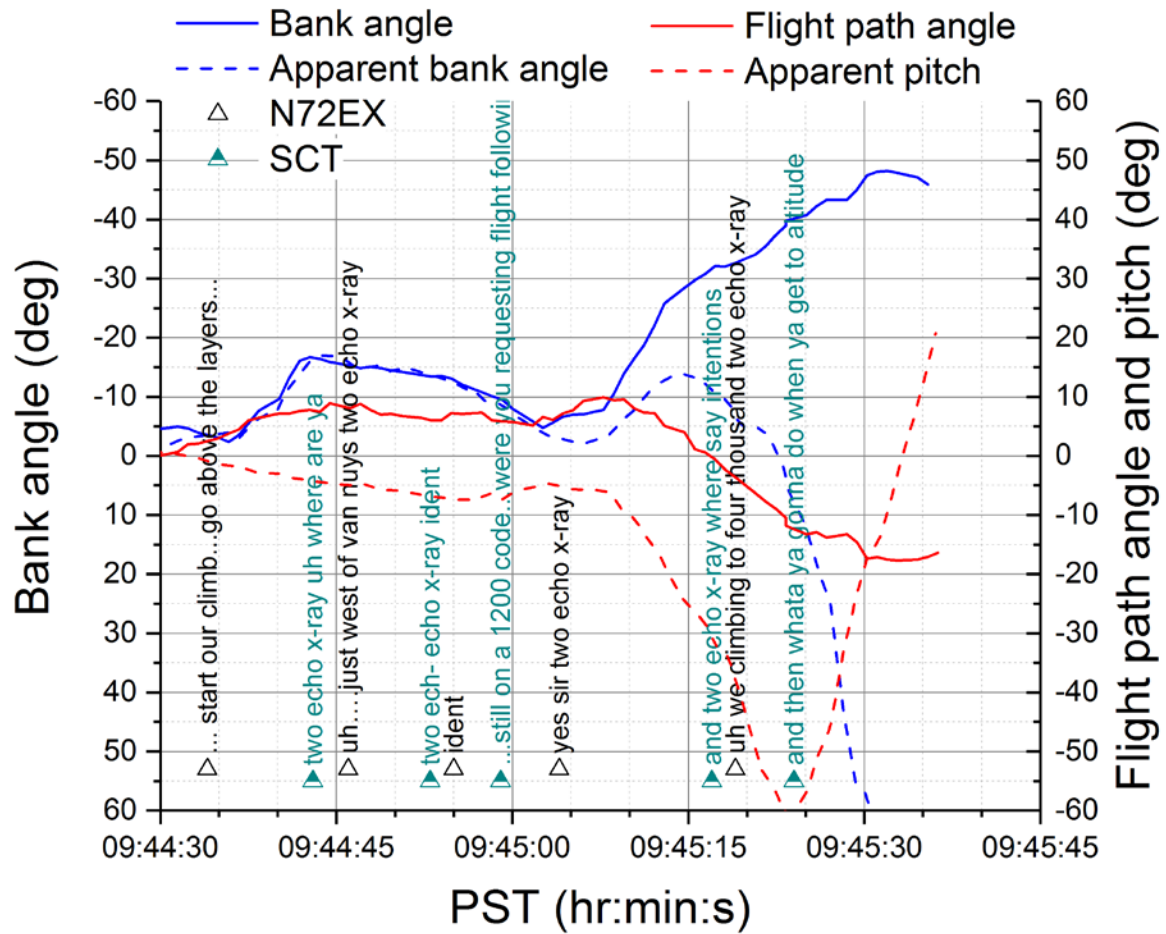
**Figure 11.** Apparent bank and pitch angles as compared to calculated bank and flight path angles with ATC communications overlaid.
