## **NATIONAL TRANSPORTATION SAFETY BOARD**

## **SEARCH AND RECOVERY**

DCA21FA174

## Transair Flight 810 Debris Survey

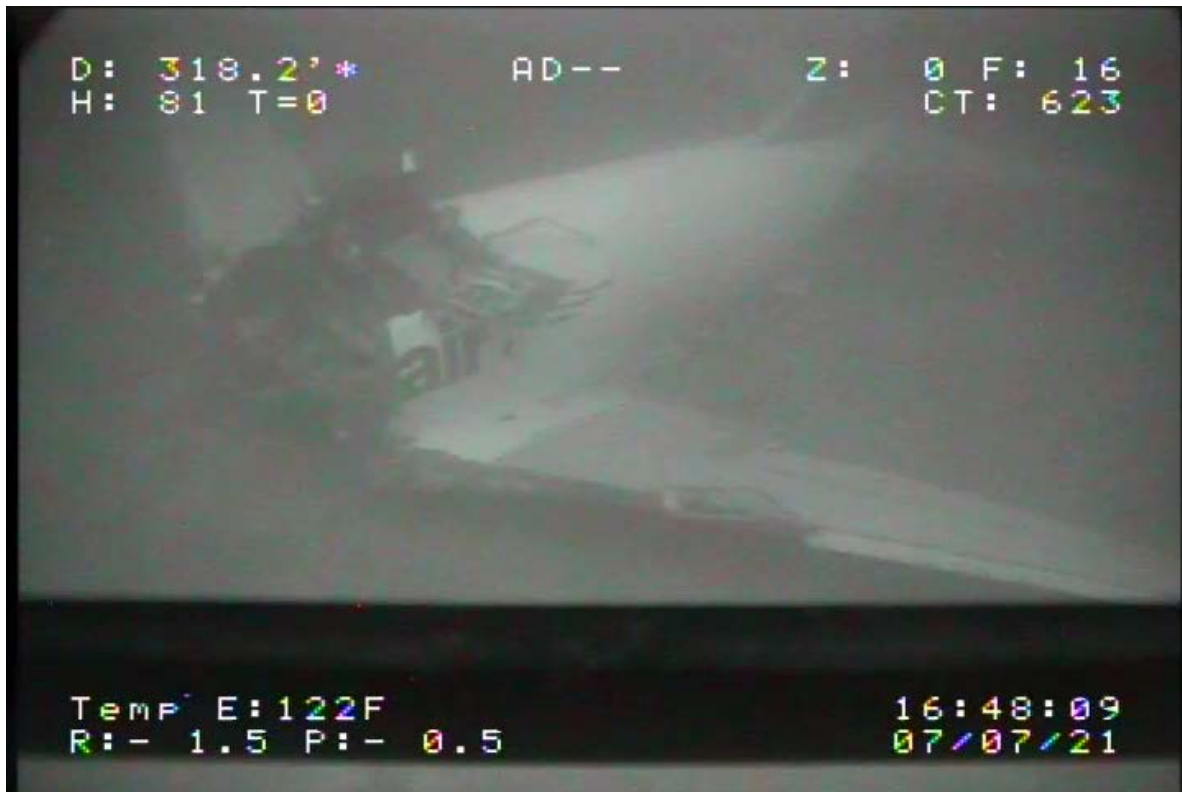
Figure 14 Tail Section of Transair Flight 810

The focused side scan survey lines identified a primary target of the aft section of the plane (shown Figure 13). The ROV was deployed and confirmed the aft of the plane (Figure 14). ROV inspection of the target identified that the forward fuselage and engines had detached from the aft section of the plane and a limited amount of debris surrounded the area.

The tail section of the plane was found on the second day of surveying. It is oriented on the bottom with a heading of 285°, and resting on hard bottom. The water depth ranges from 340ft at the front of the aft fuselage and 363ft at the rear of the aft fuselage. Both the engines were not attached to the wings. The area under the wings was clear and both wings were off the bottom. The leading edge of the wings is damaged near the fuselage. The bottom of the plane was significantly damaged and the exterior skin is crumpled at the rear of the plane. Figures pertaining to the aft fuselage are listed below:

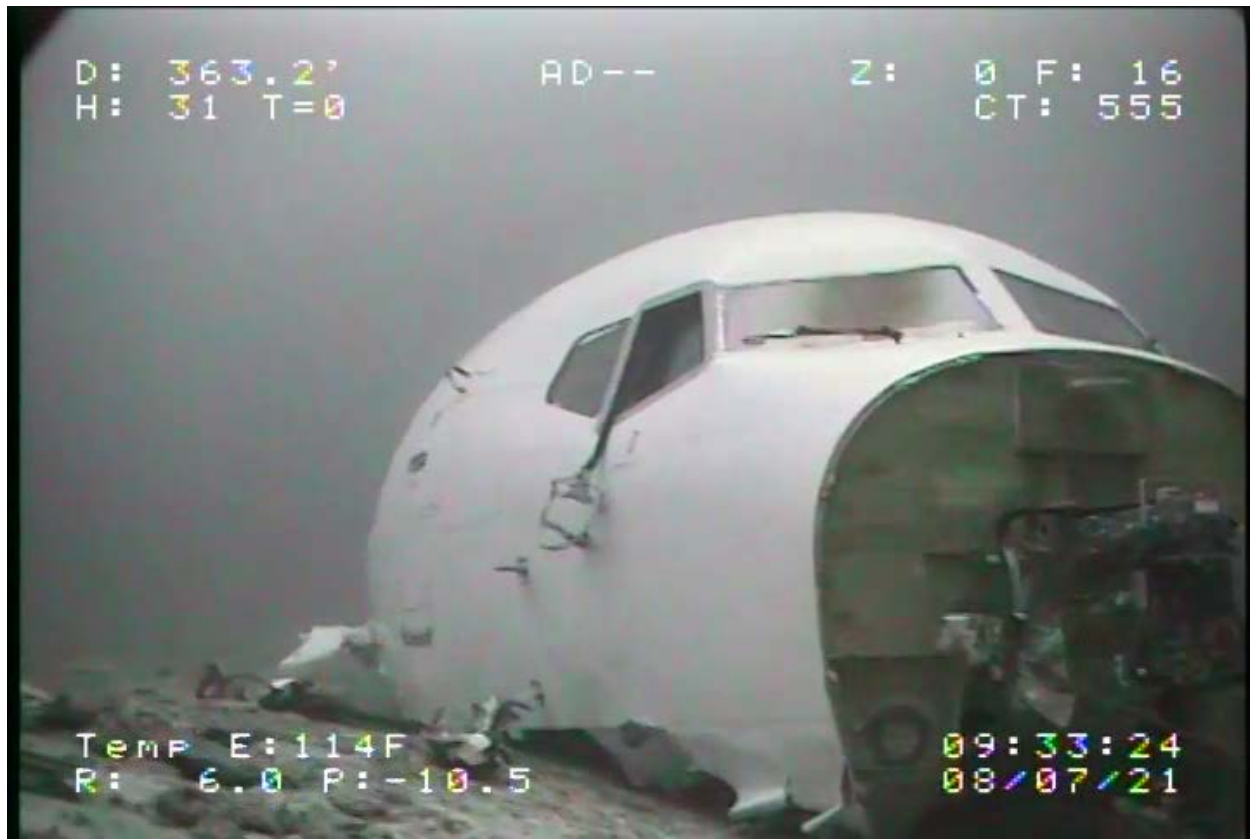
Figure 15 Cockpit of Transair Flight 810

In general, the larger items of the debris field cover an area of about 850ft x 500ft with smaller debris extending further afield. The forward fuselage section of the plane is ~450 ft from tail section of the plane. The seafloor is generally flat hard bottom with some coarse sand in places.

The forward fuselage section of the plane was found on the third day of the survey. The forward fuselage was located in 364 ft of water and is sitting on hard bottom. The forward fuselage is oriented with a heading of 200°. The forward fuselage resides in a debris field including the nose landing gear, engines, thrust reversers and a section of the keel beam, along with hundreds of smaller pieces of debris. The forward fuselage exhibits damage to the belly of the fuselage and the radome is missing. The open rear of the forward fuselage section has exposed wire and cabling. The main deck cargo door is closed but the left door is ajar. The figures listed below pertain to the cockpit section of the plane.

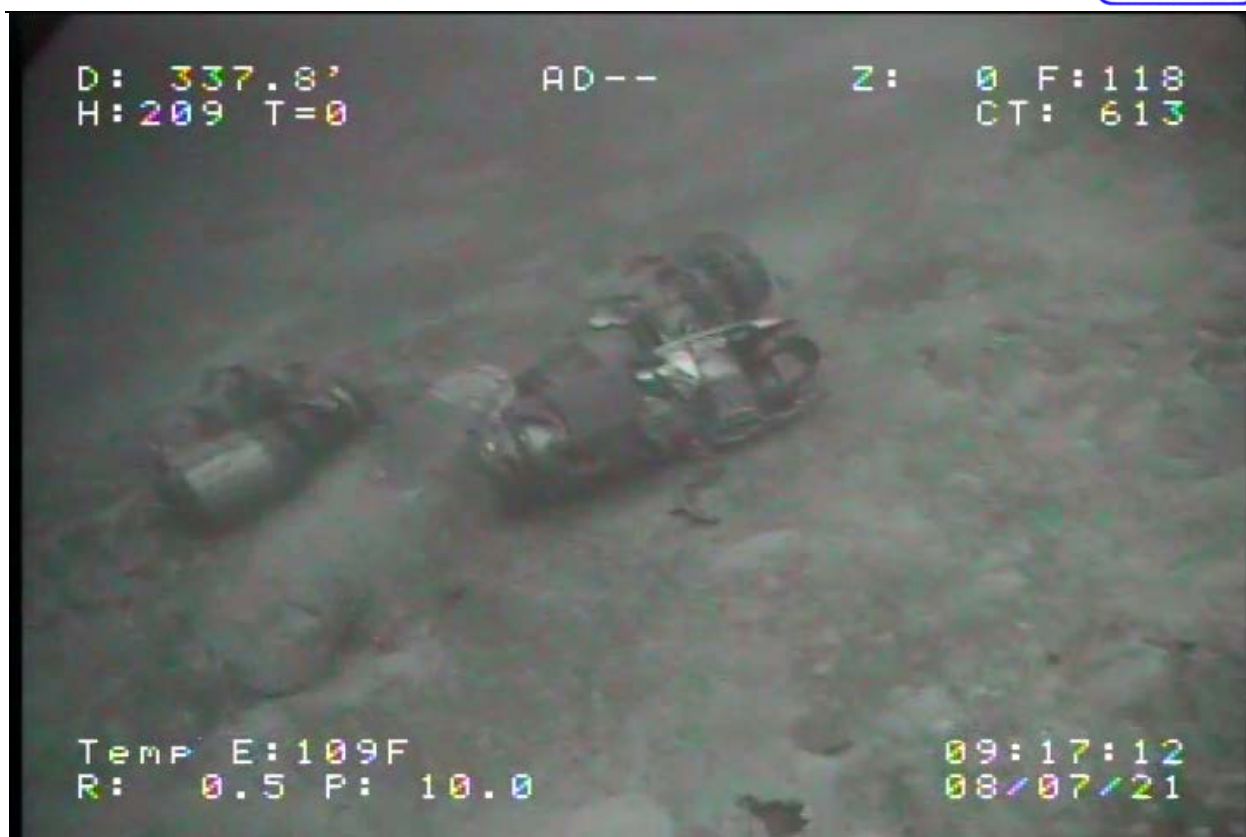
Figure 25 Engine Parts

The jet engines were not attached to the plane. The engine components are in two separate locations on the seafloor. The first location shown in Figure 25 has three large pieces. One of those has visible part number labels shown in Figure 26. A forward engine case, thrust reverser, and keel beam are shown in Figure 27, Figure 28, and Figure 29, respectively. The detached nose landing gear is shown in Figure 30.

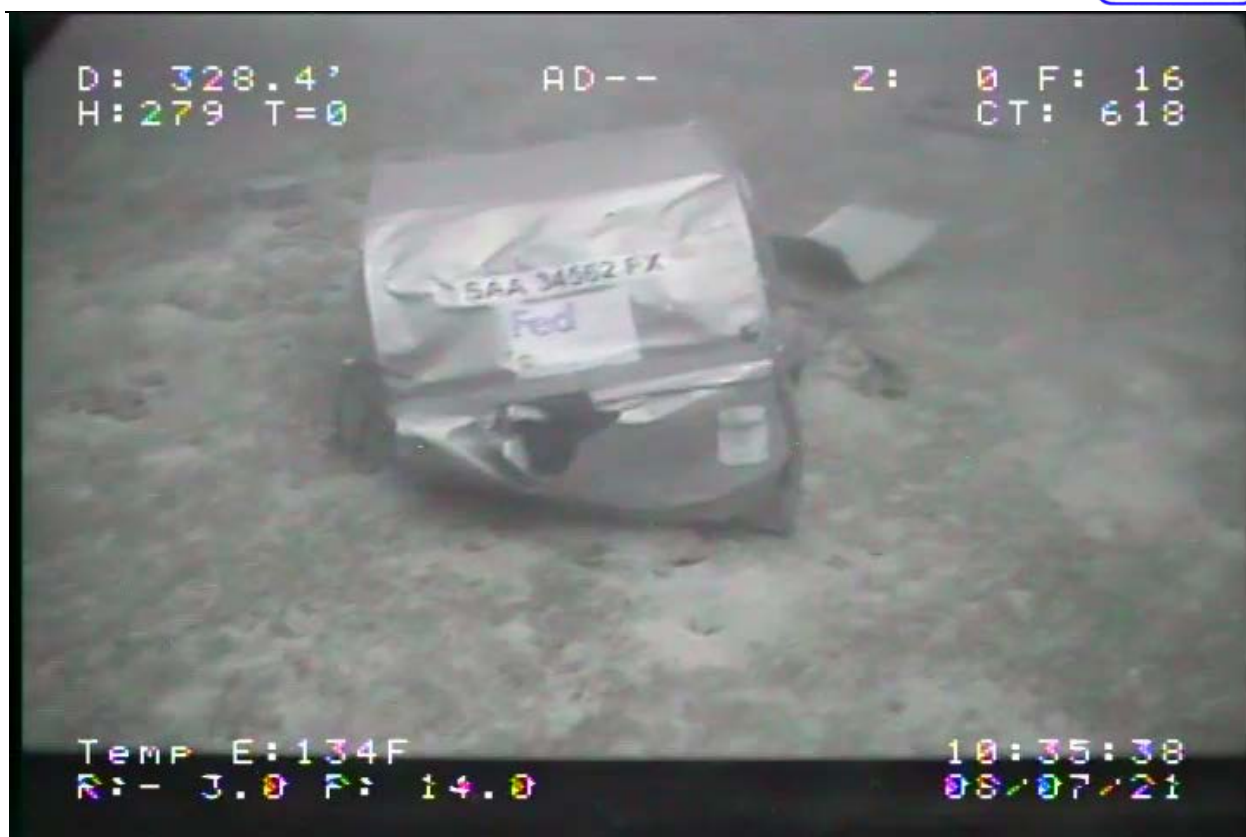
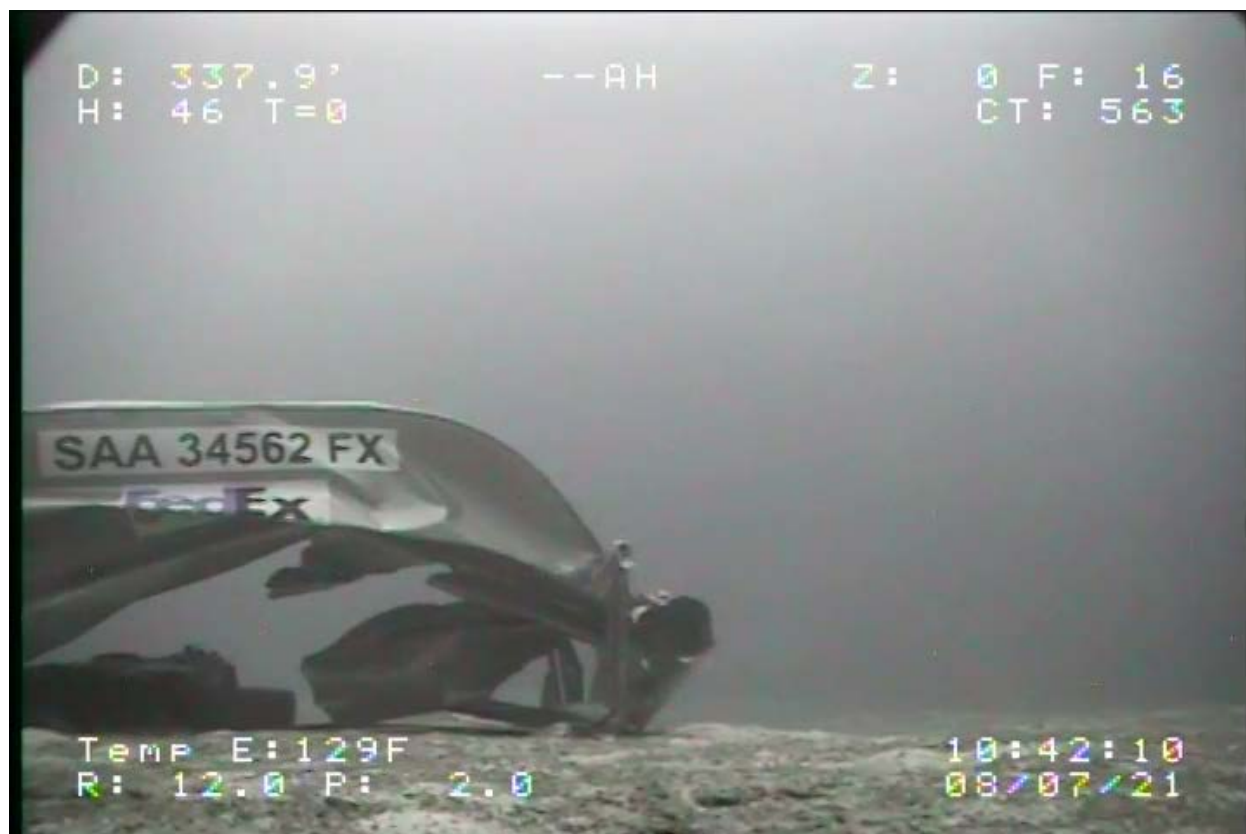
Figure 31 FedEx Cargo Can (SAA 34562 FX)

The debris field also consist of cargo from the plane as well, including two cargo canisters on the seafloor. Both were empty and severely damaged. Survey crew also noted at least a dozen tires on the seafloor, some of which are shown m in Figure 34.
