## **NATIONAL TRANSPORTATION SAFETY BOARD**

## **SEARCH AND RECOVERY**

DCA21FA174

RECOVERY OF TRANSAIR FLIGHT 810,  
BOEING 757-257C, N810TA

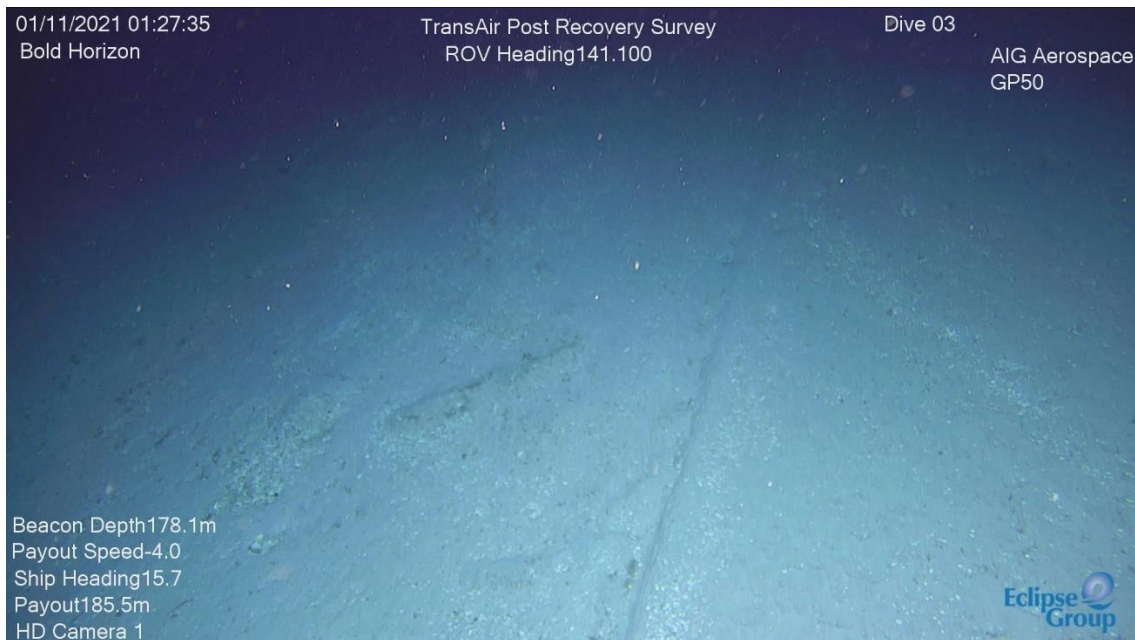
The impact and disturbance to the substrate by the anchors was minimal and no sensitive habitat was impacted. Surveys of the anchor sites revealed indications of the anchor cable and minimal disturbance to the habitat (Figures 7 - 9). These photos are representative samples of the overall area. The ROV video recordings and numerous screen grabs are available upon request.

Figure 7. Anchor cable scar on the substrate in critical habitat zone south of artificial reef area.

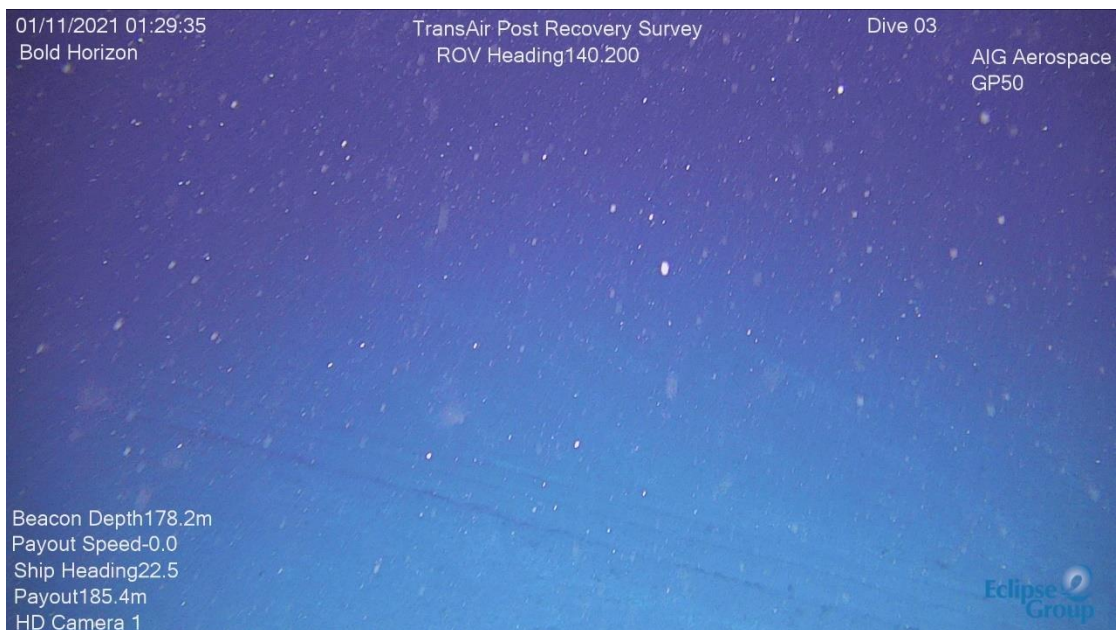
Figure 8. Anchor scar on the substrate in critical habitat zone south of artificial reef area.

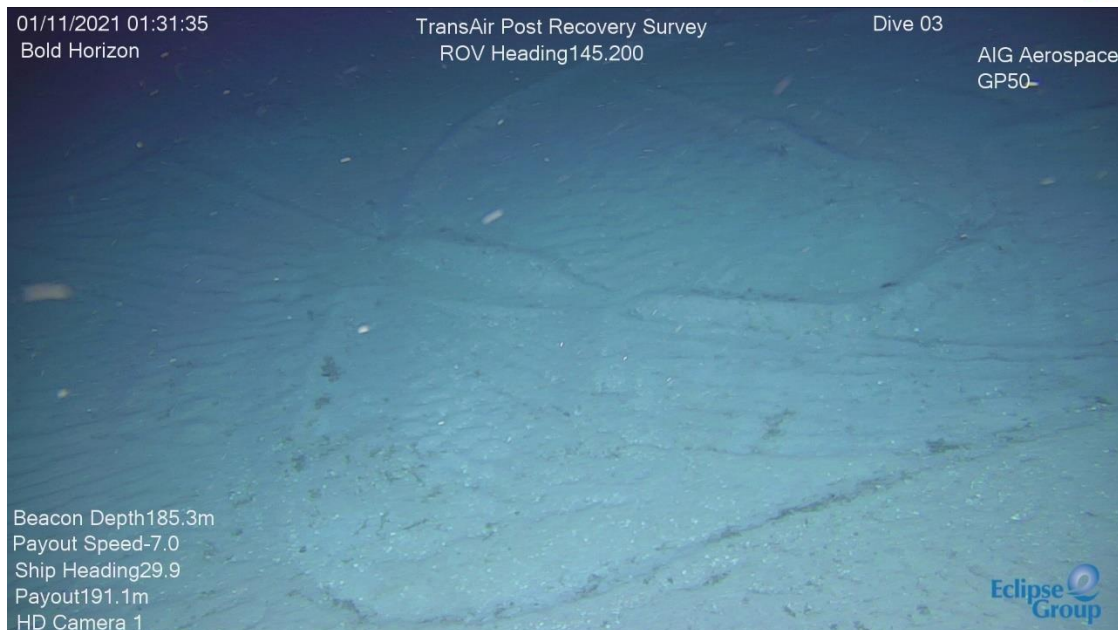
Figure 9. Anchor and cable scar on the substrate in critical habitat zone south of artificial reef area.

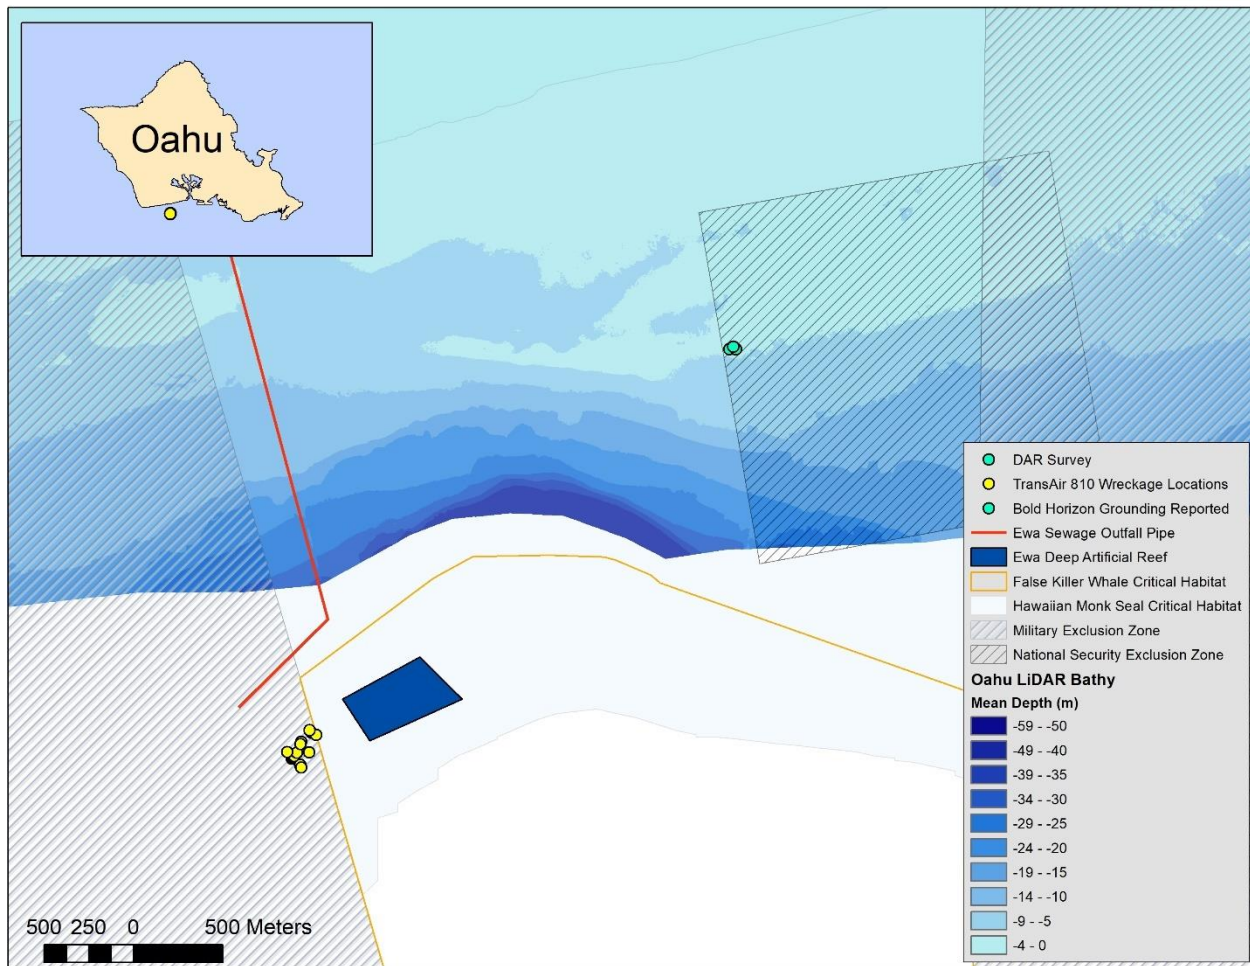
On October 23, at approximately 7:30 pm, the Bold Horizon made contact with shallow substrate briefly before heading back to deeper water approximately one mile south of Ewa Beach. The Hawaii Division of Aquatic Resources (DAR) sent a dive team out to assess the damage to the substrate and get a more accurate GPS location. Figures 10 and 11 shows the three sites listed in the report, the Bold Horizon's original reported location, DAR's Diamondhead Marker 2, and DAR's approximate midway point. These were mapped using ESRI ArcGIS ArcMap, by Darla White. The three GPS coordinates fall within the National Security Exclusion Zone boundary, as sourced from NOAA's Hawaiian Monk Seal Critical Habitat GIS files. The damage occurred 3 m and 16 m distance from the Diamondhead Marker 2 (see report Appendix C). The habitat was predominantly fleshy algae over pavement substrate. No corals were involved. The total area of the contact scar is 5.46 square meters. DAR will seek monetary fines from Eclipse Group Inc. for the live rock damage and survey costs.

Figure 10. Bold Horizon substrate contact site in relation to the TransAir 810 wreckage site with management zones.

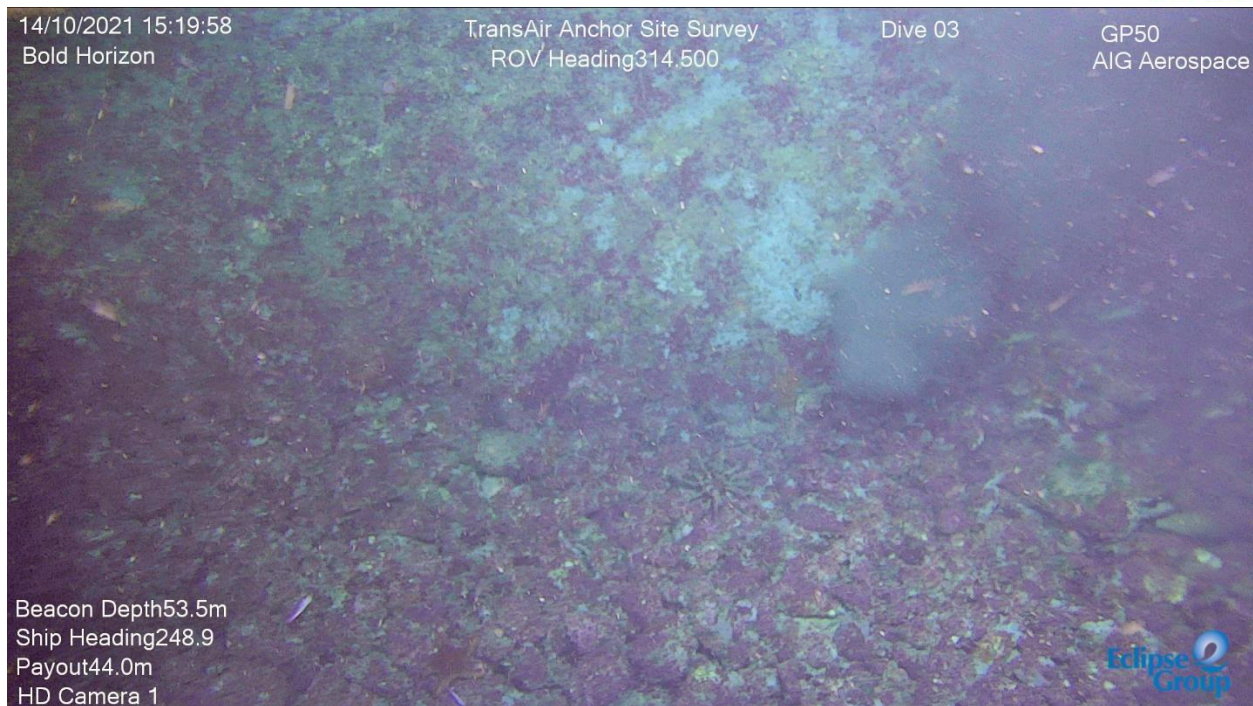
The ROV moved to investigate sewage outfall pipe at 1517 hours. The pipe had numerous leaks in it (Figures 7 & 8); several visible holes with plumes coming off the side of it that were visible in the sonar. The holes that we investigated are on the video recording. The pipe is in approximately 55 m depth. We took at least two photos of different leaking holes in the pipe, but did not capture the sonar image which elucidated more and larger plumes along a greater length than our field of view in the ROV cameras. These two holes had smaller plumes than some of the other plumes that we observed in the sonar, indicating that the other holes/leaks are likely larger. This pipe is in need of repair, or insert of a sleeve to block the leaks. The observed plumes indicate that the end of pipe pollution measures are underestimating the pollutant load.

Figure 7. Hole 1 in the sewage outfall pipe with plume.

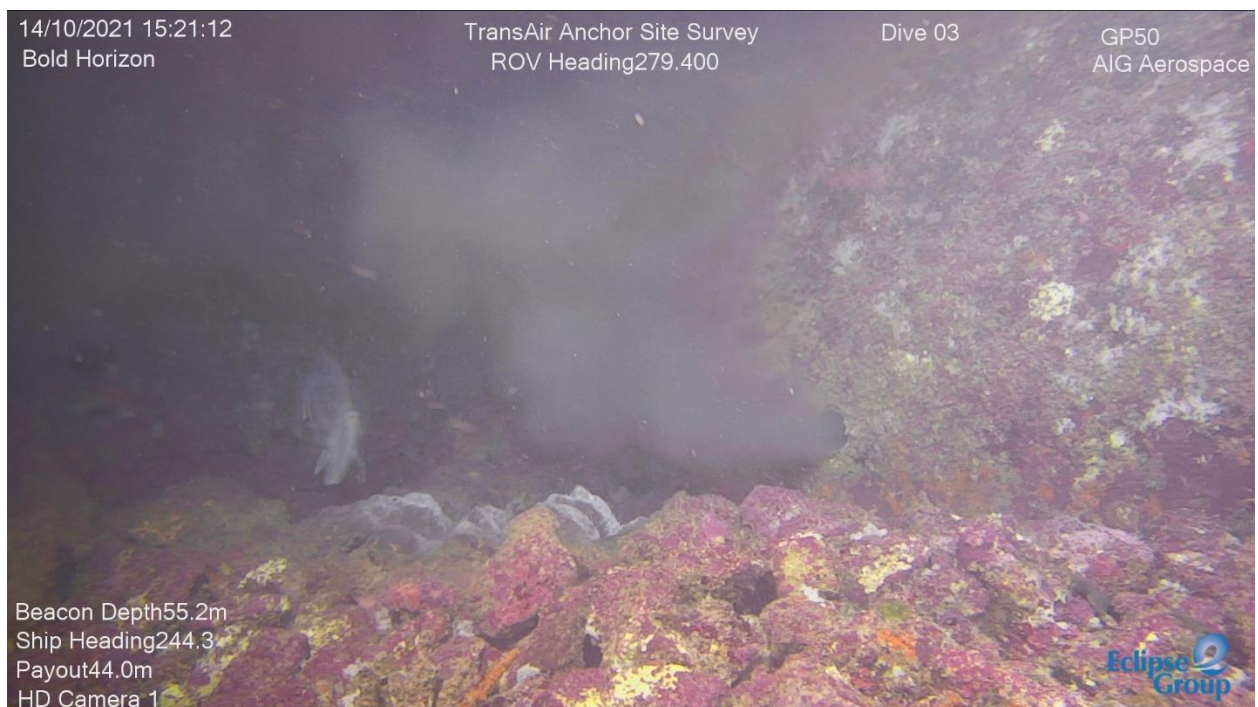
Figure 8. Hole 2 in the sewage outfall pipe with plume. This one is located a few meters west of the Hole 1.

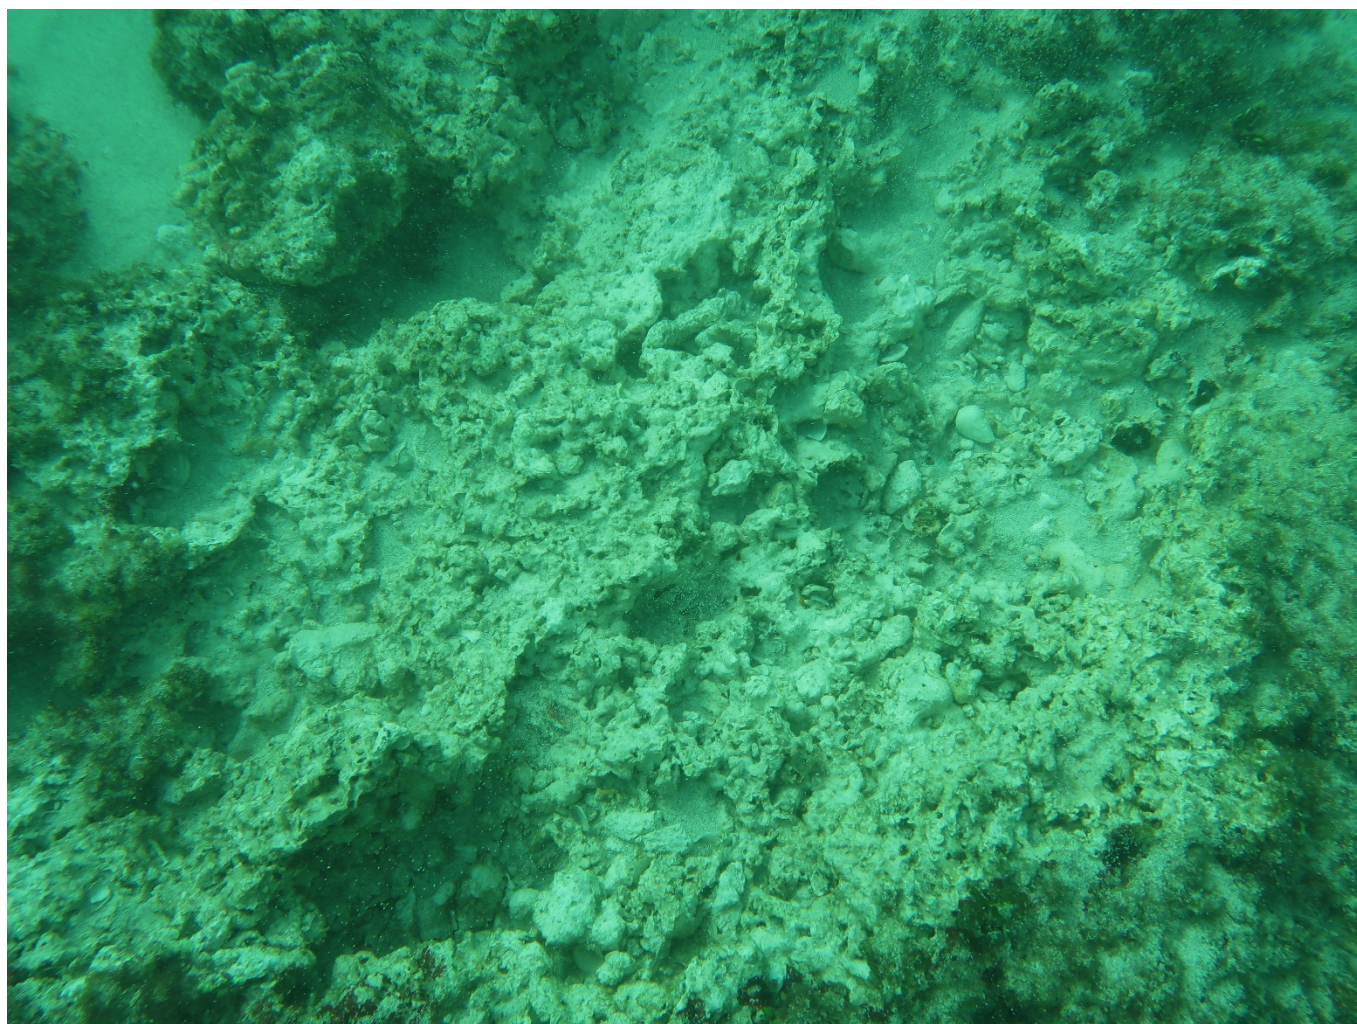
**Figure 1. First scar, first damage area.**

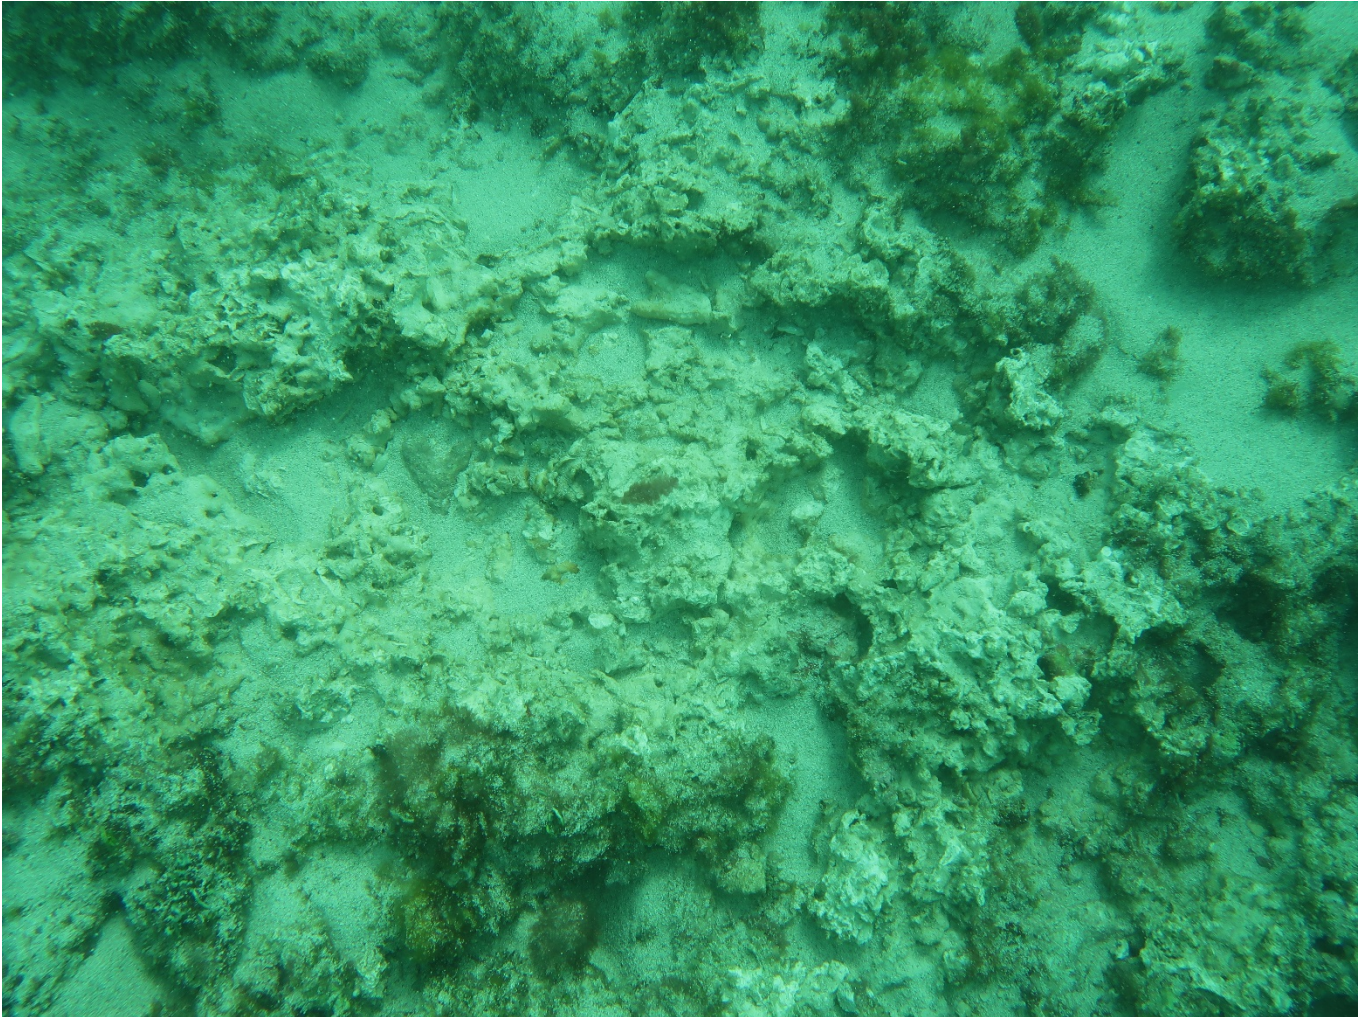
**Figure 2. First scar, second damaged area.**

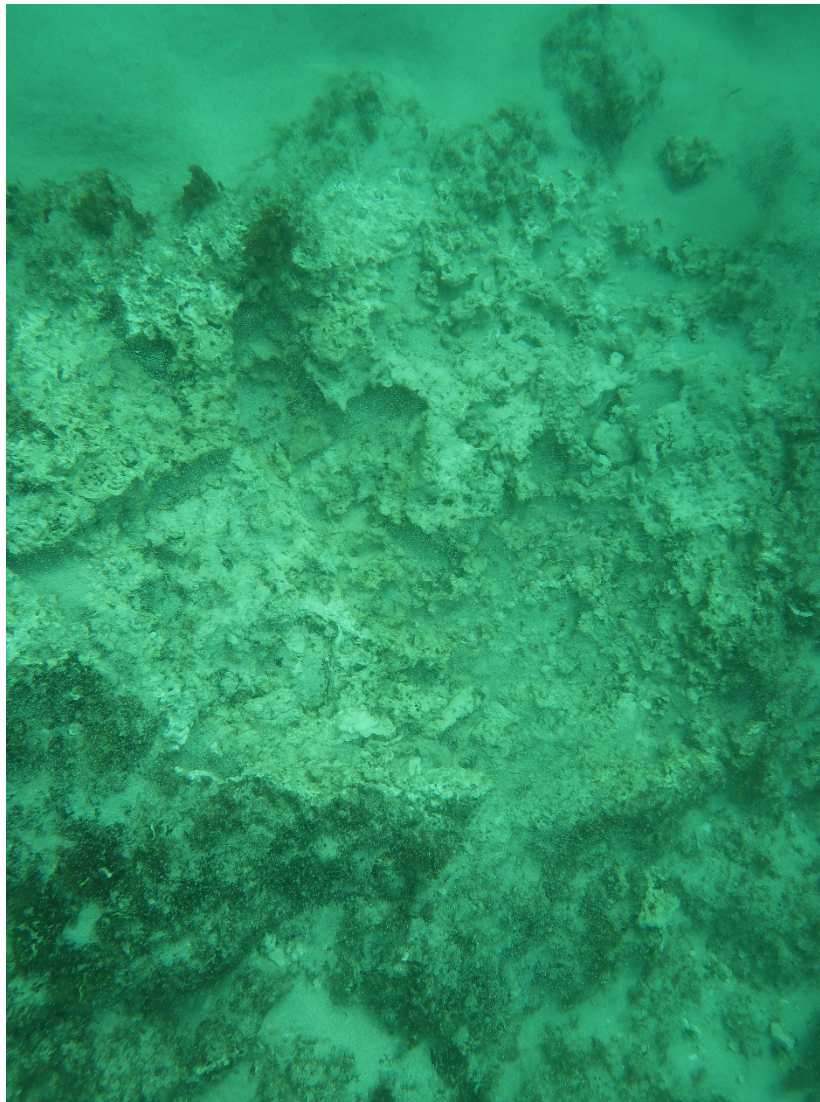
**Figure 3. First scar, third damaged area.**

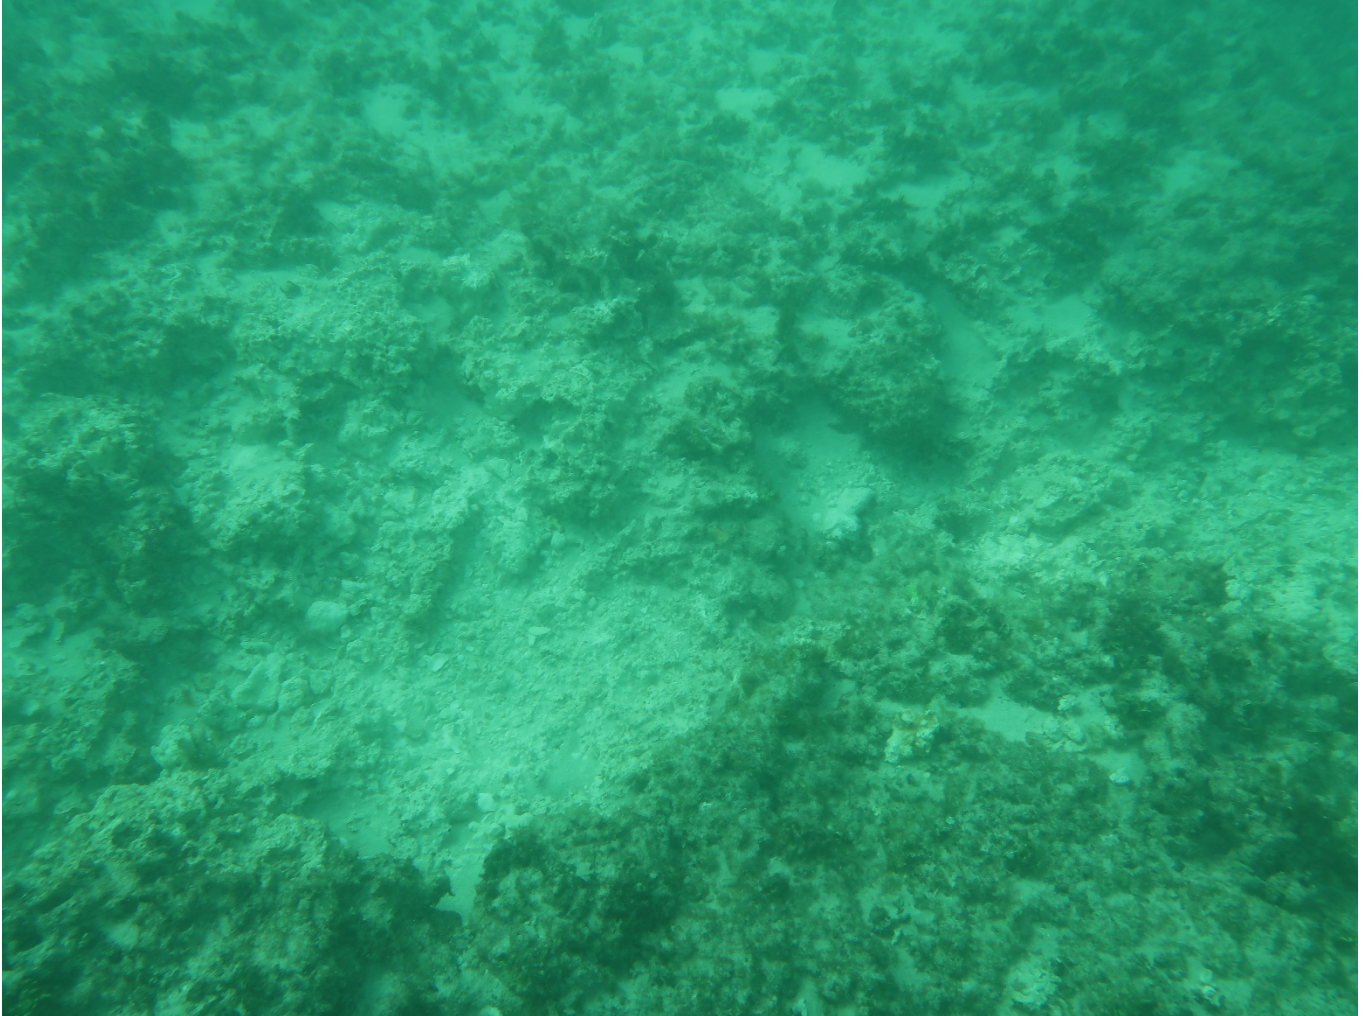
**Figure 4. Second scar area approximately 5 meters away from first scar.**
