## **NATIONAL TRANSPORTATION SAFETY BOARD**

## **SEARCH AND RECOVERY**

DCA21FA174

**EFH Environmental Statement Prepared for NOAA NMFS**

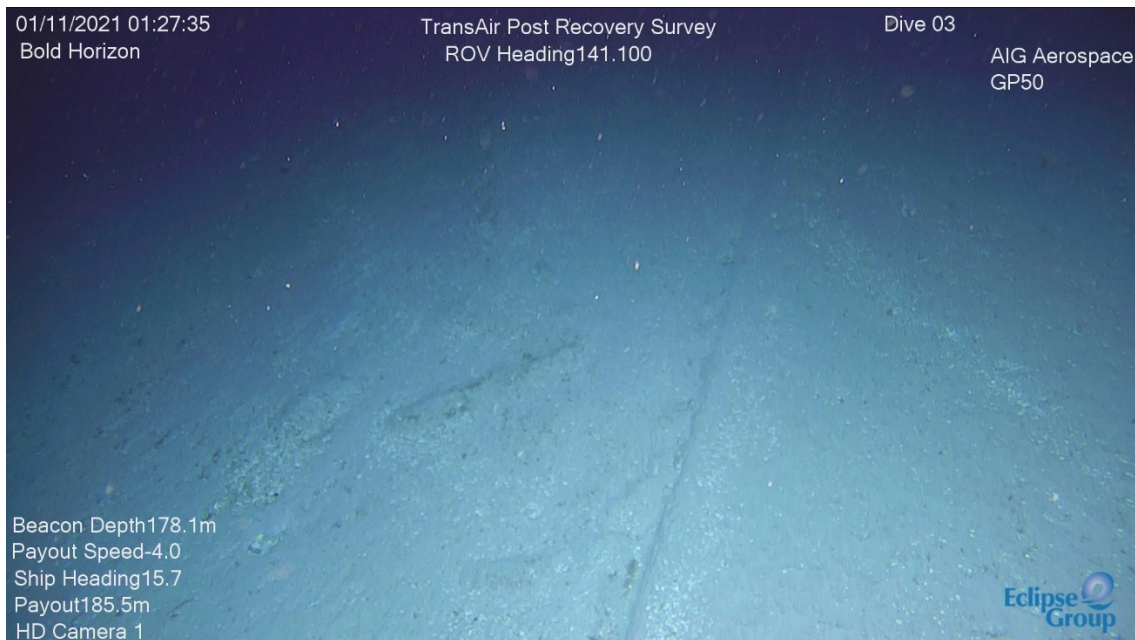
Figure 7. Anchor cable scar on the substrate in critical habitat zone south of artificial reef area.

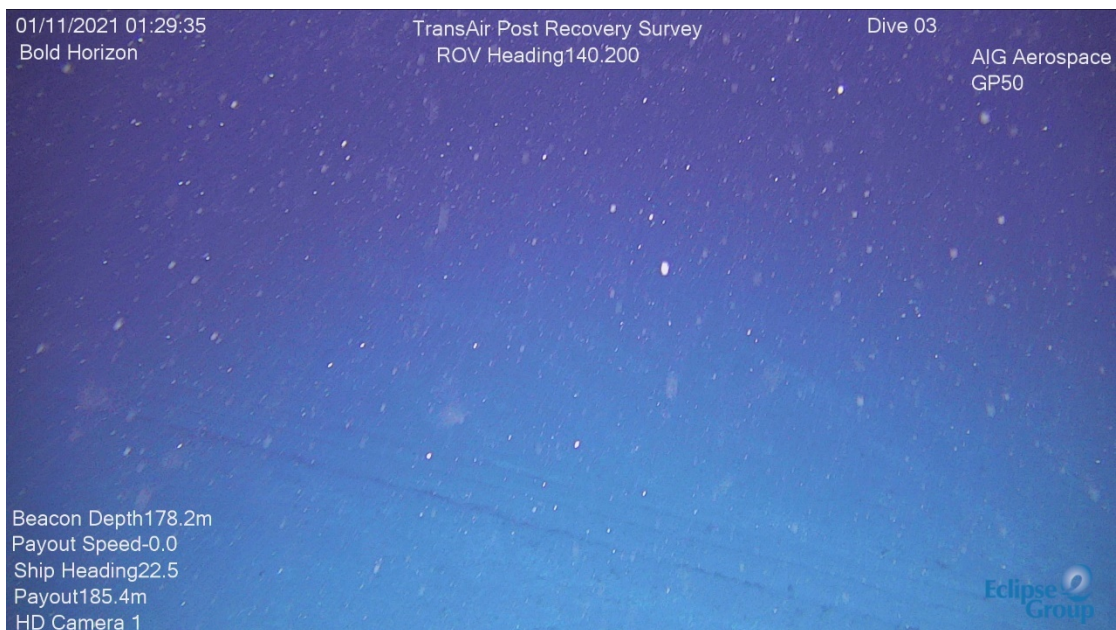
Figure 8. Anchor scar on the substrate in critical habitat zone south of artificial reef area.

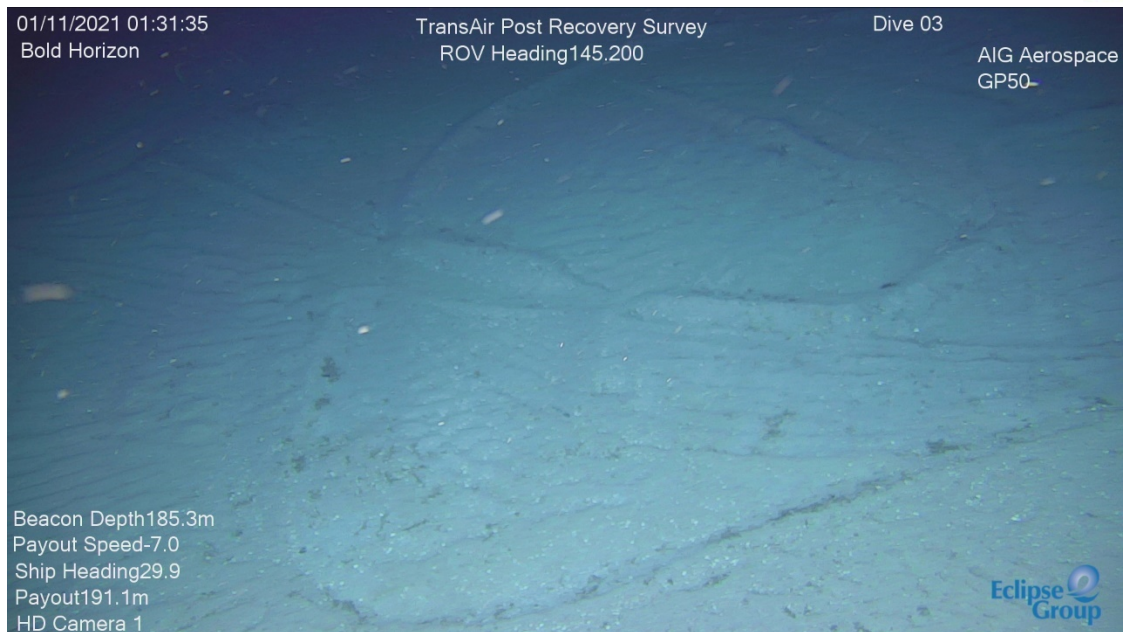
Figure 9. Anchor and cable scar on the substrate in critical habitat zone south of artificial reef area.

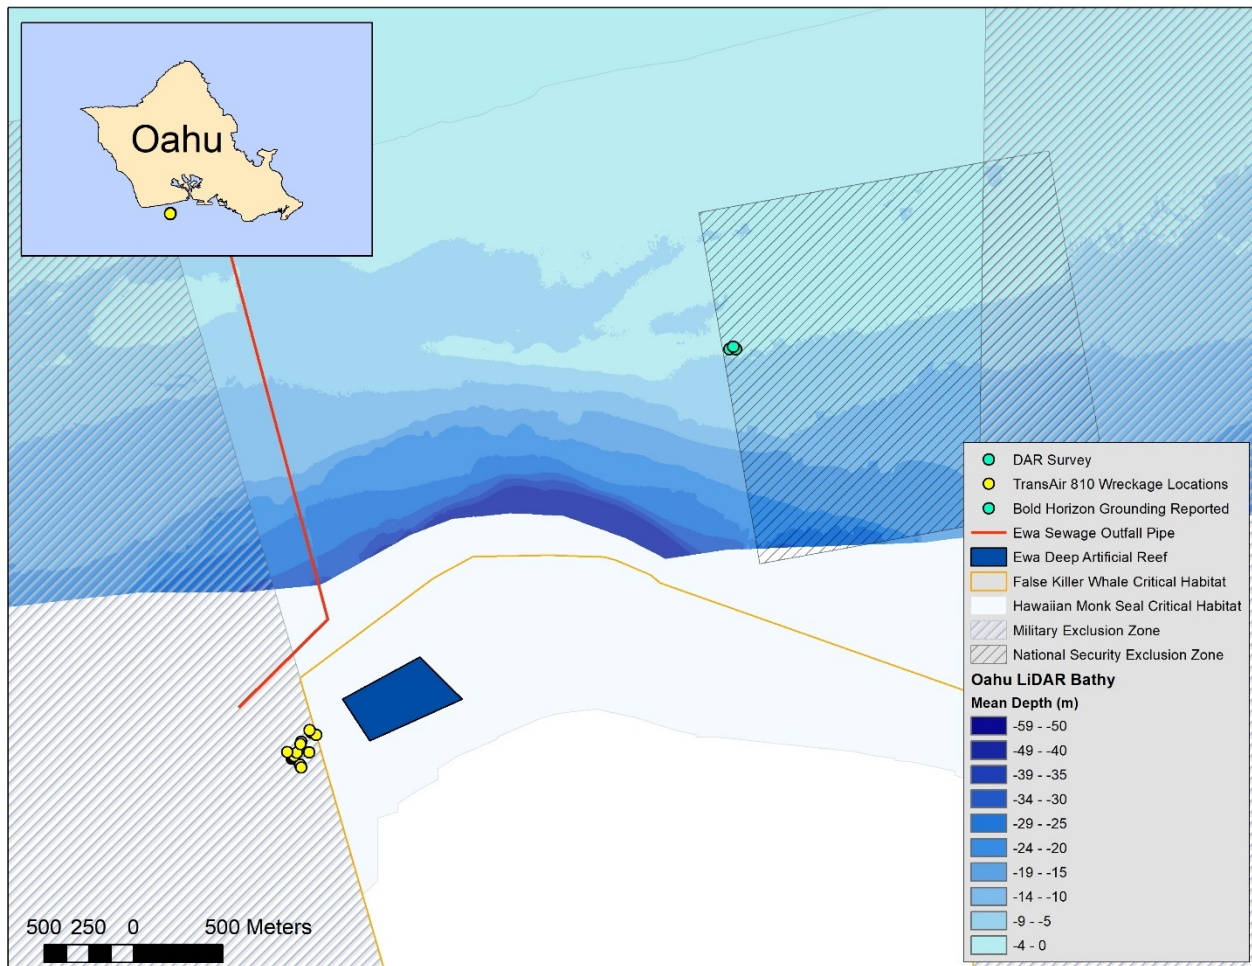
On October 23, at approximately 7:30 pm, the Bold Horizon made contact with shallow substrate briefly before heading back to deeper water approximately one mile south of Ewa Beach. The Hawaii Division of Aquatic Resources (DAR) sent a dive team out to assess the damage to the substrate and get a more accurate GPS location. Figures 10 and 11 shows the three sites listed in the report, the Bold Horizon's original reported location, DAR's Diamondhead Marker 2, and DAR's approximate midway point. These were mapped using ESRI ArcGIS ArcMap, by Darla White. The three GPS coordinates fall within the National Security Exclusion Zone boundary, as sourced from NOAA's Hawaiian Monk Seal Critical Habitat GIS files. The damage occurred 3 m and 16 m distance from the Diamondhead Marker 2 (see report Appendix C). The habitat was predominantly fleshy algae over pavement substrate. No corals were involved. The total area of the contact scar is 5.46 square meters. DAR will seek monetary fines from Eclipse Group Inc. for the live rock damage and survey costs.

Figure 10. Bold Horizon substrate contact site in relation to the TransAir 810 wreckage site with management zones.

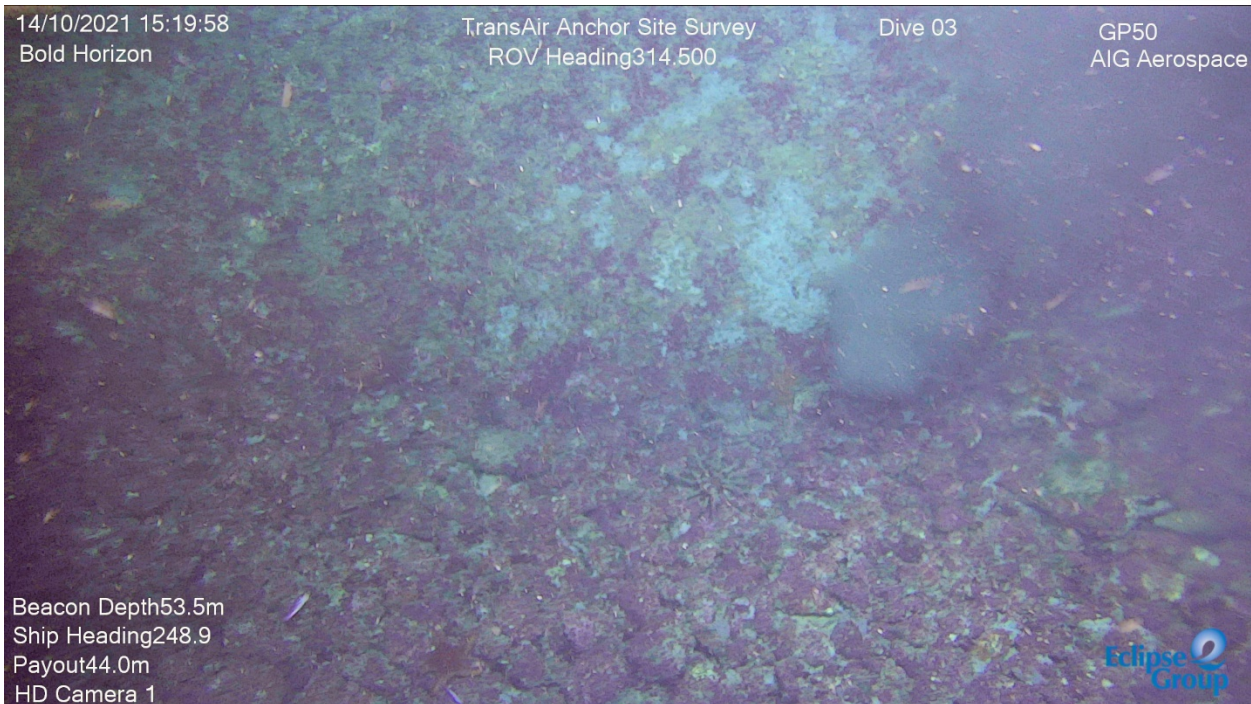
The ROV moved to investigate sewage outfall pipe at 1517 hours. The pipe had numerous leaks in it (Figures 7 & 8); several visible holes with plumes coming off the side of it that were visible in the sonar. The holes that we investigated are on the video recording. The pipe is in approximately 55 m depth. We took at least two photos of different leaking holes in the pipe, but did not capture the sonar image which elucidated more and larger plumes along a greater length than our field of view in the ROV cameras. These two holes had smaller plumes than some of the other plumes that we observed in the sonar, indicating that the other holes/leaks are likely larger. This pipe is in need of repair, or insert of a sleeve to block the leaks. The observed plumes indicate that the end of pipe pollution measures are underestimating the pollutant load.

Figure 7. Hole 1 in the sewage outfall pipe with plume.

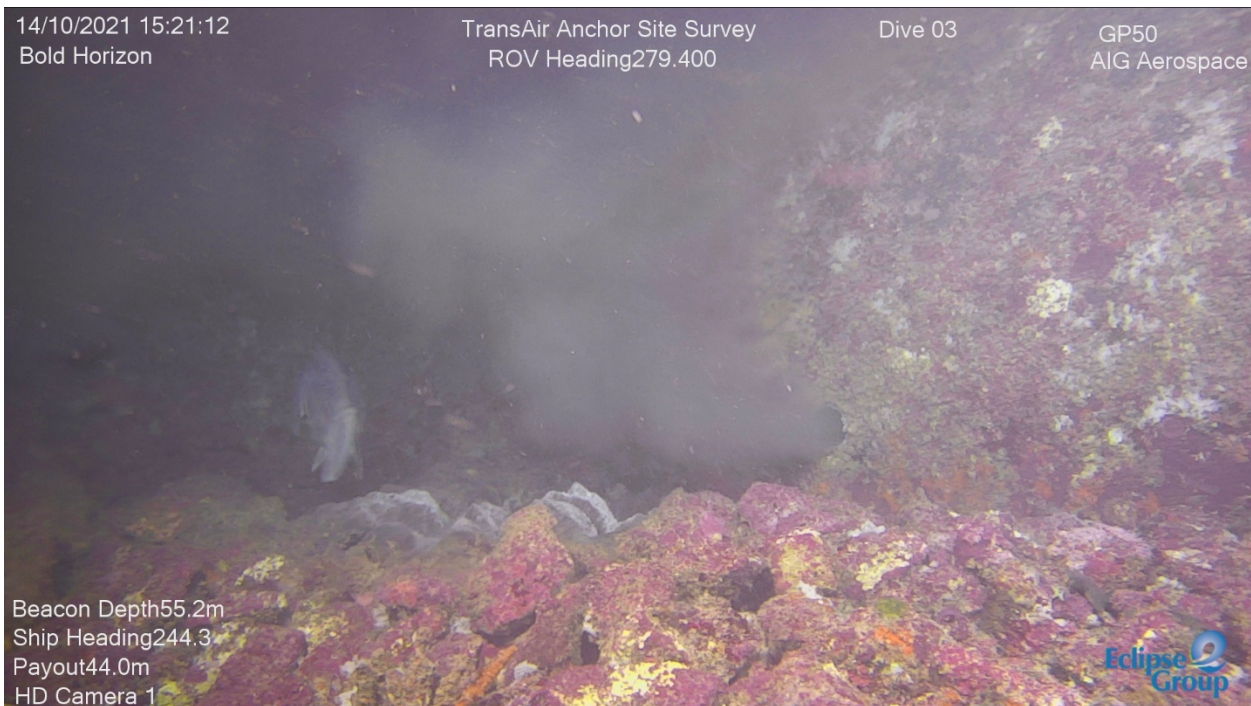
Figure 8. Hole 2 in the sewage outfall pipe with plume. This one is located a few meters west of the Hole 1.

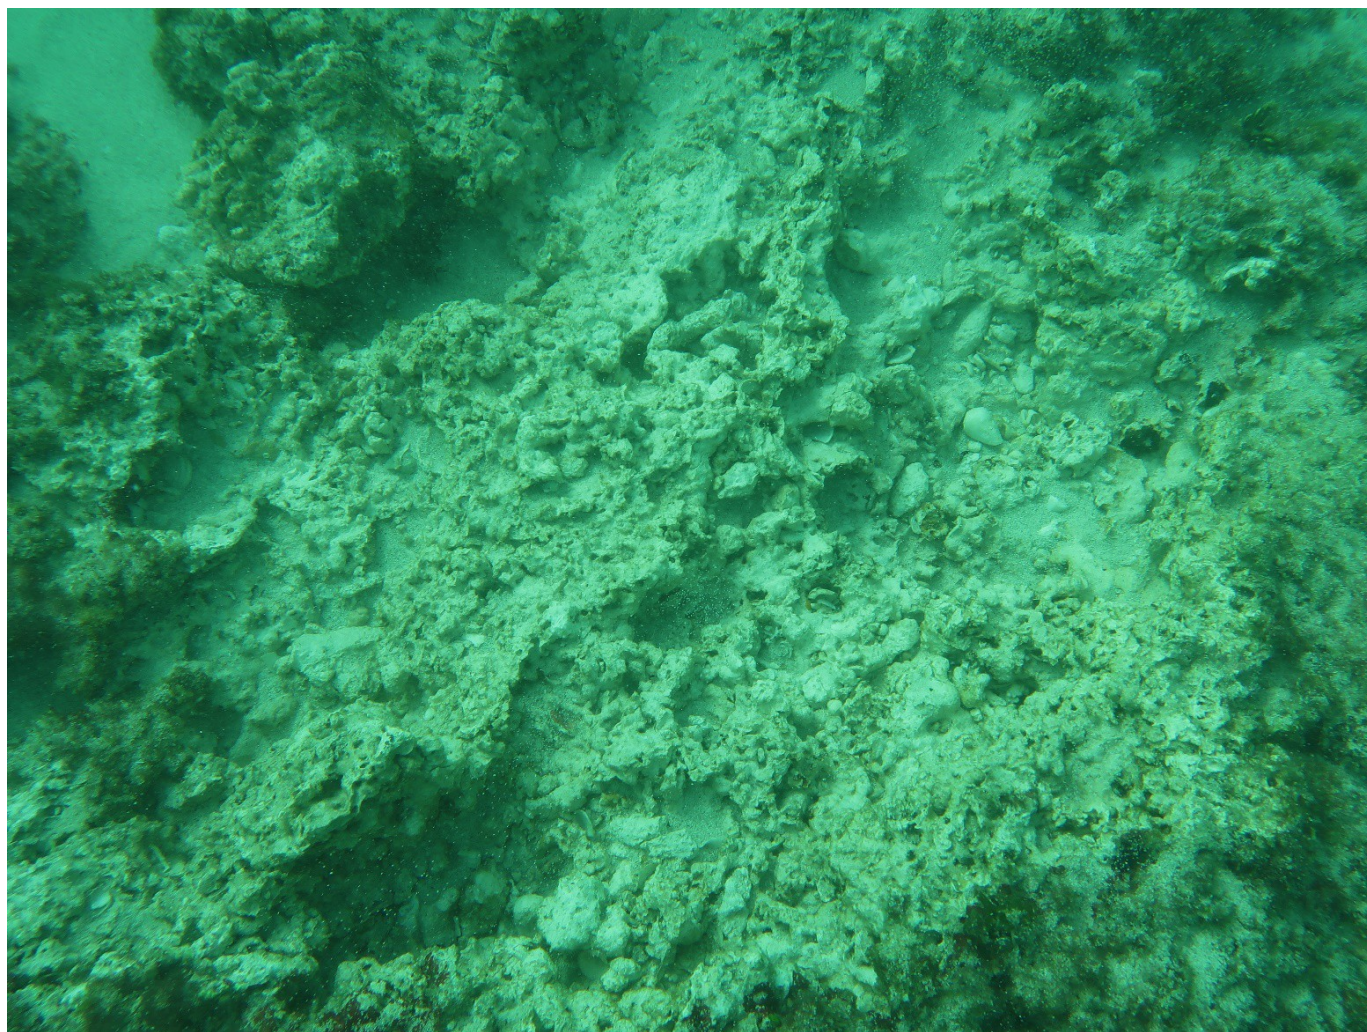
*Figure 1. First scar, first damage area.*

The total square meters of live rock damaged was 5.46 square meters. No coral resources were impacted in this incident.

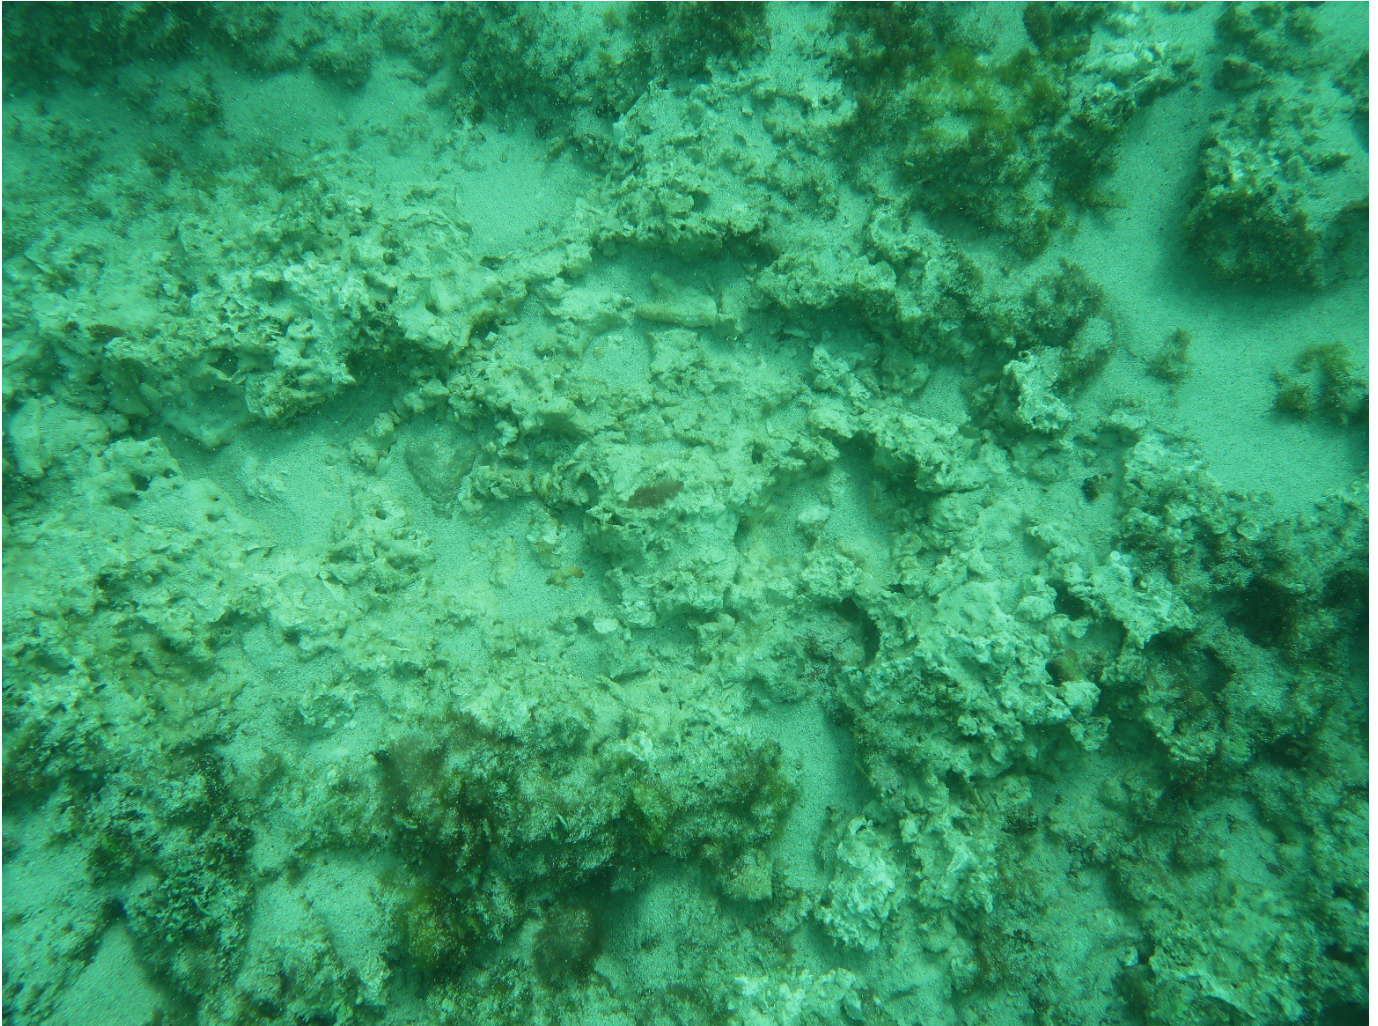
**Figure 2. First scar, second damaged area.**

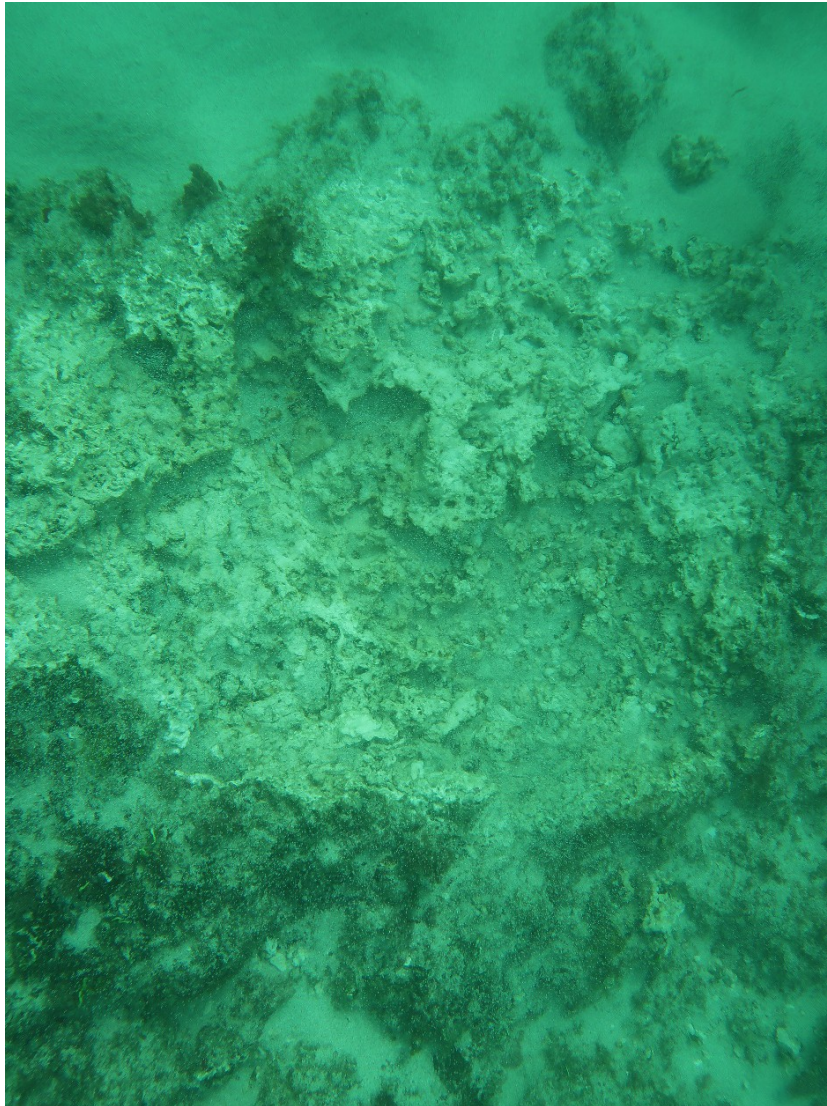
**Figure 3. First scar, third damaged area.**

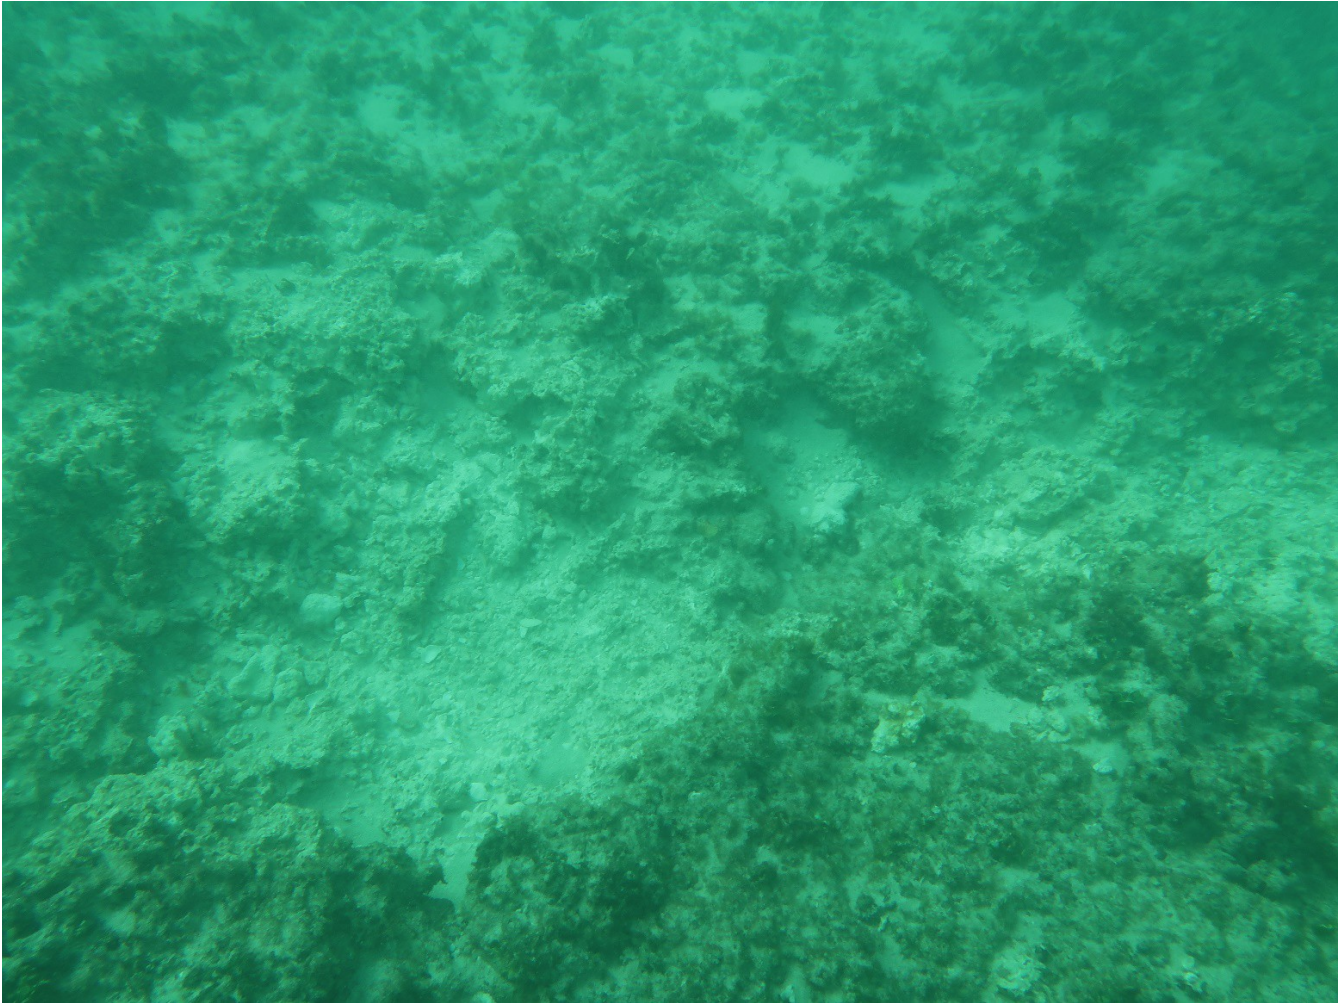
**Figure 4. Second scar area approximately 5 meters away from first scar.**
