## **NATIONAL TRANSPORTATION SAFETY BOARD**

DCA21FA174

Attachment 8 - EGI Final Report  
(51 pages)

TRANSAIR FLIGHT 810, BOEING 737-275C  
FAA REGISTRATION N810TA  
PROJECT FINAL REPORT

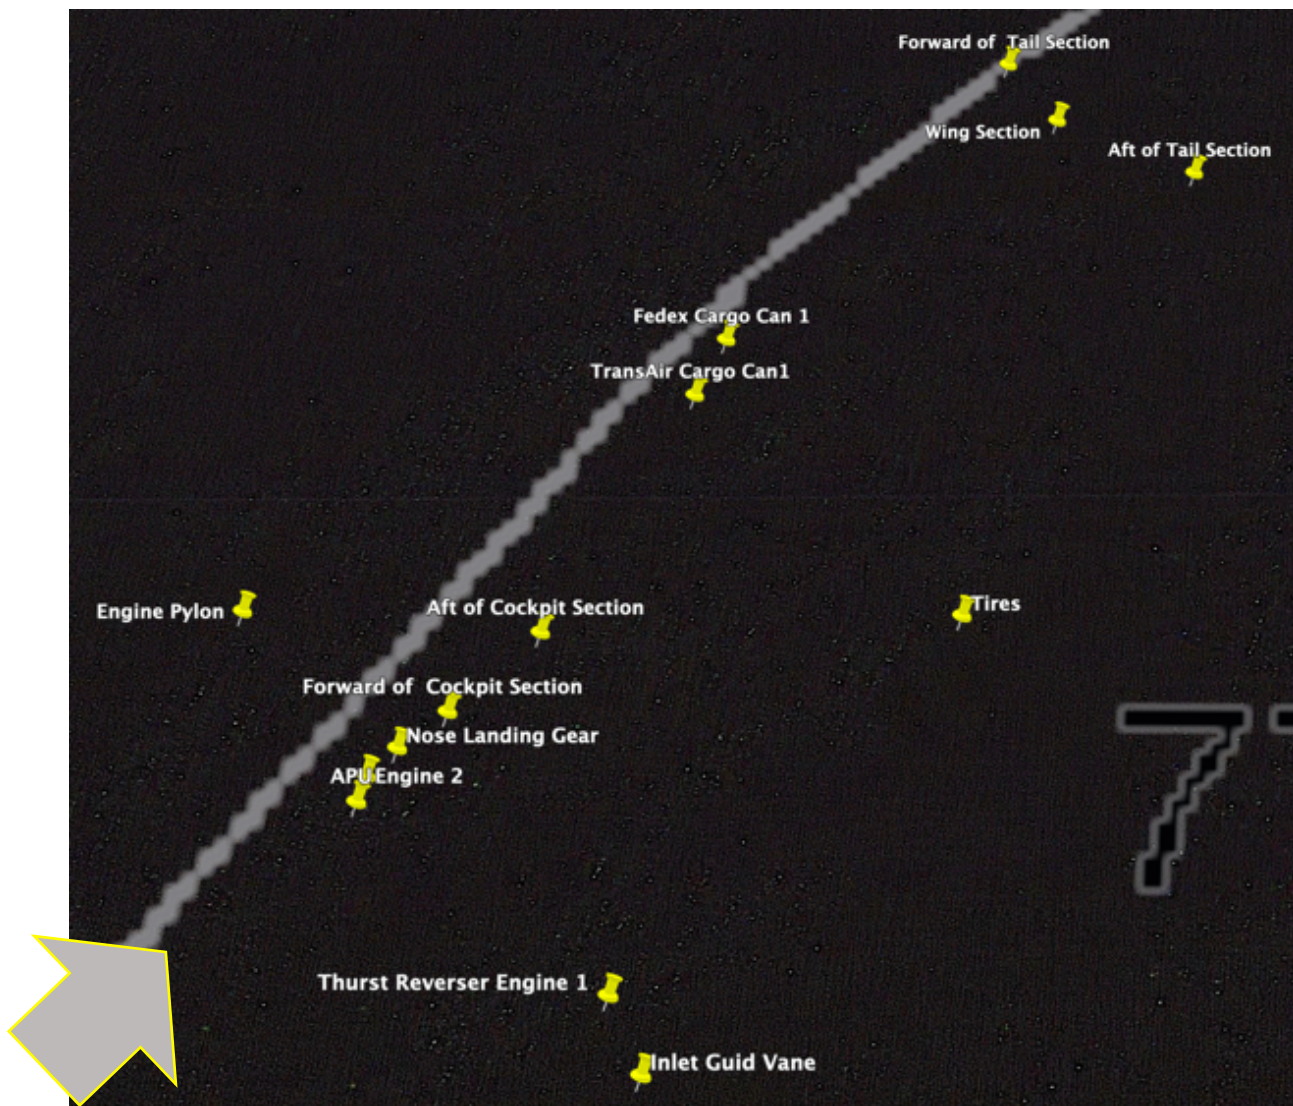
Figure 5. Relative locations of debris determined by survey ROV.

In the following chart, the distance between the Inlet Guide Vane and Forward of Tail Section is 0.11 nm (648 ft). The direction of travel was lower left to upper right (arrow) and the tail was floating when the Coast Guard arrived.

Note the following corrections:

- The part marked Engine Pylon was subsequently found to be the Keel Beam.
- The part marked APU was subsequently found to be an air conditioning pack
- The part marked Thrust Reverser Engine 1 is not confirmed to be from that engine.

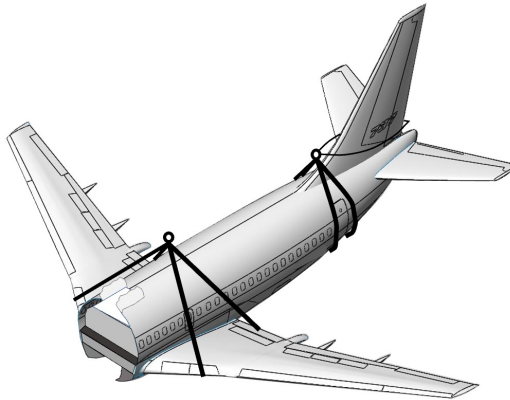
Figure 1. Aft fuselage after rear straps is passed beneath fuselage.
