# National Transportation Safety Board

DCA21FA174

## **METEOROLOGY**

Specialist's Factual Report

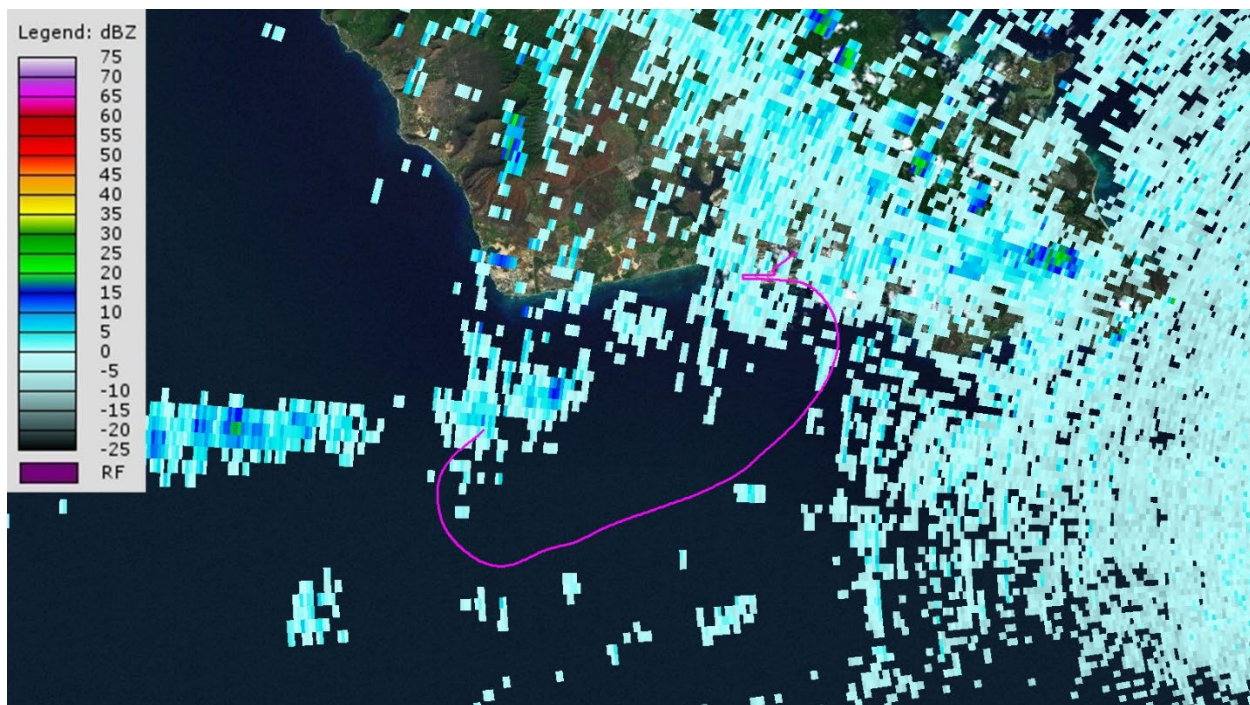
WSR-88D<sup>5</sup> Level-II base reflectivity weather radar imagery from the Molokai, Hawaii, site (PHMO) is presented in figures 1 and 2. PHMO was located approximately 47 miles east of the accident location at an elevation of about 1,450 feet. Assuming standard refraction and considering the 0.95° beam width<sup>6</sup> for the WSR-88D radar beam, the KAKQ 0.571° tilt would have “seen” altitudes above the accident location of between about 3,400 and 8,100 feet above msl. The imagery revealed light values of reflectivity along a part of the final portion of the accident aircraft’s flight path.

**Figure 1** - PHMO 0.571° Level-II base reflectivity product from a sweep initiated at 0141:48 HST. Accident aircraft flight path through 0142:00 HST depicted by the purple line.

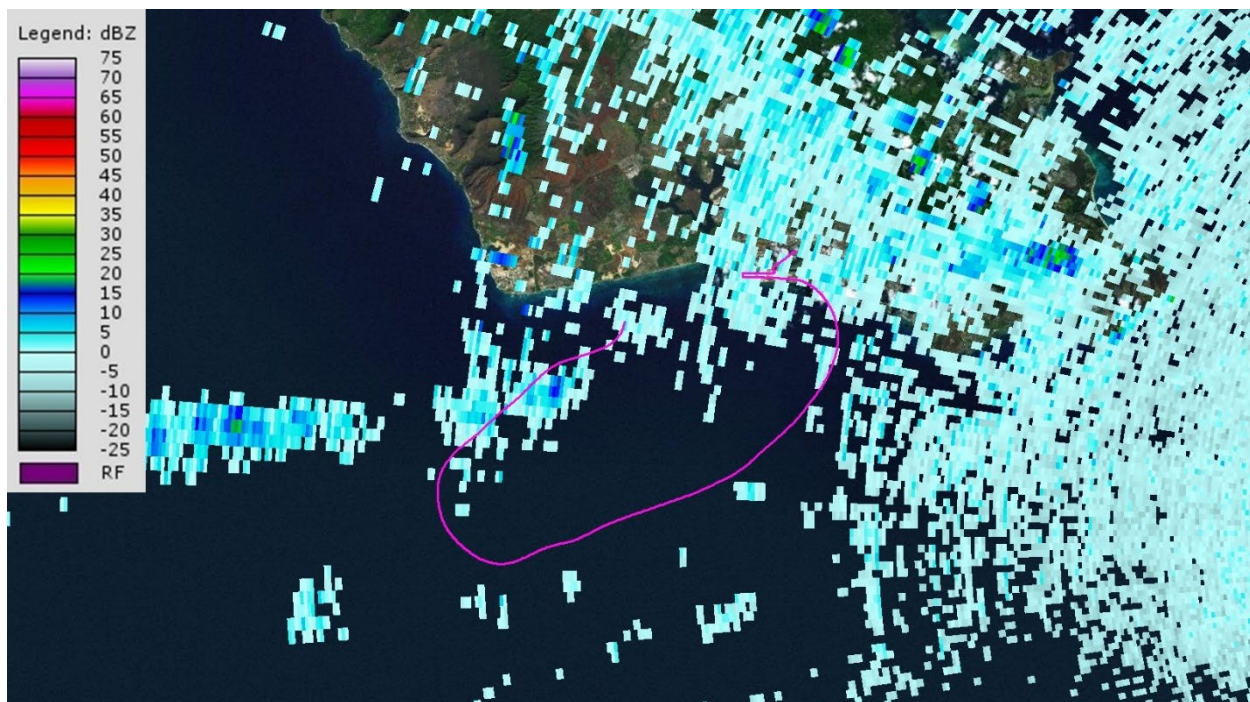
**Figure 2** - PHMO 0.571° Level-II base reflectivity product from a sweep initiated at 0141:48 HST. Accident aircraft flight path through the accident time depicted by the purple line.

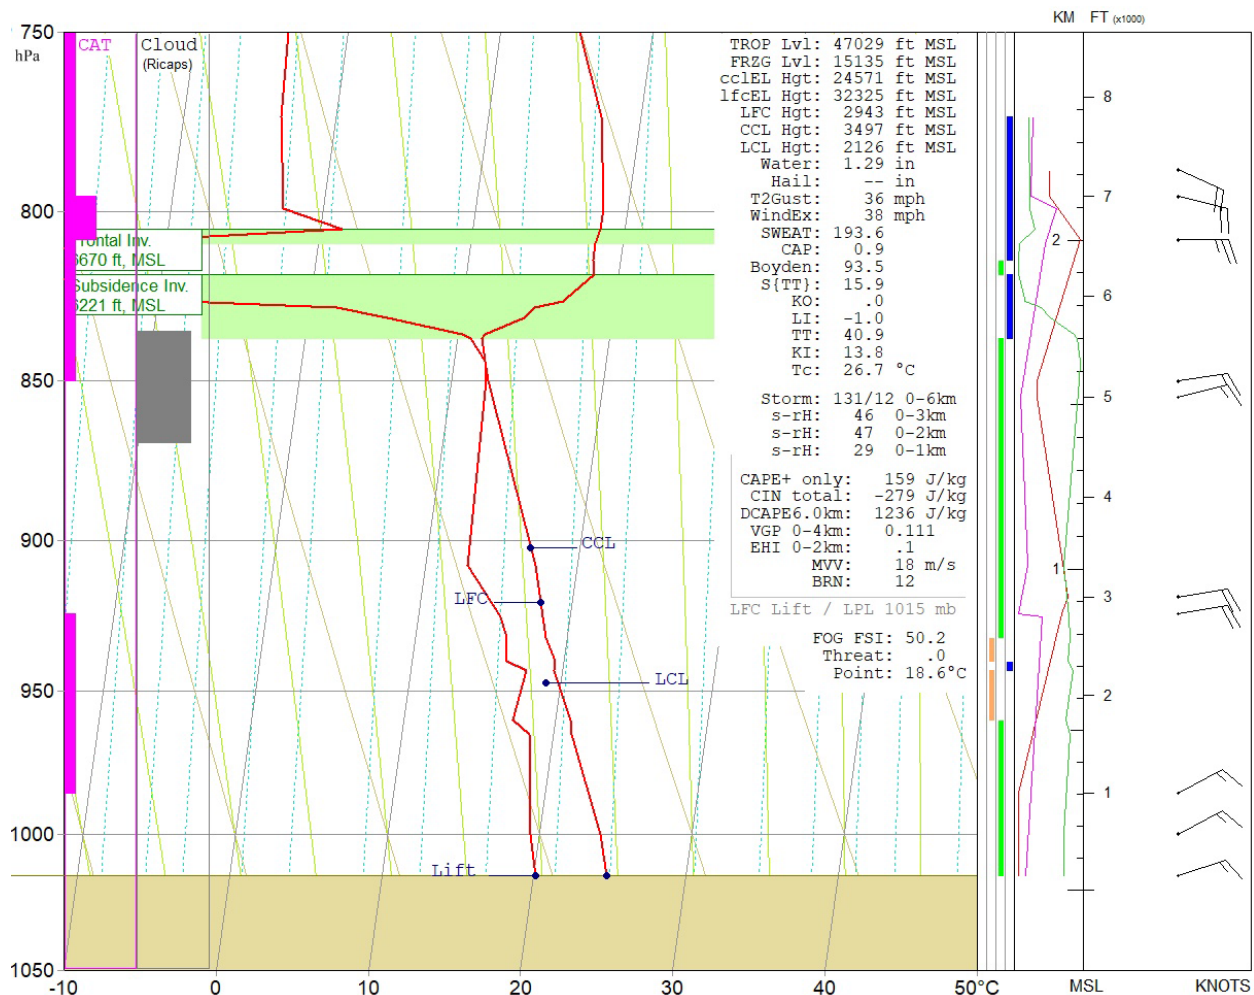
The PHLI sounding identified several temperature inversions<sup>7</sup> near 6,000 feet. Assessments made by the Universal RAwinsonde OBbservation program (RAOB) suggested cloudy conditions between about 4,500 and 5,600 feet. Below 4,000 feet the relative humidity was less than 90 percent. The freezing level was approximately 15,000 feet. RAOB did not identify any areas of significant turbulence below 5,000 feet, where the wind was generally out of the east at magnitudes between about 15 and 20 knots.

**Figure 3** - PHLI rawinsonde sounding data in SkewT/LogP format for 0200 HST, surface to 750 hPa.

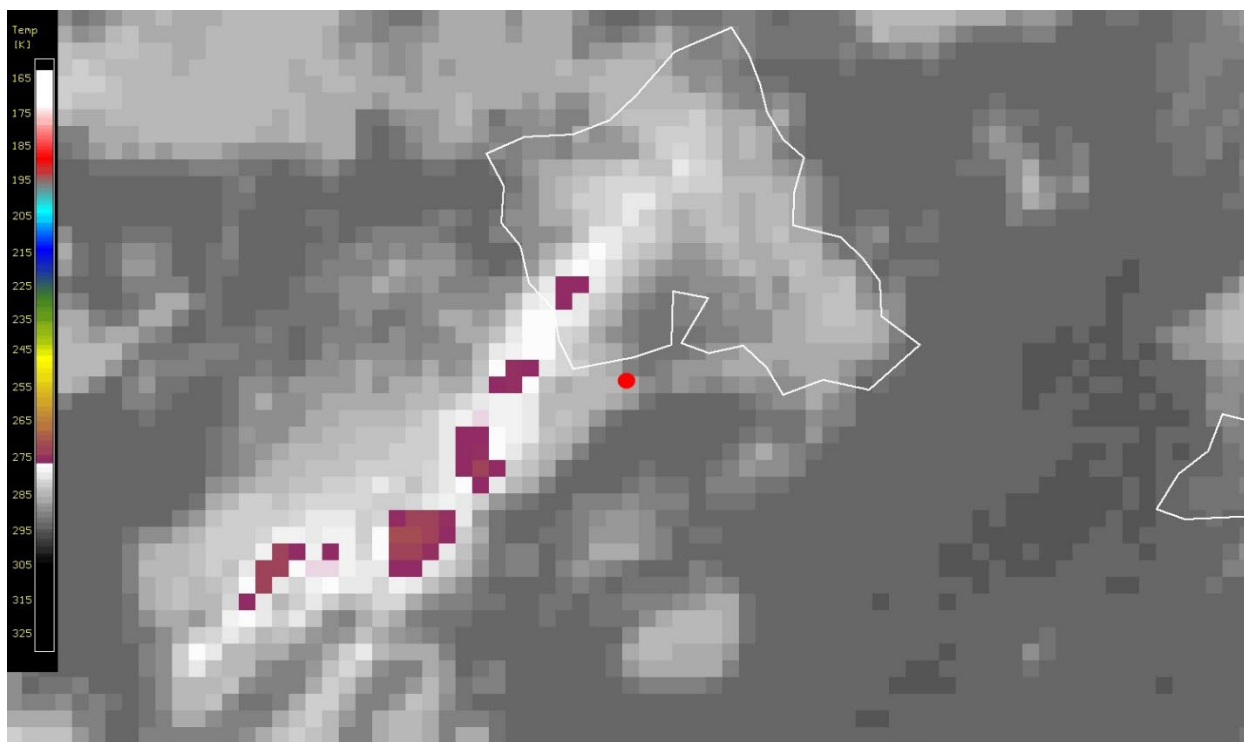
Geostationary Operational Environmental Satellite (GOES)-17 infrared (10.3 $\mu$ m) data were obtained from an archive at the Space Science Engineering Center at the University of Wisconsin-Madison. An image from 0145 HST is presented in figure 4. Infrared cloud-top temperatures over the accident site were 14°C.

**Figure 4** - GOES-17 infrared imagery from 0146 HST. Accident location denoted by red dot. Image is not corrected for parallax error.
