# National Transportation Safety Board

DCA21FA174

## **SEARCH AND RECOVERY**

Group Chair's Factual Report

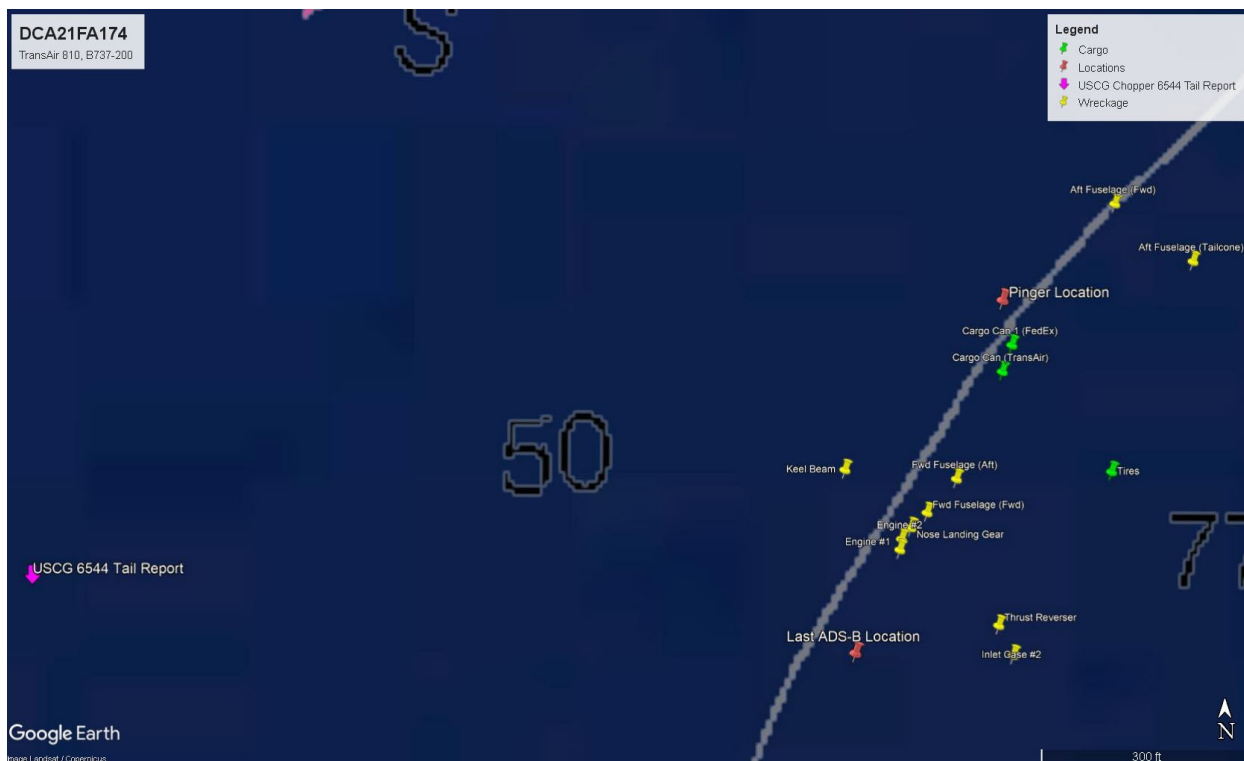
The debris field was about 0.12 miles long north-south and about 0.10 miles wide east-west (Figure 5). All major portions of the airplane were identified in the debris field.

**Figure 10.** DCA21FA174 wreckage diagram

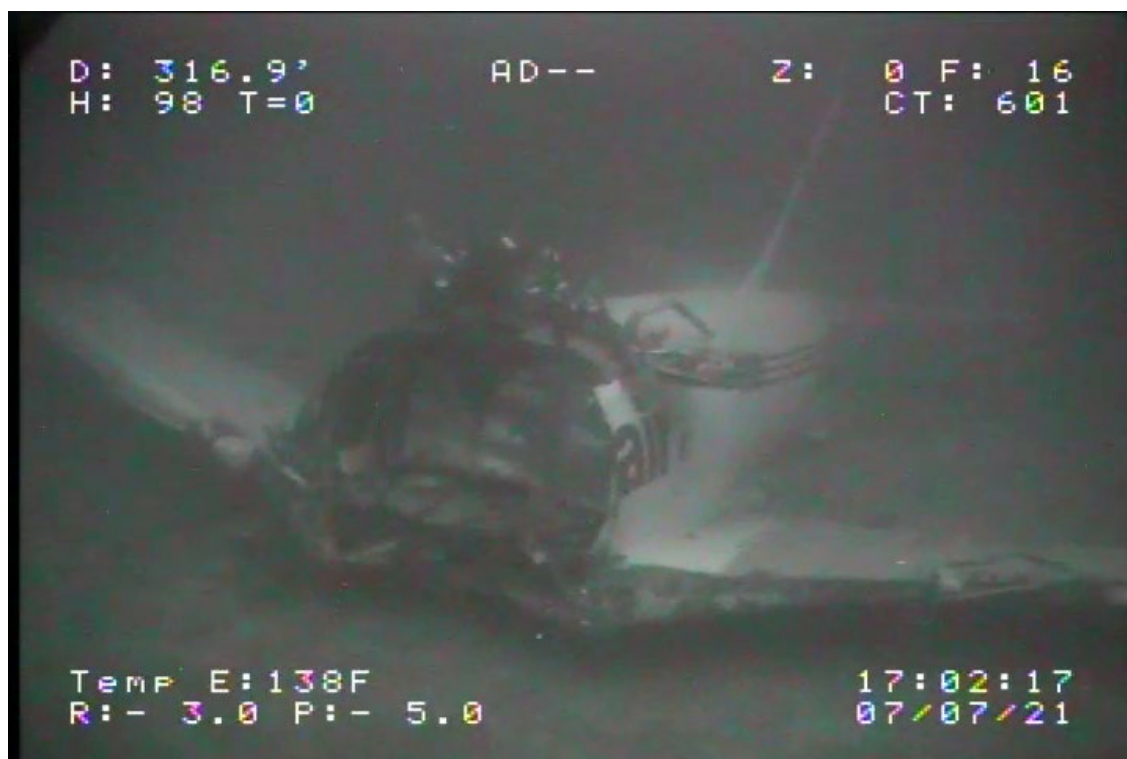
**Figure 11.** Aft fuselage, wings, and tail

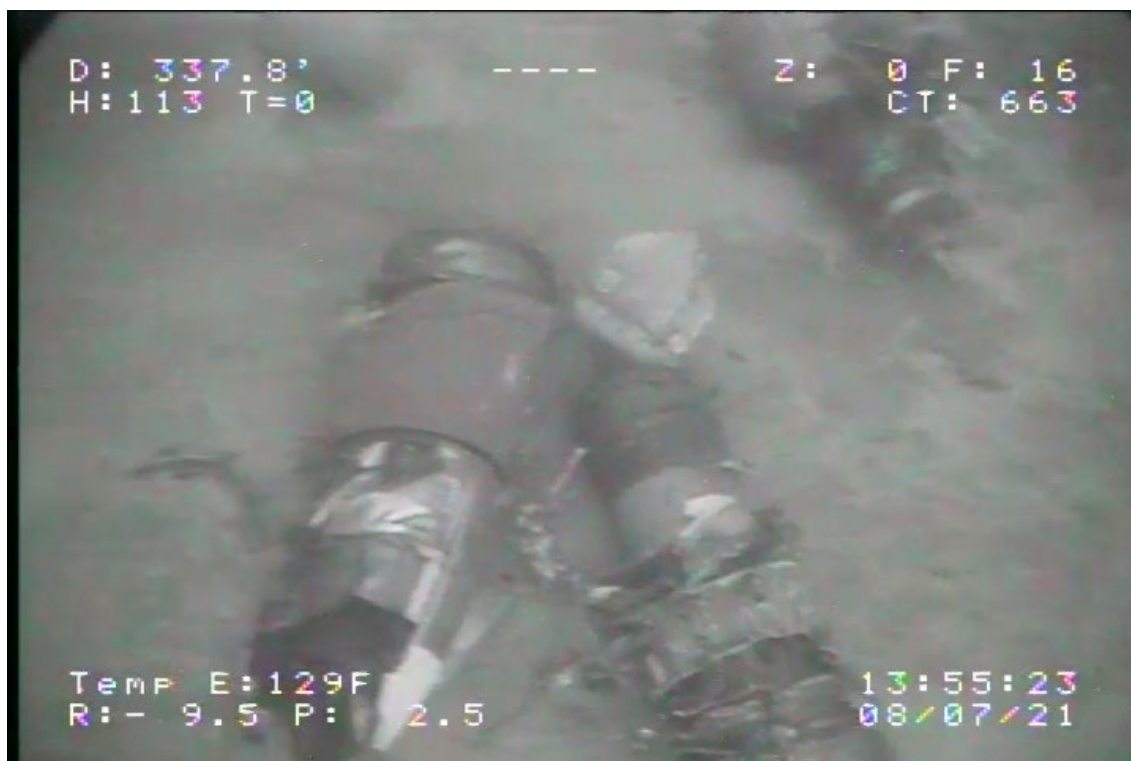
Initially it was thought that only one engine had been located so about a half a day was spent surveying the wreckage looking for the second engine. The Powerplants group examined the ROV video survey at the completion of the day's operation and concluded that both engine cores were located within about 3 feet of each other on the seafloor and adjacent to one thrust reverser.

**Figure 12.** Engine cores and one thrust reverser

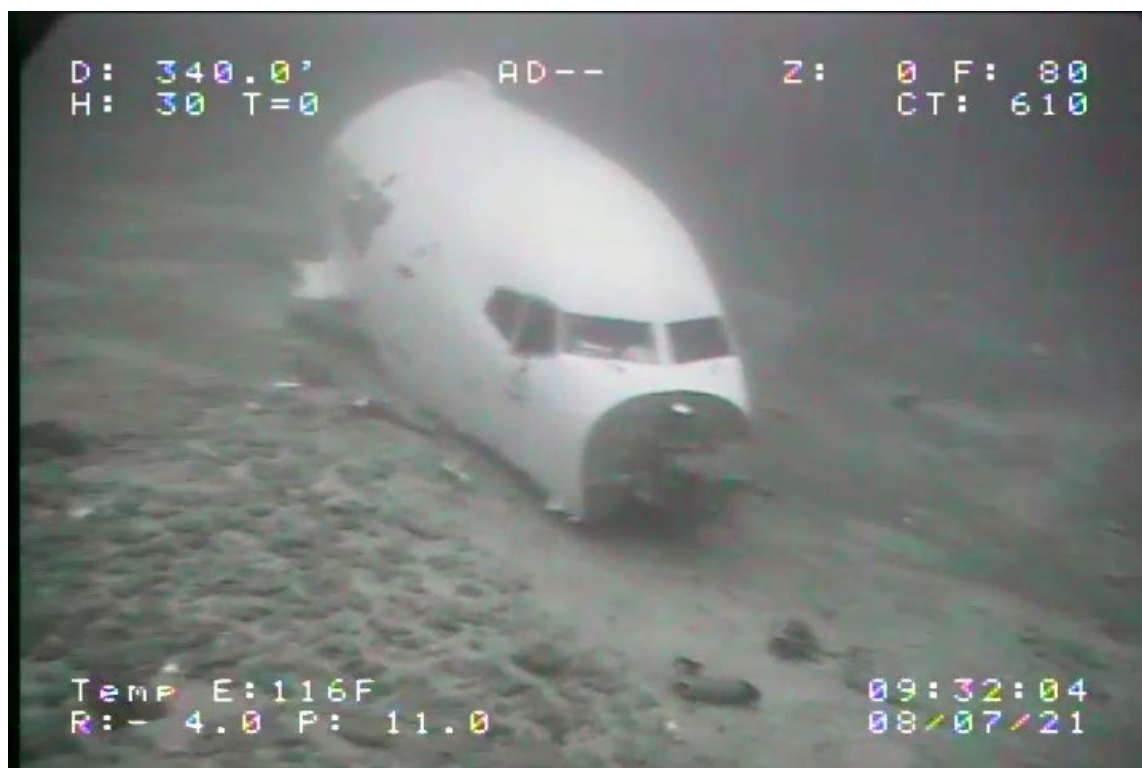
The forward fuselage was partially intact from the forward pressure bulkhead to about BS 540. There was significant damage to the lower portion evident, but the extent could not be determined. The radome was separated. The main deck cargo door was closed, the cockpit emergency windows were open, and the left entry door was ajar with the handle in the stowed position. There was no cargo present in the forward fuselage. The NLG remained attached to the wheel well structure and was in the up and locked position but the whole assembly was separated from the forward fuselage. The #2 engine inlet case was also located in the debris field separated from the engine.

**Figure 13.** Forward fuselage

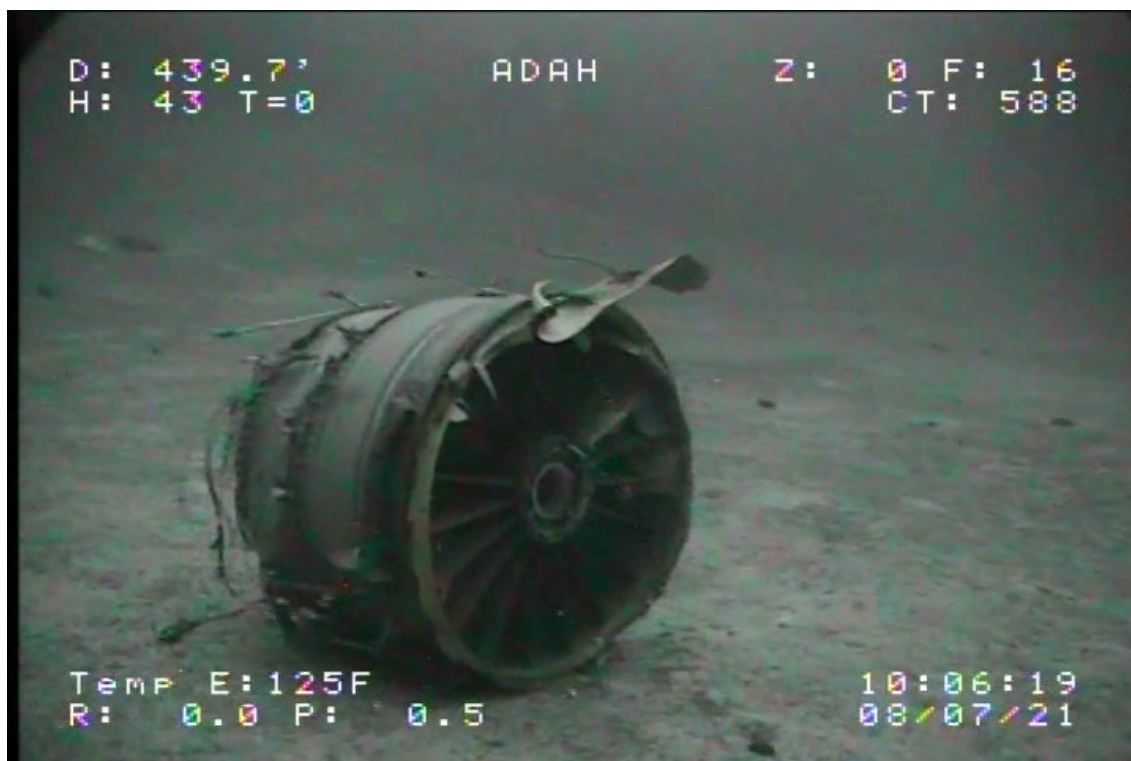
**Figure 14.** Engine #2 inlet case

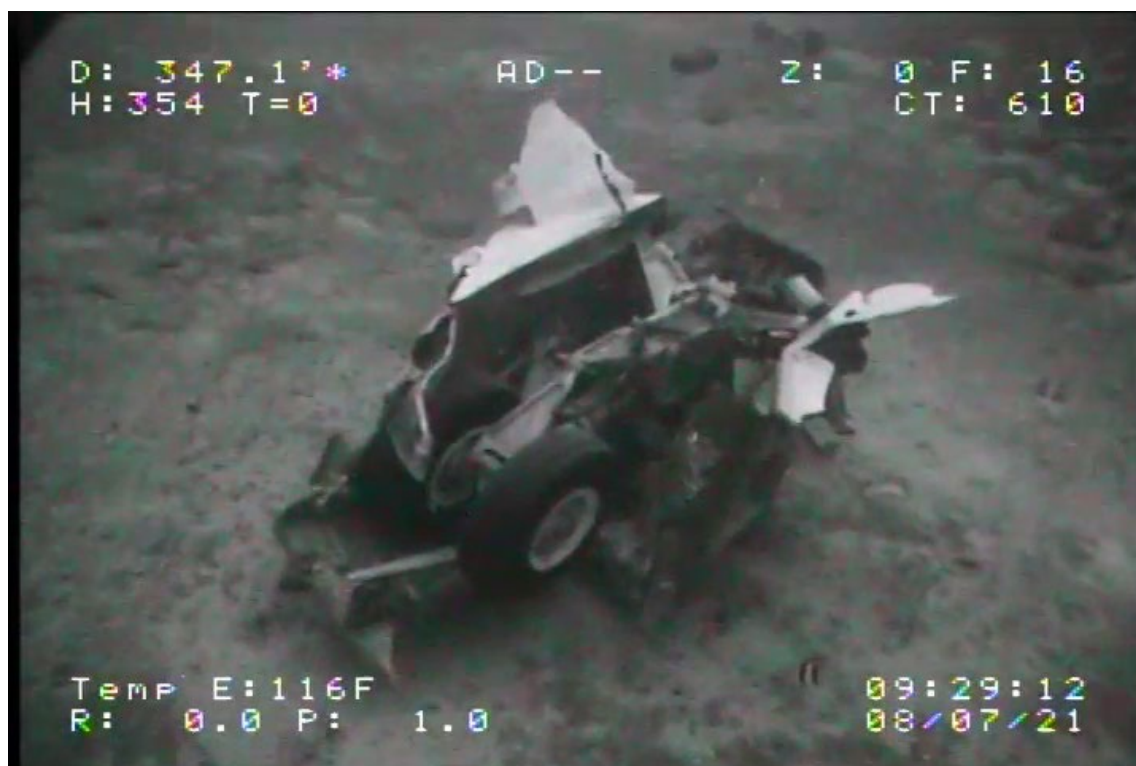
**Figure 15.** Nose landing gear

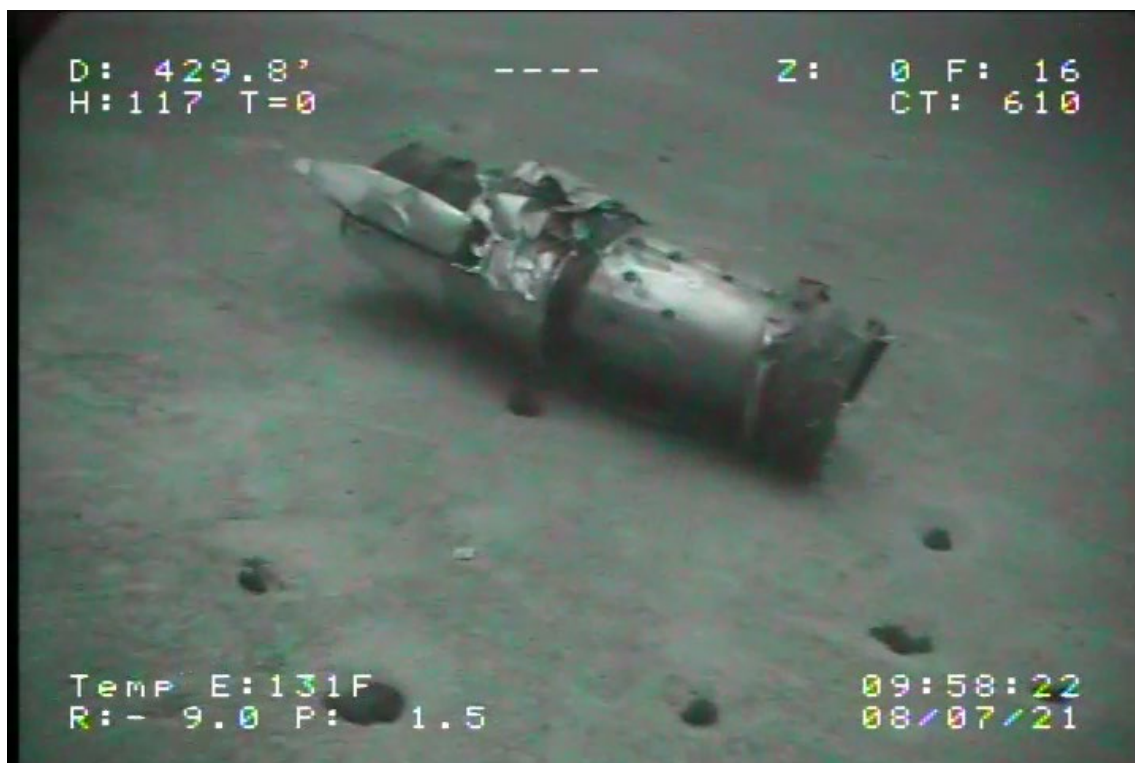
**Figure 16.** Thrust reverser

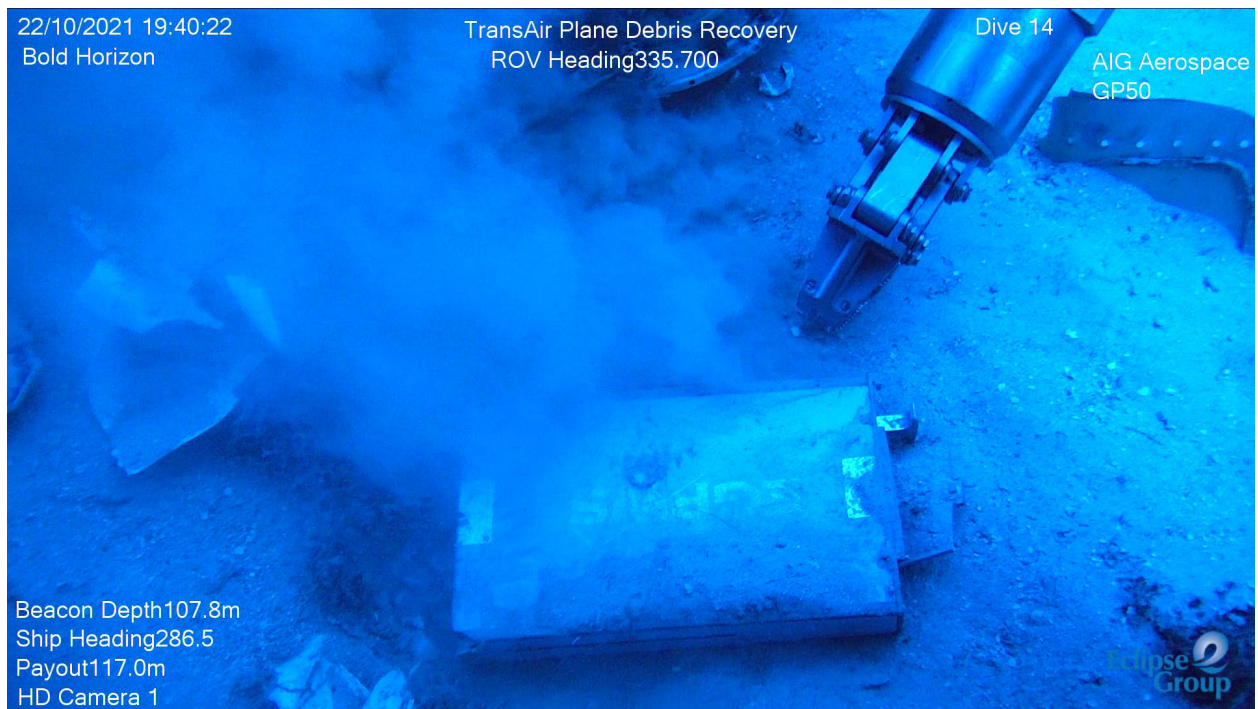
**Figure 24.** EGPWS computer on sea floor

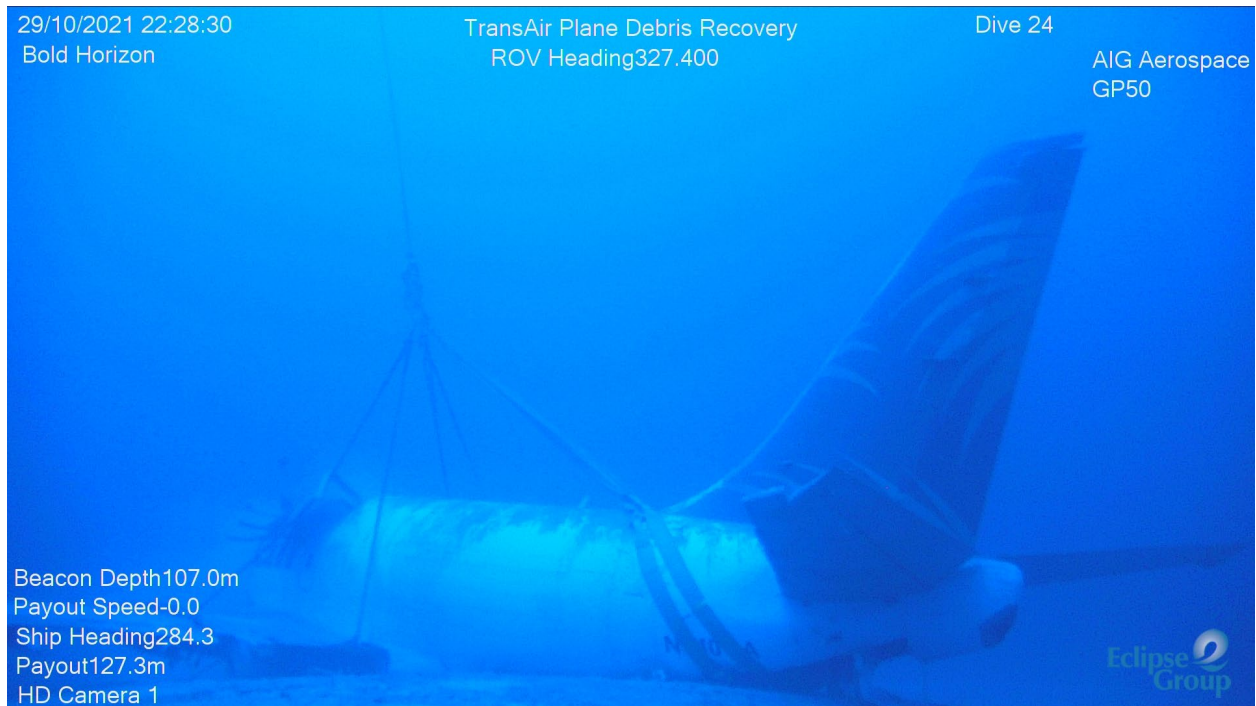
partially lifted the airplane (Figure 28). The aft fuselage was observed rocking on the sea floor while the horizontal stabilizer leading edge was moving up and down through its range of travel. The afternoon sea state was not conducive for a lift, so the tension was taken off the winch cable overnight. The ROV continued picking up smaller parts to include portions of engine cowling, sections of the lower forward fuselage, and numerous other smaller parts. LSR made arrangements for the OSRV Century to be on site the following morning to contain any fuel spills during the aft fuselage lift.

**Figure 28.** Aft fuselage rigging under tension
