## **NATIONAL TRANSPORTATION SAFETY BOARD**

### **Group Chairman's Factual Report**

# **SURVIVAL FACTORS**

DCA21FA174

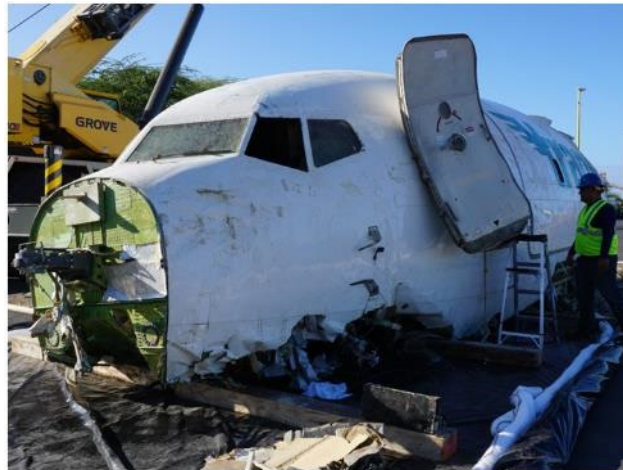
**Figure 2** The forward section of the accident airplane N810TA.

The overall floor structure of the cockpit was intact, though there was some buckling in the floor around the cockpit door. The captain cockpit window was fully open and unbroken. While the forward section of the airplane was being rigged for recovery, the first officer cockpit window was partially opened, and unbroken, but was subsequently pushed to the fully open position by the remote operated vehicle (ROV) when routing the cable through the cockpit and out the captain cockpit window. Escape ropes were stowed in their compartments. There was some minor damage to the overhead switches on the right side of the upper control panel. It was

noted that the recovery cable was routed through both cockpit windows by the ROV and may have caused this damage.

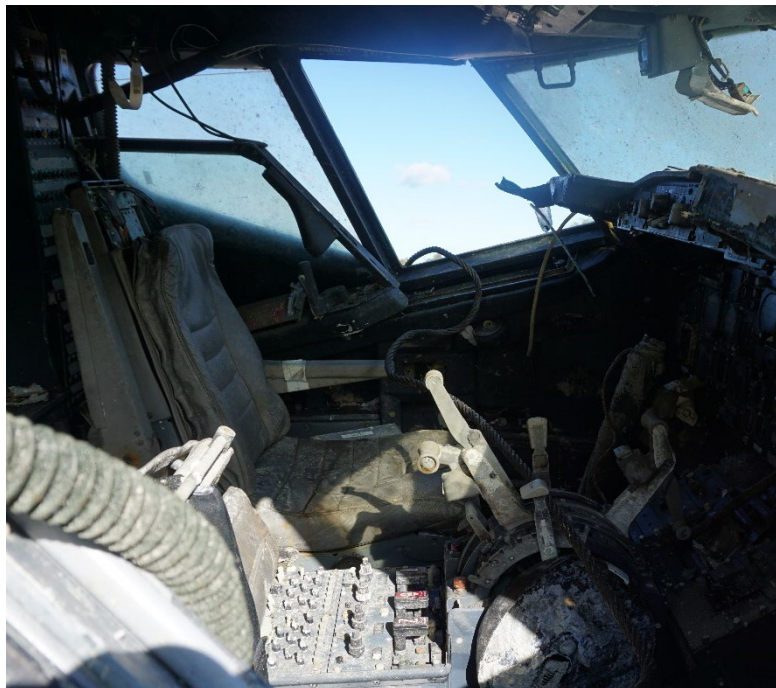
**Figure 3** Captain seat in cockpit after recovery.

After recovery the captain seat was intact, secured to the seat tracks which were fastened to a boxed structure that attached to the floor, and was positioned approximately 2.25 inches from the aft stops of the seat tracks. There was no damage to the seat cushions or deformation of the seatpan. The seat was designed to comply with TSO-39b<sup>2</sup>. There was a data tag that read:

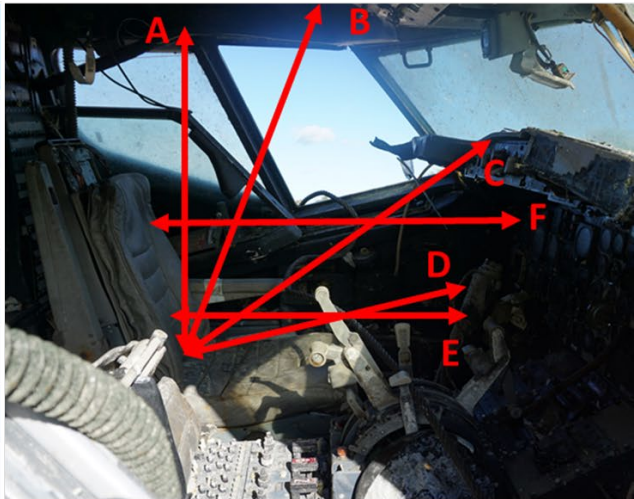
**Figure 4** Measurements of the captain seat in the airplane.

Measurements were taken from the seat to different cockpit structures after recovery to document the occupiable volume. The measurements were taken with cushions in place and with cushions removed.

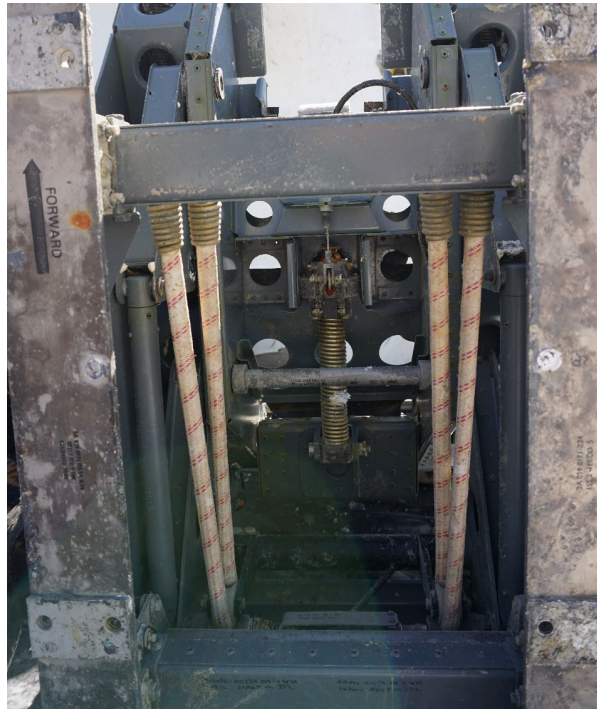
**Figure 5** View of captain seat from the bottom after removal from the airplane.

After removal from the airplane, it was noted the bungees underneath the seat remained intact as well as the threaded rod and spring which adjusted the seat angle. There was no damage to the boxed seat structure or features below the seatpan.

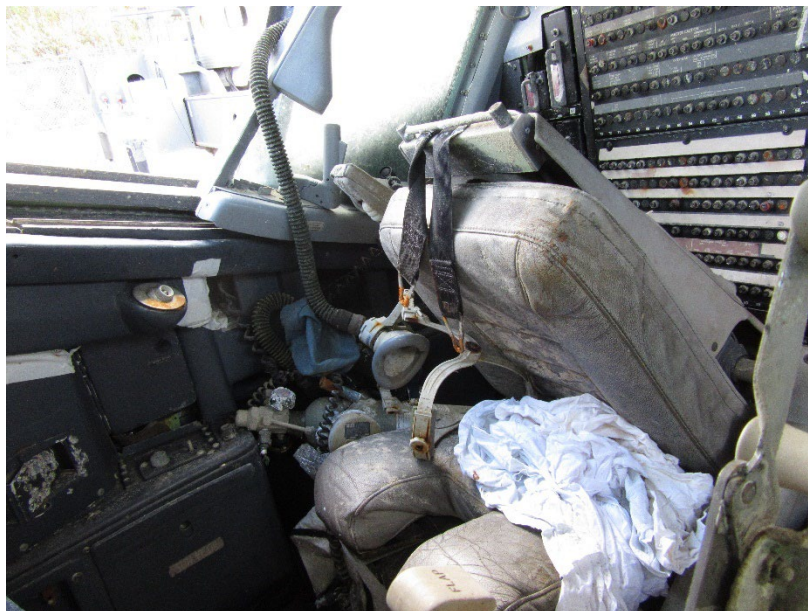
**Figure 6** First officer seat in cockpit after recovery.

After recovery the first officer seat was intact, secured to the seat tracks which were fastened to a boxed structure that attached to the floor, and was in its farthest aft position on the tracks. The seatback was rotated forward and was stuck in that

position. A measurement from the top of the seatback in the folded forward position to the instrument panel was approximately 22". The seatback was pulled upright by investigators with considerable force; however the seatback could not remain that way without support.

There was no damage to the seat cushions or deformation of the seatpan noted after removal of the cushions. The seat was designed to comply with TSO-39a<sup>3</sup>. There was a data tag that read:

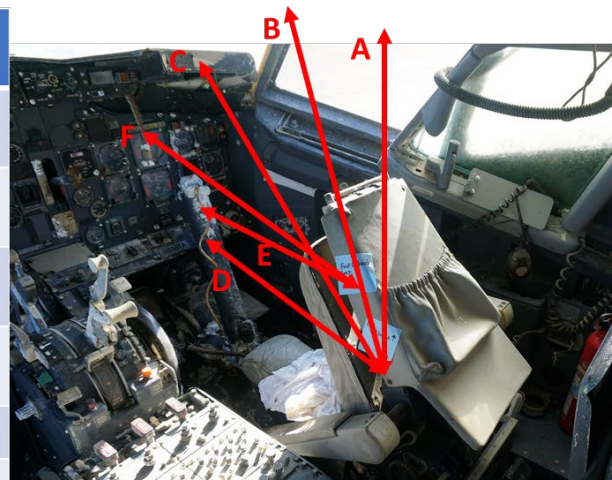
**Figure 7** Measurements of first officer seat in the airplane.

Measurements were taken from the seat to different cockpit structures after recovery to document the occupiable volume. The measurements were taken with cushions in place and with seatpan cushion removed, additionally the seat back was held in the vertical position. The seatback cushion was measured at 3" thick.

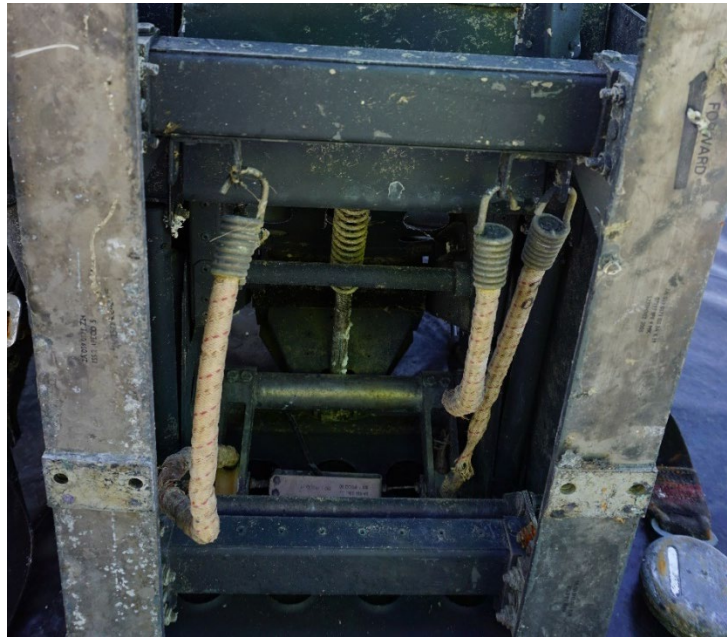
**Figure 8** View of first officer seat from the bottom after removal from the airplane.

The seat was removed with the seat tracks still attached because the rollers were seized to the seat tracks. After removal from the airplane, it was noted that there was damage to the stowage compartment below the seat. The left bungee was broken, and half was missing, the right is connected, however the elastic was broken

in multiple places. The threaded rod and spring, which adjusted the seat angle, was fractured at the forward end. The rod and spring were removed from the seat.

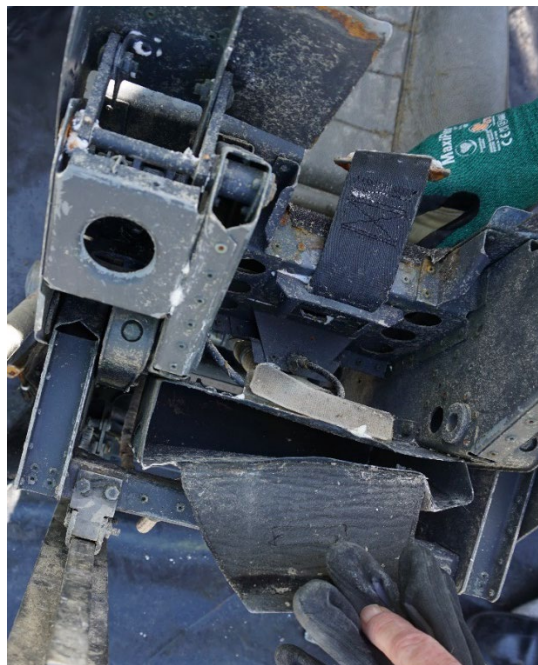
**Figure 9** First officer seat as viewed from the front looking back, showing damage to stowage compartment.

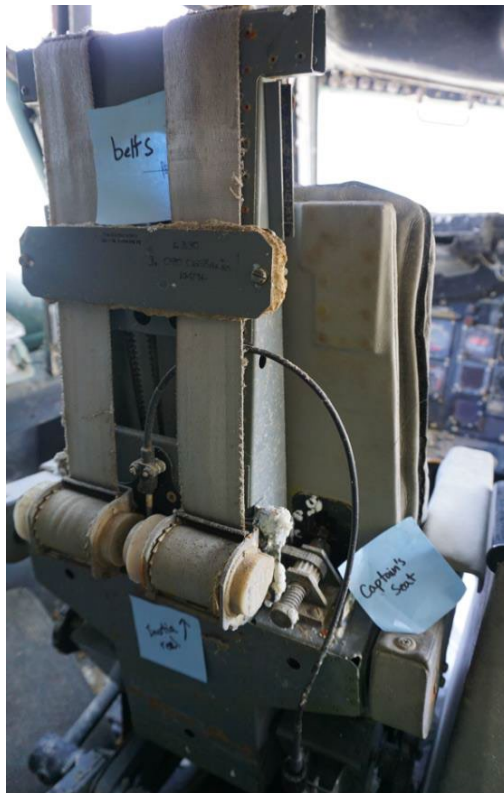
**Figure 10** Captain inertia reels after removal of seatback cover.

The captain seat upper torso restraint consisted of two belts that routed over the top of the seat into two separate inertia reels. The seatbelts were all intact, however fraying was noted along the sides of the torso belts. Corrosion on the back of the buckle allowed only the manufacturer to be identified.

The inertia reel lock lever position was set to lock. When the upper torso webbing was pulled, the inboard inertial reel allowed webbing to pay out, and the outboard reel did not. Upper torso restraint measurements were taken from where the seatbelt came through the top of the seatback to the tang prior to the seatback cover being removed. The inboard upper restraint was adjusted to a length of 4.25". The outboard upper restraint was adjusted to a length of 4". The inboard lapbelt was adjusted to a length of 20.5". The outboard lapbelt was adjusted to a length of 21.5". The crotch strap was 11". The patent number for both upper restraint inertia reels were 5312066 with a manufacturing date of 04/08 and the part numbers were:

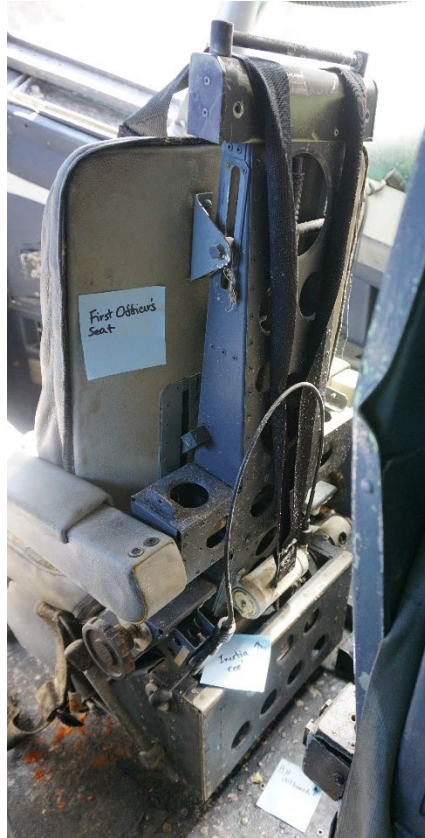
**Figure 11** First officer inertia reel after removal of seatback cover.

The first officer seat upper torso restraint consisted of two belts that routed over the top of the seat where they combined to an inverted yoke that went down to a single inertia reel. All portions of the restraint webbing were undamaged. The information on the buckle read:

The inertia reel lock lever was in the unlocked position. When the upper torso webbing was pulled, the restraints did not move. Upper torso restraint measurements were taken from where the seatbelt came through the top of the seatback to the tang prior to the seatback cover being removed. The inboard upper restraint was adjusted to a length of 10.5". The outboard upper restraint was adjusted to a length of 10.25". The inboard lapbelt was adjusted to a length of 21.5". The outboard lapbelt was adjusted to a length of 21". The crotch strap was 11.625". No part marking information could be identified on the inertia reel parts.
