# National Transportation Safety Board

DCA21FA174

## **MATERIALS LABORATORY**

Factual Report 22-010

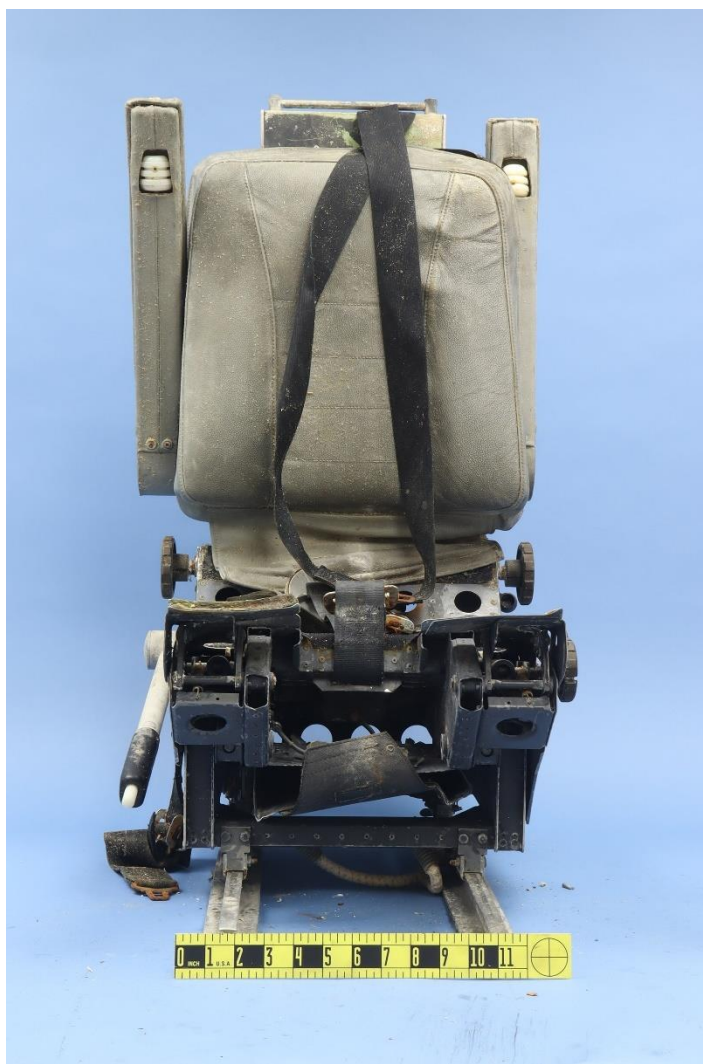
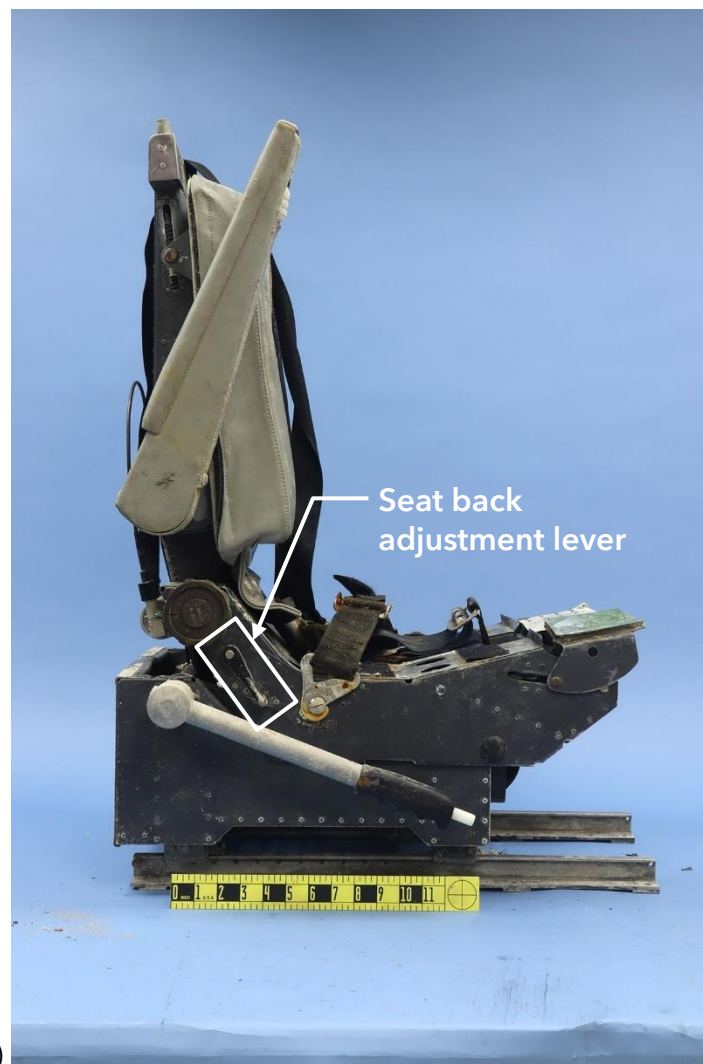
A flight deck chair (first officer's) that experienced a forward collapse of the seat back was submitted to the NTSB Materials Laboratory for examination, as shown in figures 1a - 1d. On March 1 and 2, 2022, the seat was torn down to examine and document the condition of the components that control the seat back position.

**Figure 1.** Images of the first officer's flight deck chair, as received; a) viewed forward looking aft; b) right-side view;

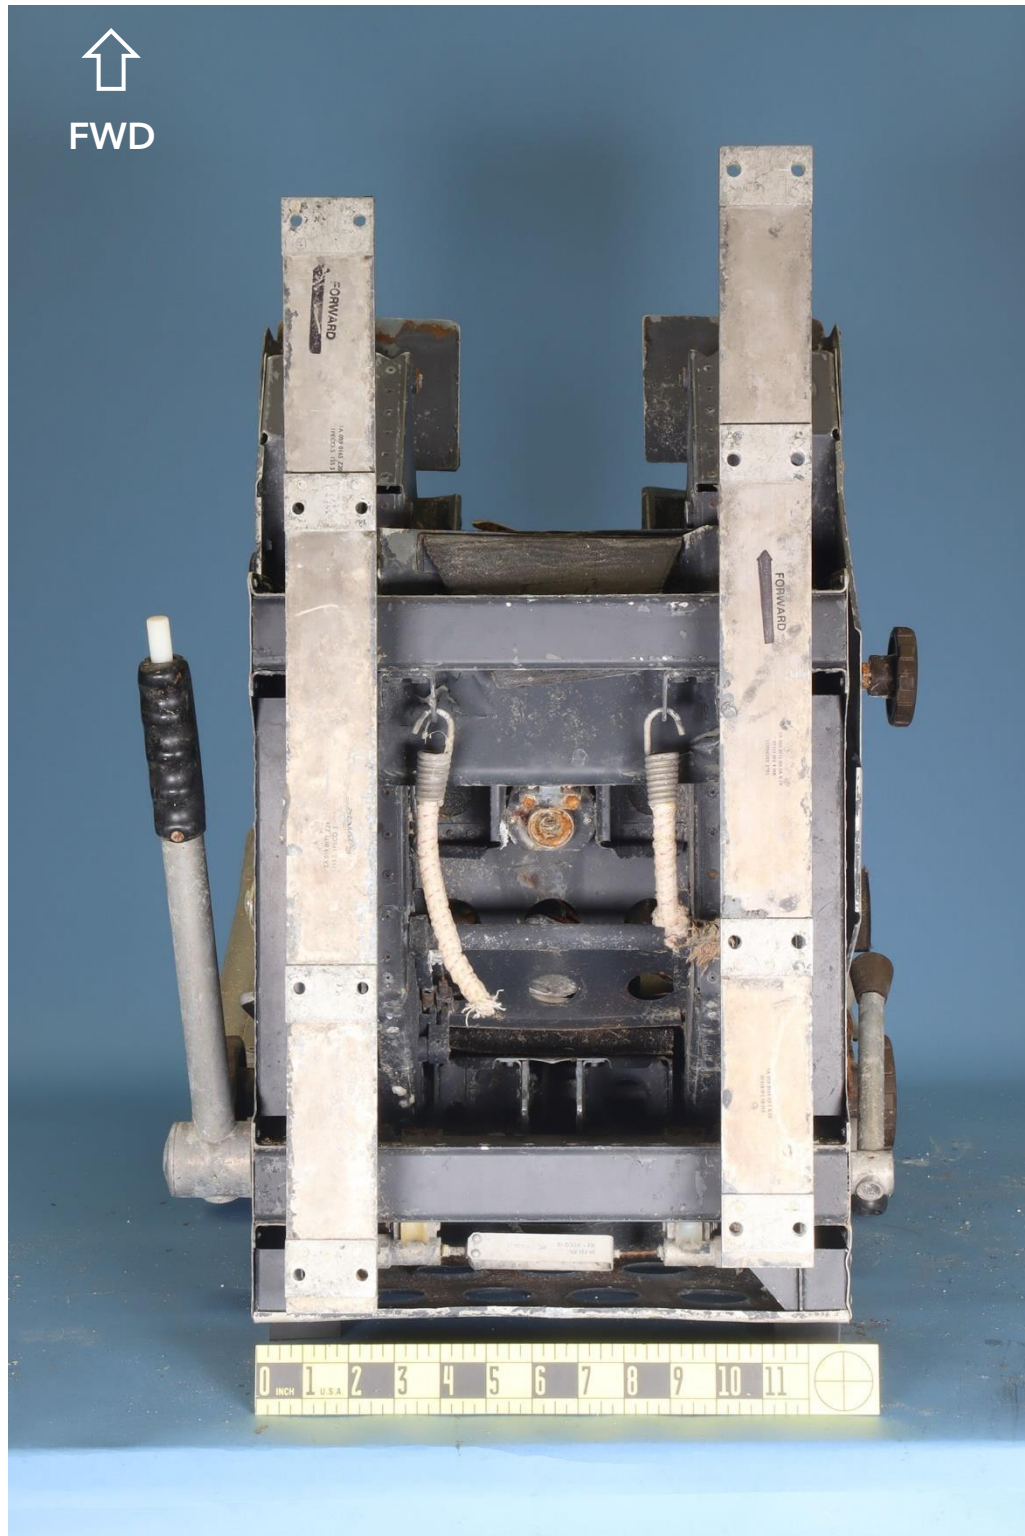
The jack screw, screw spring, and spring sleeve were previously removed in the field, as seen in figures 1c and 1d, so disassembly focused on removal of the jack nut assembly. The Bowden cable was examined and determined to be intact and rotating the nut assembly back into its typical orientation placed the cable under tension. The cable was then cut. The surrounding seat material was cut with a reciprocating saw and rivets were through-drilled until the nut assembly could be removed.

**Figure 1 (cont.).** c) viewed below looking up. The jack screw assembly is not present as it was previously removed in the field; and

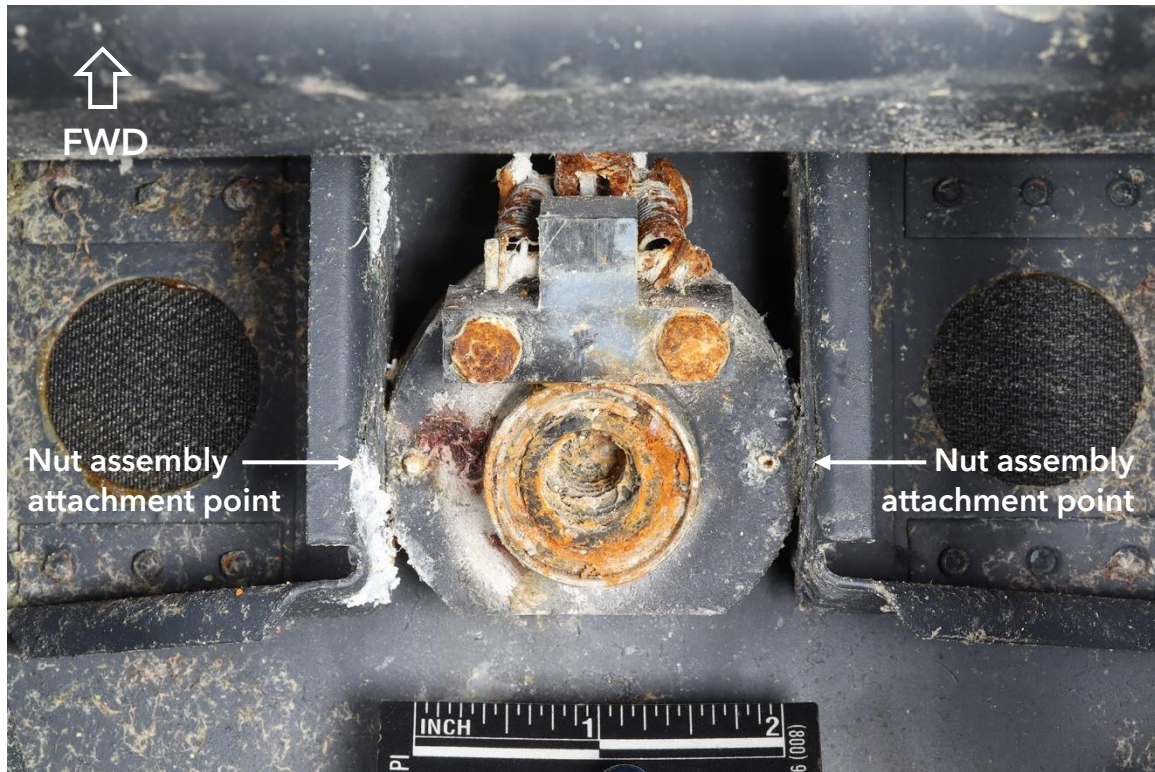
**Figure 1 (cont.).** d) higher magnification image of the jack nut assembly. The assembly rotated about its attachment points after the jack screw pulled out of the nut.

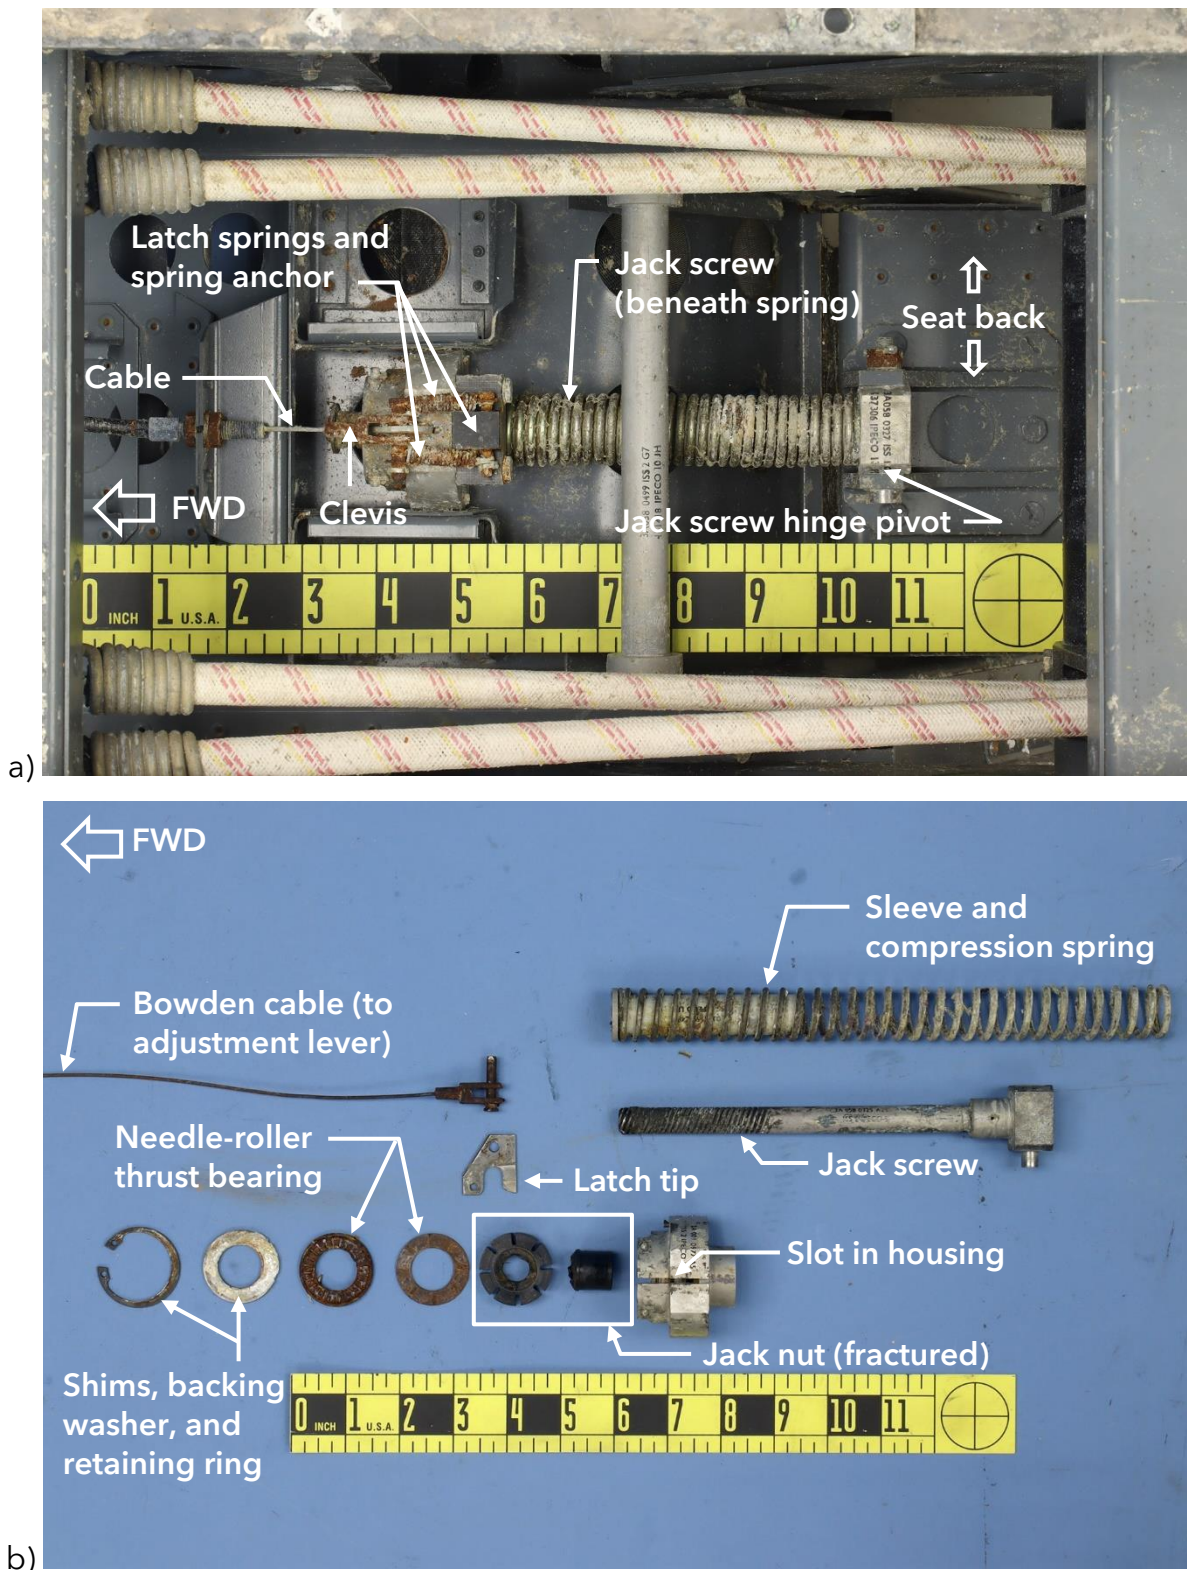
By design, the seat back position is controlled by a screw jack mechanism that is mounted to the underside of the seat, as shown for the captain's chair in figure 2a. An exploded view of the screw jack assembly from the first officer's chair, after it was disassembled, is shown in figure 2b. The occupant adjusts seat back position by pulling an adjustment lever on the right side of the chair, indicated in figure 1b. The lever is connected to a shaft that passes through the seat base into the space underneath the seat. A Bowden cable, attached to the lever assembly, runs forward along the underside of the seat, loops through a 180° bend, and attaches to an anchor point near the seat's forward end and at its mid-plane, with the cable now running in the aft direction. The cable is connected, via a clevis, to a spring-loaded latch (see figures 2a and 2b). The latch is mounted to a jack nut housing via a hinge

The base of the jack screw is connected to the seat back with a hinge pin (figure 2a). A compression spring and a sleeve are installed over the screw. The screw passes through the nut housing and the nut rotates about the screw as it translates longitudinally. A washer is attached to the end of the jack screw (not shown), which prevents the screw from backing out of the nut assembly. The spring, under residual compression, acts to push the screw hinge pivot aft, which causes the seat back to pivot forward. The seat occupant uses body weight to push against the seat back, which results in forward movement of the screw.

**Figure 2.** a) Seat back adjustment mechanism on captain's chair and b) exploded view of screw jack assembly from the first officer's chair after disassembly. The latch springs and spring anchor assembly are not shown.

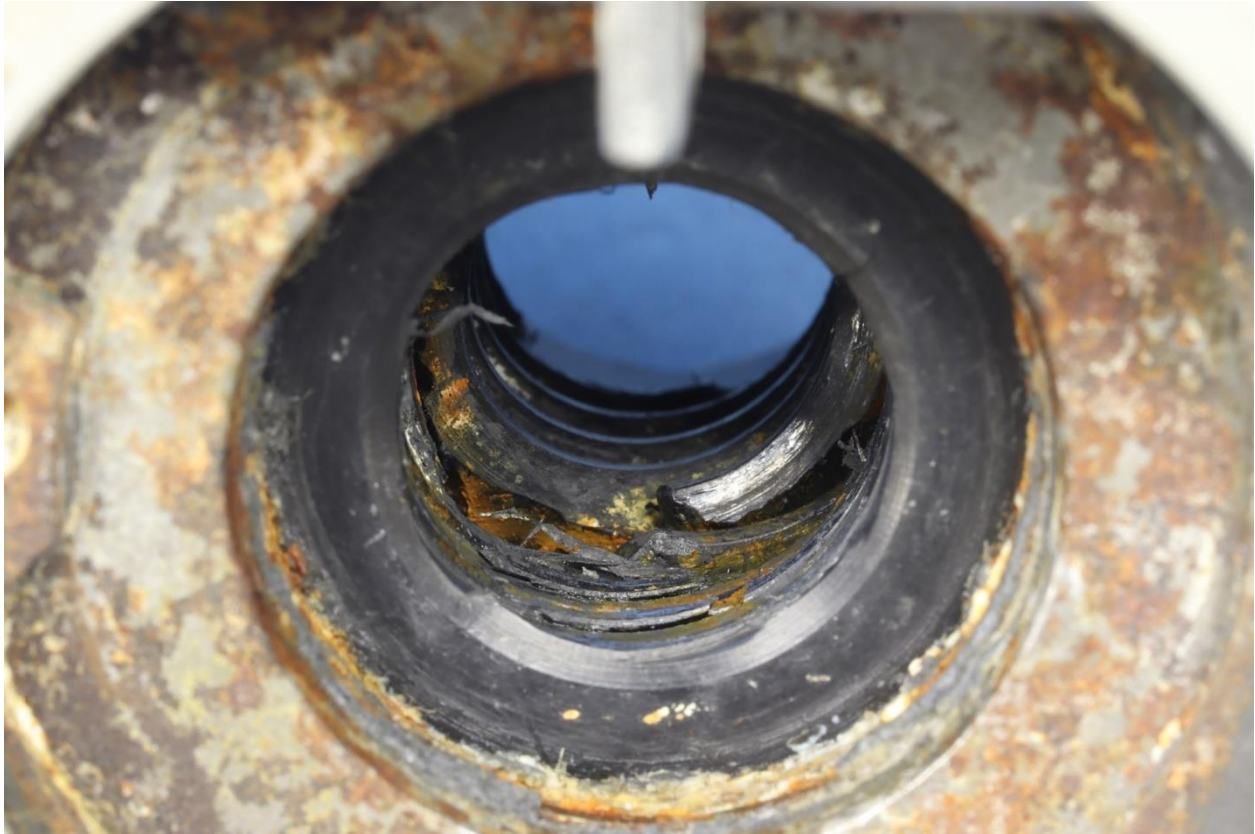
Visual examination of the nut assembly revealed that the jack nut was fractured in the transverse plane, as shown in figure 3. The latch was found in the locked position and the latch tip was rotated out of the slot to examine it. There was no apparent deformation to the tip and the nut slot appeared to be aligned with the slot in the housing (see figures 4a and 4b and the discussion below).

**Figure 3.** Image of the nut prior to disassembly. The nut was fractured in the transverse plane.

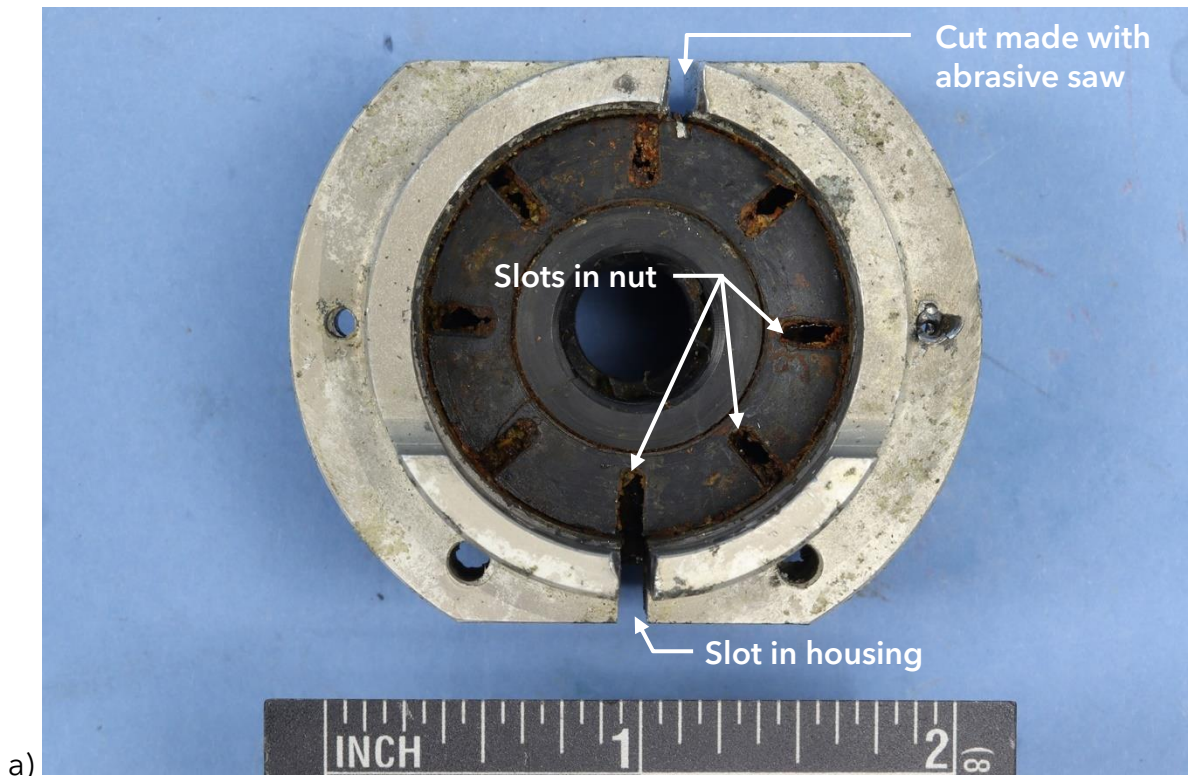
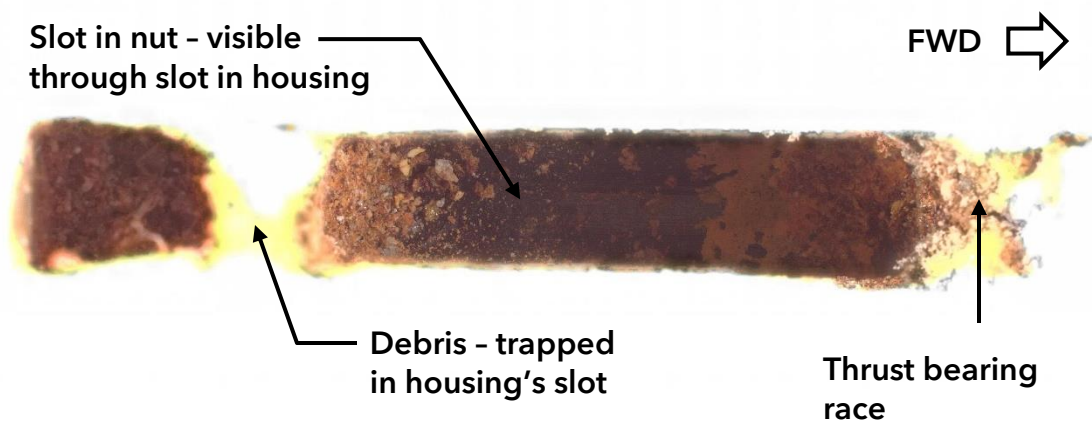
Further teardown of the nut assembly required cutting the housing approximately 180° from the latch slot. While the retention clip could be removed, corrosion and salt residues had mechanically locked the backing washer and thrust bearing within the housing. After the housing was cut (see figure 4a), a chisel and hammer were used to open the housing inner diameter. The washer and bearing assembly were then removed revealing the forward face of the nut, shown in figure 4a. During the disassembly, the nut rotated slightly so that the slot in the nut was slightly misaligned with the slot in the housing. The slot alignment was documented prior to disassembly using a digital optical microscope, as shown in

figure 4b, and the two slots appeared to be aligned. The 6 o'clock position was marked on the nut and the nut was then pressed out of the housing, as shown in figure 5.

**Figure 4.** a) Image of the nut inside its housing. The latch locking slot is located at the bottom (6 o'clock position) and a cut made with an abrasive saw is located at the top and b) image taken through the locking slot showing the slot in the nut, centered with the slot in the housing.

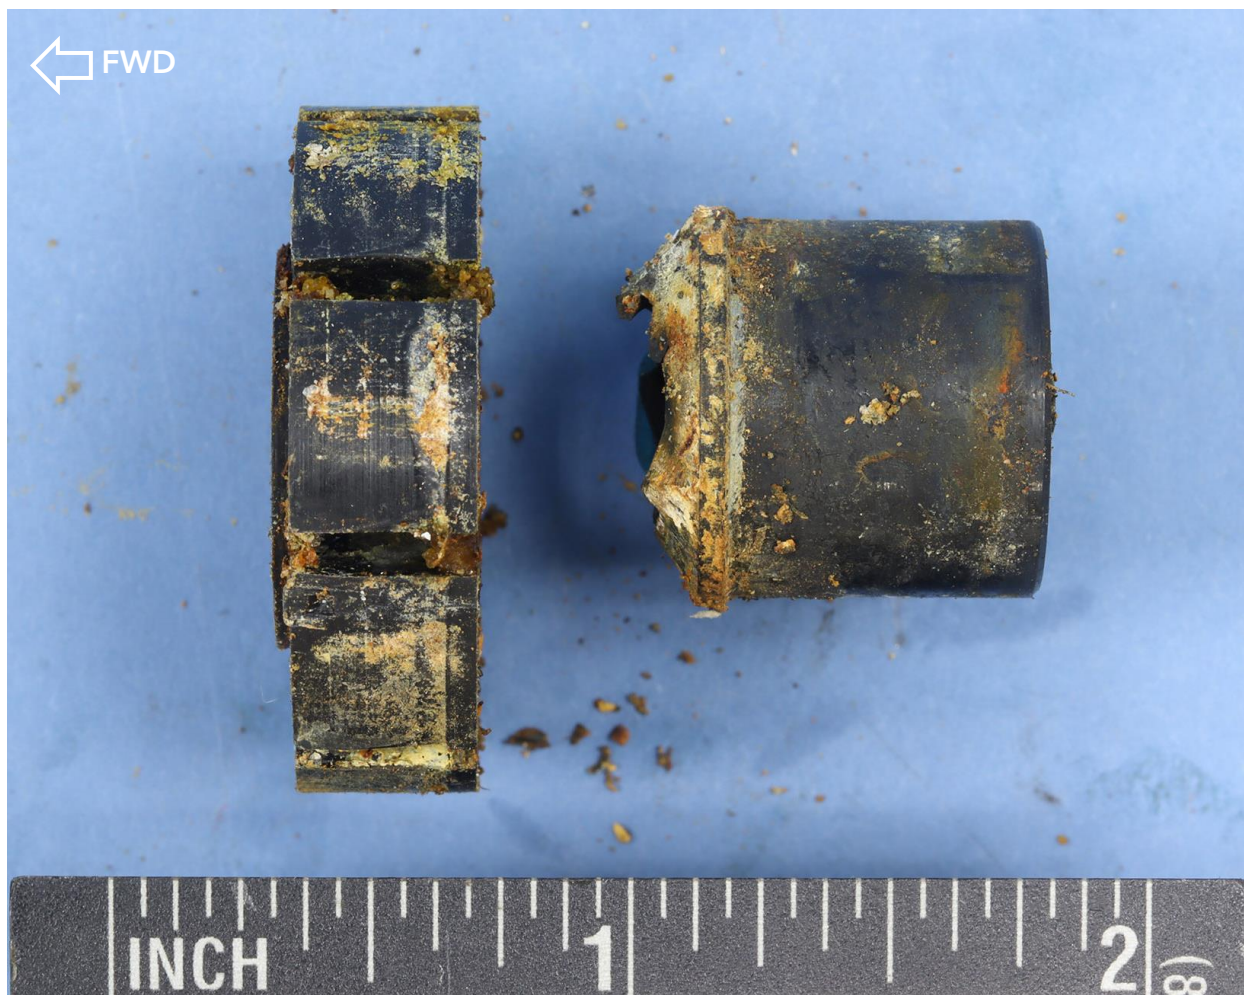
Visual examination revealed that the nut had fractured at the transition between the large- and small-diameter sections. Salt and corrosion products were removed by putting the nut pieces in a beaker filled with an alkaline detergent solution and placing the beaker in a sonicating bath. The fracture face on the large-diameter portion of the nut (the forward fracture face) is shown in figures 6 and 7, with and without fracture mapping annotations, respectively. Crack propagation marks were observed radiating from the outer diameter surface of the nut at the transition radius between the small-diameter section and the aft face of the large-diameter section. Two primary origins were observed, one on the left side and one on the right side, approximately in line with the attachment pins that connect the jack nut assembly housing to the seat frame. Each crack progressed radially inward and circumferentially around the top and bottom of the nut from their respective origins until the two cracks met at two lines of final separation. The crack originating from the left side had progressed approximately  $135^\circ$  around the top and bottom, subtending an approximately  $270^\circ$  arc angle. The crack originating from the right side accounted for the remaining  $90^\circ$ . Four smaller cracks, distributed about the inner diameter, had originated at thread roots and progressed radially outward, terminating at the primary fracture, as indicated in figure 6. Examination with a stereomicroscope did not reveal any apparent progressive cracking features. Considered as a whole, the observations were consistent with a tensile overstress fracture.

**Figure 5.** Image of the fractured nut after disassembly.

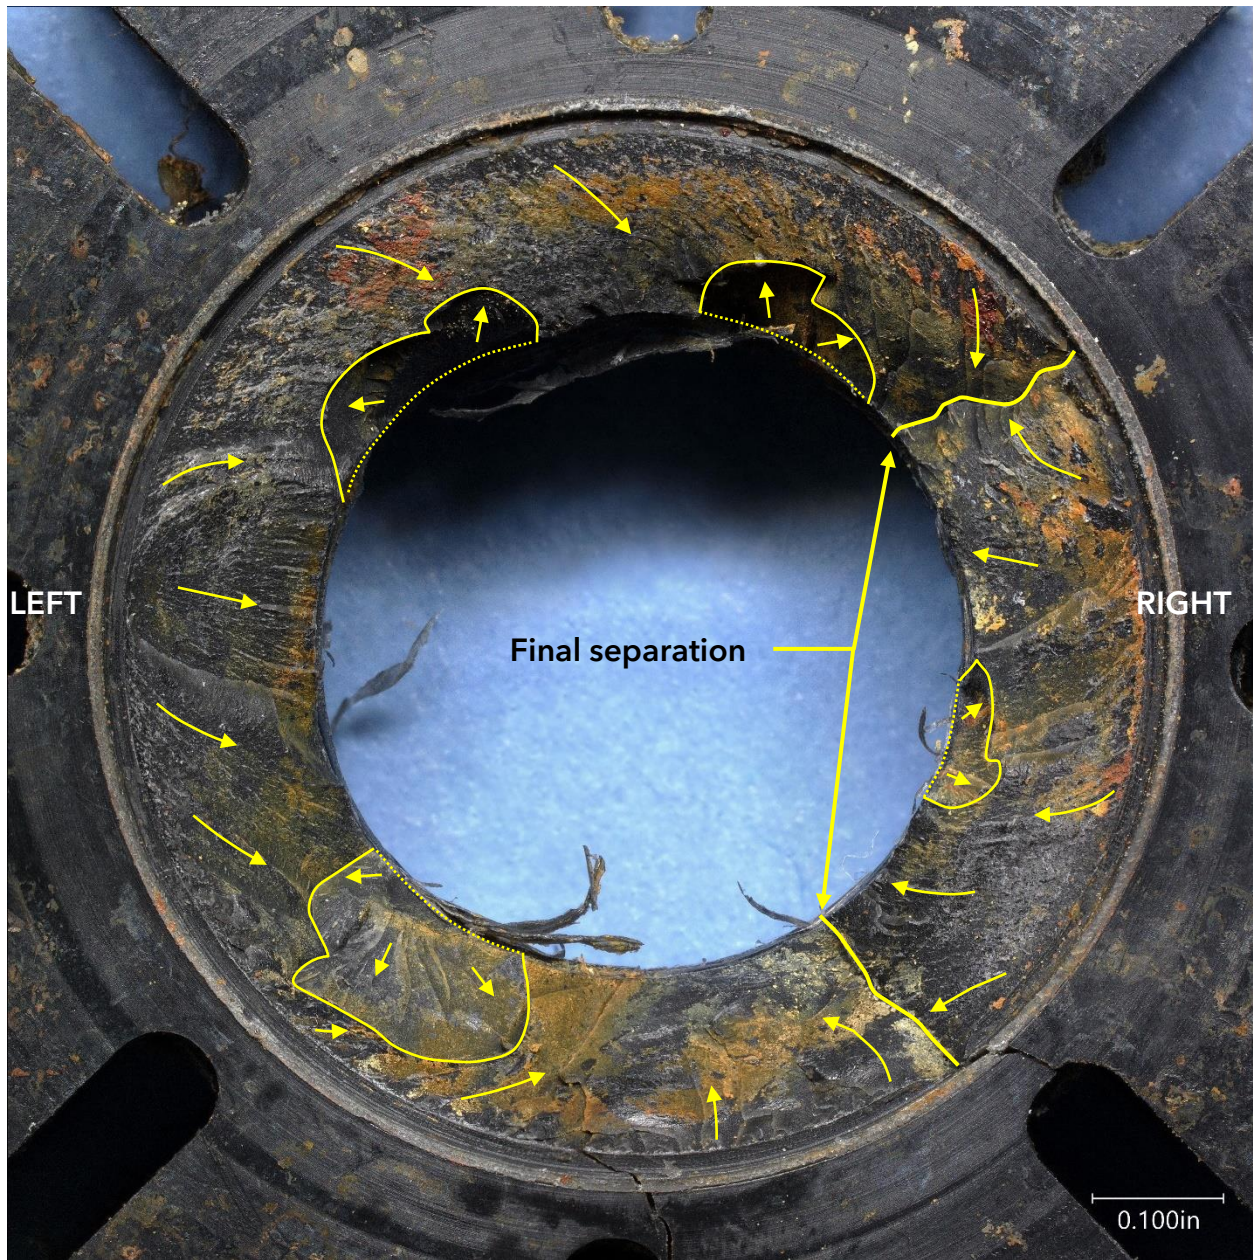
**Figure 6.** Jack nut fracture surface annotated with a fracture map. Arrows indicate the direction of crack propagation. Solid lines indicated fracture boundaries where two cracks meet.

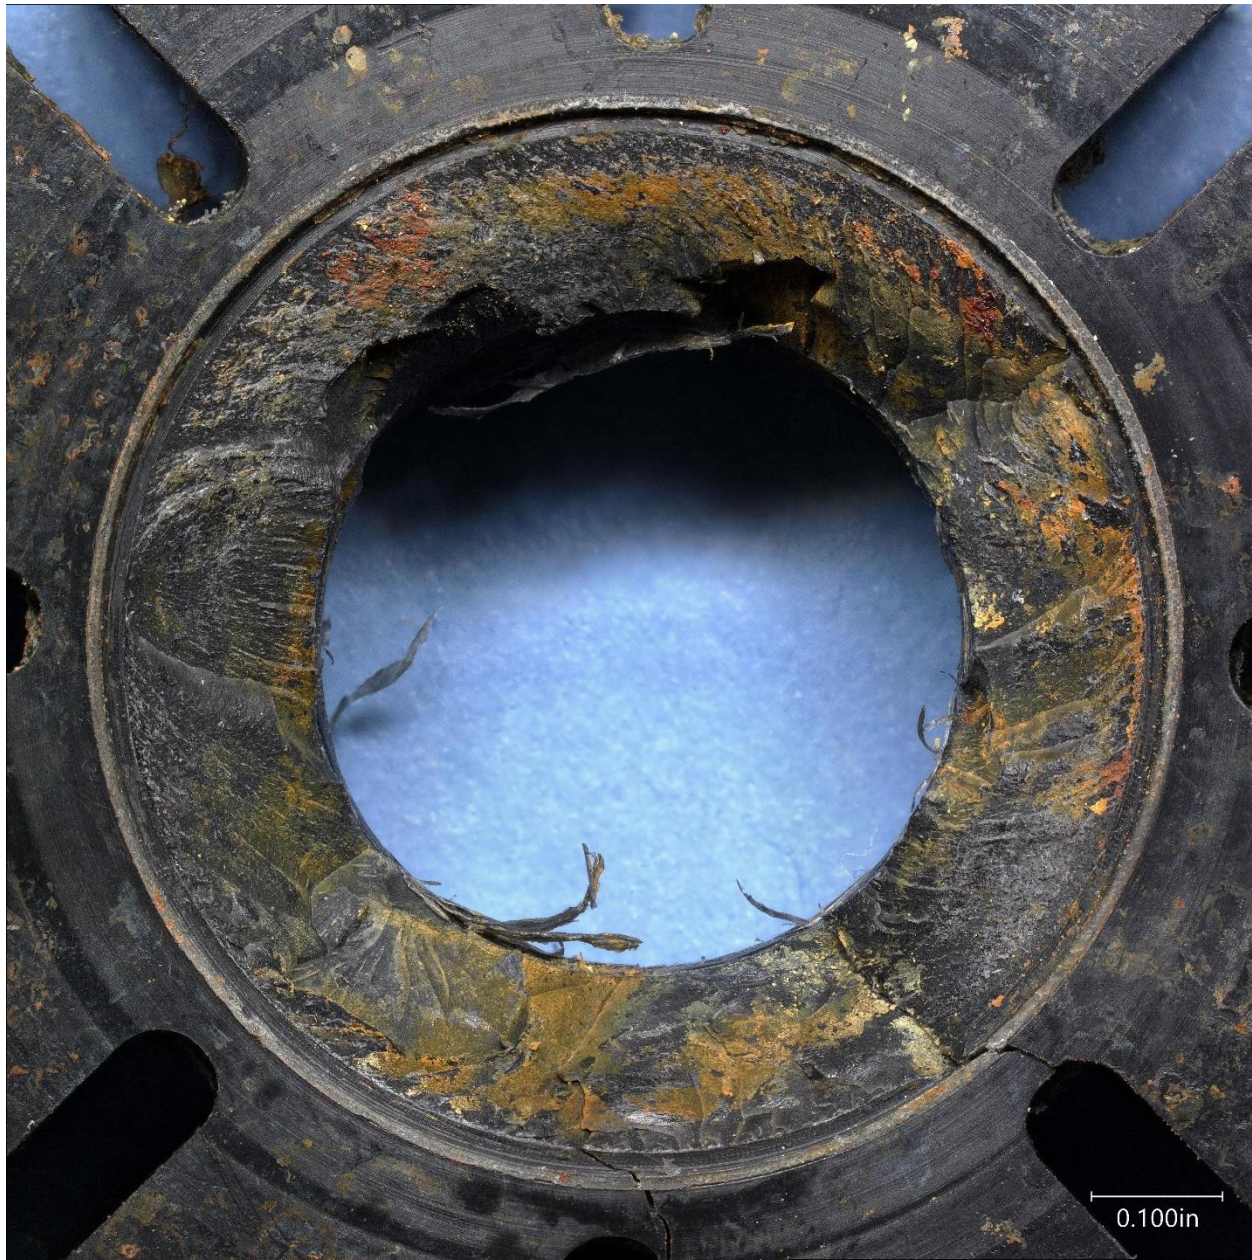
**Figure 7.** Jack nut fracture surface without annotations.

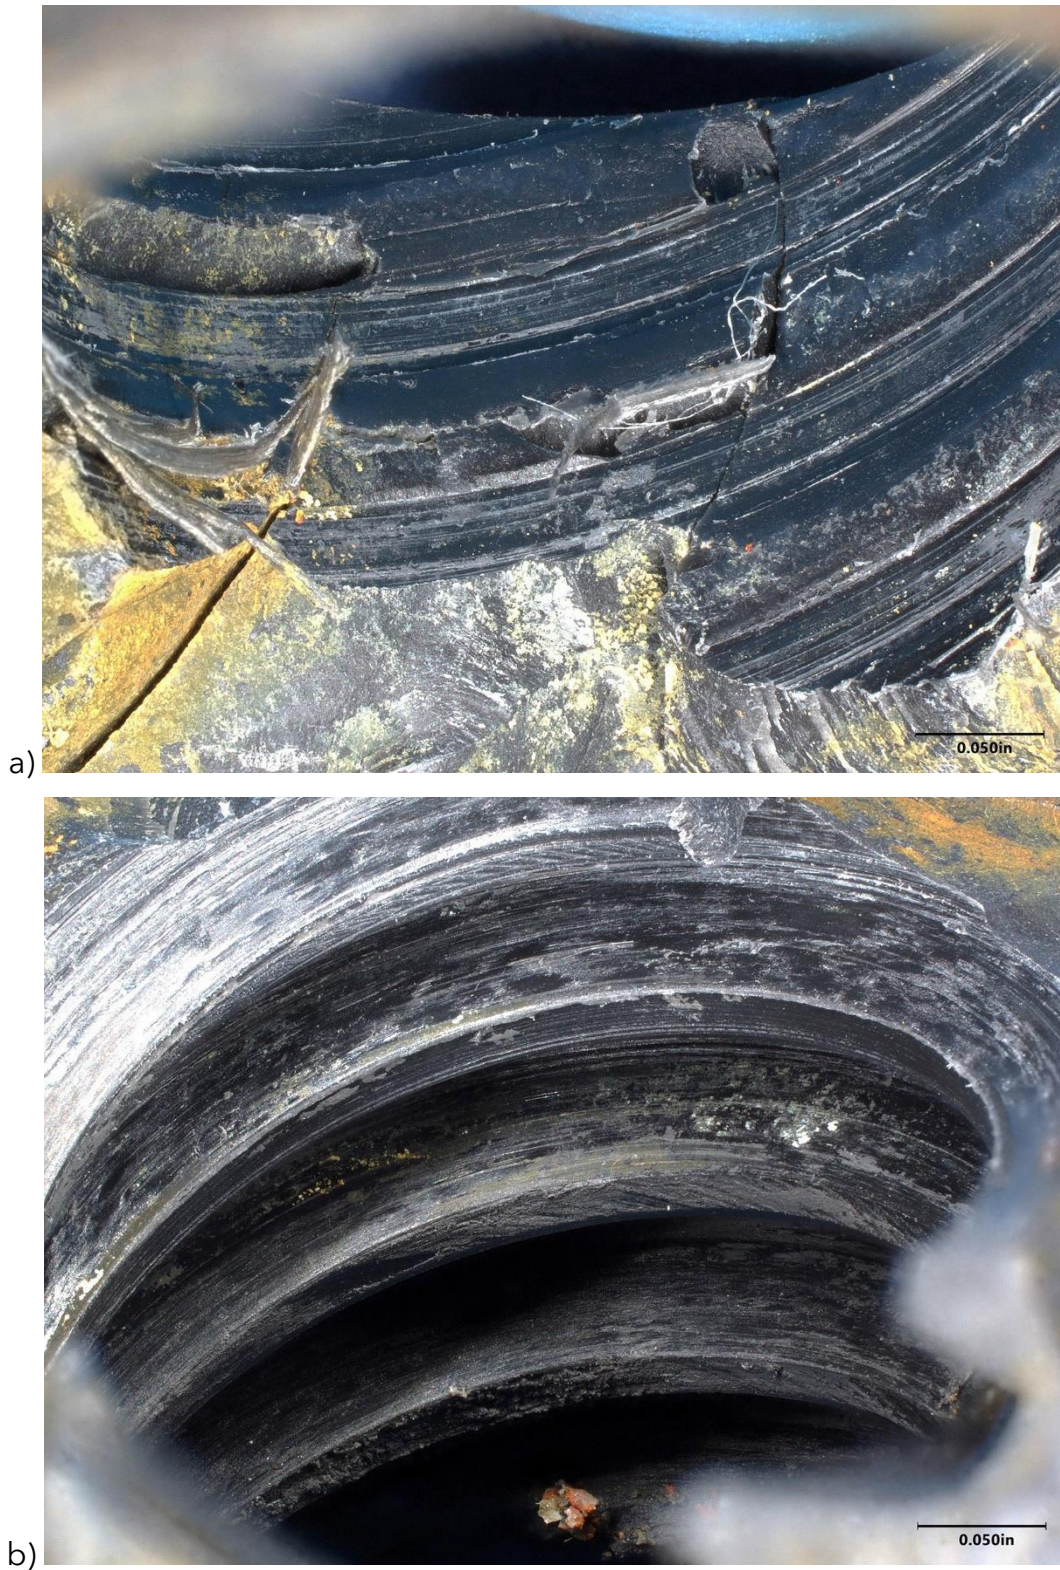
The threads on the large-diameter portion of the nut exhibited a stripped appearance, as shown in figure 8a. By contrast, the threads on the small-diameter portion of the nut did not, as shown in figure 8b. The attachment screw that secured the retaining washer to the end of the jack screw had fractured, as shown in figure 9. The fracture exhibited a rough appearance with a slanted fracture surface, consistent with a tensile overstress fracture.

**Figure 8.** Images of the jack nut threads; a) stripped threads in the large-diameter portion with the locking slots and b) intact threads on the smooth-barrel small-diameter portion.

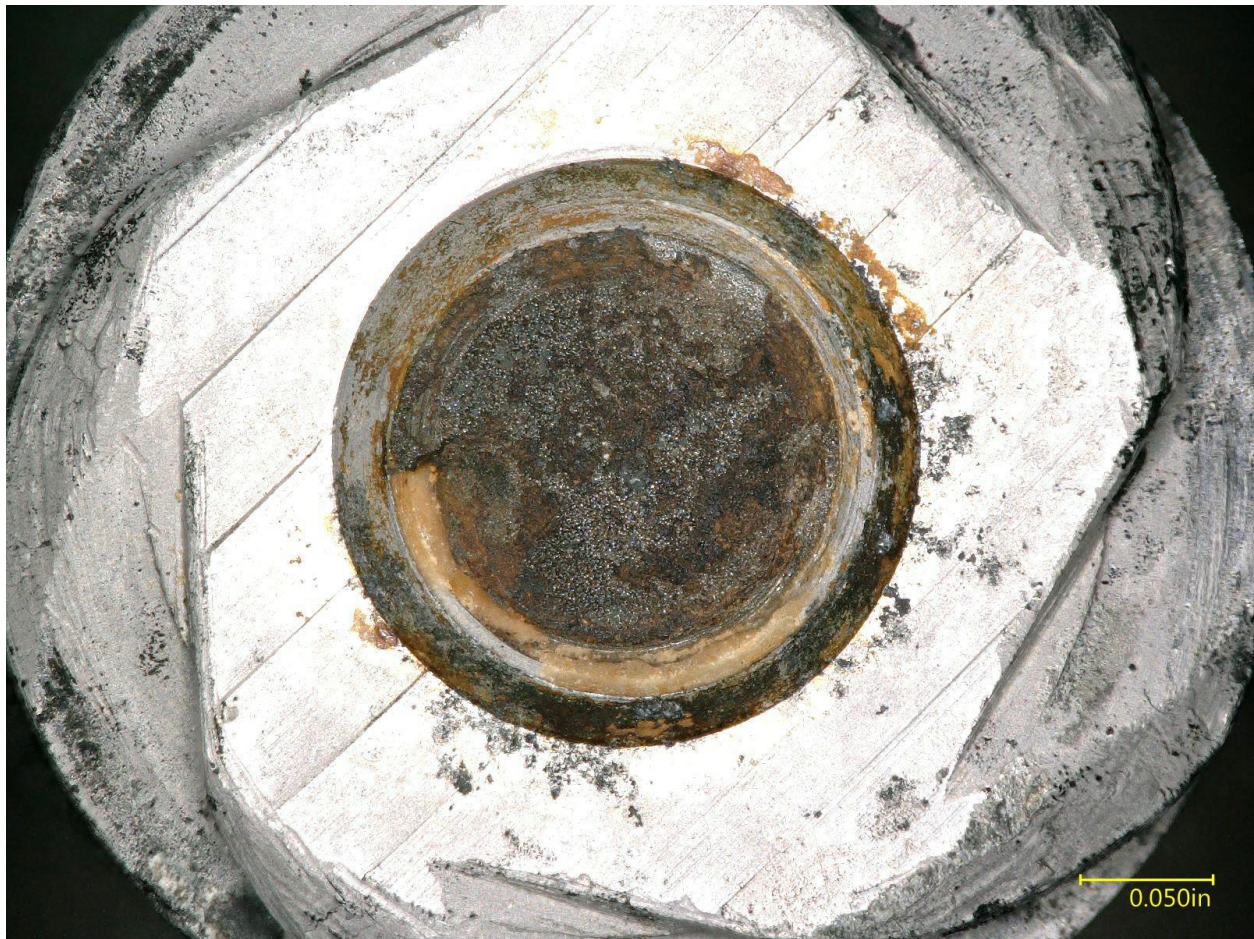
**Figure 9.** Image of the fractured attachment screw used to secure the stop washer to the end of the jack screw. The fracture had a rough appearance and a conical profile, consistent with an overstress fracture.
