# National Transportation Safety Board

DCA21FA174

## **FLIGHT DATA RECORDER**

Location: Honolulu, Hawaii  
Date: July 2, 2021  
Time: 0145 Hawaii standard time (HST)  
1145 coordinated universal time (UTC)  
Airplane: Boeing 737-200, N810TA, Rhoades Aviation Inc, dba TransAir Flight 810

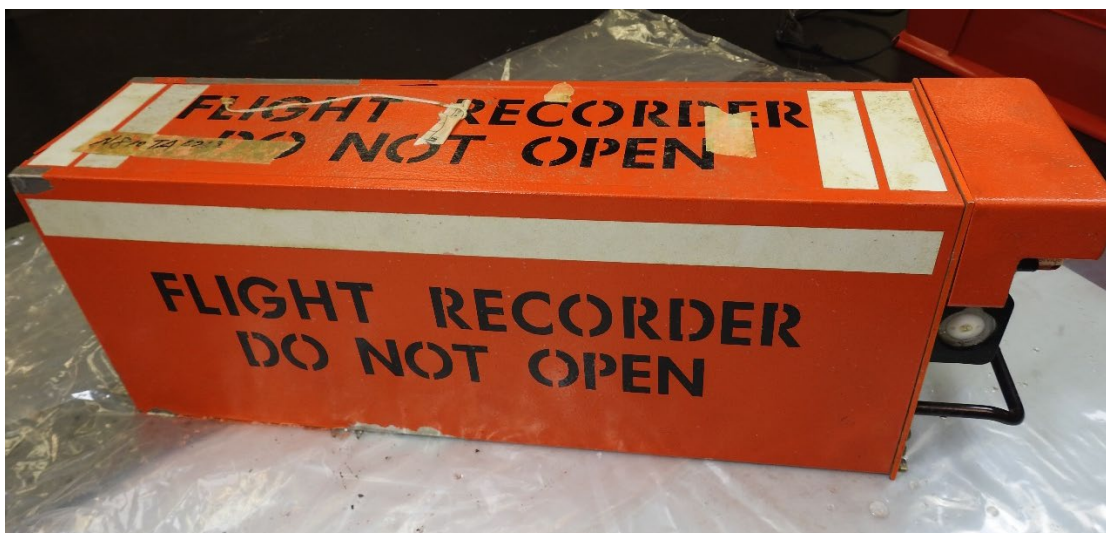
The recorder was recovered from the wreckage at a depth of 350-450 feet after about 4 months. The recorder was immediately rinsed and repacked with fresh water and arrived at the NTSB's vehicle recorder laboratory in a cooler filled with fresh water. The recorder after removal from the water is shown in figure 1. The memory module was removed from the recorder, as shown in figure 2. As seen in figure 3, the red rubberized RTV sealant surrounding the module was found to be defective in several places due to the way the sealant was applied and cured at the time of manufacture. The RTV was thin and cracked along one edge and had never fully sealed around the connector end of the boards. The RTV is designed to protect the boards from water damage and corrosion and should fully envelop the entire circuit board assembly with a uniform thickness of sealant. This defect allowed a path for sea water to flood the circuit boards as the recorder sank with the aircraft wreckage.

**Figure 1.** Exterior of flight data recorder after removal from water.

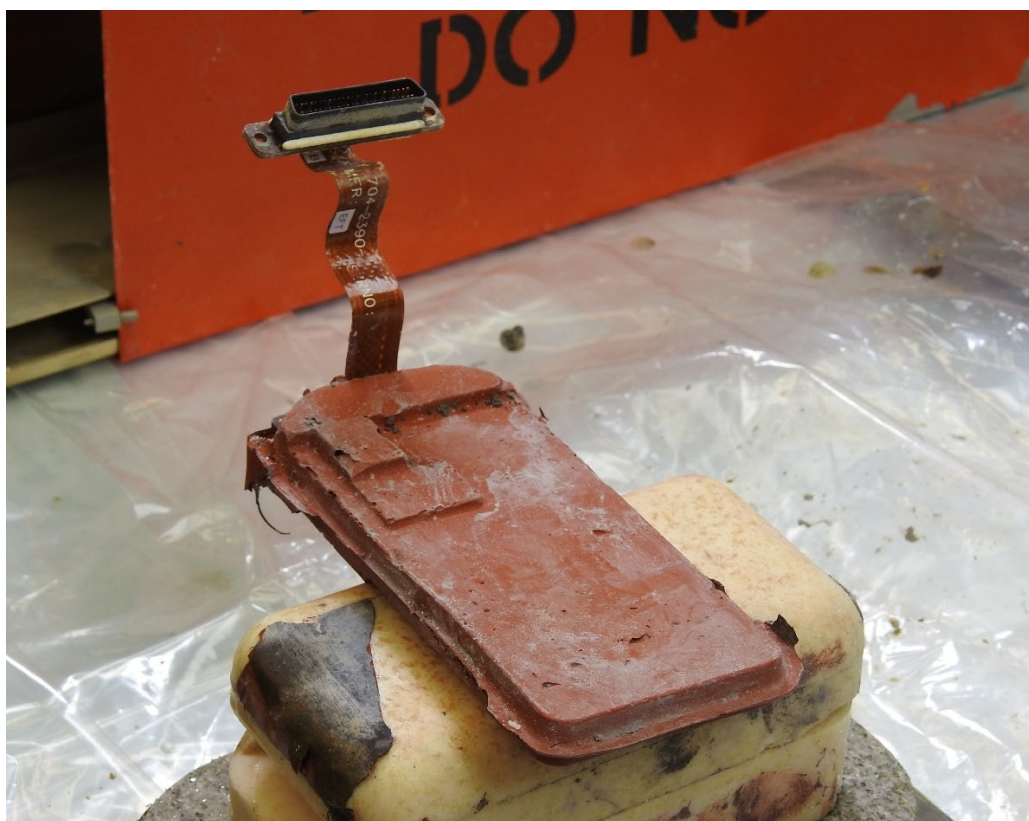
**Figure 2.** Memory module removed from the recorder.

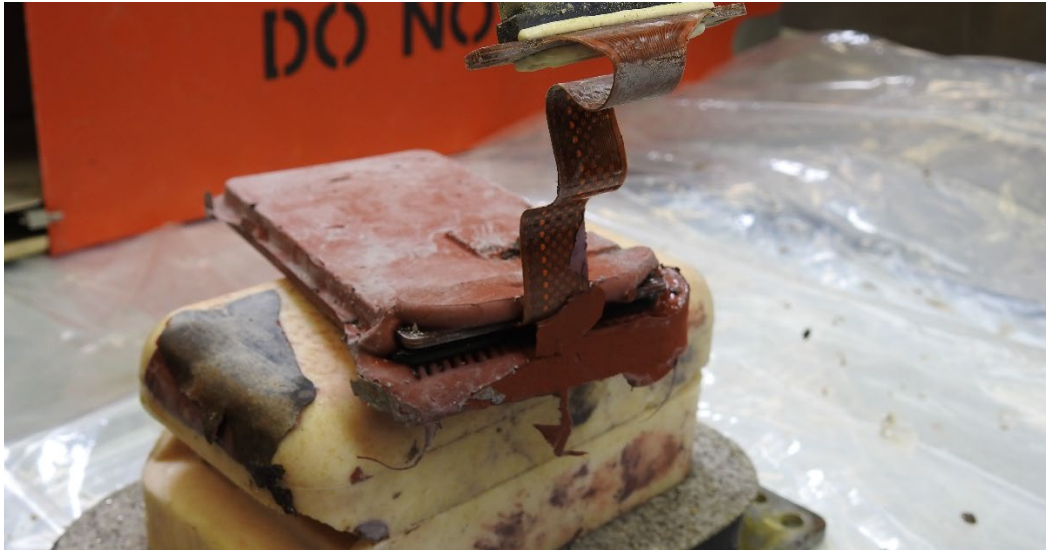
**Figure 3.** Memory module showing defective RTV sealant around the connector end of the board.

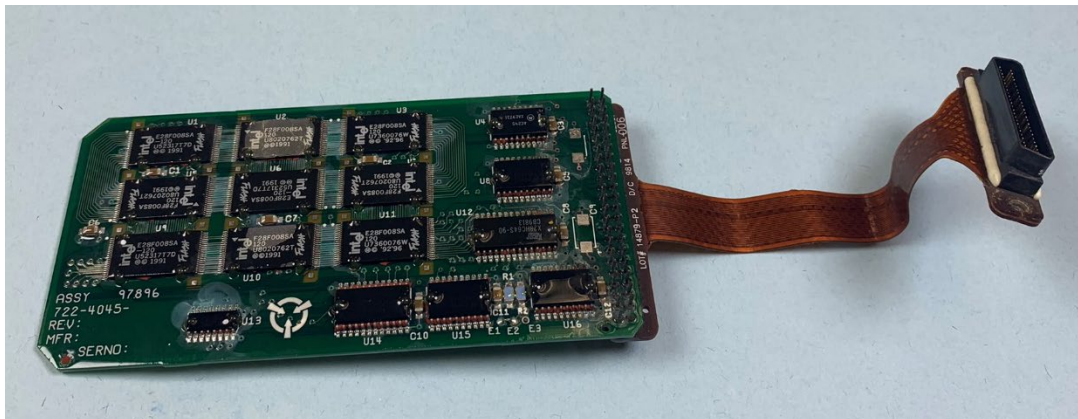
The memory module's red rubberized RTV was peeled back for cleaning, drying, and inspection. Figure 4 shows the cleaned circuit board. Some spots in the board conformal coating were compromised and had become hazy, but microscopic inspection found no evidence of corrosion in any of the leads, connections, or solder pads.

**Figure 4.** Memory module after cleaning, drying, and cable replacement.

A new ribbon cable was attached to the memory module and the memory module was downloaded using NTSB's equipment and the recorder manufacturer's software.

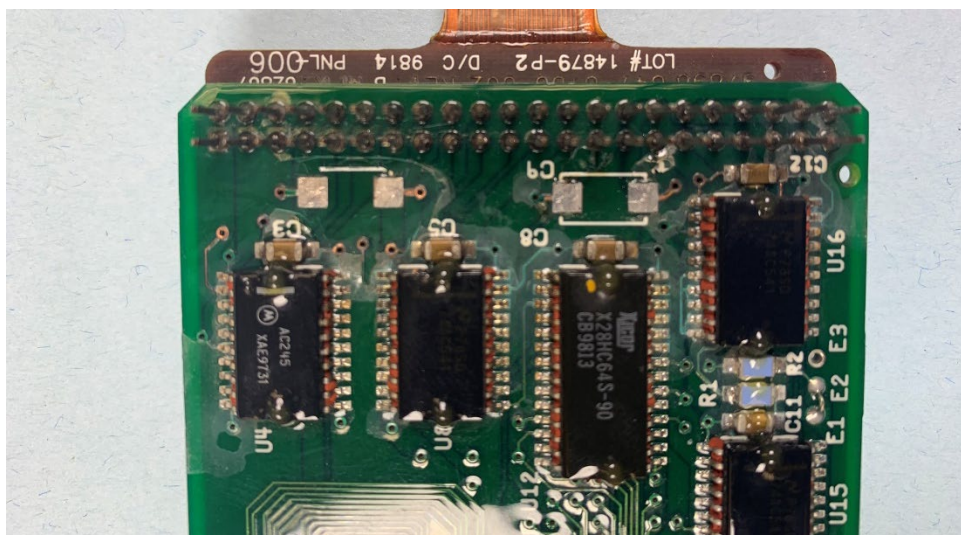
Two capacitors near the connector were found to be damaged, likely from extended contact with sea water. These capacitors were included on the board for the purpose of power conditioning and preventing "dirty" transient power effects from reaching the electronics. In a lab environment with a known good power supply this power conditioning effect is unnecessary, so these two capacitors were removed from the board with no ill effects to the recovery of data. Figure 5 shows a detail view of the area around the removed capacitors.

**Figure 5.** Detail view of area where two damaged capacitors were removed prior to readout.

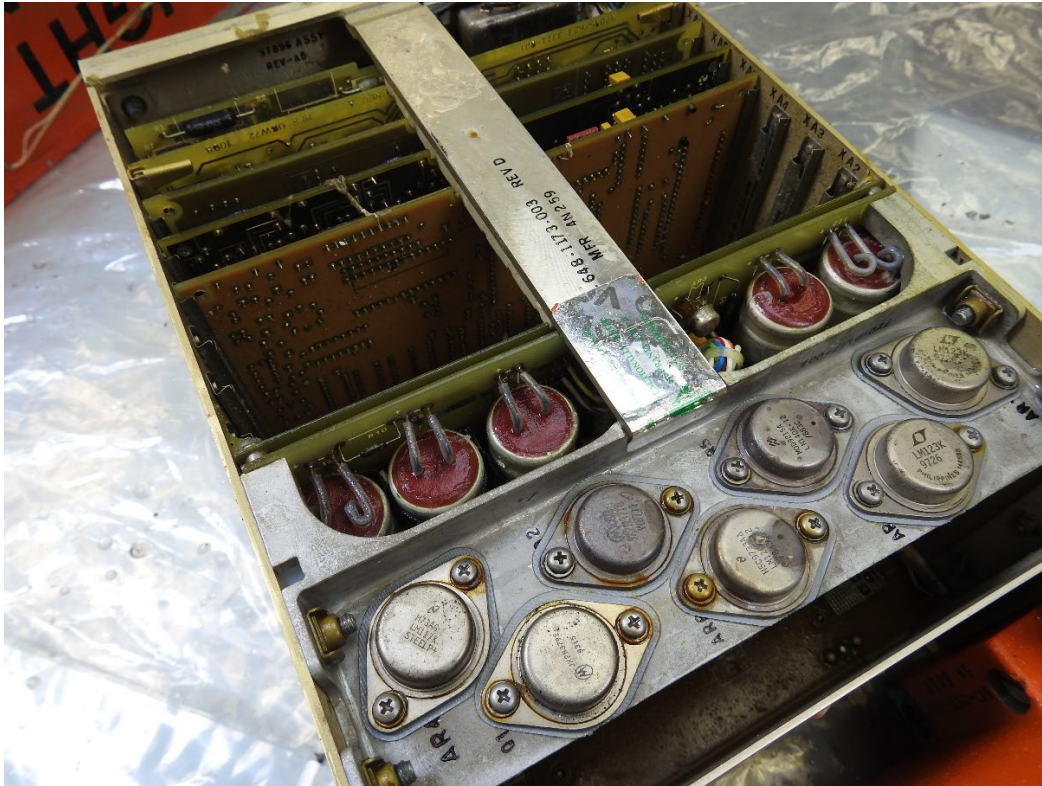
The circuitry generating the FDR's internal clock signal and data stream was removed from the recorder and inspected to look for damage that could explain the data rate issue. Figure 6 shows the processor and data acquisition portion of the recorder chassis. Each individual board making up the main processing and data acquisition functions was removed and visually inspected. One board, A7, which is a data acquisition and multiplexing board aiding in processing some parameters, was found to have burn or scorch marks on the connector and pins, see figures 7 and 8. These marks were consistent with electrical arcing inside the connector. The burned pins were data signal pins, however it could not be determined which signals would have been affected without having access to the full aircraft wiring. It was not possible to determine if the arcing was present before the accident or was a result of the recorder entering the water, and it was also not possible to test the boards due to the corrosion present after four months in sea water.

**Figure 6.** Processor and data acquisition cards inside FDR.

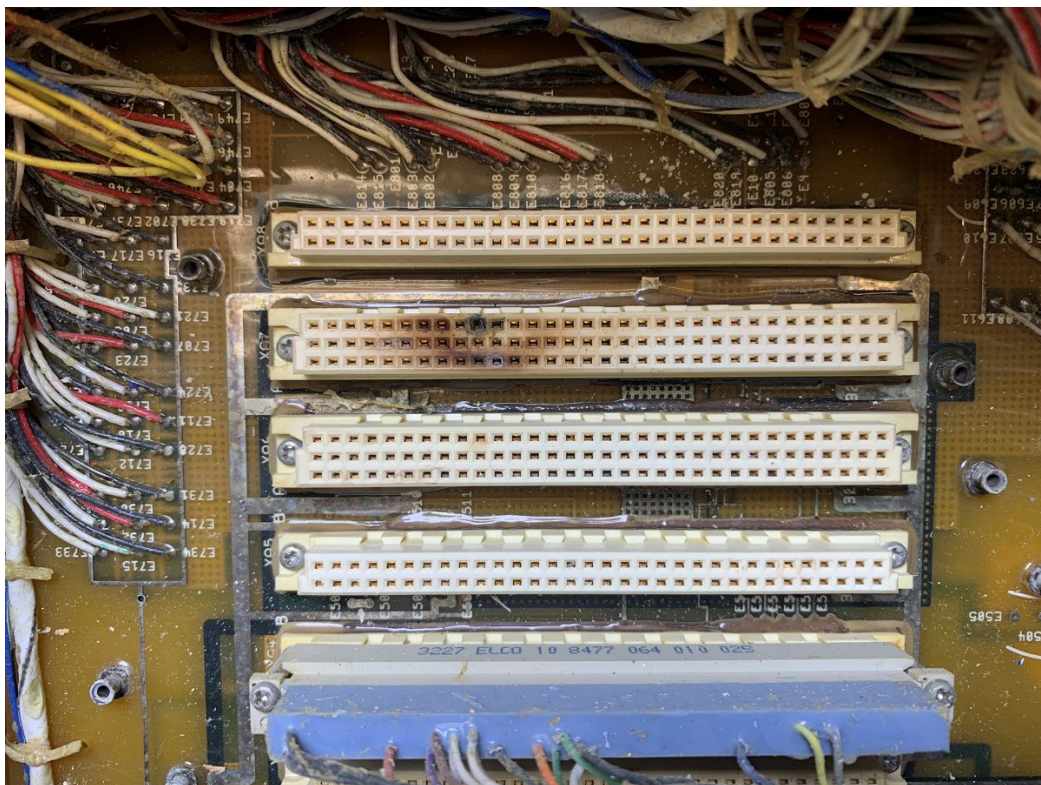
**Figure 7.** Processor and data acquisition card connectors in FDR chassis.

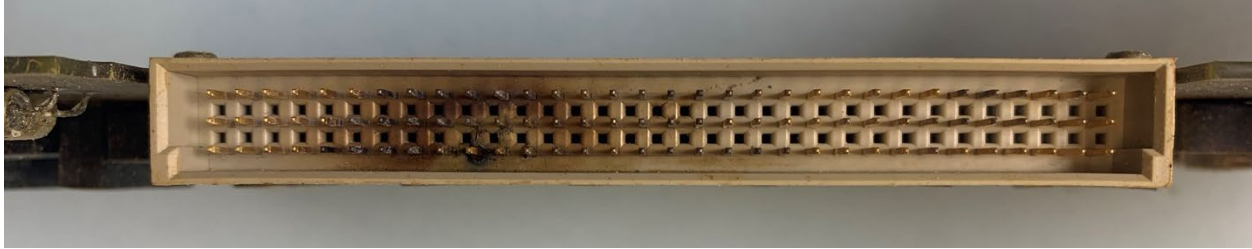
**Figure 8.** Connector pins on data acquisition card A7.

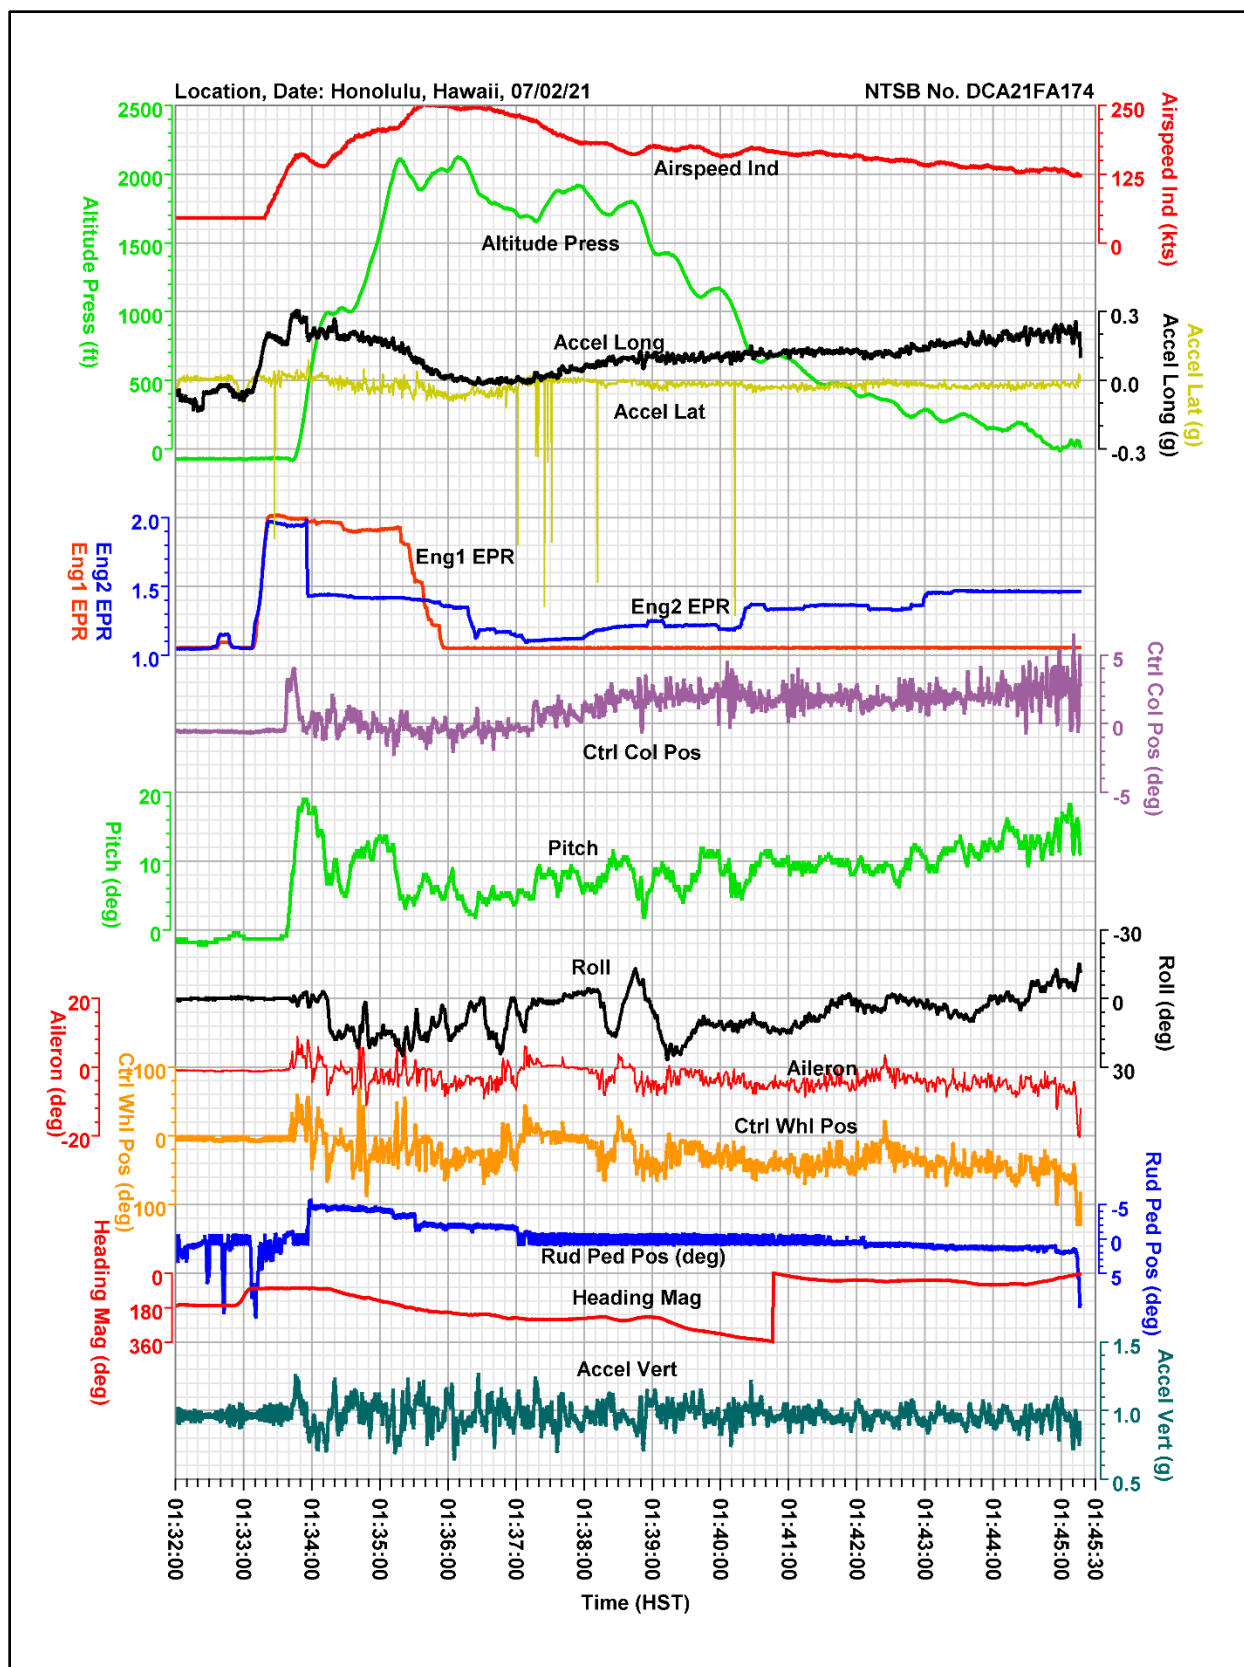
Figure 9 shows the valid parameters recorded by the FDR from 01:32:00 HST to 01:45:30 HST. This starts with the aircraft prior to turning on to the runway and ends when the aircraft ditches in the ocean.

As the aircraft passed through about 390 ft at 155 knots, engine 2 EPR suddenly dropped to 1.43, while engine 1 remained at its previously set takeoff power. Immediately after engine 2 EPR dropped, the rudder pedal moved to about 5.5 degrees of left rudder, consistent with a command to counteract the adverse yaw of losing thrust on the right engine. The climb paused at 1,000 feet for 25 seconds, then continued to 2,000 ft.

At 2,000 feet, engine 1 EPR reduced to a value of 1.051, which is consistent with idle power in previous flights. It stayed at this value for the remainder of the flight.

Engine 2 EPR also reduced at 2,000 feet, however it continued to be advanced and reduced several times until the end of the flight.

Altitude and airspeed decreased over the next 9 minutes until the end of the recording. At the end of the recording, engine 2 EPR was 1.462 and engine 1 EPR, having been stable since it reduced at 2,000 feet, was still consistent with previous flight idle settings at 1.052.

**Figure 9.** Plot of FDR data from the entire flight.

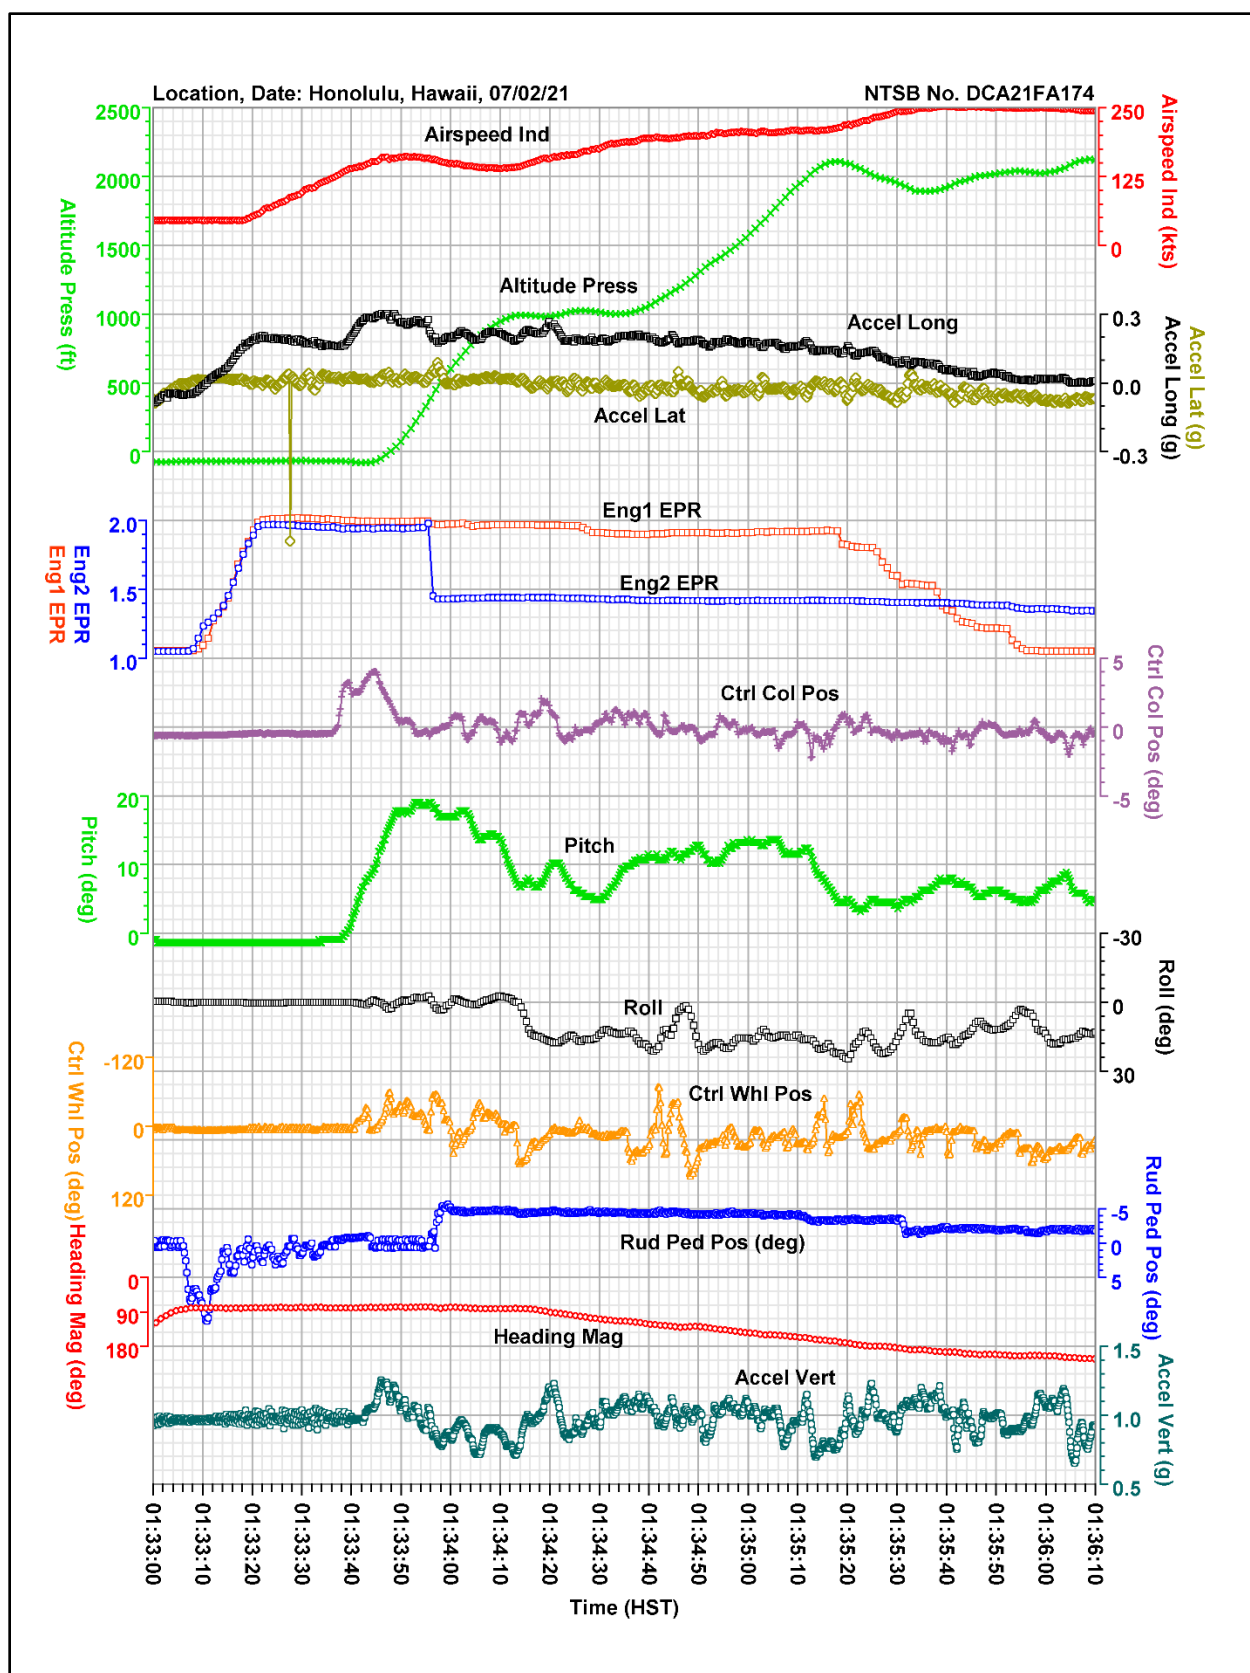
Figure 10 shows FDR data from 01:33:00 HST to 01:36:10 HST. This provides greater detail of the takeoff sequence and engine failure than figure 9.

In the accident flight, the engines were advanced to takeoff power starting at 01:33:08 HST, and both stabilized at an EPR consistent with takeoff. Engine 1 (the left engine) was at 2.00 EPR and engine 2 (the right engine) was at 1.97 EPR. Longitudinal acceleration peaked at 0.2055 g during the takeoff roll. The aircraft rotated at about 140 knots and took off on a heading of 80 degrees.

**Figure 10.** Plot of FDR data from the takeoff portion of the flight.
