## **NATIONAL TRANSPORTATION SAFETY BOARD**

### **Group Chairman's Factual Report**

# **SYSTEMS**

DCA21FA174

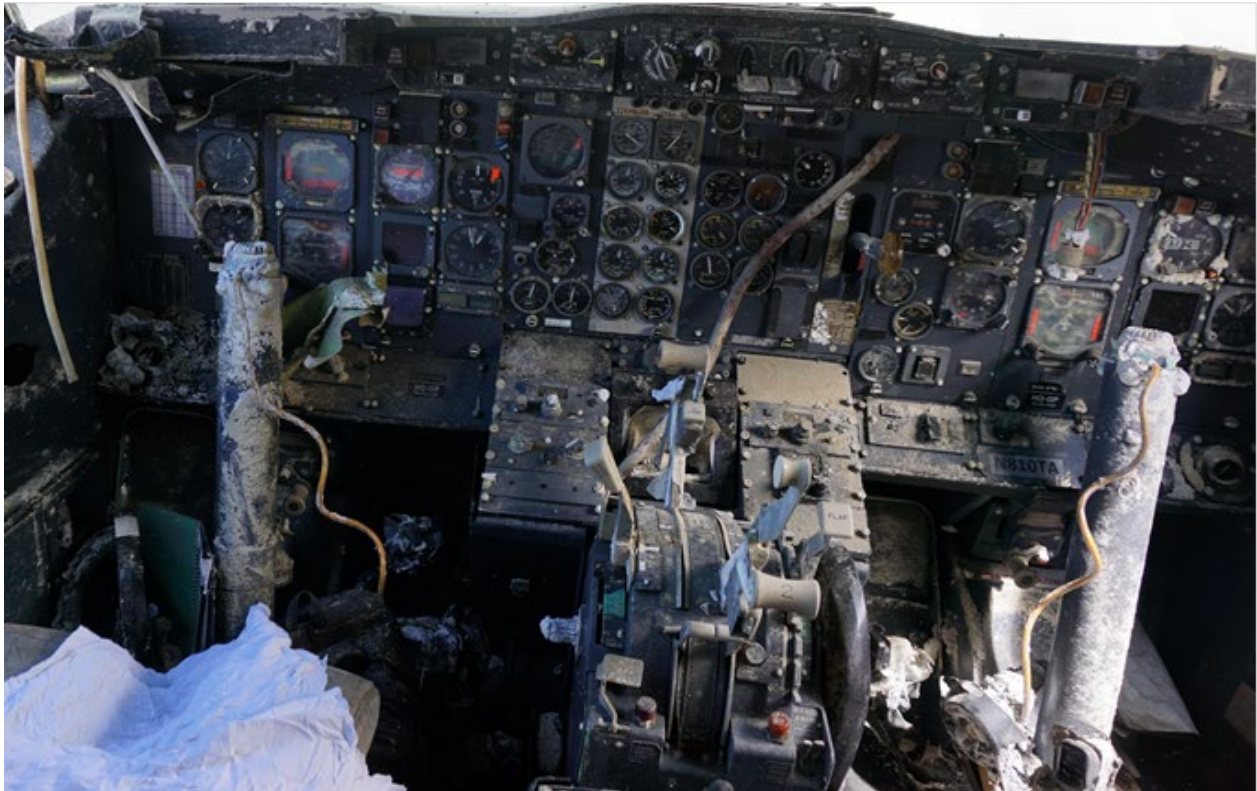
The cockpit appeared to be intact structurally with both pilots' seats firmly attached to the floor (see Figure 1). The control columns were heavily corroded and both control wheels had detached and were laying on the floor adjacent to the columns with very heavy corrosion on the column gearing. Both left and right sliding windows were fully open. The entire cockpit had a coating of corrosion or salt water organic residue evident on every hard surface. Many of the instruments had glass lens breakage or crazing and were difficult to read. The instrument indications and switch positions were as noted below.

**Figure 1.** Overall View of Cockpit Main Instrument Panel

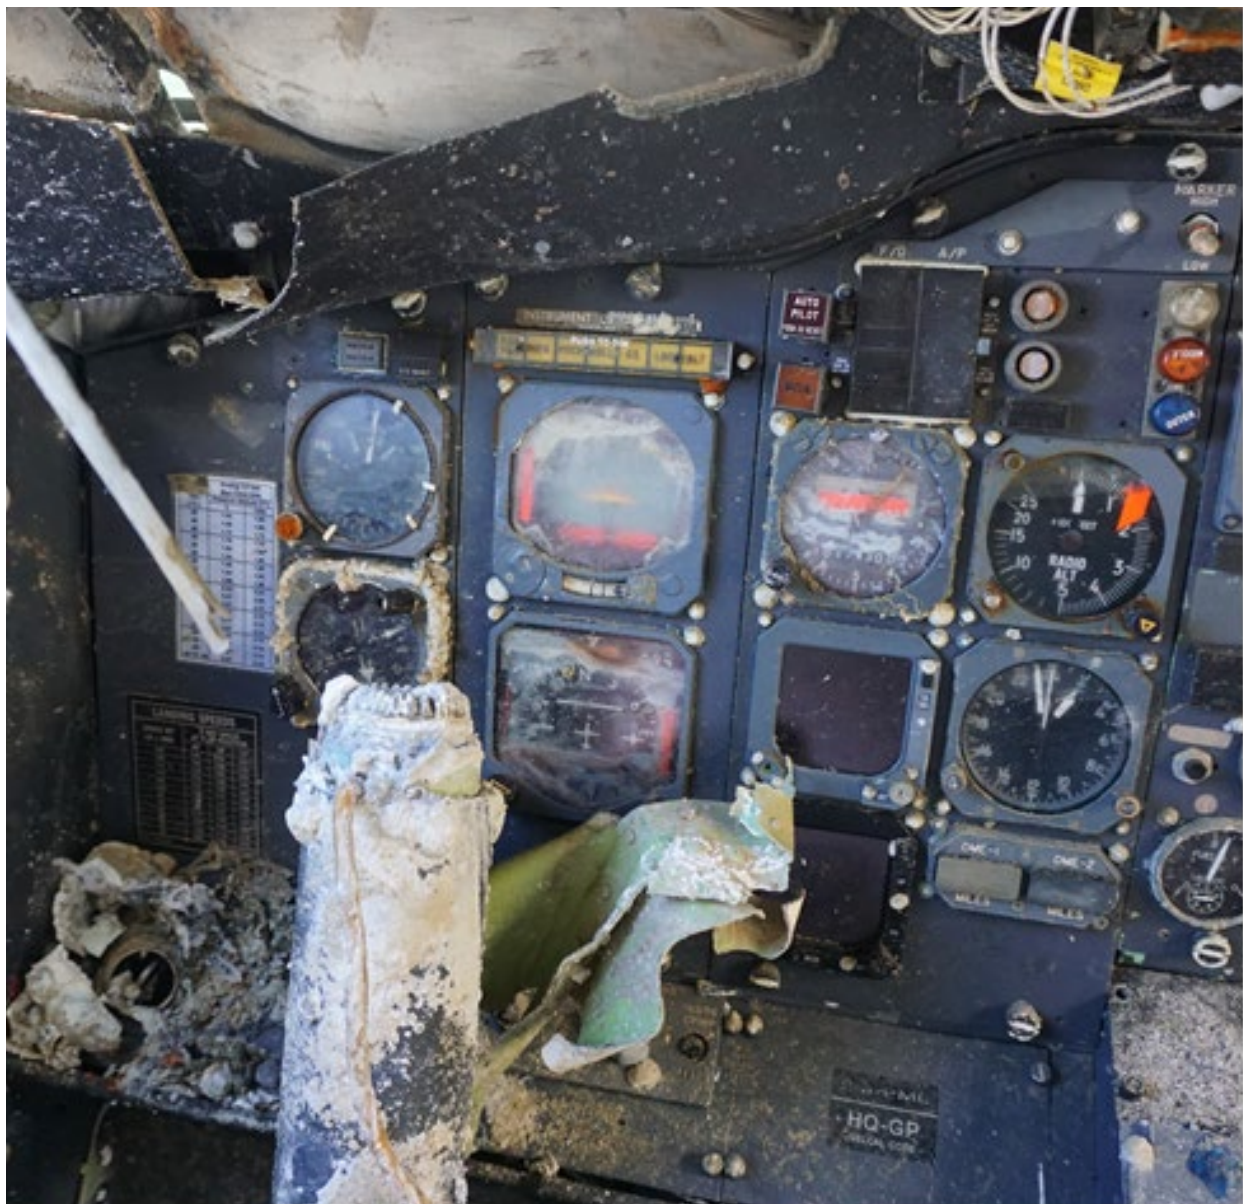
- Airspeed Indicator and speed bugs. 4 movable bugs present and located at:
  - bug 1- 76 kts,
  - bug 2 -128kts,
  - bug 3 -146kts,
  - bug 4 - 225kts
- Radio Magnetic Indicator (RMI)
  - Very High Frequency Omni-Directional Range 1 (VOR 1) pointer parked at 2 o'clock.
  - VOR 2 pointer parked at 5 o'clock.
  - Compass card shown at northerly and actual position obscured by corrosion/sea life contamination
- Instrument (Inst) comparator - intact
- Captain's Attitude Director Indicator (ADI)
  - Not erect and Bendix style (flying Vee) integrated turn ball
- Captain's Horizontal Situation Indicator (HSI)
  - Fail flag in view, selected heading 345, actual heading near zero obscured visibility due to water damage
- Background Light - 11 o'clock position
- Map light - 1130 o'clock position on gusset
- Main Panel Brightness - 2 o'clock position

- Approach Progress Display (APD)–intact and not illuminated
- Marker Beacon lights - intact with all 3 present
- Altimeter - Flagged
  - Baroset - 1017/3004
- Instantaneous Vertical Speed Indicator (IVSI) - Aftermarket unit with Traffic Advisory (TA) switch
- Distance Measuring Equipment (DME) - Present
- Radio altitude - Flagged
- Clock - 01:58
- 2 photo electric cells next to APD panel are intact
- Unknown display below IVSI (approx. 3 inch x 3 inch square)
- Non factory annunciators below HSI "HSI on NAV/HSI on GPS"
- Non factory annunciator "Windshear/Windshear" upper left corner of panel
- Selective Calling System (Selcal) code placard with tail "9M-PML" identified bottom of Panel
- Placard showing "N810TA" on lower center instrument panel

**Figure 2.** Captain's Instrument Panel

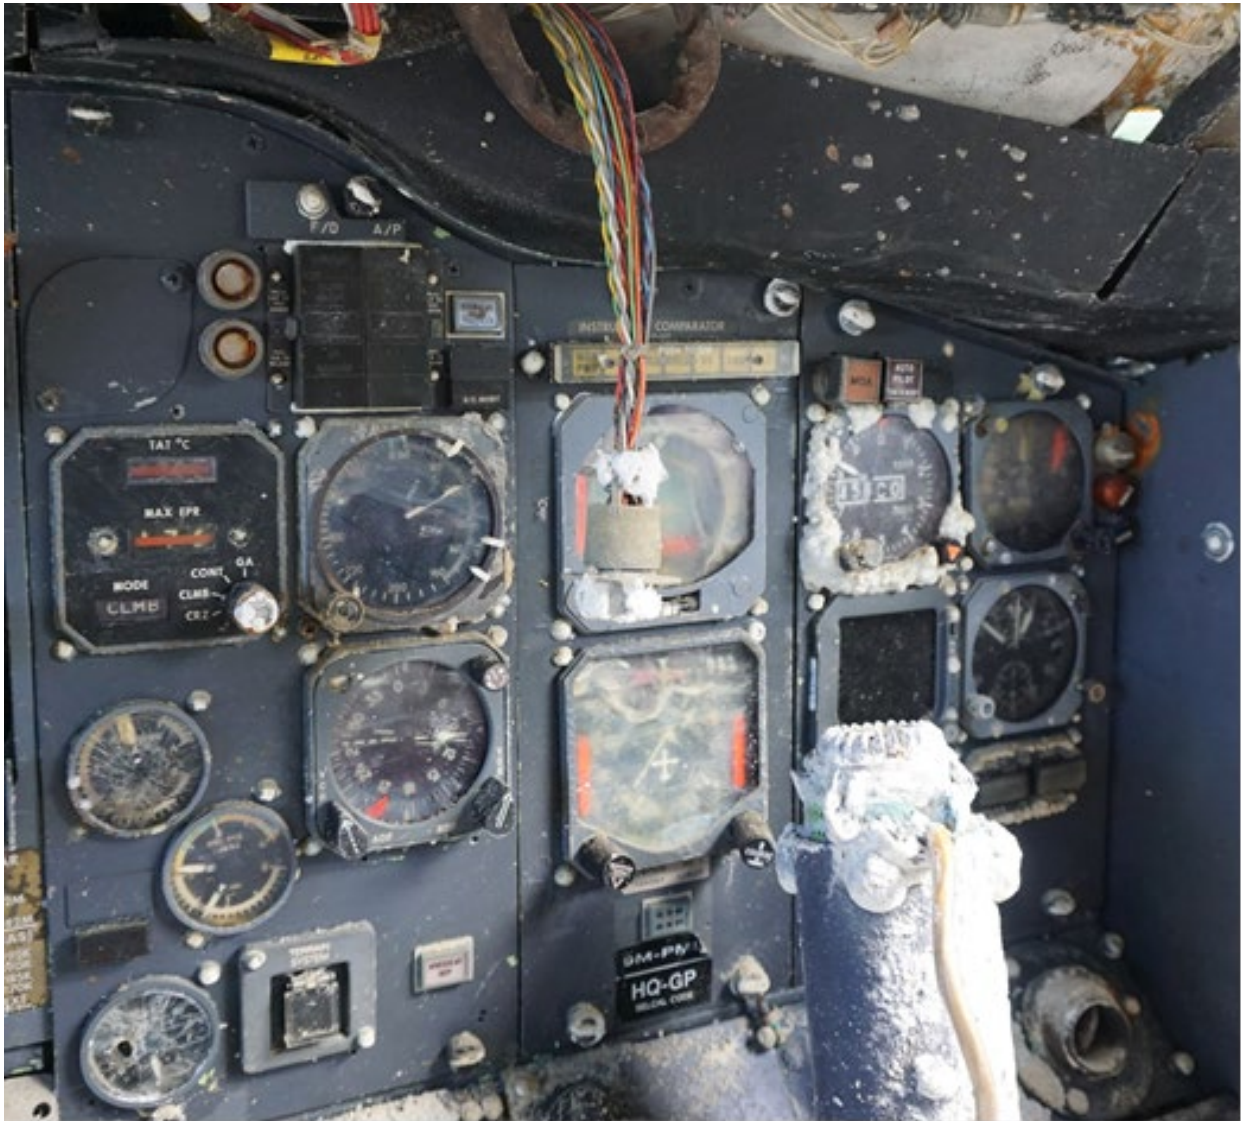
**Figure 3.** First Officer's Instrument Panel

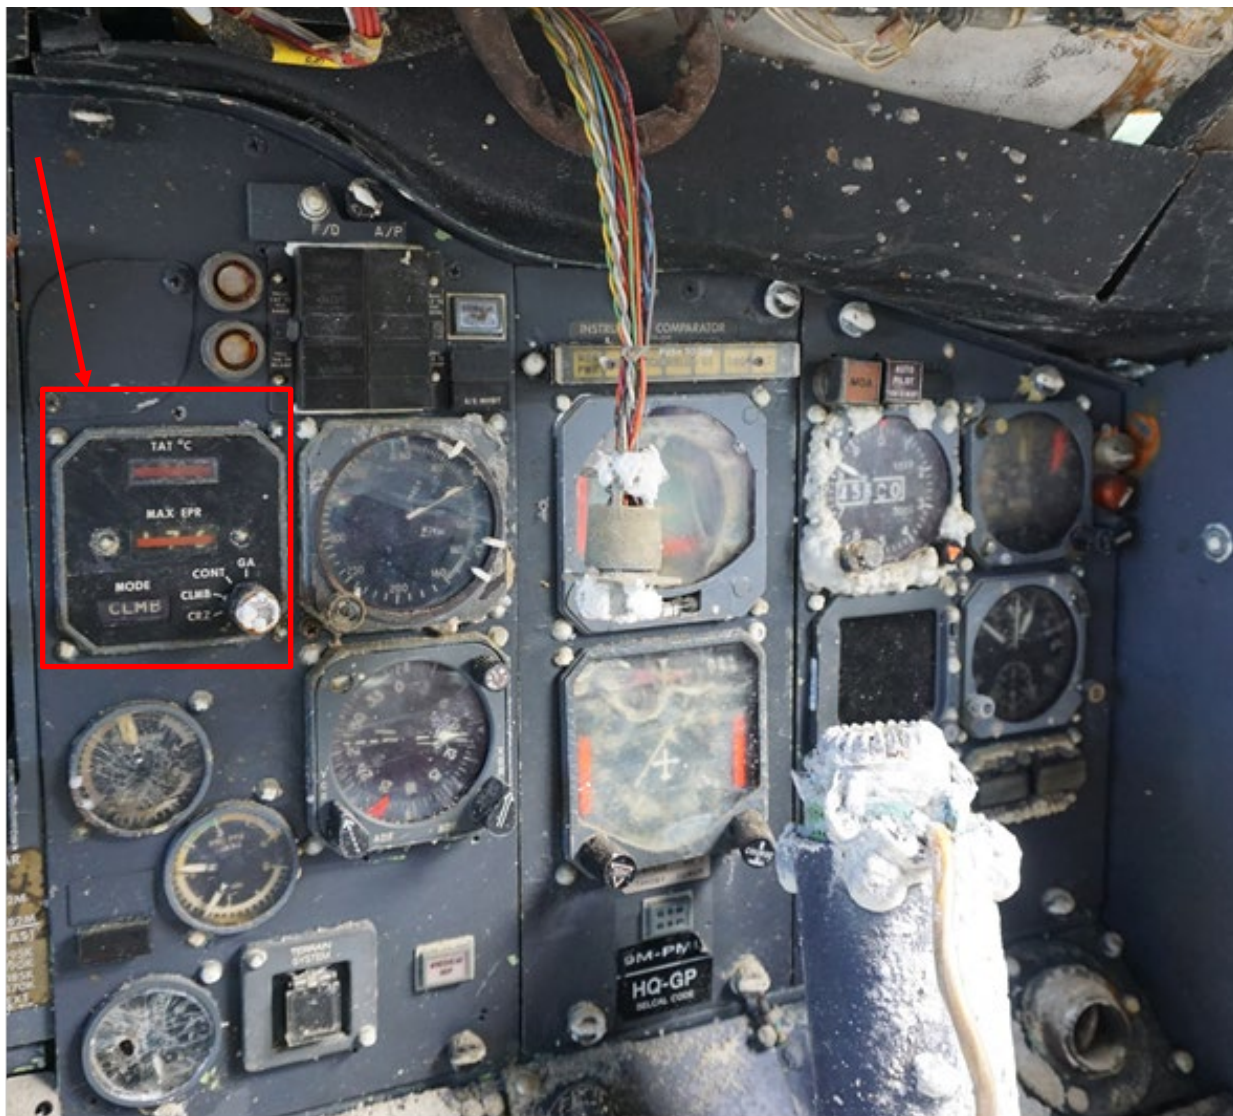
- Total Air Temperature (TAT) Indicator (on Thrust Rating Panel)
- Thrust Panel
  - Climb mode selected and shown
  - Max Engine Pressure Ratio (EPR) 1.76 behind flag (see Figure 4)

**Figure 4.** First Officer's Instrument Panel with Thrust Panel Noted by Arrow and Box

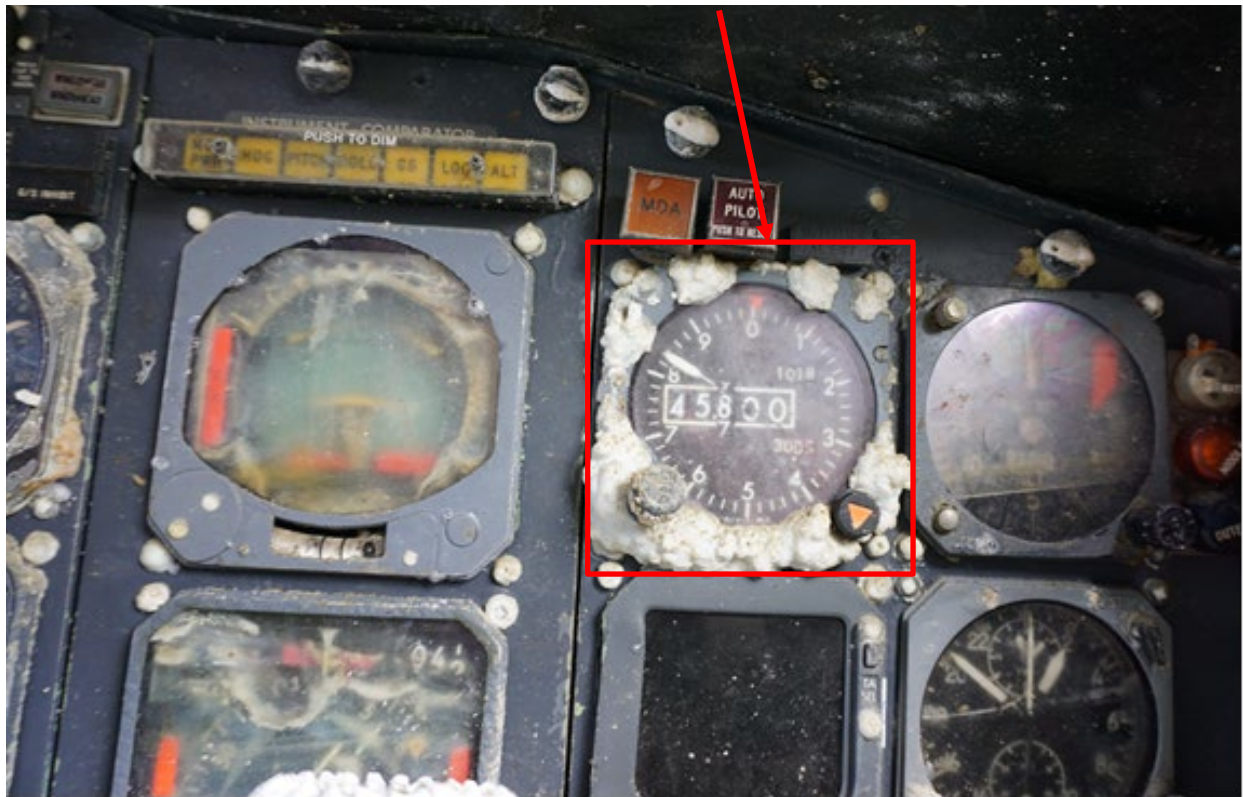
- Main Panel Brightness - 12 o'clock position
- APD - intact
- Marker Beacon lights - intact with all 3 present
- Altimeter - not flagged reading 45,800 (see Figure 5)

**Figure 5.** First Officer's Altimeter Noted by Arrow and Box

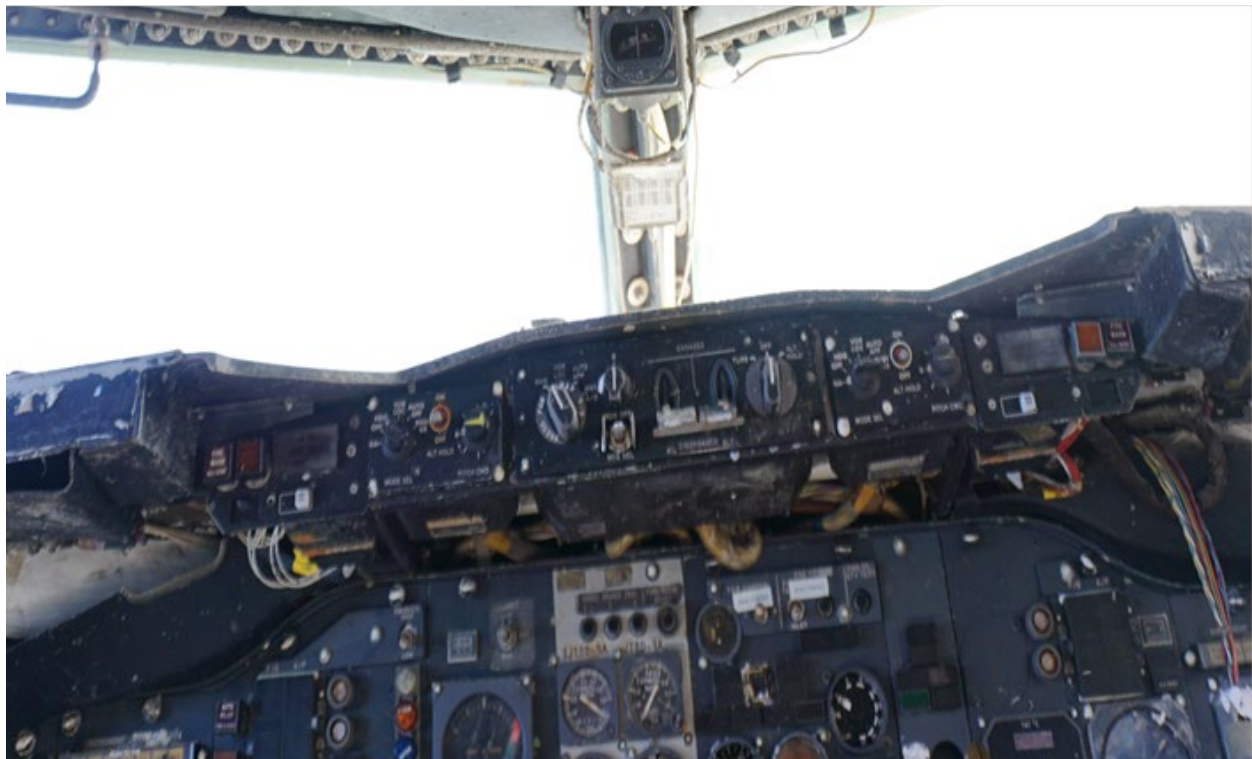
- Both Master Caution and Fire Warning annunciators in place
- Six pack lights
  - Captain's - intact-
  - FO's - intact
- Autopilot Control Panel
  - Manual/B/Heading (Man/B/Hdg) OFF (switch centered and is spring loaded)
  - Autopilot (AP) engage OFF/OFF
  - Pitch mode OFF
- Non Factory Navigation/Global Positioning System (NAV/GPS) switch under both six packs
- Captain's Flight Director Mode Panel:
  - Mode select OFF
  - Altitude Hold- OFF
  - Pitch control "0"
- FO's Flight Director Mode Select Panel:
  - Mode select Go-Around (G/A)
  - Altitude Hold- OFF
  - Pitch control "0"

**Figure 6.** Autoflight Control Panel and Glare Shield

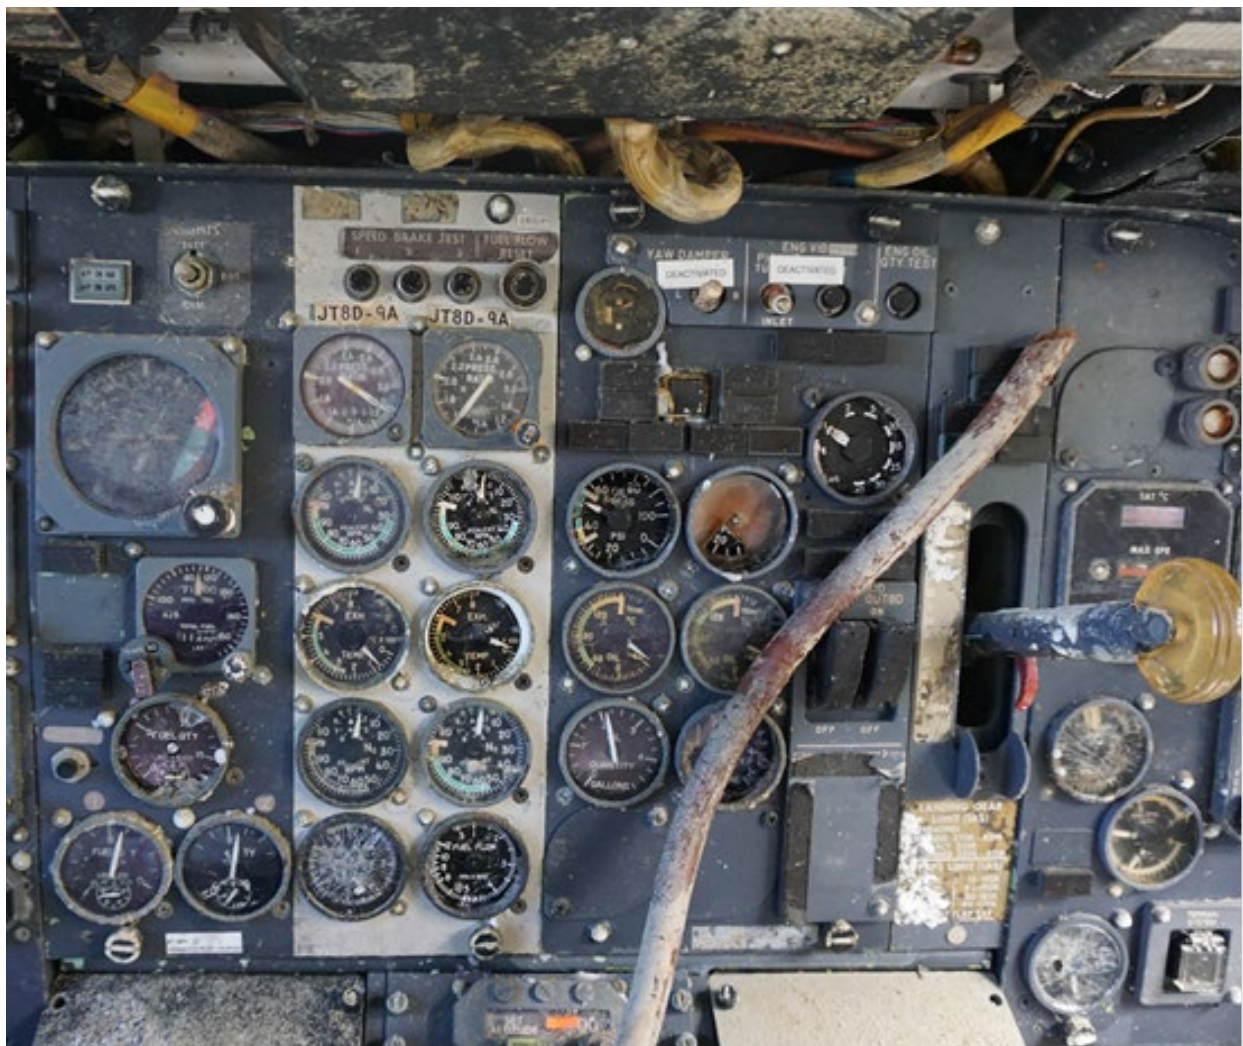
- Standby attitude - Flagged and not erected
- Yaw Indicator - biased to extreme left of center
- Fuel Quantity Totalizer: 11,350/ Zero Fuel 71,100/ Flaps 30 indicated

**Figure 7.** Center Instrument Panel

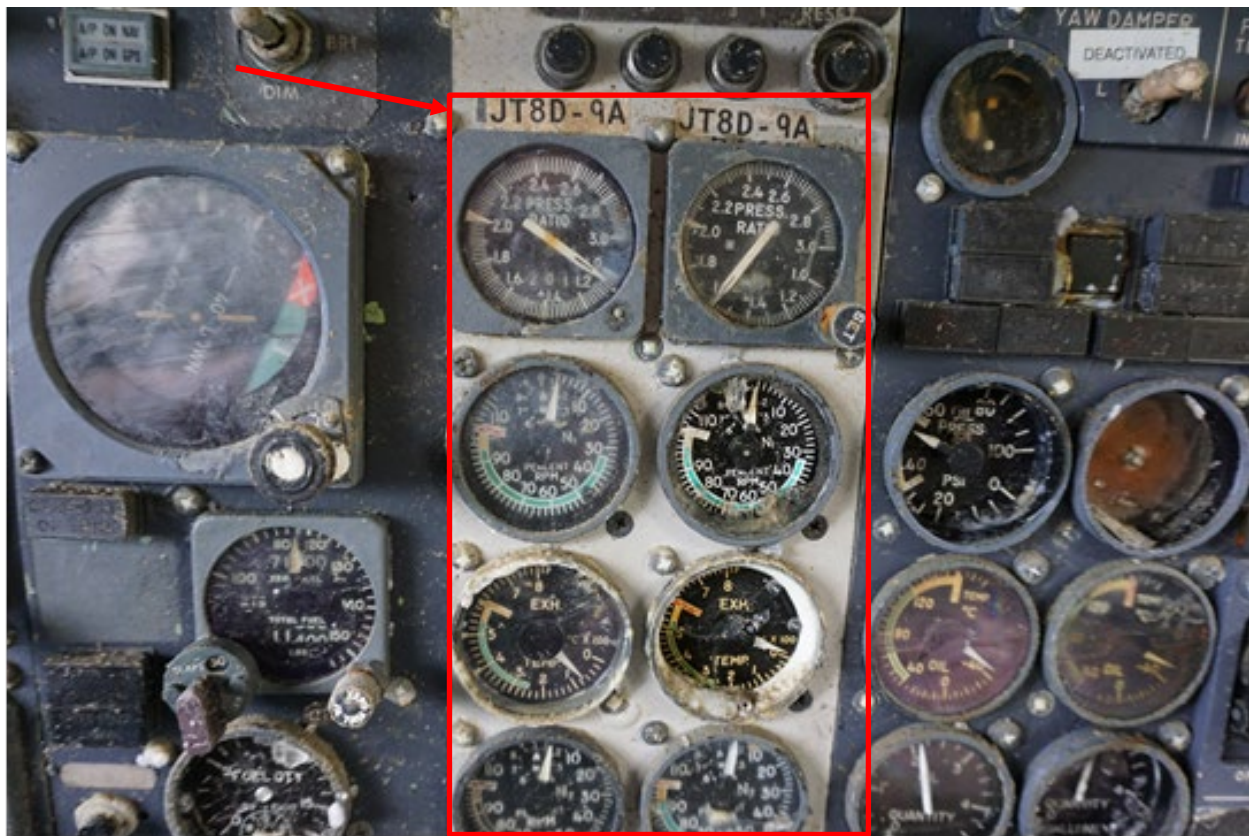
- Center Tank: Not readable ~200 LBS on small dial
- Left (L) tank 5720 Lbs / Right (R) tank 5600 Lbs
- Engine instruments: (JT8D-9A stickers) (see Figure 8)

- Engine Pressure Ratio (EPR) 1: 1.04                      EPR2: 1.6
  - EPR Set L: 2.0                                                  EPR Set R: 2.0

- N1 L: 5                                                              N1 R: 4.5
  - Exhaust Gas Temperature (EGT) L: 70                      EGT R: <0

- N2 L: 0                                                              N2 R: 0
  - Fuel Flow (FF): not readable
- Yaw Damper and Engine Vibe Test Switches marked as Deactivated

- Oil Pressure L: ~55      Oil Pressure R: Damaged and unreadable
- Oil temperature L/R: <-40
- Oil Quantity L 2.125      Oil Quantity R: 3
- Flap Indicator - L and R both at 1 deg

**Figure 8.** Engine Instruments Noted by Arrow and Box

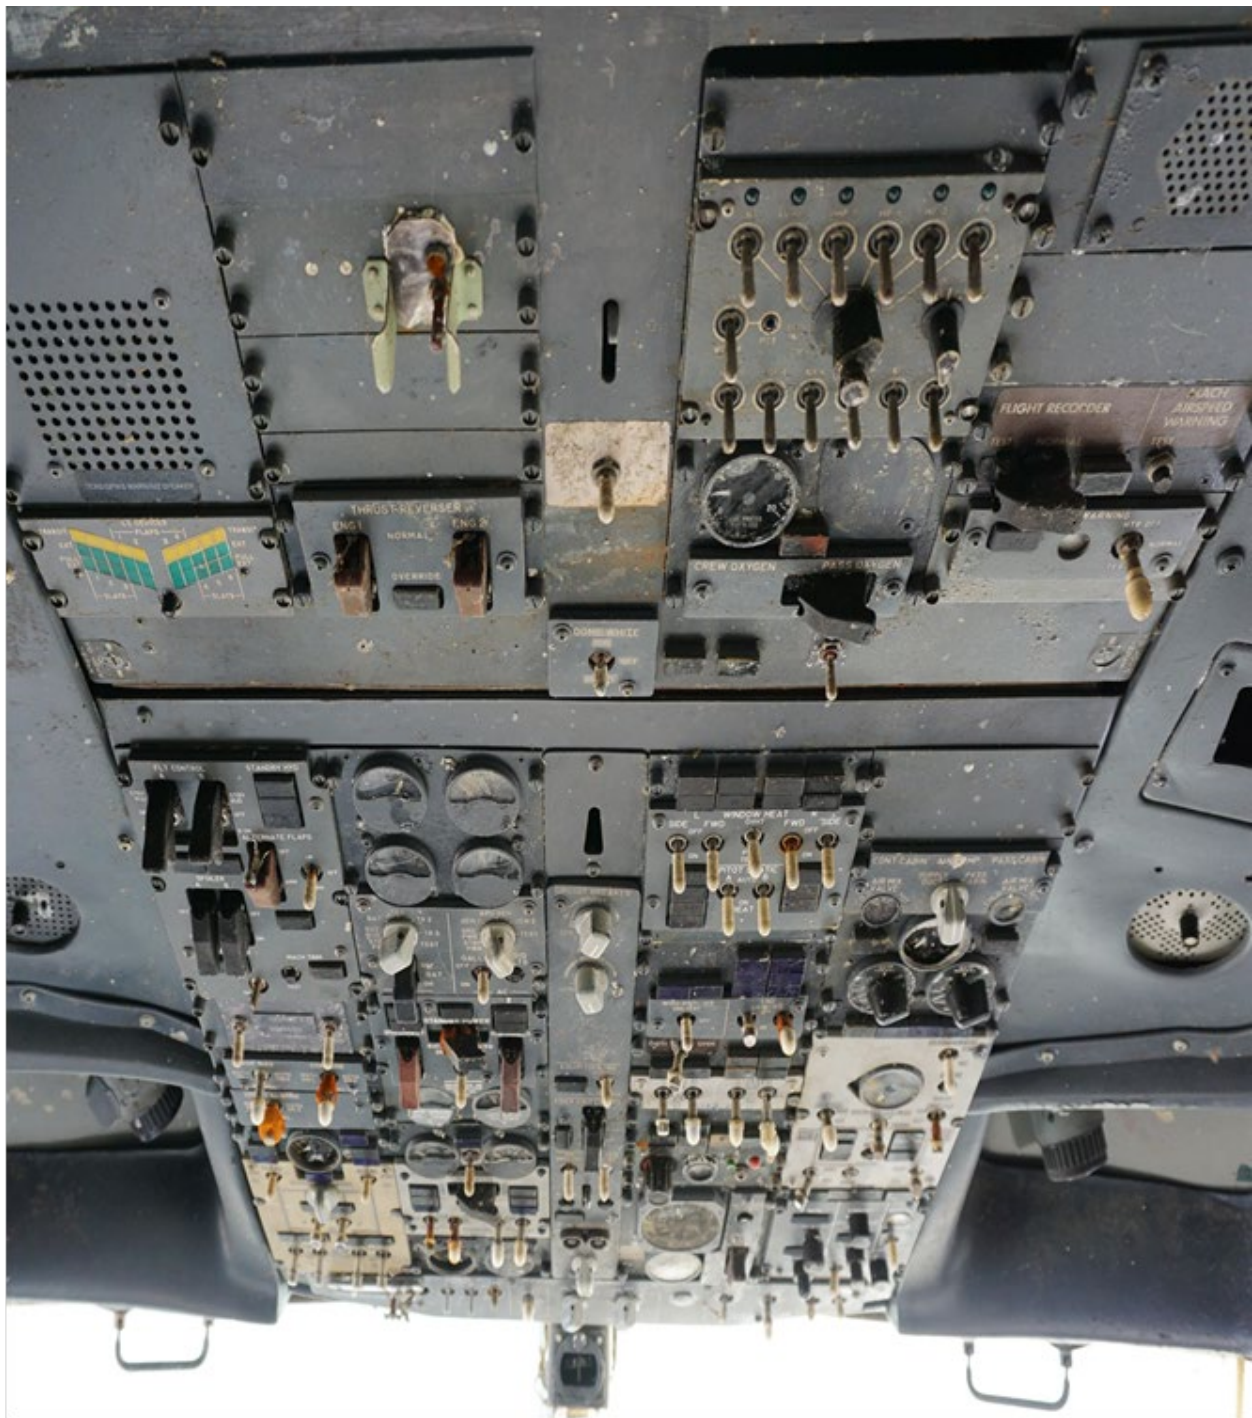
- Lights - Fixed - L - ON
- Lights - Fixed - R - ON
- Runway Turnoff - L - ON
- Runway Turnoff - R - ON
- Taxi - OFF
- Engine start - 1 - Low Ignition (IGN)
- Engine start - 2 - Low IGN
- Logo light - ON
- Position - ON
- Anti-collision - ON
- Wing - ON
- Wheel well - OFF (INOP Placard)

**Figure 9.** Overhead panel

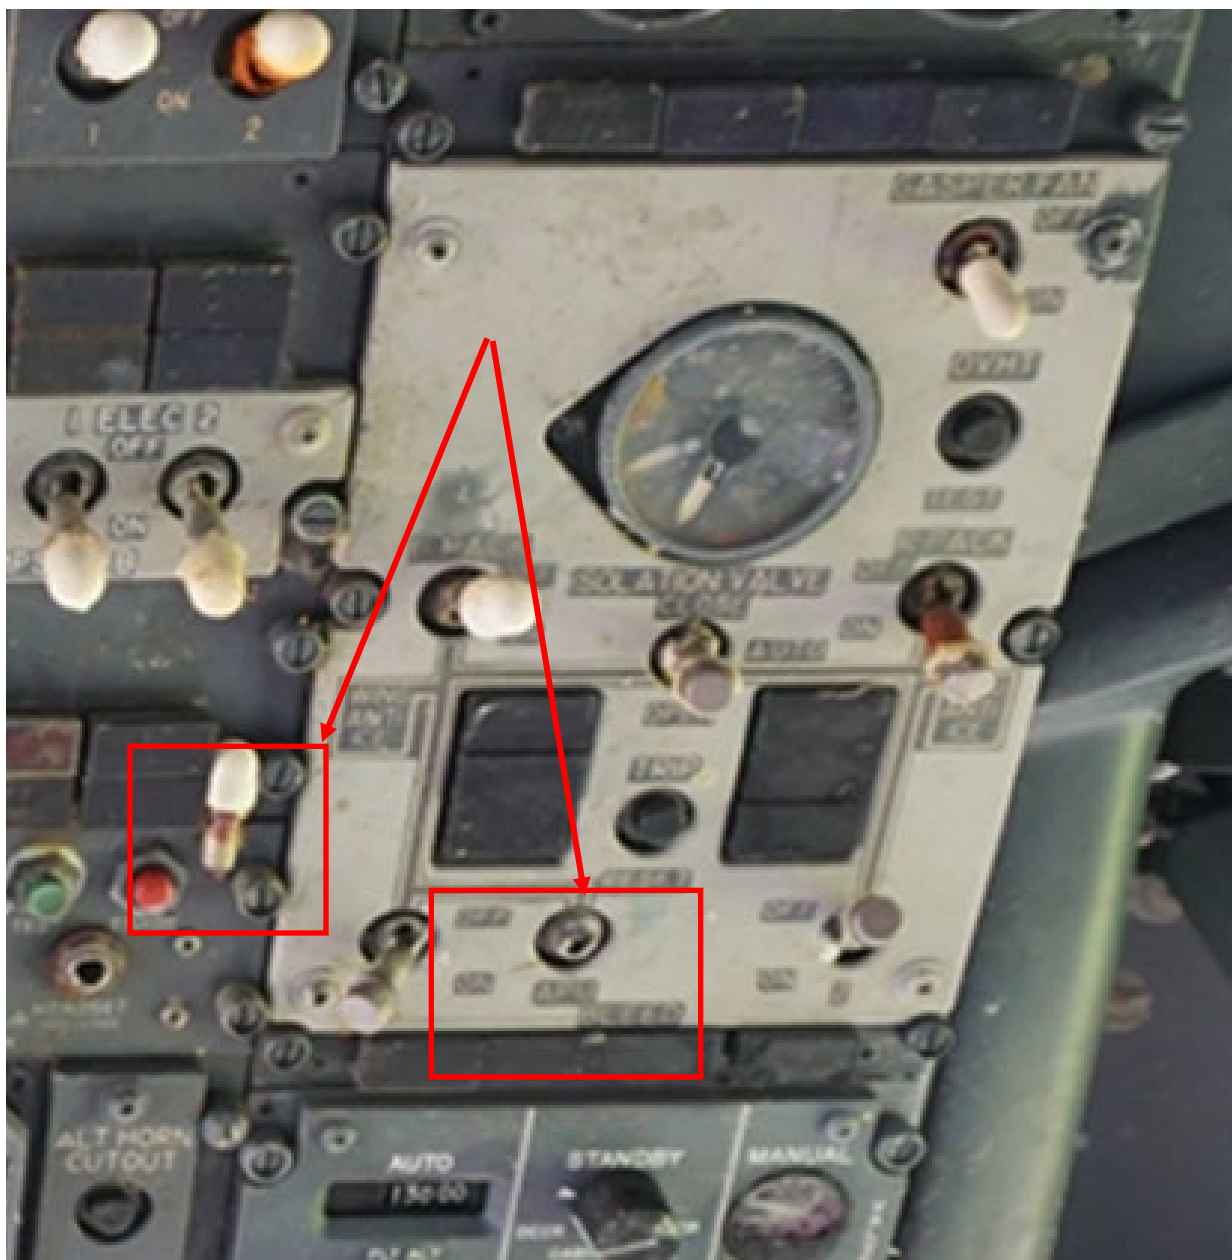
Broken switch lever (APU Bleed) stuck between outboard side of service door light and panel Dzus fastener (see Figure 10)

**Figure 10.** Bleed Panel Switch Damage Noted by Arrows and Boxes

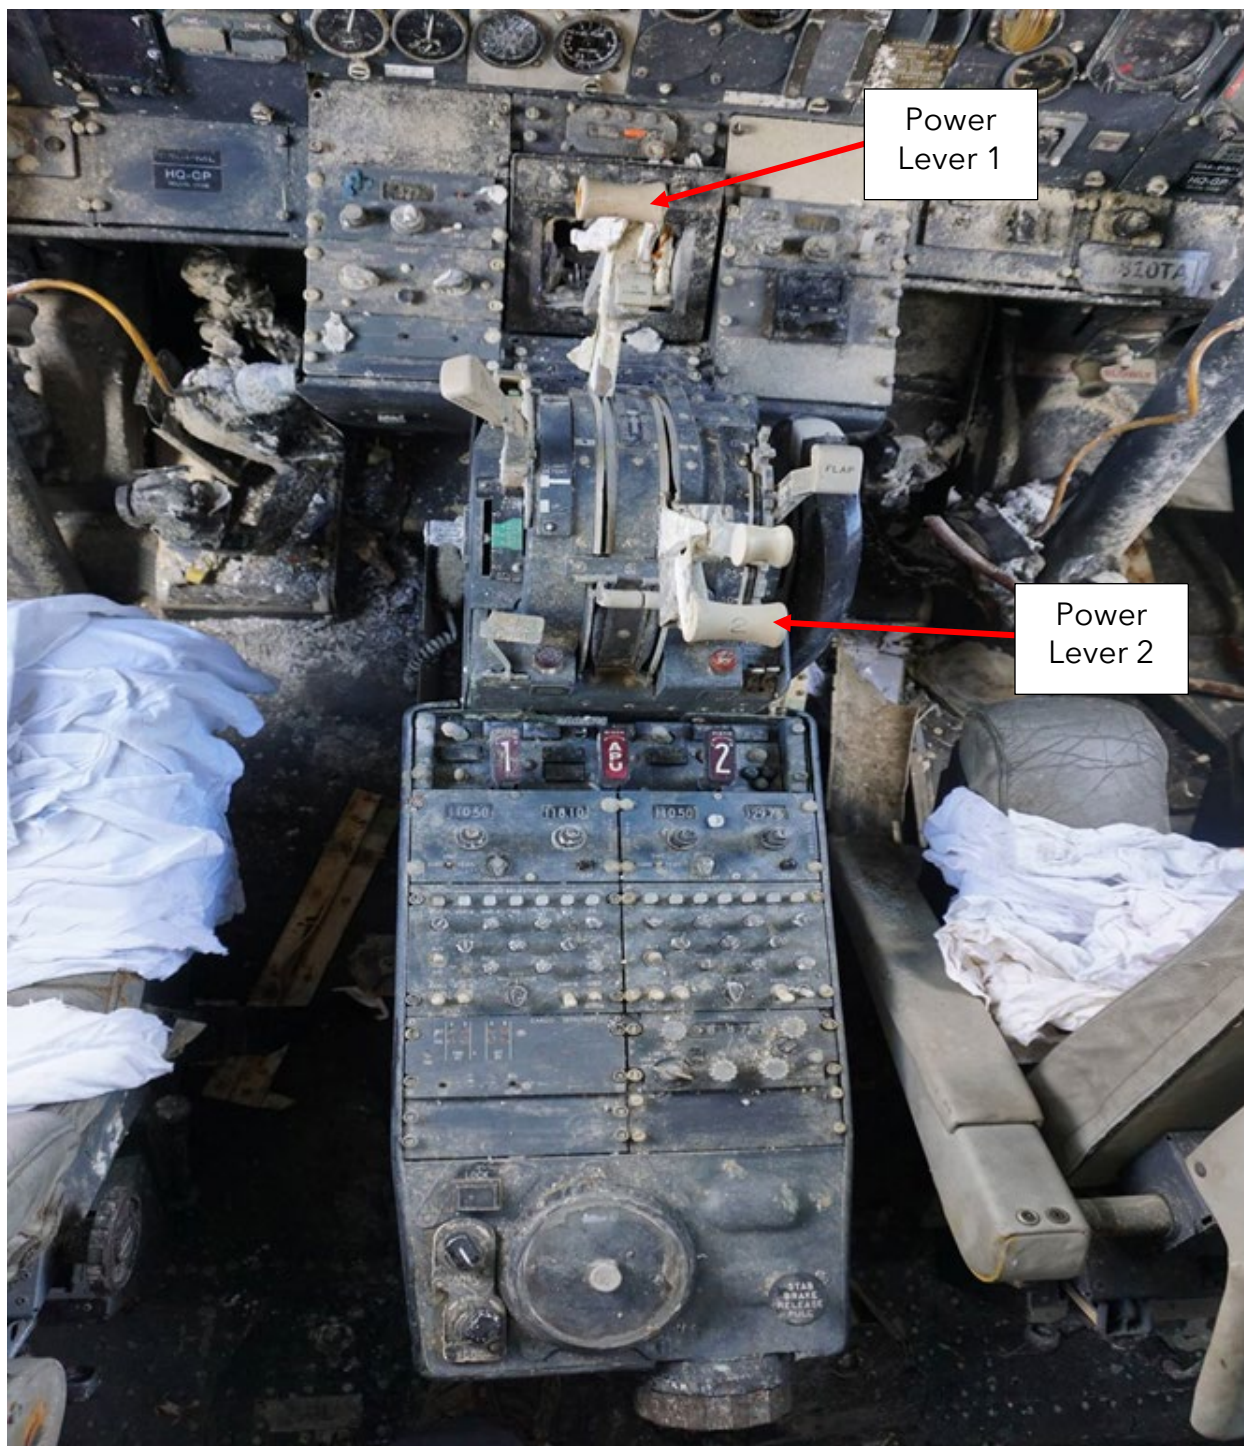
- Parking Brake - disengaged
- Power Lever 1 - Full Fwd (Max thrust) - piggyback lever was down
- Power Lever 2 - Full Aft (Idle) - piggyback lever was up Go-Around (GA) switch activator missing

- Note: Power lever positions noted "as found" and may not reflect the actual inflight position due to control cables connected to the engine being disturbed when the nose separated from the tail section.

**Figure 11.** Aisle Stand with Power Levers 1 and 2 Noted

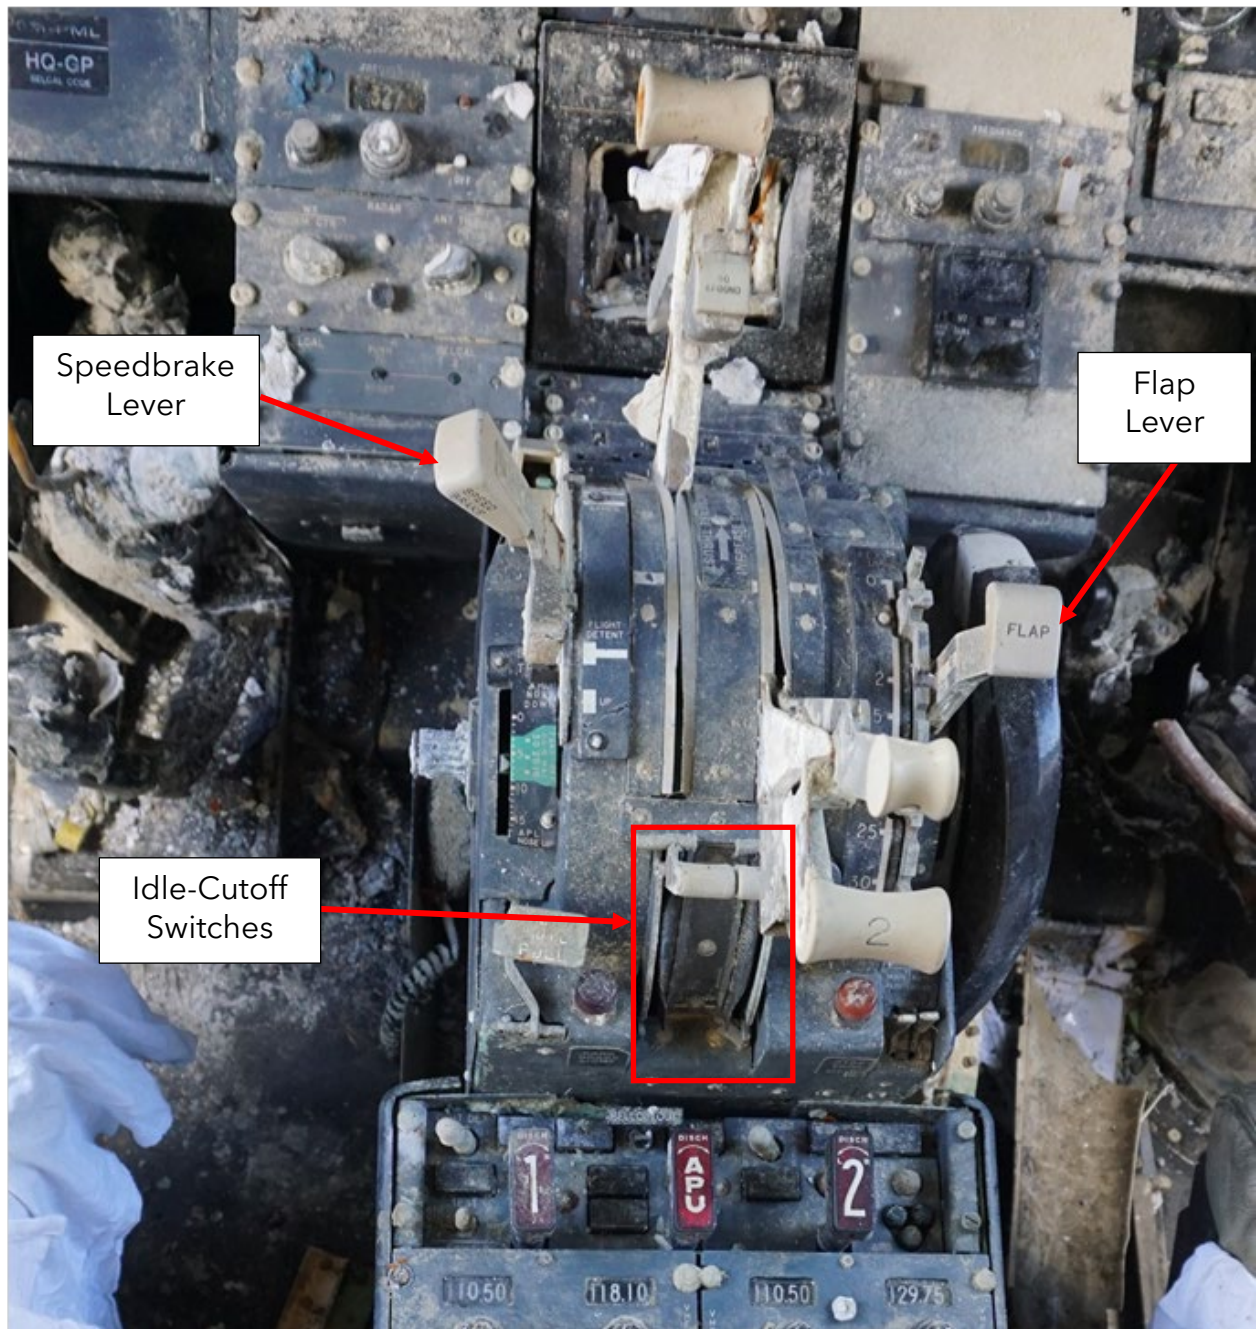
- Flap Lever - 2 deg
- Stab Trim - Main electric - Normal
- Stab Trim - Autopilot - Normal
- Engine Cutoff Lever - 1 - Idle (On/Up)
- Engine Cutoff Lever - 2 - Idle (On/Up)

**Figure 12.** Aisle Stand with Fuel Cutoff, Spoiler, and Flap Lever Positions Noted

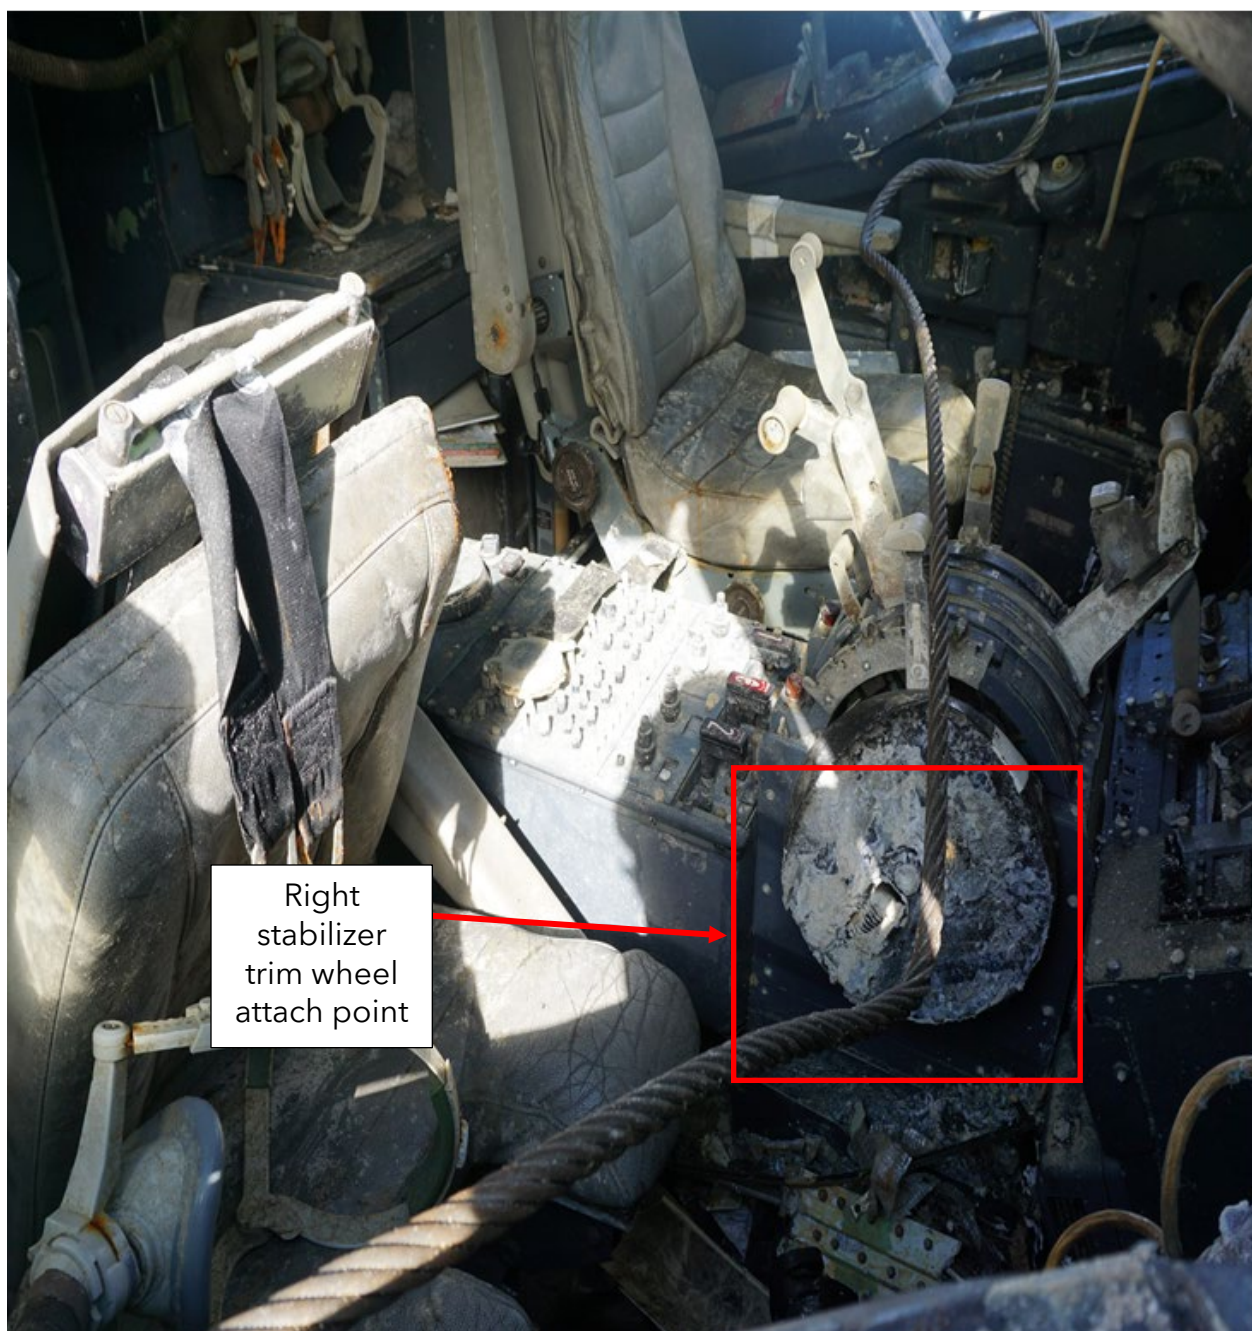
- Speedbrake -at flight position
- Stab Trim - 6.5 units nose up
- Stab trim manual wheel missing on Captain's side of the aisle stand. The FO's stab trim wheel was initially in place on the aisle stand, but it became detached during recovery and examination activities. Heavy corrosion was noted on the wheel's former position on the aisle stand.

**Figure 13.** Right Stabilizer Trim Wheel Attach Point Location

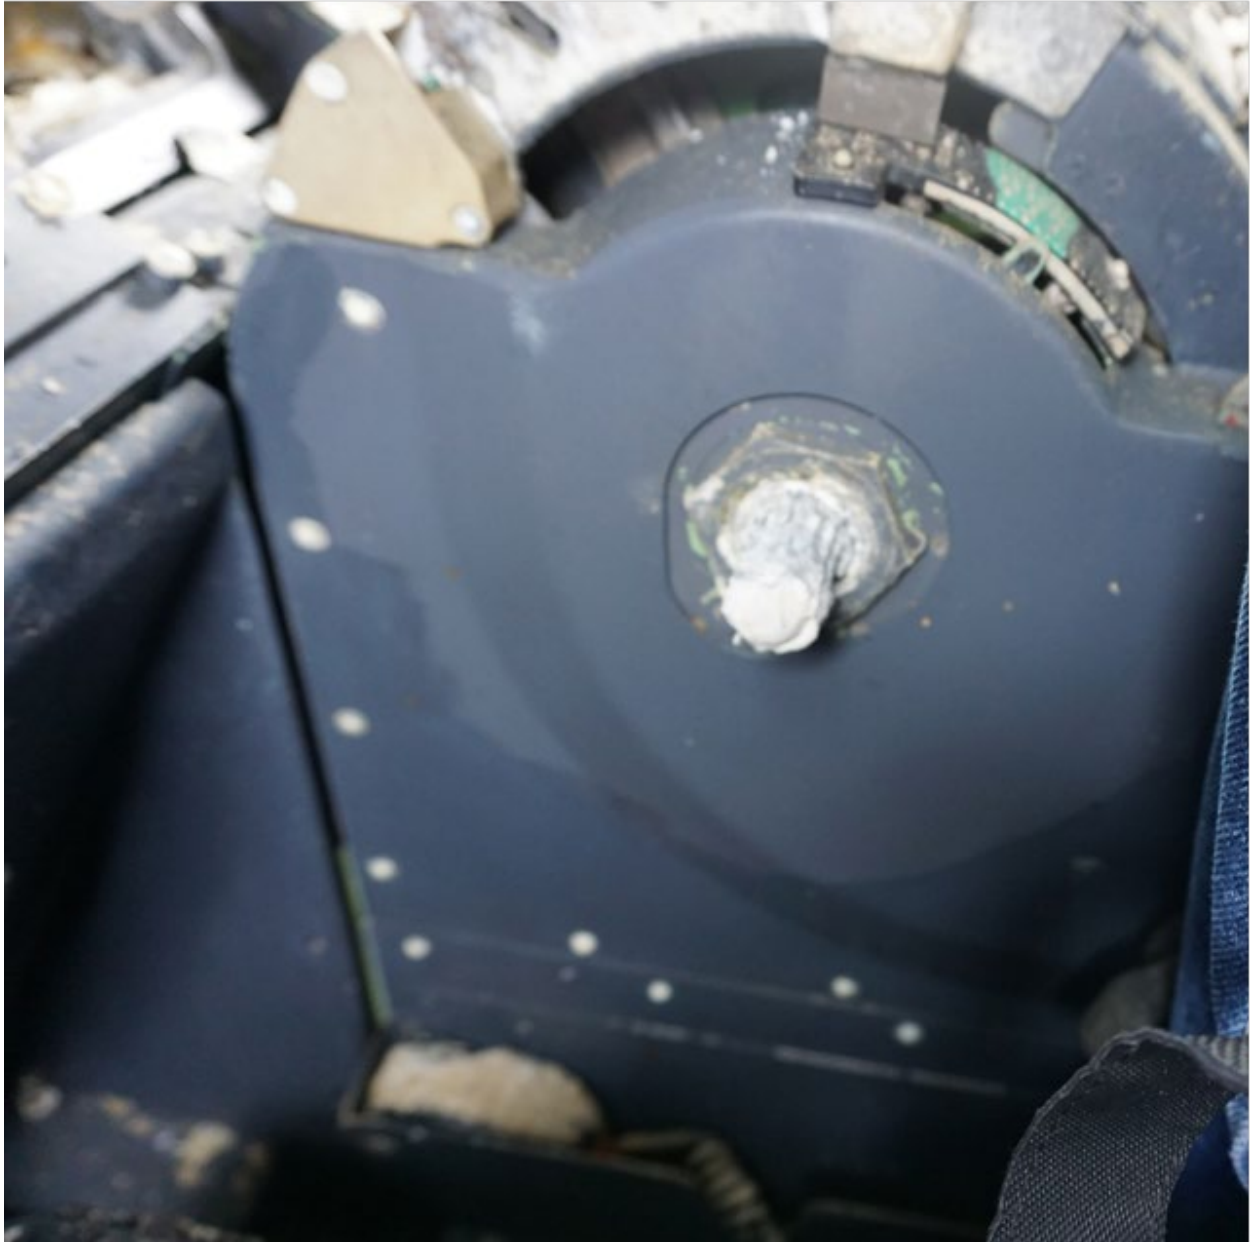
**Figure 14.** Left Stabilizer Wheel Attach Point/Stab Trim Position Indicator

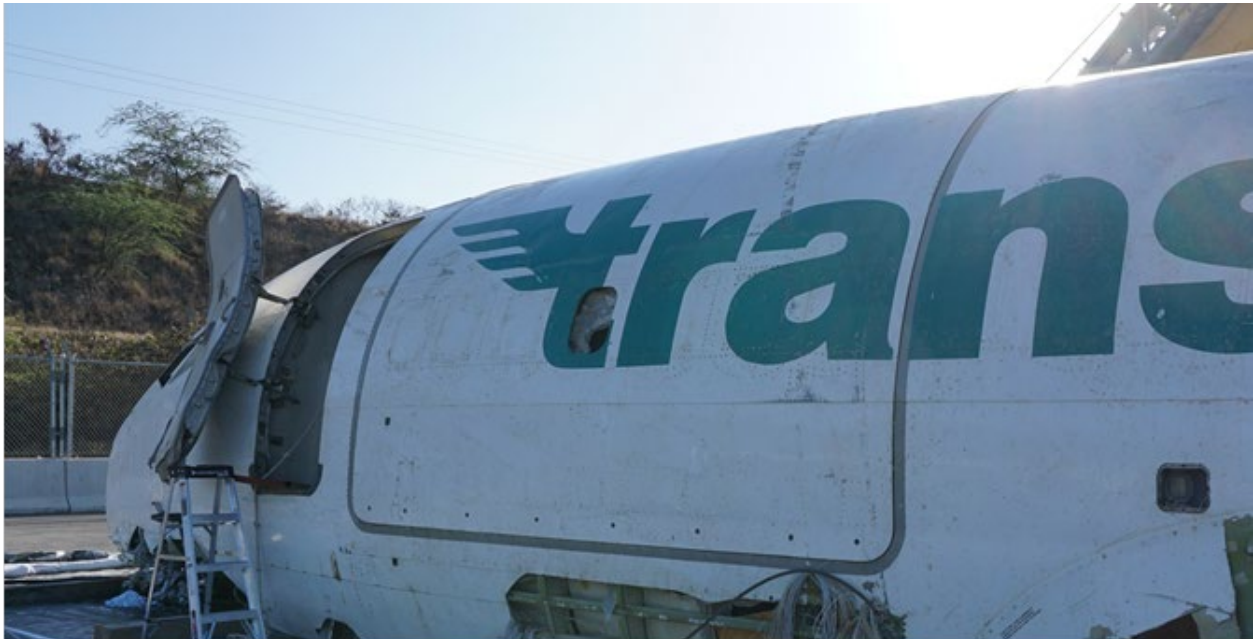
The upper cargo door (see Figures 15 and 16) was examined and confirmed locked/latched as evidenced by the "pins" shown in the viewing windows. The door external latch handle was noted as faired/latched. There was a window plug missing 4 positions forward from the rear of the door.

**Figure 15.** Upper Cargo Door
