## **NATIONAL TRANSPORTATION SAFETY BOARD**

### **Group Chairman's Factual Report**

# **SYSTEMS**

DCA21FA174

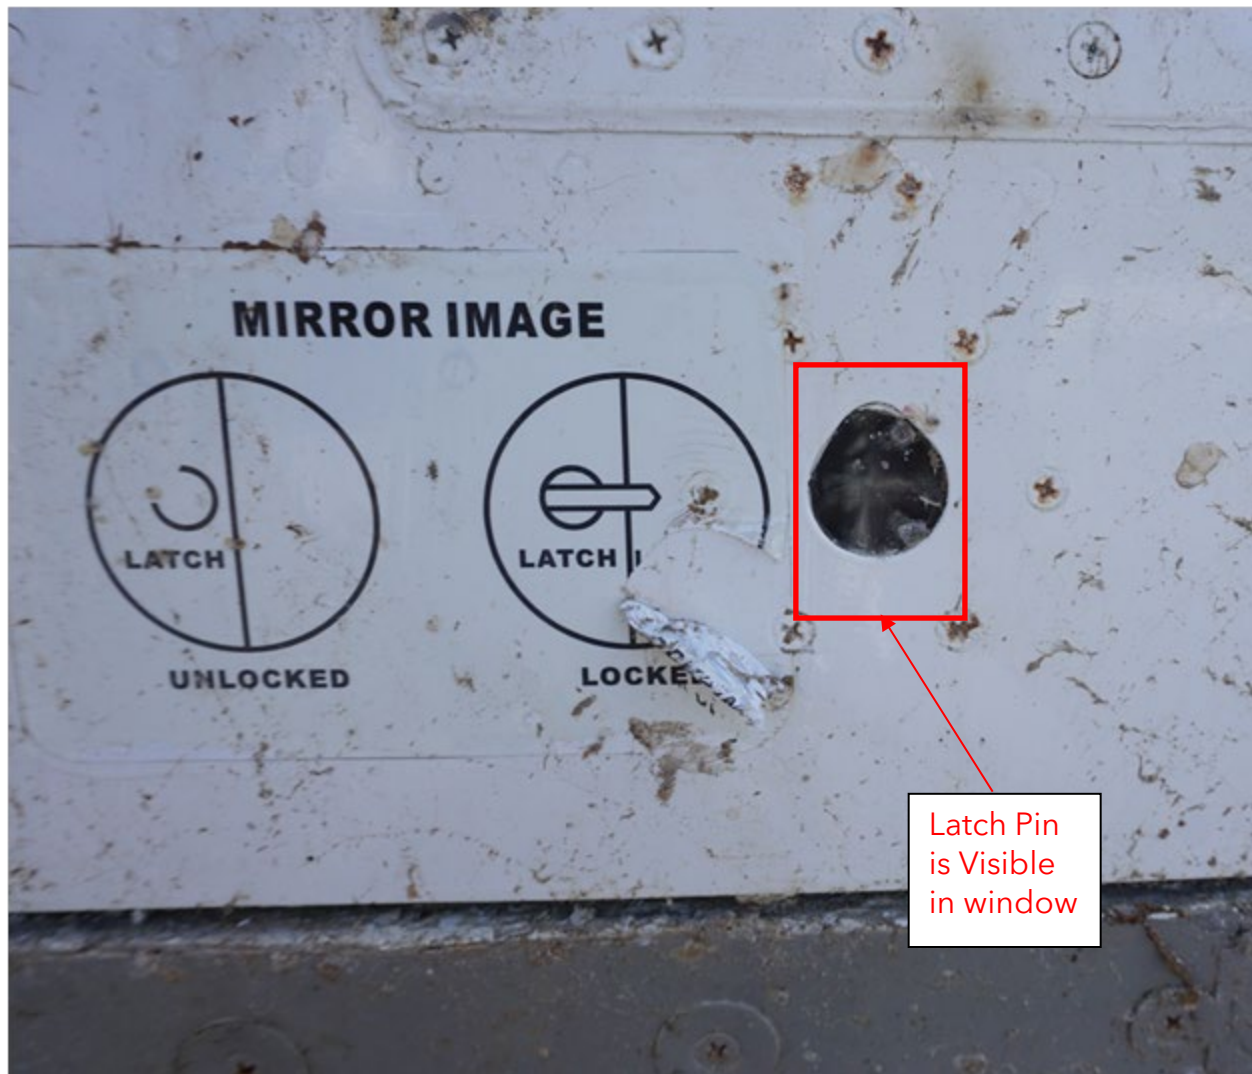
The upper cargo door (see Figures 15 and 16) was examined and confirmed locked/latched as evidenced by the "pins" shown in the viewing windows. The door external latch handle was noted as faired/latched. There was a window plug missing 4 positions forward from the rear of the door.

**Figure 16.** Upper Cargo Door Latch Pin

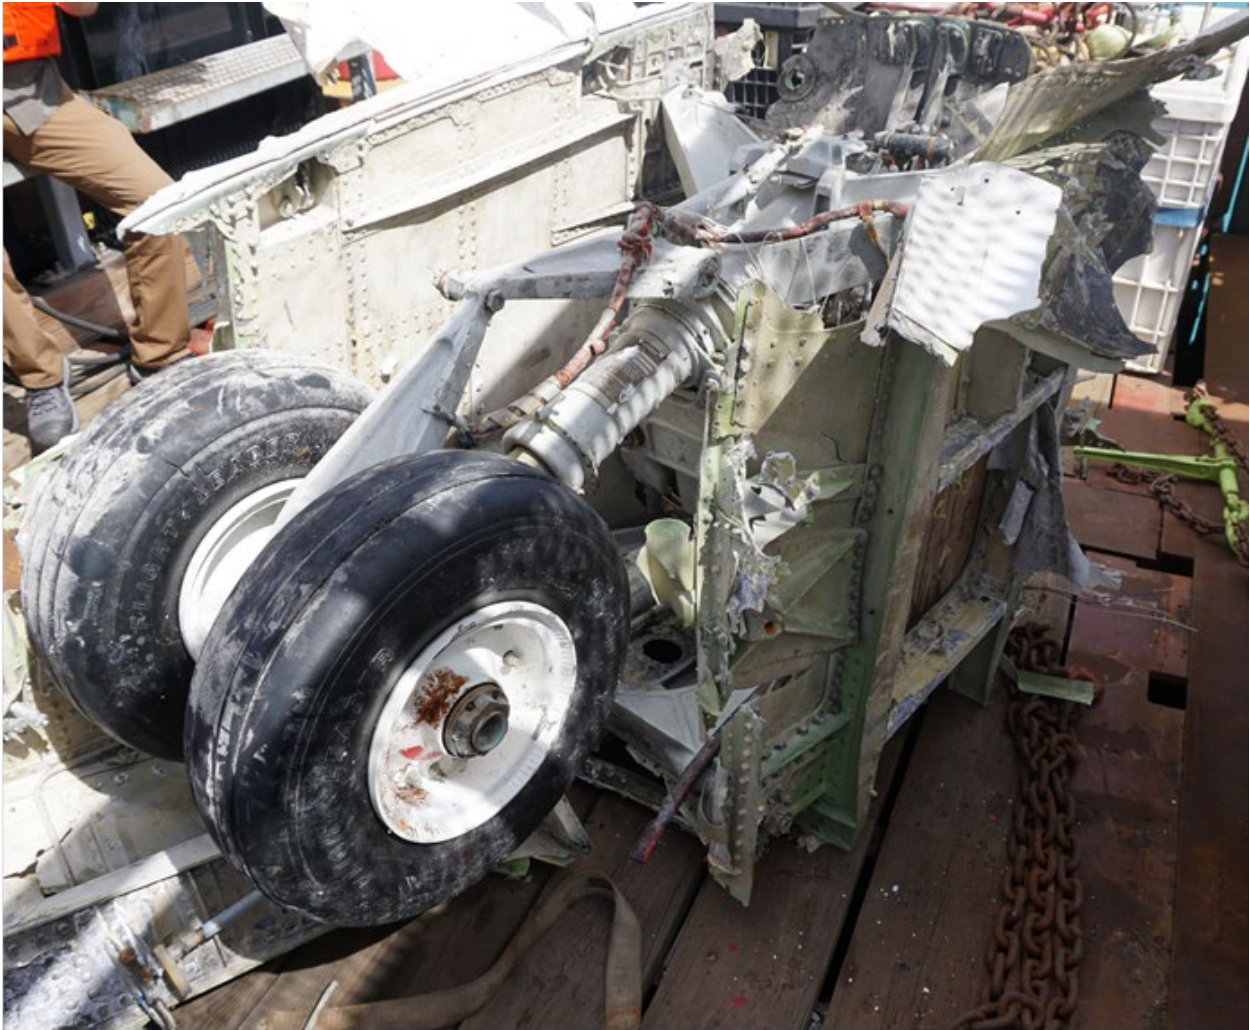
The nose gear was retrieved as part of the nose gear wheel well structure/box and was examined by the structure group member. The nose landing gear strut and mechanism appeared complete including the two tires (see Figure 17).

**Figure 17.** Nose Gear and Attach Box Structure

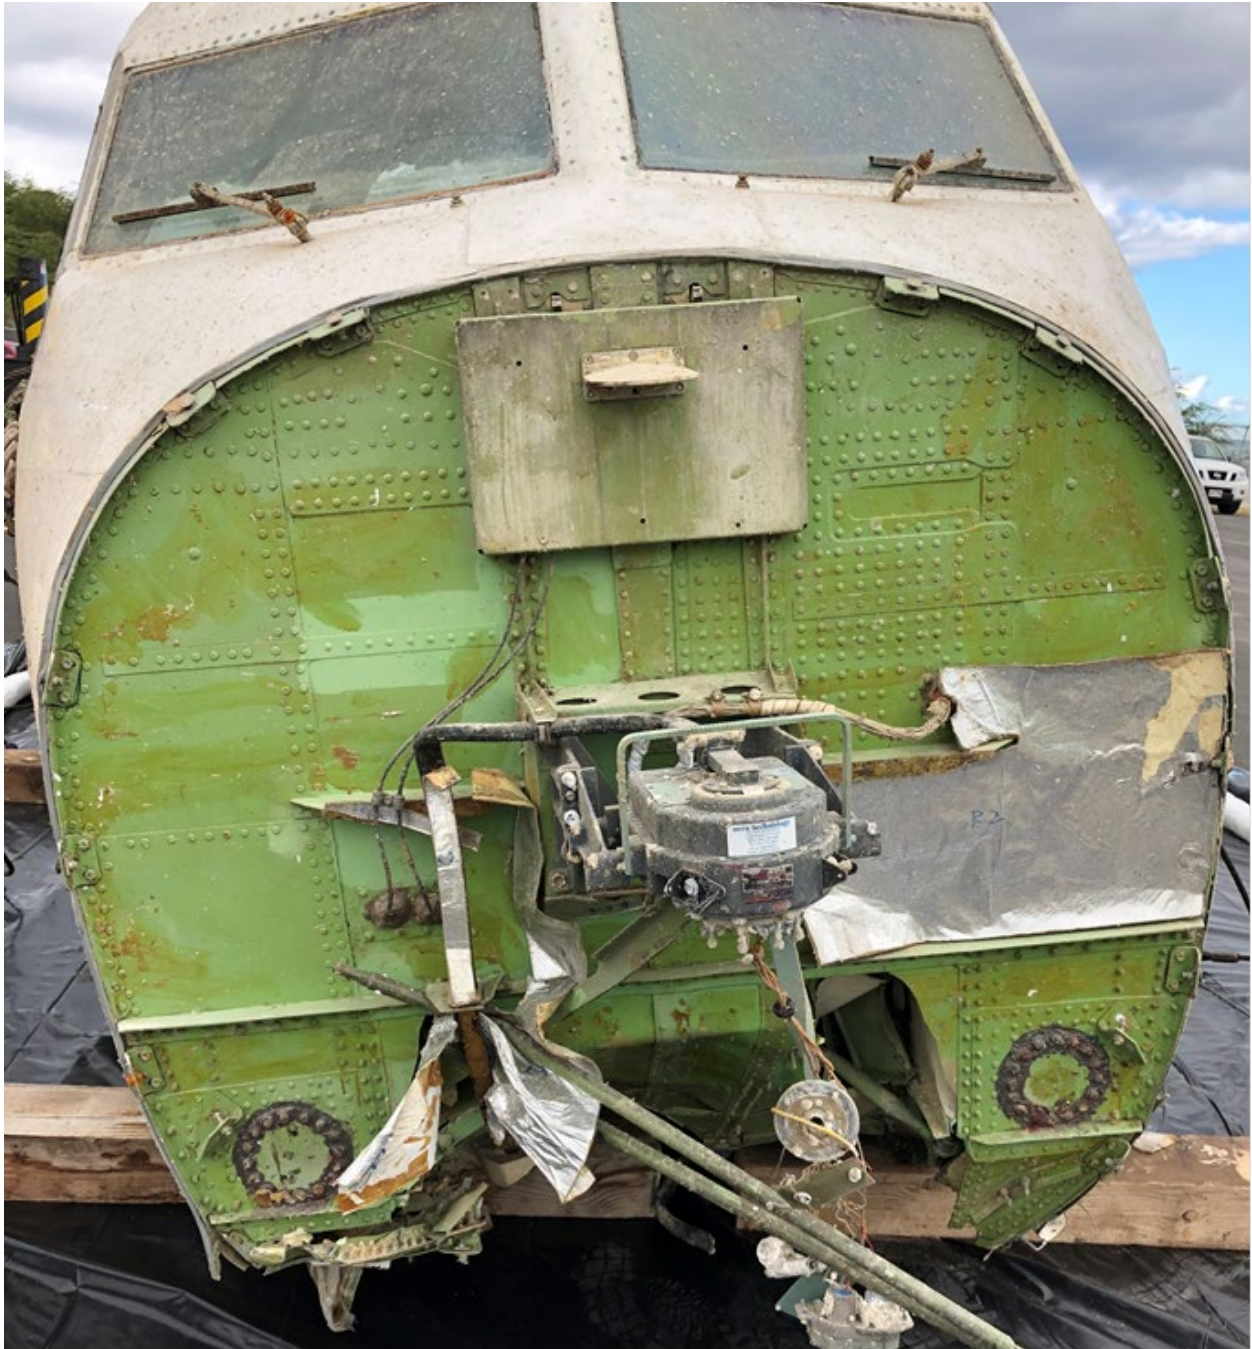
The radome was not present on the recovered nose section. The weather radar antenna plate was missing; however, the mount pedestal was still partially intact. The glideslope antenna was still present above the radar unit (see Figure 18).

**Figure 18.** Forward Bulkhead/Radar Mounting

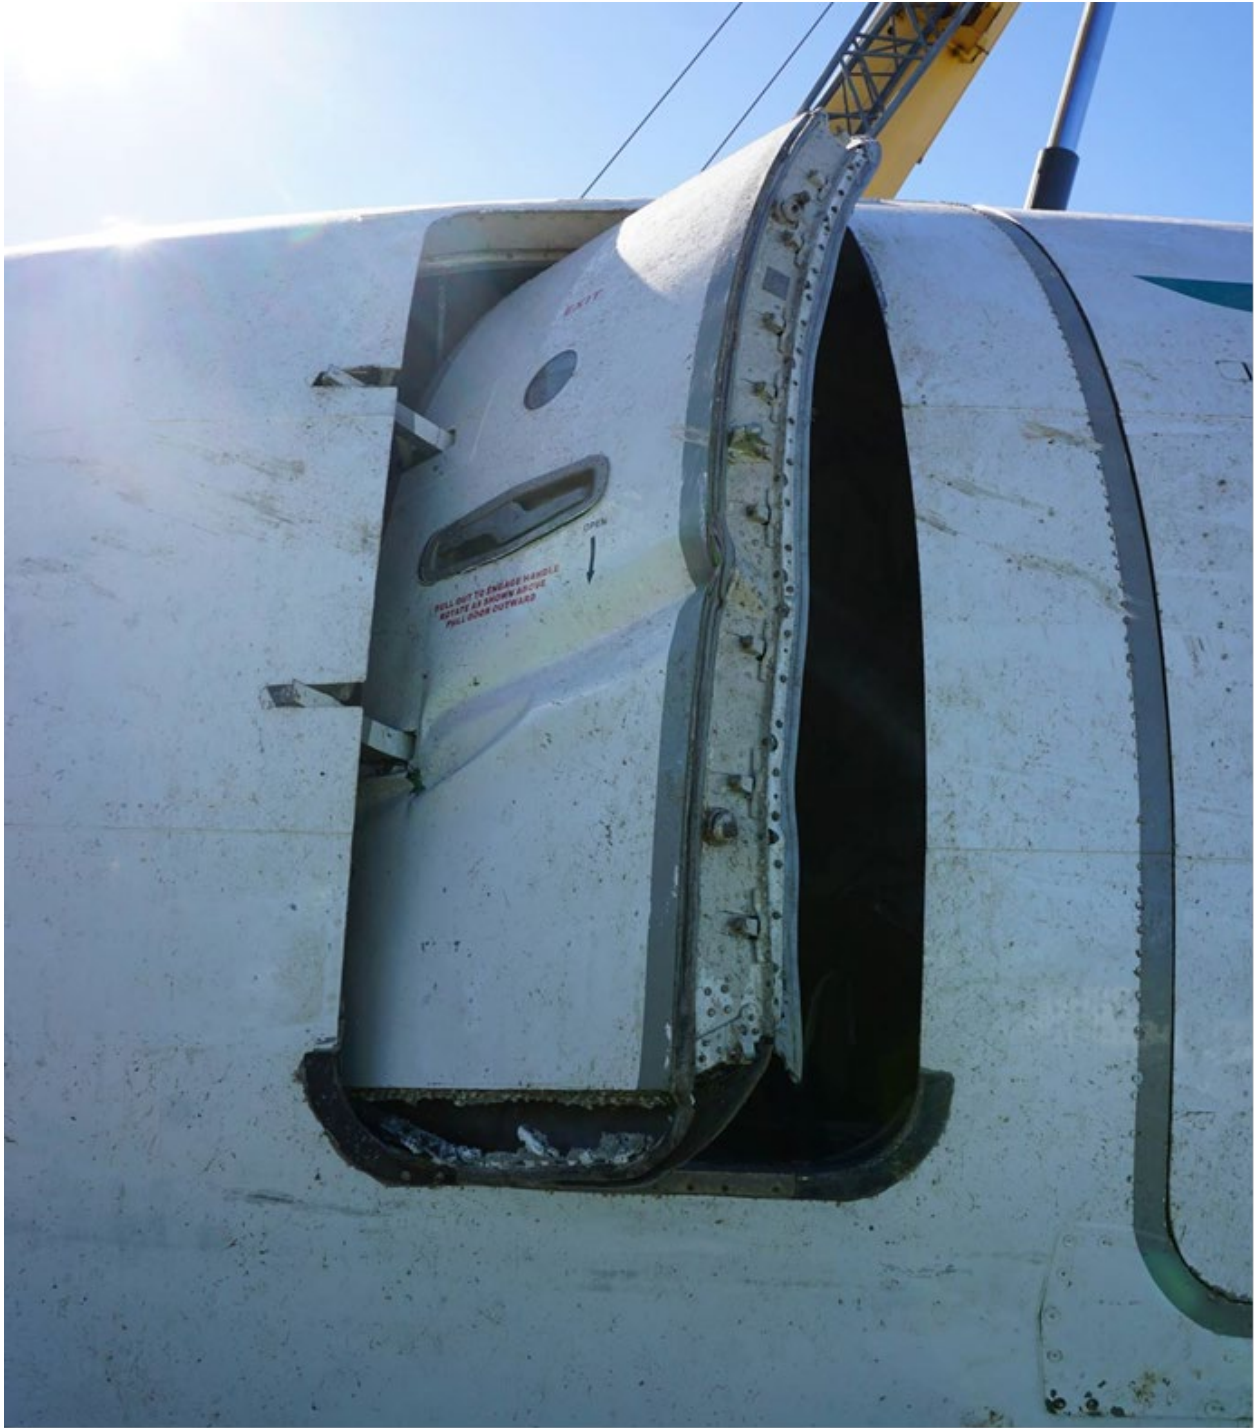
The cabin doors were examined. Both the left front and right front doors suffered structural damage to the skins and hinge mechanisms. The uppermost and lowermost articulating panels are highly corroded and not entirely in place.

The left forward door (see Figure 19) was unlatched and opened on the recovery vessel after its initial recovery from the sea bed. Upon first access to the nose section during the examination activities at Barbers Point, the left door was noted as unlocked and partially opened.

**Figure 19.** Left Forward Cabin Door

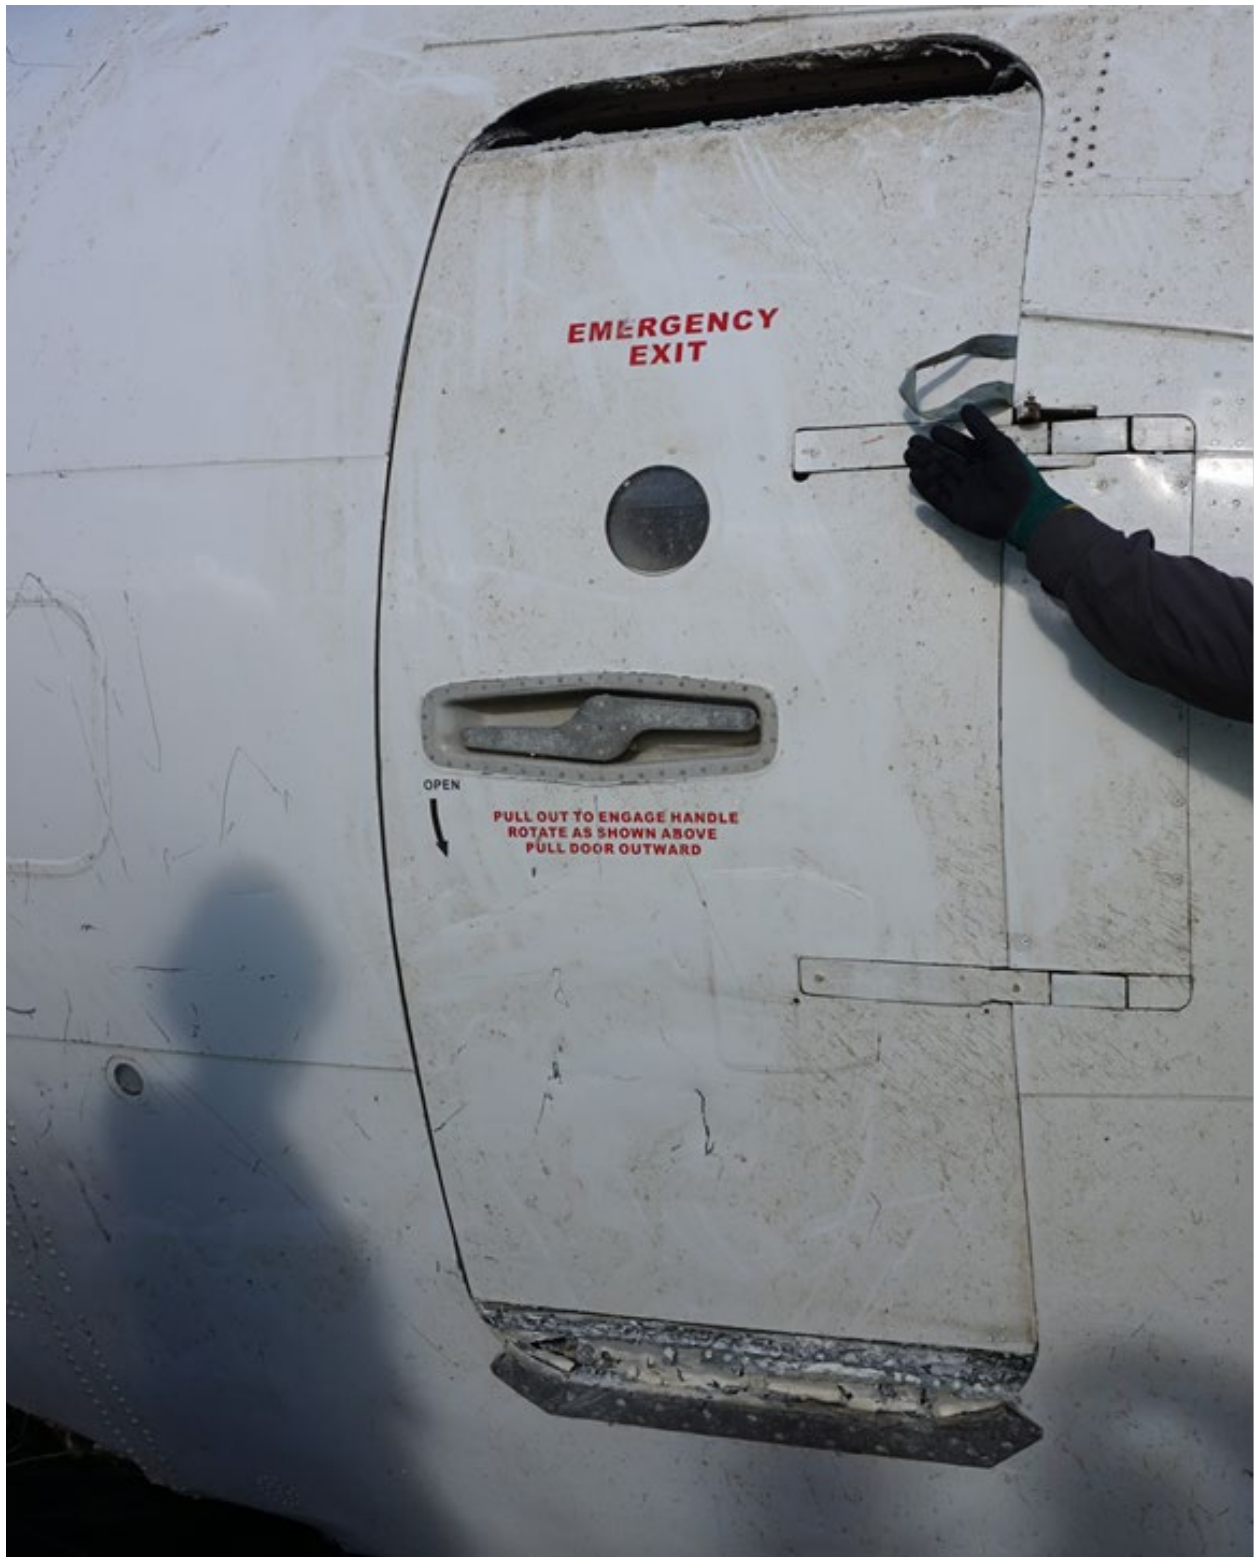
The right forward door (see Figure 20) was physically stuck in the faired and locked position upon the initial access to the nose section. There was a flat strap stuck in the upper forward latch roller mechanism. TransAir employees opened the right forward door after wreckage recovery on Oct 23, 2021.

**Figure 20.** Right Forward Cabin Door

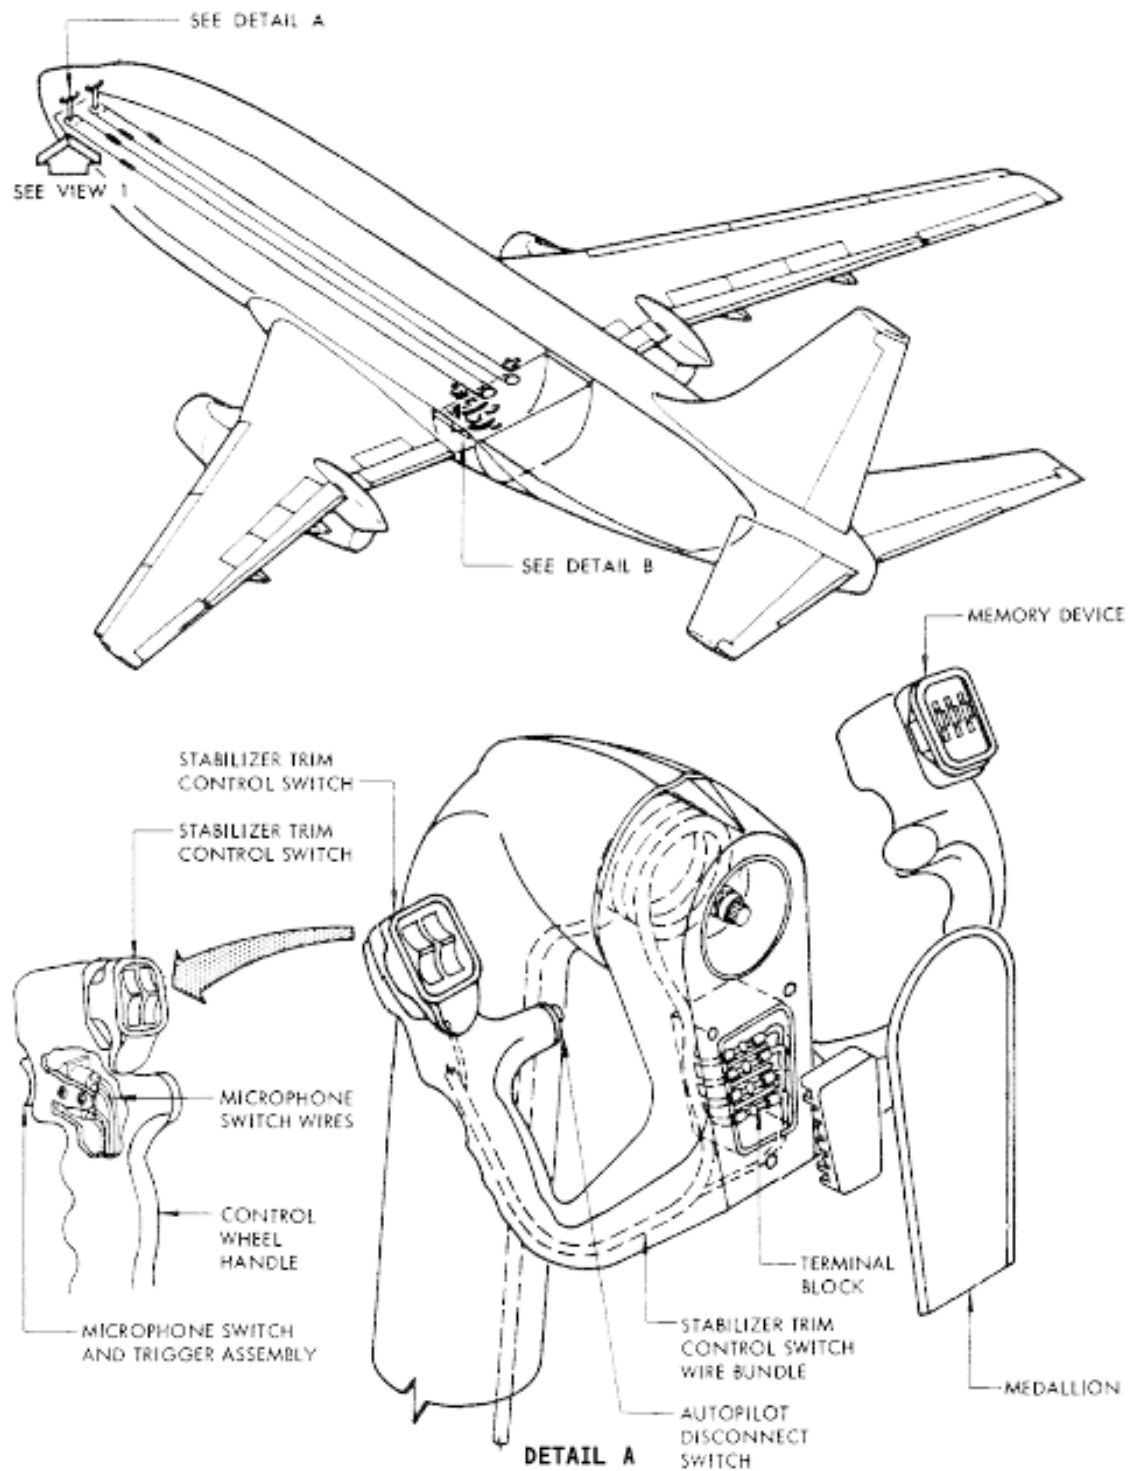
In the wreckage, the cable routing area was damaged, and the cables were broken in the area of the fuselage break.

**Figure 21.** Roll Axis Flight Control Cable Routing (Courtesy of Boeing)

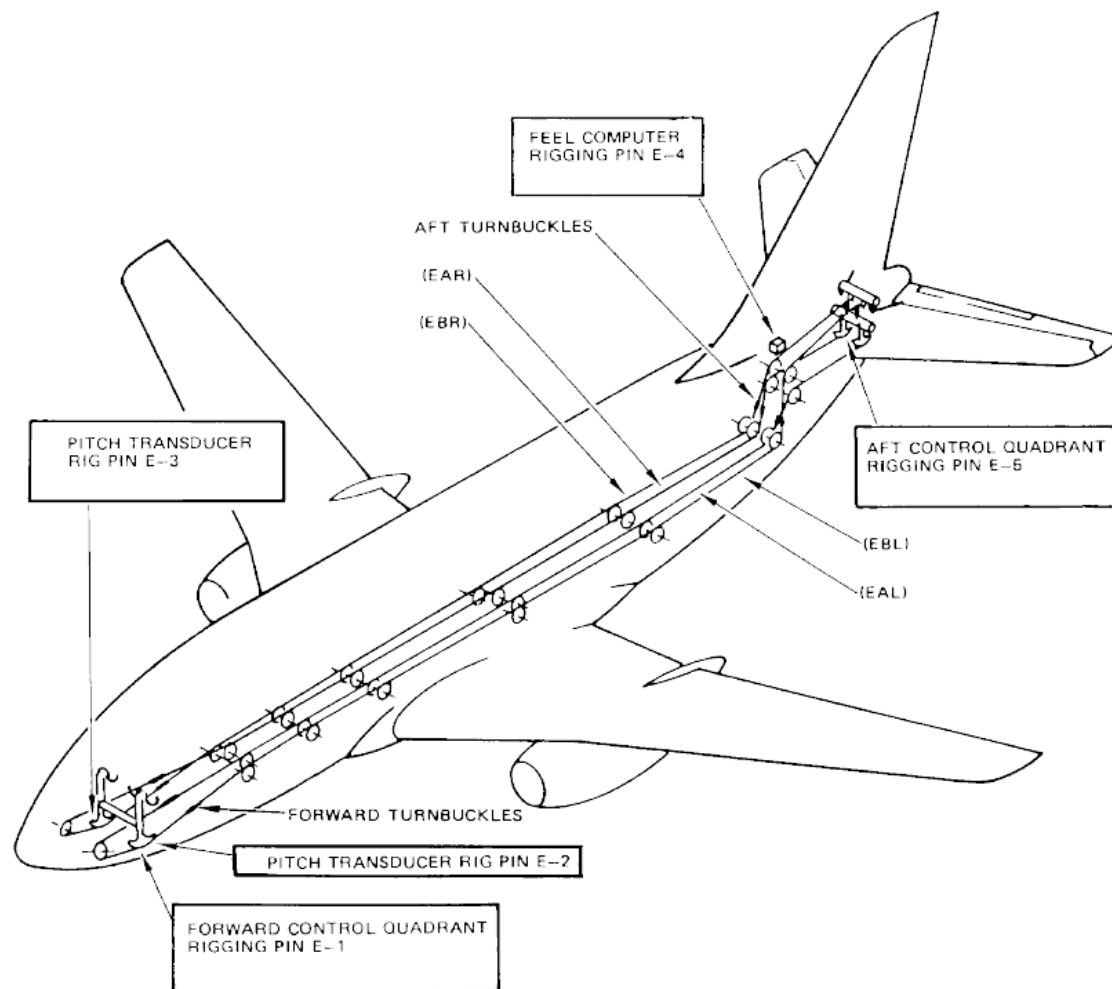
**Figure 22.** Pitch Axis Flight Control Cable Routing (Courtesy of Boeing)

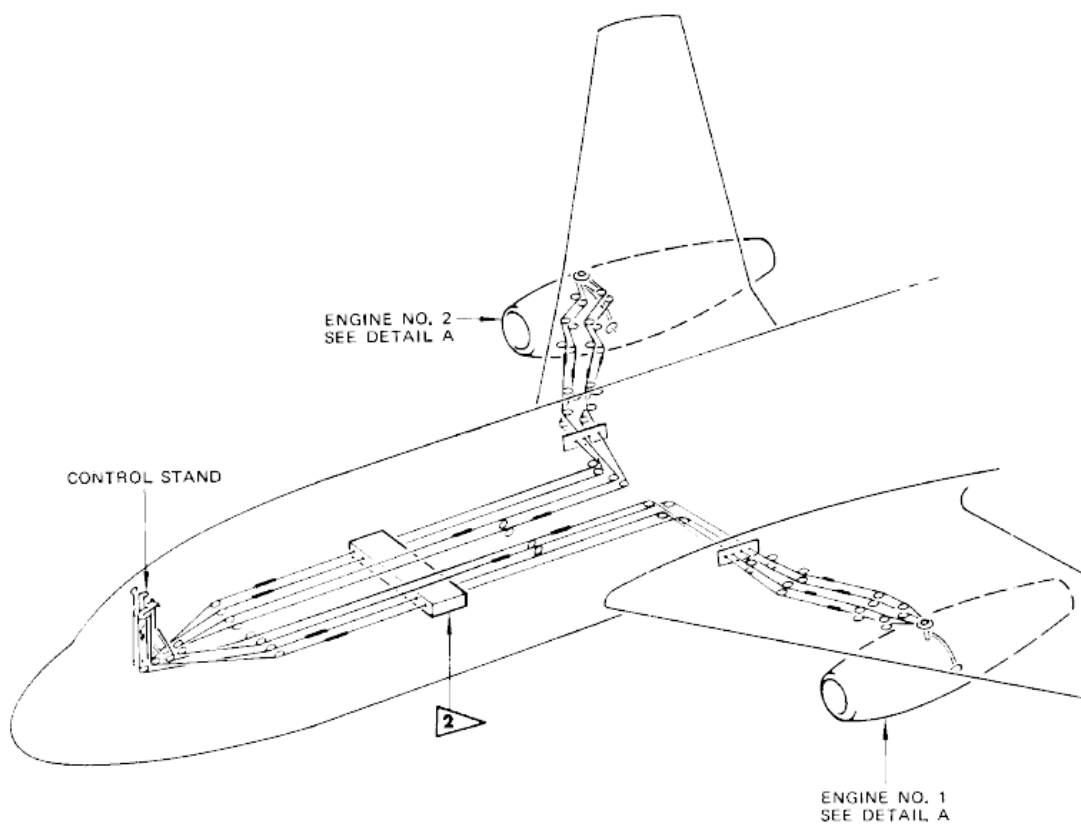
The forward thrust control system consists of a thrust lever assembly for each engine, connected to each engine fuel control unit by control cables, a push-pull cable, and a rod linkage. The forward thrust control system regulates the engine fuel flow, and hence forward thrust. The cables are routed through the lower portion of the fuselage (see Figure 23). In the wreckage, the cable routing area was damaged, and the cables were broken in the area of the fuselage break.

**Figure 23. Engine Thrust Control Cable Routing** (Courtesy of Boeing)
