**Figure 1 – Tail Strike Damage between FR61-69 and S-39L to S-42R Actual Pictures**  
(Sheet 1 of 6)

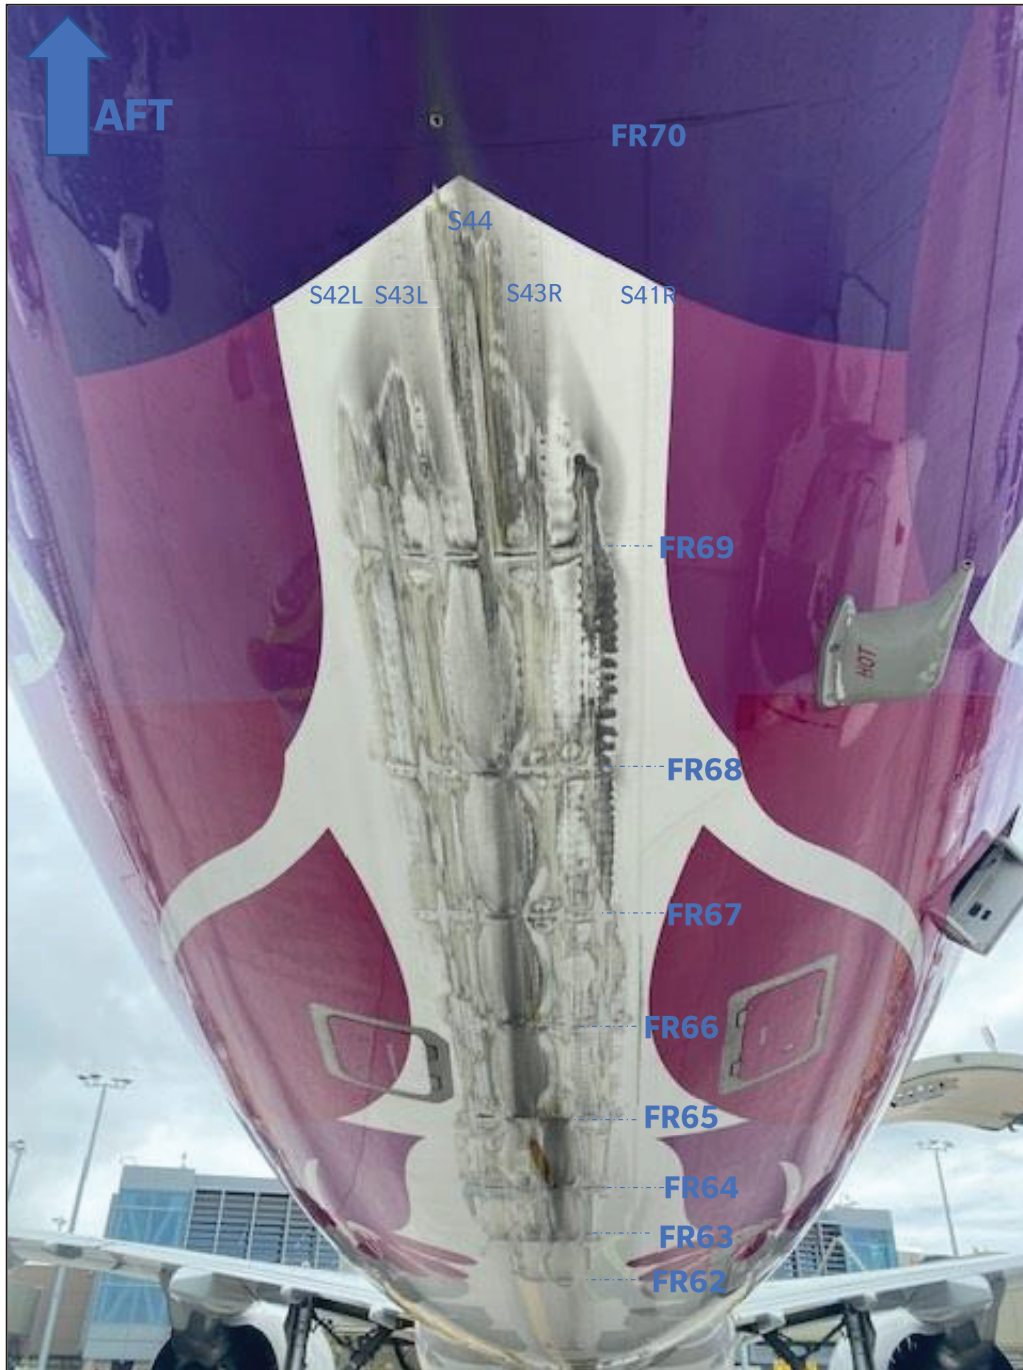
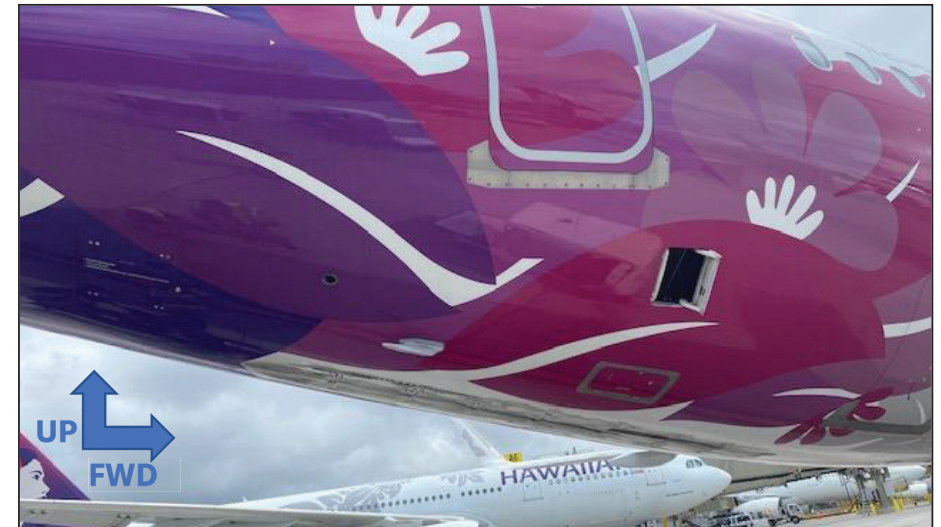
- Section 18 and partial Section 17 lower skin damage 4in OTBD of FR62 to FR 70 between S-41L to 41R

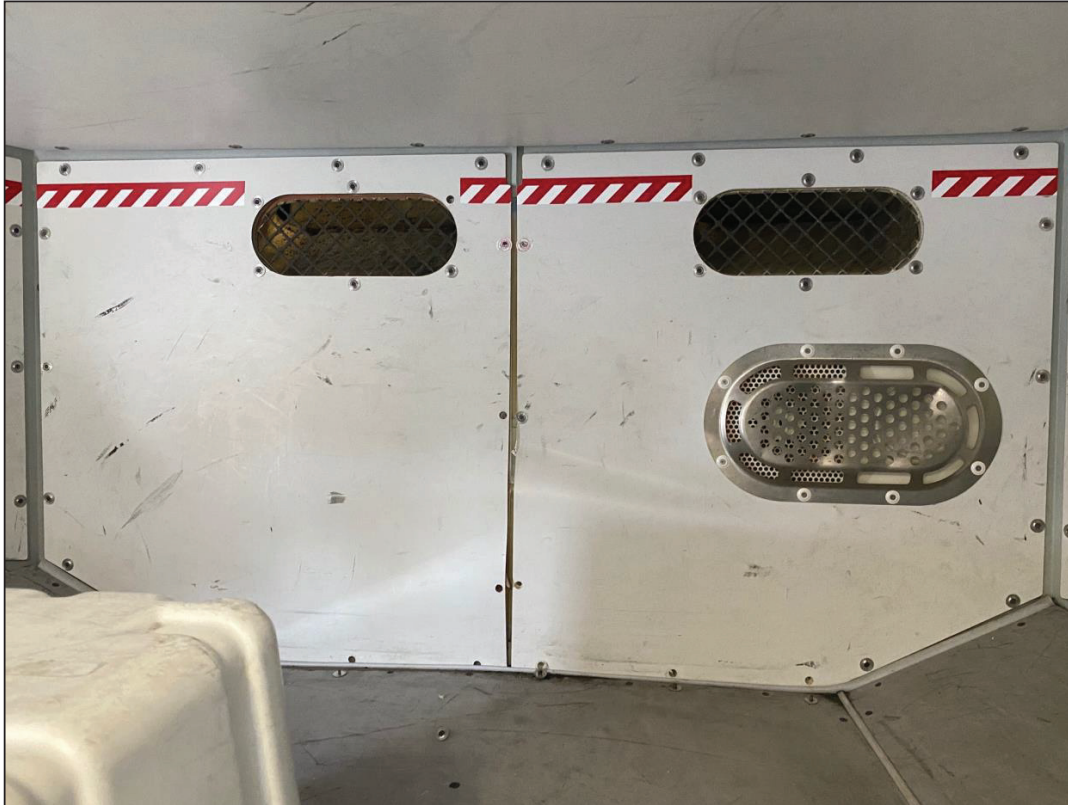
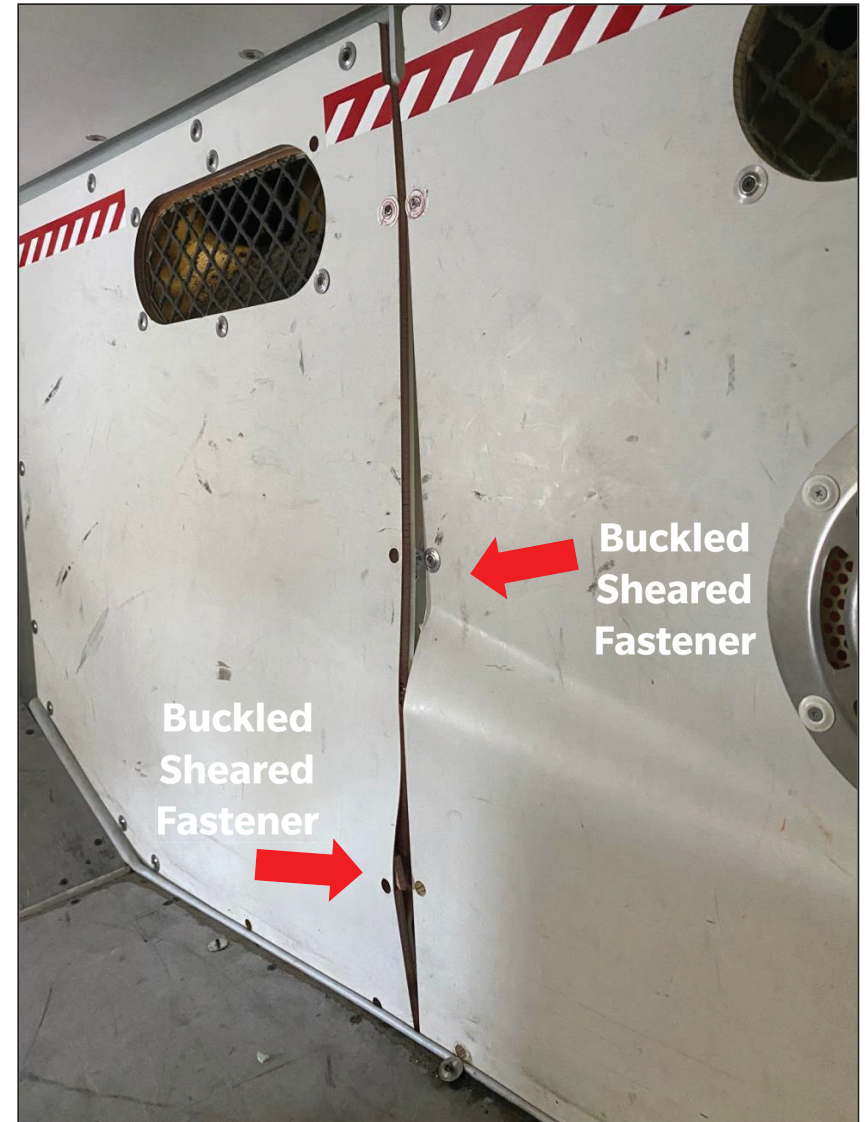
**Figure 1 – Tail Strike Damage between FR61-69 and S-39L to S-42R Actual Pictures**  
(Sheet 4 of 6)

- Bulk Cargo Compartment:
  - P/N: D25579152020 and D2557915400200

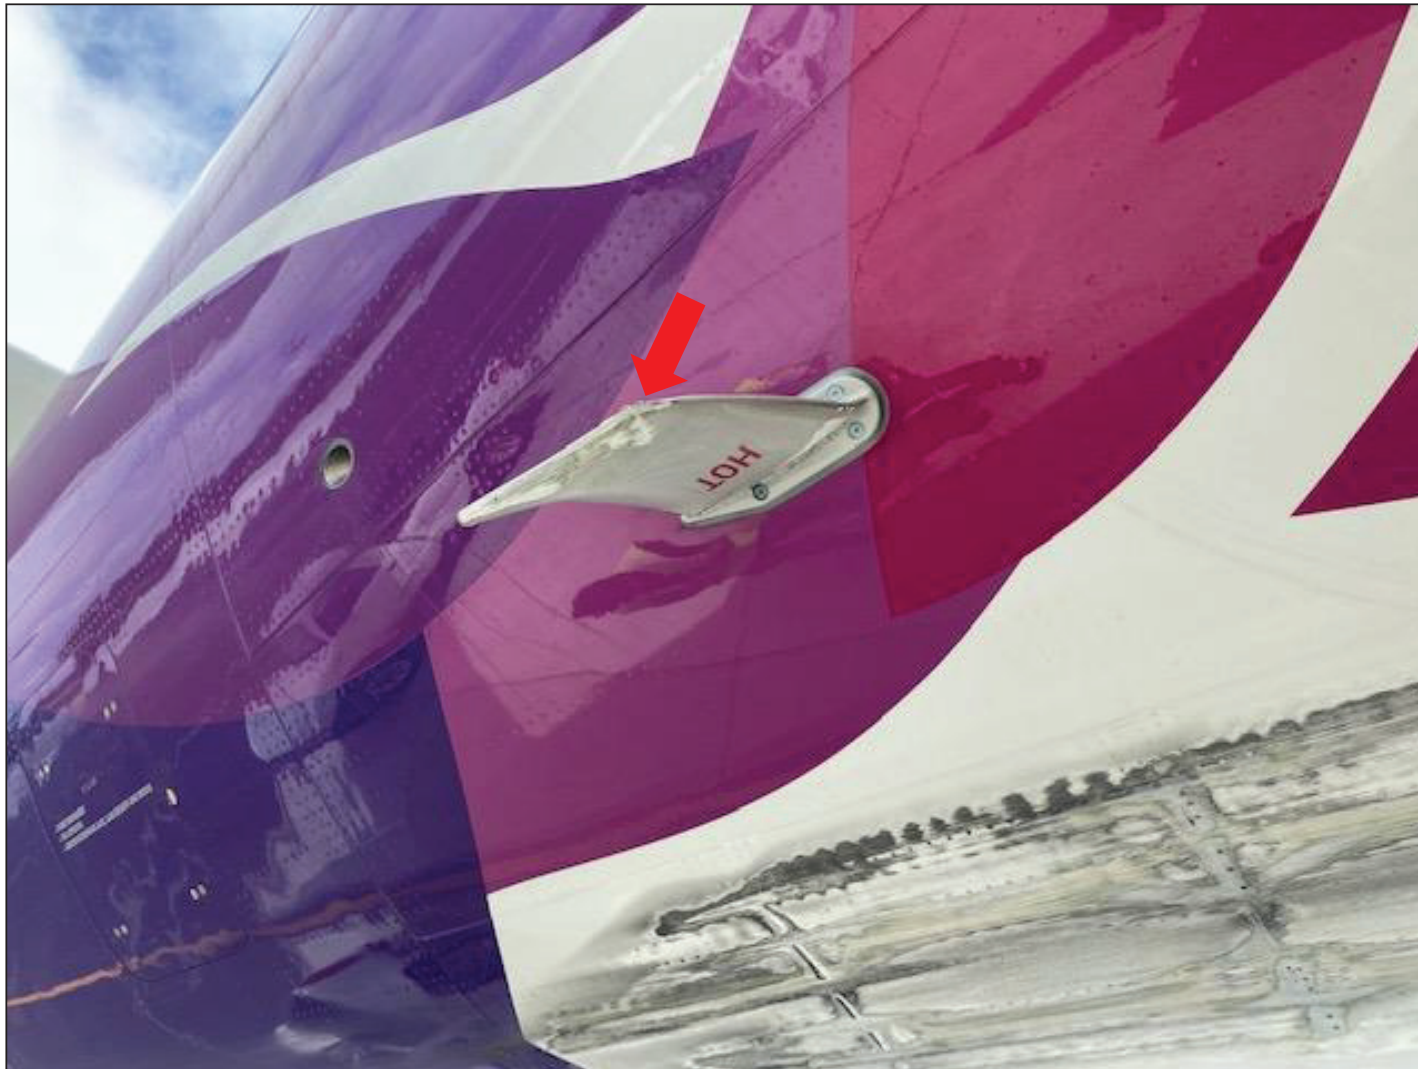
**Figure 2 – Tail Strike Damage between FR61-69 and S-39L to S-42R Actual Pictures**  
(Sheet 1 of 1)

AFT Drain Mast Damage
