## Summary

While taxiing in at KEWR aerodrome, on 31<sup>st</sup> December 2021, the A330-303 aircraft (TC-JOK, MSN: 1642) hit its winglet to the rudder of a United Airlines E170-100SE (N633RW, MSN: 54) aircraft which is being operated by Republic Airways. Flight crew weren't aware of the incident until ATC stated that they may have had an incident and advised to check the aircraft.

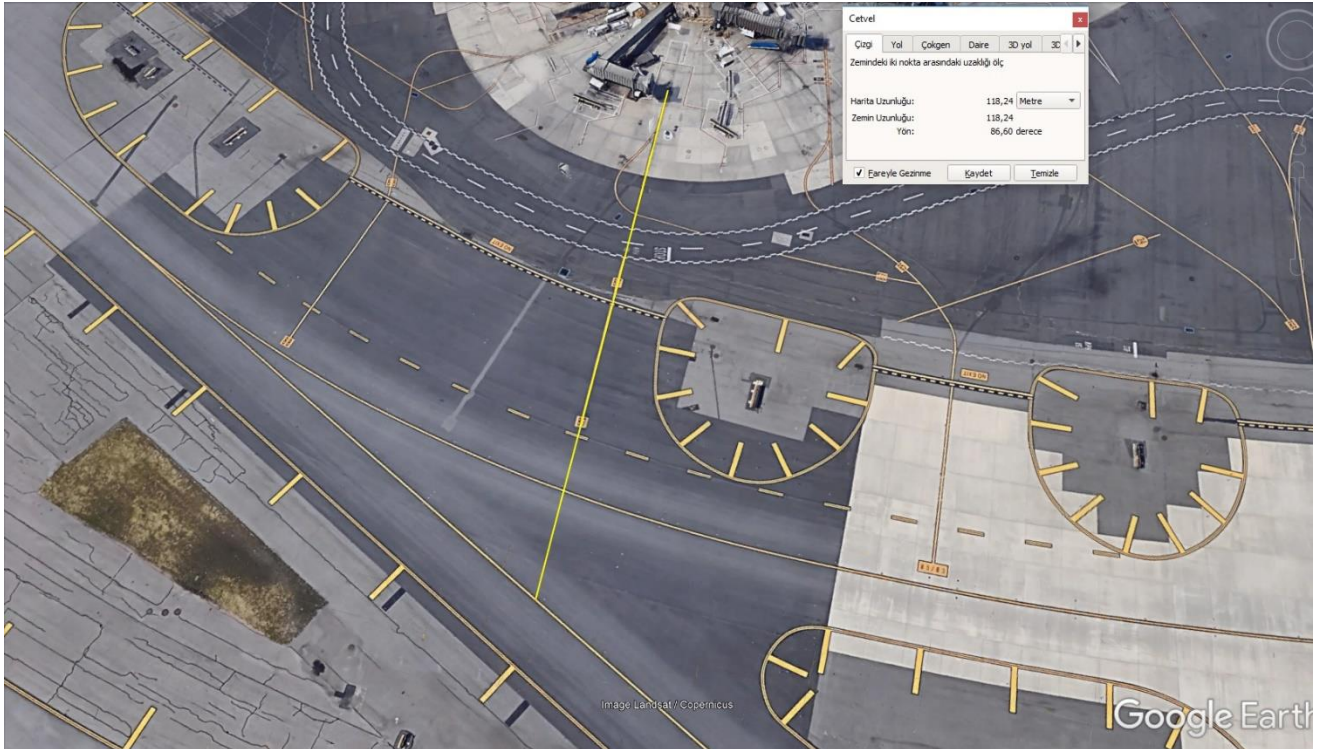
Wingspan of A330-303 aircraft is 60.3 m. Length of E170 aircraft is 29.90 m. The distance between center line of A taxiway and nose position at gate 87 is approximately 118.24 m. The gap between wing tip of an A330 aircraft on A taxiway and tail of an E170 aircraft fully parked at gate 87 is calculated as:

$$118.24 \text{ m} - ((60.30 \text{ m} / 2) + 29.90 \text{ m}) = 58.19 \text{ m}$$

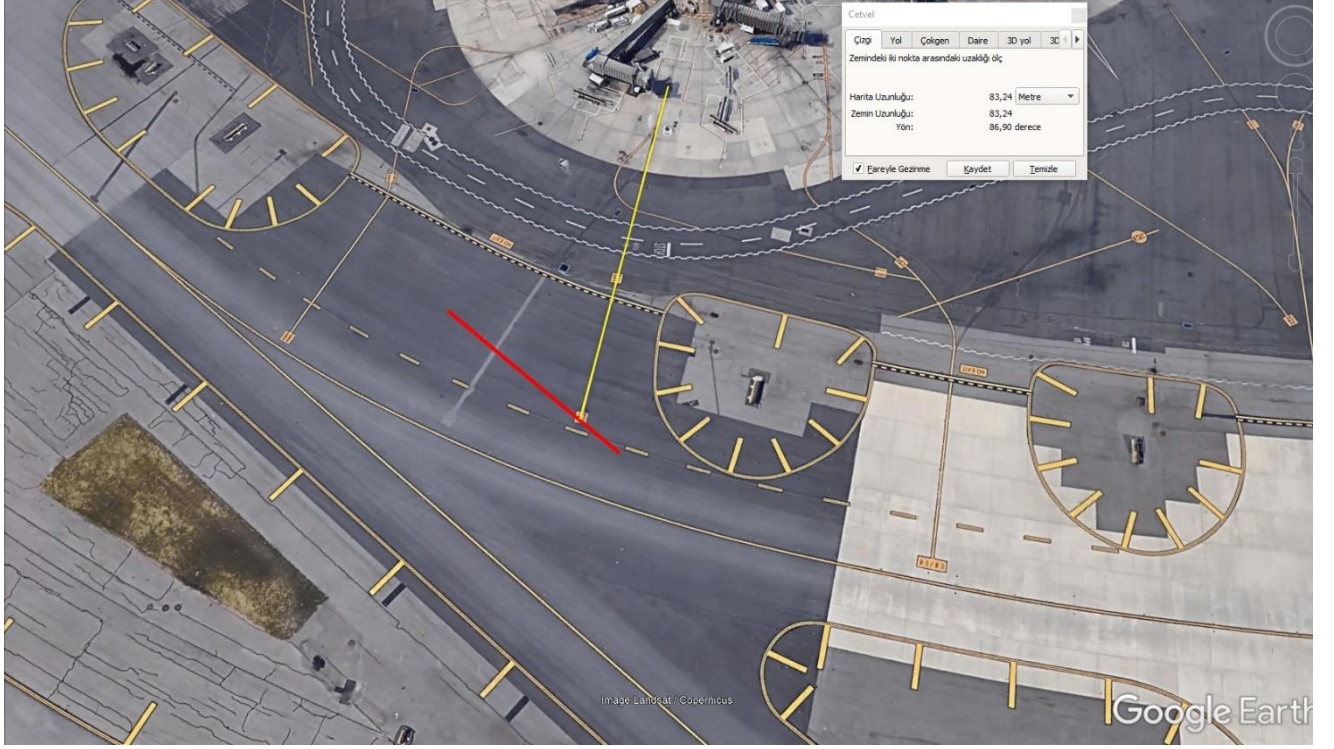
The actual distance is expected to be shorter because of the angle between the taxiway center line and stand entry guidance line. The red line on the figure below depicts the trace of wing tip of A330 aircraft when it is exactly on center line of A taxiway. The distance between nose position at gate and wing tip trace is 83.24 m. The gap can be calculated as:

$$83.24 \text{ m} - 29.90 \text{ m} = 53.34 \text{ m}$$

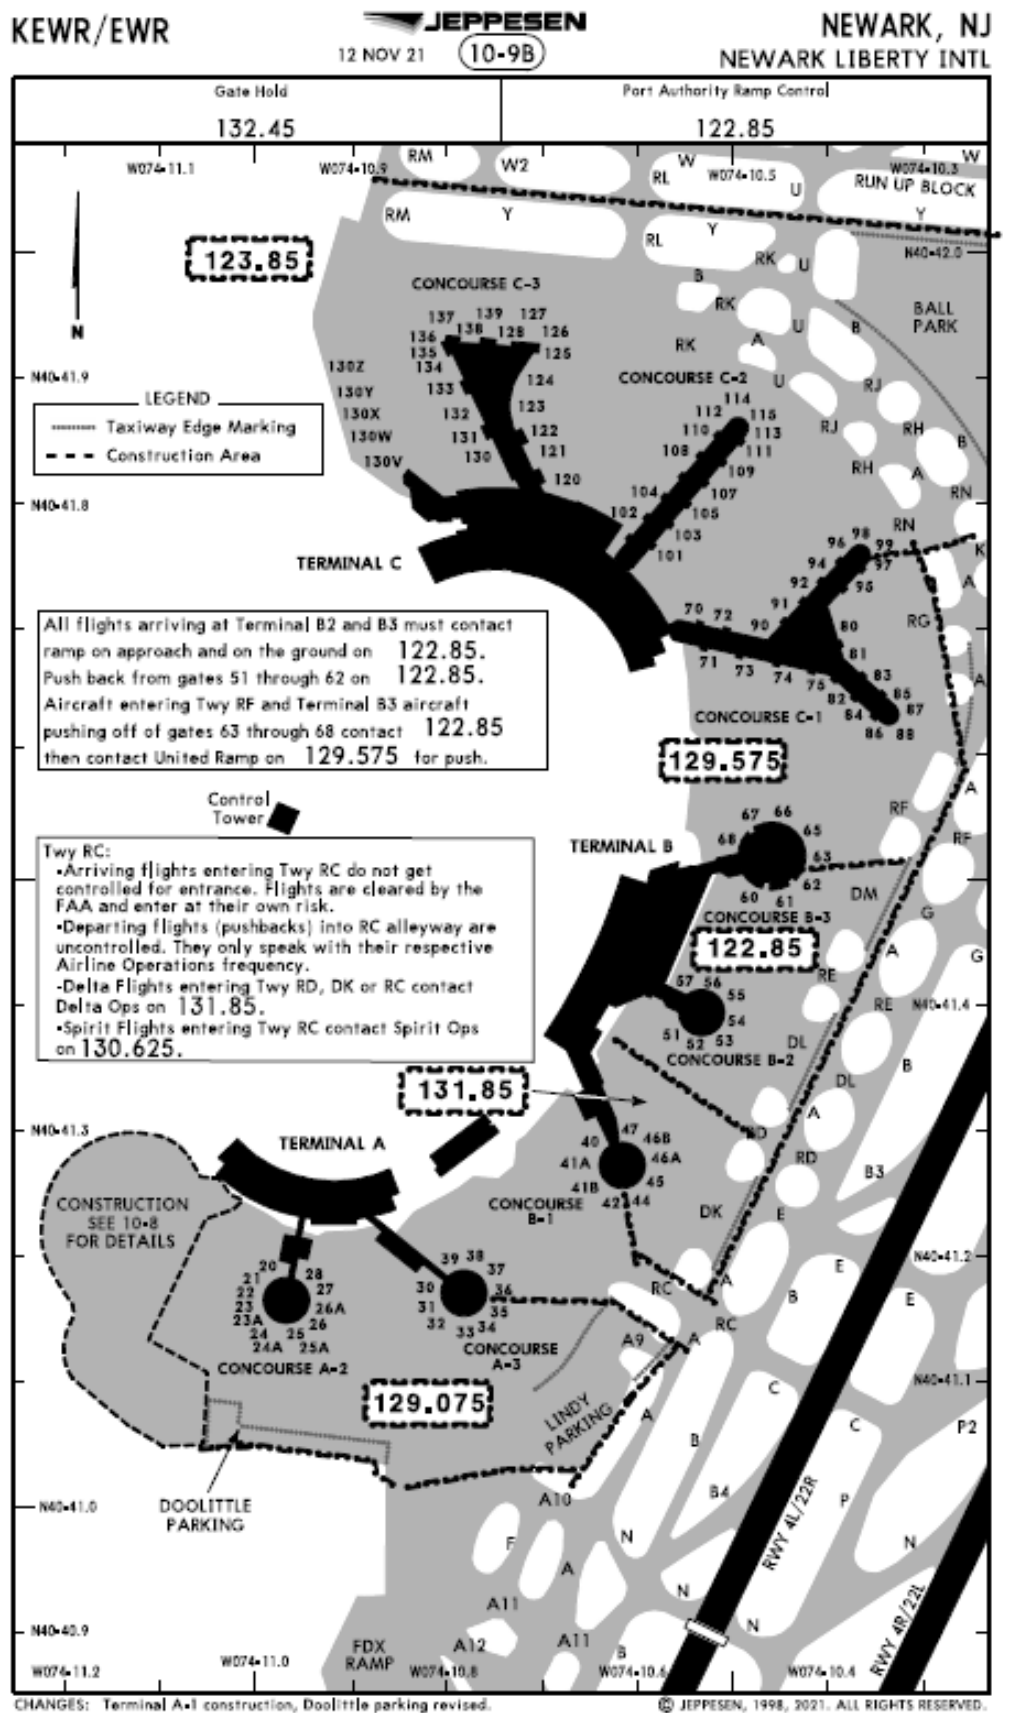
Flight crew stated in their written reports, also verbally when interviewed, that they landed at runway 04R, under wet surface condition, vacated runway via P4, crossed parallel runway via L and contacted Ground Control for further taxi instructions. Then they were cleared to taxi on S and A taxiways respectively. The flight data acquired from the aircraft matches the statements of the crew. They also stated that CM2 contacted Ramp Control, by third radio (VHF3), initially on 129.575 MHz, then directed to 123.850 MHz, then finally to 122.850 Mhz. They were then cleared to gate 63 via DM taxiway. Crew were monitoring Ground Control on first radio (VHF1) at all times. There wasn't any information relayed to flight crew about the traffic which was short of parking position along their route. The crew declared that they slowed down and checked twice if there is enough space between two aircrafts. The chart below depicts the parking positions and responsibility areas of each frequency.

- To improve communications procedure for ground movements at KEWR airport in order to let ground controller be informed of and inform relevant traffic of any aircraft in an inappropriate/unusual position along its route. Effective information exchange between various ground traffic frequencies (aprons/ground) should be assured for irregularities such as partially parked aircraft or for any location an aircraft may be concerning both ground and apron area of responsibility.

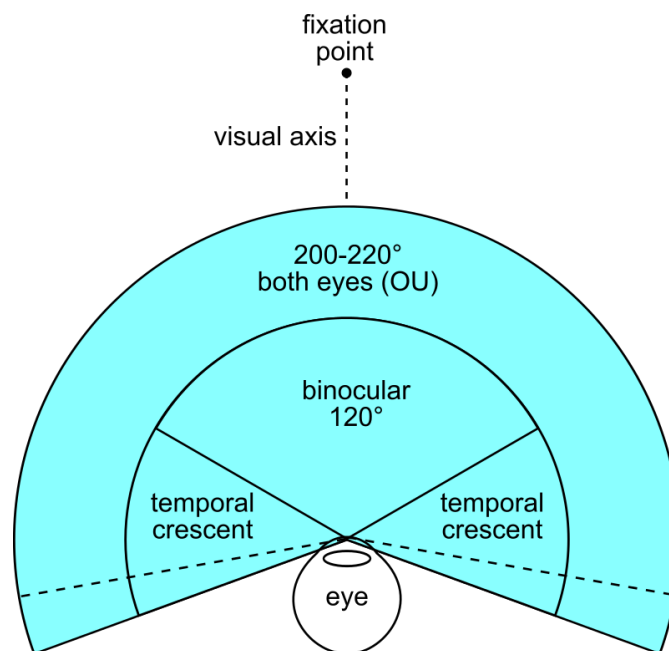
Various studies state that, the field of vision in humans is approximately 190 degrees (95 degrees to both sides) horizontally. 3D vision is achieved in the area where both eyes are able to see and it expands up to approximately 60 degrees to both sides. This makes total of 120 degrees area of 3D vision. The remaining peripheral on each side have only 2D vision. 3D vision area is depicted as binocular at the figure below.

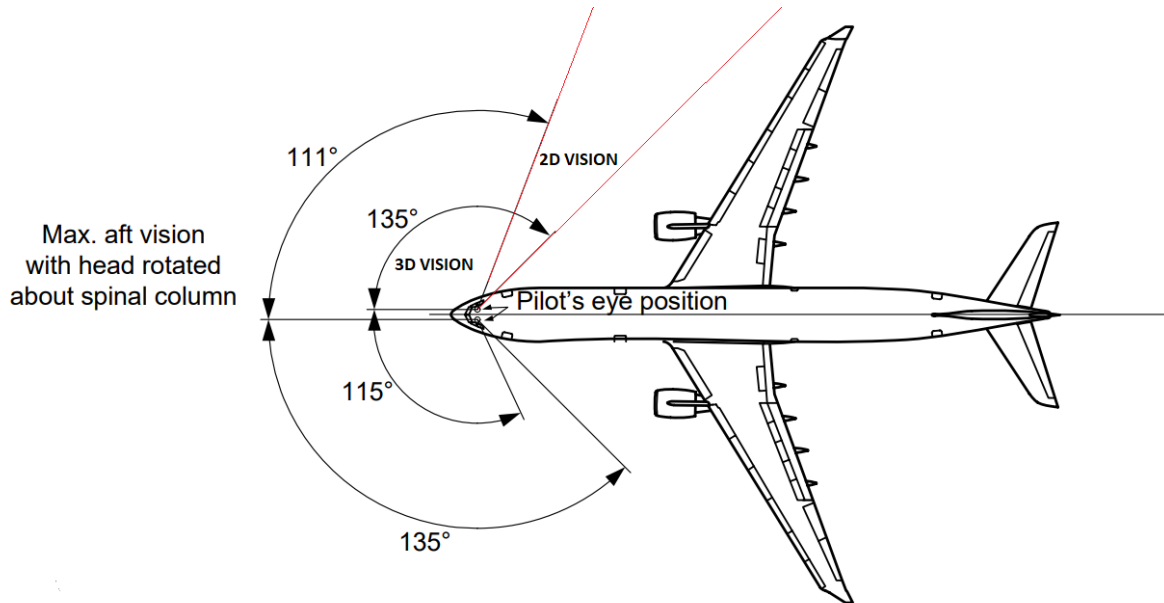
The figure below is from a document named *A330 Flight Deck and Systems Briefing for Pilots*, which was published by Airbus Company. Although it is stated that it must not be used as an official reference, it gives a good idea about field of view of a pilot from the cockpit. The figure is modified to show areas of 3D and 2D visions.

Field of view may be expanded by bending towards side window but most probably wing tip will remain in 2D vision area.

- To remind crews that they must stop and ask for any available assistance (follow me or wing man) if they are approaching an aircraft which is not on its parking stand and/or if they have any doubt about ground clearance at any time.
