# National Transportation Safety Board

DCA22LA126

## **AIR TRAFFIC CONTROL**

Group Chair's Factual Report

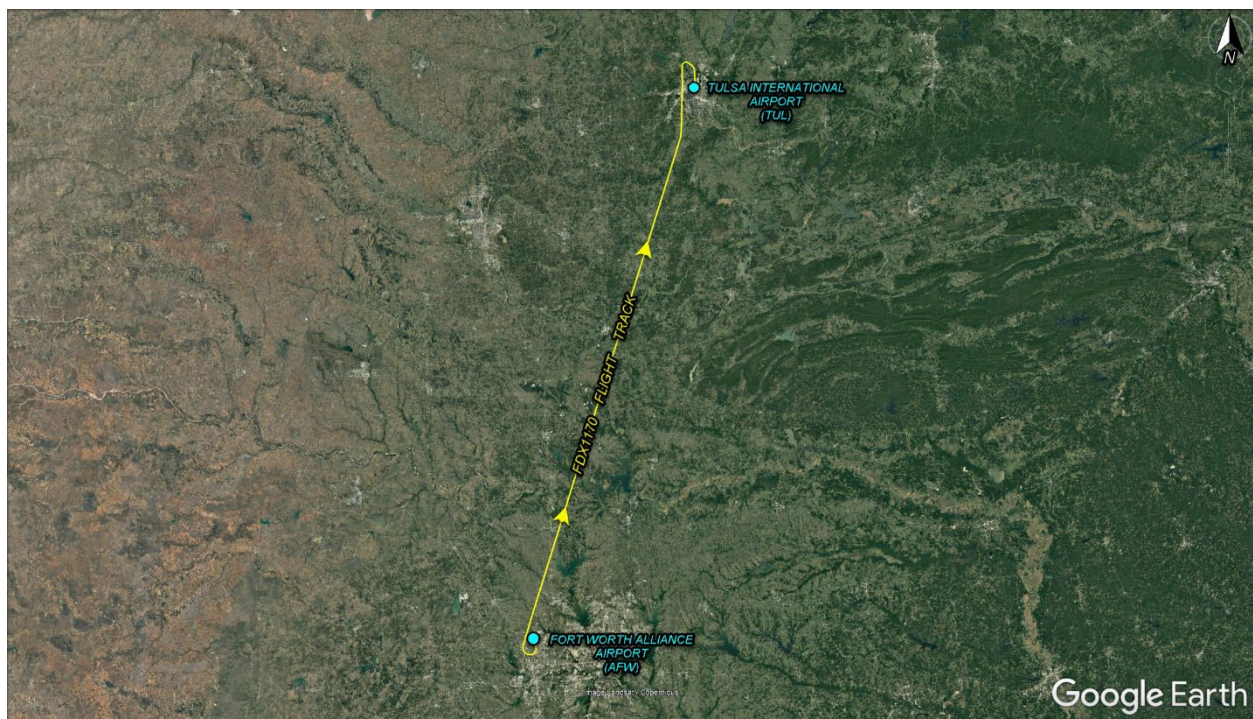
**Figure 1.** Overview of the entire incident flight track overlaid on satellite imagery.

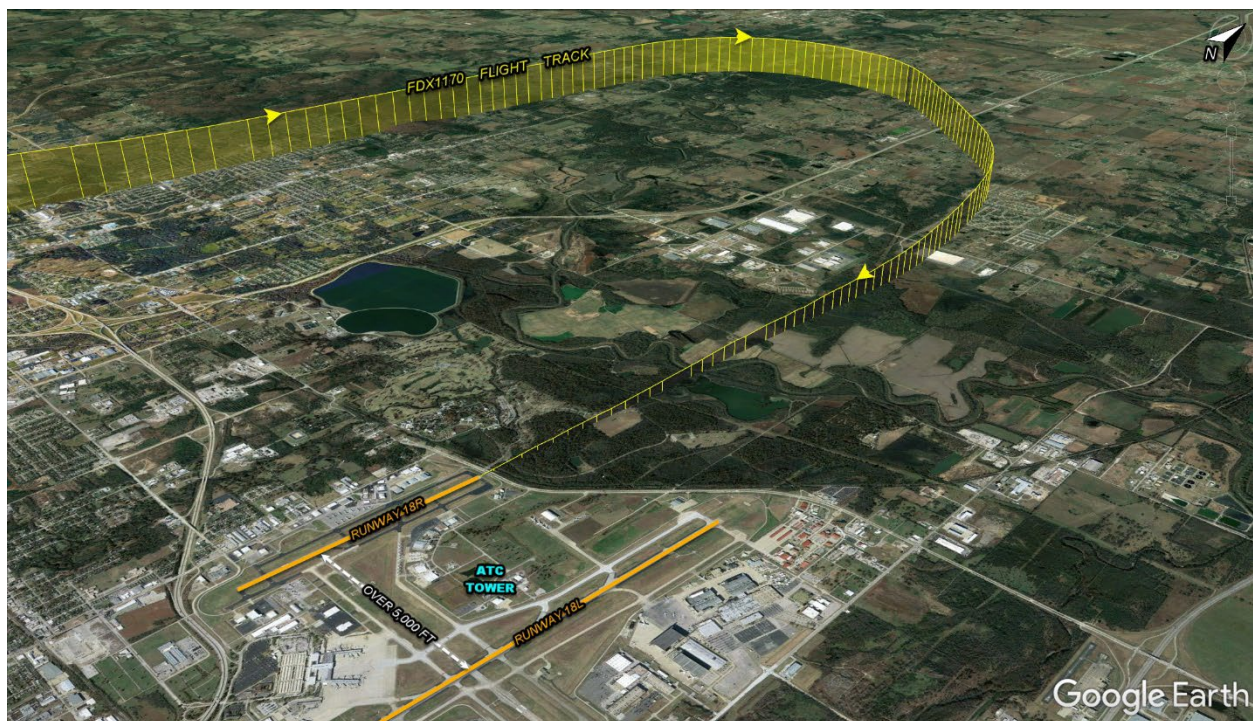
In all three figures, the incident airplane's flight track is indicated in yellow, and arrows are used to indicate direction of flight. In figure 2, the runways are highlighted in orange for visual reference and in figure 3 runway 18R is indicated in orange and runway 18 left is indicated in green. The dashed lines illustrate the approximate straight-in final approach course for each runway.

**Figure 2.** Final portion of the incident flight track in profile view, viewed from SE to NW and overlaid on satellite imagery.

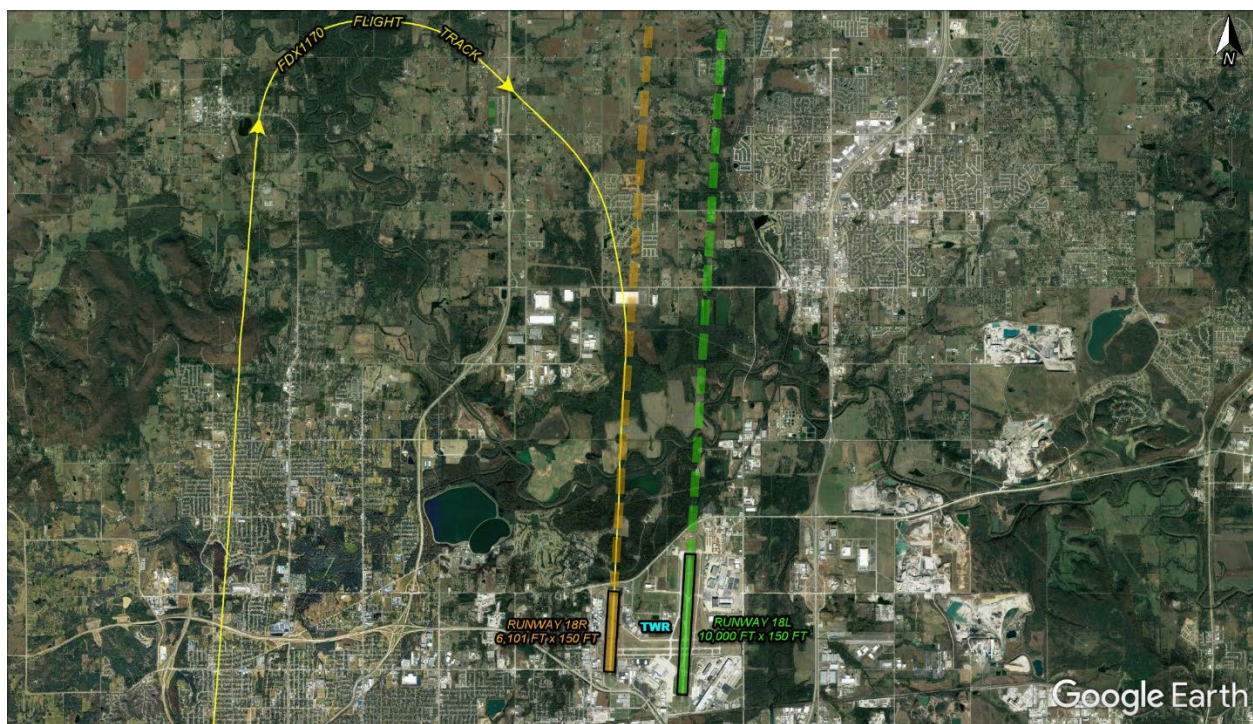
- 0414 After landing rollout the pilot advised the controller they had landed on the wrong runway [runway 18R] and requested to taxi to parking. The controller then provided taxi instructions to parking.

**Figure 3.** Final portion of the incident flight track in overhead view and overlaid on satellite imagery.
