# National Transportation Safety Board

DCA22LA126

## **OPERATIONAL FACTORS/HUMAN PERFORMANCE**

Group Chairs' Factual Report

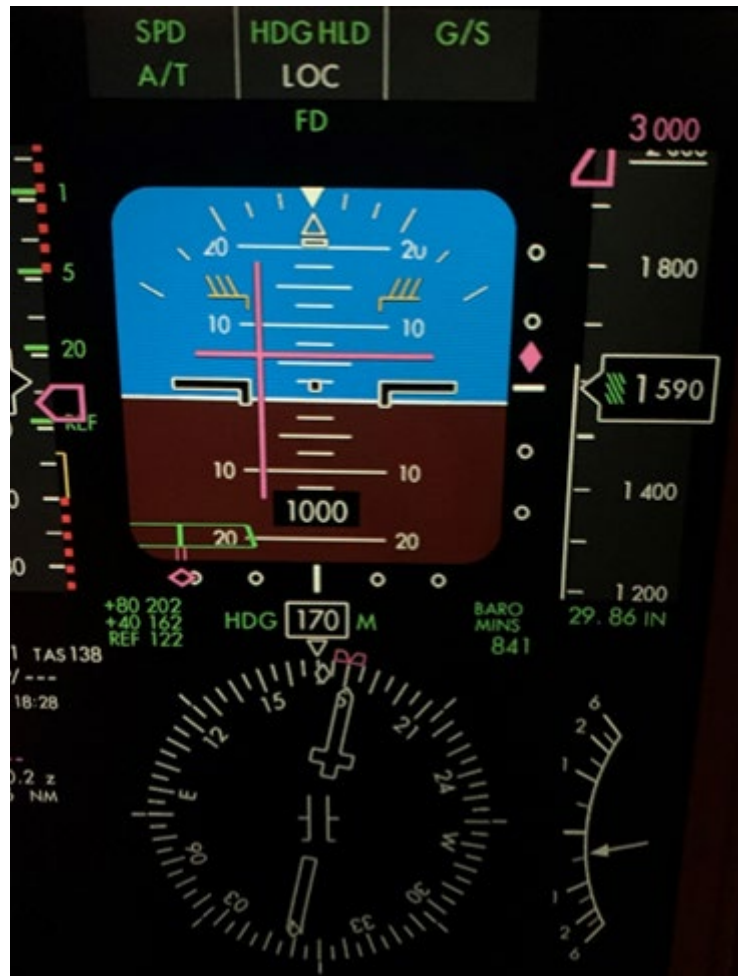
**Figure 10.** Simulator PFD as viewed approaching runway 18R.

ILS to runway 18L. During the visual approach to runway 18R the PFD (see figure 10 below) and HUD, as seen in section 8.4 of this report, indicated that the aircraft was to the right of course and below the glideslope.

Several approaches were made to runway 18R and 18L. In these approaches the RAAS annunciated approaching the runway the airplane was aligned with, irrespective of the ILS frequency that was selected. One item that was noted during the approach to runway 18R was the EGPWS "glideslope" audible warning was annunciated approximately 13 times. During the crew interviews there was no indication that they received the aural alert. On approaches to 18R the flight mode annunciator indicated the glideslope was captured but the localizer (LOC) was still illuminated in the armed (white) mode indicating it had not captured.
