# National Transportation Safety Board

DCA22LA133

## **SYSTEMS**

Group Chair's Factual Report

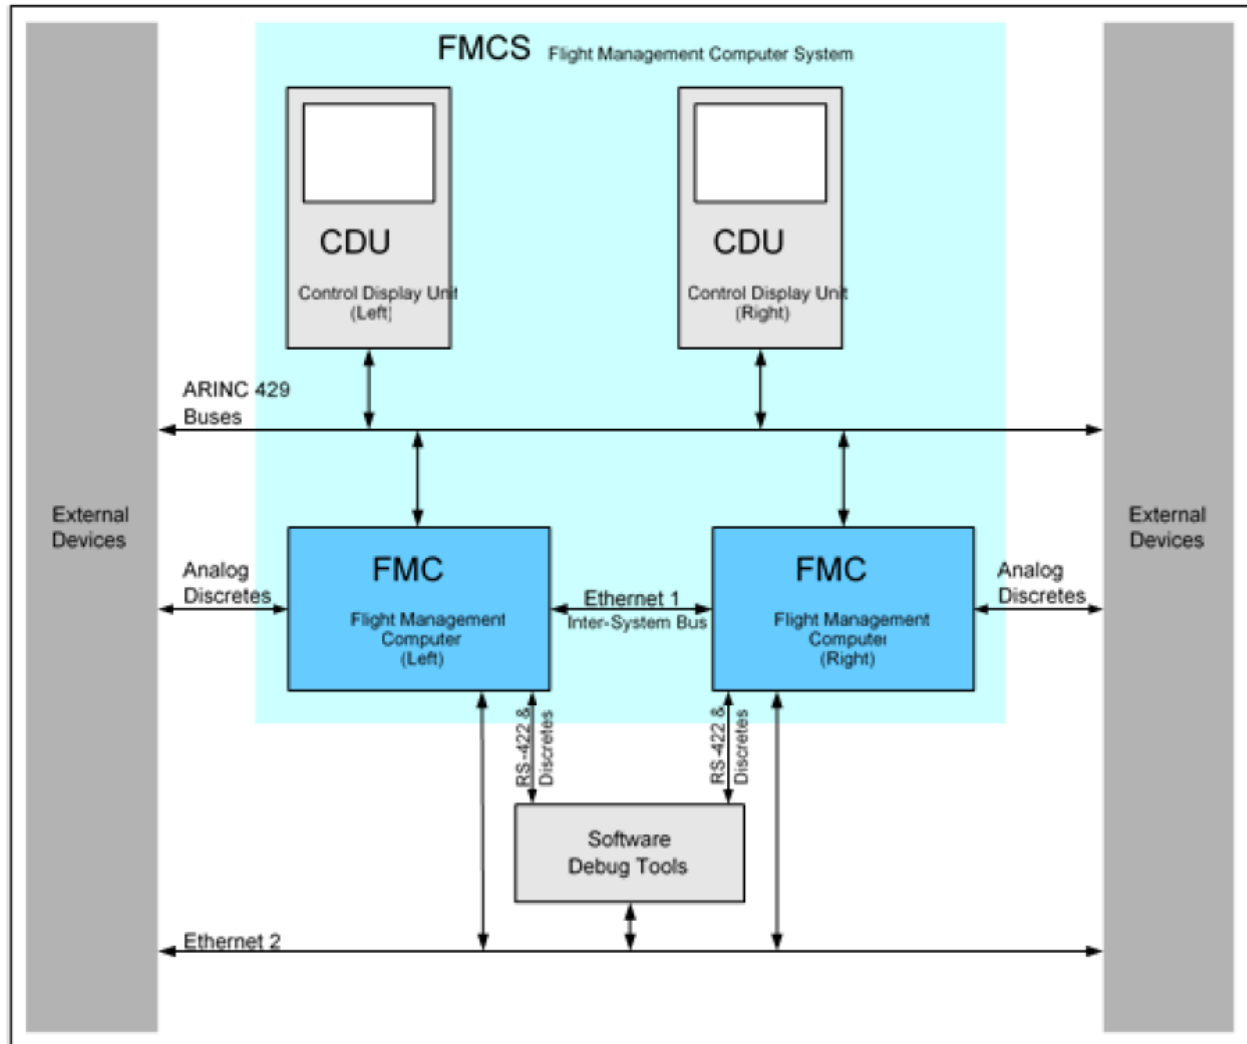
**Figure 1.** FMCS Simplified Block Diagram. (Courtesy of GE)
