**FROM / ÉMETTEUR:** RAPHAËL ROCHETTE**TO / DESTINATAIRE:** EXTERNAL**INTERNAL DISTRIBUTION:** JOHN CLOSE, BOGDAN PANTELIMON, RAVI SANGHERA, CRAIG BOVAIRD, ALEX CHEN, MURRAY WYVILLE, GARY LAI, SHAWN KEHOE**SUBJECT/OBJET:** SKYWEST CRJ MSN 7871 RUNWAY EXCURSION INVESTIGATION – KES, SEDC & SLS VISIT REPORT

This report relates to the investigation of the off-runway excursion involving SkyWest Airlines CRJ-200 MSN 7871 which happened at Houston's George Bush Intercontinental Airport on May 11, 2022. There were no injuries to any of the passengers or crew, and no damage to the aircraft was reported. The aircraft had 3 points landing, touching down at 109 kts. At about 71 kts, the aircraft started to deviate to the right of the runway. Differential braking and left rudder were applied to counteract and correct the lateral deviation. The aircraft veered off the runway at 50 kts, and came to a stop in a grassy area. FDR data showed that the NWS FAIL Caution parameter was triggered after the aircraft exited the runway. Inspection of the Nose Landing Gear was conducted at SafranLS and did not identify a cause for the incident. A full steering ATP was performed on the NLG assembly and was co

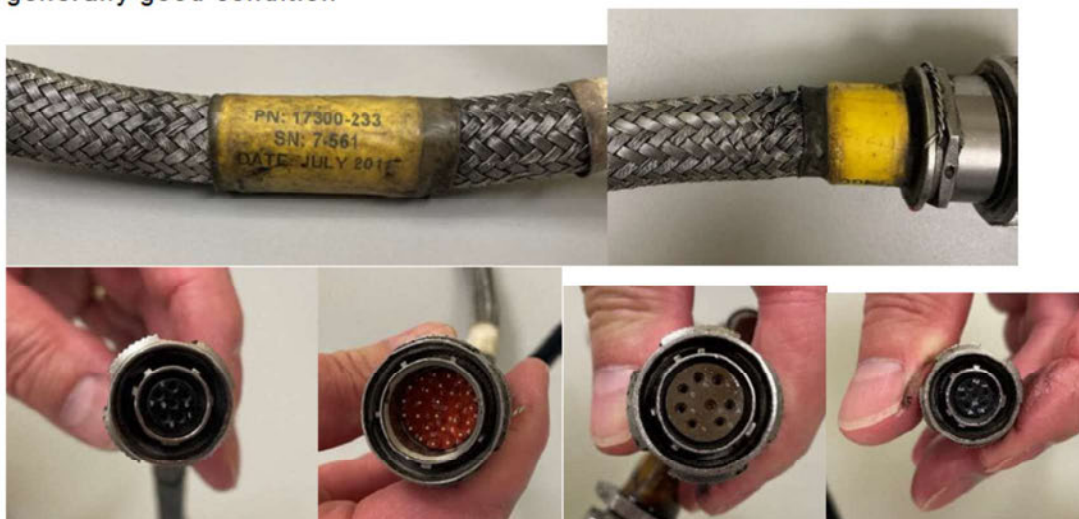
- Unboxed harness and moved to the test area
- Visual inspection revealed that the harness was repaired by a third party based on appearance of the ID label. This was further observed during disassembly based on the quality of the solder joints and some of the products used (unidentified brown tape found under some of the heatshrink). Some fraying of the stainless steel braiding was observed. All connectors appeared to be in generally good condition

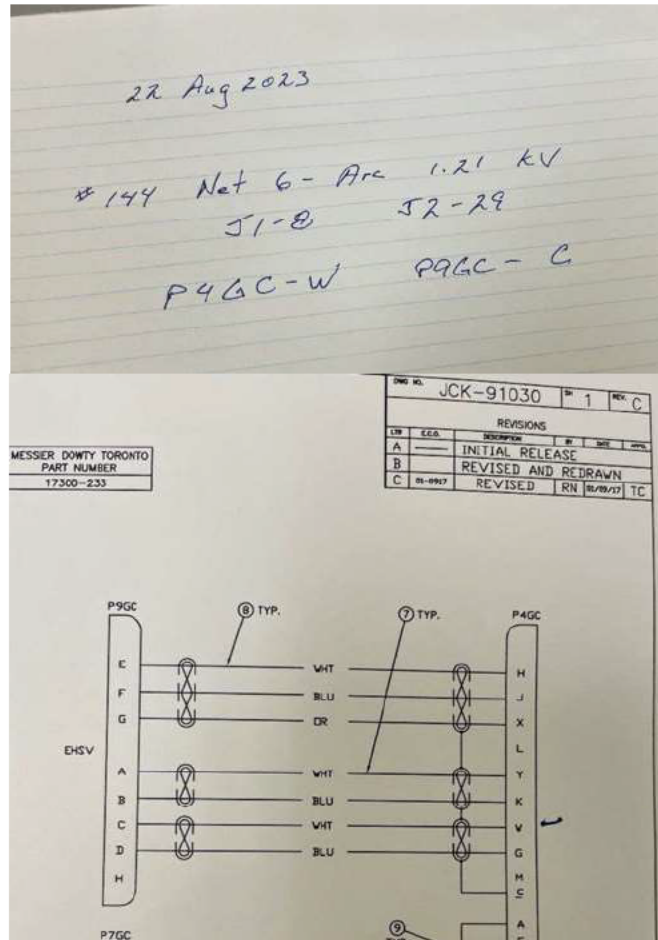
- The harness was connected to the test equipment and tested in accordance with Test Procedure 7619-1 rev.B. This is the same ATP revision as when the harness was manufactured. The harness passed the electrical bonding and conduit conductivity test as well as the continuity test but failed the hipot test for dielectric strength (Error code #144 Net6 DW Arc at 1.21 kV). Result indicated that the failure came from the connection P4GC-W to P9GC-C

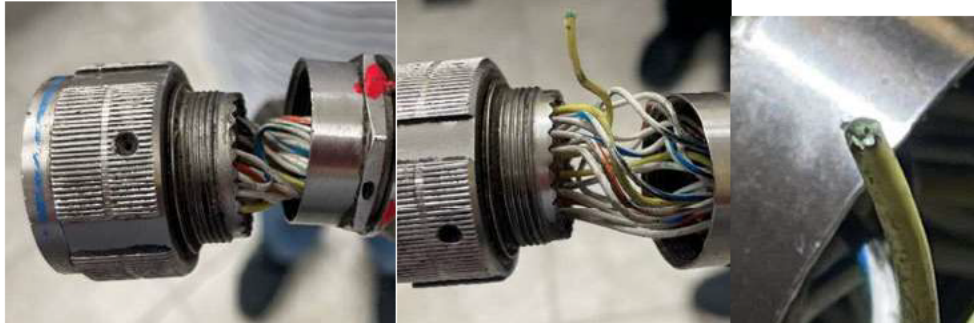
- It was observed that the connectors on the harness were not torqued to the required 50in-lb. The disassembly torque was not measured.
- The harness was disassembled at the P4GC connector in an attempt to identify the cause of the ATP failure. Upon disassembly, it was observed that the wires were twisted and one of the wires was broken. The broken end appeared green in colour suggesting corrosion of the copper conductor

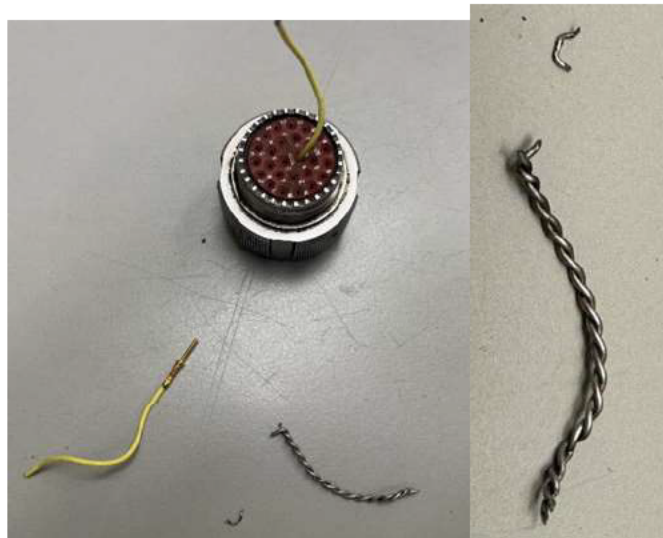
- The connector was removed by pulling each pin. In doing so, a second wire was found to be broken and a piece of FOD fell out. The FOD was similar in appearance to lockwire. Origin of the FOD could not be determined, however it was measure to be smaller in diameter than the lockwire that initially secured the connector in place.

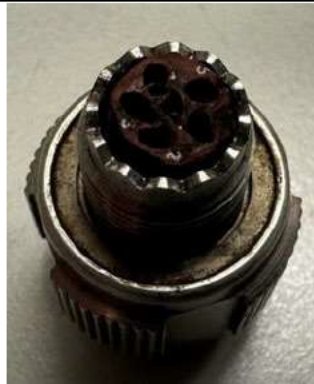
- The two broken wires were identified as the shield wires A and b.
- Disassembly continued to remove all conduit sections and expose all wiring. The rubber boot of connector P9GC was observed to be deformed. There were no other significant findings and the wiring appeared to be in good condition.

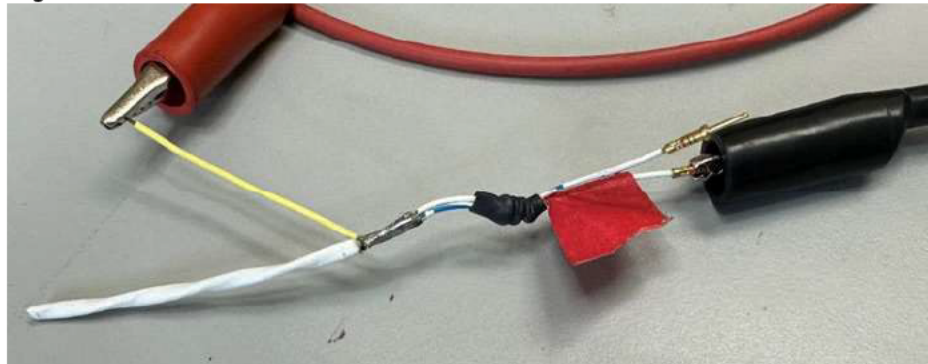
- The hipot test was repeated at multiple points during disassembly with always the same results. This lead to the conclusion that the source of hipot failure was located at the connection between the shield wire c and the cable shielding. This conclusion was validated by cutting the wires C-W and D-G just after the connection in question and reproducing the hipot failure on that small section of wiring.

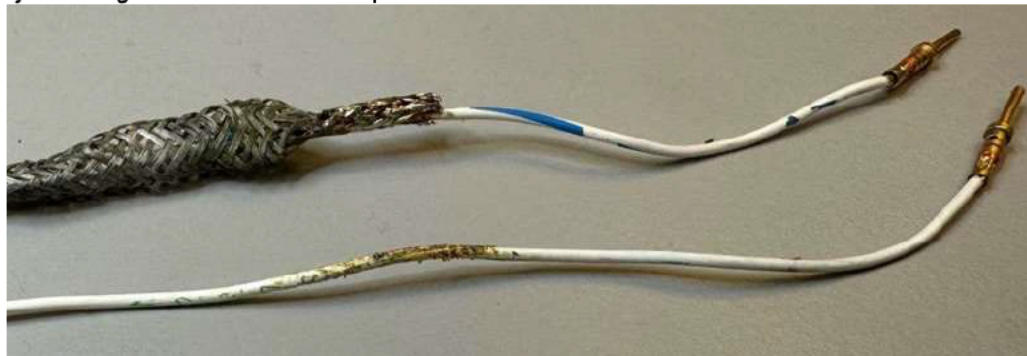
- The solder joint between shield wire c and the cable shielding was removed to allow inspection of the wire C-W. Visual inspection under 10x magnification identified one area of interest where the wire insulation located under the solder joint might have been compromised.

- Further inspection under optical microscope will be performed by SafranLS to confirm the finding.

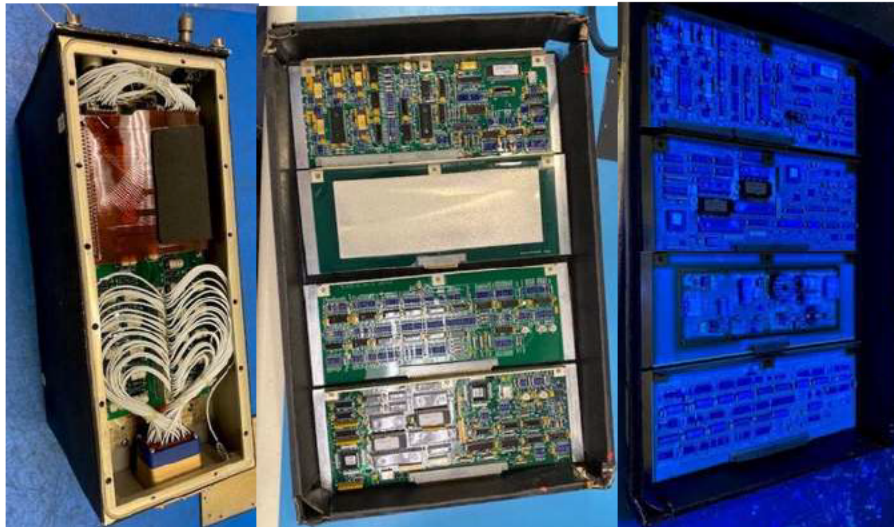
- The unit was disassembled and visually inspected. The PCB were inspected under UV light. The inspections revealed no abnormal findings.

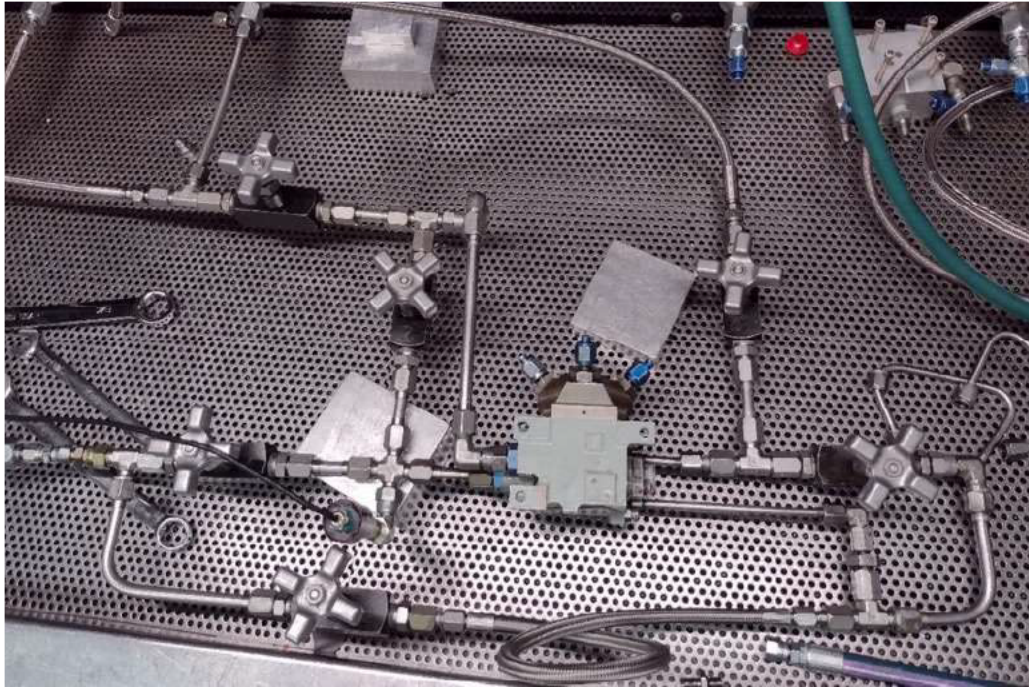
- The Manifold was tested per ATP 16480 Rev A. The unit failed at Step 5.4.4 where Flow1 is required to be between 0.95 to 1.40 GPM and was measured to be at 1.41 GPM. It was noted that this result is not unusual for a used unit and that this result could be due to wear.

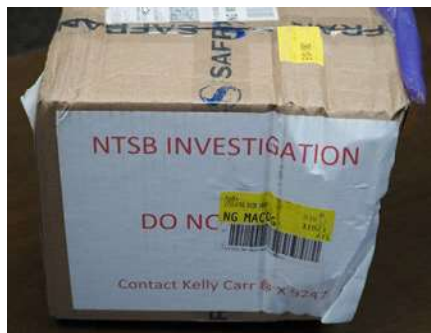
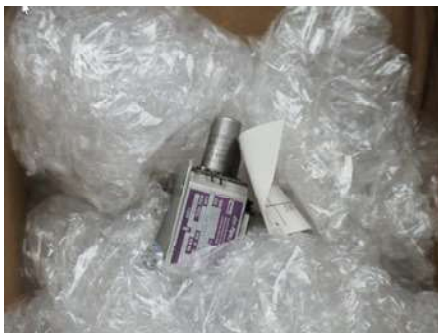
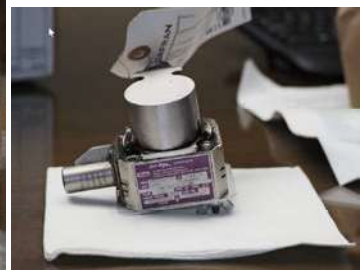
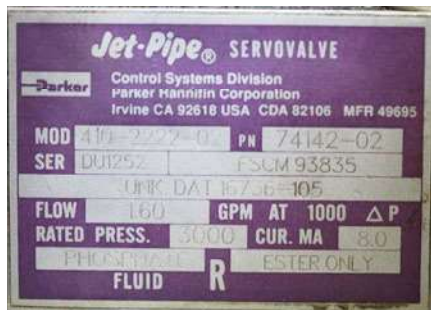
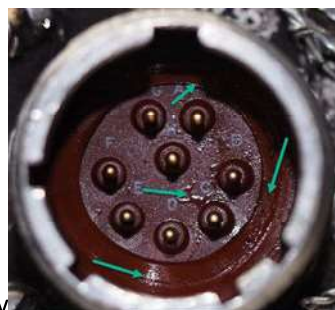
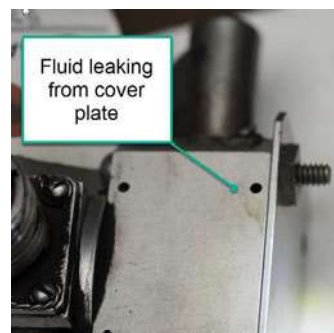
The EHSV was shipped to Parker Dublin and received on 9/11/2023 and was placed unopened into secured storage. The package was opened during the exam and the EHSV had a cover plate installed and was not bagged but was surrounded by plastic and paper. The connector had some shiny areas with what appeared to be fluid in the bottom of the connector (Green arrows show general areas of shiny fluid). Fluid was also observed coming from the cover plate. EHSV S/N DU1252 was previously repaired in Dublin in May of 2019 and the "DU" signifies the data plate had been replaced as it was missing when it was returned for repair. See Appendix C for Repair ATP data. All lockwire was present and consistent with typical Dublin practices and installation.

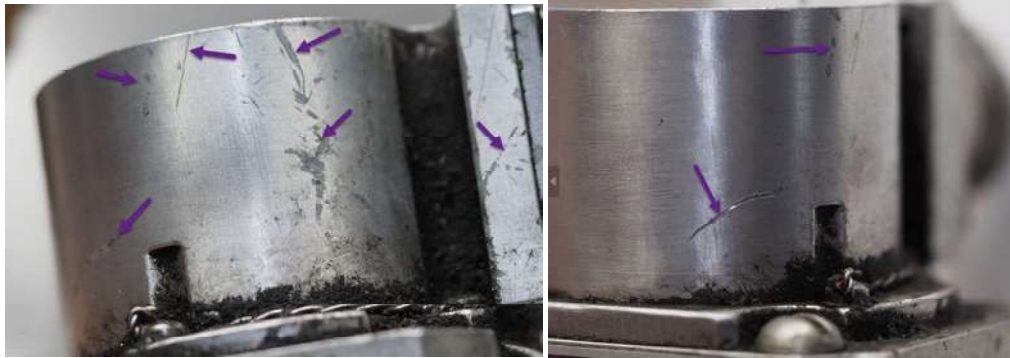
The torque motor cover had a gouge mark and other areas of contact marks on the torque motor cover (purple arrows showing some of the contact marks). The gouge or marks did not pierce the cover.

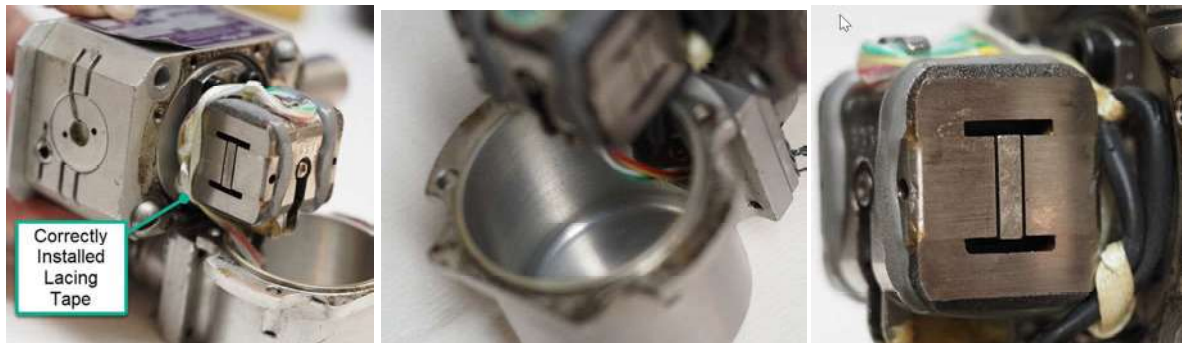
The EHSV was disassembled and the torque cover motor was removed. The lacing tape was correctly installed with short cutoff tails and were white in color and not interfering with the torque motor cover environmental O-ring. The torque motor cavity was dry with no evidence of corrosion or moisture. The torque motor armature airgaps were inspected under 10x magnification and no FOD was observed on either side. The inlet filter was removed and inspected under 10x magnification and no debris or FOD observed. The second stage spool and sleeve were removed and the spool had typical velocity marks but no heavy or deep scratching. All metering edges were sharp with no damage observed. The receiver jet had some slight erosion but overall appeared normal.

Armature Gaps under 10x Magnification – No FOD

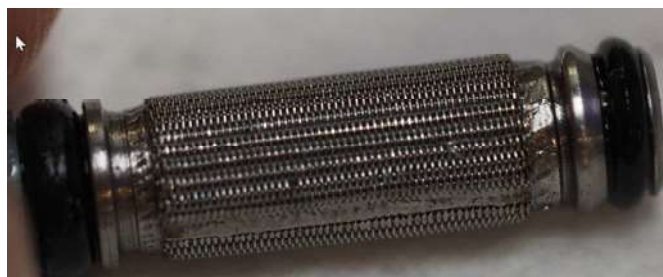
Inlet Filter – No FOD or Debris Observed

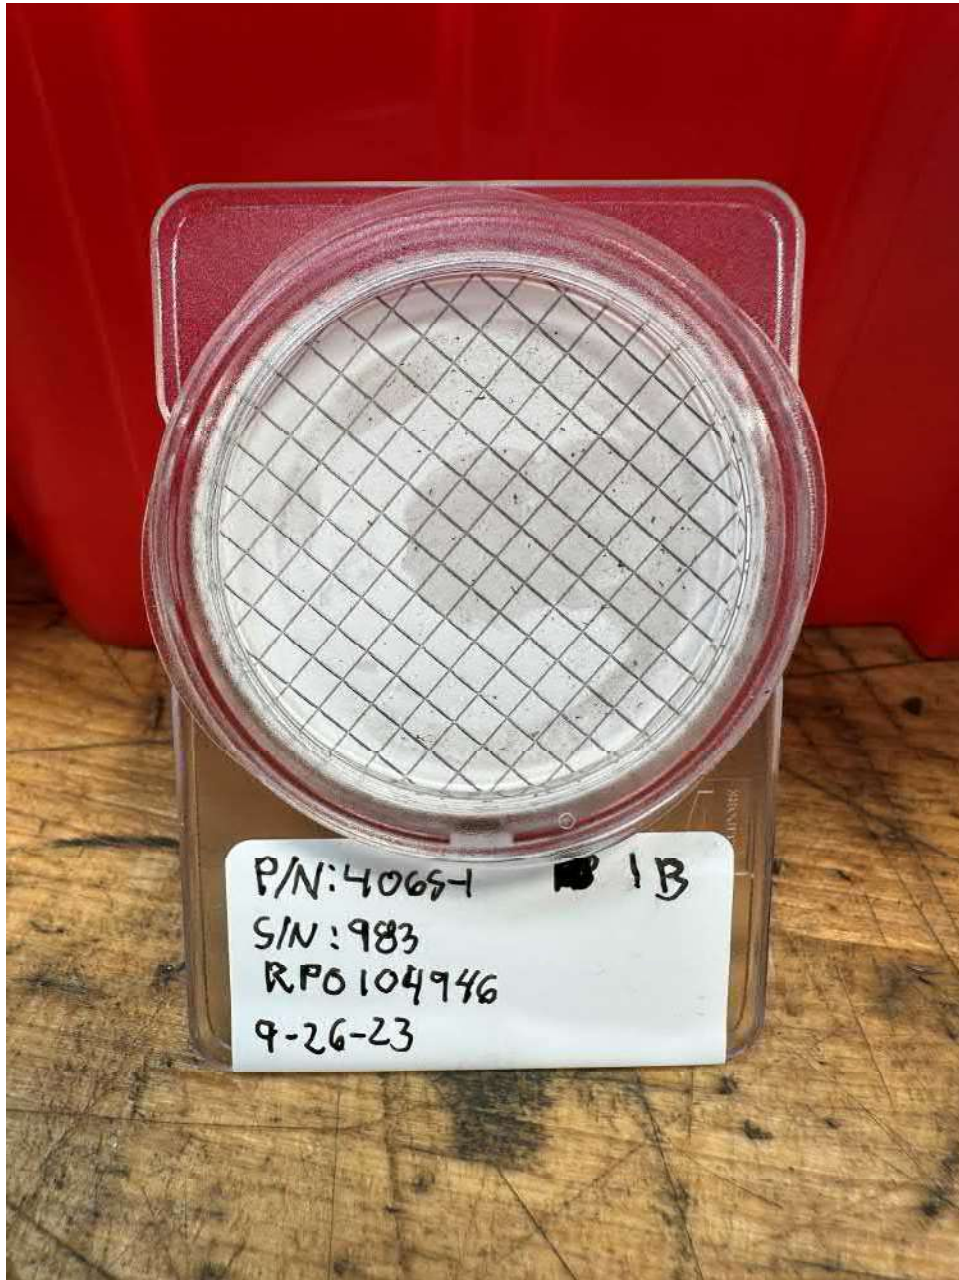
View of the inbound filter patch showing evidence of particulate FOD (deemed irrelevant in this case) from the aircraft hydraulic system upon which the component was installed.
