# National Transportation Safety Board

DCA22LA212

## **AIRCRAFT SYSTEMS**

Group Chair's Factual Report

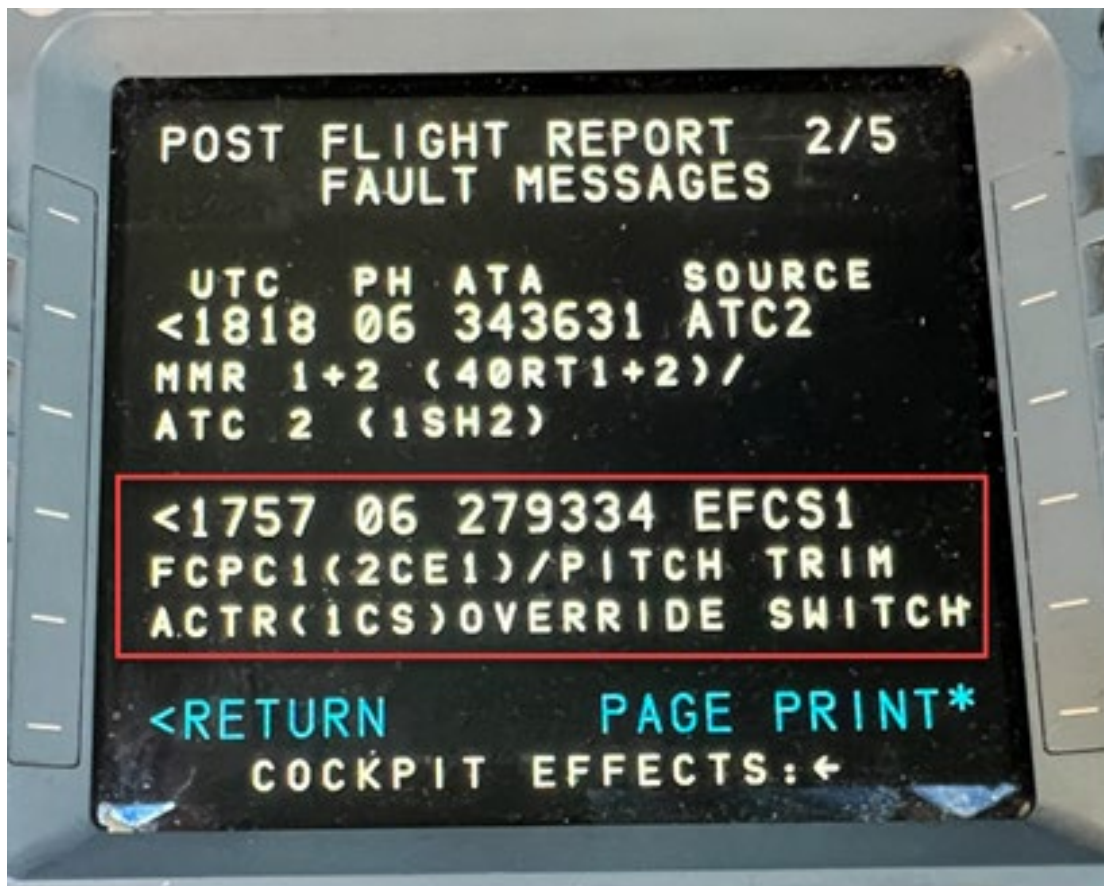
Following the flight, a post flight report accessed through the Multi-Function Control and Display Unit (MCDU) by the airline revealed a fault message "PITCH TRIM ACTR OVERRIDE SWITCH". See Figure 1.

**Figure 1. Post Flight Report Fault Message, as displayed on the airplane's MCDU.**

The fault message, along with guidance from Airbus, led Hawaiian Airlines maintenance personnel to perform Airbus' A330 Troubleshooting Manual (TSM) Task 27-44-00-810-801-A. The TSM task, when accomplished, required the replacement of the PTA via Aircraft Maintenance Manual (AMM) 27-44-57. The PTA serial number 1590 was replaced by PTA serial number 414. Once the PTA was replaced, the THS actuator tested good per AMM 27-44-00-710-805-A, "Operational Test of the Trimmable Horizontal (THS) Actuator". The maintenance crew was unable to replicate the fault on ground.

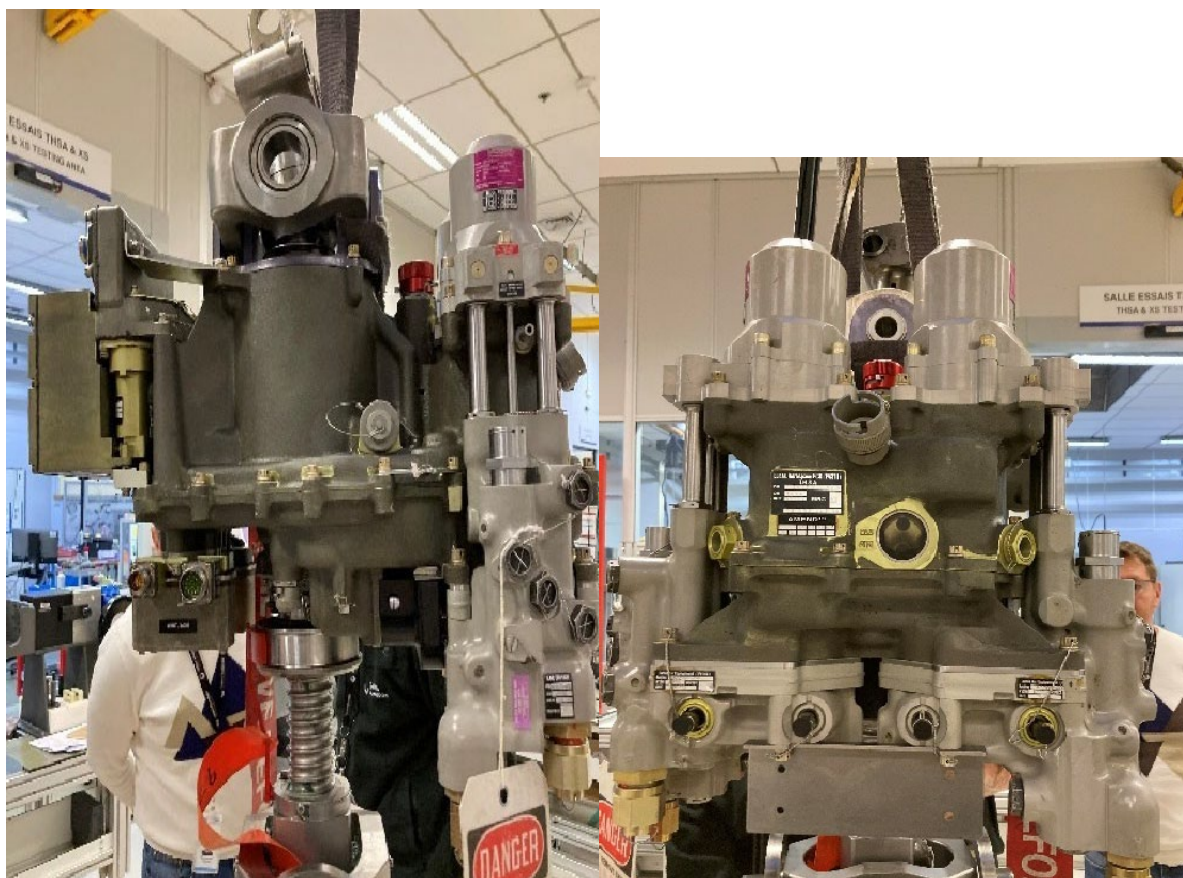
**Figure 5. The THSA, as received at Collins.**

1. The sub-component MON RVDT (part number 423473-100, serial number 823) was different than the MON RVDT (s/n AR00476) that was installed on the THSA for the September 22 incident flight. The incident MON RVDT was removed in November, 2022.
2. The sub-component COM RVDT (part number 450102, serial number AR00066) was different than COM RVDT s/n AR00450) that was installed on the THSA for the September 22 incident flight. The incident COM RVDT had been removed and replaced from the THSA in November, 2022.
3. The sub-component PTA (part number 47148-122, serial number 920) was different than the PTA (47148-122, serial number 1590) installed on the THSA at the time of the incident, as the PTA was replaced following the September 22 incident flight.
4. No significant physical damage was noted on the unit.

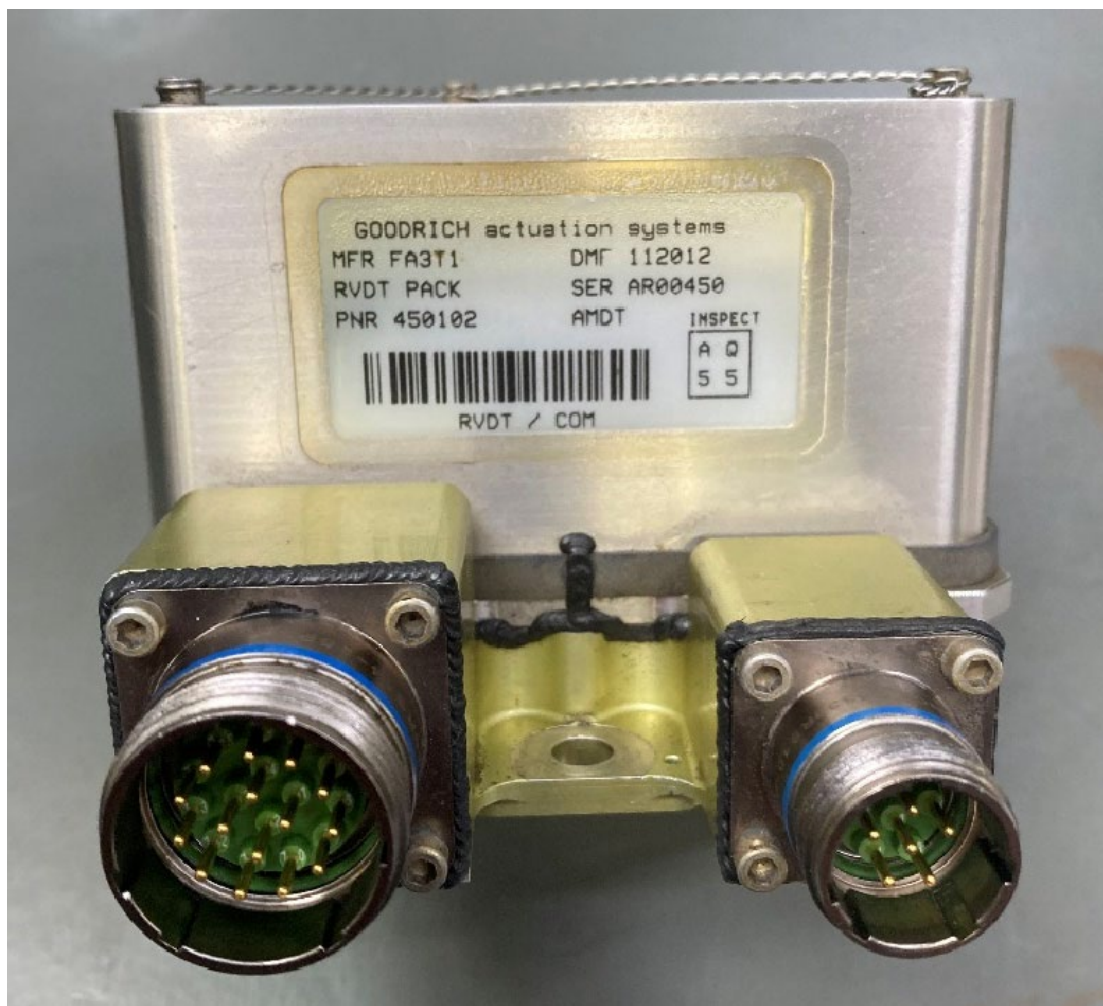
**Figure 6. The COM RVDT, serial number AR00450, prior to its sub-assembly test.**

- For both RVDTs, the visual examination determined no evidence of physical damage or corrosion. The black sealant compound on both packs was in good condition.
- For both RVDTs, no anomalies were found with the electrical connectors.
- The check of the COM RVDT position sensor accuracy at a THS position of 0 degrees and 14.9 degrees passed within CMM limits.
- The check of the MON RVDT position sensor accuracy at a THS position of 0 degrees was out of CMM limits. For the accuracy determination, the two root mean square (RMS) voltages for each of the three position transducers is calculated to a ratio. The ratio should be within  $\pm 0.0016$  to be considered within CMM limits. The ratio was calculated at -0.0048, -0.0025, and -0.0036 for the MON transducer Number 1, Number 2, and Number 3, respectively. When checked second time, the ratio was calculated at -0.0047, -0.0019, and -0.0033

- The check of insulation resistance for both components was found within CMM limits.
- In addition to the CMM tests, the DC resistance for the units was checked. All sensors measured were compliant, except for the Number 2 sensor of the RVDT MON, which exceeded the sensor data. The resistance was measured at 74.3 ohms instead of the maximum allowed value of 28.76 ohms.

- Following the disassembly, the two units were placed into a climatic chamber and cold-soaked at -55 degrees Celsius for 85 minutes. Following the climatic chamber, the COM RVDT and MON RVDT were again checked for their DC resistance. For the COM RVDT, all the measured values were consistent with the previously measurements. For the MON RVDT, all the measured values were consistent with those previously measured, and the Sensor #2 failed again.

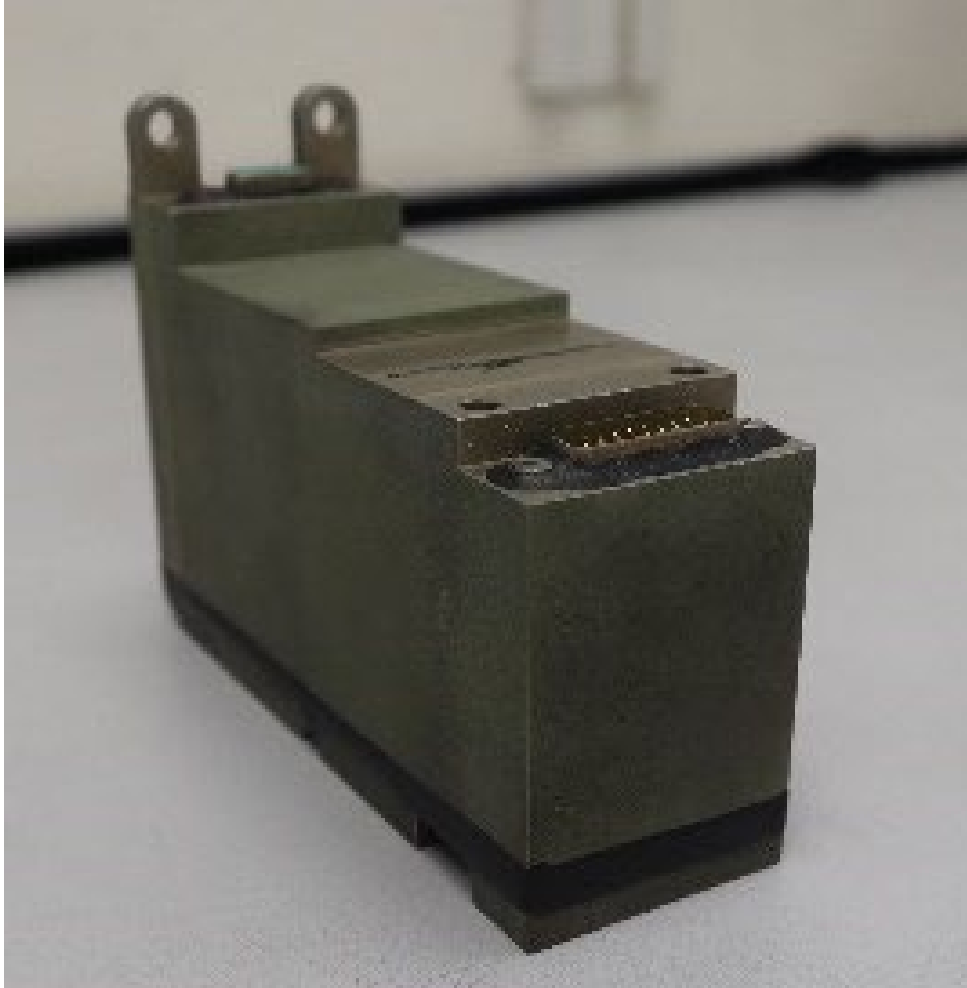
**Figure 7. The DEM1, prior to examination.**

- The isolation and bonding tests were found within CMM limits.
- The DEM leakage test failed as the recorded pressure was below the CMM minimum limit<sup>3</sup>. For the test, the DEM internal pressure is raised to 199.0 kilo Pascals (kPA) and checked after 1 minute; the pressure should not drop by more than 40 kPA during the minute. The recorded pressure after 1 minute was 124.7 kPA.
- The DEM passed the automatic test equipment tests within CMM limits.
- The DEM was placed in a climatic chamber, the temperature lowered to -55 degrees C and held for twenty minutes, and the unit then re-tested to the CMM. The DEM passed; no anomaly or oscillations were noted.

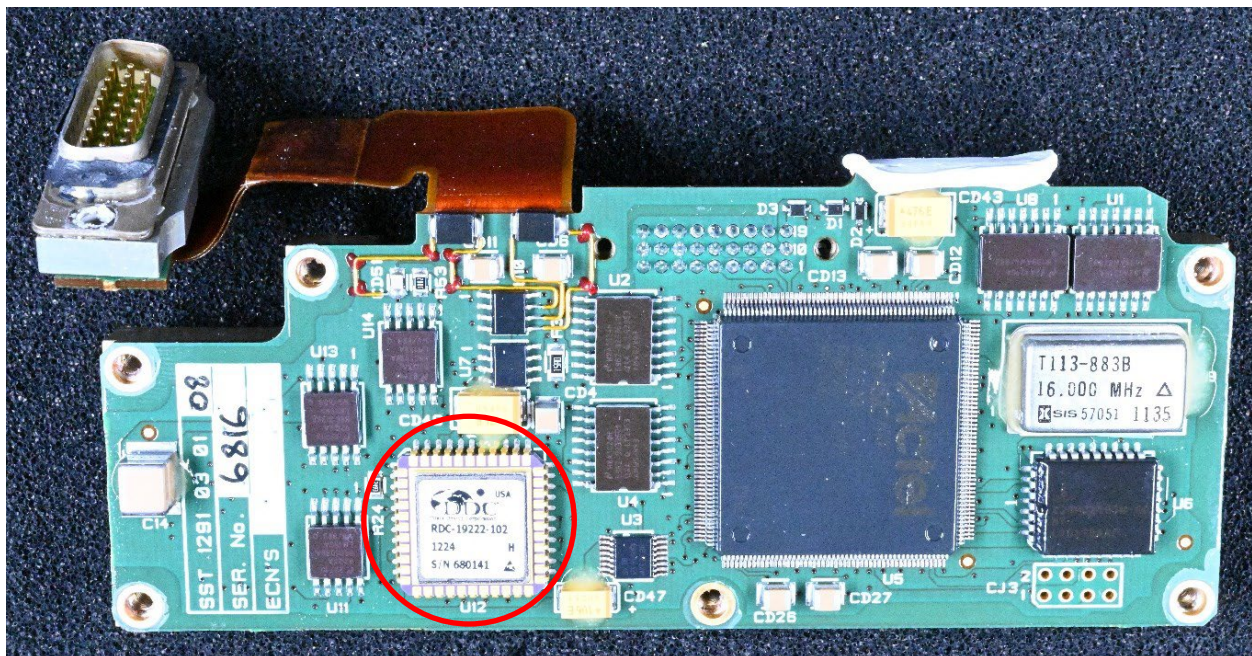
**Figure 8. The DEM1's Control Board, external side. The RDC device (U12) is circled in red.**

- The boards were examined under microscopes. The boards were noted in good condition with no traces of moisture or corrosion noted.
- No anomalies were observed on the interconnectors or the boards' surface components.
- A detailed examination of the RDC digital controller was conducted. The connector pins were observed to be in good condition, with no faults noted on any of the pin solder joints. See Figure 10.

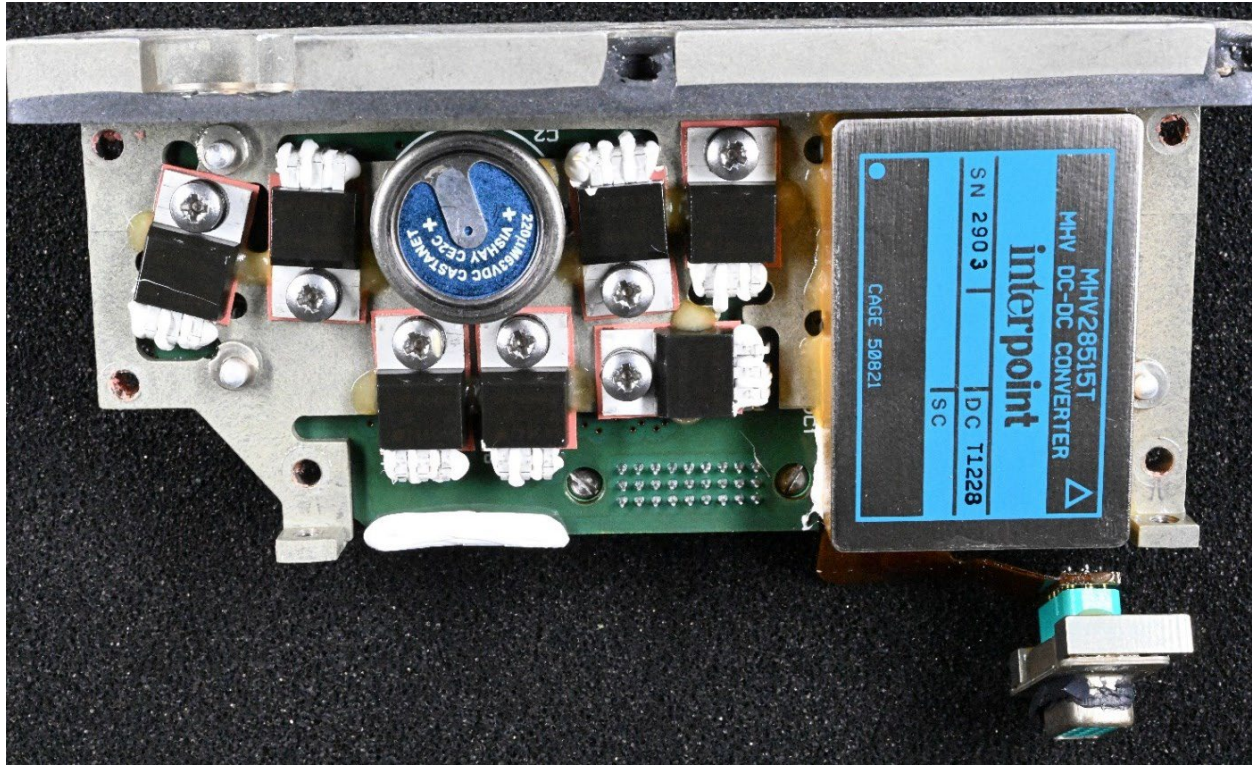
**Figure 9. The DEM1's Power Board, external side.**

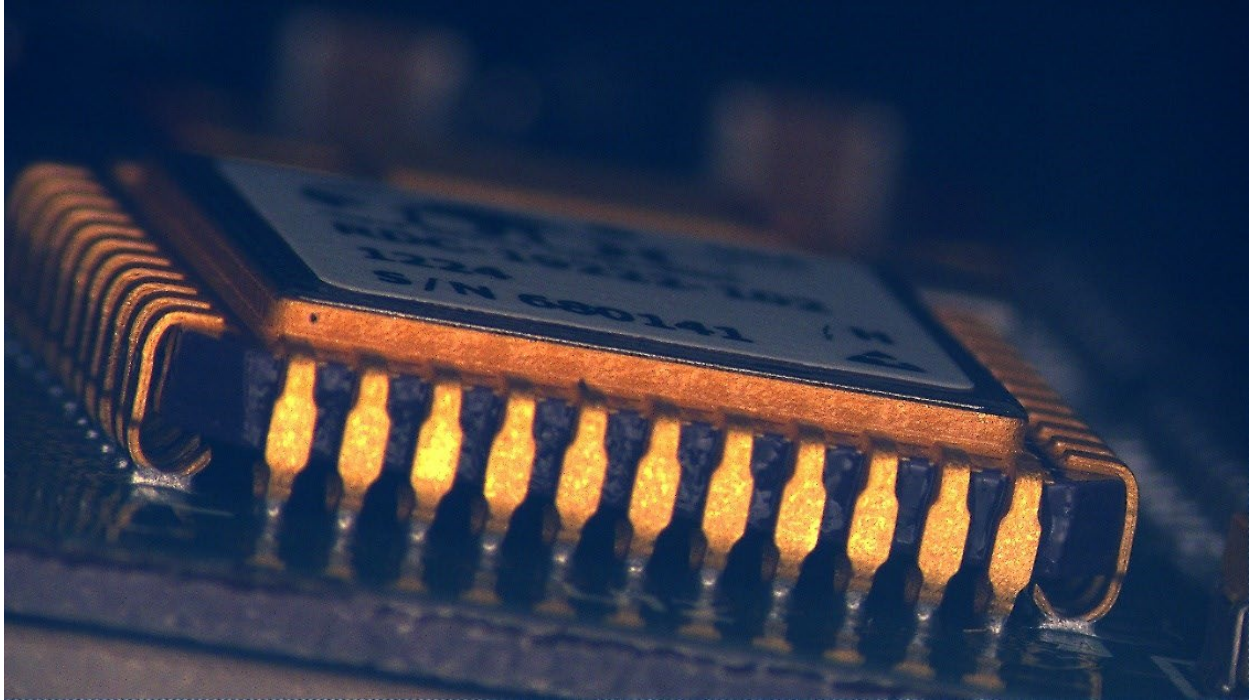
**Figure 10. The RDC device, side view to show connector pins.**

- An X-ray examination of the control board was performed, with no faults observed on the interconnection circuit nor on the surface components or connection bonding.
- A CT scan was performed on the control board. After the scans were conducted and the board rendered in three dimensions, all the RDC pins were examined individually, with no damage observed. No anomalies were noted on the tracks from RDC data pins to the field-programmable gate array.
