# National Transportation Safety Board

DCA23FA339

Group Chair's Factual Report

Location: Charlotte, NC  
Date: June 28, 2023  
Time: 08:52 EDT  
12:52 UTC  
Airplane: Boeing 717-200, N955AT

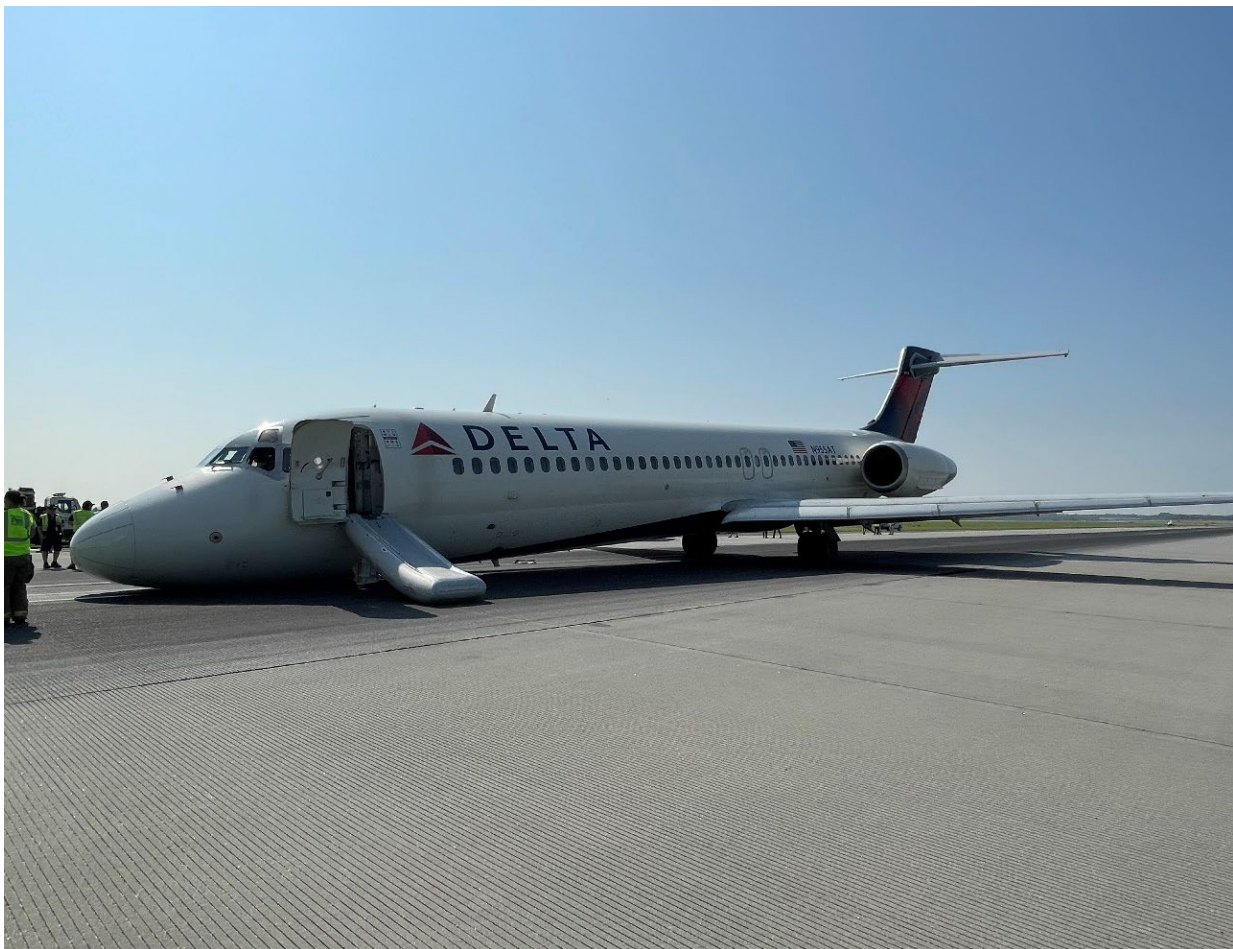
The Systems group convened on June 29, 2023, at Charlotte Douglas International Airport, to examine the accident airplane. The airplane landed without the nose landing gear in the down and locked position and the airplane came to rest on the runway centerline (see Figure 4). On June 28, 2023, Delta Air Lines Inc., in coordination with the NTSB via phone and with the FAA Charlotte Flight Standards District Office (FSDO) on-scene, recovered the aircraft from the runway to a maintenance ramp. A NTSB representative arrived at the airport at approximately 6:00pm EDT on June 28, at which time the aircraft was being towed from the runway.

**Figure 4:** Aircraft on runway following the accident landing. (Photograph used with permission from the FAA)

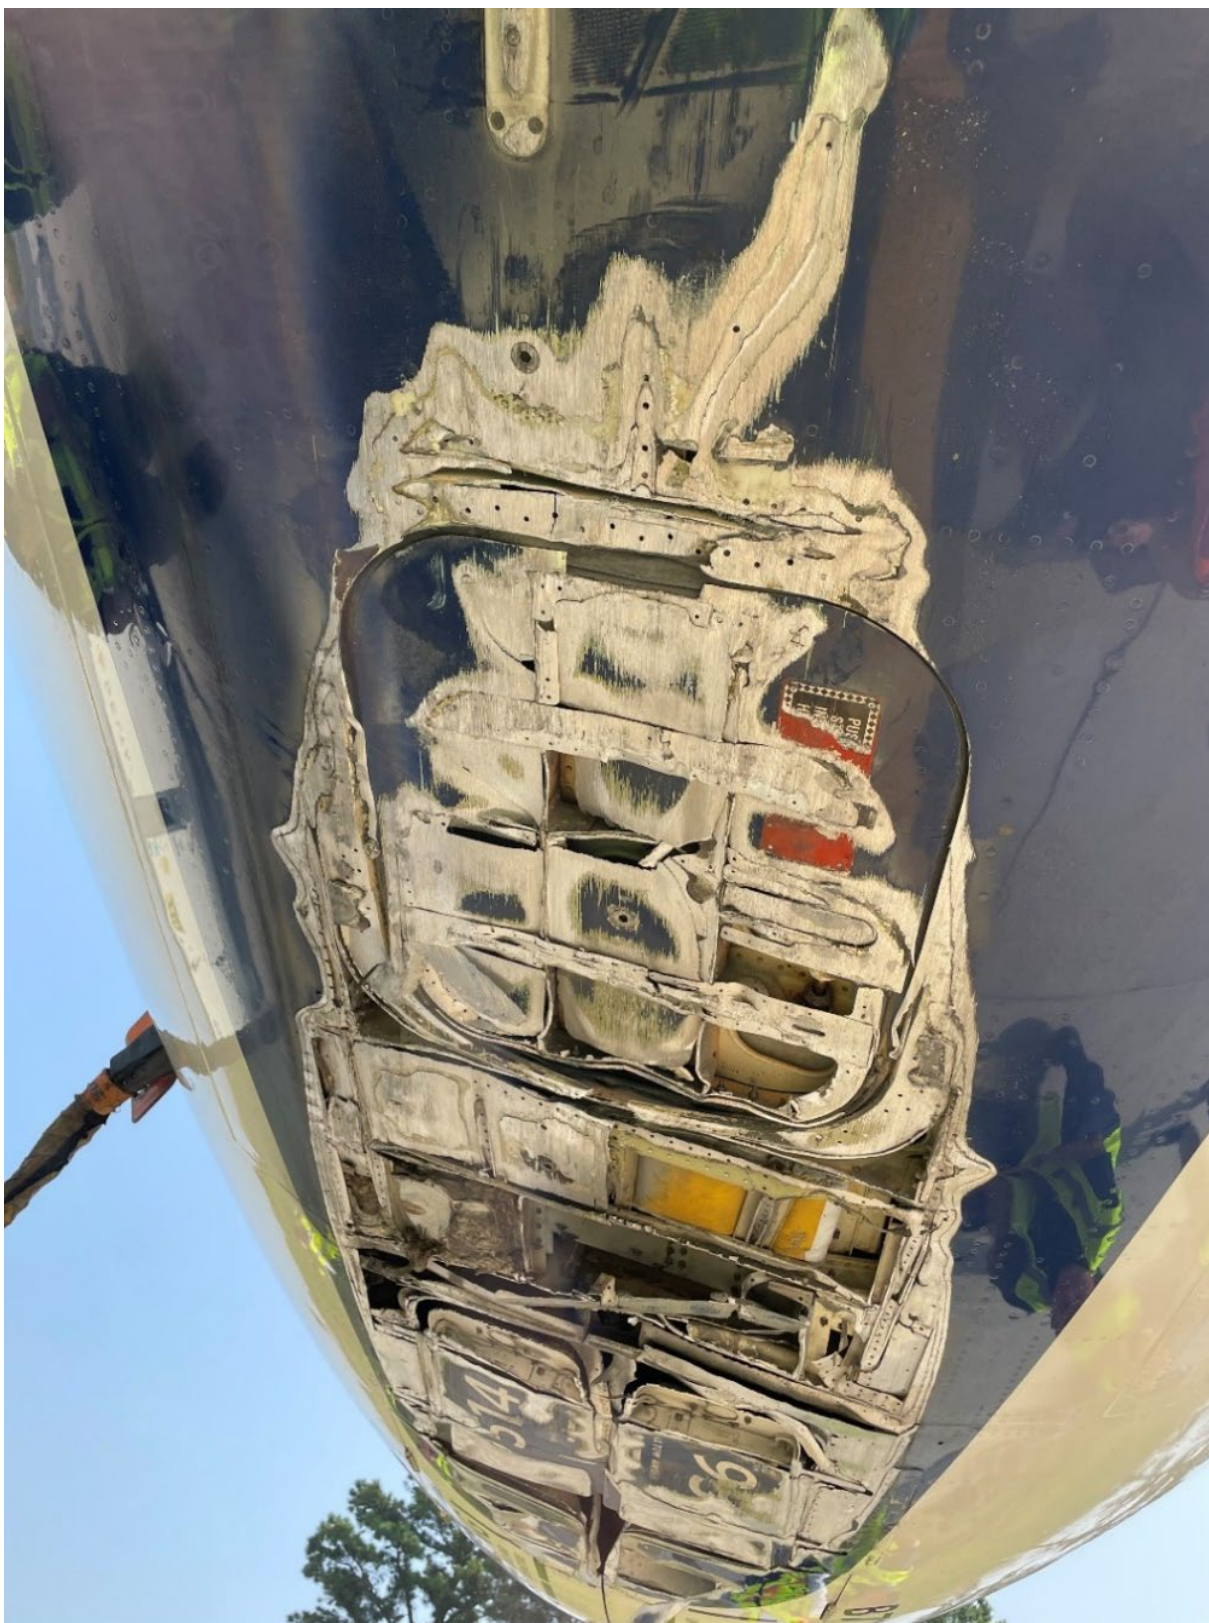
See Figure 5 for a fuselage station (FS) reference diagram to assist with the following damage description. The lower fuselage skin and lower fuselage doors from about FS 68 to FS 180 exhibited heavy abrasion damage from contact with the runway (see Figure 6). At FS 180 there was a slight buckle observed in the skin on the bottom side of the fuselage. The electronics bay door and the forward and aft nose landing gear doors were significantly damaged; however, as noted later in this report, still functioned normally. In addition, the Air Traffic Control 1 antenna located at FS 170, Marker Beacon antenna located at FS 190, drain mast located at FS 218, and Very High Frequency 1 antenna located at FS 294 all demonstrated damage consistent with the nose gear up landing.

**Figure 6:** Abrasion damage to the lower fuselage skin, frames, and doors (view is looking forward towards nose).

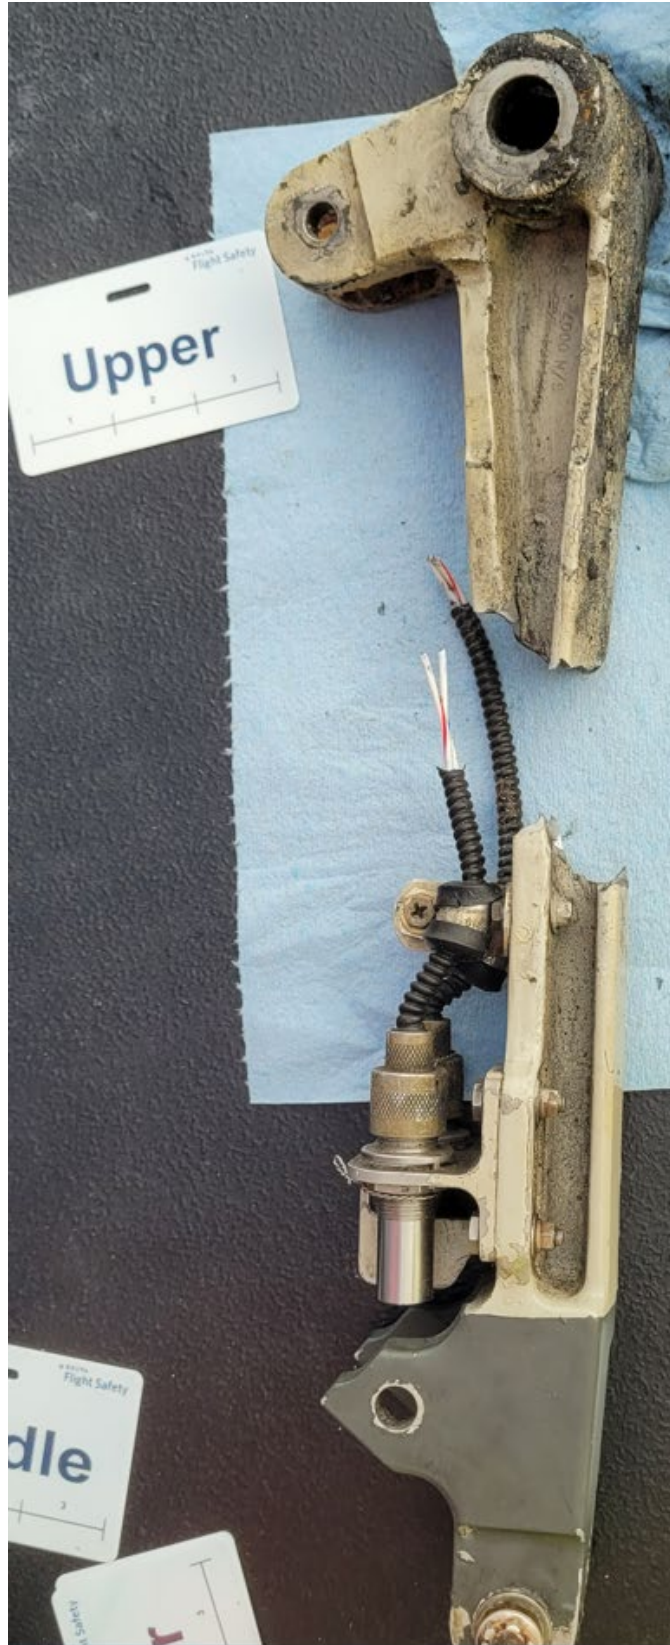
During the recovery effort maintenance found that the nose landing gear upper lock link was fractured in half. Maintenance removed the lower half of the upper lock link during the recovery to facilitate getting the gear down. To facilitate the removal of the lower half of the upper lock link, maintenance had to cut the wires going to the attached proximity switches.

**Figure 7:** Fractured upper lock link.

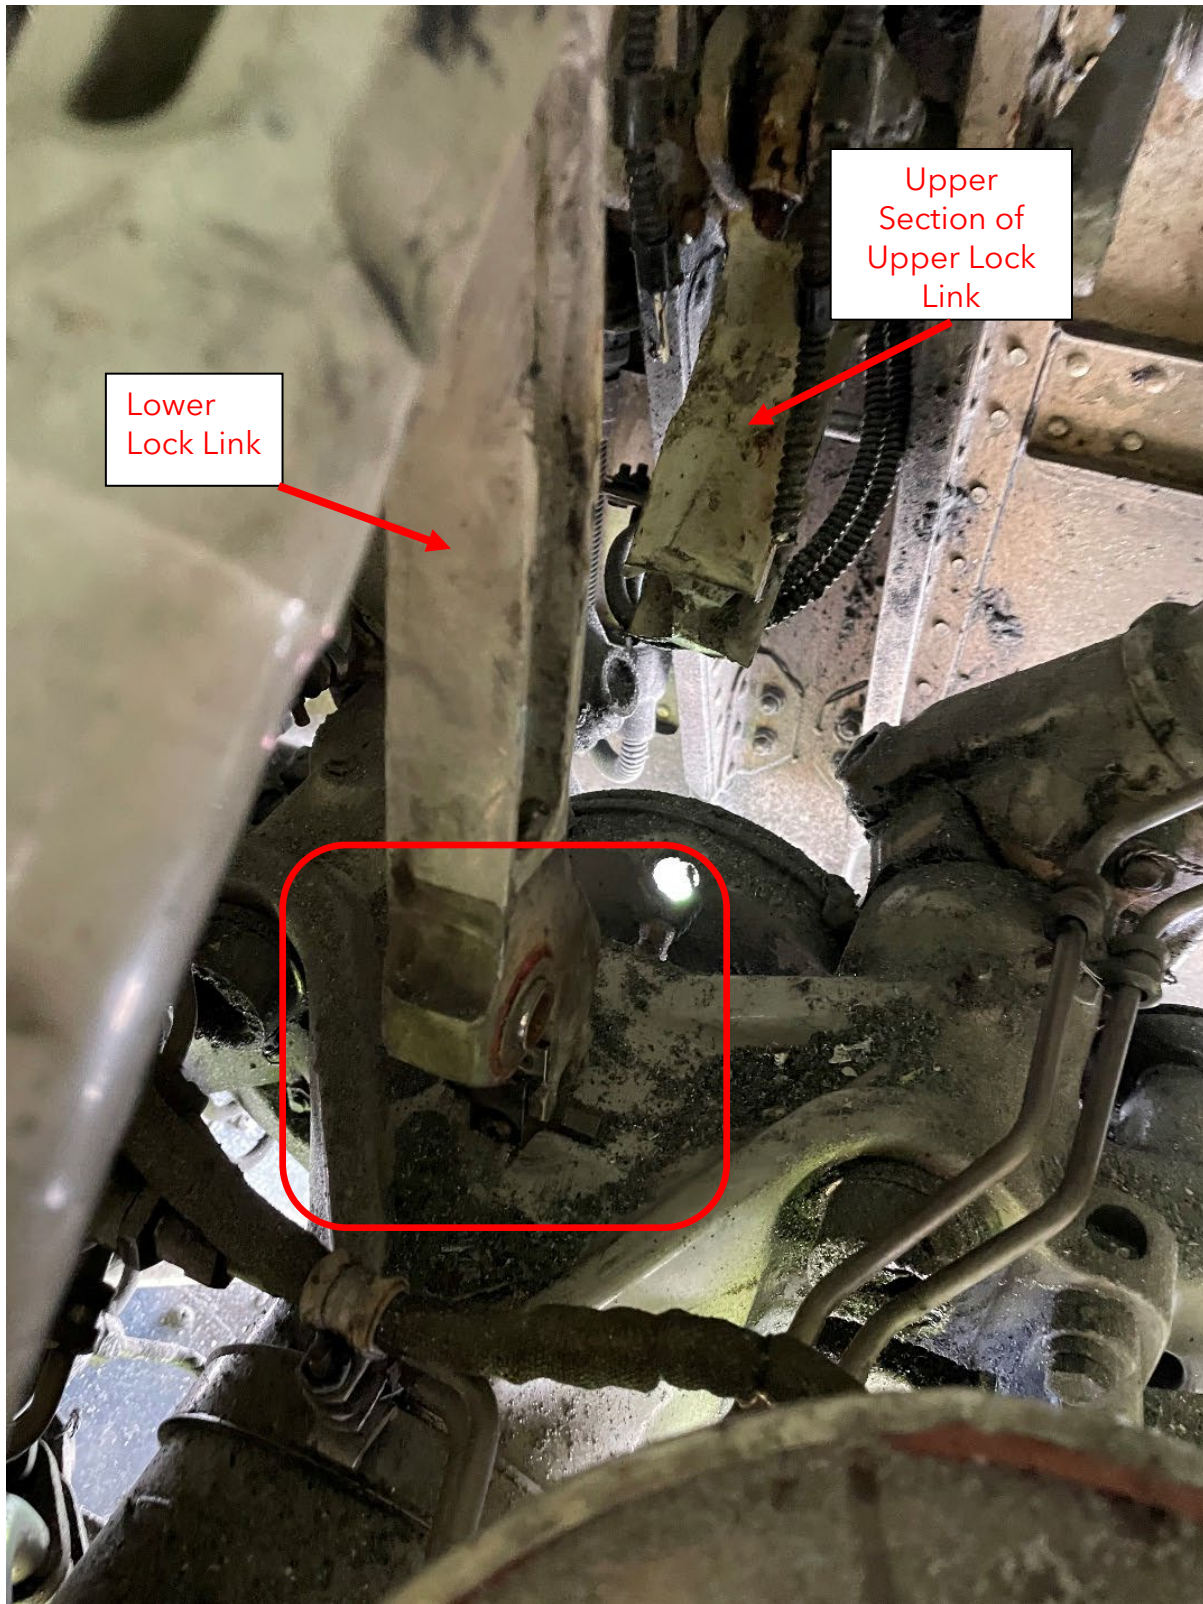
After the aircraft was removed from the runway, the main landing gear was locked out with gear pins and the nose of the aircraft was placed on a jack. The gear handle was moved to the down position, but the gear only came down slightly (axles approximately in line with the bottom of the fuselage). It was observed that because the upper lock link was fractured (see Figure 7), the lower lock link was free to swing down to a vertical position and was making contact with the top of the landing gear assembly, preventing the gear from extending (see Figure 8). There was scratched paint on the upper surface of the landing gear assembly in the area where the lower lock link was making contact.

**Figure 8:** Lower lock link contacting nose gear assembly in foreground. The upper section of the severed upper lock link is in the background. View looking down and aft.

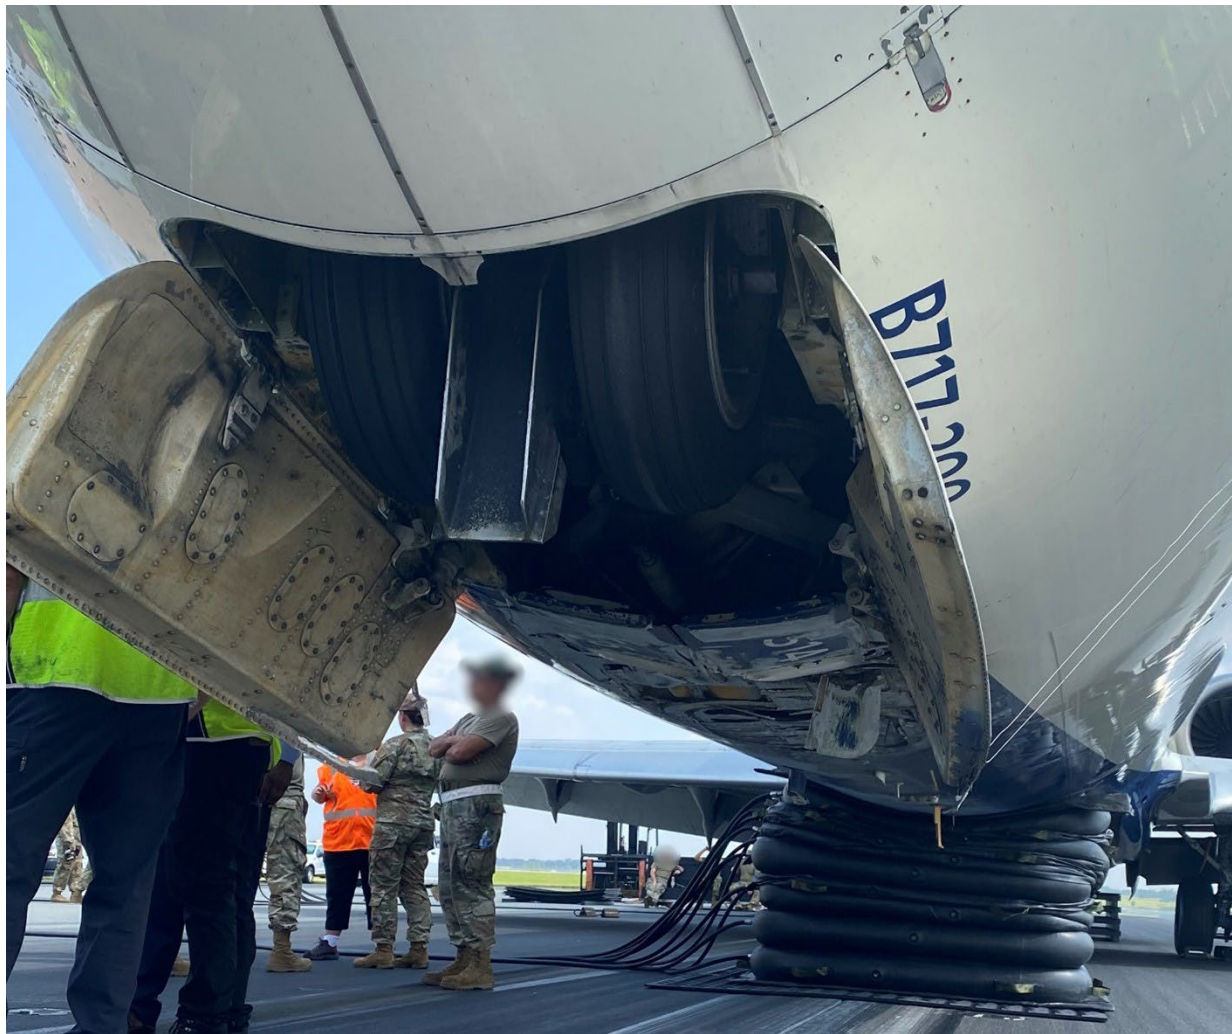
"On 6/28/2023 at approximately 1659 local time, after the nose of N955AT was initially being raised off the ground, [we] witnessed the nose gear doors open and the nose gear slightly extend to the point where the tires extended about an inch below the lower line of the nose section of the aircraft. It did not travel any further. Maintenance found that the over center lock had broken preventing the nose gear from moving any further. After coordination with NTSB and DALA [Delta Air Lines Inc.], it was agreed to attempt to lower the gear by the pilot alternate extension procedure using the gear unsafe checklist. DALA mechanics followed the procedure but the nose gear was unable to move. After further coordination, it was determined to remove the damaged part [lower half of upper lock link] so that the gear could come down and be towed to the ramp with the nose gear down as this was determined to be the safest option. But since the nose gear could not be pinned down due to the broken part the gear needed to be raised and gear doors closed so it could be laid on the flatbed cart to be moved off the runway as this was now the safest option."

**Figure 9:** Nose gear wheel position during aircraft recovery from the runway.  
(Photograph used with permission from the FAA)
