# National Transportation Safety Board

DCA23FA339

## **MATERIALS LABORATORY**

Factual Report 23-069

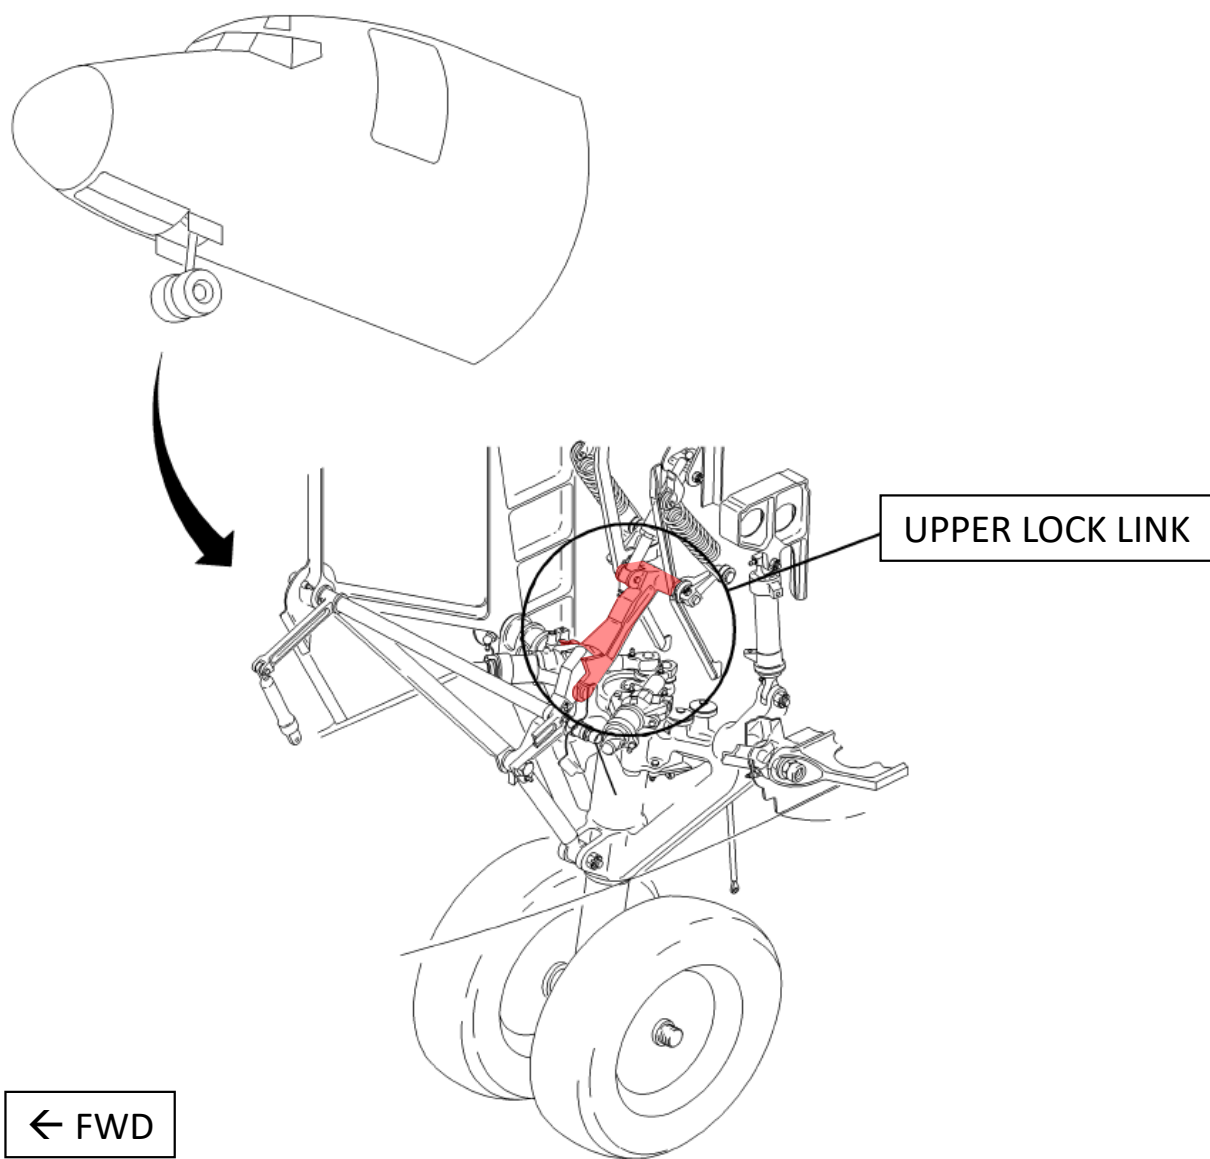
A post-accident examination of the nose landing gear system revealed a fractured upper lock link, the component highlighted in red in the schematic in figure 1, which was sent to the NTSB materials laboratory for examination.

**Figure 1.** A schematic showing the position of the upper lock link component, highlighted in red, with the nose landing gear in the extended position. (Source: Boeing Service Bulletin 717-32-002)

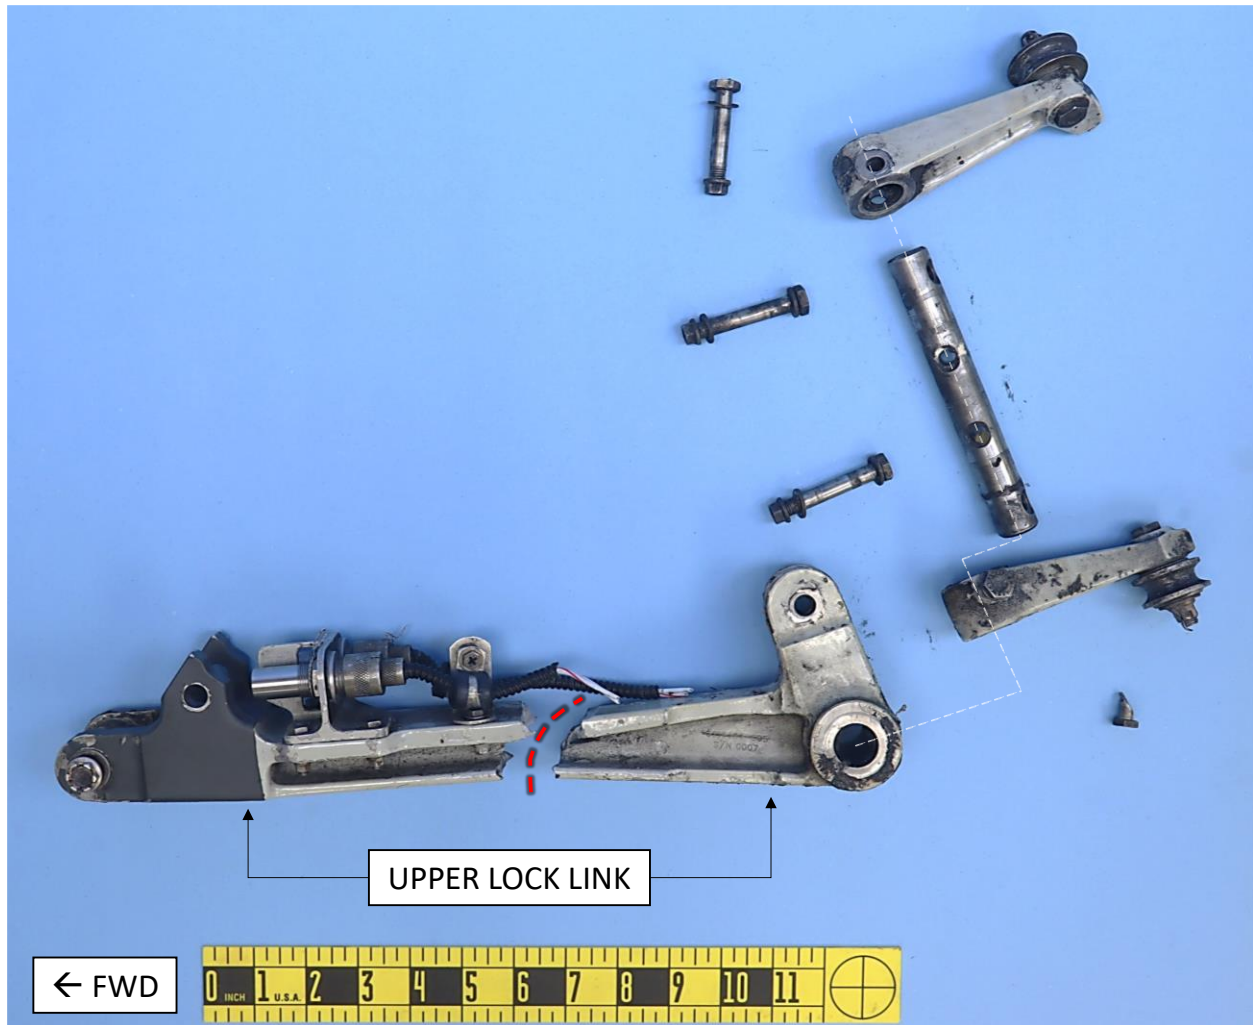
Figure 2 shows the as received fractured upper lock link component. Greasy soil deposits were observed covering some areas of the part and some areas of chipped, bubbled, and wrinkled paint were observed. The following part identification information was observed stamped or vibro-etched on the web of the aft piece:

The component was fractured at approximately mid-span, between 7.2 and 7.9 inches from the forward lug. The section height of the component was 1.122 inches as measured on the forward piece, just below the point of fracture. Figure 3 shows both sides of the fracture surface, as received. A relatively shiny and flat thumbnail shaped region approximately 1.07 inches wide by 0.42 inch deep was observed emanating from the lower surface with visible curved crack arrest (beach) marks,

**Figure 2.** A photograph showing an exploded view of the as received components with the fracture location highlighted by the red dashed line.

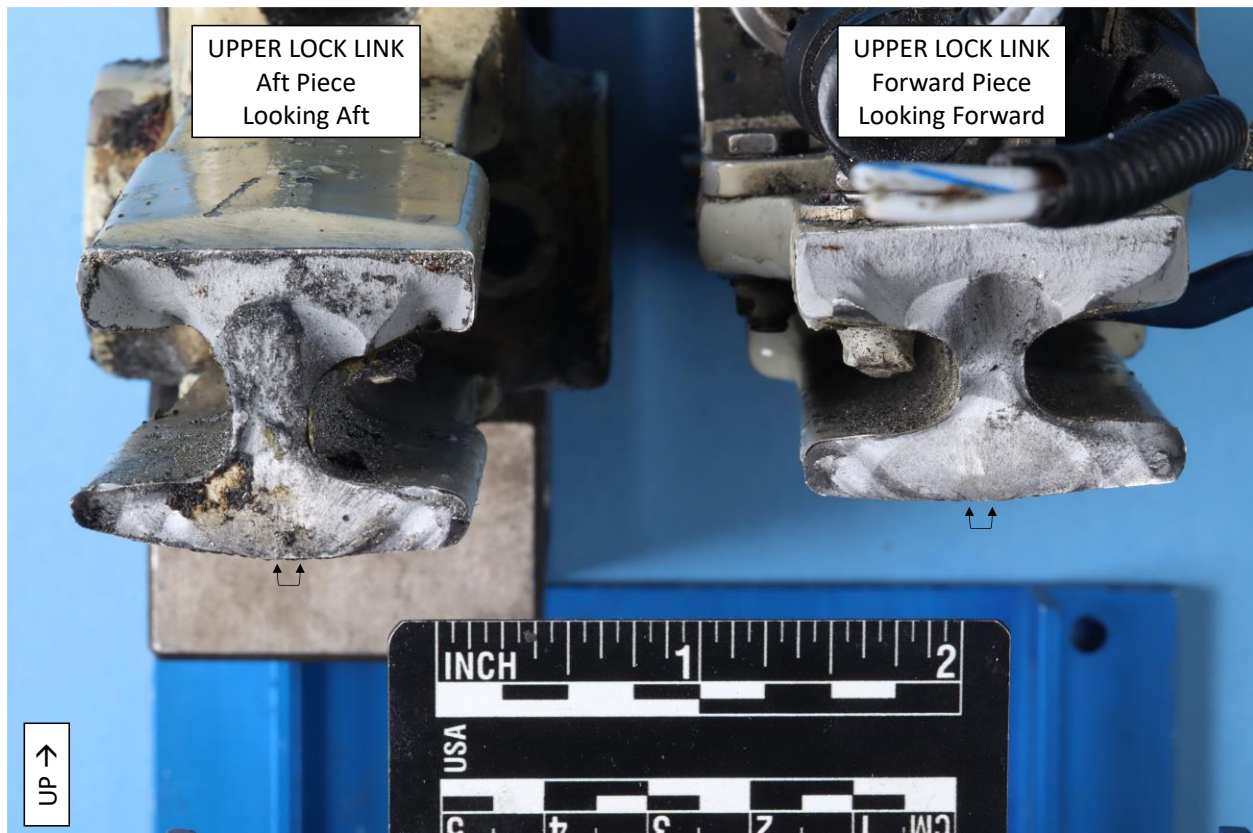
consistent with a progressive cracking mechanism. Outside of the thumbnail shaped region, the fracture surface was rougher and exhibited a generally matte appearance. Figure 4 shows a view of the lower surface of the part adjacent to the fracture origin area which exhibited evidence of horizontal and vertical scratch features near the fracture surface and under the paint layer.

**Figure 3.** A photograph showing both sides of the fracture surface of the upper lock link, as received, with the fracture origin area indicated with a black bracket.

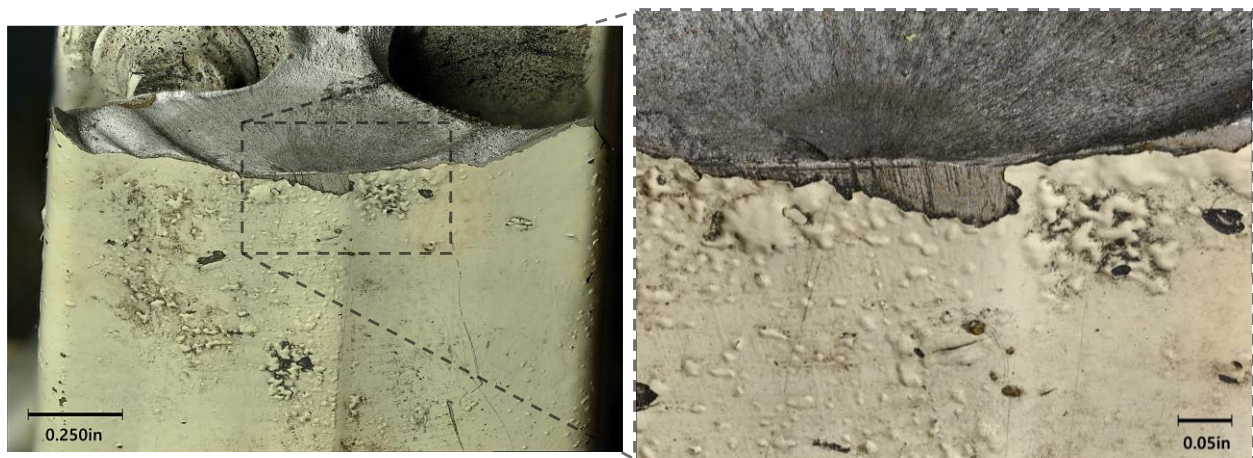
**Figure 4.** Digital microscope images of the fracture origin area and adjacent lower surface on the forward piece, as received. Horizontal and vertical scratch features were observed near the origin on the adjacent surface beneath the paint layer.

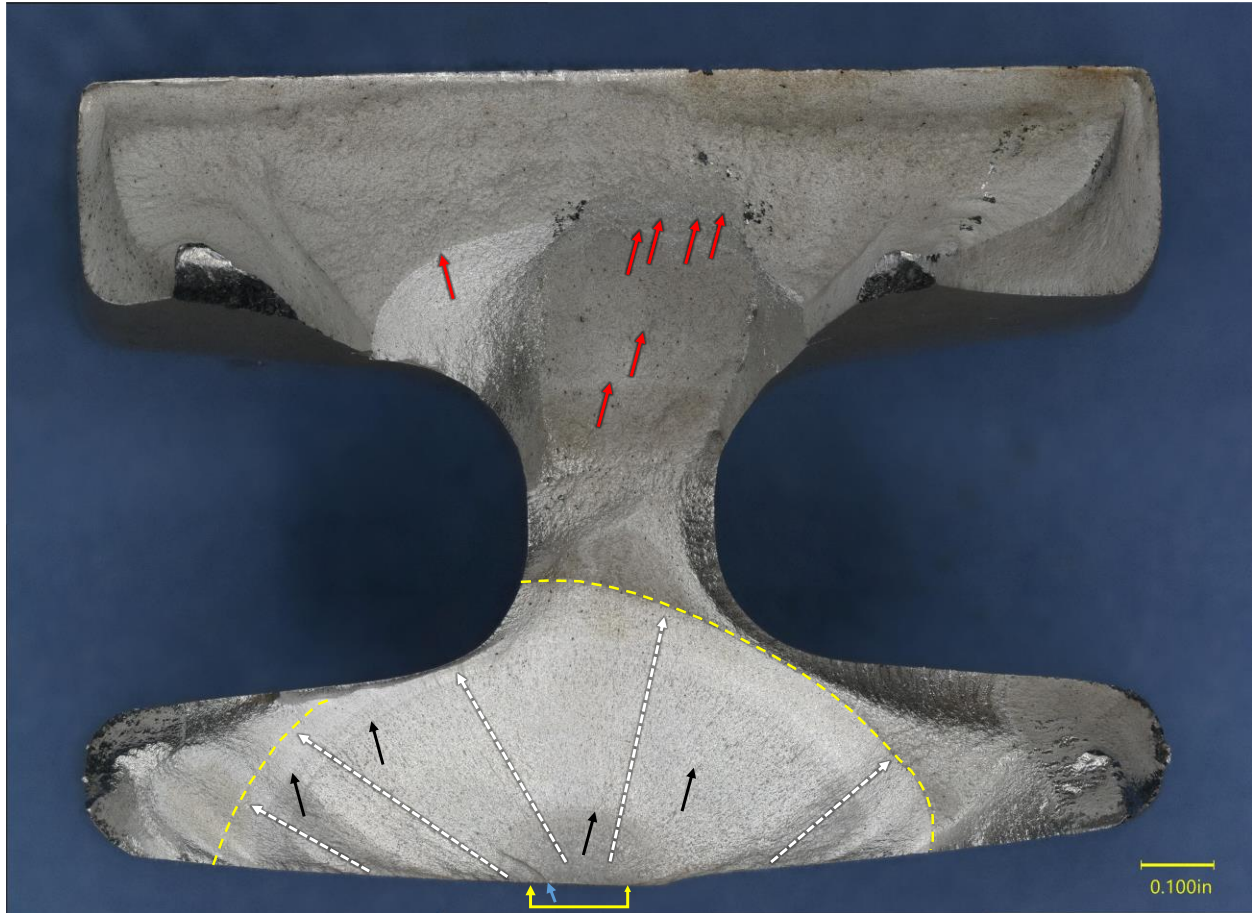
A section cut was performed on the forward piece of the upper lock link approximately 0.6 inch below the fracture surface to facilitate closer examination. Figure 5 shows a digital microscope image of the cleaned fracture surface. The fracture origin area, as marked by a yellow bracket, was observed on the lower surface of the part near a parting line feature.<sup>1</sup> A prominent ratchet mark was observed at the origin area as indicated by the blue arrow.<sup>2</sup> A darker thumbnail shaped region approximately 0.26 inch wide by 0.10 inch deep was observed emanating from the fracture origin area. Several crack arrest (beach) marks were observed within this region. A larger thumbnail shaped region that was lighter and shinier in appearance extended outward and terminated at the yellow boundary. Several crack arrest (beach) marks were observed in this region with prominent ones indicated by black arrows. This relatively flat thumbnail shaped region of fracture with curved arrest marks was consistent with a region of progressive fracture with growth direction indicated by white arrows. The portion of the fracture surface outside of this region was relatively rough and matte in appearance with some curved progression marks indicated by red arrows and shear lip features observed at the free edges of the part. The overall appearance of the fracture surface was consistent with cyclic tensile or bending loads and progressive fracture from the lower surface with an overstress dominated fracture mode at final separation.

**Figure 5.** A digital microscope image of the cleaned fracture surface on the forward piece of the upper lock link. The fracture origin area is indicated by a yellow bracket with progressive crack growth direction indicated by white arrows. A ratchet mark was observed as indicated by the blue arrow. The curved yellow line highlights the boundary of progressive crack growth with several curved arrest (beach) marks indicated by black arrows. Curved arrest marks observed outside of the progressive region are indicated by red arrows.

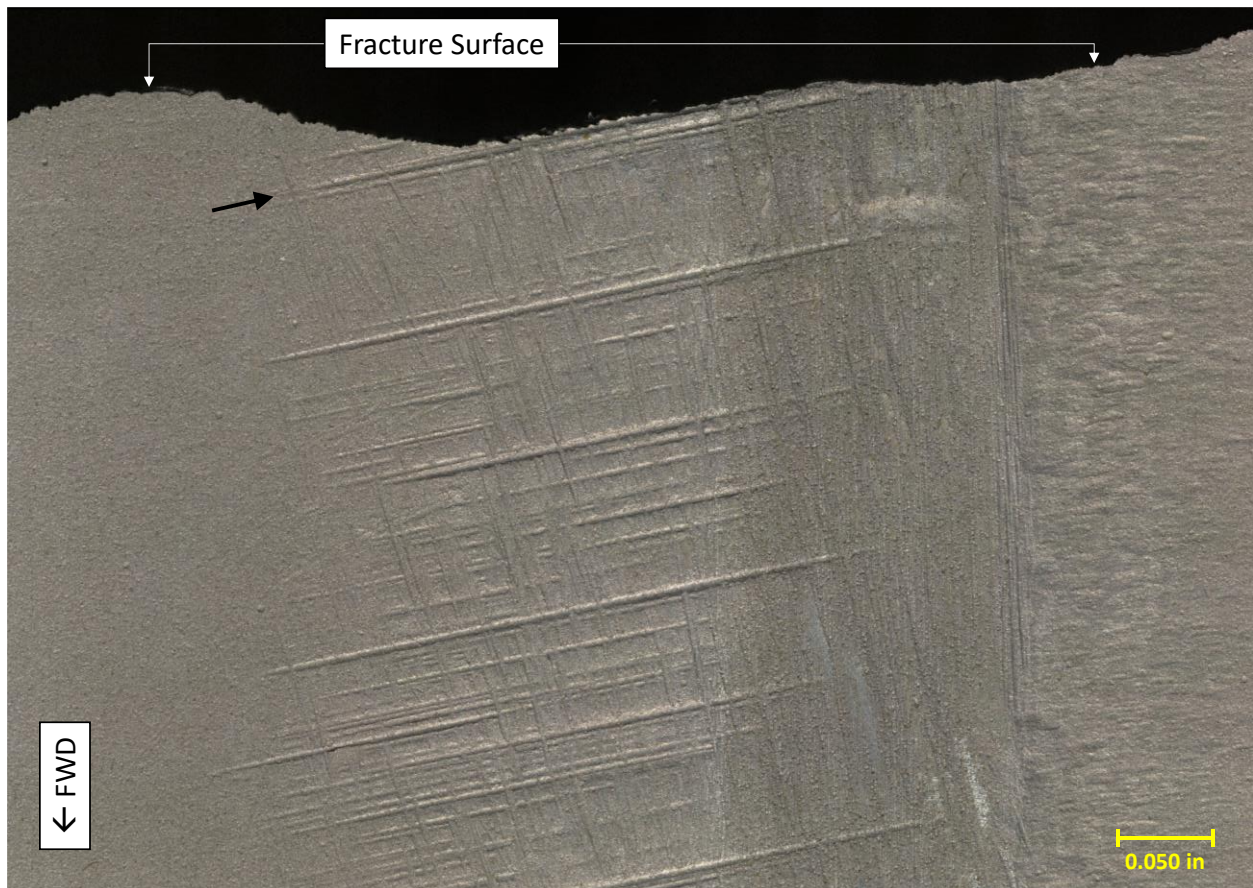
The surface adjacent to the fracture surface near the origin area showed evidence of vertical and horizontal scratch features near the parting line as shown more closely in figure 6. The fracture plane at the origin was oriented parallel to a horizontal scratch feature just below the fracture surface, indicated by a black arrow.

**Figure 6.** A digital microscope image of the lower surface of the forward lower lock link piece adjacent to the fracture origin area. Visible horizontal and vertical scratches were observed. The fracture plane was oriented parallel to a horizontal scratch as indicated by the black arrow.

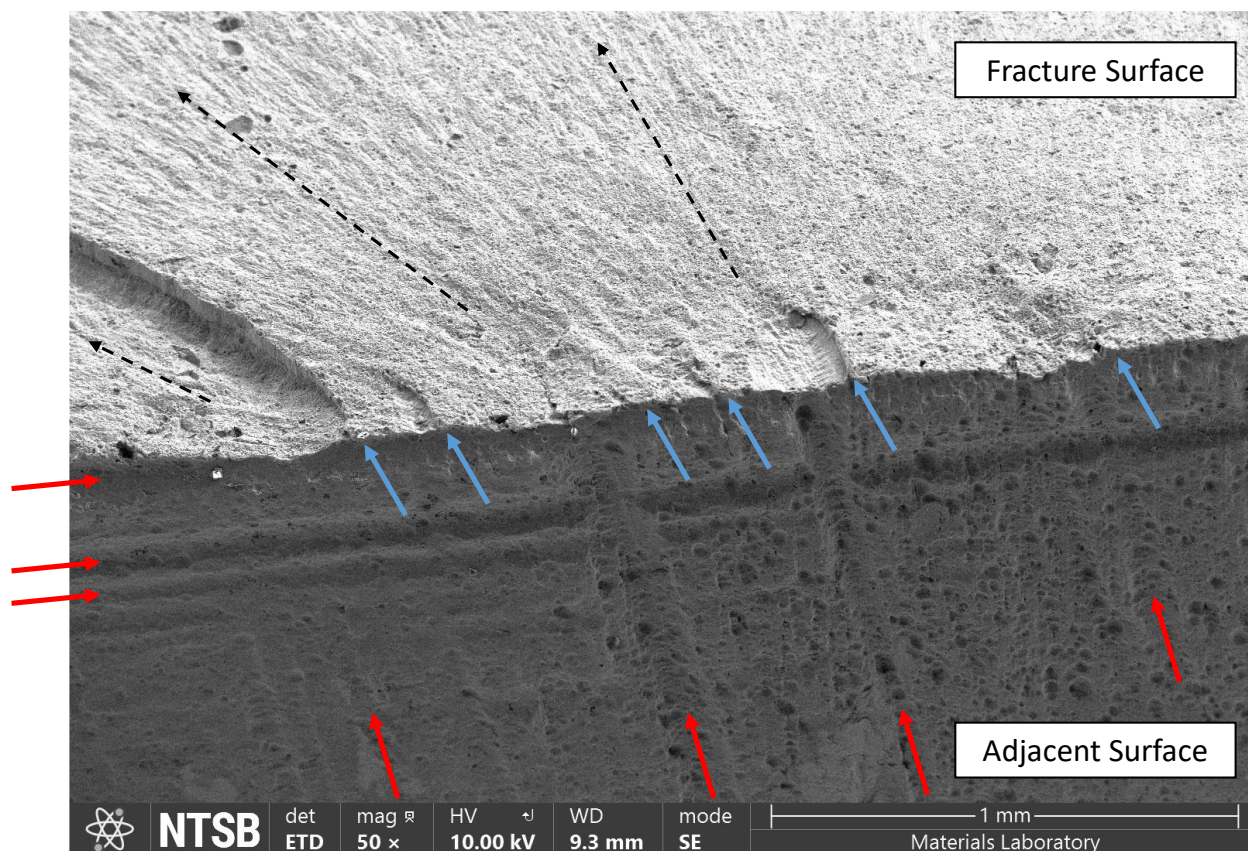
The fracture surface was examined more closely using a Thermo Fisher Scientific Apreo S field emission scanning electron microscope (SEM). Figure 7 shows a secondary electron image of the fracture origin area and the adjacent surface. Several ratchet marks were observed as indicated by blue arrows, consistent with multiple fracture initiation sites. The fracture had a feathery appearance with radial features emanating in the direction of crack growth indicated by black arrows. A horizontally oriented trough shaped feature, consistent with a scratch, was observed along the edge of the fracture origin area along with several other horizontal and vertical scratches on the adjacent surface as indicated by red arrows. Figure 8 shows secondary electron images at different magnification levels near the fracture origin area within the darker colored thumbnail shaped region. Prominent fatigue striations were apparent with smaller fatigue striations observed in between, consistent with a fatigue fracture mechanism under block or spectrum type loading conditions. Fracture direction is upward these images, perpendicular to striation features. Figure 9 shows secondary electron images at different magnification levels closer to the end of the fatigue crack. Similar striation features were observed with generally wider spacing, consistent with a higher crack growth rate. Figure 10 shows SEM images at the fatigue crack terminus, indicated by the yellow dashed line with the general crack growth direction indicated by the white arrow. Just below this region, curved arrest marks were observed intermixed with dimpled features. Above the terminus, dimpled fracture features were observed consistent with microvoid coalescence and overstress separation.

**Figure 7.** A secondary electron image of the fracture origin area and adjacent lower surface. Several ratchet marks were observed at the edge of the fracture surface as indicated by blue arrows. Crack growth direction is indicated by black arrows. Red arrows highlight several scratches observed near the fracture origin area.

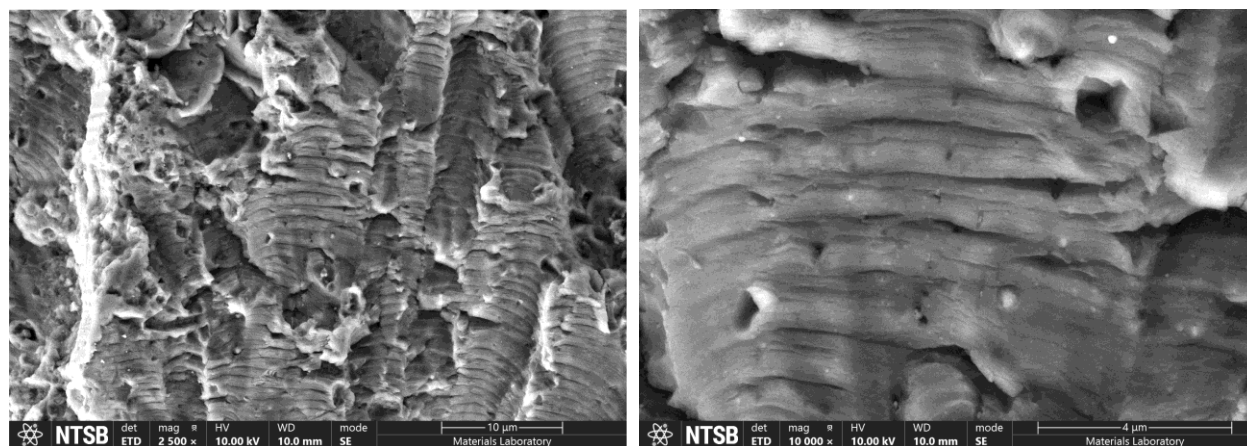
**Figure 8.** Secondary electron fractographs showing fatigue striations observed in the dark thumbnail shaped region near the fracture origin area.

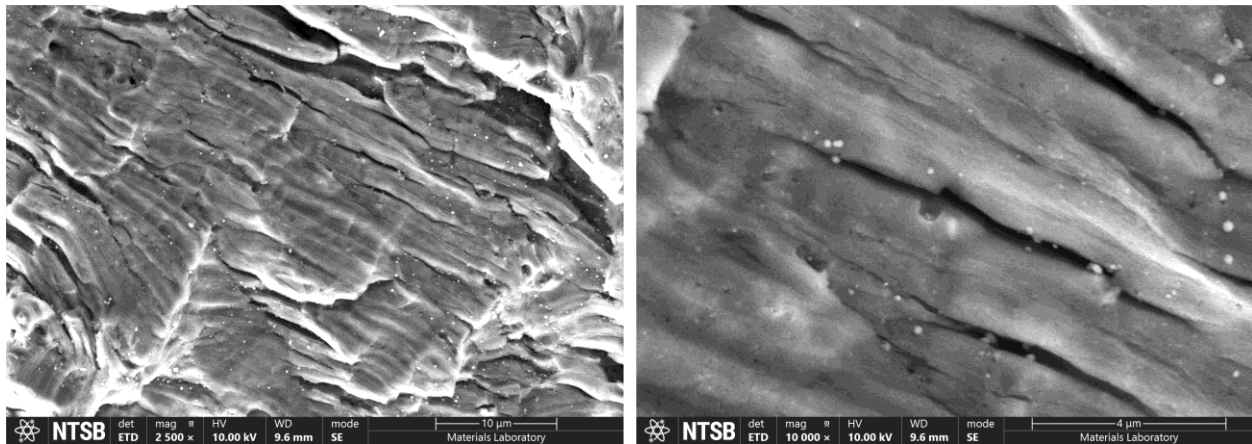
**Figure 9.** Secondary electron fractographs showing fatigue striations near the end of the progressive crack growth region.

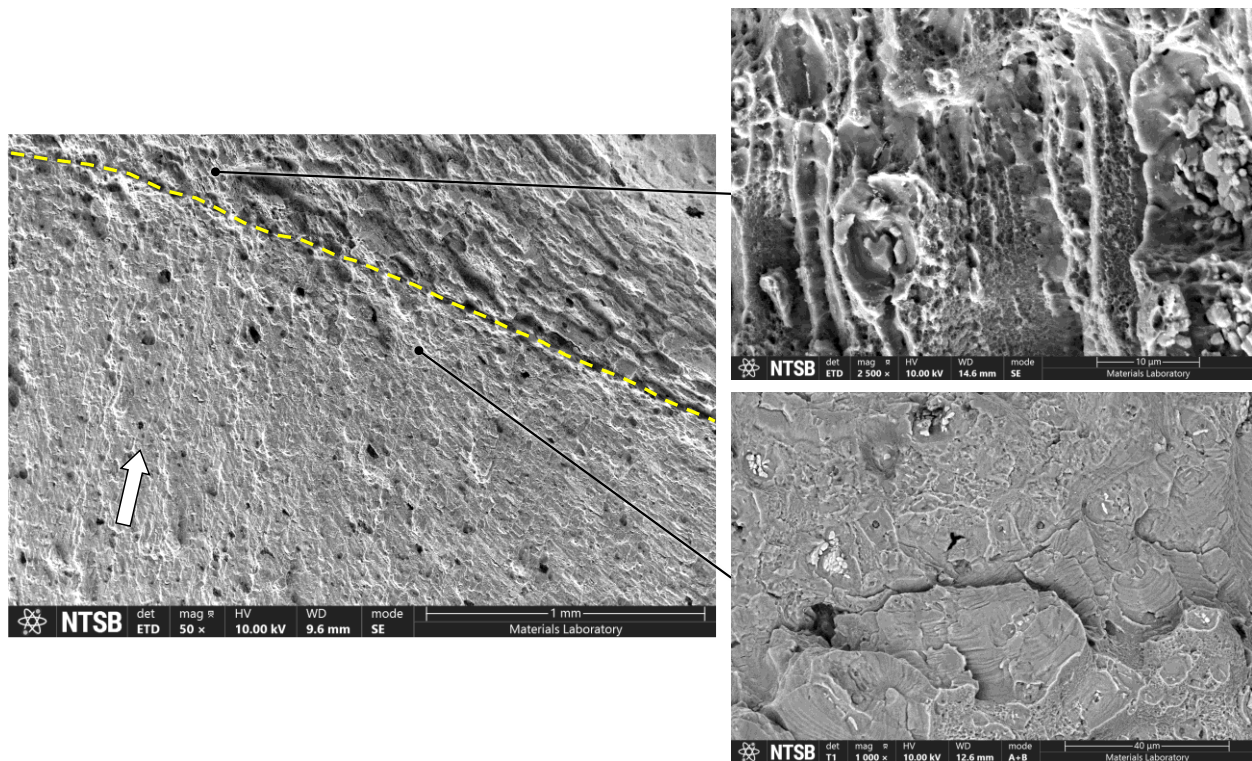
**Figure 10.** SEM fractographs showing the fatigue crack terminus highlighted by the yellow boundary and general crack growth direction indicated by the white arrow. Closer views of the indicated areas show fatigue striations intermixed with microvoid coalescence (lower right) and microvoid coalescence (upper right).

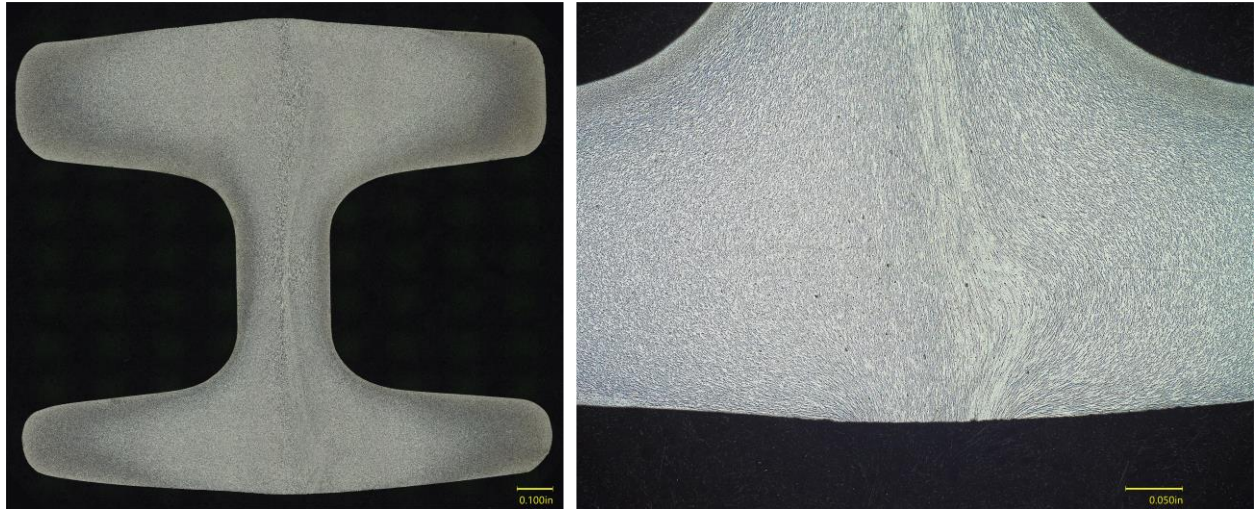
overaged T73 or T76 temper, per AMS 2658.<sup>6</sup> A transverse section of the component was mounted, polished, and etched with Keller's reagent to reveal the microstructure, as shown in figure 11, which was consistent with a forged aluminum alloy component.<sup>7</sup>

**Figure 11.** A bright field optical micrograph showing a cross section view of the component (left) and a closer view of the lower surface at the parting line (right). Grain flow lines were consistent with a forged component. (Etched with Keller's Reagent)
