Subject: Boeing Submission for Delta Air Lines 717-200 N955AT Landing with Nose  
Gear Retracted at Charlotte, NC, on June 26, 2023

**Delta Air Lines 717-200 N955AT  
Landing with Nose Gear Retracted  
at Charlotte, NC  
June 28, 2023**

**The Boeing Company  
18 October 2024**

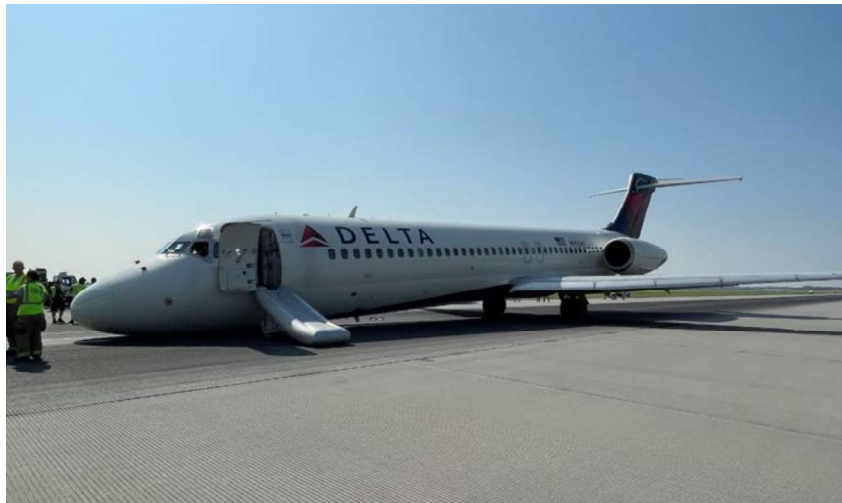
The airplane came to rest on the runway centerline. On June 28, 2023, Delta Air Lines, in coordination with the NTSB via phone and the FAA Charlotte Flight Standards District Office on-scene, recovered the aircraft from the runway to a maintenance ramp.

Figure 4 - Aircraft on runway following the accident landing.<sup>17</sup>

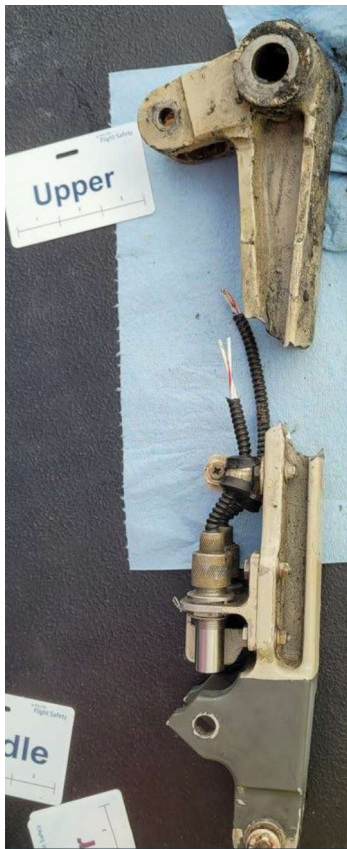
During the effort to recover the airplane from the runway, the nose landing gear upper lock link was found to be fractured in half. The lower half of the fractured lock link was removed, and the airplane was moved off the runway. Subsequently, the main landing gear was locked out with gear pins and the nose of the airplane was placed on a jack. The gear handle was moved to the down position, but the gear only came down slightly (axles approximately in line with the bottom of the fuselage). It was observed that because the upper lock link was fractured, the lower lock link was free to swing down to a vertical position and was contacting the top of the landing gear assembly, preventing the gear from extending.<sup>18</sup>

Figure 4 - Fractured upper lock link<sup>19</sup>

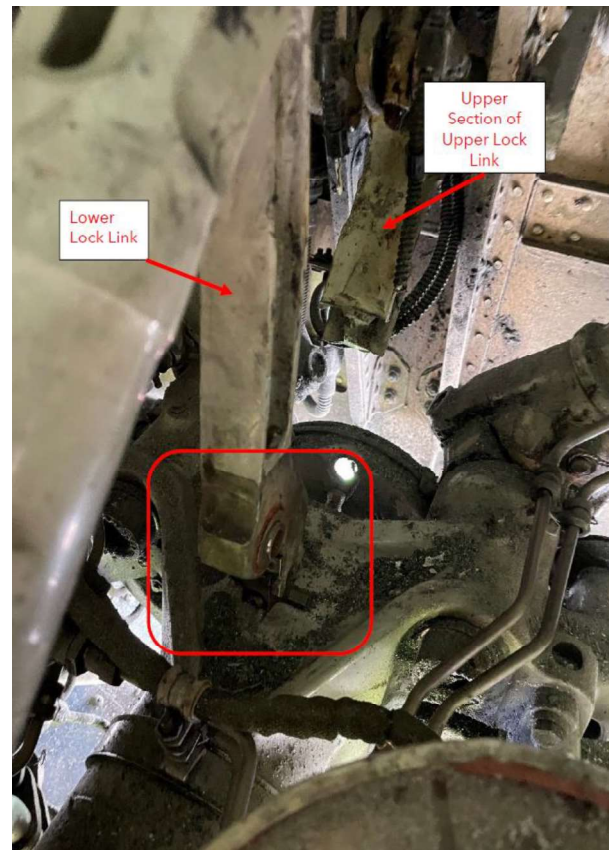
Figure 5 - Lower lock link contacting nose gear assembly in foreground. The upper section of the fully fractured upper lock link is in the background and the lower section had been removed. View looking down and aft.<sup>20</sup>

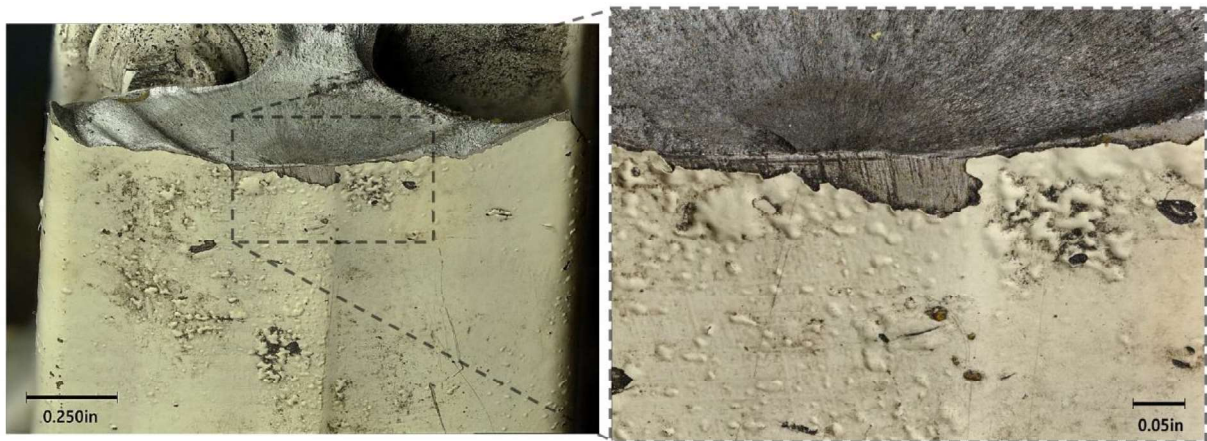
The component was fractured at approximately mid-span, between 7.2 and 7.9 inches from the forward lug. The section height of the component was 1.122 inches as measured on the forward piece, just below the point of fracture. A relatively shiny and flat thumbnail shaped region approximately 1.07 inches wide by 0.42 inch deep was observed emanating from the lower surface with visible curved crack arrest (beach) marks, consistent with a progressive fatigue cracking mechanism. Outside of the thumbnail shaped region, the fracture surface was rougher and exhibited a generally matte appearance. Figure 6 shows a view of the lower surface of the part adjacent to the fracture origin area which exhibited evidence of horizontal and vertical scratch features near the fracture surface and under the paint layer.

Figure 6 – Digital microscope images of the fracture origin area and adjacent lower surface on the forward piece.<sup>25</sup>

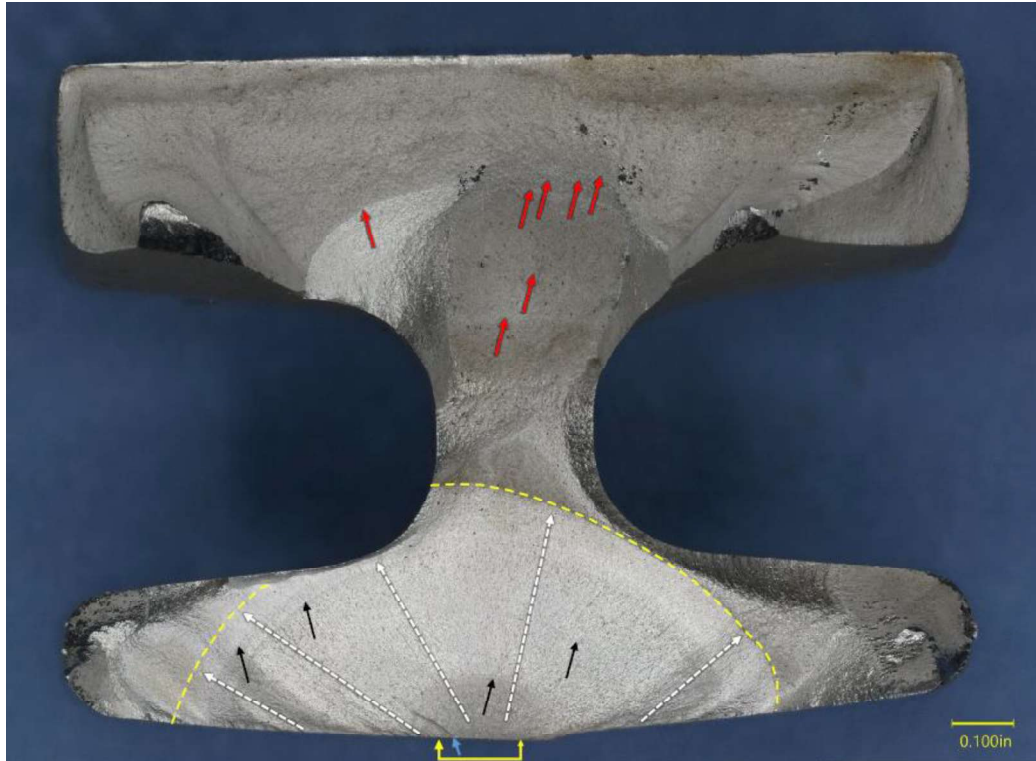
A section cut was performed on the forward piece of the upper lock link approximately 0.6 inch below the fracture surface to facilitate closer examination. Figure 7 shows a digital microscope image of the cleaned fracture surface. The fracture origin area, as marked by a yellow bracket, was observed on the lower surface of the part near a parting line feature. A prominent ratchet mark (tool mark) was observed at the origin area as indicated by the blue arrow. The overall appearance of the fracture surface was consistent with cyclic tensile or bending loads and progressive fatigue fracture from the lower surface with and an overstress dominated fracture mode at final separation. The surface adjacent to the fracture surface near the origin area showed evidence of vertical and horizontal scratch features near the parting line.

Figure 7 – A digital microscope image of the cleaned fracture surface on the forward piece of the upper lock link. The fracture origin area is indicated by a yellow bracket with progressive crack growth direction indicated by white arrows. A ratchet mark was observed as indicated by the blue arrow.<sup>26</sup>

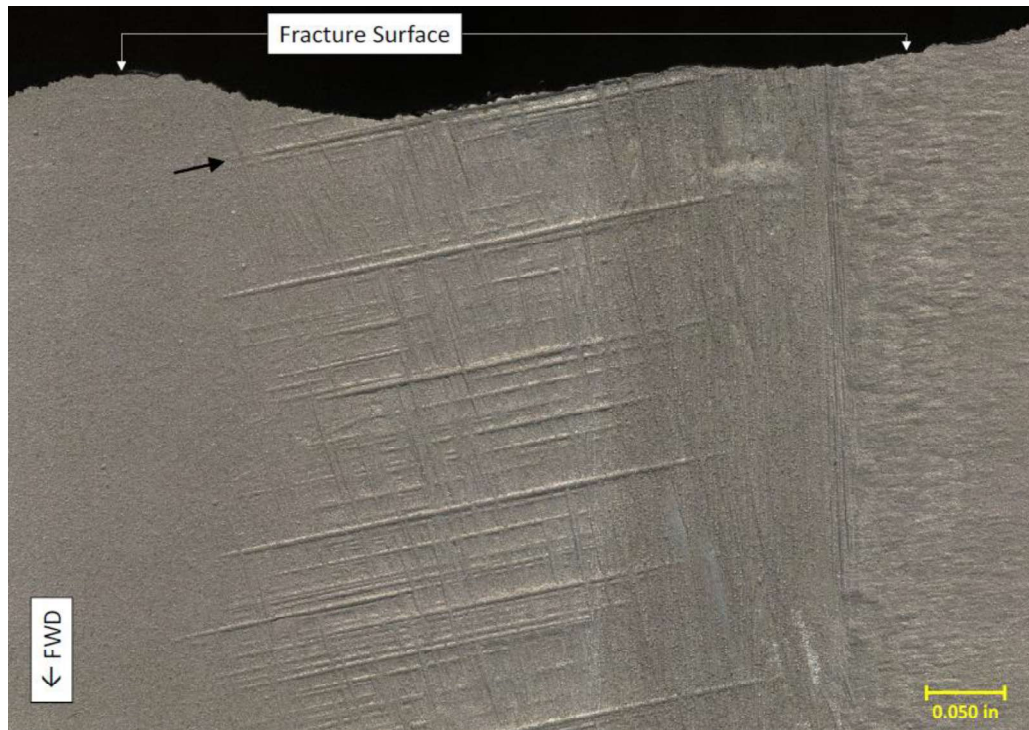
The fracture plane at the origin was oriented parallel to a horizontal scratch feature just below the fracture surface, as indicated by a black arrow in Figure 8. Surface roughness profile measurements were performed longitudinally and transversely along the parting line and the lower surface away from the parting line. Roughness measured over a 0.03-inch sampling length on the lower surface was 59-66 micro-inches compared to 185 – 508 micro-inches on the parting line. Roughness measured over a 0.1-inch sampling length was performed in the longitudinal direction and resulted in values of 86 micro-inches and 347 micro-inches for the lower surface and parting line, respectively.<sup>27</sup>

Figure 8 - A digital microscope image of the lower surface of the forward lower lock link piece adjacent to the fracture origin area. Visible horizontal and vertical scratches were observed. The fracture plane was oriented parallel to a horizontal scratch as indicated by the black arrow.<sup>28</sup>

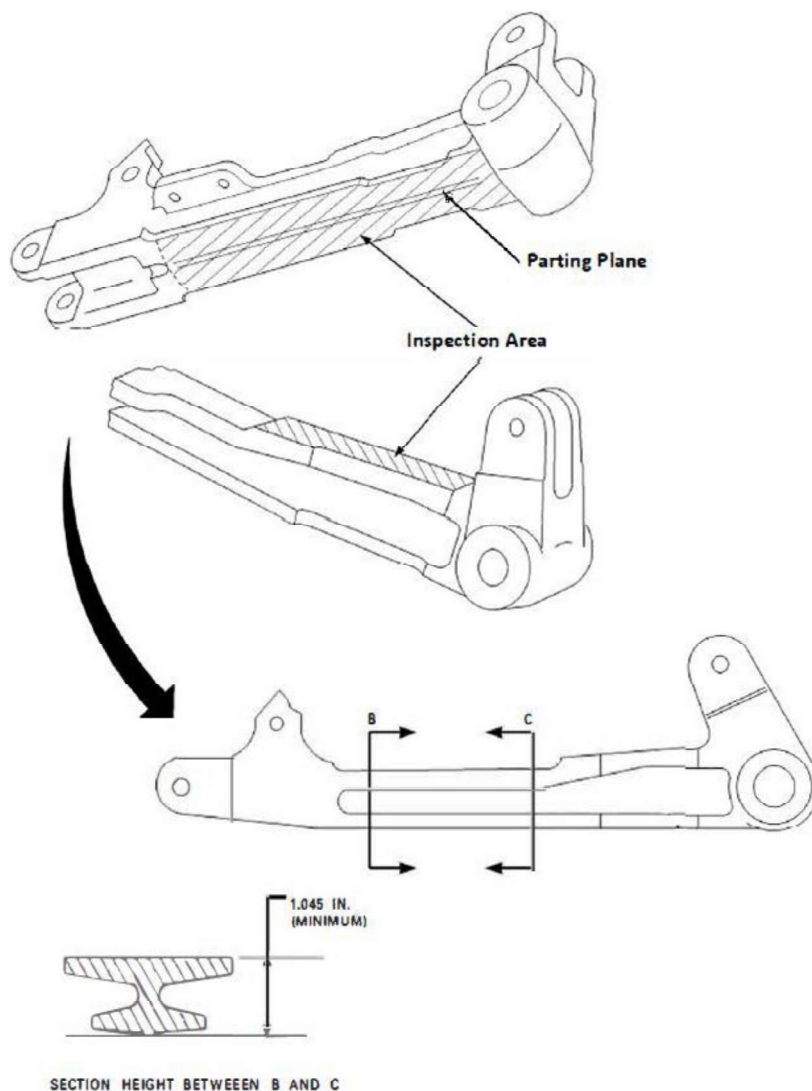
Figure 8 – Service Bulletin 717-32-0002 inspection areas

In 2001, Boeing became aware of information which indicated that E.O. 3914464 Rev Z may have been inadequately performed on 23 upper lock links. As a result, Boeing issued Service Bulletin 717-32-0002 in December 2001, to recommend operators with the 23 suspect upper lock links perform an on-wing eddy current inspection of the nose landing gear upper lock link. If cracks were found by the eddy current inspection, the service bulletin provided two options: (1) remove, modify, re-identify, and re-install the lock link, or (2) remove and replace with a new or modified upper lock link. The service bulletin modification instructions ensured the parting planes were free of scratches, nicks, or tool marks, and verified a 125 micro-inches surface finish. The service bulletin also ensured a minimum section height of 1.045 inches. Upper lock links that were reworked per the service bulletin were marked with a "V" after the part number (i.e. 3914464-509 V).

Boeing Service Bulletin 717-32-0002 work instructions were not properly followed on upper lock link S/N 0007, as a tool mark was found at the origin of the fracture.
