# National Transportation Safety Board

DCA23FA417

## **STRUCTURES**

Group Chairman's Factual Report

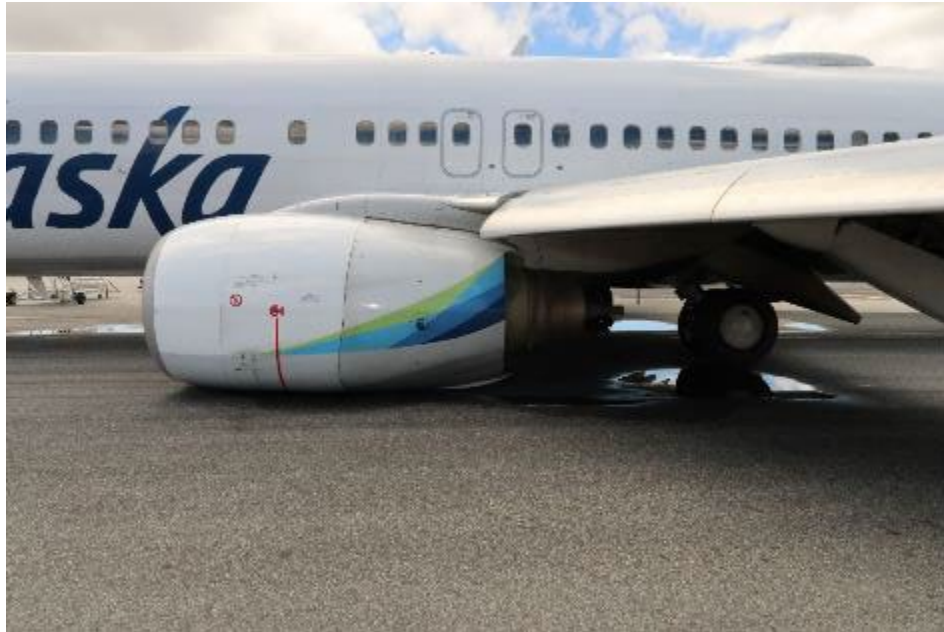
The captain stopped the airplane on the taxiway and set the parking brake. He opened his window, looked outside, and noticed that the aircraft was resting on the left engine (No. 1) nacelle (figure 1), and the engine appeared to be still running normally. He immediately shut down the left engine. The captain also noted that the left main landing gear position indicator light was not illuminated, whereas the nose and right main landing gear position indicator lights were still green. After confirming the APU was running, he shut down the right engine (No. 2).

**Figure 1.** Left side view of the airplane resting on the left engine nacelle and left main landing gear displaced aft.

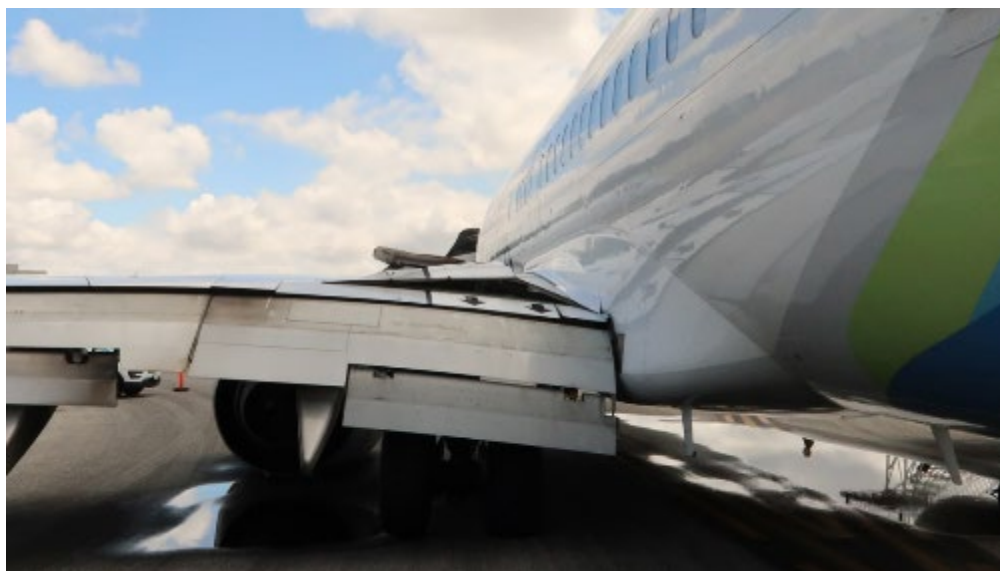
The airplane was observed resting on the left engine nacelle with the right MLG and nose gear fully extended. The left MLG was displaced aft about 45 degrees and the panels of the upper surface of the wing were fractured and pushed upward by the MLG outer cylinder immediately forward of the wing's rear spar (figure 3). Three upper wing skin panels were pushed and fractured upward by the displaced MLG outer cylinder's upward impact.<sup>2</sup> There was no visible damage to the left-wing flaps and spoilers.

**Figure 3.** Aft view of the left wing showing upper wing panels displaced upward.

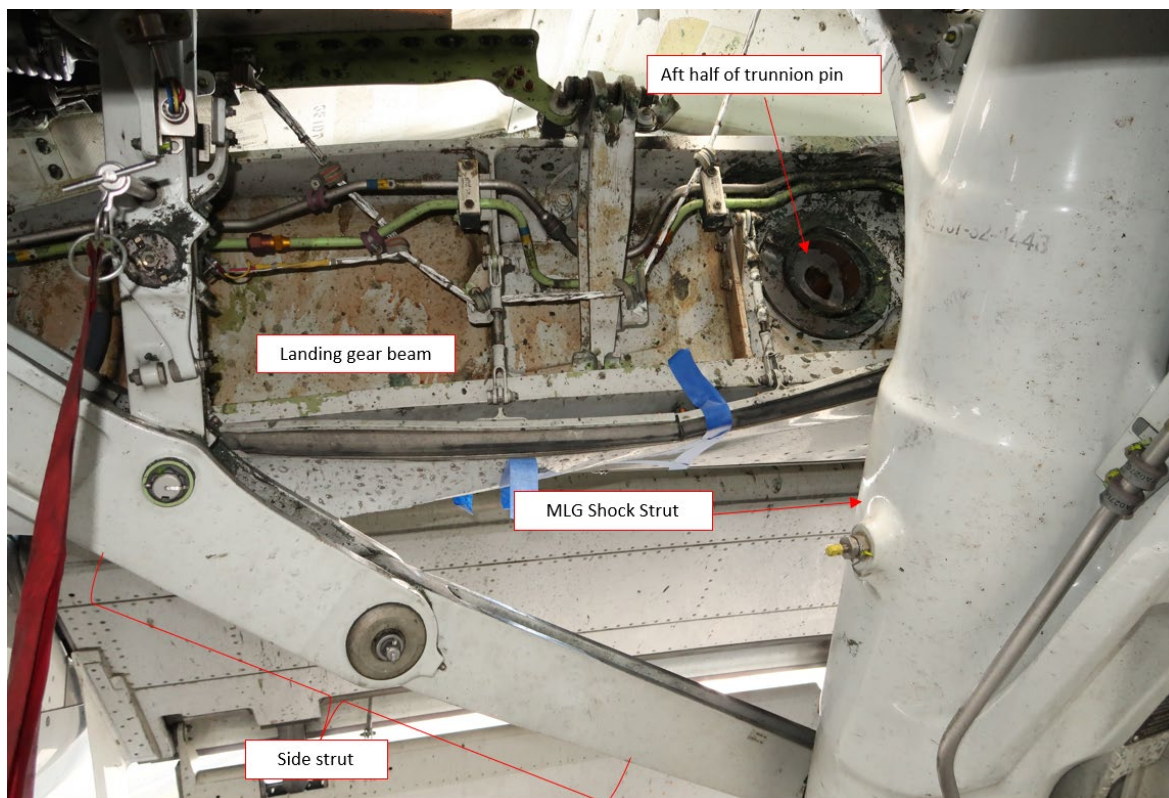
Within the left hand MLG wheel well and trunnion area, the forward trunnion/spherical bearing were in place (figure 4). There was no visible damage to the wing spar. The MLG shock strut outer cylinder was in contact with the MLG retract actuator hydraulic lines. There was no evidence of hydraulic line leakage. The aft trunnion pin (PN<sup>3</sup>: 161A1192-4, 161A1192-13, SN: E5514) had fractured in half vertically across the pin diameter. Half the trunnion pin remained within the spherical bearing of the rear landing gear beam, and the other half remained in the outer cylinder of the MLG trunnion (figure 5). The trunnion pin half that remained in the landing gear beam spherical bearing migrated aft and was found protruding from the aft side of the spherical bearing (figure 5). The trunnion pin half (figures 6 and 7) was easily slid out of the spherical bearing by hand.

**Figure 4.** Interior view (looking aft) of the left main landing gear wheel well. The main landing gear shock strut is displaced aft at an angle and a fractured portion of the trunnion pin remained in the landing gear beam spherical bearing.

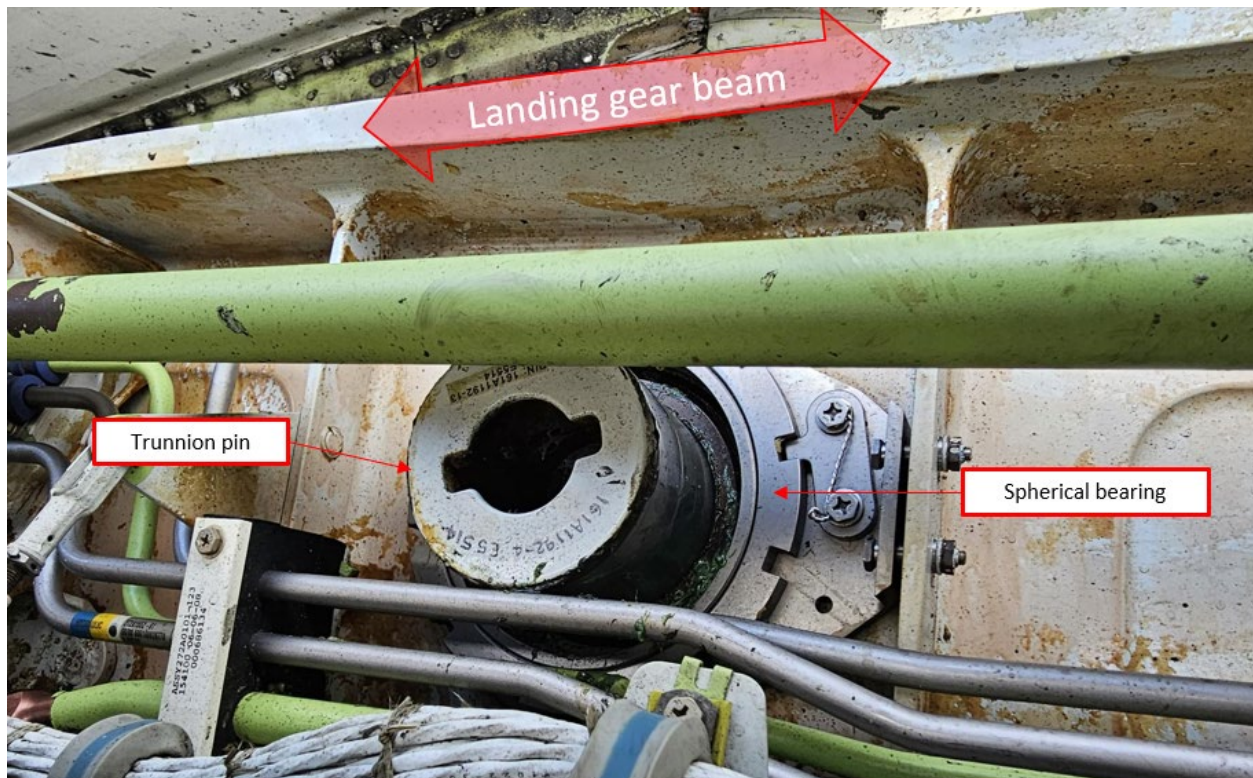
**Figure 5.** View of the aft side of the landing gear beam. The trunnion pin half had migrated aft out of the spherical bearing. (Source: Alaska Airlines)

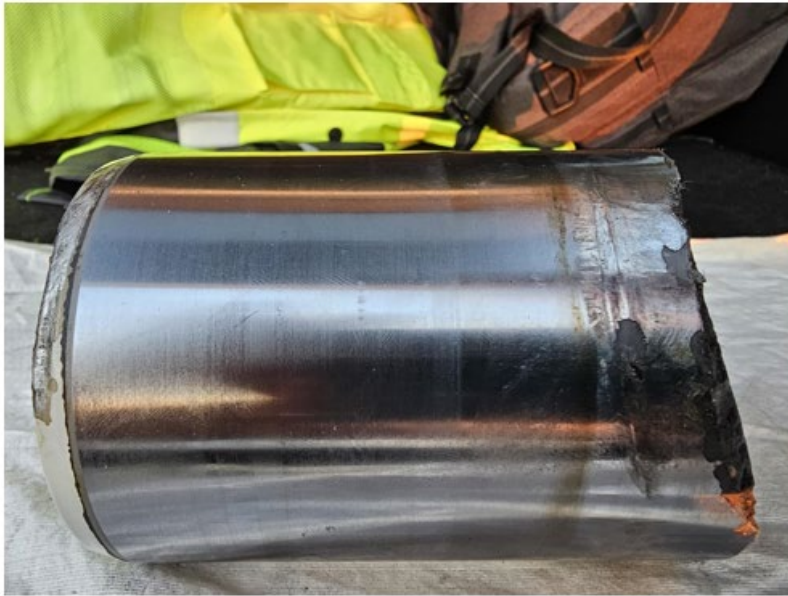
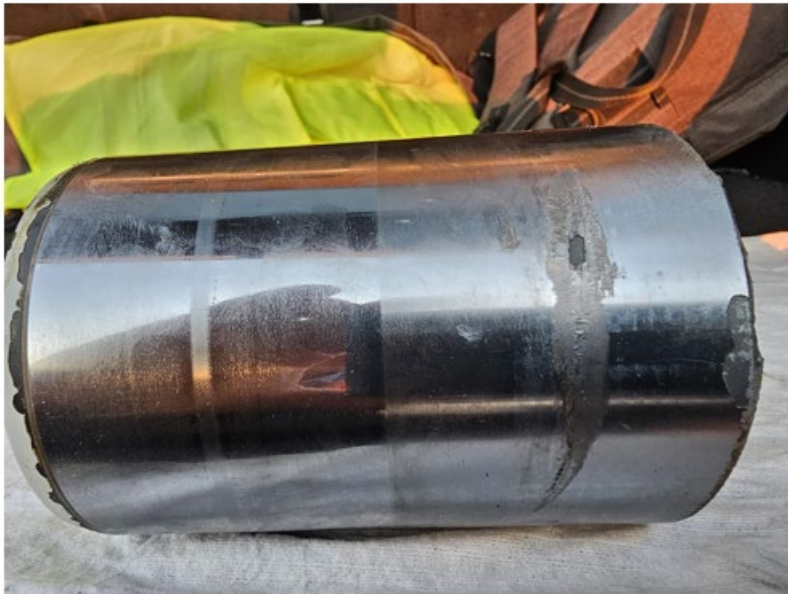
**Figure 6.** Two views of the trunnion pin half that was removed from the landing gear beam. (Source: Alaska Airlines,)

The trunnion pin half that was removed from the landing gear beam was sent to the Boeing EQA (Equipment Quality Analysis) laboratory, Seattle, Washington, for examination.

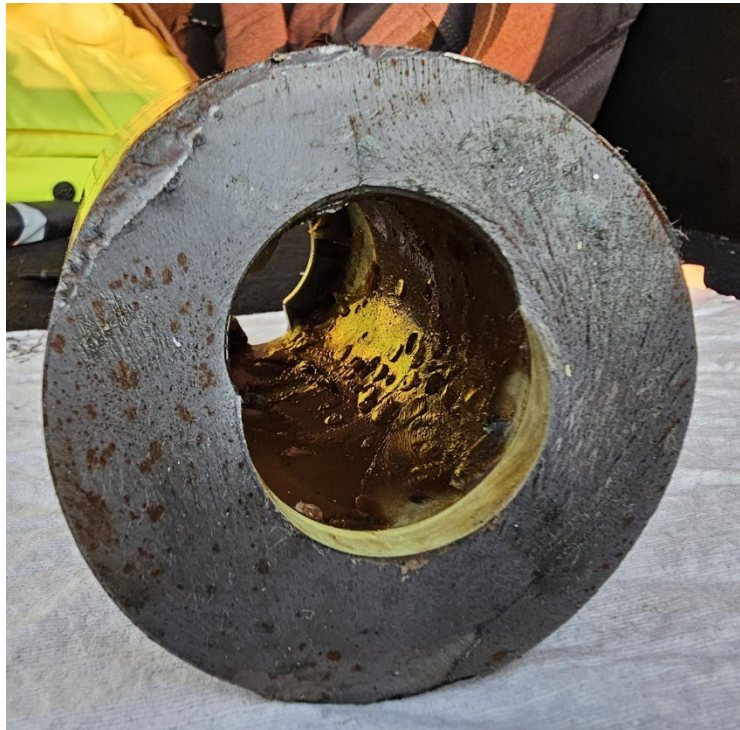
**Figure 7.** View of the trunnion pin fracture face. (Source: Alaska Airlines)

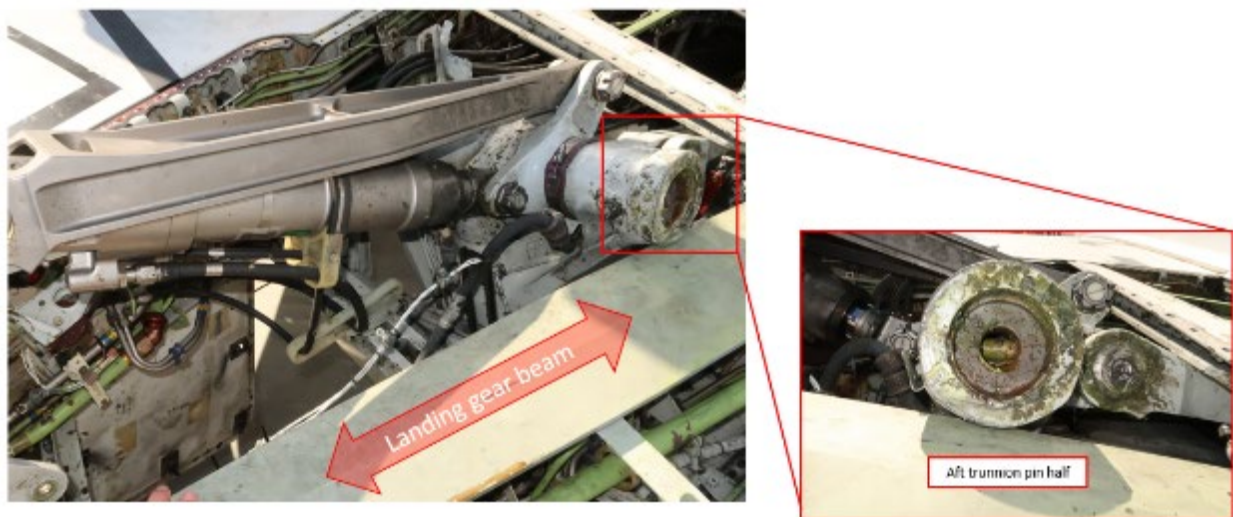
**Figure 8.** Overhead view of the left main landing gear trunnion after the upper wing panels had been removed. Inset box is a close up view of the half of the trunnion pin than remained in the outer cylinder.

The MLG shock strut outer cylinder had rotated aft and made contact with the underwing and landing gear beam. The upper side brace was bent and was in contact with the lower portion of the landing gear beam. The data plate on the MLG

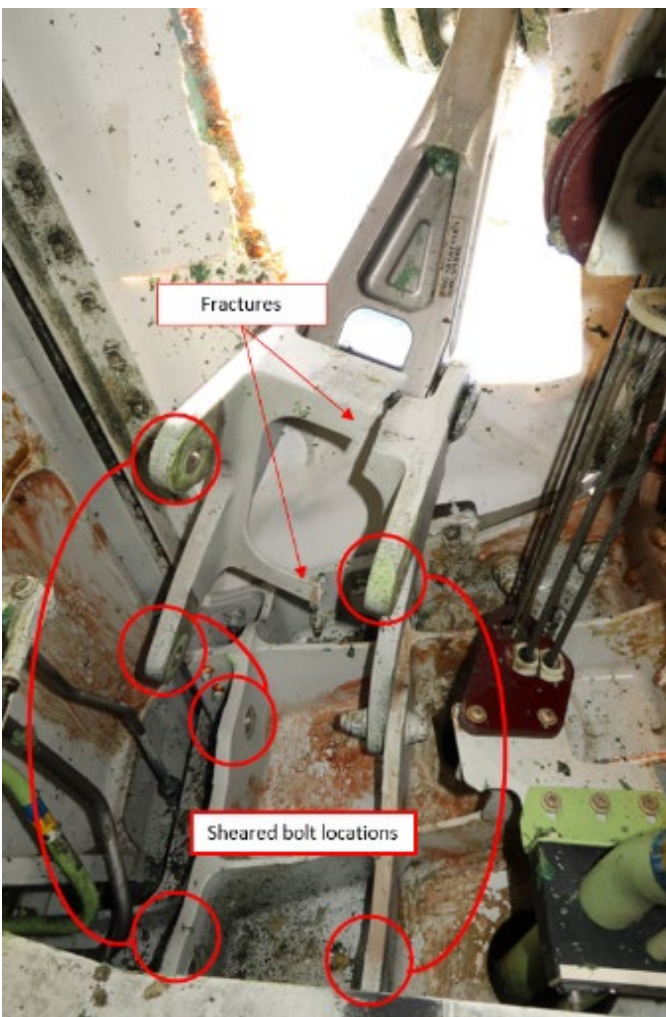
One leg of the idler link support fitting assembly (PN: 115A5313-5) remained attached to structure via the installed bolt and nut. The three other idler link bolt and nut fasteners were not in place (figure 9); however, fractured portions of the three fasteners were found lying free within the wing wheel well area (figure 10). Two bolt heads and 3 nuts with bolt fragments threaded in them were recovered. The idler link support assembly had fractured in two locations.

Figure 9. The fractured idler link support assembly.

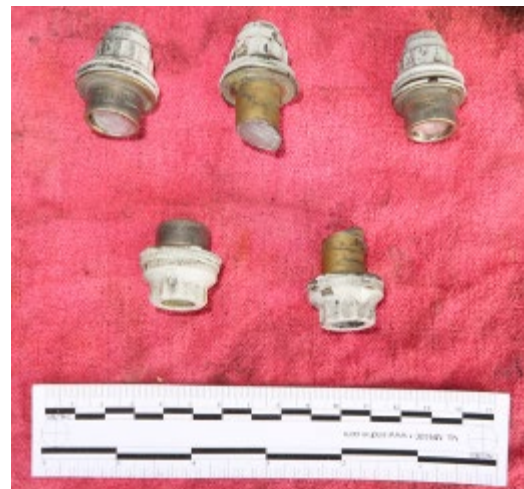
Figure 10. Sheared bolt fragments located within the wing main landing gear wing and wheel well area.

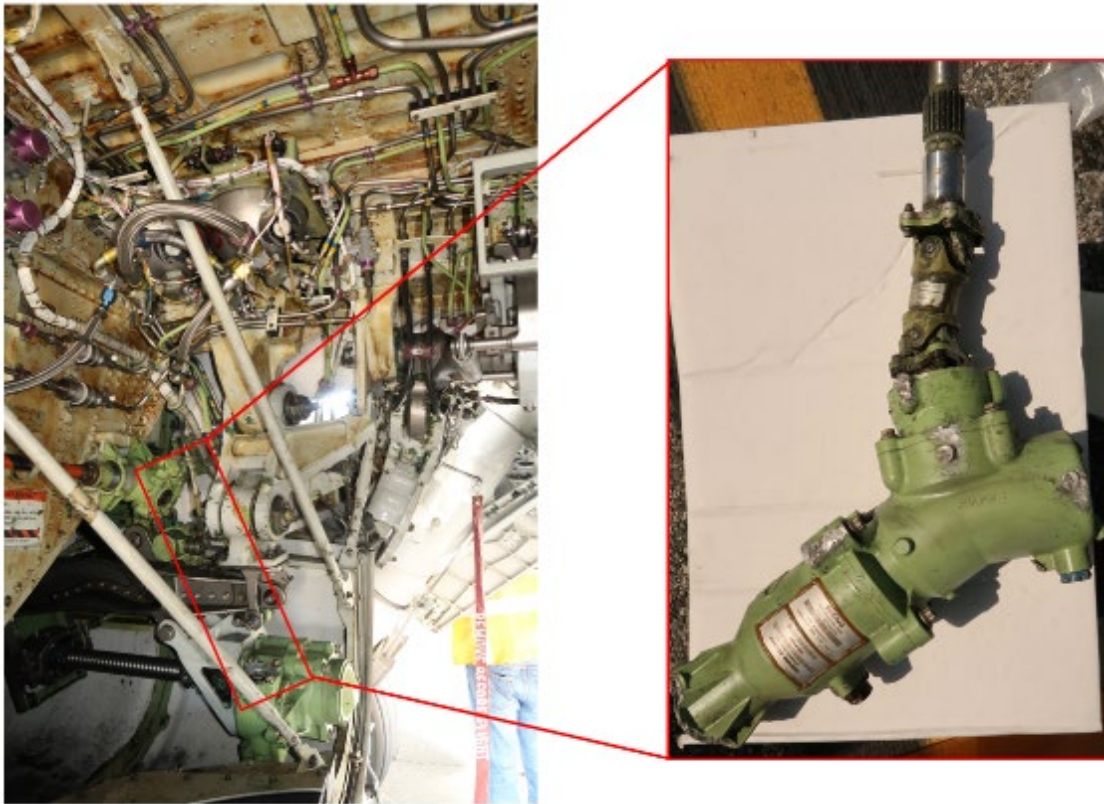
Within the left MLG wheel well the flap drive transmission unit had been liberated and found on the runway near the initial landing touchdown area (figure 11).

**Figure 11.** Left main landing gear wheel well depicting the location of the separated left flap drive transmission and the recovered flap drive unit found near the runway touchdown zone.

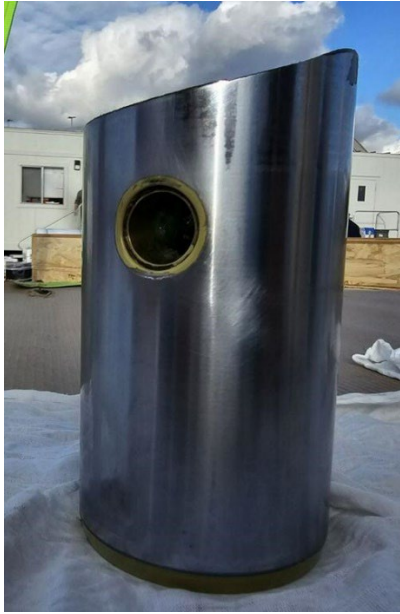
The trunnion pin retaining bolt was removed and the remaining half of the trunnion pin was easily slid out of the outer cylinder. The trunnion pin half (figures 13 and 14) was sent to the NTSB materials laboratory for further examination.

**Figure 13.** Side view of the trunnion pin half after removal from the outer cylinder. (Source: Troy Levanen, Alaska Airlines)

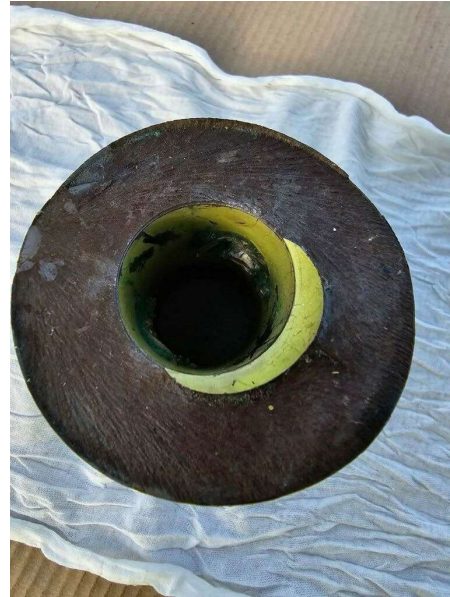
**Figure 14.** View of the fracture face of the trunnion pin half. (Source: Troy Levanen, Alaska Airlines)
