# National Transportation Safety Board

## **MATERIALS LABORATORY**

Factual Report 24-015

Location: Santa Ana, California  
Date: August 20, 2023  
Time: 23:15 Pacific daylight time  
06:15 coordinated universal time  
Vehicle: Boeing 737-890, N516AS  
Investigator: Michael Hauf, AS-10

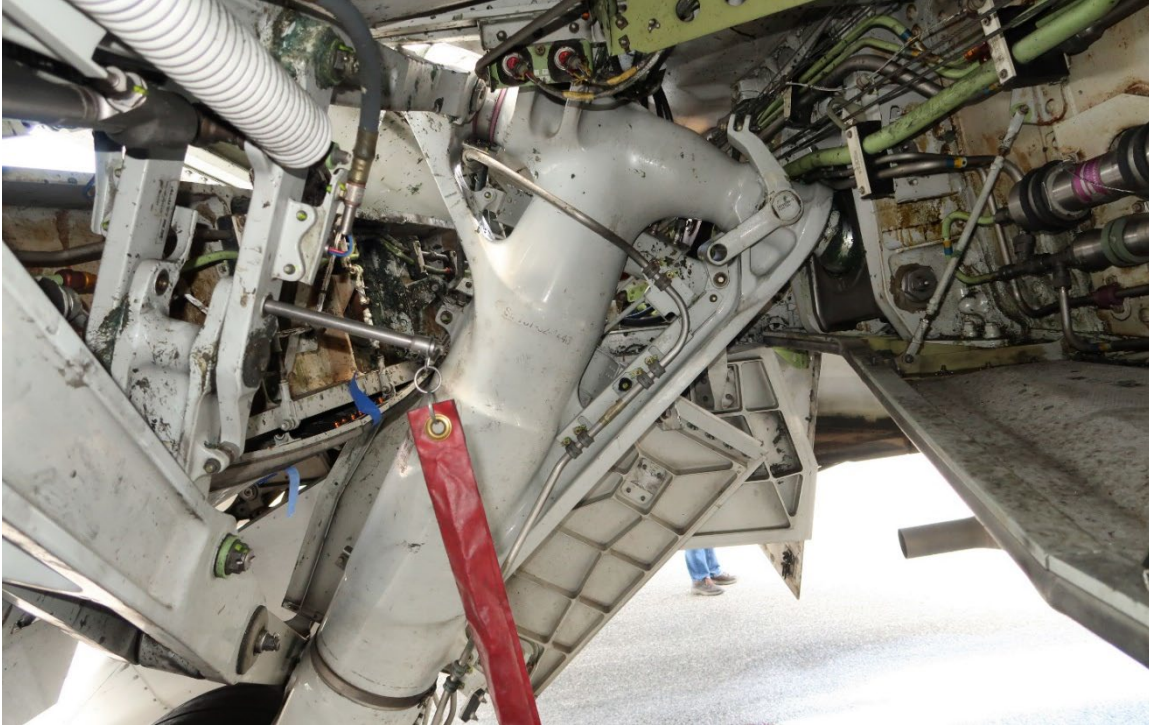
On August 20, 2023, Alaska Airlines flight 1288, a Boeing 737-890, sustained damage when the left main landing gear collapsed after landing on runway 20R at John Wayne-Orange County Airport (SNA). The 112 passengers and crew evacuated the airplane via stairs onto a taxiway with no reported injuries. A post-accident examination found the left main landing gear assembly was found to have failed, as illustrated in Figure 1.

**Figure 1.** View of the fractured and damaged areas of the main landing gear taken in scene.

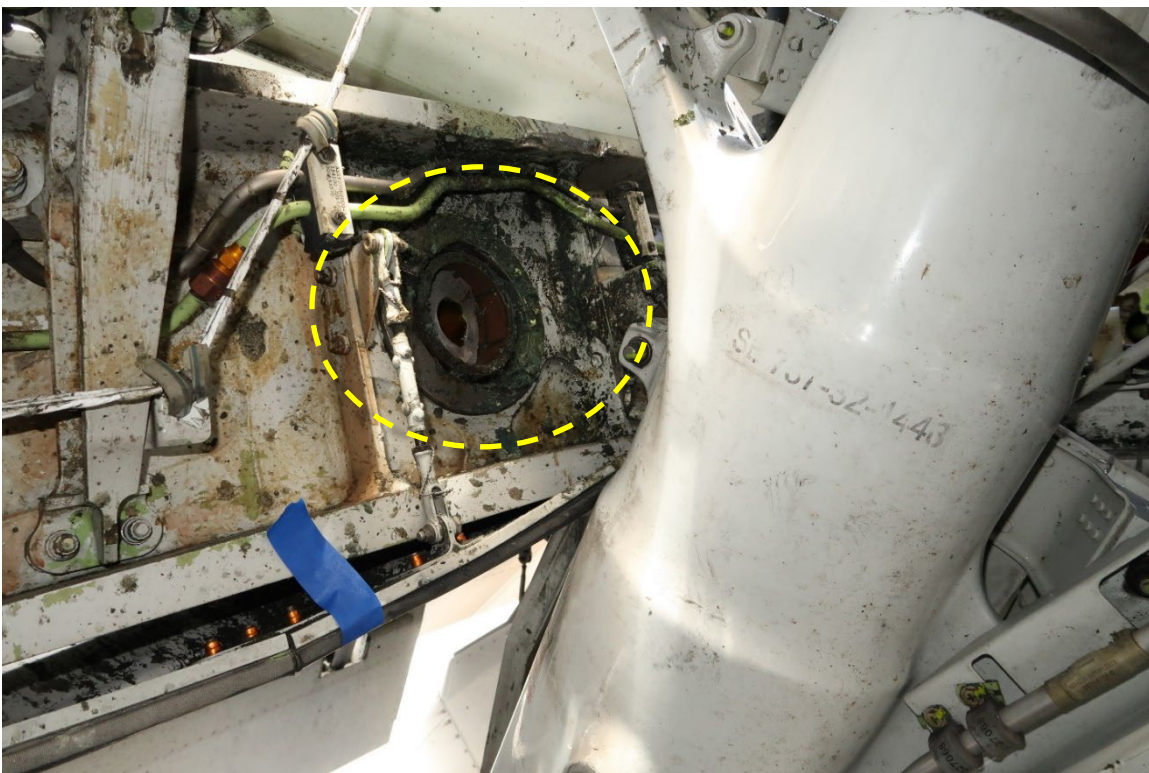
From the on-scene examination, the left-hand main landing gear aft trunnion pin was found to have fractured, as illustrated in Figure 2 through Figure 4. The aft section of the trunnion pin, shown from the opposite side, was more accessible and extracted first (see Figure 5). This fragment was sent to Boeing Equipment Quality Analysis (EQA) in Seattle, WA, for examination. Later, the forward portion of the fractured trunnion pin was removed and examined at both the NTSB Materials Laboratory and Boeing EQA.

**Figure 2.** View of the fractured trunnion pin of the main landing gear on-scene.

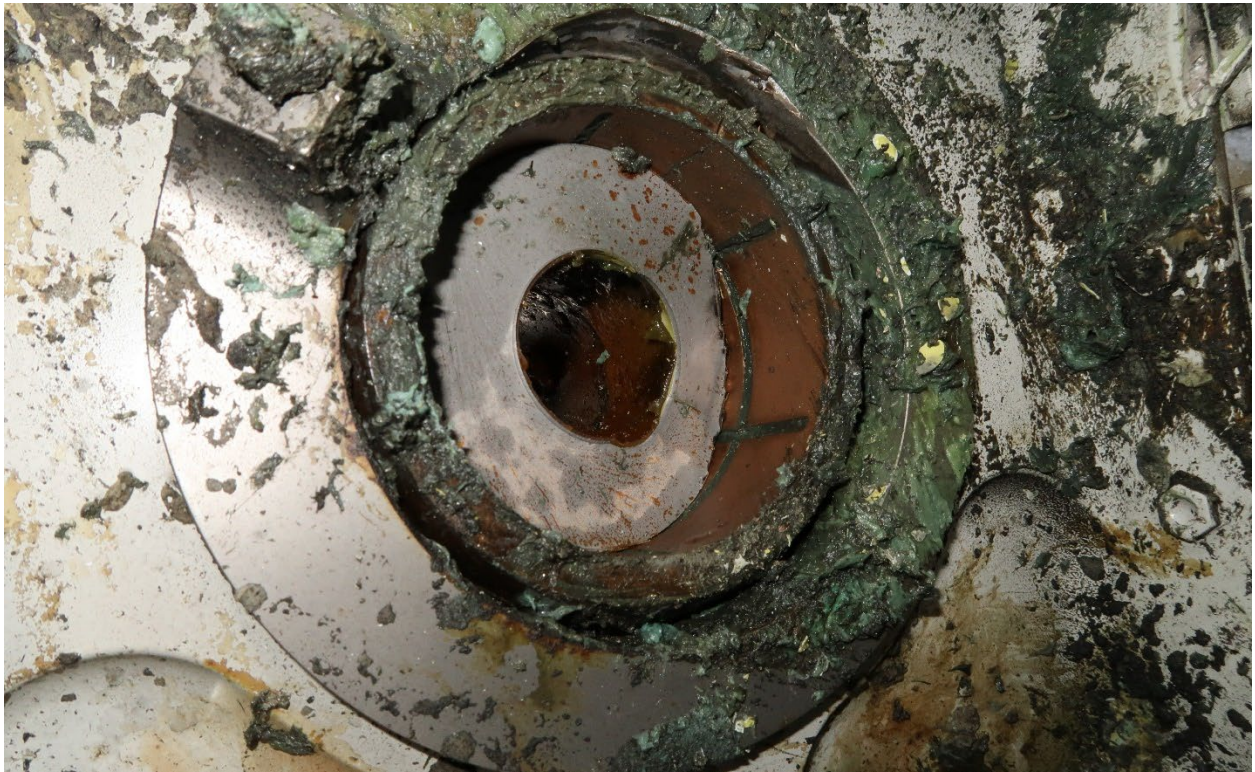
**Figure 3.** View of the fracture surface of the aft remnant of the aft trunnion pin remnant, on-scene.

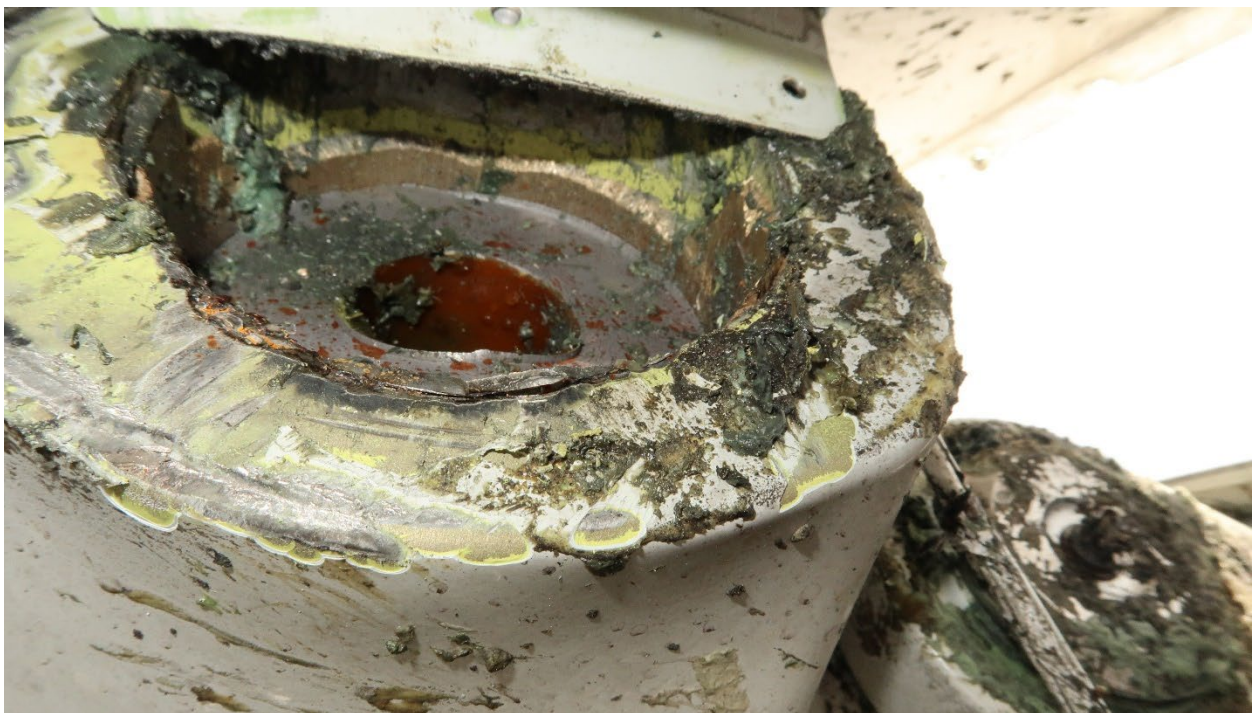
**Figure 4.** View of the mating fracture surface of the forward half of the aft trunnion pin, on-scene.

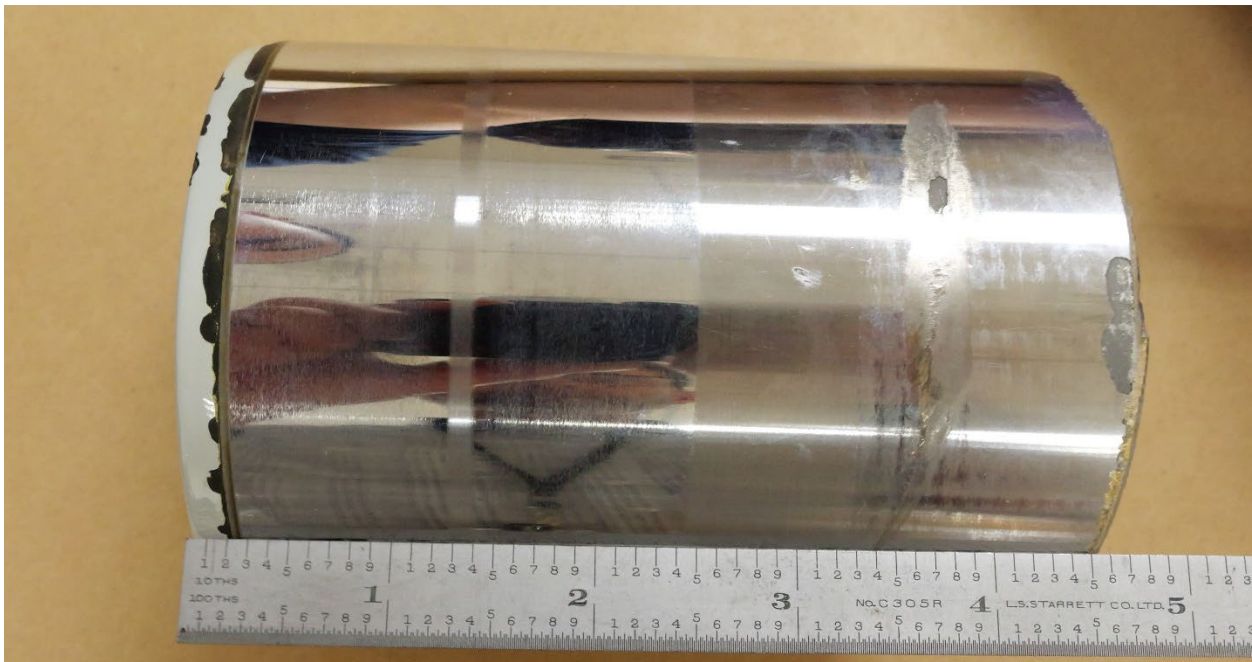
Figure 6 shows the aft remnant of the fractured aft trunnion pin, as received at Boeing EQA. This remnant was between 4.5 and 5.0 inches in length, and it exhibited the following markings shown in Figure 7:

**Figure 6.** Side view of the aft remnant of the aft trunnion pin, after removal and receipt at Boeing EQA (courtesy: Boeing).

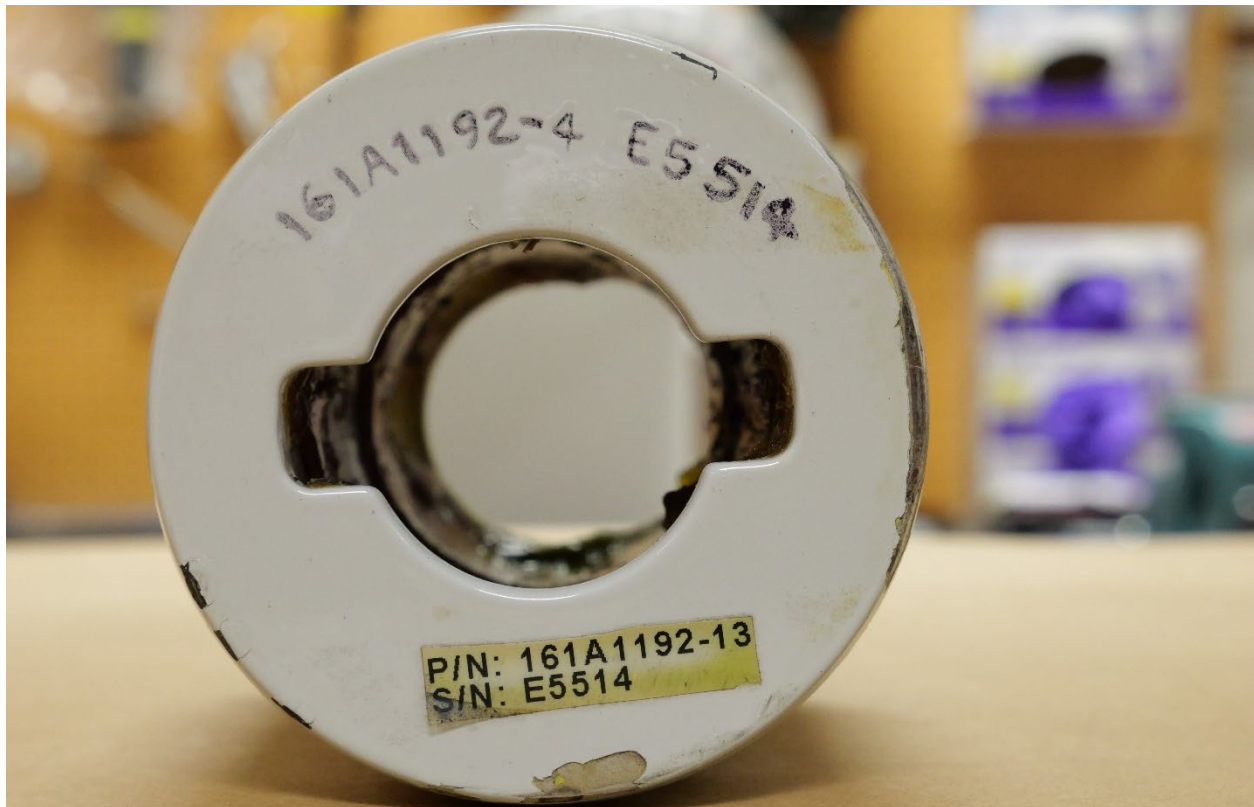
**Figure 7.** View of the flat, painted end opposite the fracture surface of the aft remnant of the aft trunnion pin, showing part markings.

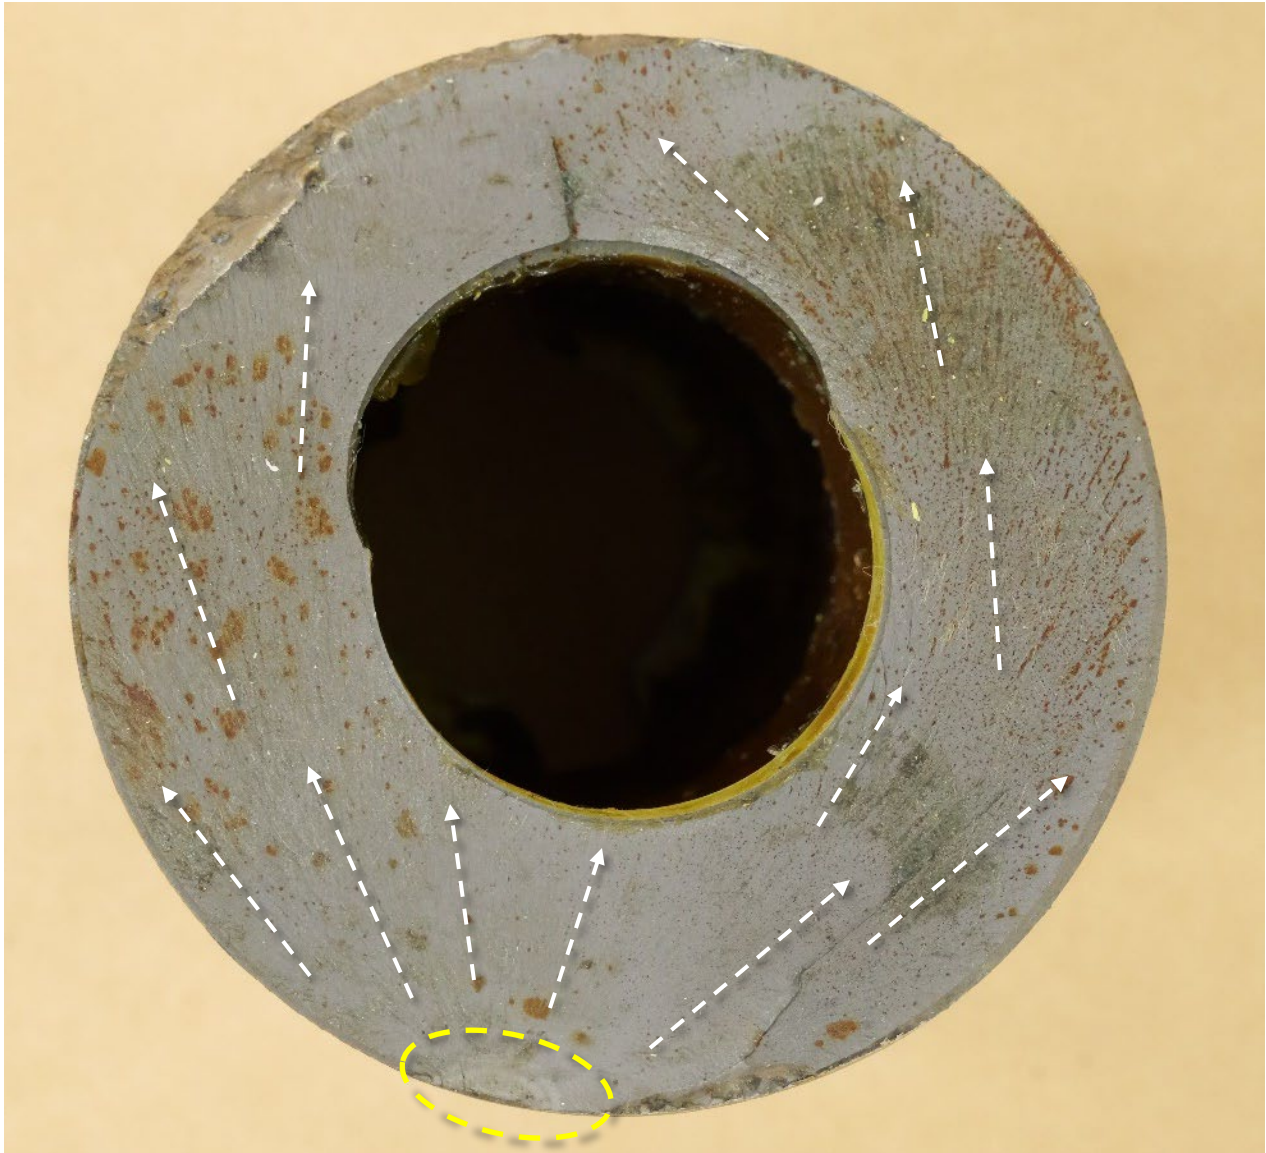
The fracture surface of the forward trunnion pin fragment is shown as received in Figure 8. Most of the fracture surface exhibited a rough surface with a dull gray luster, and much of the edges featured small shear lips, except for the lower left corner. The surface exhibited river patterns and chevron marks that indicated fracture from an area on the bottom left of Figure 8. This corner of the fracture surface contained a thumbnail crack with crack arrest marks, consistent with an initial crack propagation region.

**Figure 8.** View of the fracture surface of the aft remnant of the aft trunnion pin, annotated to show the initial thumbnail crack (oval) and the later fracture directions (arrows) (courtesy: Boeing).

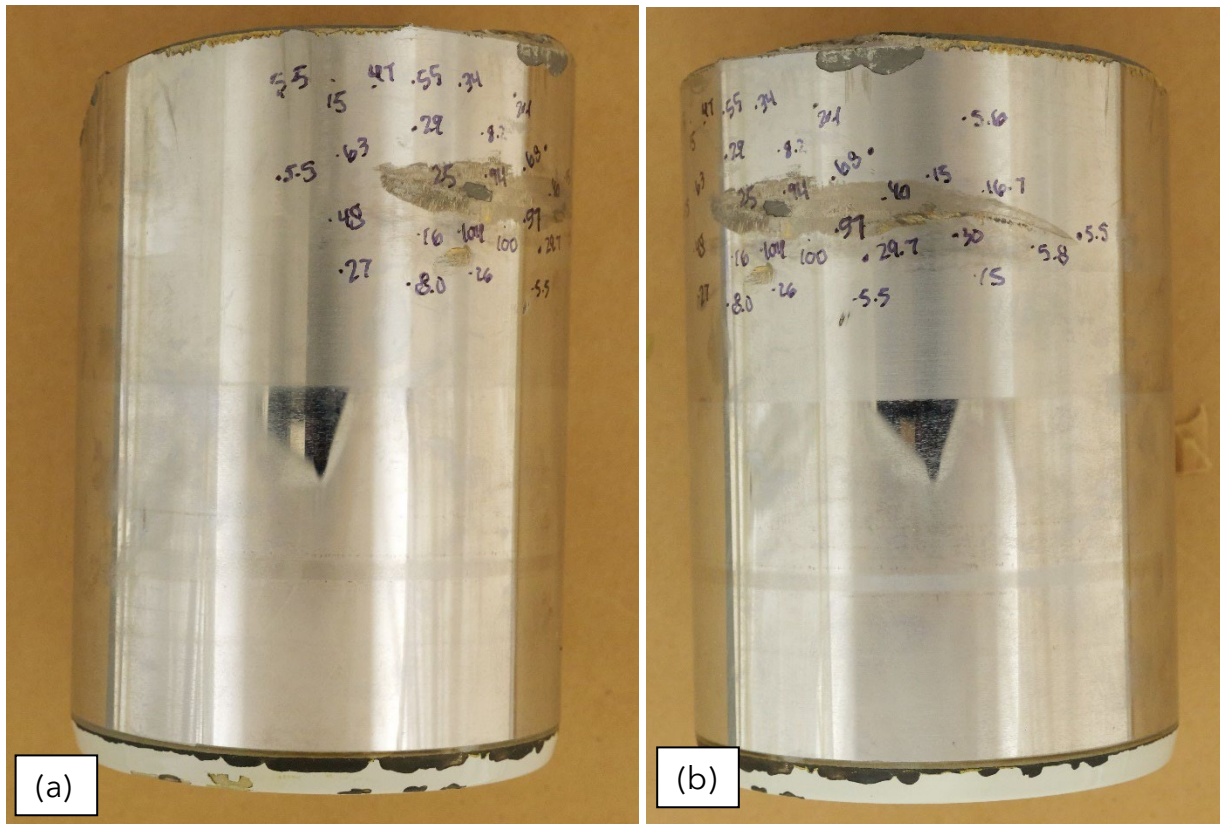
The part had been inspected visually, as well as with Barkhausen noise inspection (BNI), fluorescent penetrant inspection (FPI), and magnetic particle inspection (MPI).<sup>1</sup> The BNI probes were calibrated to a specially designed shot-peened steel standard that had simulated grinding burn regions, created from an induction heating process. The thickness of the chromium electroplated layer of the pin pieces was inspected and used to determine a shim thickness for more accurate calibration. The BNI detected areas of elevated readings near the fracture surface. These readings were directly labeled onto the part, as illustrated in Figure 9 and Figure 10. The highest readings exceeded 100, whereas many of the base readings were as low as 34. The highest readings were in areas with visible physical damage to the pin surface and near the thumbnail crack in Figure 8.

**Figure 9.** View of the aft trunnion pin remnant opposite the thumbnail crack edge, showing Barkhausen data directly on the exterior surface (courtesy: Boeing).

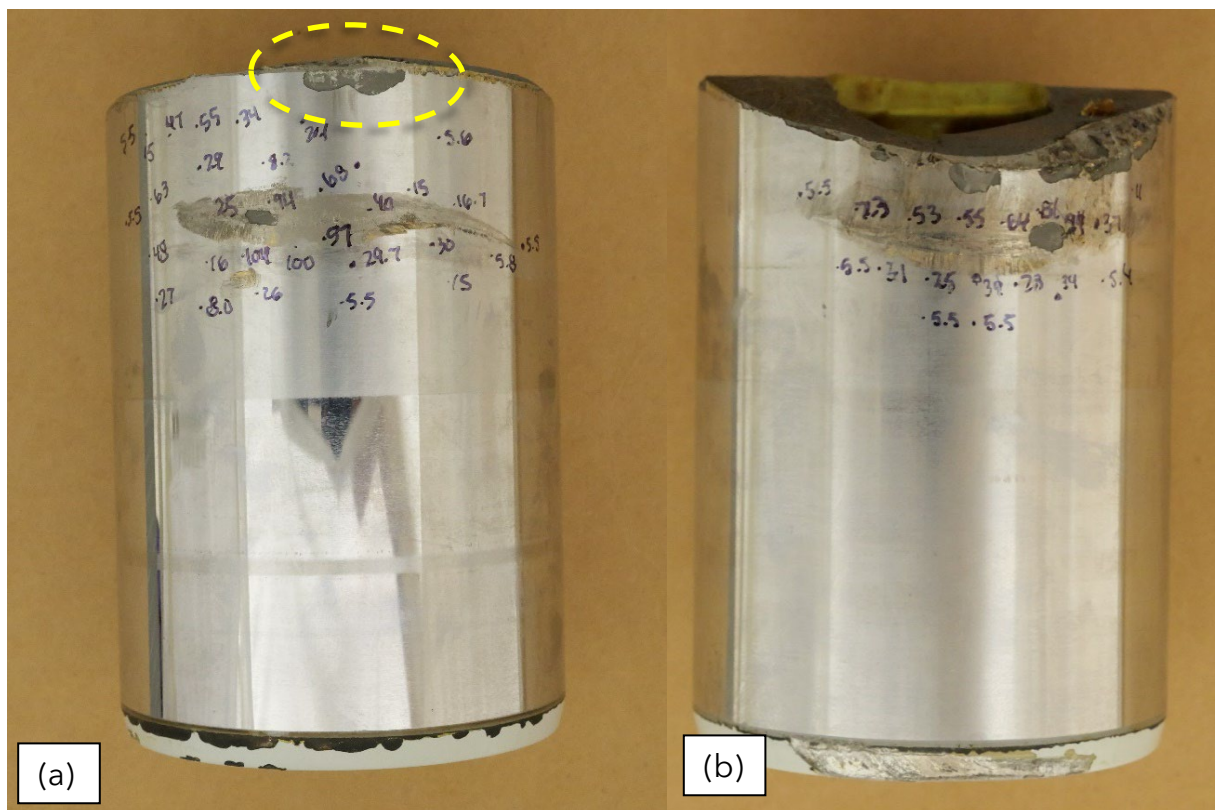
**Figure 10.** Side view of the aft trunnion pin remnant on the thumbnail crack edge (circled) showing the Barkhausen data directly on the surface.

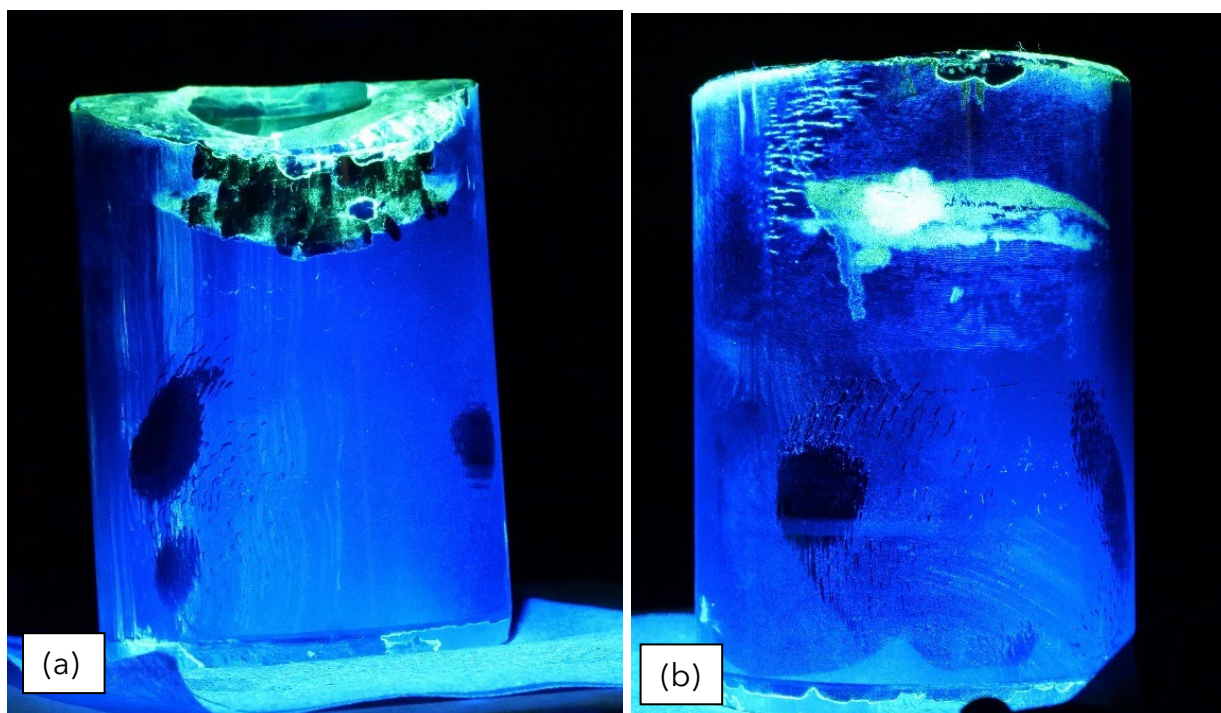
FPI and MPI inspections were performed on the forward fragment of the pin. Figure 11 and Figure 12 show some of the images under ultraviolet light of the FPI. From this inspection, no indications of an abnormal network of cracks (such as “chicken wire” cracks) were observed on the surfaces of the parts. Small cracks parallel and adjacent to the fracture surface were found in the chromium electroplated layer. These cracks were observed near the fracture origins (Figure 12). Additional indications were observed on the surface, in areas that exhibited impact damage to the surface (indicated by the bright circumferential area in Figure 11b and the U-shaped area under the fracture in Figure 11a).

**Figure 11.** Ultraviolet light images of the aft pin remnant from (a) the thumbnail crack side and (b) the opposite side during FPI (courtesy: Boeing).

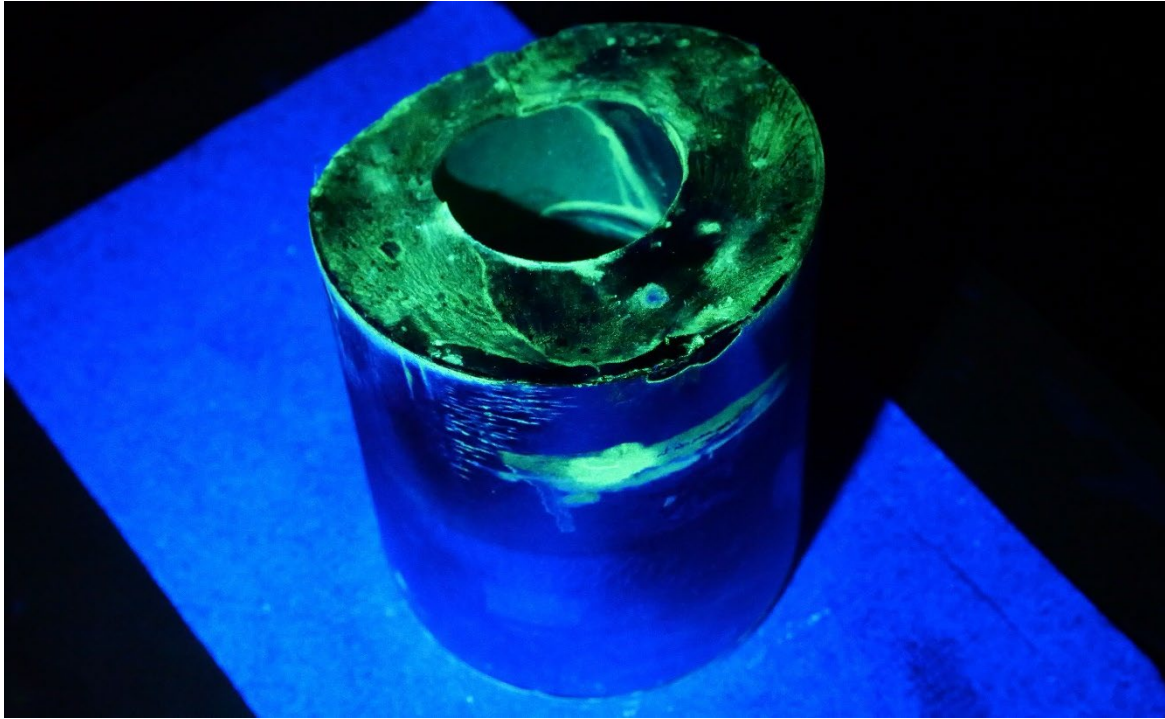
**Figure 12.** Ultraviolet view of the edge of the fracture surface with the thumbnail crack under FPI inspection (courtesy: Boeing).

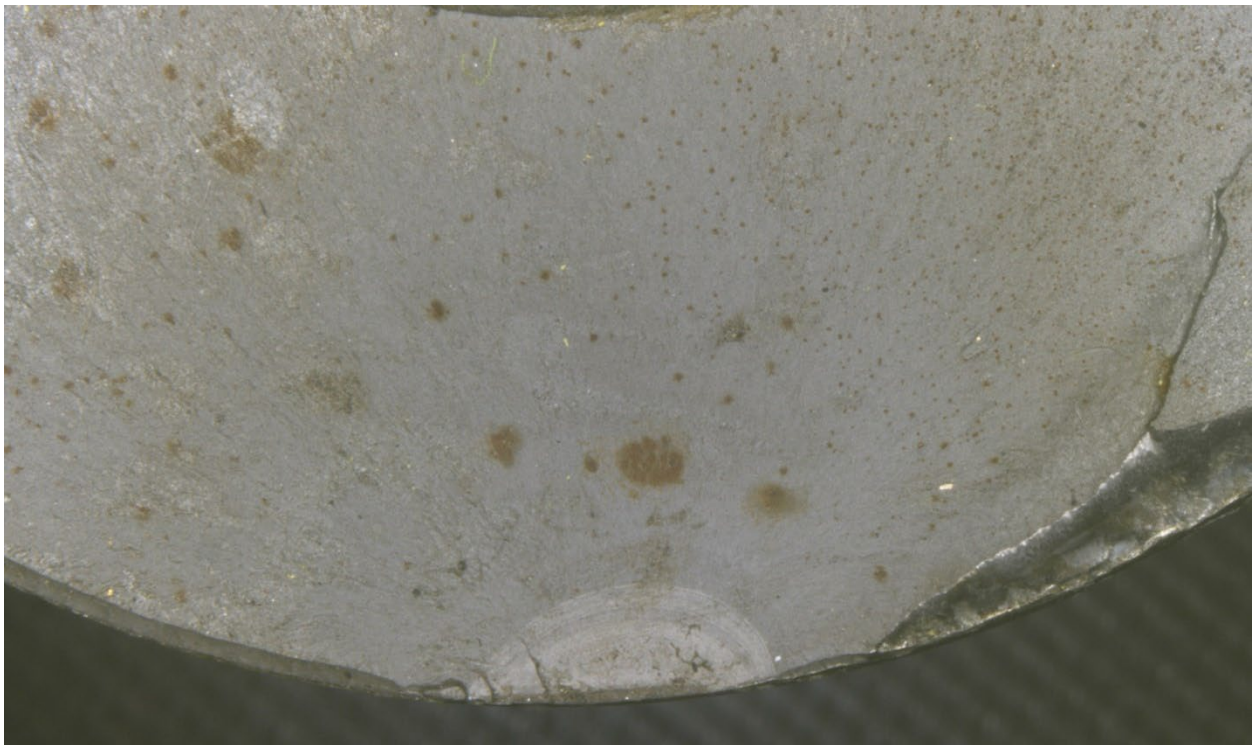
Figure 13 shows a closer view of the thumbnail crack on the forward pin remnant fracture surface. This thumbnail crack exhibited diverse colors visually and crack arrest marks (see Figure 14). These features were consistent with pre-existing progressive cracking in this pin section.

**Figure 13.** The edge of the fracture surface, showing the thumbnail crack and adjacent shear lips (courtesy: Boeing).

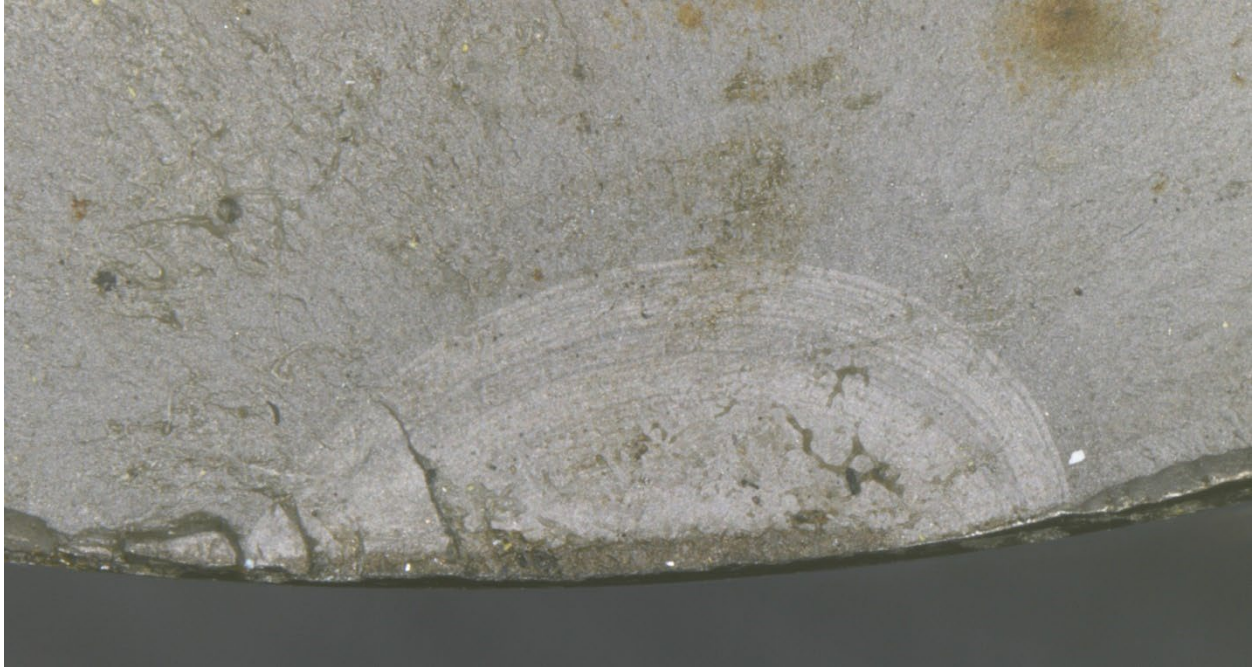
**Figure 14.** Closer view of the thumbnail crack in **Figure 13**, showing crack arrest marks (courtesy: Boeing).

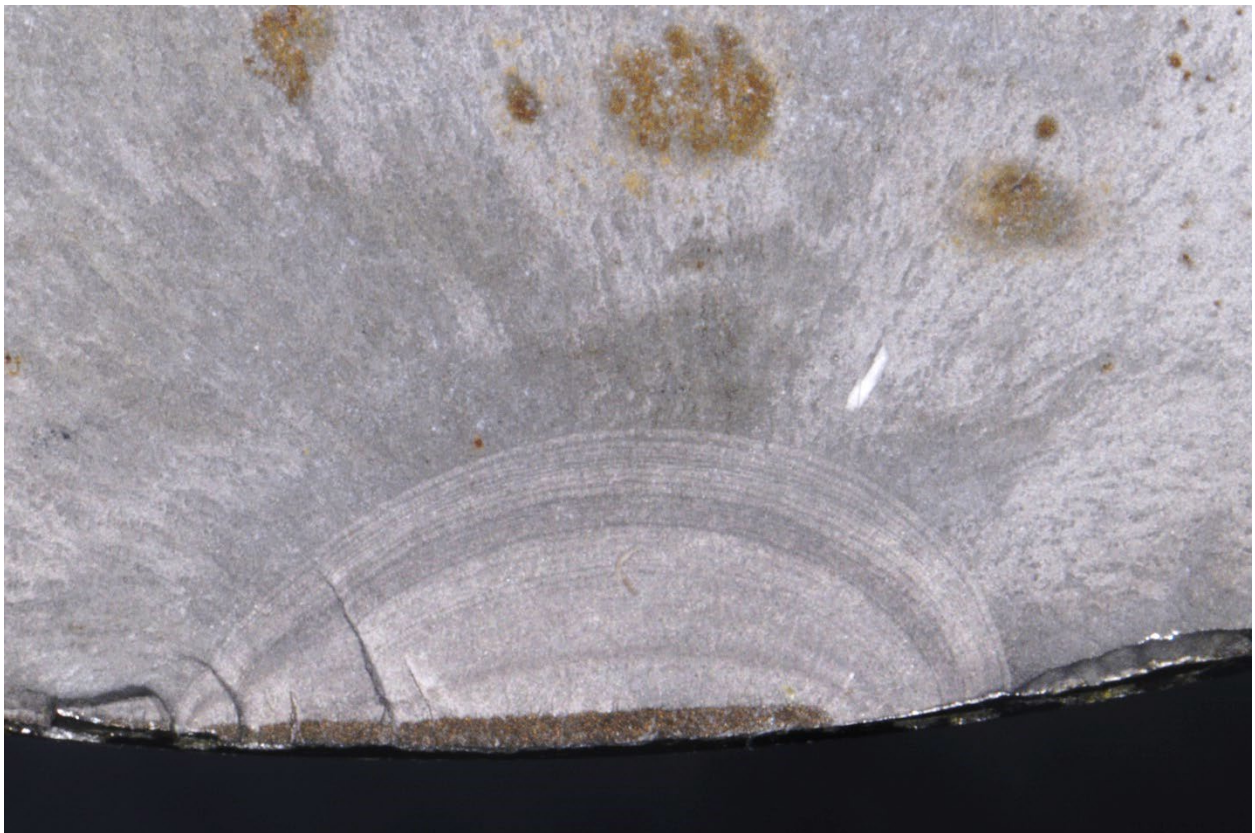
Figure 13 and Figure 14 show the forward thumbnail crack before and after cleaning with acetone, and Figure 15 shows a dark-field image of the region. These different views demonstrate the crack arrest marks, seen bowing convexly into the pin cross-section from the surface. There were also vertically oriented ratchet marks, consistent with crack initiation along multiple sites. A rectangular region of faceted features was located between the crack arrest mark features of the thumbnail crack and the pin surface. This region appears dark in Figure 14 and Figure 15 and lighter in Figure 16: an adherent shiny external layer and a subsurface darker, faceted region.

**Figure 15.** Closer view of the thumbnail crack after cleaning (courtesy: Boeing).

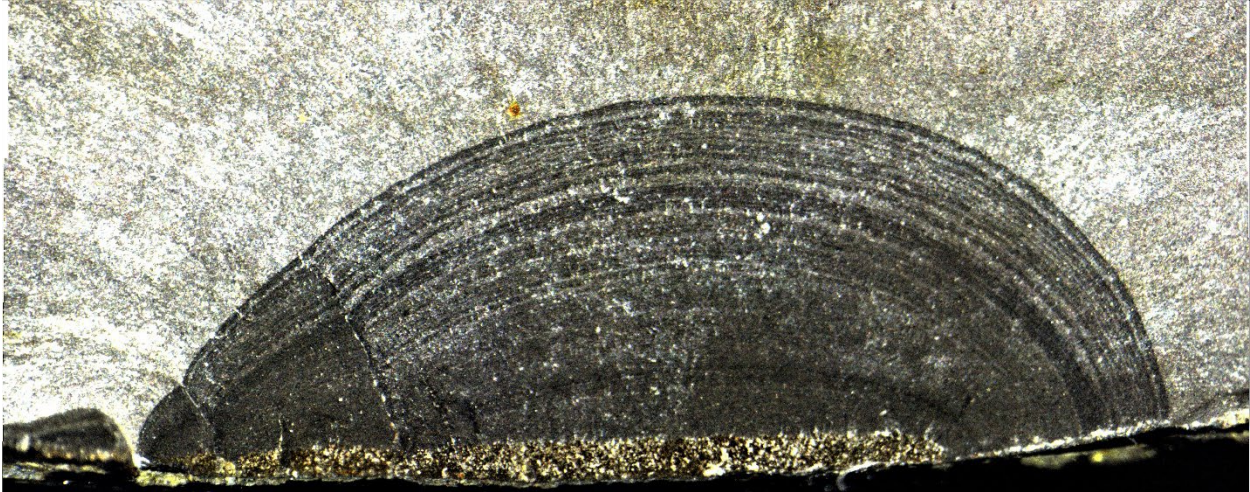
**Figure 16.** Angled dark field lighting view of the thumbnail crack in , highlighting the major arrest marks and subsurface rough zone of the fracture (courtesy: Boeing).

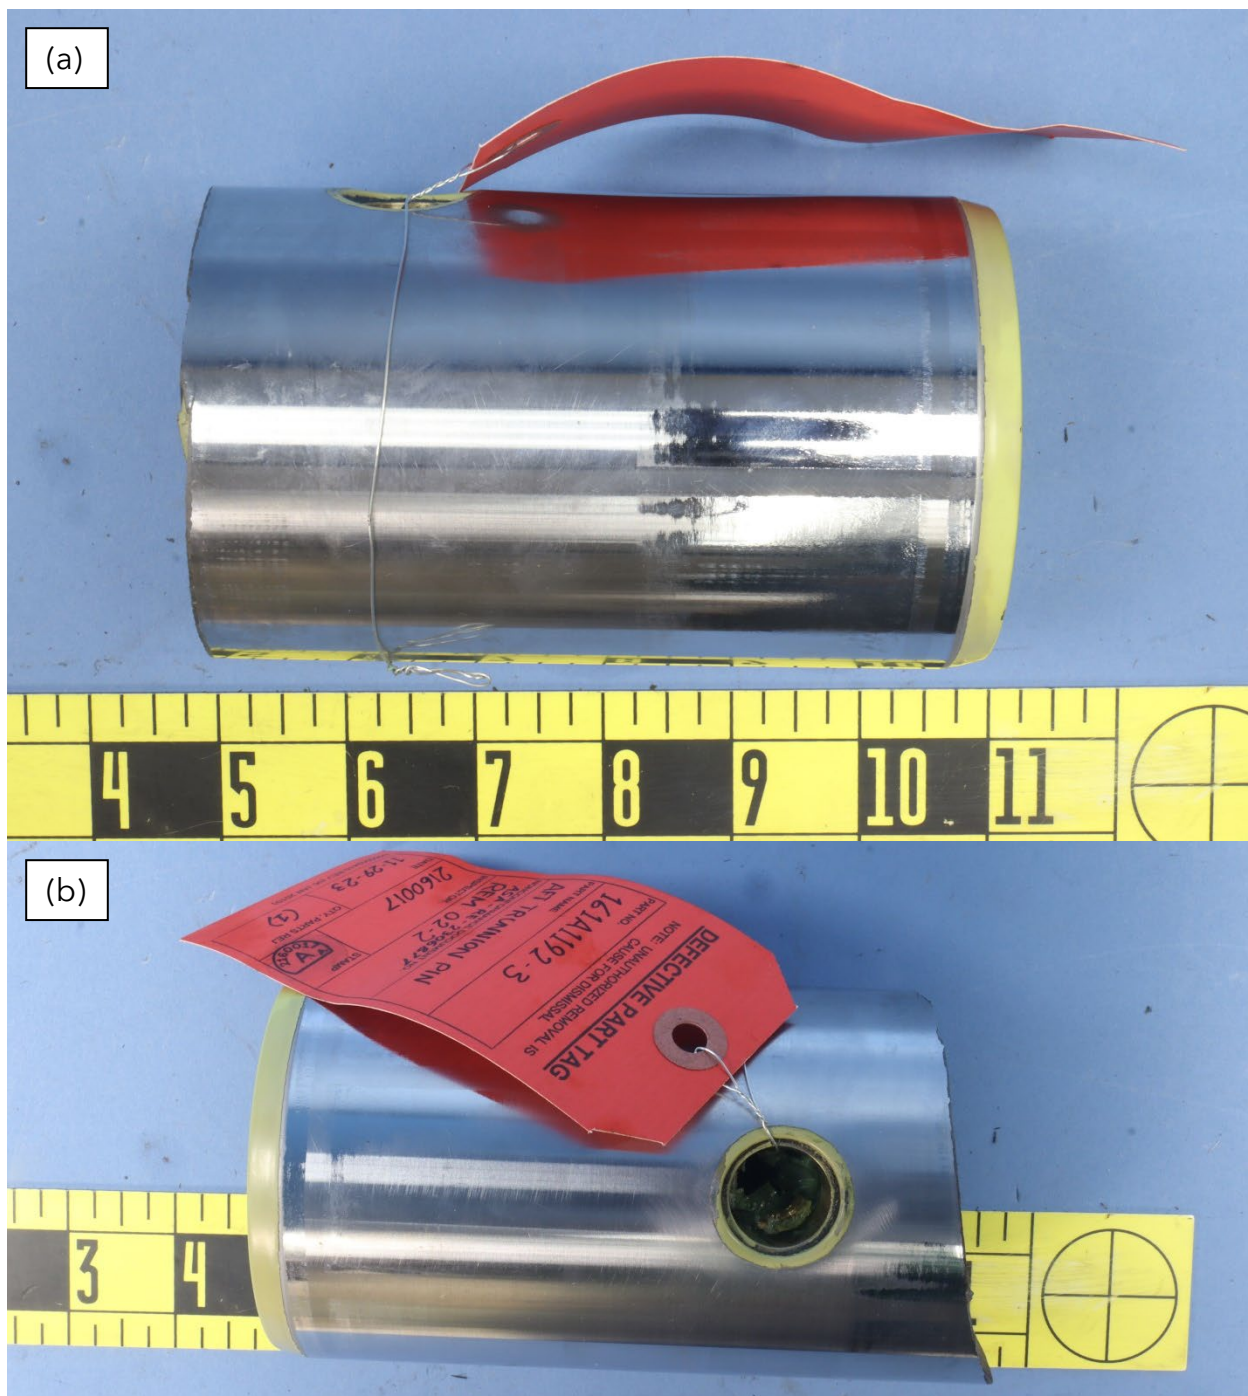
Figure 17 shows the aft remnant of the aft trunnion pin, as received by the NTSB Materials Laboratory. This remnant measured between 5.25 and 6 inches in length. The features of the aft fracture surface mirrored those of the forward side, including the thumbnail crack along the edge, shown in Figure 18 through Figure 20.

**Figure 17.** Side view(s) of the forward remnant of the aft trunnion pin, as received.

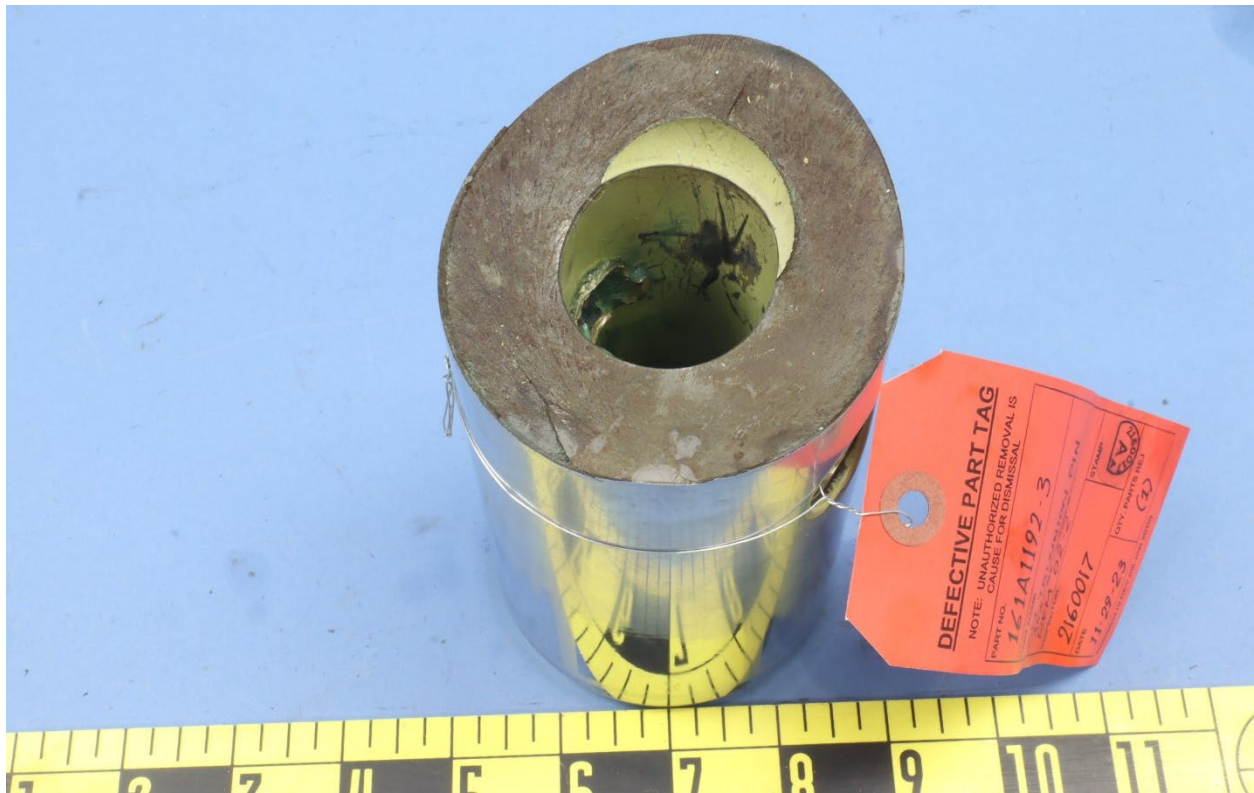
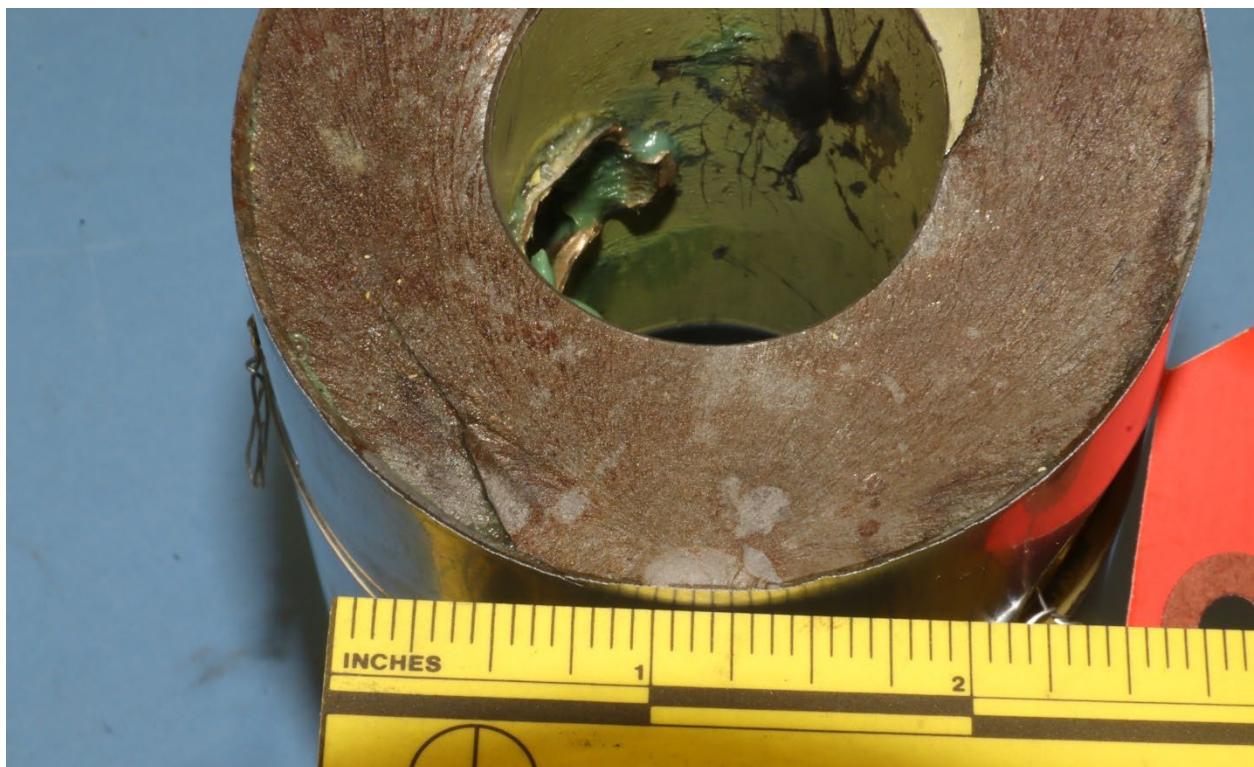
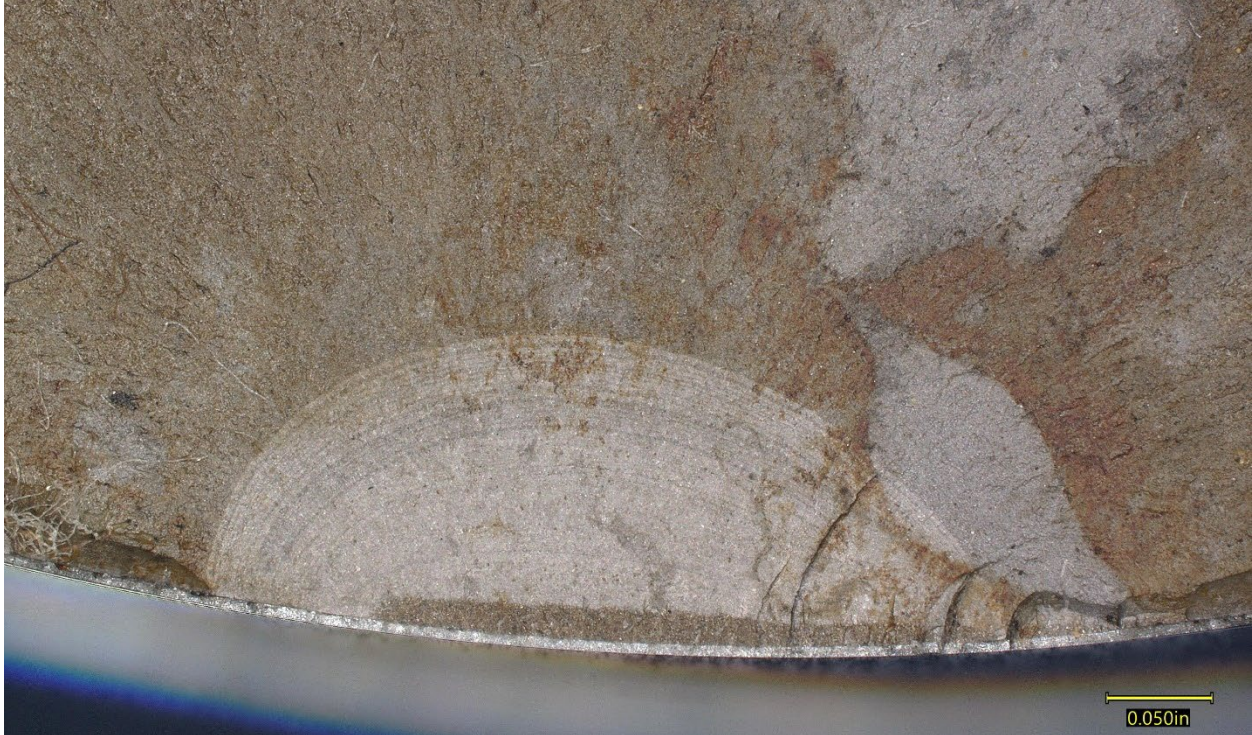
**Figure 18.** View of the forward pin remnant fracture surface, with the thumbnail crack positioned on the bottom edge.

**Figure 19.** Closer view of the edge with the thumbnail crack from **Figure 18**.

**Figure 20.** Close-up view of the thumbnail crack on the forward pin remnant.

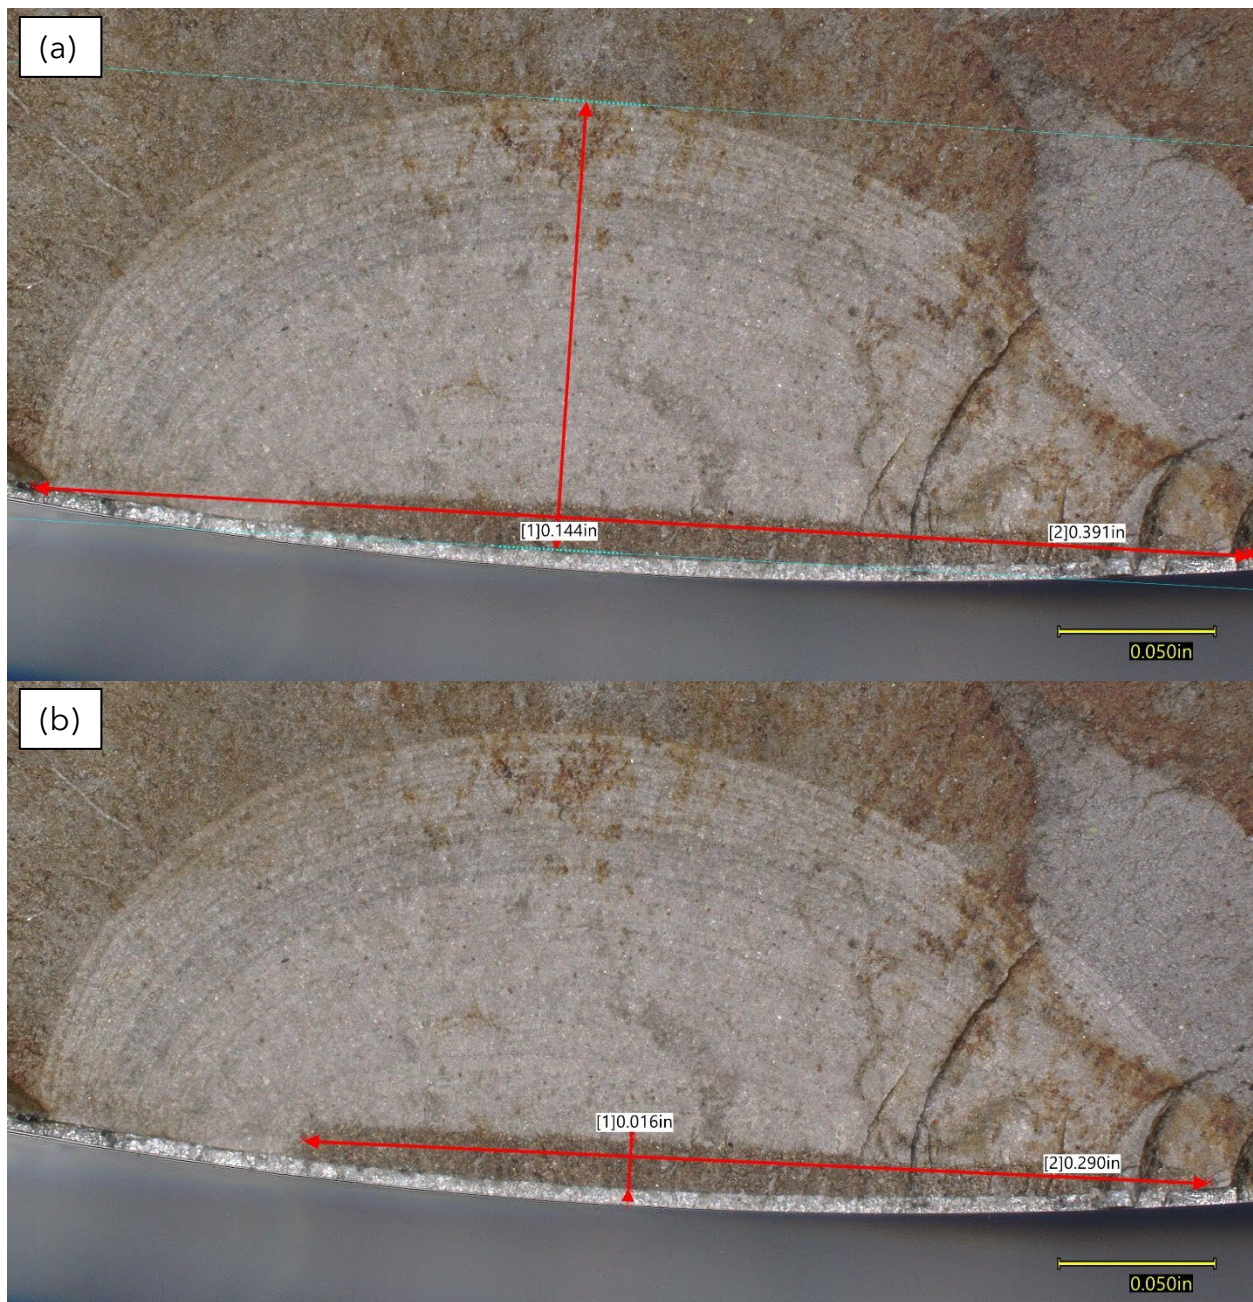
The thumbnail crack dimensions were measured with a digital optical microscope, as annotated in Figure 21. The crack measured 0.144 inches deep, with a linear length on the outer diameter (OD) of 0.391 inches. This subsurface intergranular region measured 0.016 inches deep by 0.290 inches long inside the thumbnail crack.

**Figure 21.** Measurements of various dimensions on the thumbnail crack image in **Figure 20**.
