# National Transportation Safety Board

## **MATERIALS LABORATORY**

Factual Report 24-015

Location: Santa Ana, California  
Date: August 20, 2023  
Time: 23:15 Pacific daylight time  
06:15 coordinated universal time  
Vehicle: Boeing 737-890, N516AS  
Investigator: Michael Hauf, AS-10

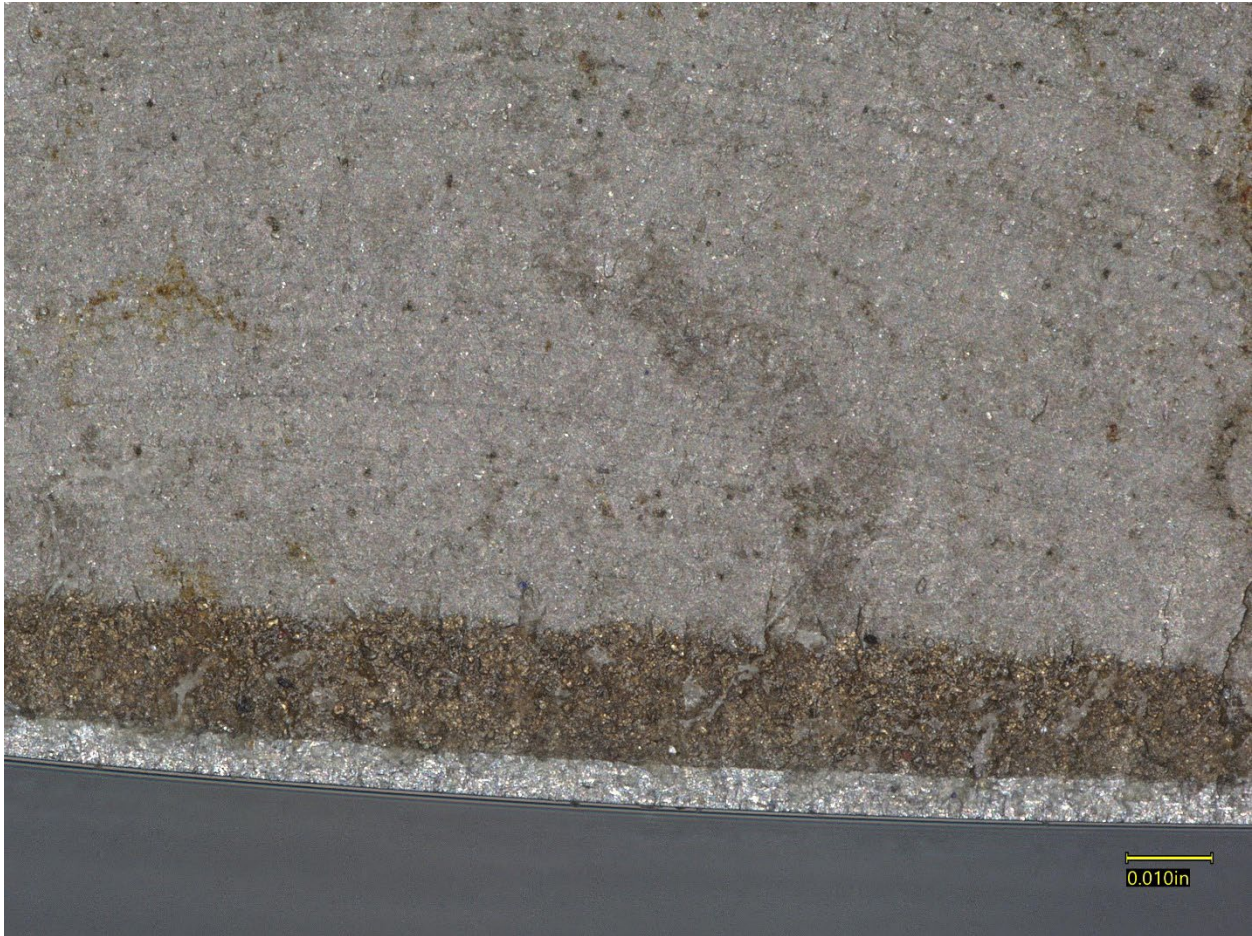
The darker, brownish-colored subsurface intergranular area is shown closer in Figure 22. Smaller ratchet marks were present on the progressive region of the thumbnail crack adjacent to the intergranular area. This crack area was examined using a field-emission scanning electron microscope (SEM), as shown in Figure 23 and Figure 24. This region was below an area of the fractured external chromium electroplating layer, shown in more detail in Figure 25. The plating layer exhibited layered fan-shaped characteristics, with radiating or tongue features, as typified in Figure 26. The intergranular region is shown in more detail in Figure 27. The faceted morphology of the area was consistent with fracture between grain boundaries. Much of the intergranular surfaces exhibited ridged or smooth surface features, with clear triple points and some secondary cracking, typified in Figure 28.

**Figure 22.** Closer view of the initiation region of the thumbnail crack, showing the Cr-plating surface layer and the darker subsurface intergranular layer.

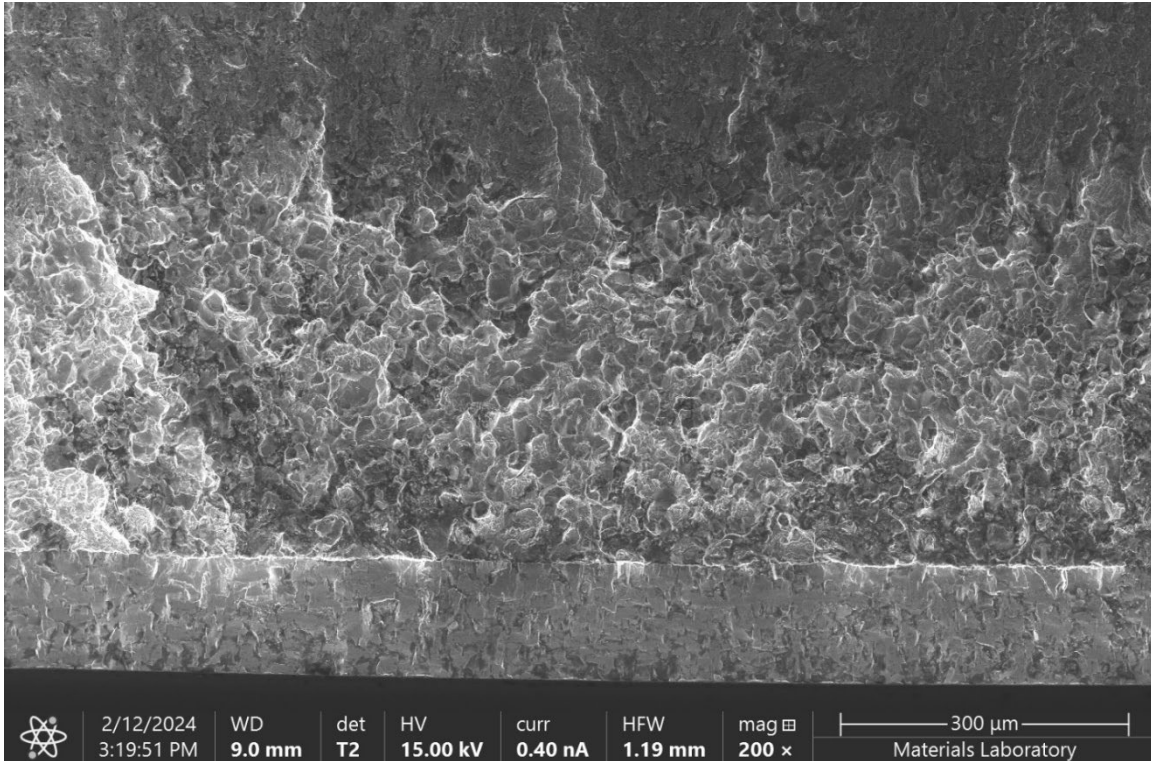
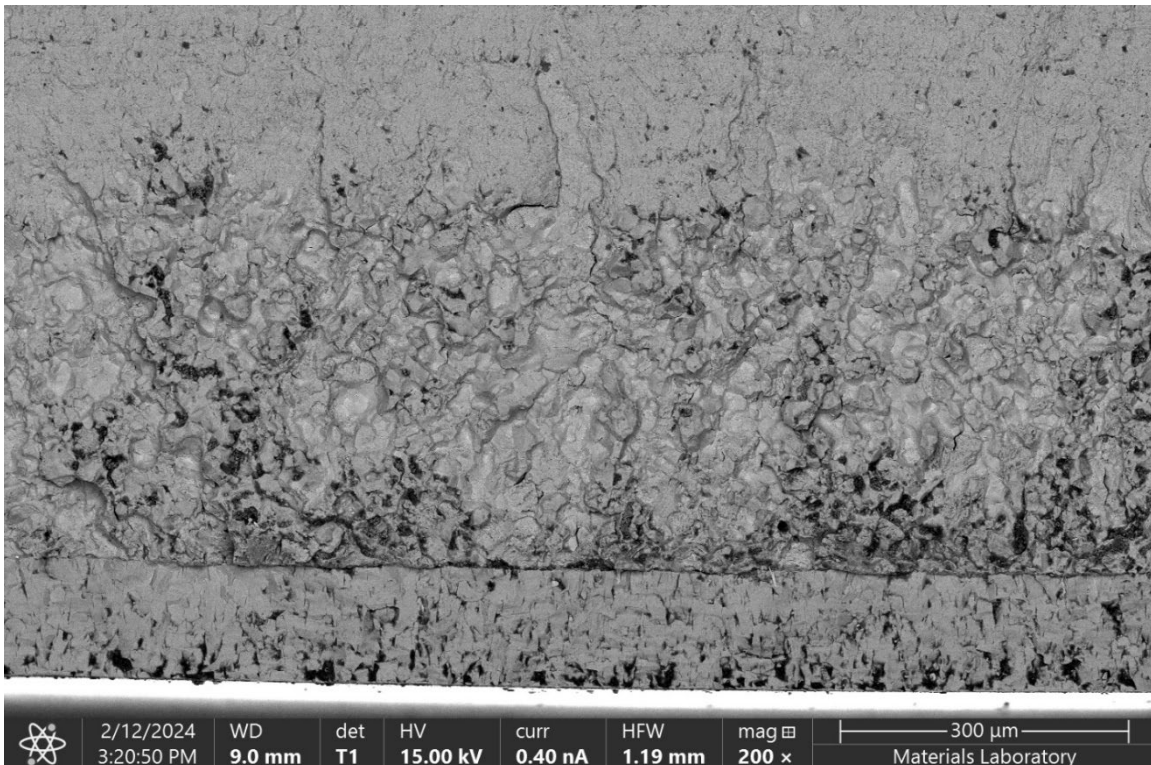
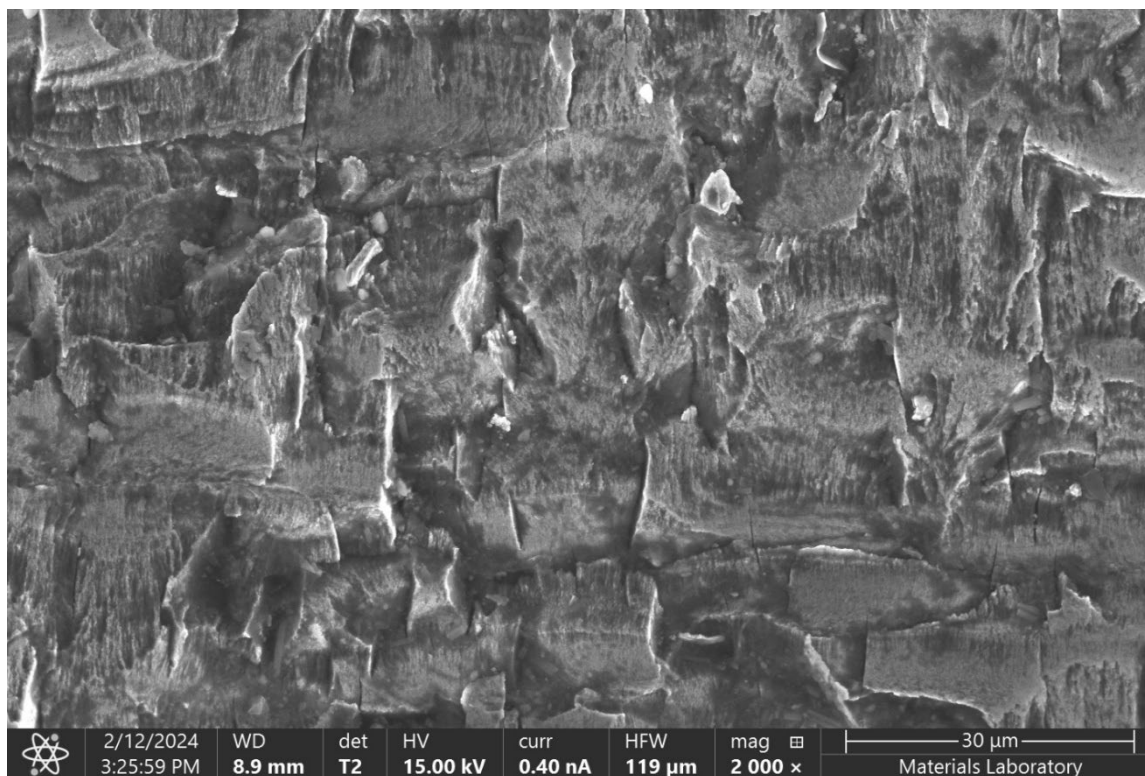
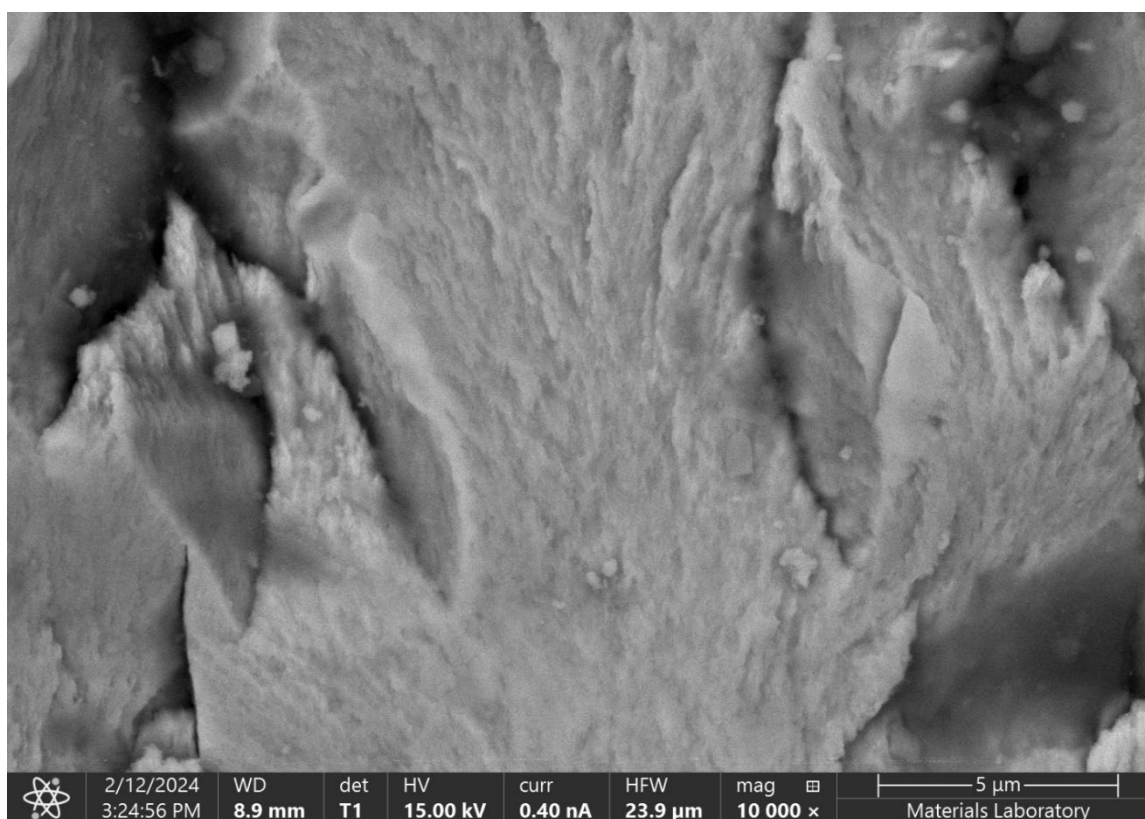
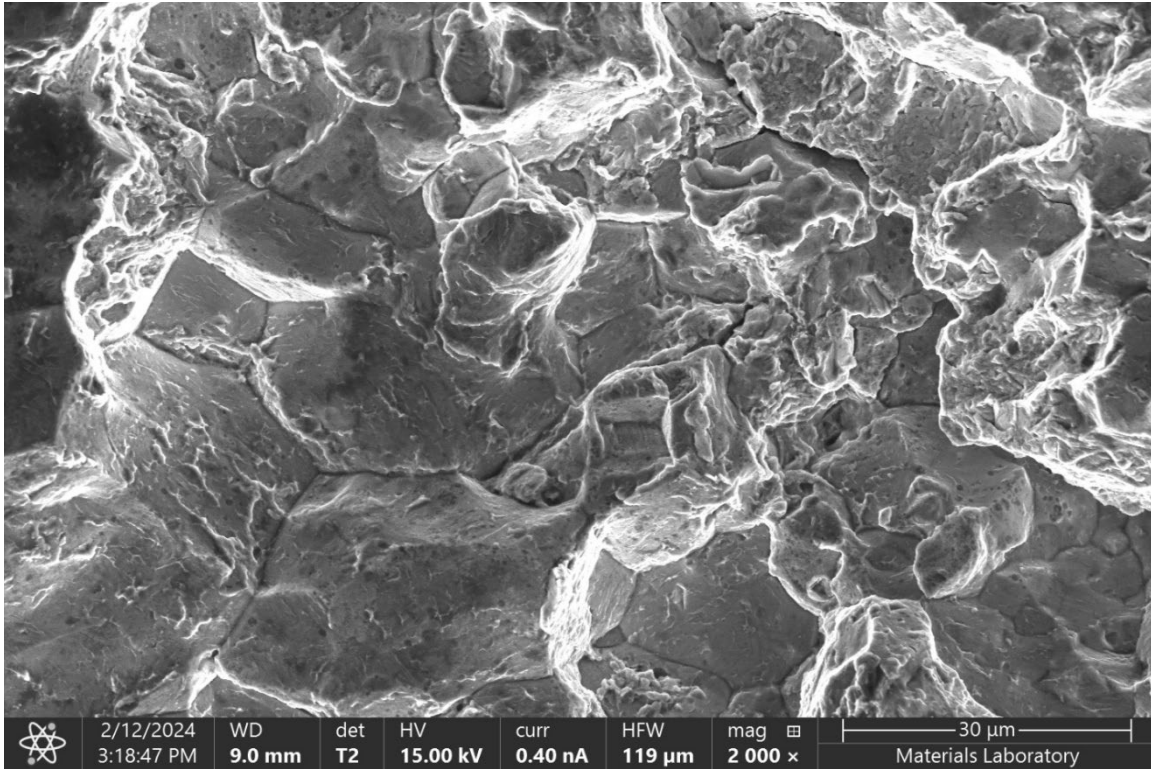
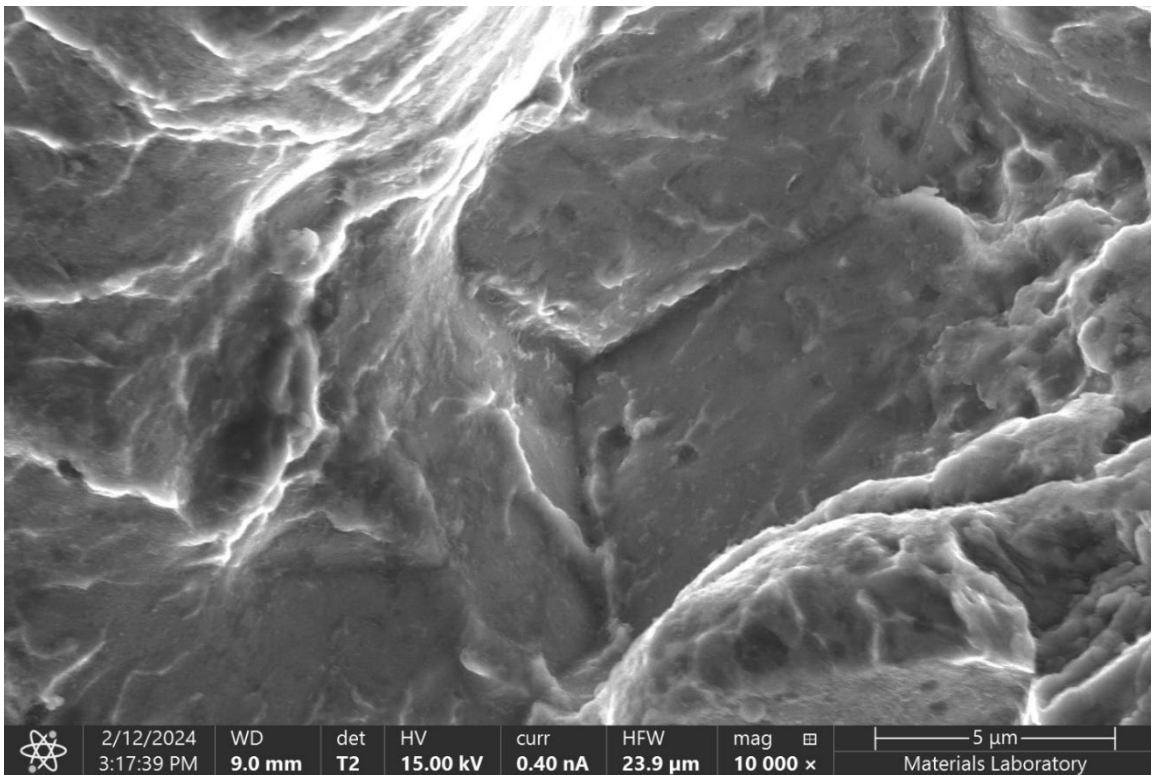
**Figure 23.** Secondary electron (SE) micrograph of the intergranular region of the initial crack.

**Figure 24.** Backscattered electron (BE) micrograph of the intergranular and Cr-plating region of the thumbnail crack in **Figure 23**.

**Figure 25.** SE micrograph of the fractured Cr electroplating surface coating.

**Figure 26.** BE micrograph of one of the facets in **Figure 25**.

**Figure 27.** SE micrograph of a typical area of the initial intergranular region.

**Figure 28.** SE micrograph of a triple point in the intergranular region in **Figure 27**.

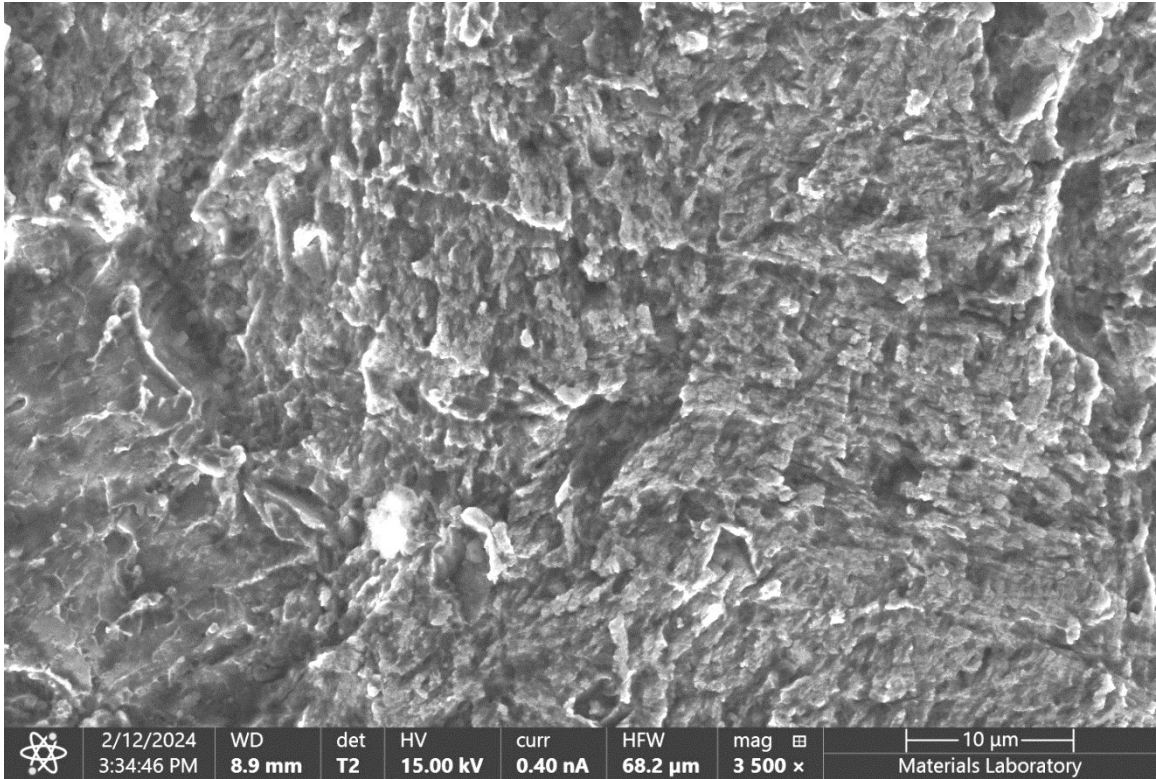
Beyond the intergranular region, the thumbnail crack exhibited fatigue striations, as shown in Figure 29. These features were consistent with fatigue crack propagation. As shown in Figure 30, these striations originated along the edge of the intergranular region of the fracture surface. The ratchet marks, indicative of multiple initiation sites, indicate that the fatigue crack started along stress concentrations created by the tortuous morphology of the initial intergranular zone. There was no indication of mixed mode features, such as dimpled rupture or intergranular cracking within the fatigue regions of the darker portions of the thumbnail crack.

**Figure 29.** SE micrograph of a typical area of fatigue crack propagation in the thumbnail crack of the forward pin remnant fracture surface.

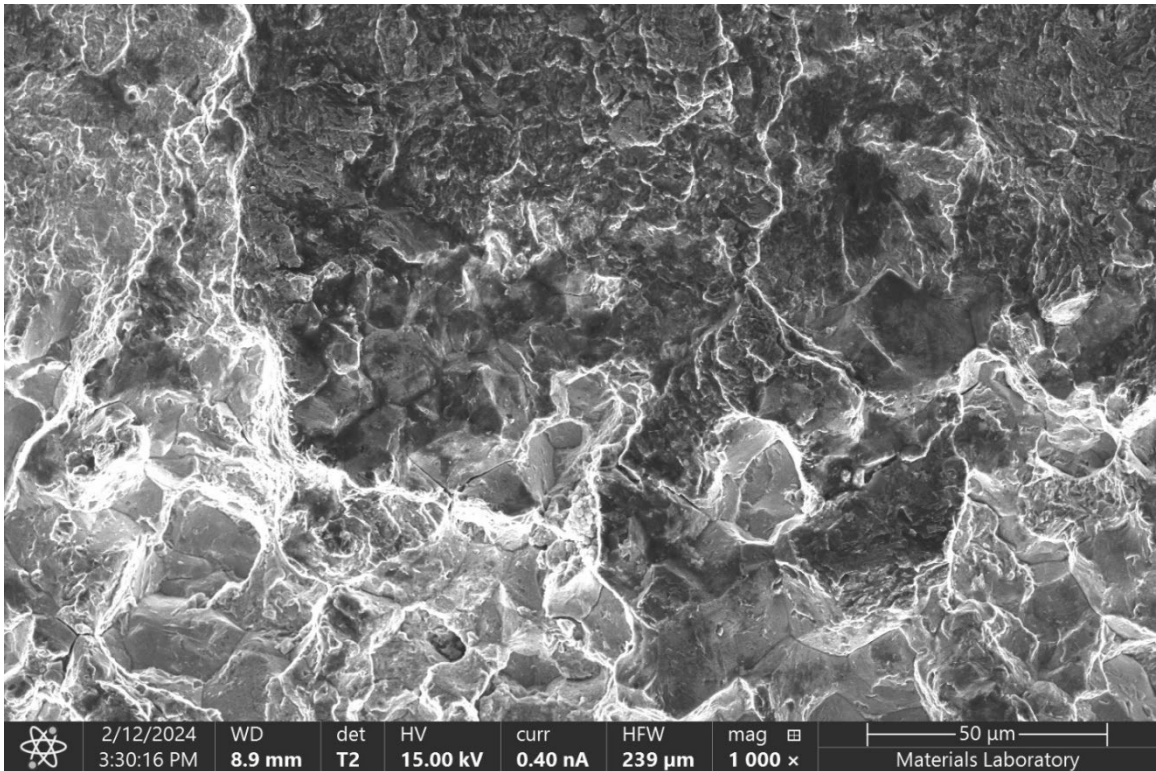
**Figure 30.** SE micrograph showing fatigue initiation sites off the intergranular region.

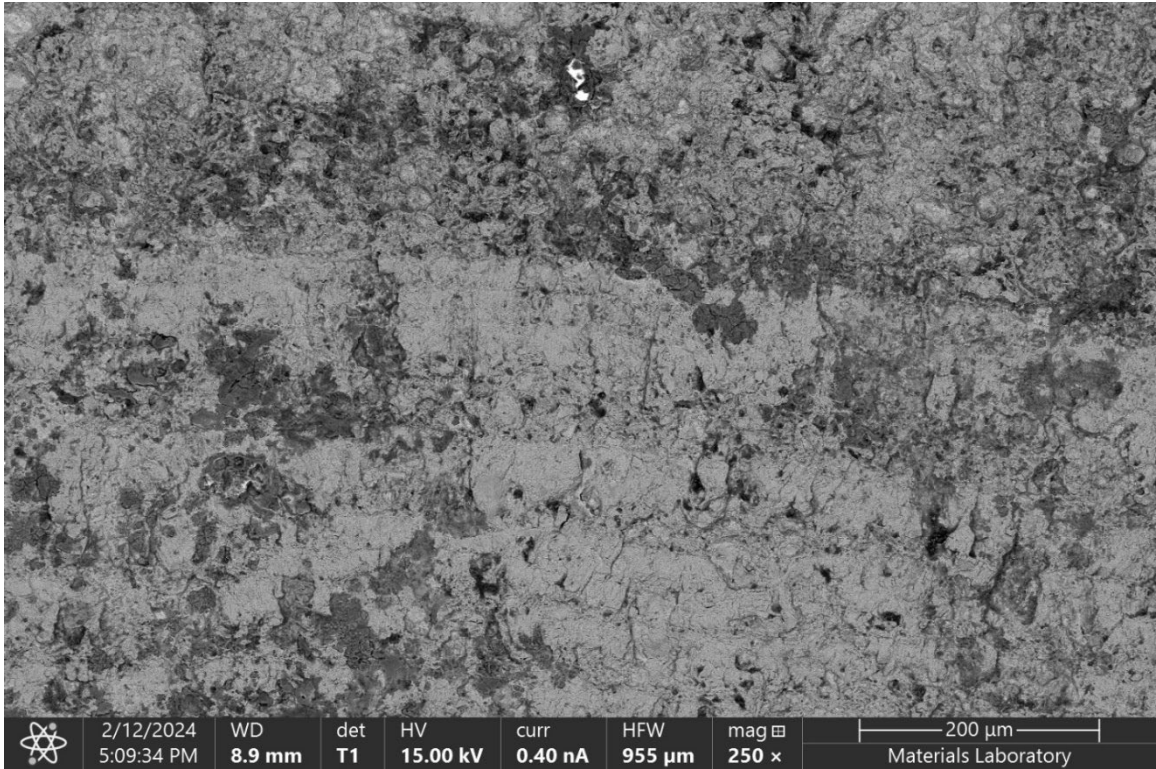
At the terminus of the fatigue thumbnail crack (Figure 31), there was an abrupt change in fracture features. Outside the striations comprising the fatigue crack in Figure 32, the fracture surface exhibited dimpled rupture, consistent with subsequent

**Figure 31.** BE micrograph showing the terminus of the fatigue thumbnail crack.

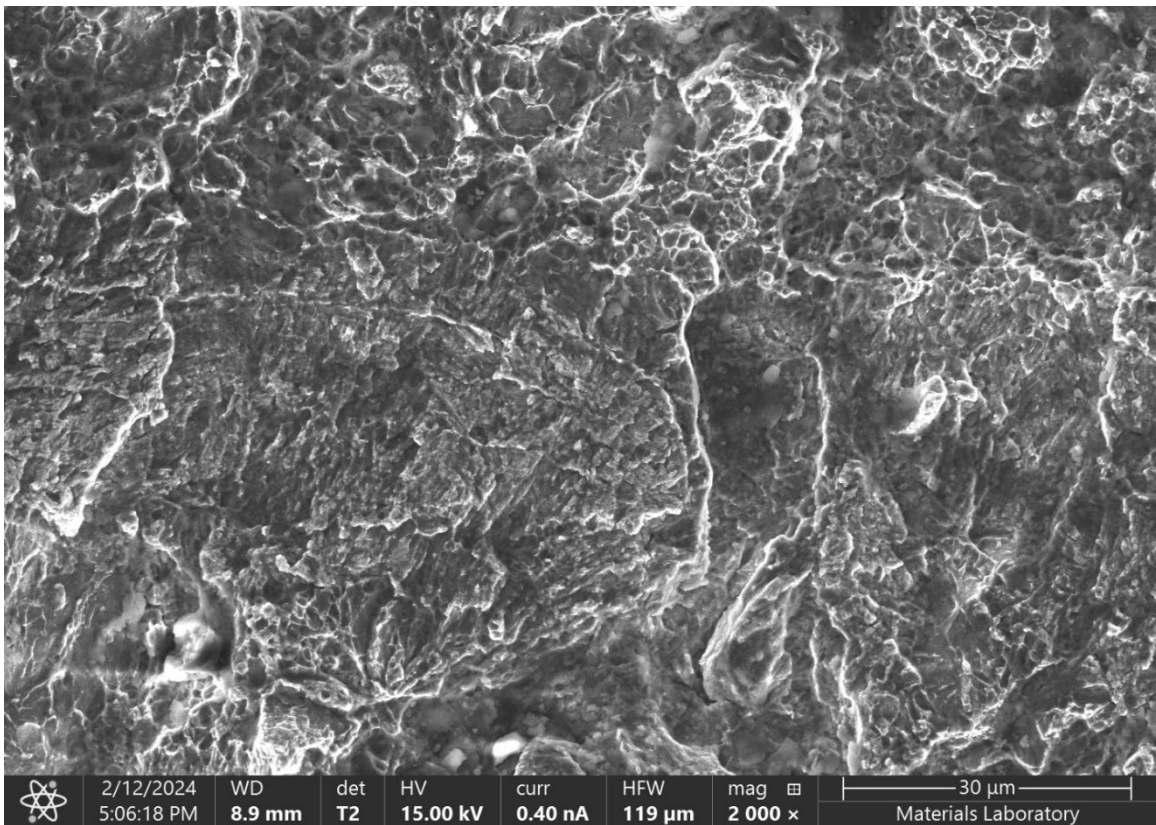
overstress fracture of the pin during the final fracture upon the accident landing event.

**Figure 32.** SE micrograph of the end of the fatigue thumbnail crack.

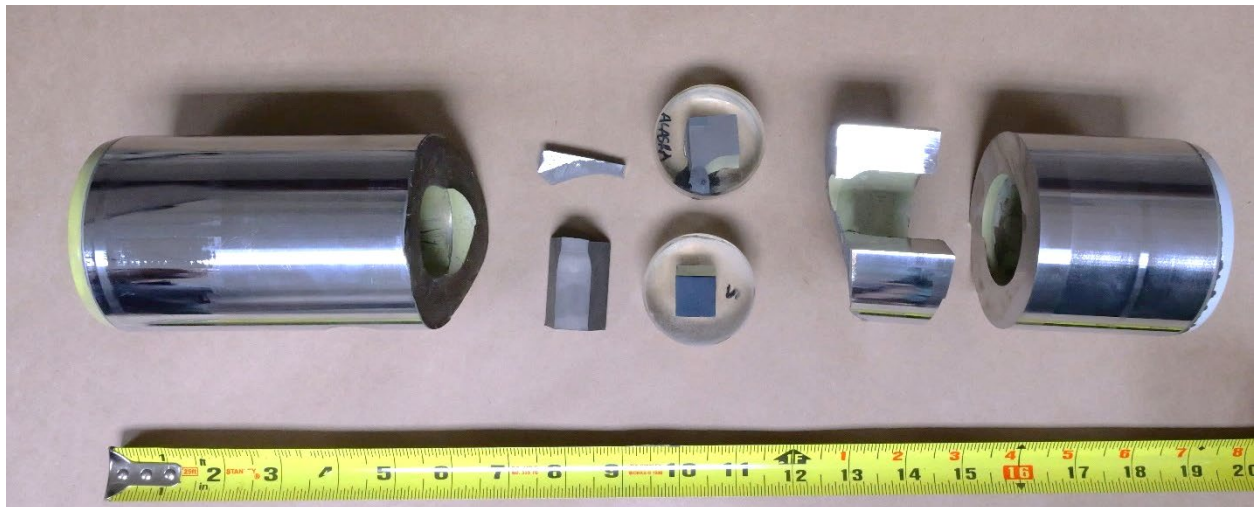
Figure 33 shows the different pieces of the trunnion pin sections, including the later recovered forward fragment, after sectioning of various areas for metallographic and microscopic examination. Figure 34 shows the aft remnant, with data from a Barkhausen noise inspection (BNI) written directly on the cylindrical surface. The highest numbers were areas of potential excessive heat input for the part (Figure 34).

**Figure 33.** View of all the remnants and sections of the aft trunnion pin, taken after receipt and sectioning of the aft remnant (courtesy: Boeing EQA).

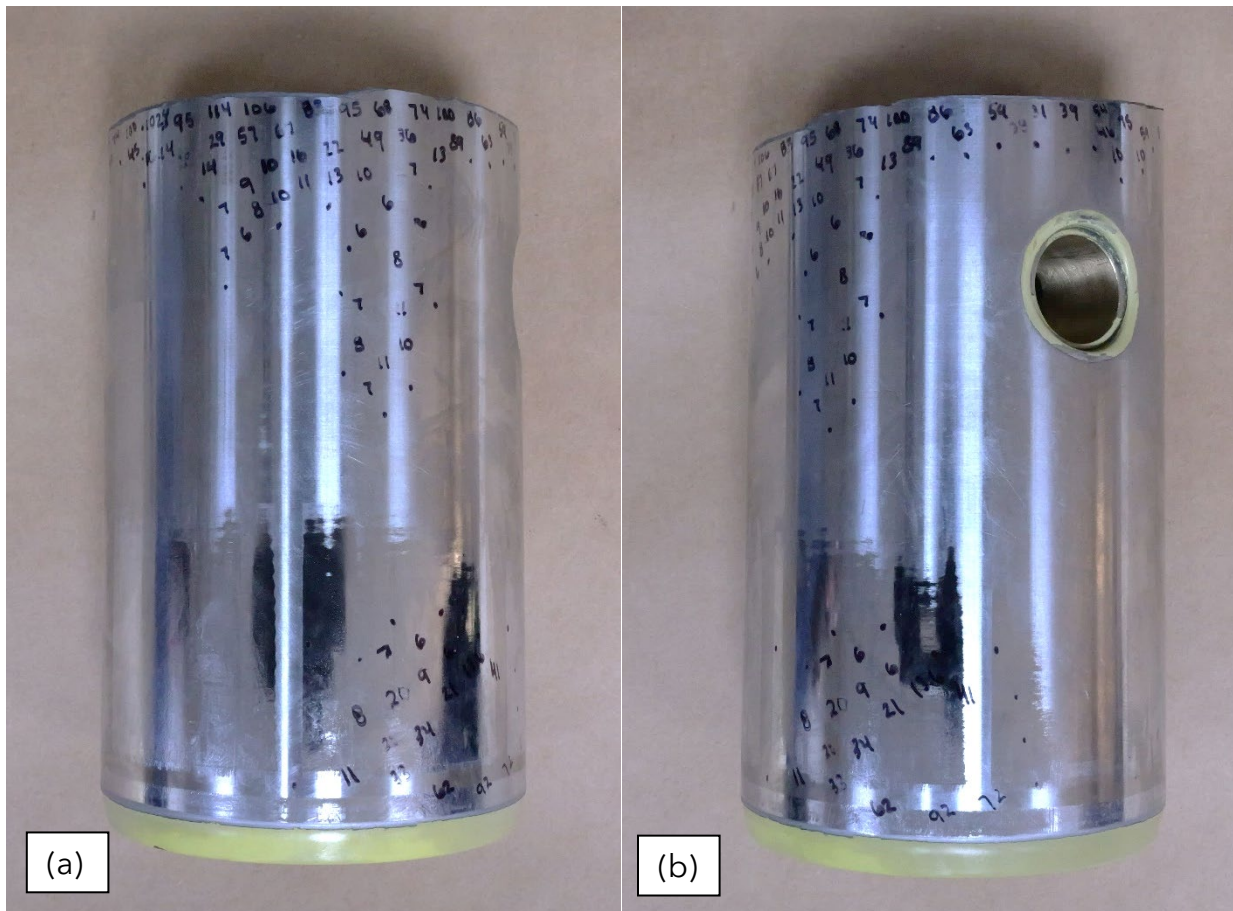
After calibrating the equipment with a shim to simulate the chromium electroplating layer thickness, the areas of most severe potential damage exhibited reading between 100 and 120. Most of the rest of the trunnion surfaces with no indications of damage exhibited readings between 5 and 7. The areas of highest readings were concentrated in areas near the fatigue crack initiation site, along a longitudinal area of the pin, and an area of visible impact damage on the lower portion near the part edge.

**Figure 34.** The aft remnant of the aft trunnion pin, with Barkhausen data written directly on the exterior surface (courtesy: Boeing EQA).

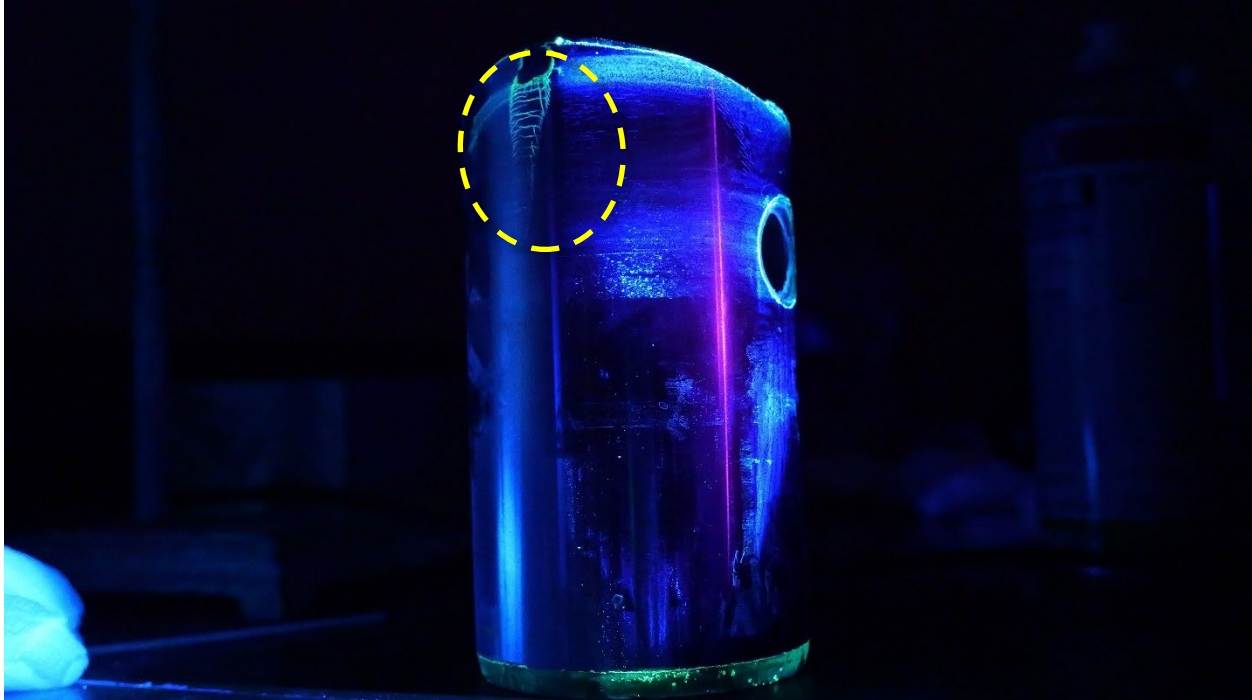
The aft remnant was also inspected using FPI and MPI, as exemplified in Figure 35 and Figure 36, respectively. These nondestructive examinations revealed similar areas of surfaced damage, most notably with areas of visible impact damage consistent with post-fracture damage. Some of these areas are highlighted in the tow figures, visible at parallel ladder cracking on the exterior electroplating layer.

**Figure 35.** Ultraviolet light image of the aft pin remnant during FPI examination, with areas of parallel cracks highlighted (circle) (courtesy: Boeing EQA)

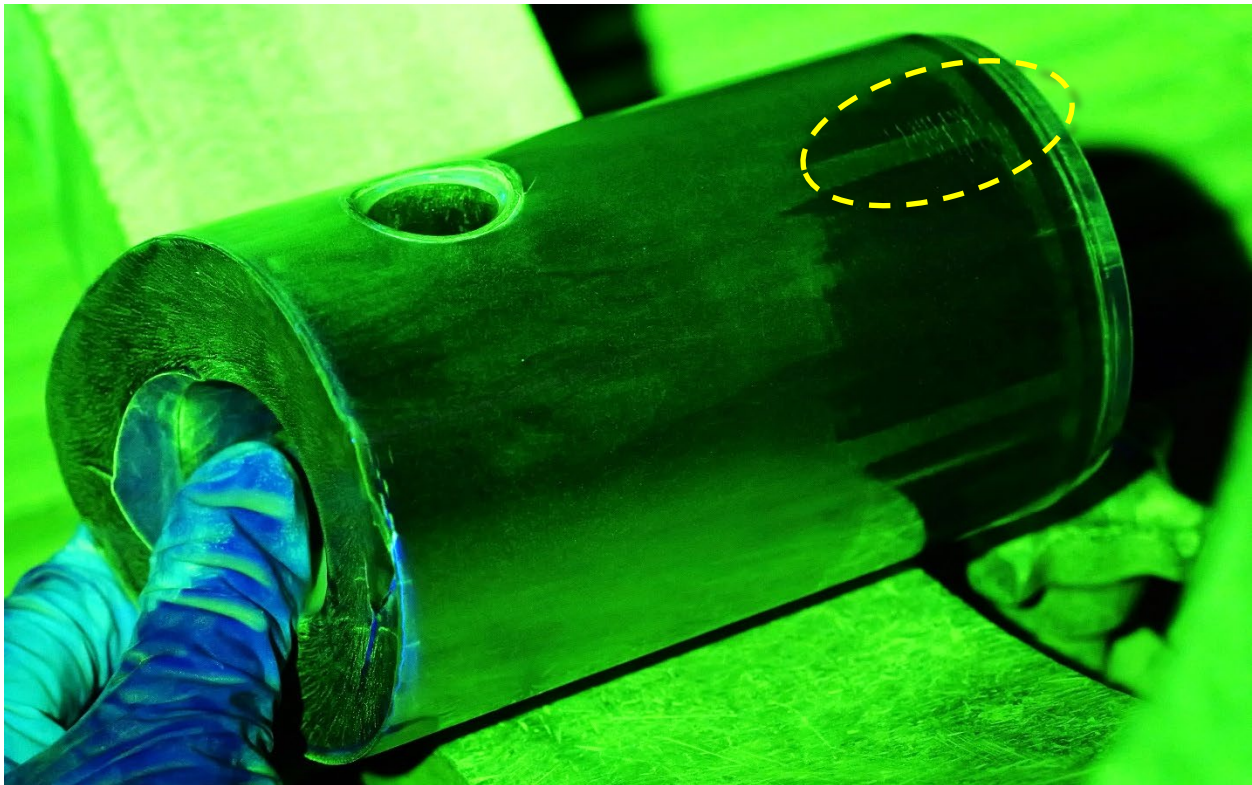
**Figure 36.** Ultraviolet light image of the aft pin remnant under MPI examination, with the area of parallel cracking circled (courtesy: Boeing EQA).

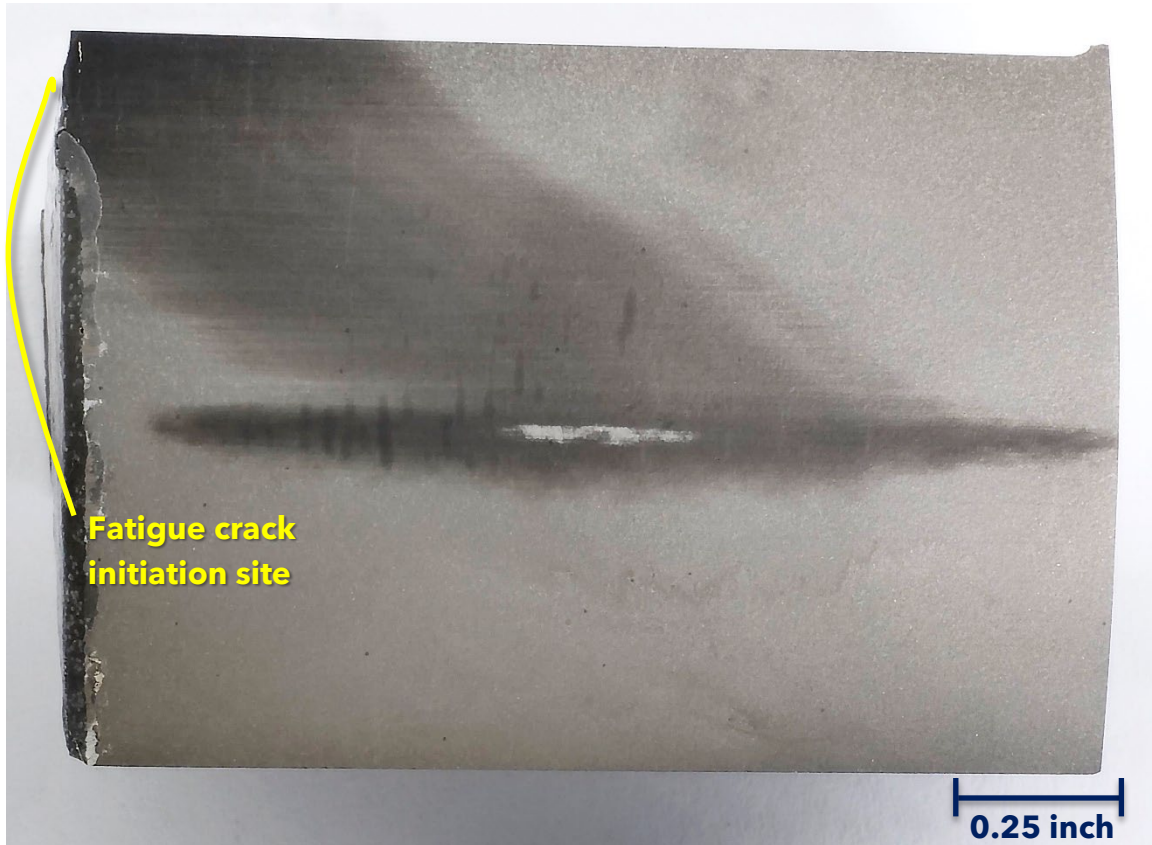
Figure 37 shows the main surface of the aft remnant following the etching process. The two primary indications are a longitudinal elongated oval of dark contrast with a central white area, and a 45° angled wider dark indication that intersected the

fracture surface edge at the location of the fatigue crack and its initiation sites. The darker regions correspond to localized elevated iron carbide content, indicative of localized overtempering, consistent with heat exposure. In addition, the temper etch inspection found a longitudinal indication of white-etched material surrounded by darker-etched regions. This region was consistent with an area of undertempering from lighter-etching martensite, consistent with localized heat input exceeding 727 °C (1340 °F).

**Figure 37.** Images of the aft remnant of the aft trunnion pin showing temper etch surface contrast (courtesy: Boeing). The fracture surface is identified in the upper left.

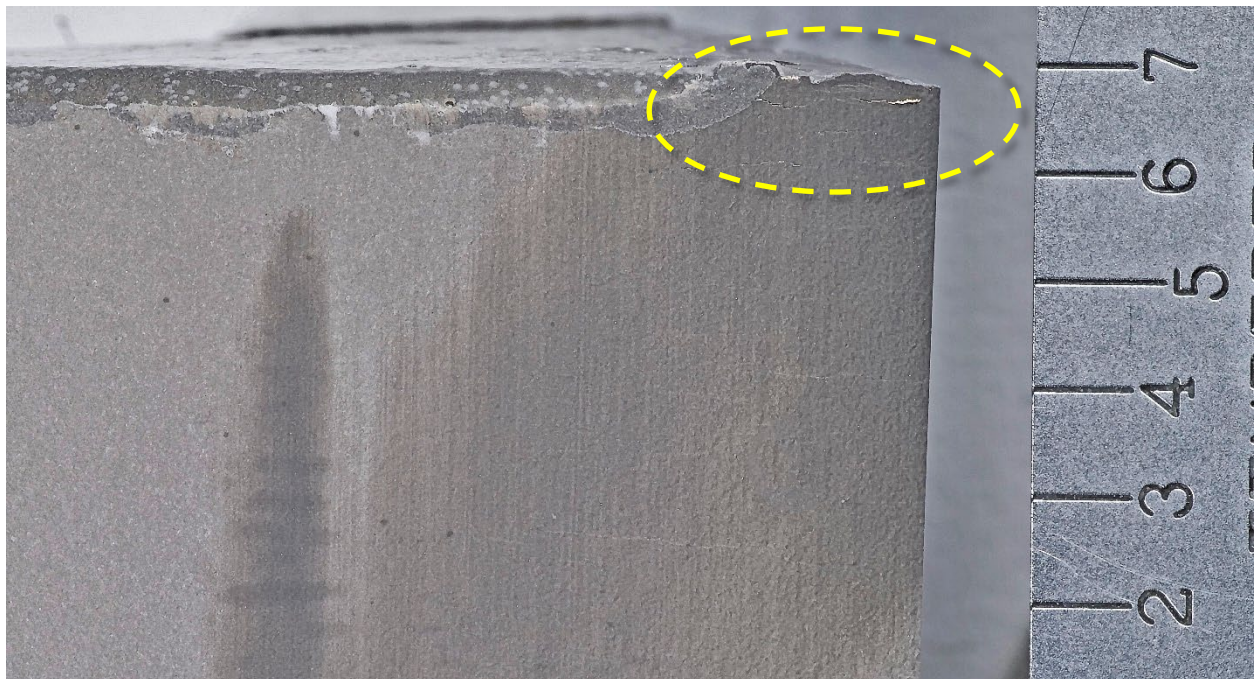
Of note was the angled dark region, which corresponded to the parallel ladder crack indications found from FPI. As illustrated in Figure 38 and Figure 39, the center of this angled dark band coincided with the center of the fatigue crack initiation site (which had been bisected in Figure 39). When contrasted with mating forward section of the trunnion pin, the areas of highest Barkhausen noise readings were located on an angle along the path of the dark band from the temper etch inspection (Figure 40).

**Figure 38.** Closer view of the fatigue crack initiation site edge (circled) after temper etch.

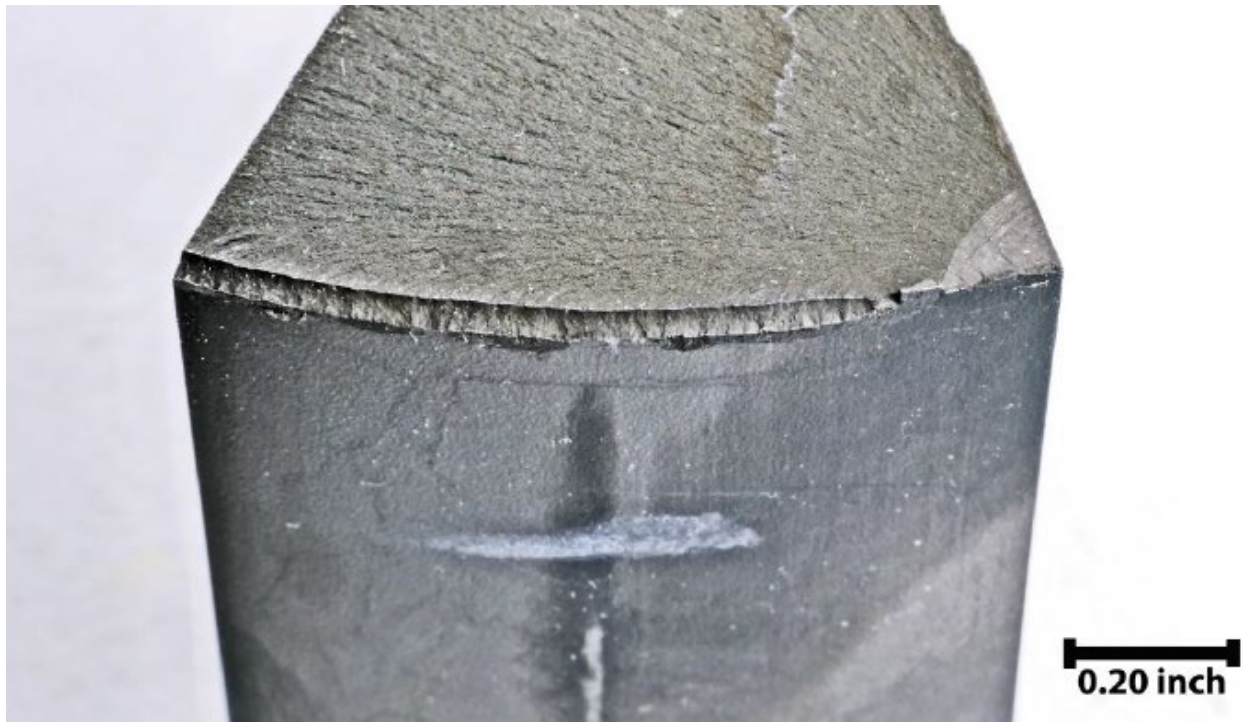
**Figure 39.** View of the temper etch indications relative to the sectioned thumbnail crack of the aft pin remnant (courtesy: Boeing).

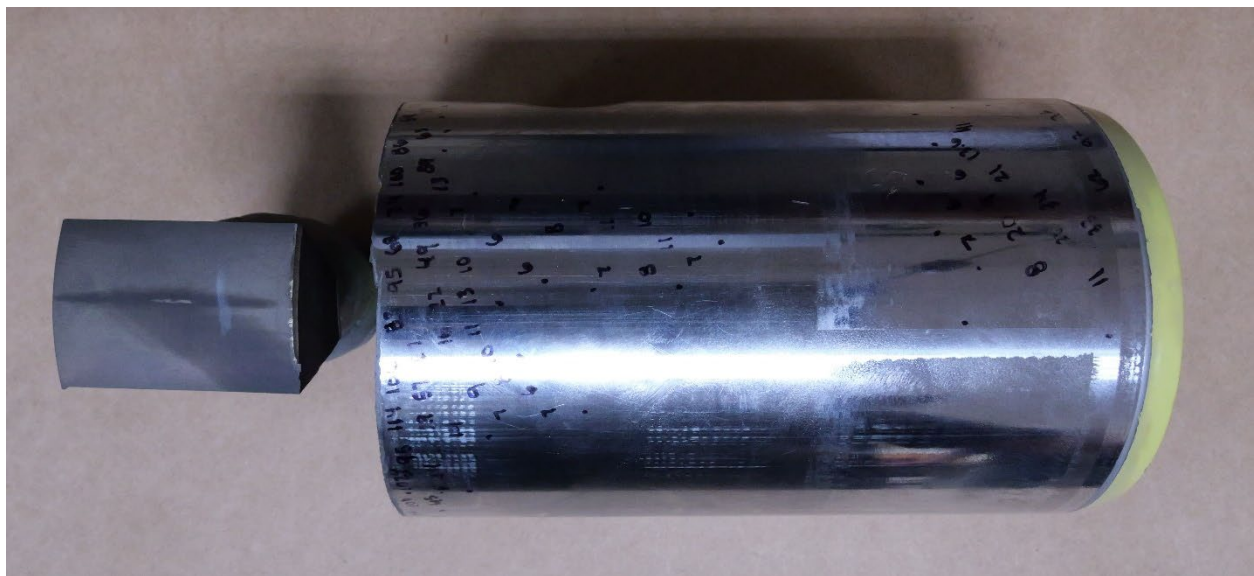
**Figure 40.** View of the mating sides of the fatigue crack portions of the fracture surface from the forward and aft remnants of the trunnion pin (courtesy: Boeing EQA).

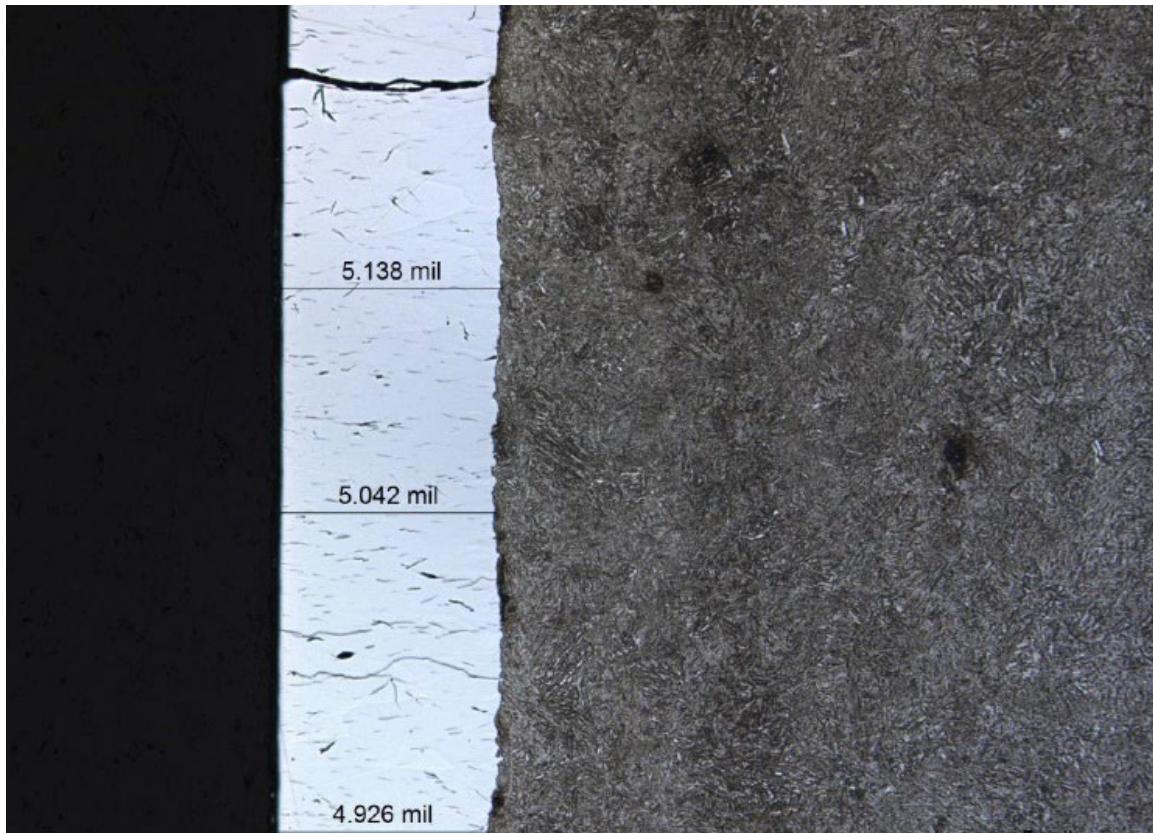
A portion of the cross-sectioned pin was mounted, polished, and etched with a 2% Nital solution. Figure 41 shows a cross section through the surface, showing the surface-facing chromium electroplating layer. Microscopic measurements found this layer averaged about 0.005 inches (5 mils) in thickness. For the most part, this layer was intact and adherent. However, there were indications of surface cracking, as demonstrated from the exterior in Figure 42.

**Figure 41.** Bright-field (BF) optical micrograph through the surface of the aft pin remnant, showing the Cr electroplated surface layer, and annotated measurements (courtesy: Boeing EQA).

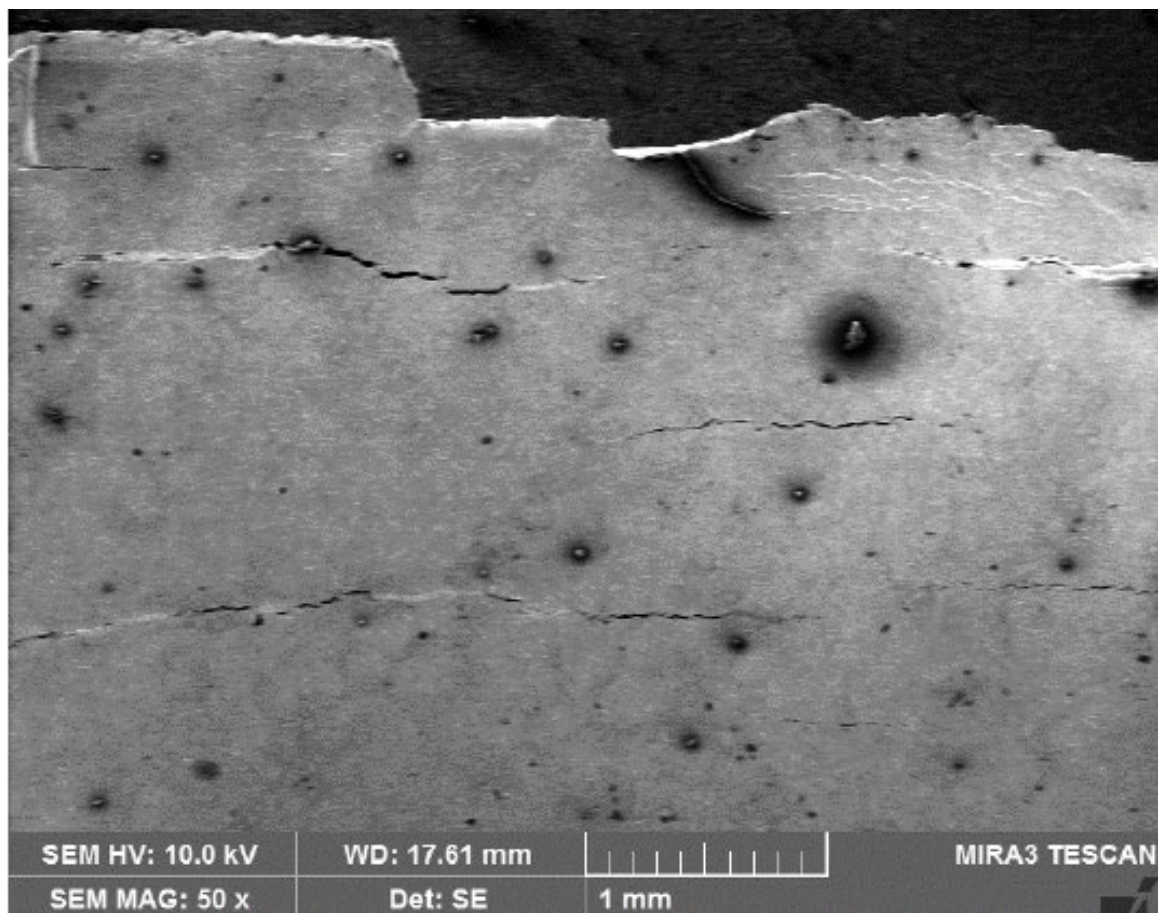
**Figure 42.** SE micrograph of surface cracks in the Cr electroplating layer near the thumbnail crack on the aft pin remnant (courtesy: Boeing).

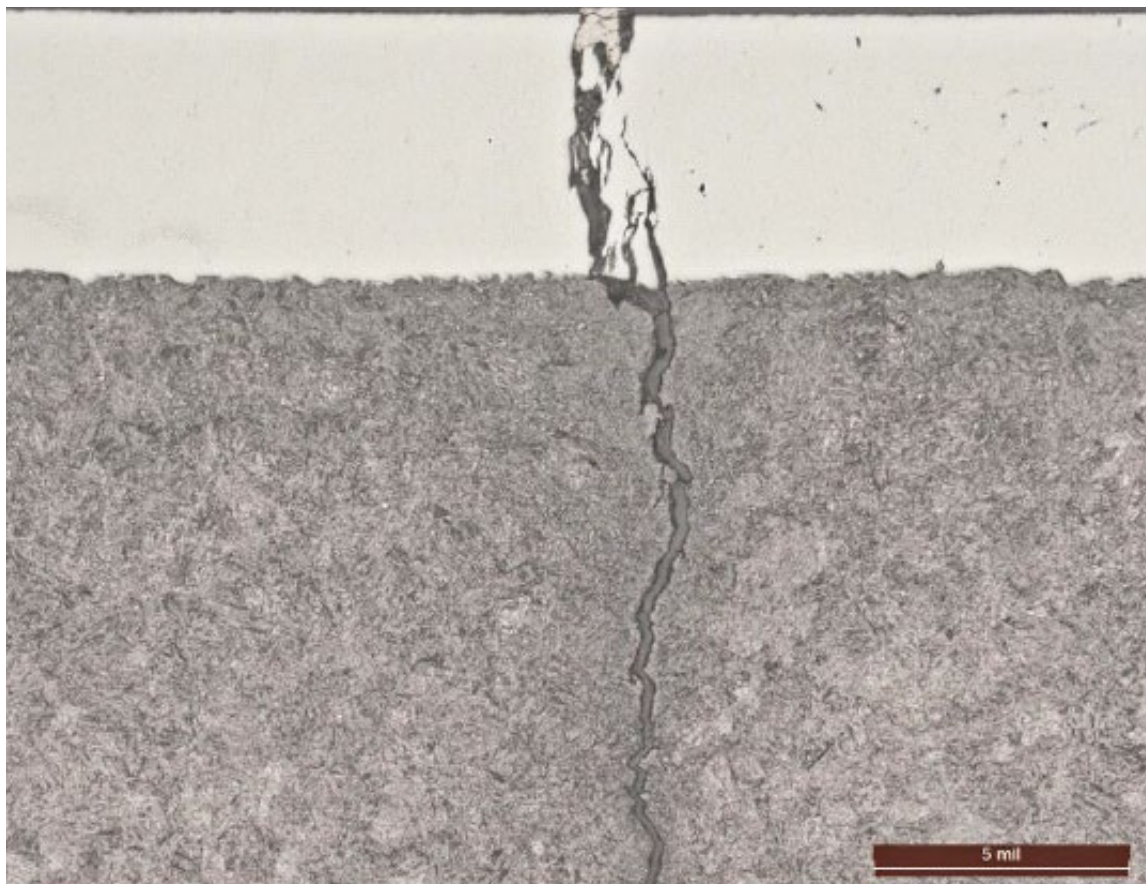
A cross-section through this cracking found it perpendicular to the surface and branched, but the branching was flat and generally parallel to each other. These features were consistent with the morphology seen on the fracture surface with the electroplating, shown in Figure 43. Within the steel body of the pin, the crack was absent such branching, progressing in a mainly transgranular manner through the tempered martensite microstructure. Other cross-sectioned surface cracks exhibited similar features, as illustrated in Figure 44.

**Figure 43.** BF optical micrograph of a section through one of the surface cracks in **Figure 42** (courtesy: Boeing).
