# National Transportation Safety Board

## **MATERIALS LABORATORY**

Factual Report 24-015

Location: Santa Ana, California  
Date: August 20, 2023  
Time: 23:15 Pacific daylight time  
06:15 coordinated universal time  
Vehicle: Boeing 737-890, N516AS  
Investigator: Michael Hauf, AS-10

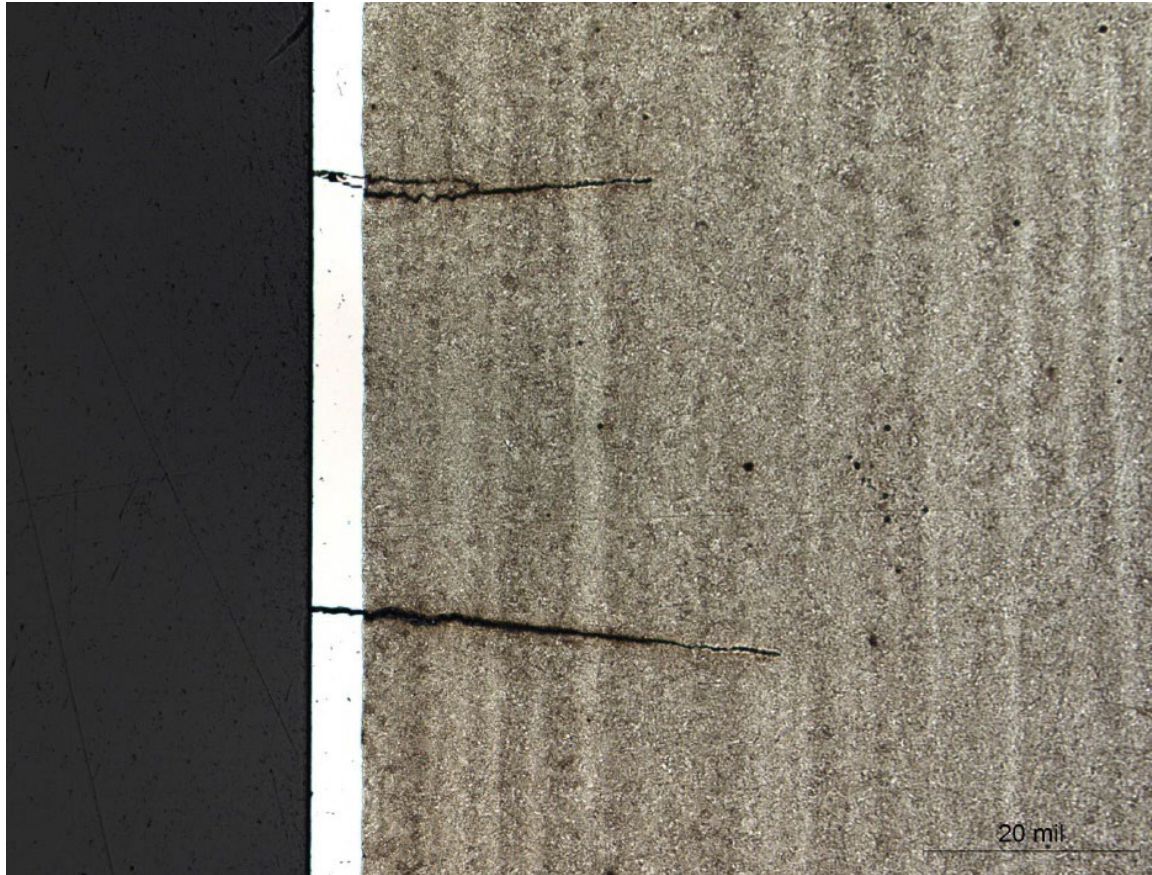
A cross-section through this cracking found it perpendicular to the surface and branched, but the branching was flat and generally parallel to each other. These features were consistent with the morphology seen on the fracture surface with the electroplating, shown in Figure 43. Within the steel body of the pin, the crack was absent such branching, progressing in a mainly transgranular manner through the tempered martensite microstructure. Other cross-sectioned surface cracks exhibited similar features, as illustrated in Figure 44.

**Figure 44.** BF micrograph of additional cracks through the aft pin remnant surface (courtesy: Boeing).
