# National Transportation Safety Board

DCA23FA417

## **MATERIALS LABORATORY**

Addendum Factual Report 24-015B

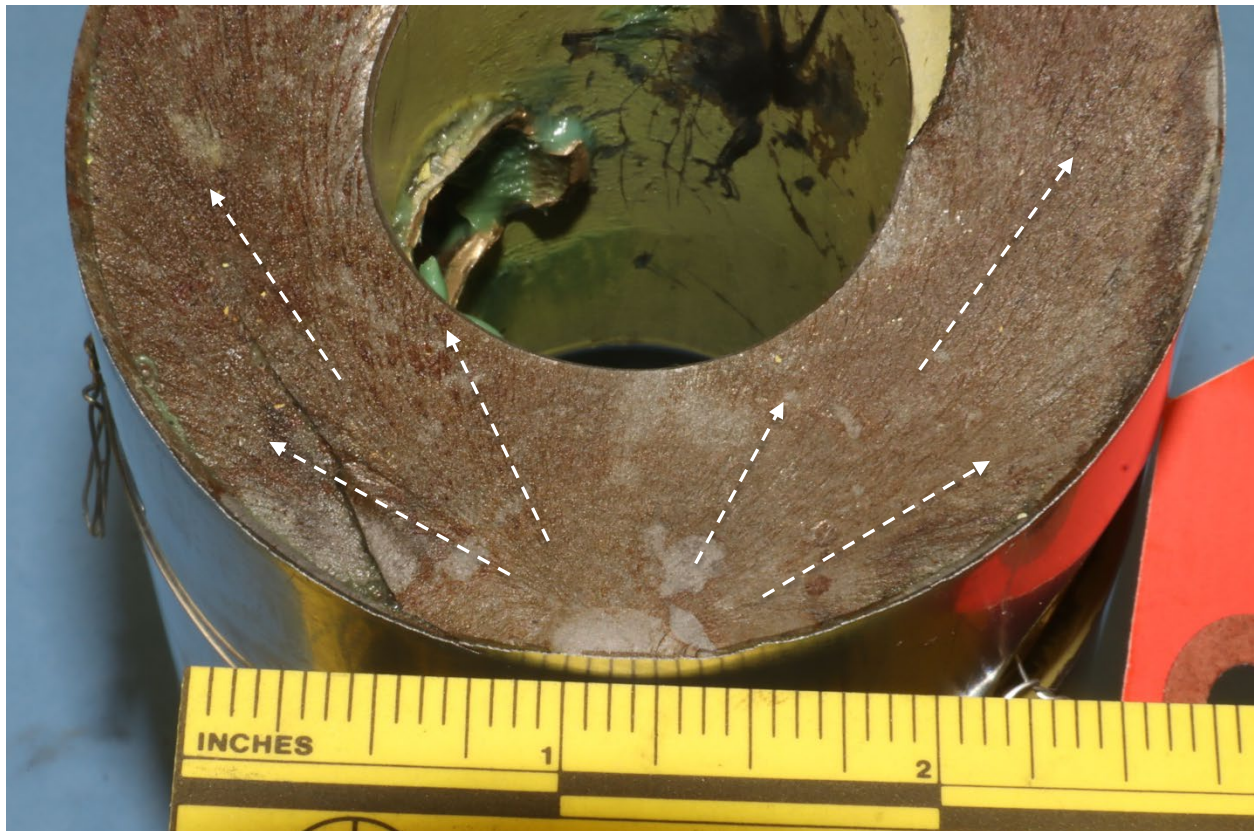
The trunnion pin, P/N 161A1192-13 and S/N 65780-0066, exhibited a small thumbnail crack at approximately the 12 o'clock position (see Figure 1). This crack exhibited crack arrest marks, consistent with crack propagation, and ratchet marks, consistent with multiple crack initiation sites. Figure 2 shows a closer view of this crack from the forward pin remnant fracture surface. The depth and length of the crack were 0.144 inches and 0.391 inches, respectively. While most of the thumbnail crack exhibited fatigue striations, a thinner subsurface area exhibited intergranular fracture (see Figure 3). This region's depth was 0.016 inches below the chromium electroplating layer and was 0.29 inches long.

**Figure 1.** Fracture surface of the forward fracture surface of the aft trunnion pin, showing a thumbnail crack with dashed arrows denote the fracture direction from the thumbnail.

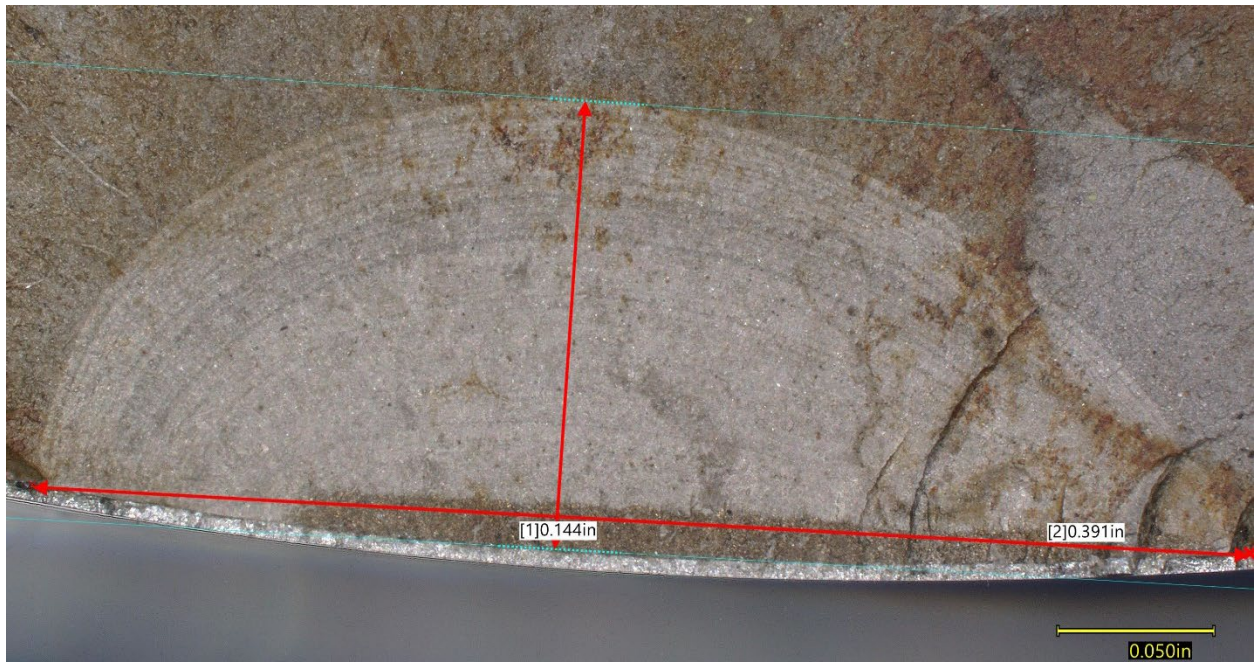
**Figure 2.** Microscopic view of the thumbnail crack in Figure 1., annotated to show various dimensions.

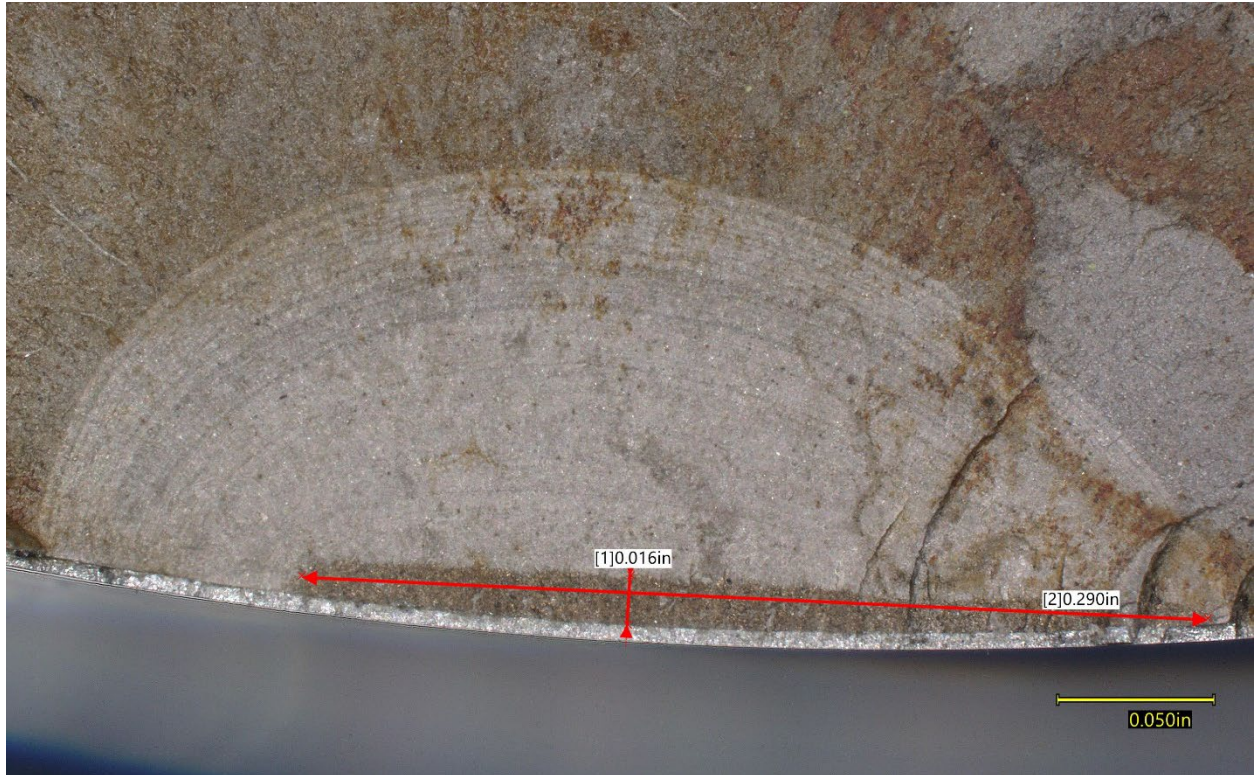
**Figure 3.** Secondary electron (SE) micrograph of the overall view of the thumbnail crack, annotated to show various measurements.

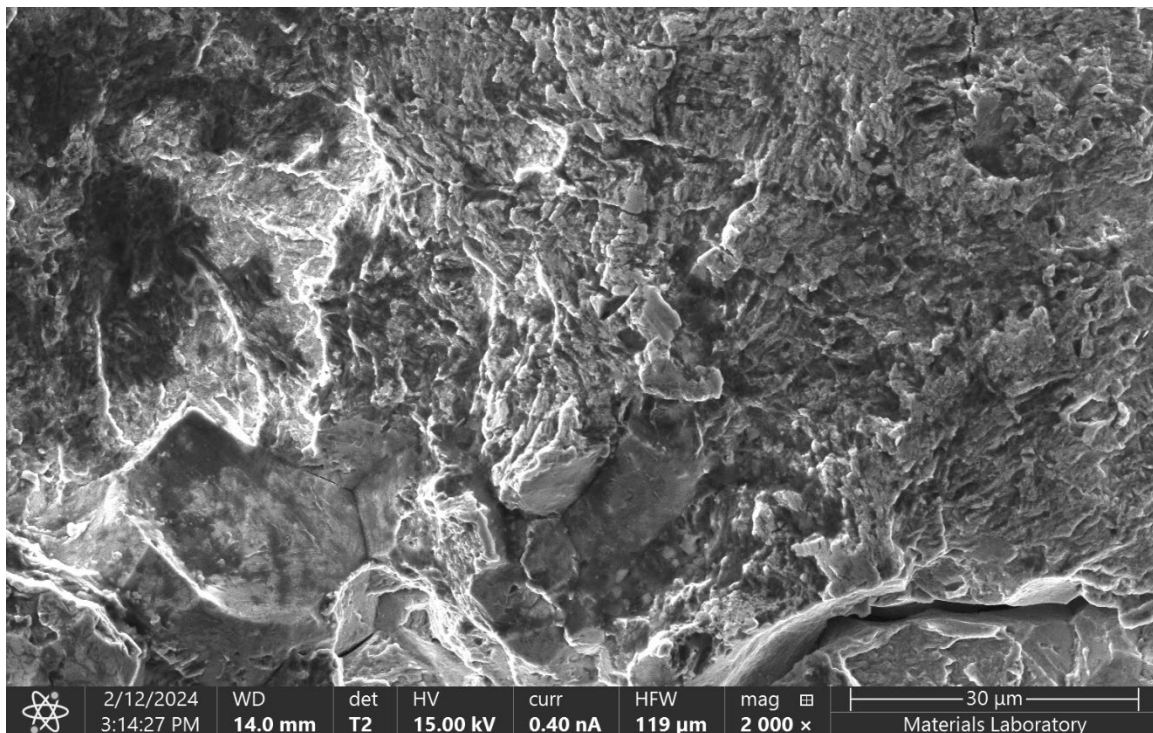
minutes. The fatigue striation counts were taken at 32 random, unique, and non-duplicated places on the fracture surface, with the distances from the initiation site recorded. Figure 4 shows one of the central crack initiation sites of fatigue cracking, occurring at the end of the intergranular region.

This initiation site was labeled as the origin and was located at 41.12585 mm in the X-direction and 0.735 mm in the Y-direction. The working distance (or Z-direction) was initially 10 mm. The distances were measured via a calibrated stage on a field emission scanning electron microscope (FESEM). The location, number of striations counted, and total cycles that occurred up to that location are listed in Table I. The cumulative cycles per crack length and crack growth rate ( $da/dN$ ) over crack depth are illustrated in charts in Figure 5 and Figure 6. The locations for the 32 spots examined are shown in Figures These locations and the measurements are shown in Figure 7 through Figure 37. No measurements were taken in any overstress, intergranular, or electroplated regions.

**Figure 4.** Secondary electron (SE) micrograph of an initiation site of fatigue cracking at the end of the intergranular region, used as the origin for counting.

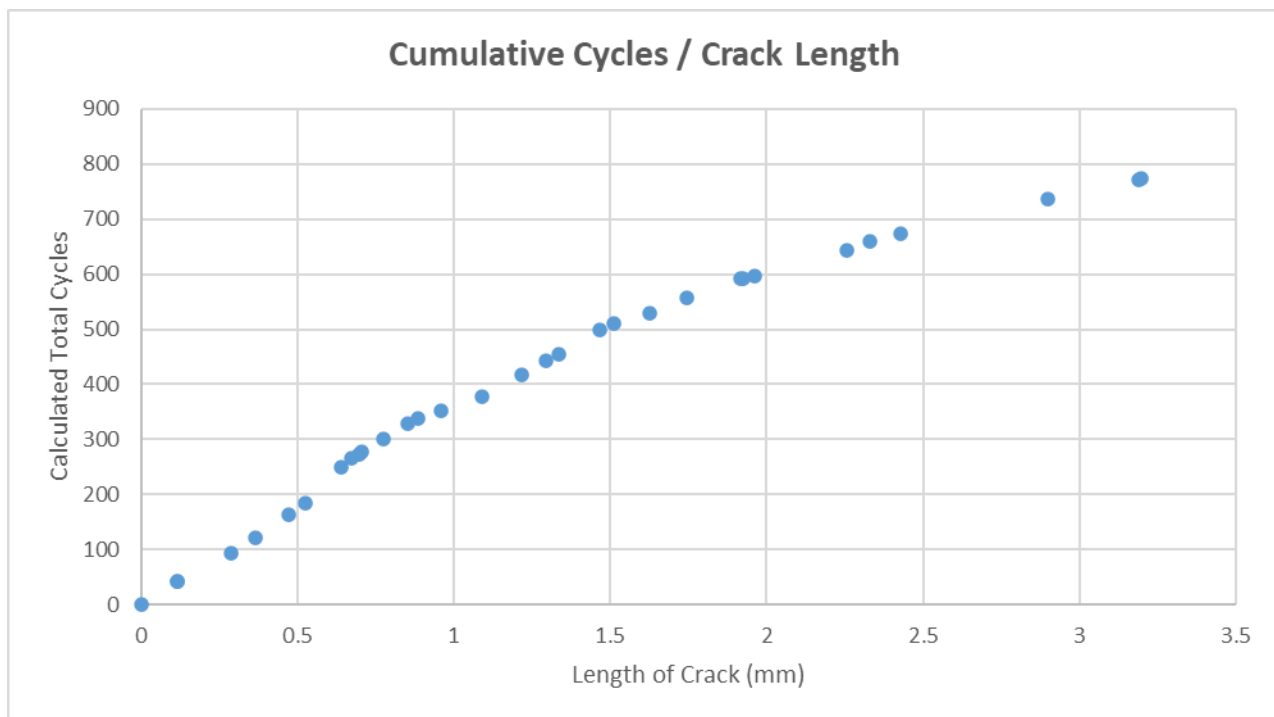
Of note from the data was that the total number of cycles from the intergranular initiation site used as the origin to the end of the crack was 797. From the chart in Figure 5, the crack depth steadily increased over time, corresponding with an expected increase in crack growth rate, demonstrated in Figure 6.

The number of landings since the last overhaul at Sunvair was 4710 cycles. The number of striations counted on this fatigue crack, 797, was an order of magnitude lower than the number of landings since the overhaul. These data indicate that a detectable fatigue crack had not been present at, or prior to, the part overhaul.

**Figure 5.** Chart of the total cycles per location at the distance from the intergranular area, representing crack depth.

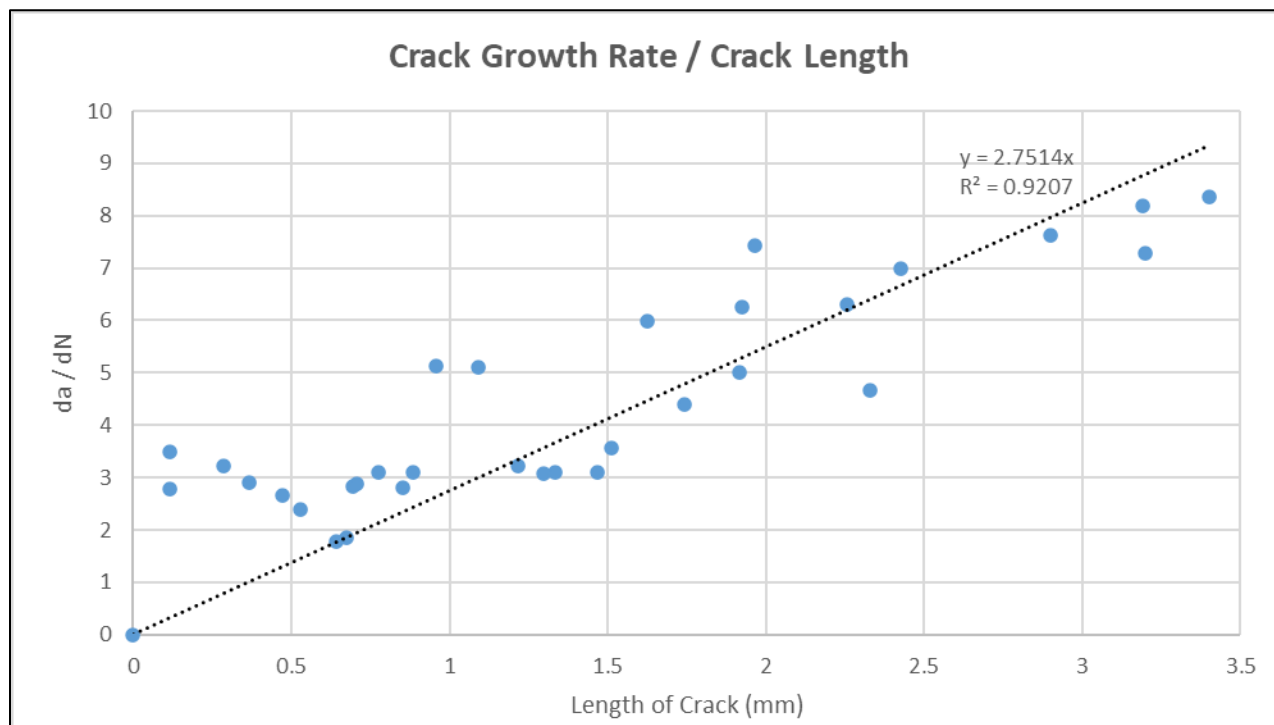
**Figure 6.** Chart of the da/dN versus the crack depth, with a linear regression superimposed (with y-intercept fixed to 0).
