# National Transportation Safety Board

DCA23FA428

## **AIR TRAFFIC CONTROL**

Group Chair's Factual Report

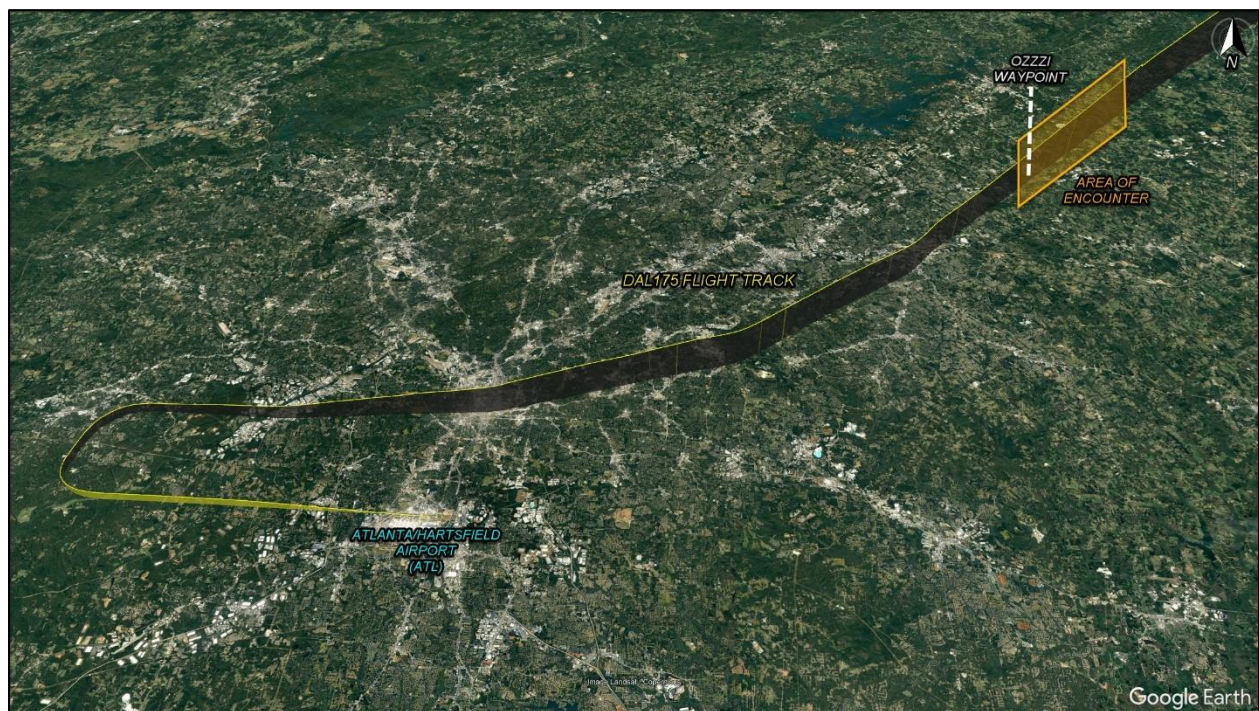
- 1832:33 The crew of DAL175 advised the radar controller that they had just "*hit a pretty good bump*" over OZZZI and that they would not want to go through that again. The controller asked the severity of turbulence and the crew reported "*it was pretty much severe.*"

**Figure 2.** Profile view of the latter segment of the accident flight track of DAL175 with the area of turbulence encounter highlighted and overlaid onto satellite imagery.

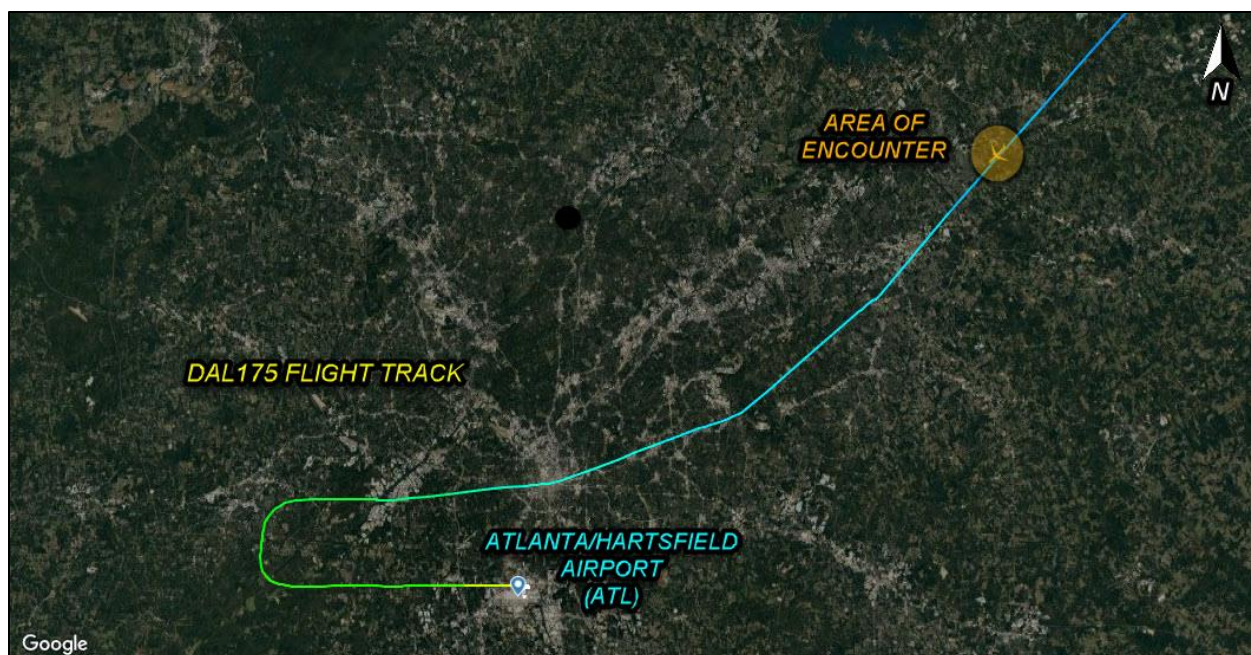
**Figure 3.** Overhead view of latter segment of the accident flight track of DAL175 with area of turbulence encounter highlighted, destination airport depicted, and overlaid onto satellite imagery.

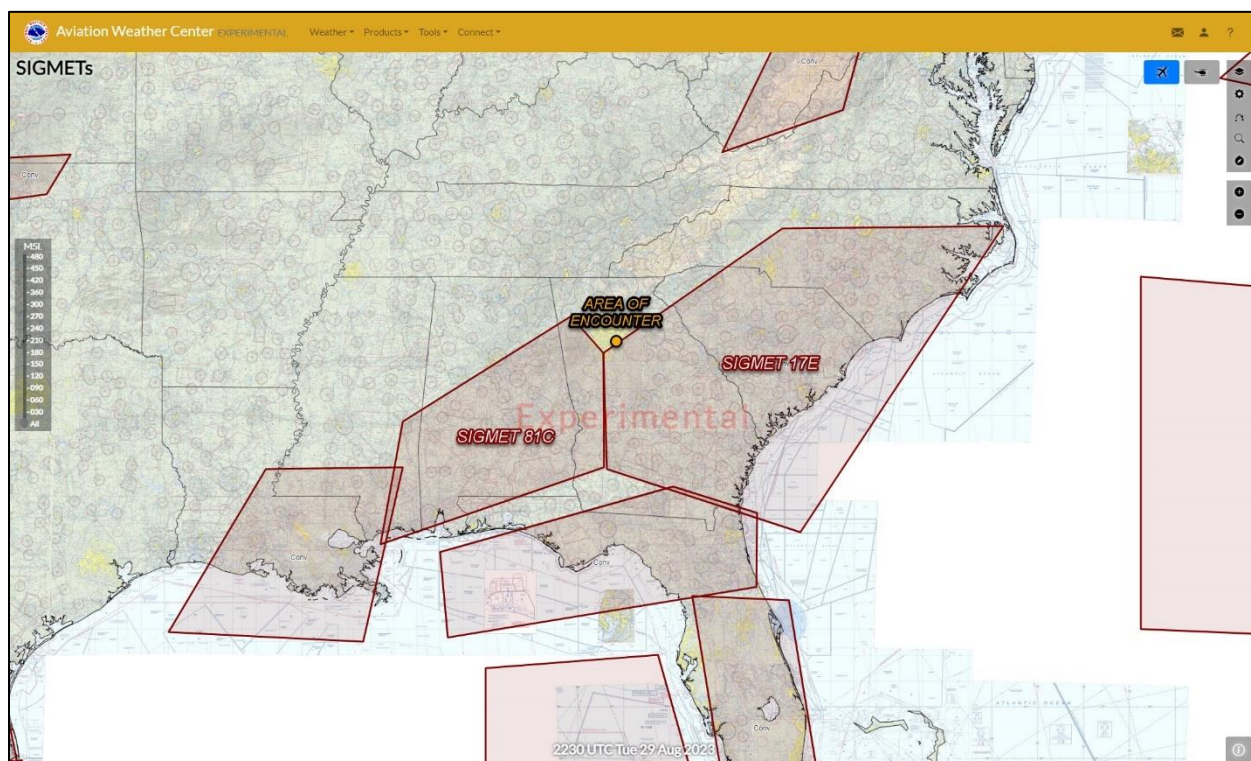
Convective SIGMET<sup>13</sup> 17E was in effect from 2155 to 2255 UTC in the vicinity of the accident airplane's route of flight and reported area of turbulence encounter. Figure 4 in section F shows the graphical boundary of the SIGMET and below is the textual format as published by the National Weather Service (NWS):

**Figure 4.** Graphical boundaries of the SIGMETs that were active at the time of the accident and overlaid on aeronautical charting.
