# MEMO

**SUBJECT** MSN 7812, Runway Excursion – 5 October 2022 – Factual Report

**REF** CRJ/ISE/2022/015

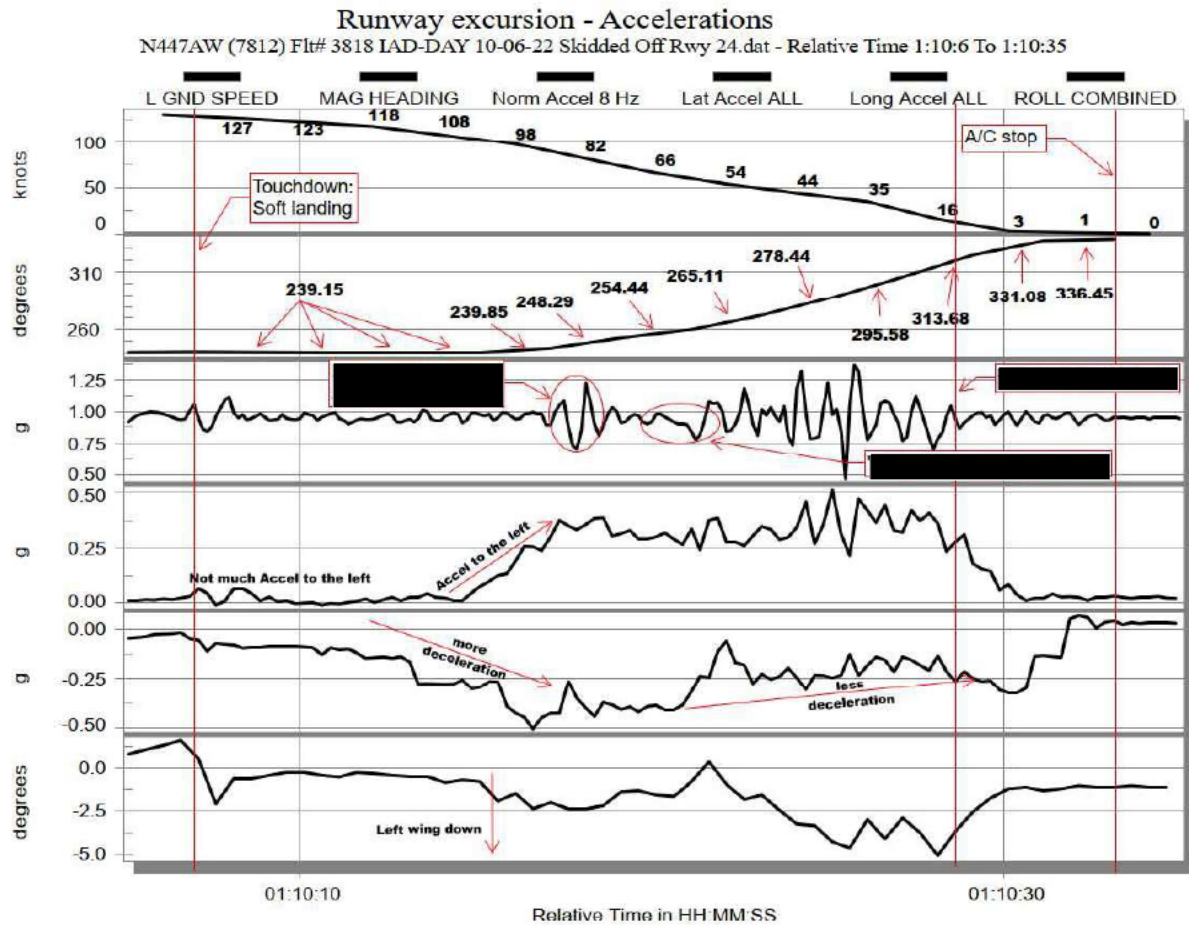
Fig 1: Runway Excursion graph set 1

As the aircraft yawed to the right, it crossed the runway limit with the shoulder and then continue veering to the right onto the grass and then back on the taxiway "E" which is parallel to runway 24. See Fig. 1 and A.

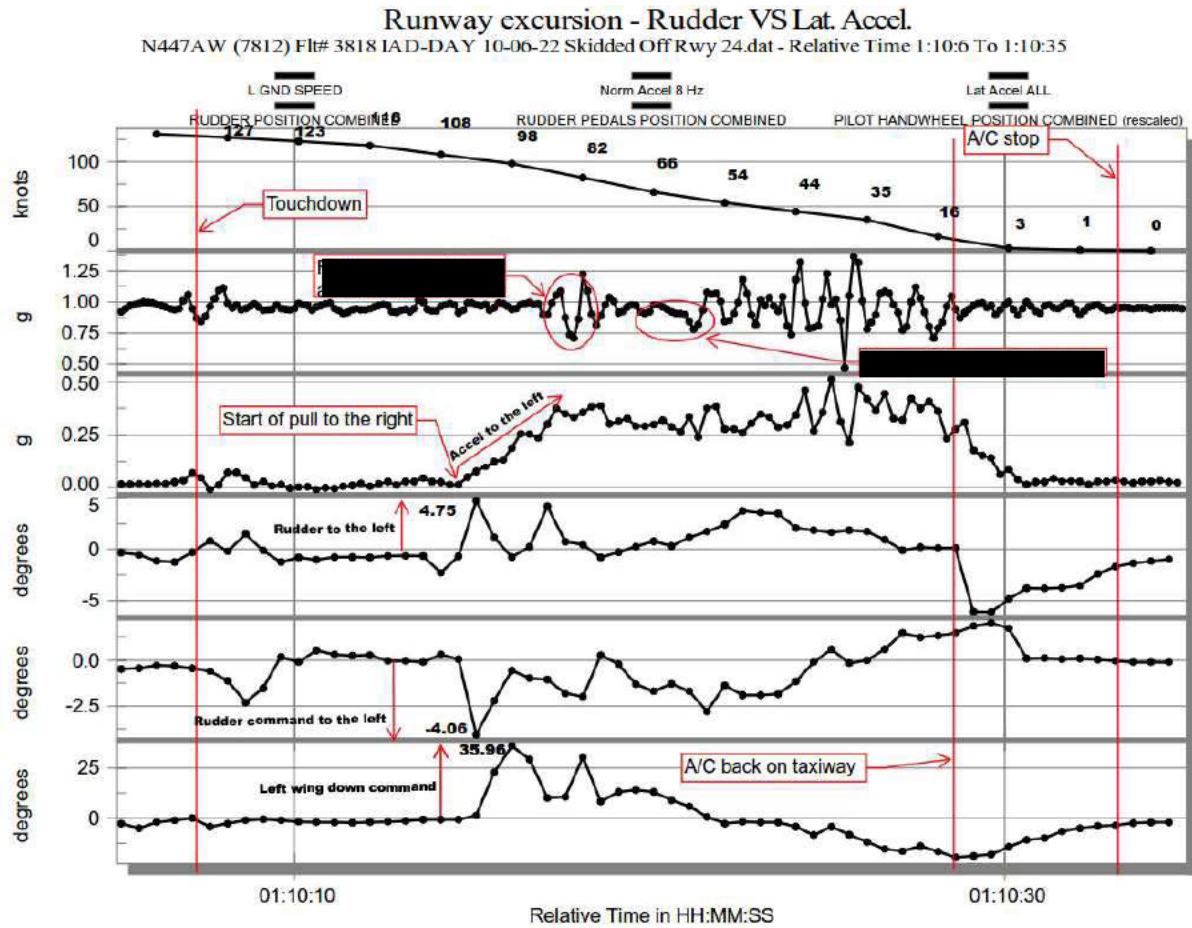
Fig 2: Runway Excursion graph set 2

When a yaw to the right was felt (1:10:16), the pilot commanded (for less than 2 sec.) the rudder to the left (4.75°) which slightly reduced the lat. accel. to the left. When pilot commanded the rudder back to center (0.75° R), the lat. accel. increased more significantly. Then the pilot reapplied (for less than 2 sec.)

the rudder to the left (4.19°). The Lat. Accel. flattened for approx. 12 sec. which coincide with the exit of runway into the grass. See Fig. 2.

At approx. the same time as the pilot applied rudder, he also provided two Roll (handwheel) commands to the left for 4 to 8 sec. See Fig 2.

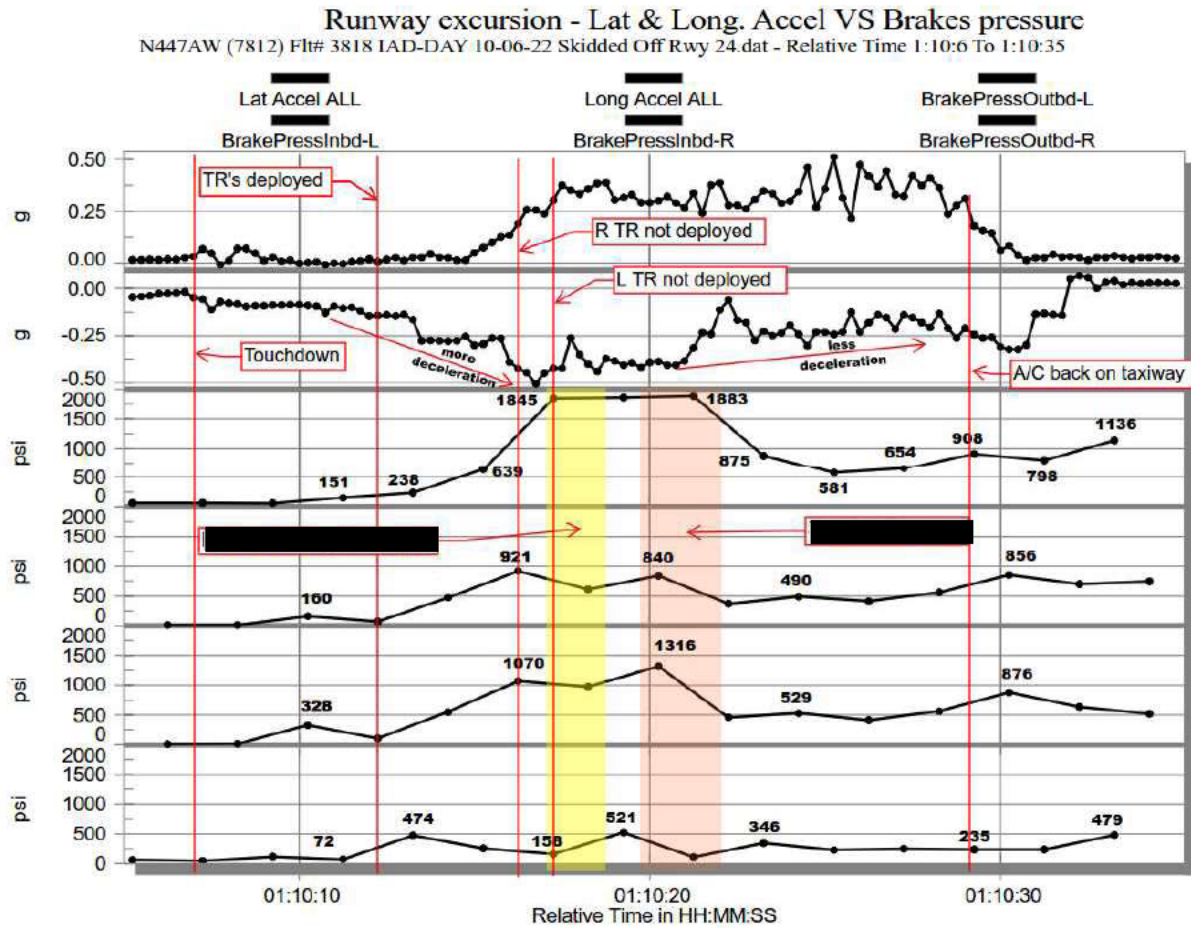
Fig 3: Runway Excursion graph set 3

A/C exited the runway 5 sec. after the lateral acceleration started to increase significantly. Maximum LH braking was achieved at approx. the same time as the A/C passed the runway to shoulder transit. See Figure 3 yellow band. Prior to A/C exit onto the grass (see Fig 3 red band) the LH and RH brakes were maintained with a less significant differential braking shown by a lateral acceleration that flattened.

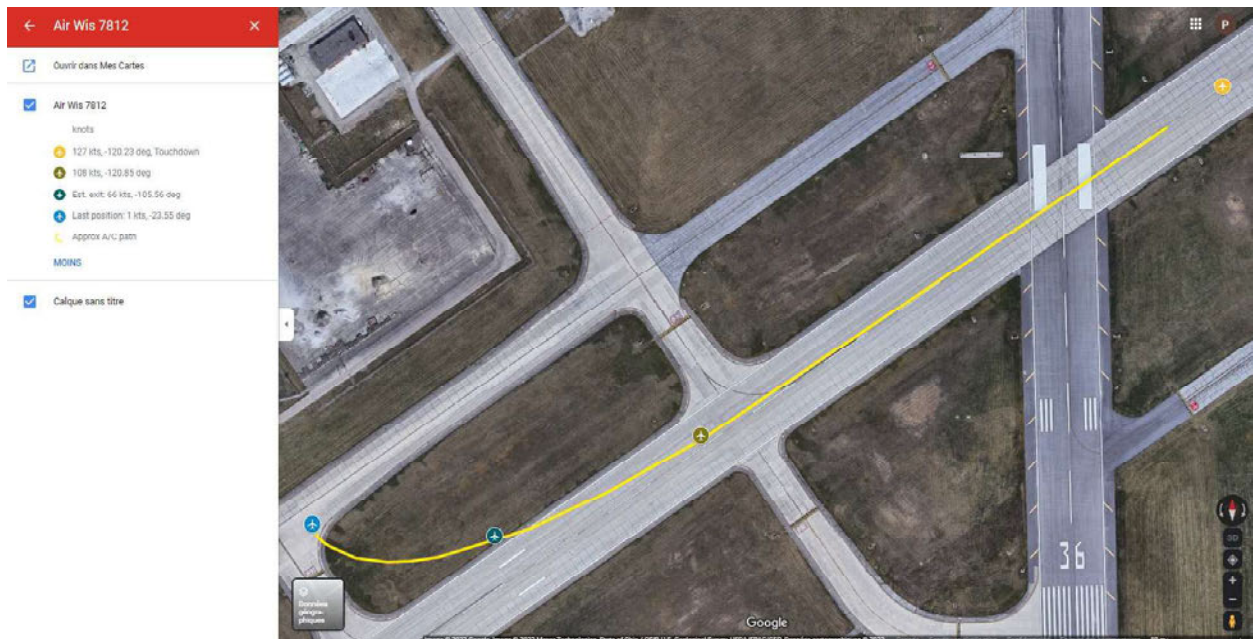
The aircraft landed smooth at 1:10:08 and remained aligned with runway 24 for 8-9 sec. An approximated path is shown on Fig. A.

Fig A: Landing (touchdown) and Runway estimated excursion path.

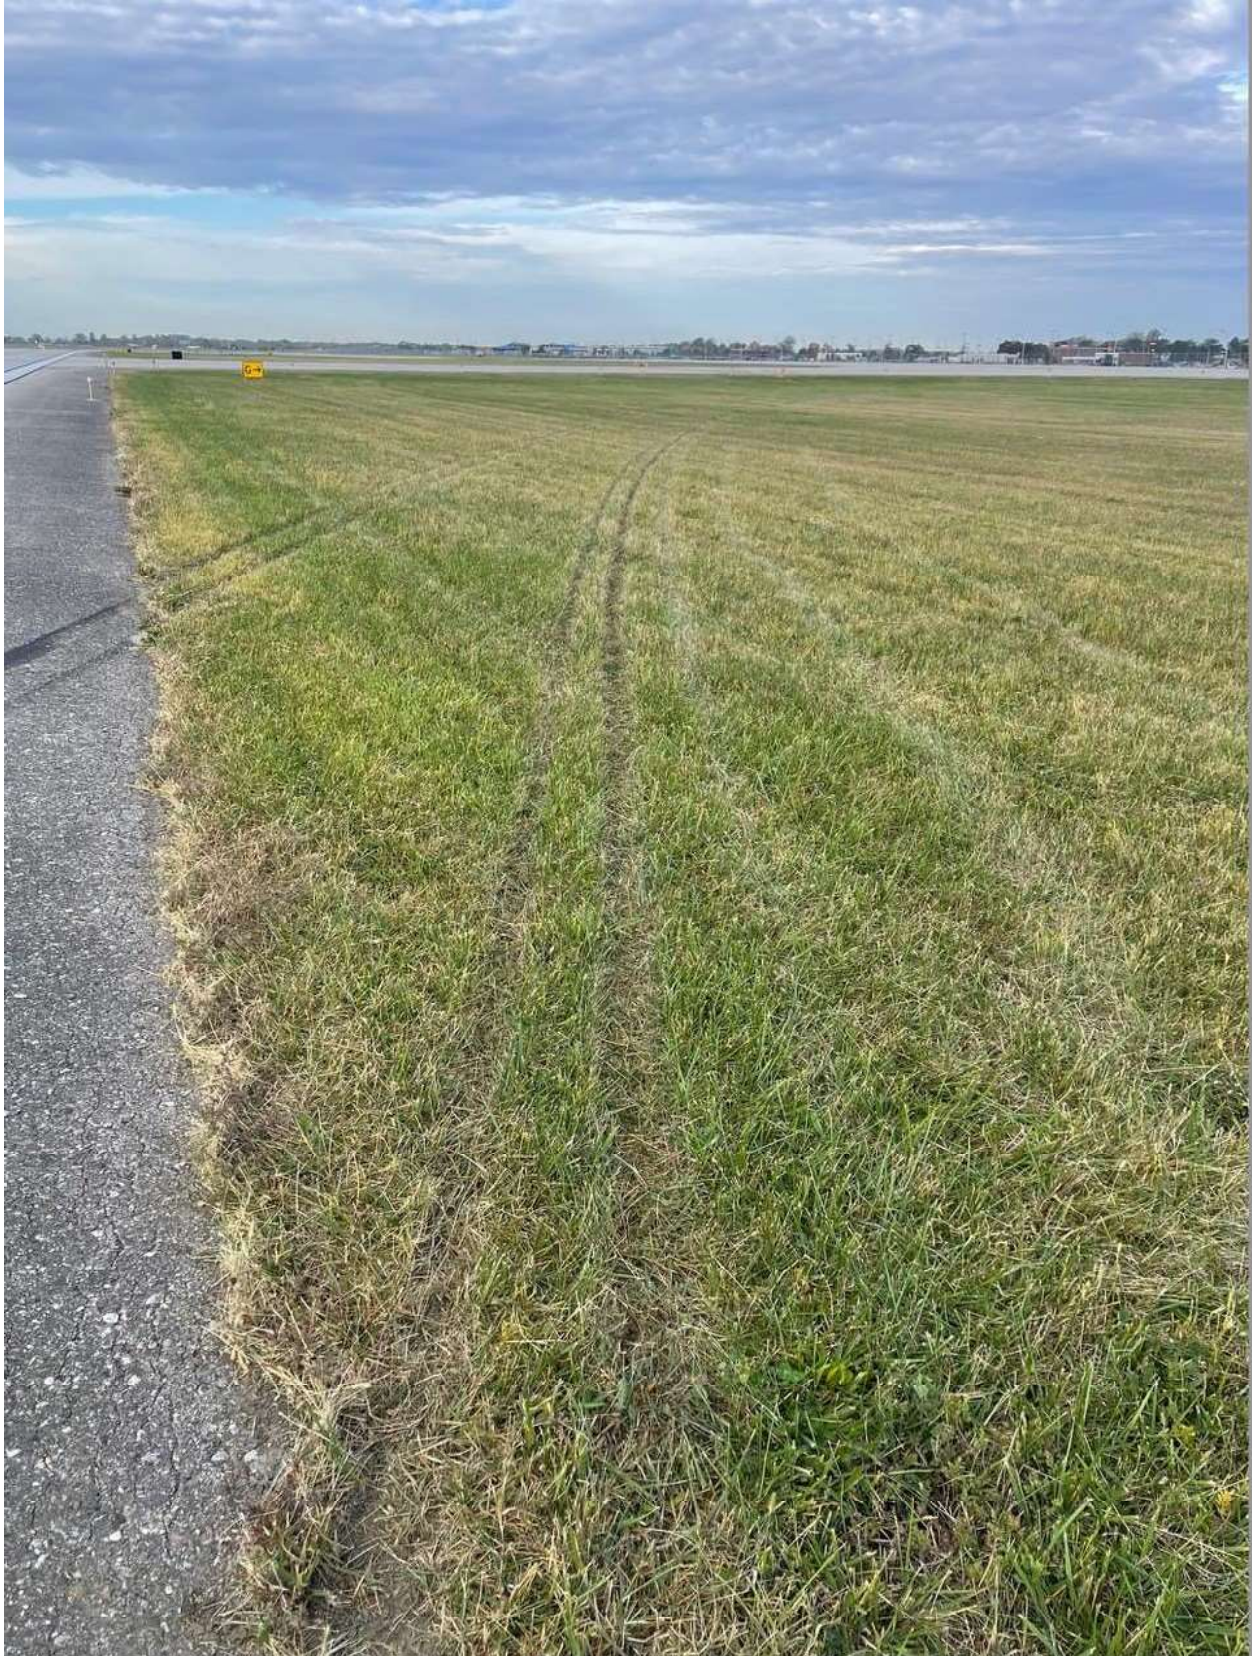
Fig B: Entry onto the grass (picture taken the day after the event)

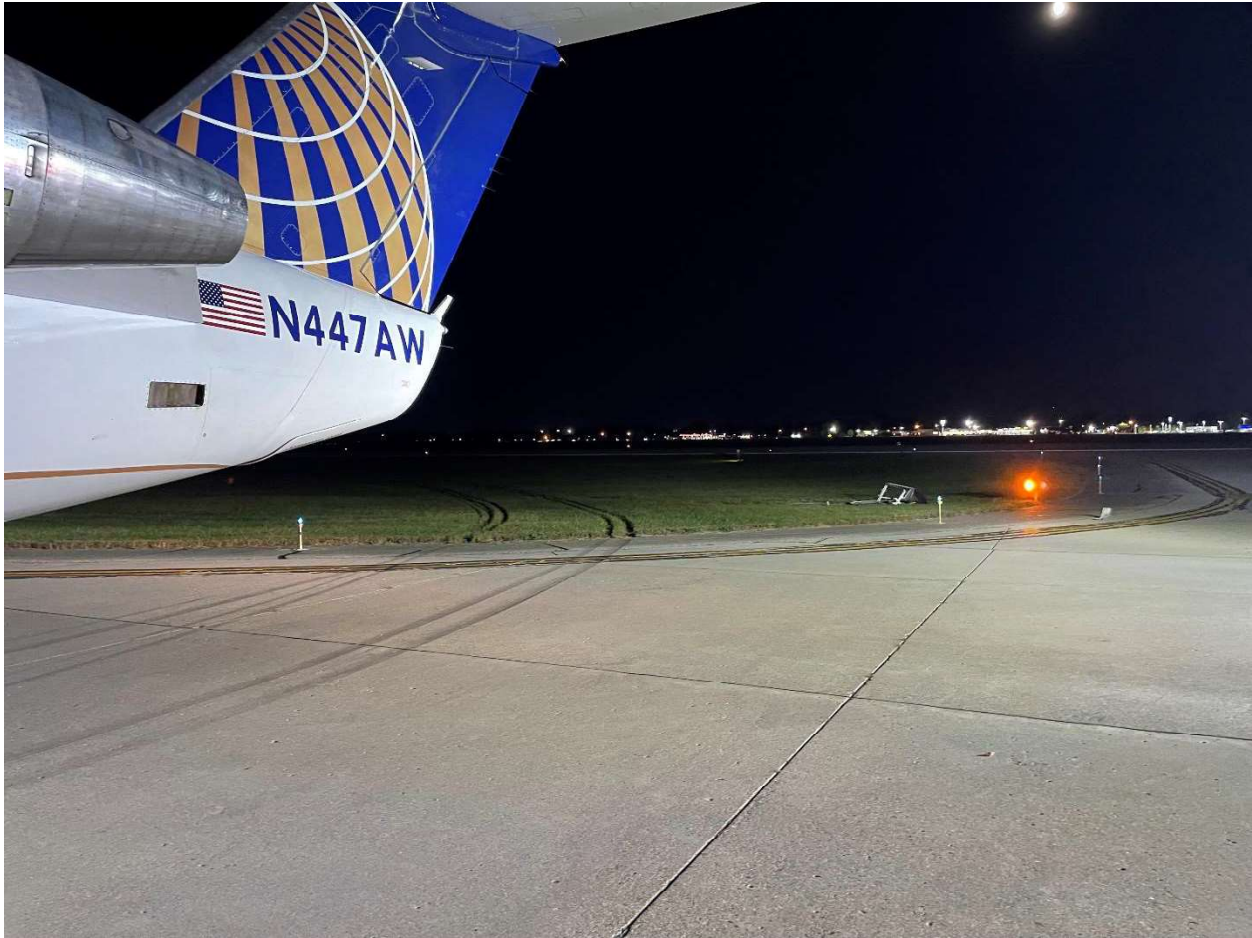
Fig C: Aircraft stop and exit from grass to taxiway
