# National Transportation Safety Board

DCA23LA109

## **SECURITY VIDEO**

Location: Montgomery, Alabama  
Date: December 31, 2022  
Time: 15:39 central standard time (CST)  
Airplane: Embraer ERJ 170-200 LR, American Eagle, N264NN

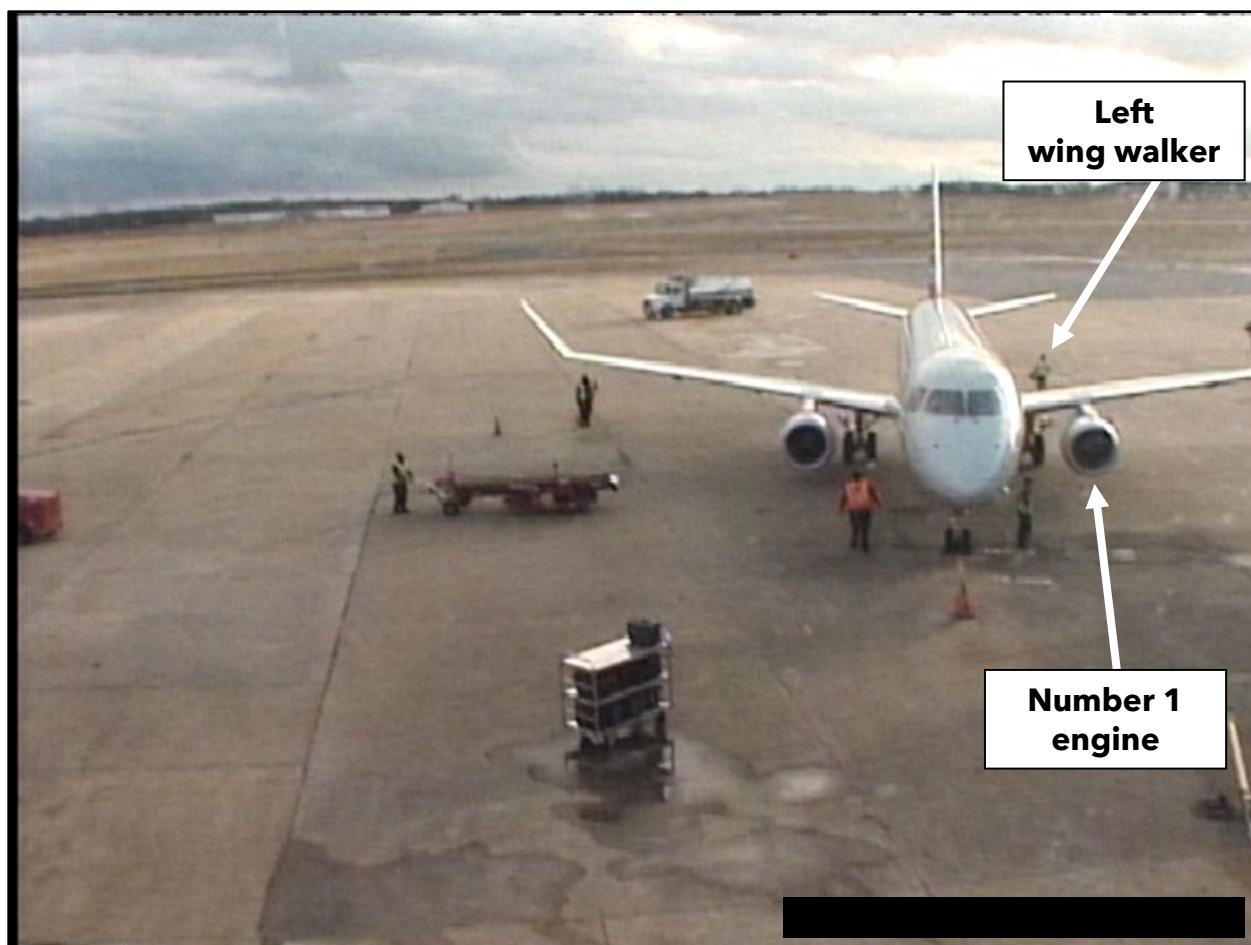
At 15:39:01, the ground crew member involved in the accident, hereafter referred to as left wing walker (LLW), was visible carrying a traffic cone to the tail of the aircraft. As the LLW walked towards the tail of the aircraft, the LLW stumbled from the jet blast of the still-operating number 1 engine (see Figure 1)<sup>2</sup>. After witnessing the LLW stumbling, the right wing walker motioned to the LLW with their left hand to move away from the aircraft. The jet bridge began maneuvering towards the forward entry door.

**Figure 1.** Security camera frame at about 15:39:01, showing the LLW in the path of the jet blast from the operating number 1 engine.

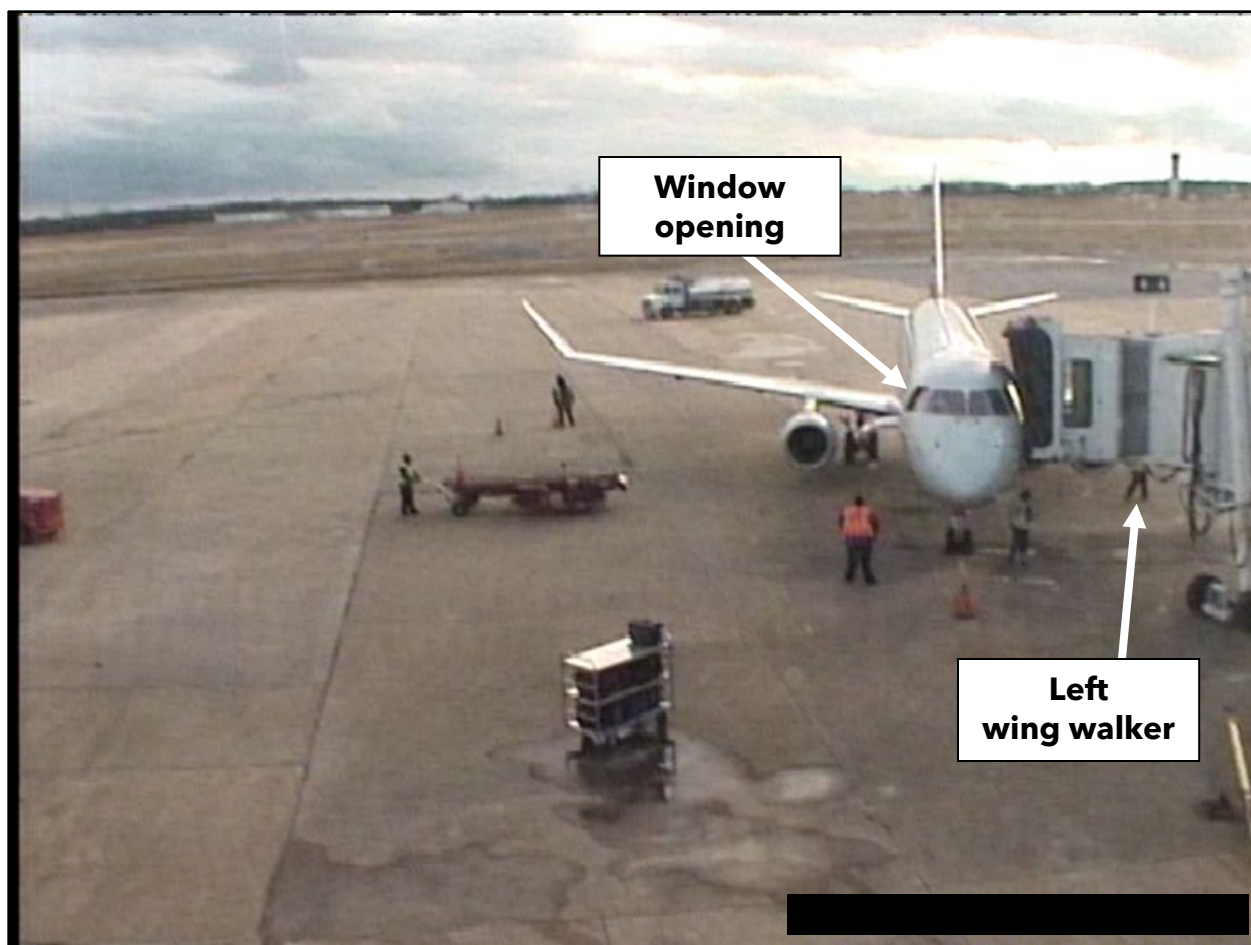
At 15:39:44, the legs and feet of the LLW were visible walking towards the aircraft fuselage parallel to the leading edge of the left wing just outboard of the number 1 engine. The upper body of the LLW was not visible due to the jet bridge obstructing the view.

At 15:39:45, the copilot's sliding cockpit window opened, as shown in Figure 2. The aircraft's beacon was still flashing.

**Figure 2.** Security camera frame at about 15:39:45, showing the LLW walking towards the operating number 1 engine.
