# National Transportation Safety Board

DCA23LA185

## **FDR AND ADS-B STUDY**

Aircraft Performance Study

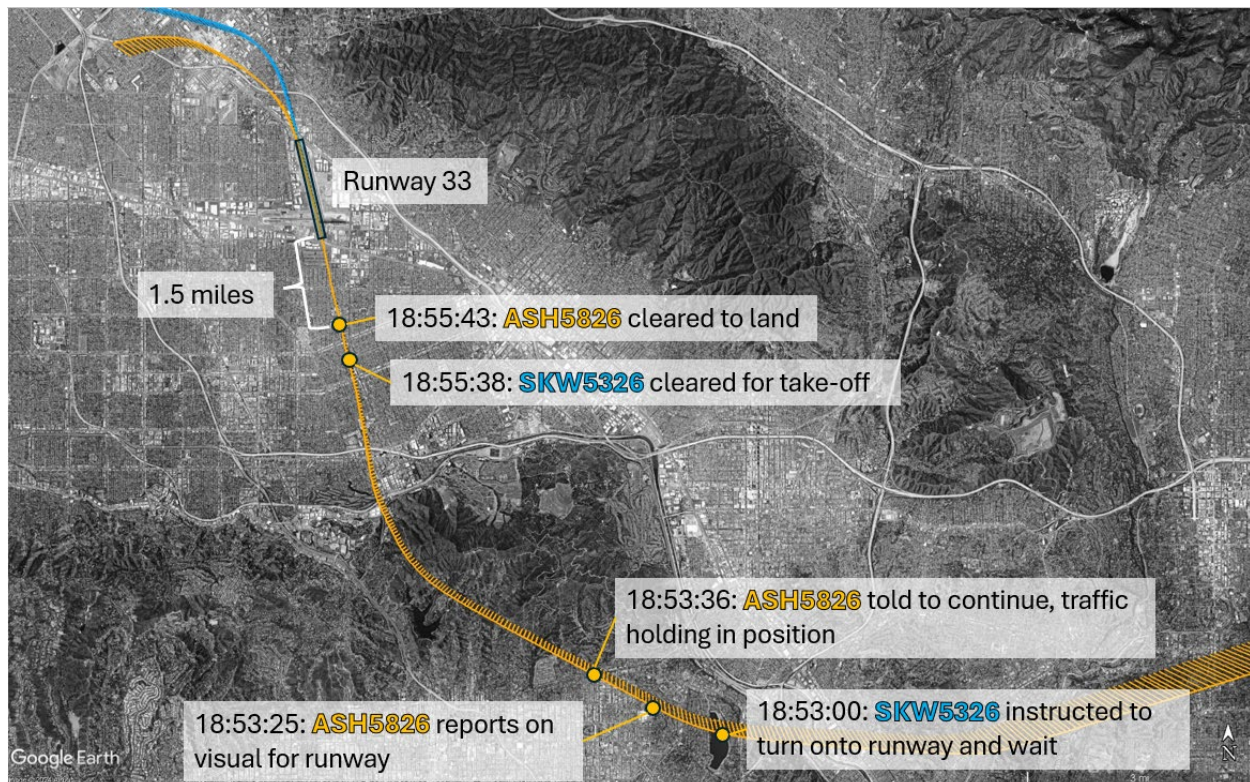
At 18:53:06, Local Control (LC) instructed SKW5326, which was on the ground departing Burbank, to turn onto runway 33, back taxi if necessary, and to line up and wait. At this time, ASH5826, was 7.9 NM (9 statute miles) from the threshold, at 2,800 ft above ground level (agl), and approaching runway 33 at Burbank (Figure 4).

At 18:53:25, ASH5826 reported they were visual for runway 33. The LC informed them that traffic (SKW5326) was holding in position on the runway but to continue. SKW5326 entered runway 33 about 18:53:45 and by 18:54:30 the airplane had made a 180° turn, aligned with the runway heading, and stopped behind the runway threshold.

**Figure 4.** ADS-B flight paths for ASH5826 (orange) and SKW5326 (blue). Selected times and ATC communications are shown.

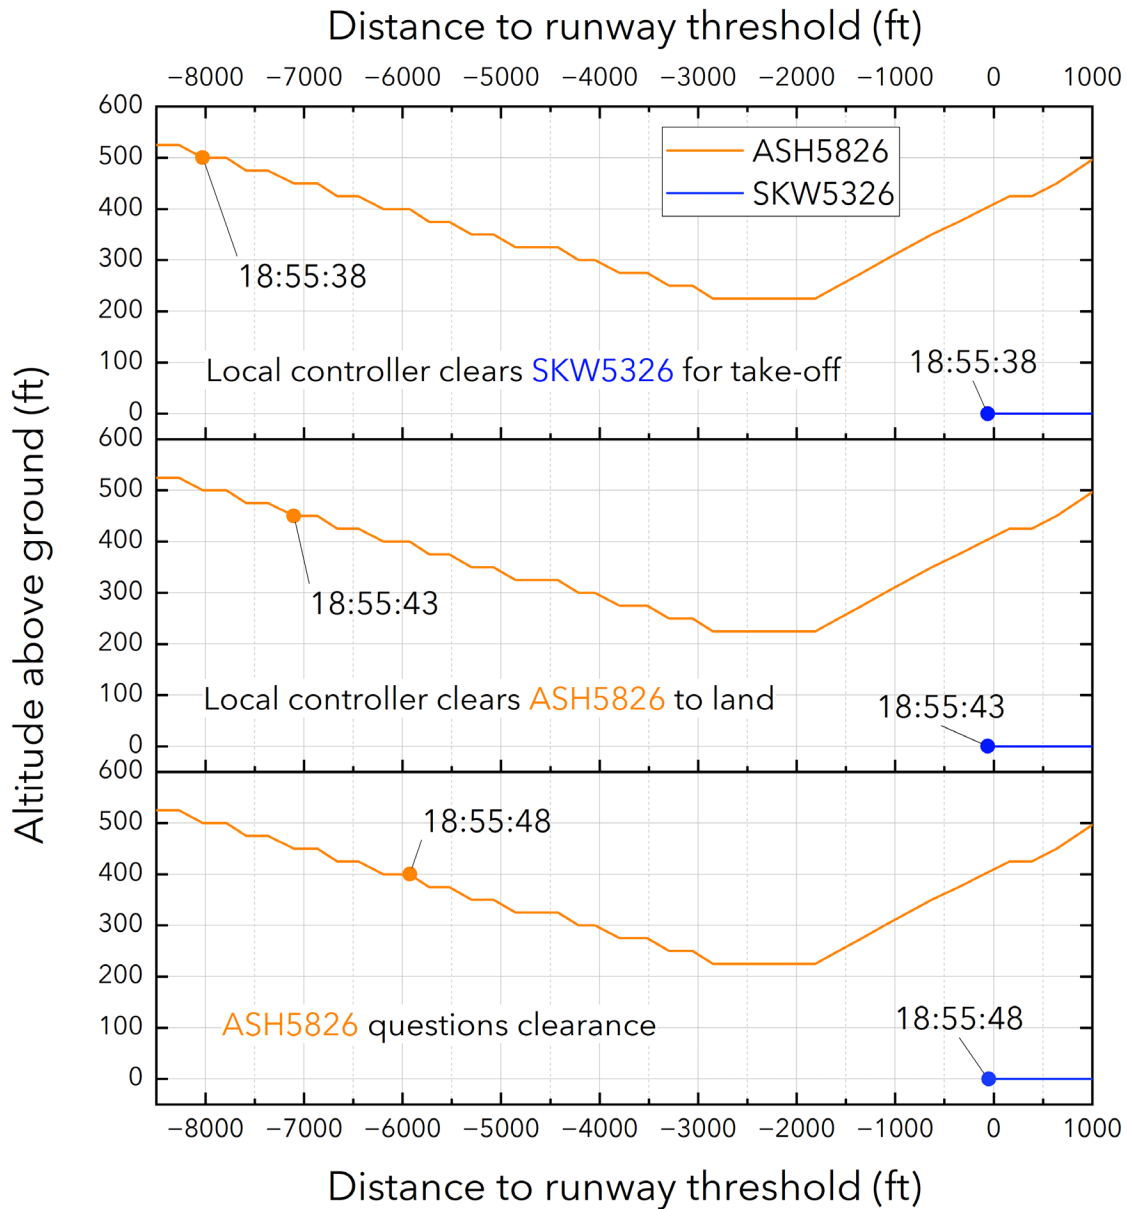
At 18:55:38, the LC cleared SKW5326 for take-off. ASH5826 was 1.6 miles from the threshold and at 500 ft agl (Figure 5). The LC then, at 18:55:43, cleared ASH5826 to land. The pilot of ASH5826 requested confirmation of the landing clearance, which LC confirmed. SKW5326 began its take-off roll (Figure 6) at 18:55:50, between the ASH5826's request for confirmation and the LC's confirmation of their landing clearance.

**Figure 5.** Altitude versus distance to runway threshold for ASH5826 (orange) and SKW5326 (blue). Selected times and ATC communications are shown.

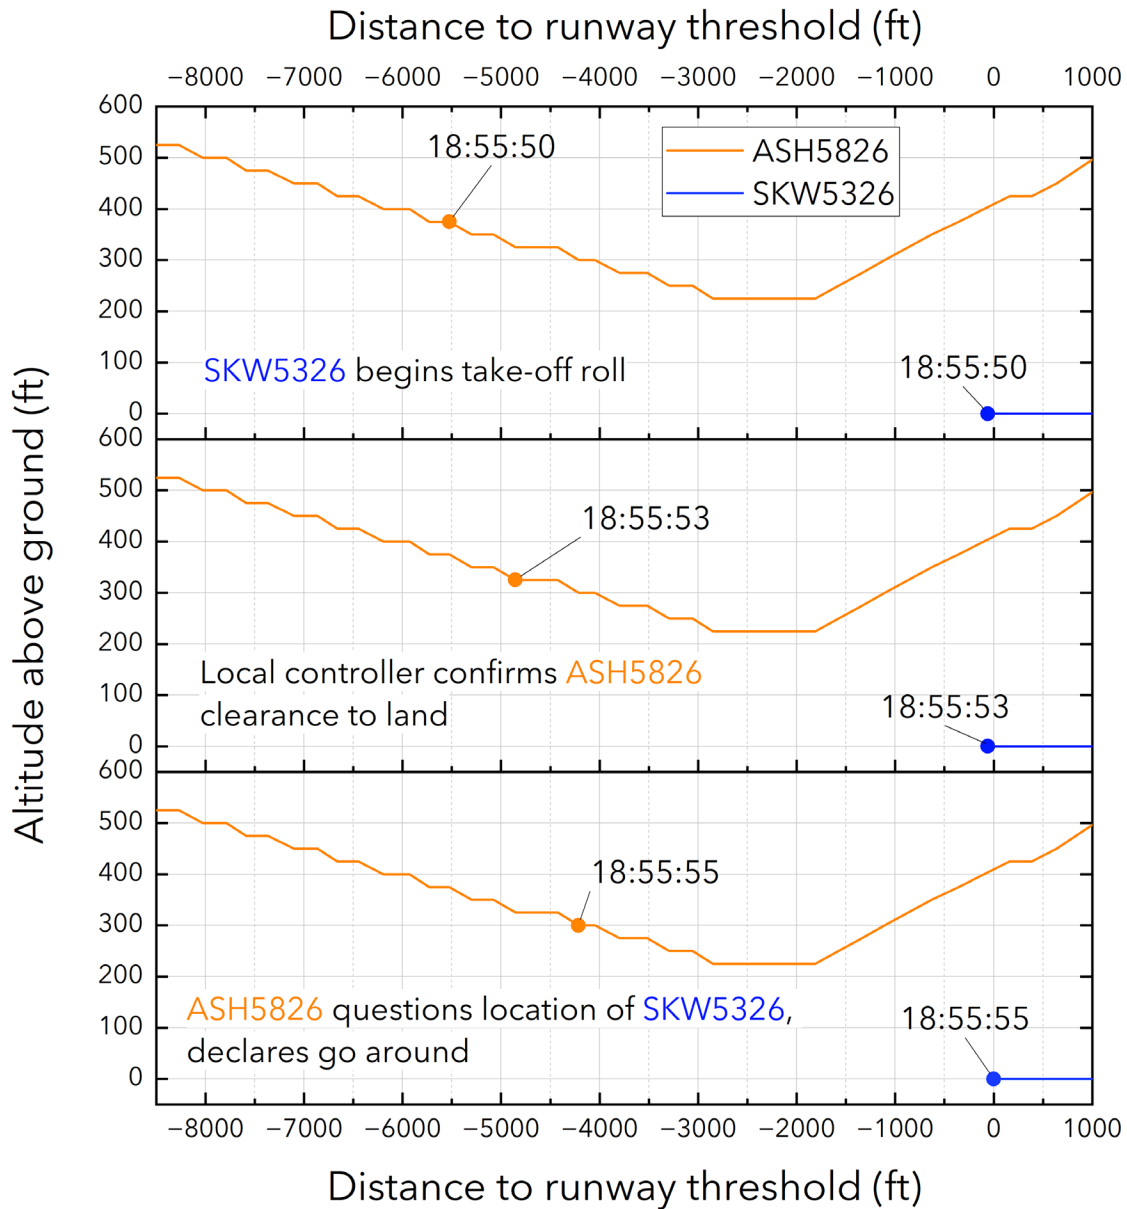
One pilot of ASH5826 then asked if SKW5326 was off the runway yet and the other pilot of ASH5826 interjected on the radio "no he... we're going around" at 18:55:55. At this point, SKW5326 was at a groundspeed of 27 kts and accelerating across the runway threshold. ASH5826 was 4,200 ft from the threshold and at 300 ft agl.

**Figure 6.** Altitude versus distance to runway threshold for ASH5826 (orange) and SKW5326 (blue). Selected times and ATC communications are shown.

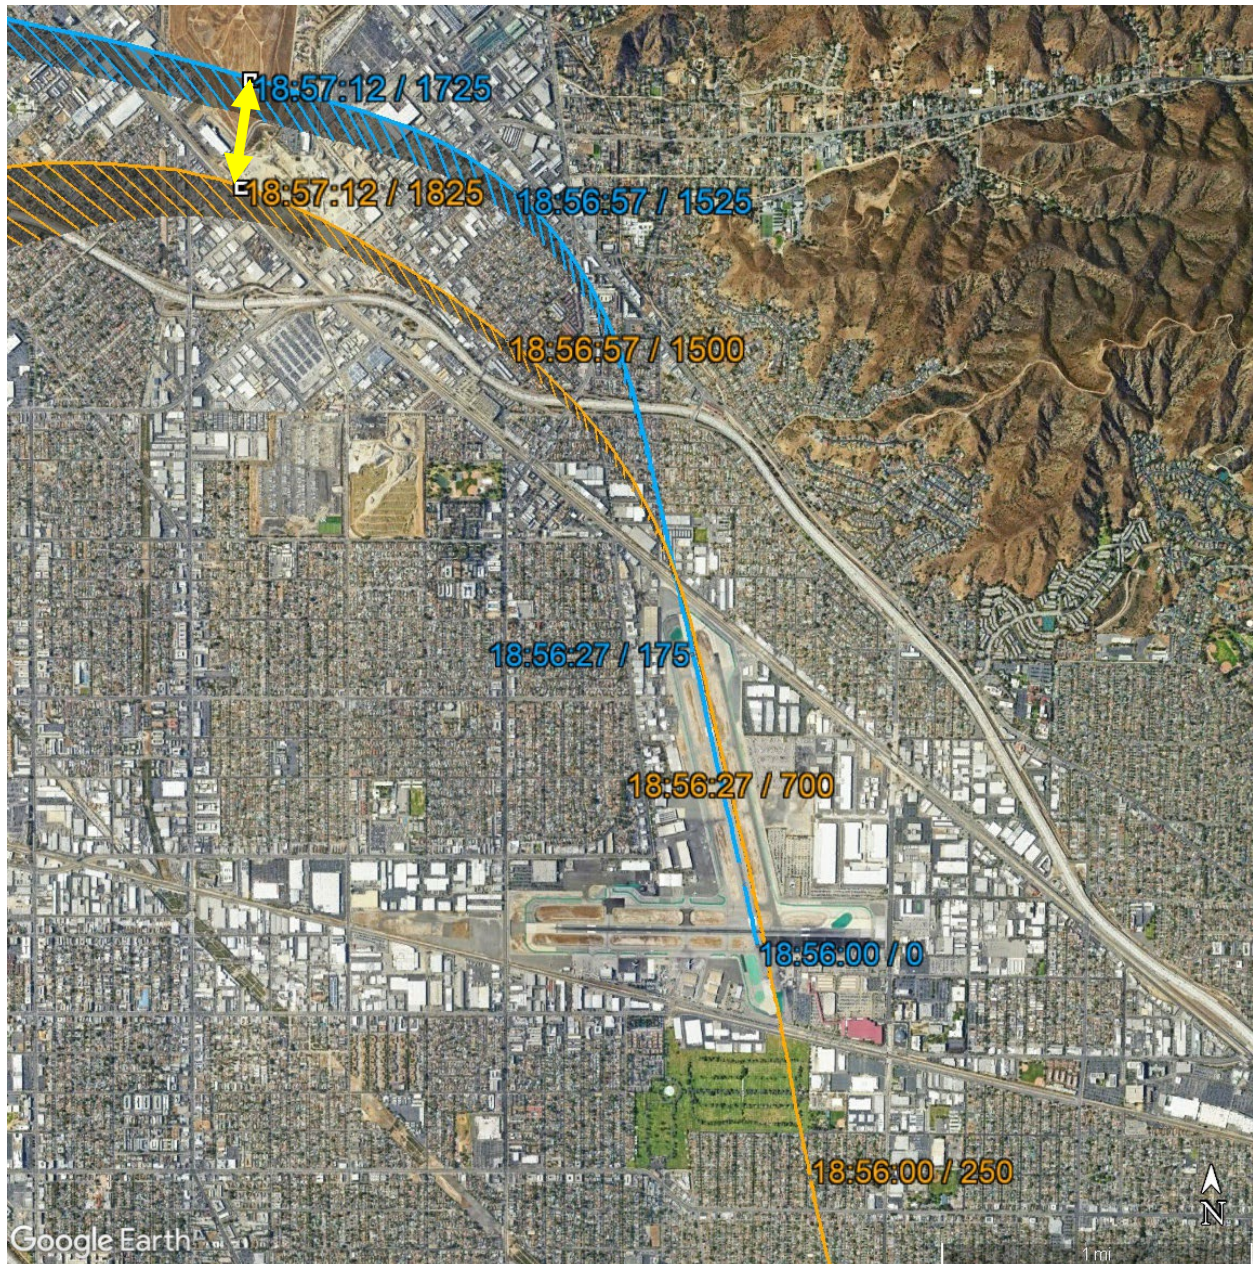
At 18:56:00 the LC replied "roger" and instructed ASH5826 to climb and maintain 4,000 ft, and to fly the runway heading. The airplanes were 4,000 ft apart at this time. At 18:56:27 the LC instructed ASH5826 to turn to heading 270. The pilot read back left 270. Both airplanes began left turns once past the runway surface.

**Figure 7.** ADS-B flight paths for ASH5826 (orange) and SKW5326 (blue). Selected times and altitude above ground are shown. A yellow arrow highlights the point of minimum separation between the airplanes at 18:57:12.

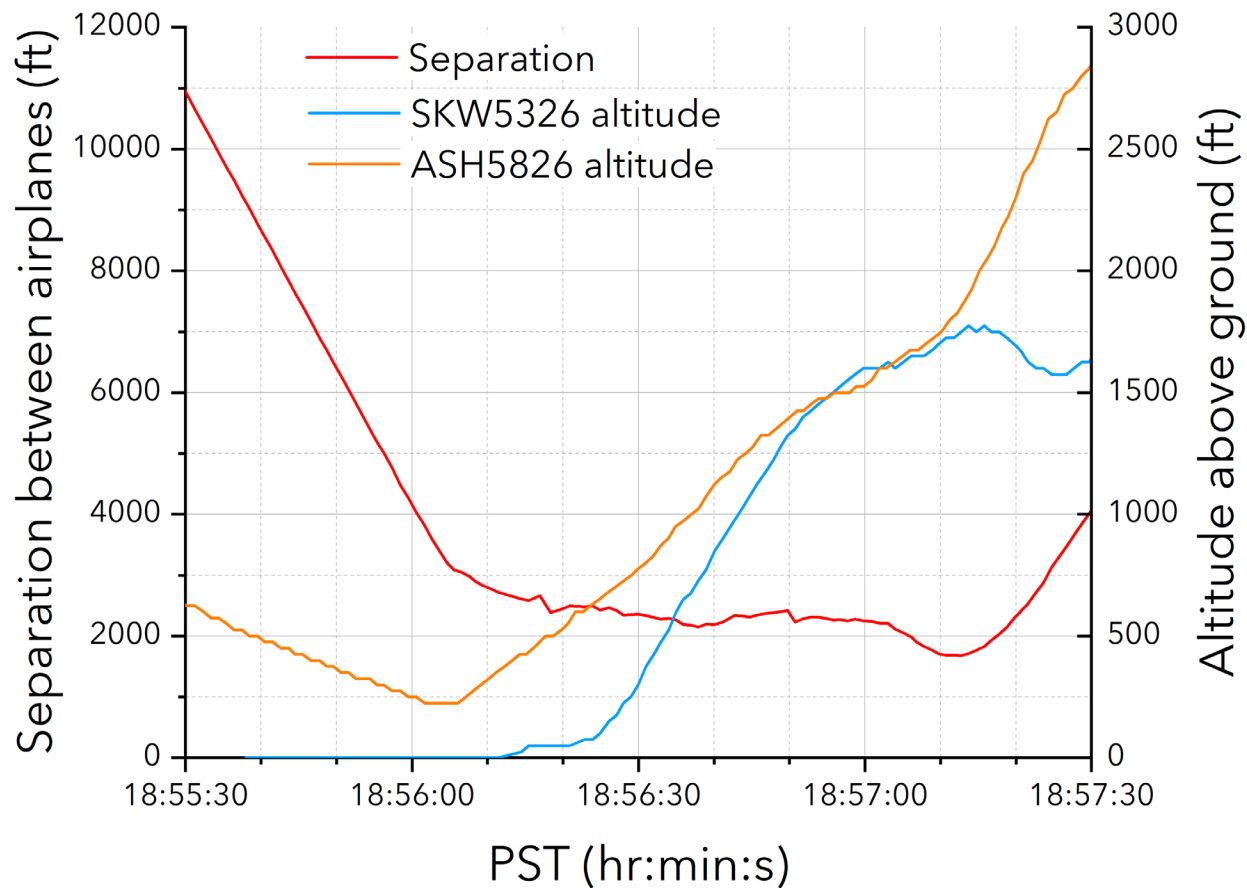
Figure 8 shows the calculated separation of the two airplanes and their respective altitudes. From 18:56:15 to 18:56:35, ASH5826 was over the runway surface. From 18:56:20 to 18:57:00, the airplanes were about 2,300 ft apart. The airplanes' closest point of separation was at 18:57:12 when the airplanes were within 1,680 ft.

**Figure 8.** Calculated separation between airplanes and recorded altitude for each airplane.

The airplanes were about 2,300 ft apart while on the runway heading. Shortly after beginning left turns, the airplanes came within 1,680 ft of each other at 18:57:12.
