# National Transportation Safety Board

DCA24FA017

## **OPERATIONAL FACTORS/HUMAN PERFORMANCE**

Group Chairs' Factual Report

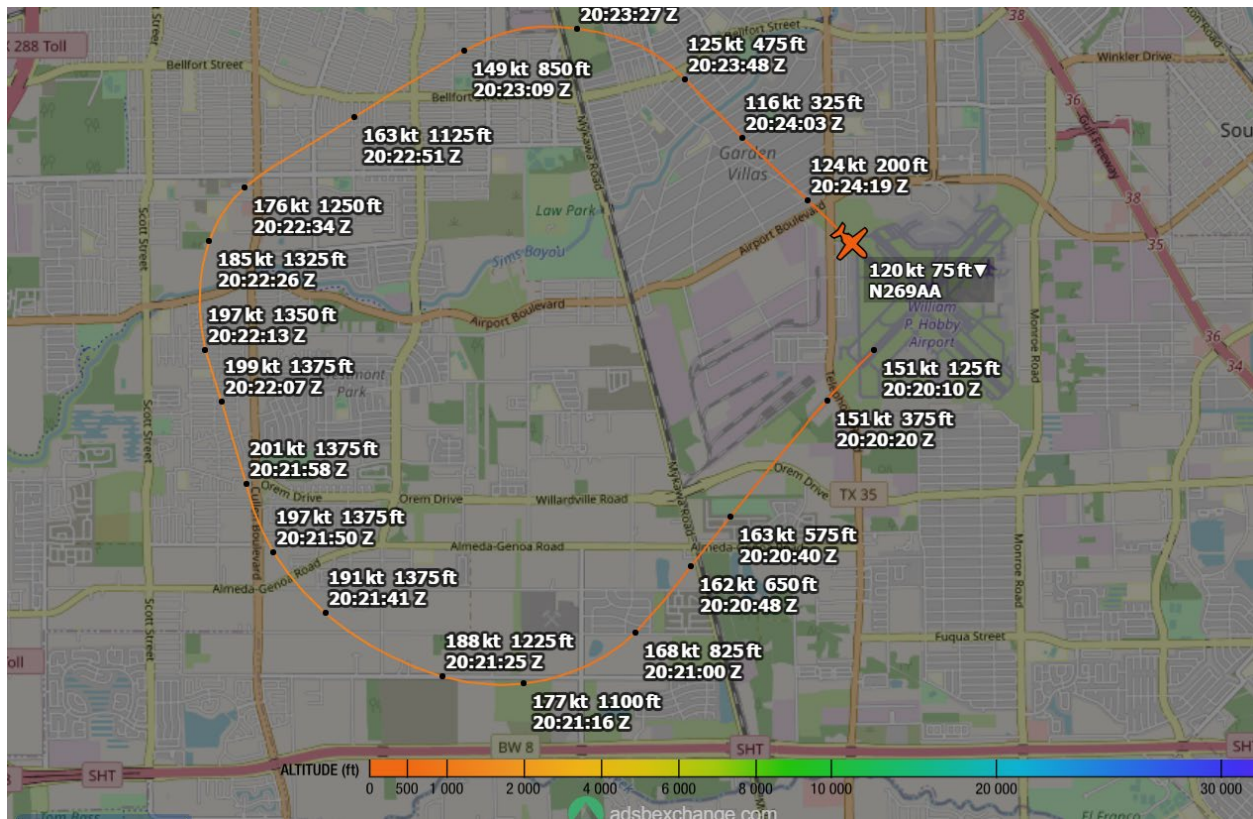
**Figure 1.** N269AA Accident Flight (Source: ADSBExchange.com)

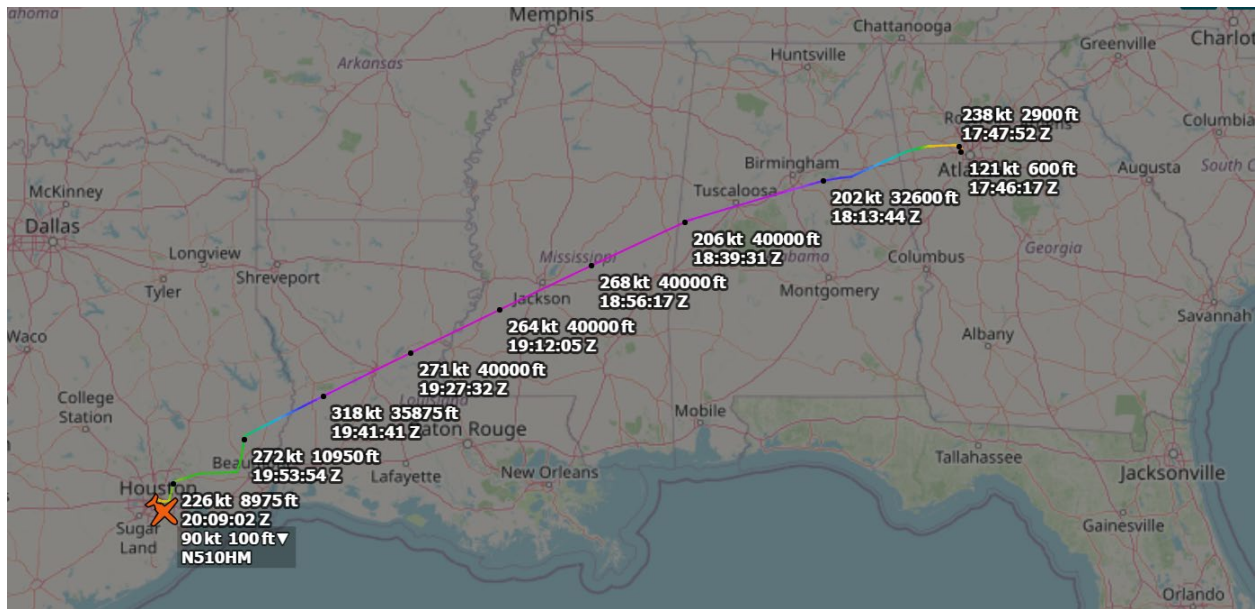
**Figure 2.** N510HM Accident Flight (ADSExchange.com)

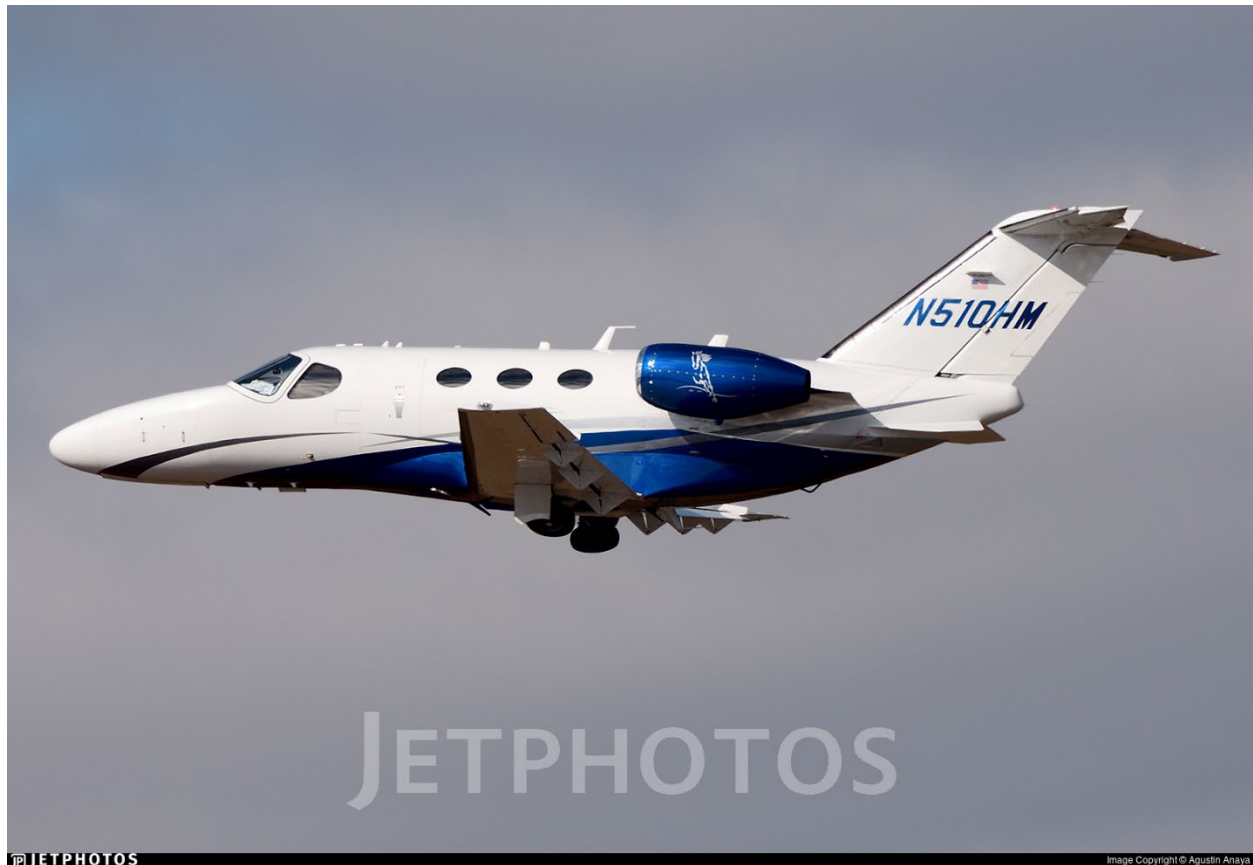
**Figure 3:** Accident Airplane (Cessna Citation Mustang) (Source: JetPhotos.com)

In an interview with the pilot, he stated that he did not see the Hawker airplane but heard a sound similar to a truck tire blowing out on a highway. He further stated there was no yaw and the airplane had no controllability issues rolling down the runway or taxiing to the ramp. It wasn't until the pilot got out of the airplane that he saw the damage to the airplane.

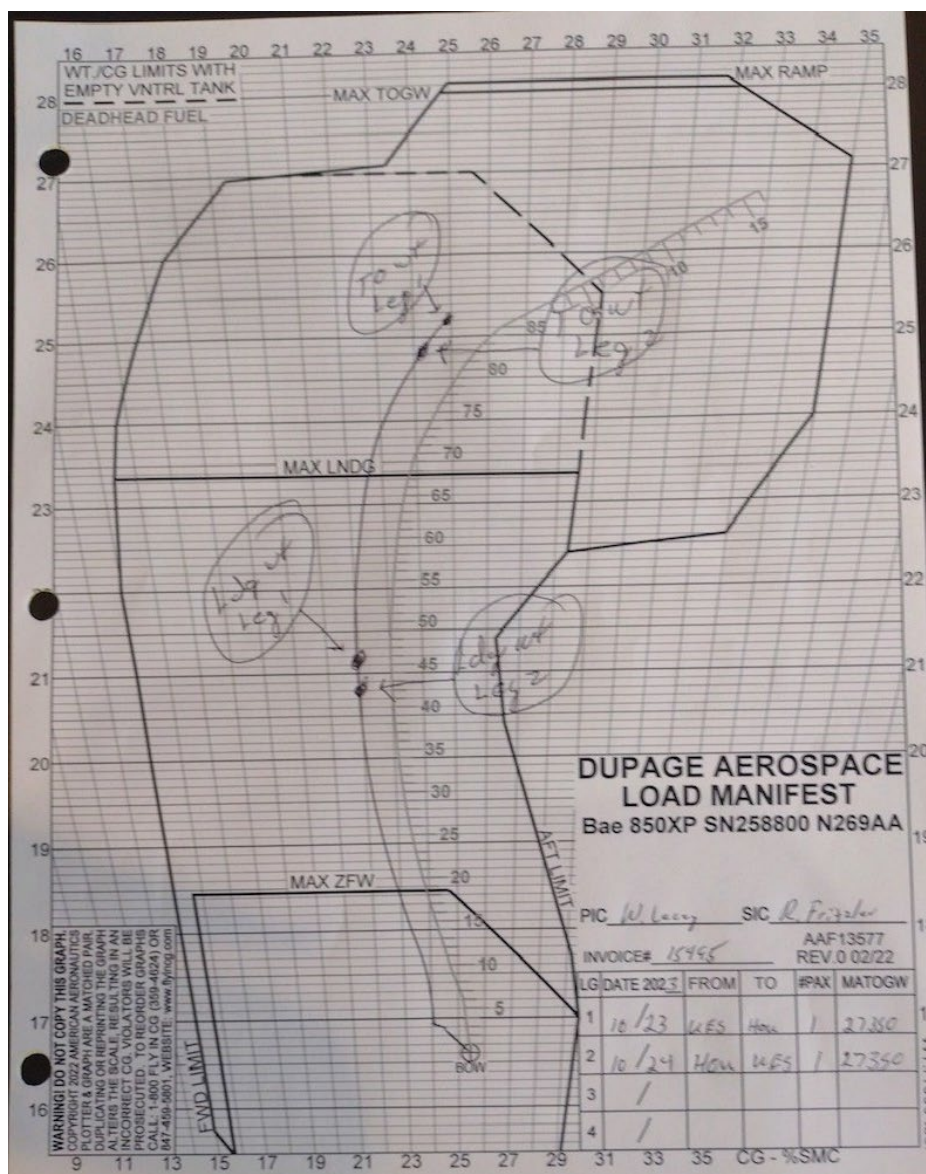
The N269AA's weight and balance graphical depiction (pictured below) indicated that the take off for "leg 2" was below the maximum takeoff weight and above the maximum landing weight. The center of gravity also was within the allowable range.

Figure 5: Actual Weight and Balance for Accident Flight (Note: Accident Flight is "Leg 2")
