## Air Safety Investigations Aircraft Incident/Accident Technical Report

| Aircraft and Incident/<br>Accident Information | Year: 2006 | Make: Hawker Beechcraft | Model: 850XP |
| Senior Air Safety Investigator: Ernest C. Hall | | Report #: ASI-23-CQ-T | Report date: 02-15-24 |

| Senior Air Safety Investigator: Casey J. Love | | Report #: ASI-23-CR-T | Report date: 05-08-24 |

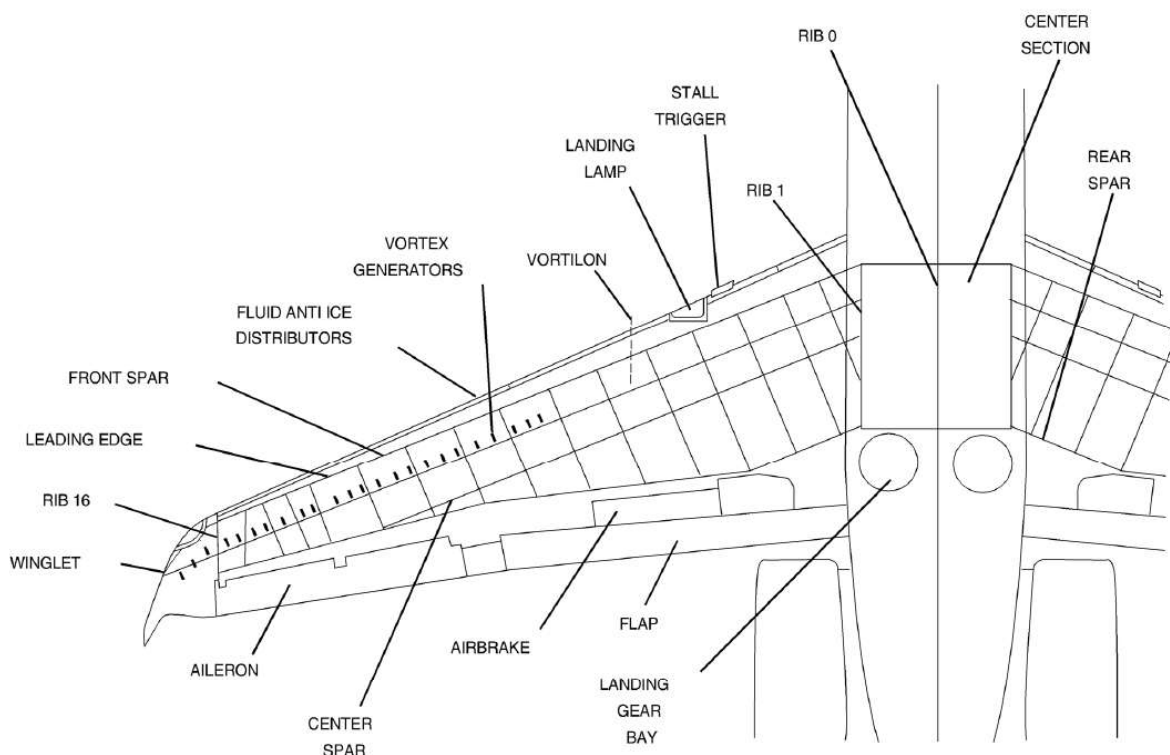
AMM 57-00-00, (Figure 1, Sheet 2) Wing

A composite winglet is installed to the outboard side of rib 16 to complete the wing structure. The winglet is constructed from composite upper and lower skins and internal spar with a metallic leading edge. The spar and skins are made from woven graphite cloth impregnated with resin. The winglet houses the twin wing navigation light assemblies and a single strobe light assembly (Ref. Figure 1, Sheet 2).

Twenty-four vortex generators are attached to the upper surface of the wing and winglet, between the front and rear spar. Numbers 1 thru 21 extend from between ribs 8 and 9 to rib 16, with numbers 22 thru 24 attached to the winglet (Ref. Figure 1, Sheet 2).

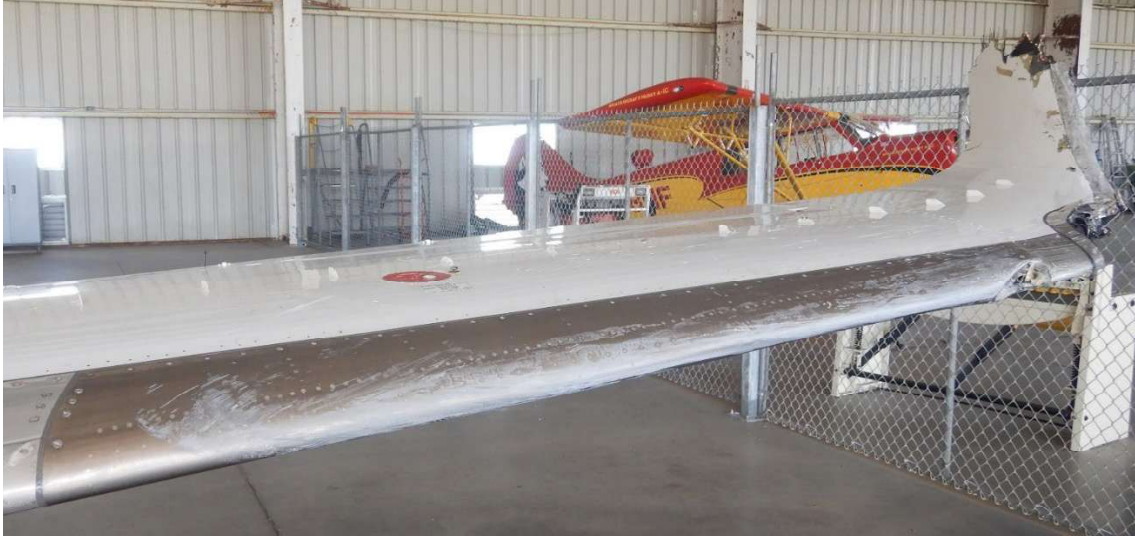
A visual examination of the aircraft revealed that the left wing exhibited impact damage. Starting from approximately wing rib 11 (Station 232.5) outboard to wing rib 16 (Station 311.3), the titanium leading edge panel exhibited white paint transfer marks and at wing rib 16, the titanium leading-edge panel exhibited a "V-shape" aft indentation to the wing front spar with sheet metal remnants of the Cessna Mustang.

Cropped - ASI-23-CQ-024 – Left Wing Titanium Leading Edge Panel

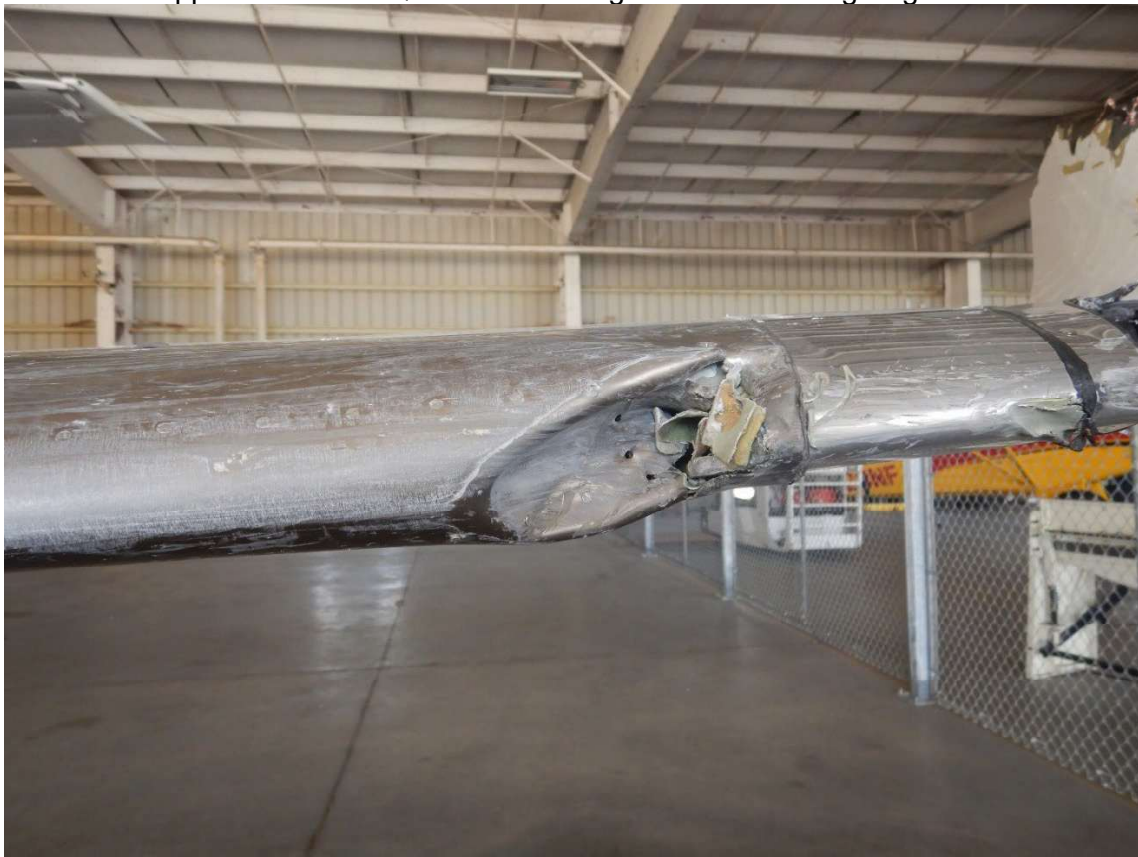
ASI-23-CQ-026 – Left Wing Leading Edge

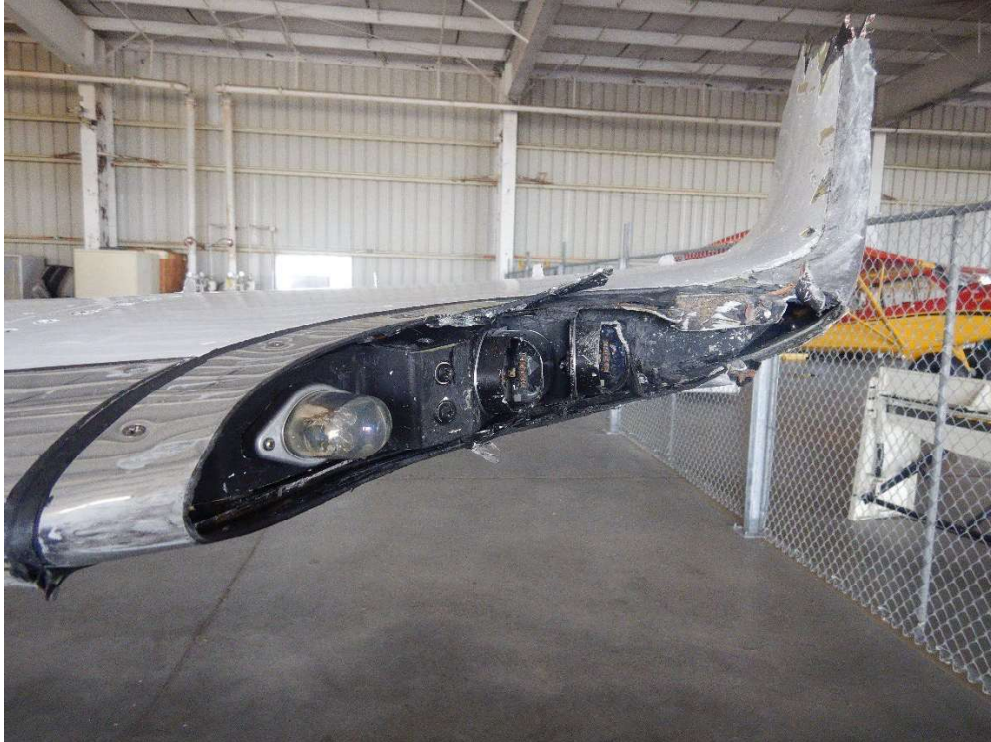
The left-wing winglet remained attached to the left wing. The winglet leading edge exhibited white transfer marks and the navigation light lens was impact separated and pieces of the glass were found in the Cessna Mustang tail cone/stinger. The top section of the winglet, approximately ten inches, was impact separated.

ASI-23-CQ-037 – Left Winglet/Navigation Light Assembly

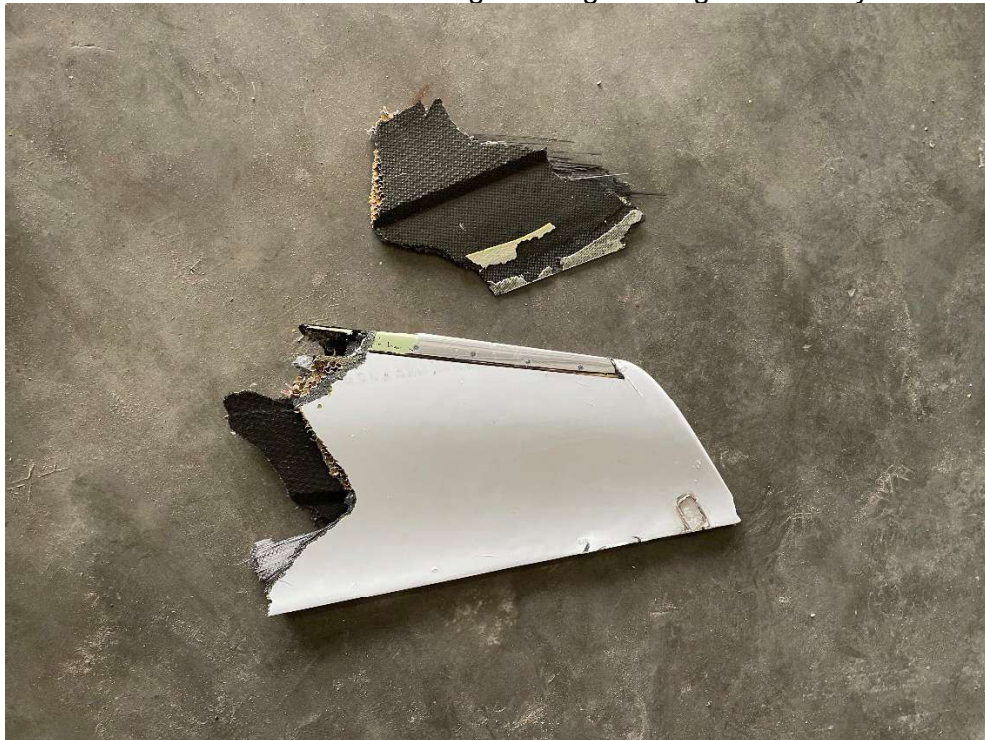
ASI-23-CQ-041 – Left Winglet Top Separated Section

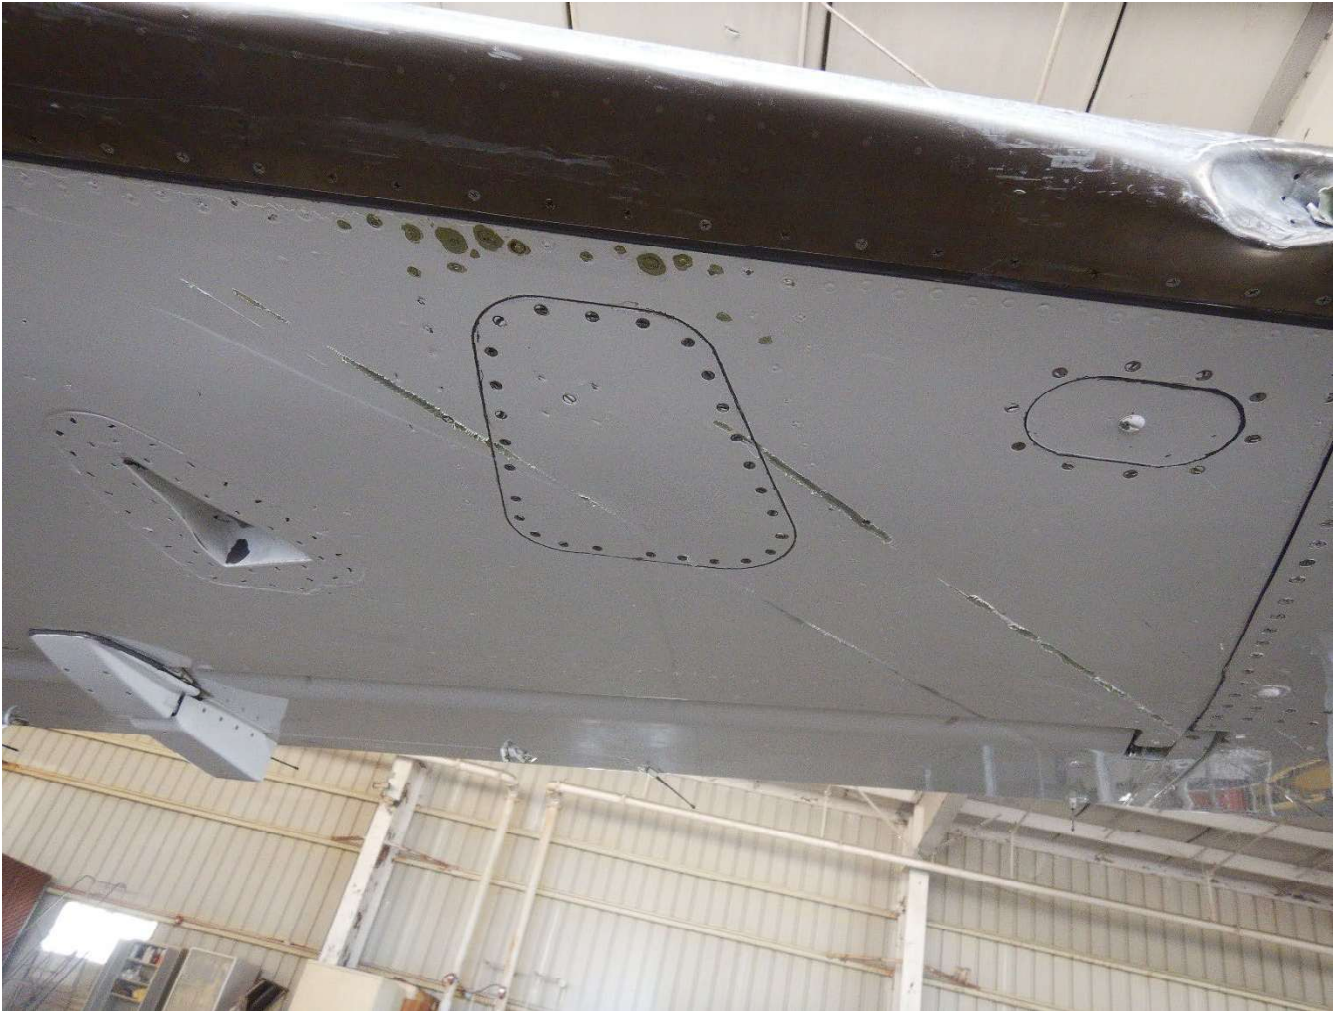
The left-wing bottom skin exhibited two scratch marks approximately a quarter inch wide that extended diagonally from the front wing spar at approximately rib 13 aft to the wing trailing edge and across the aileron and the winglet.

ASI-23-CQ-028 – Left Wing Bottom Skin

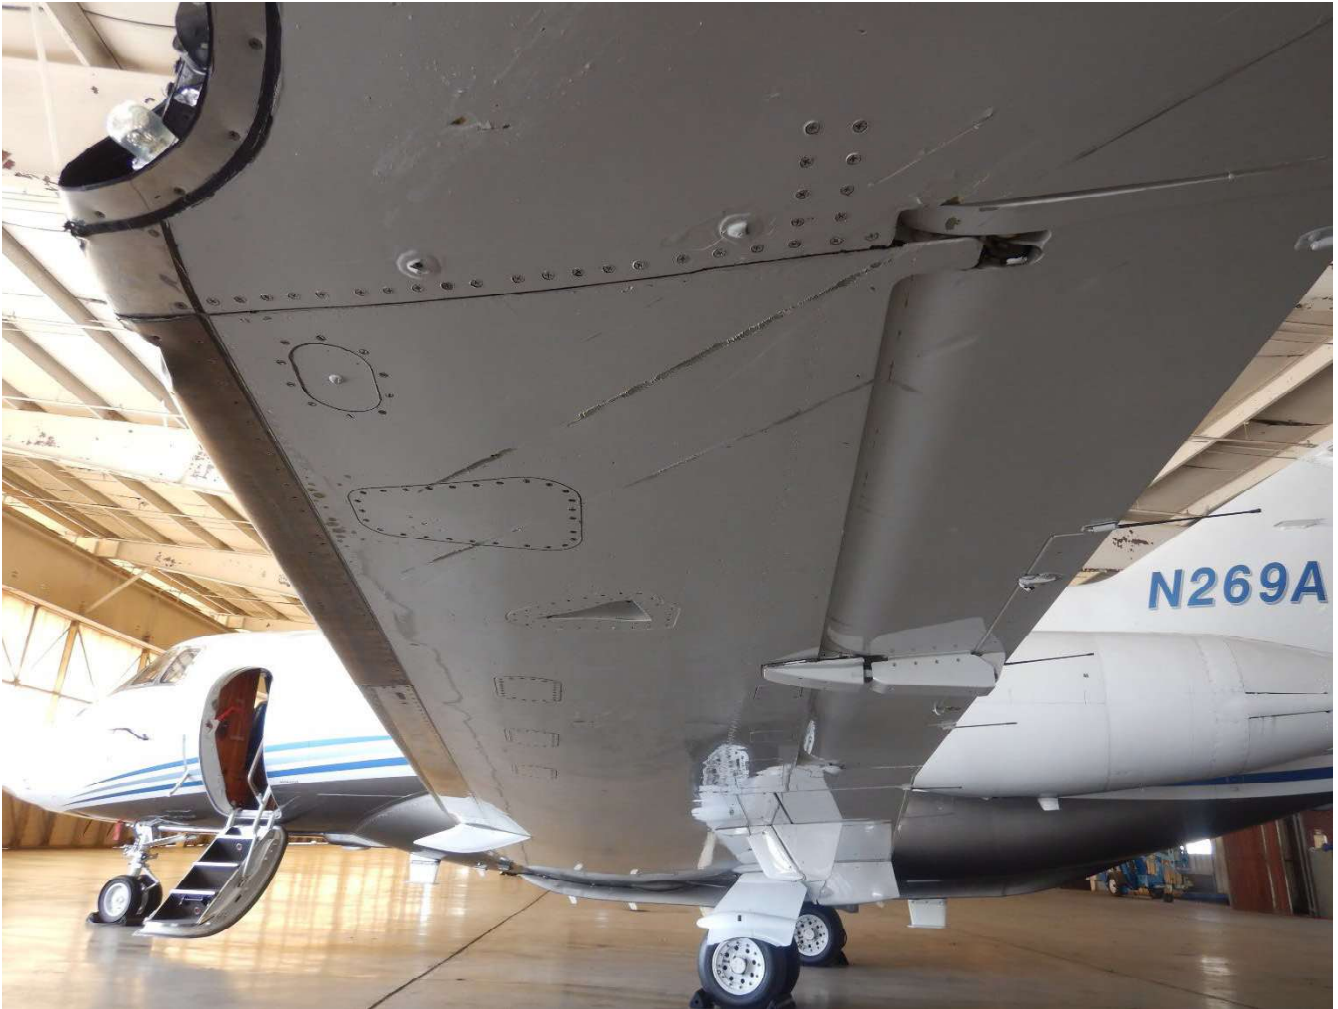
ASI-23-CQ-029 – Left Wing Bottom Skin

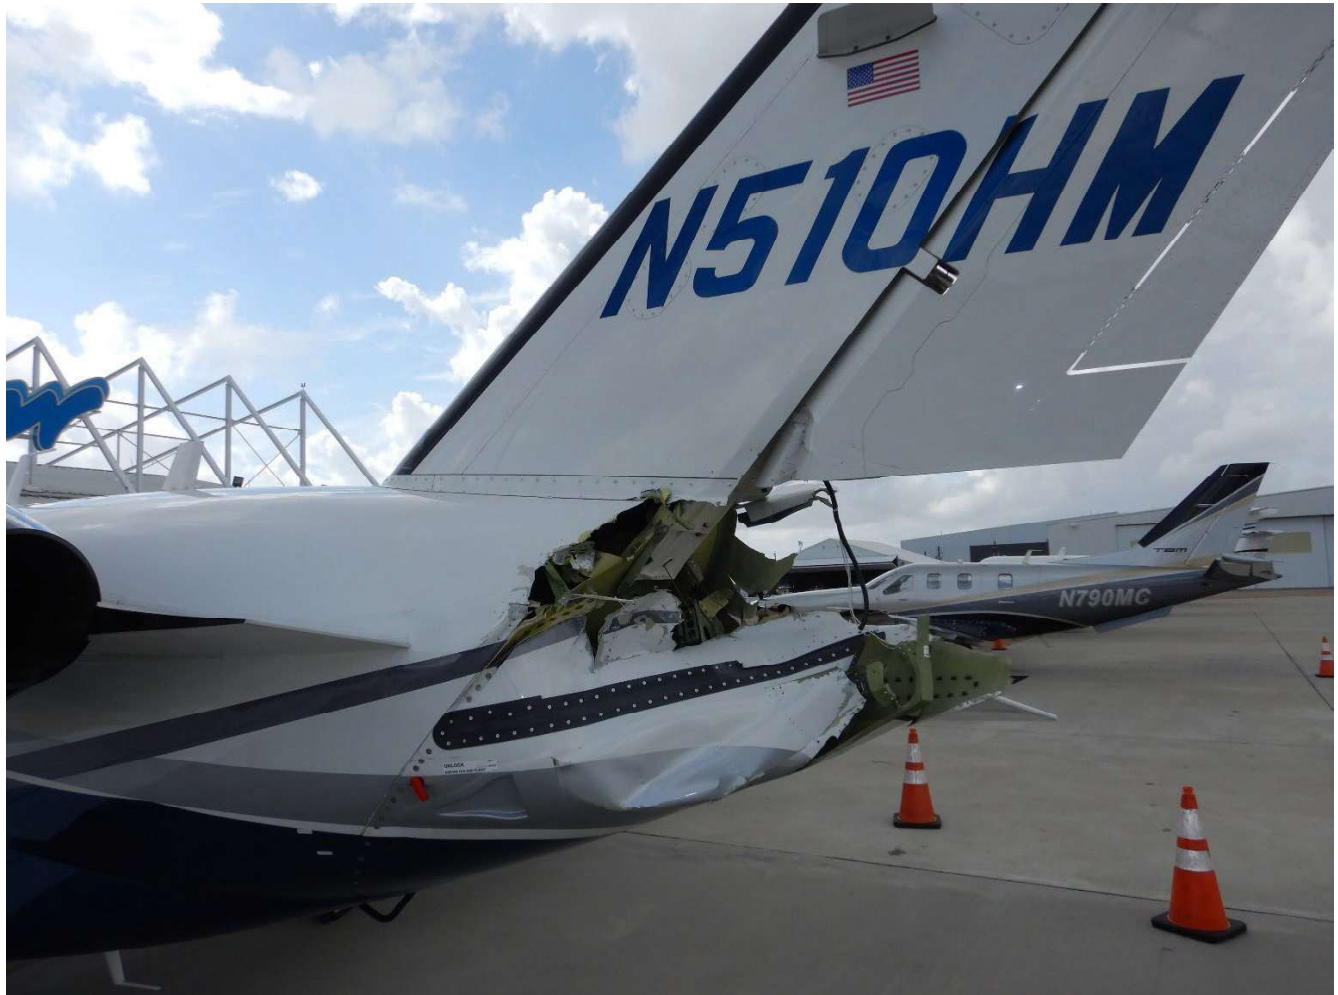
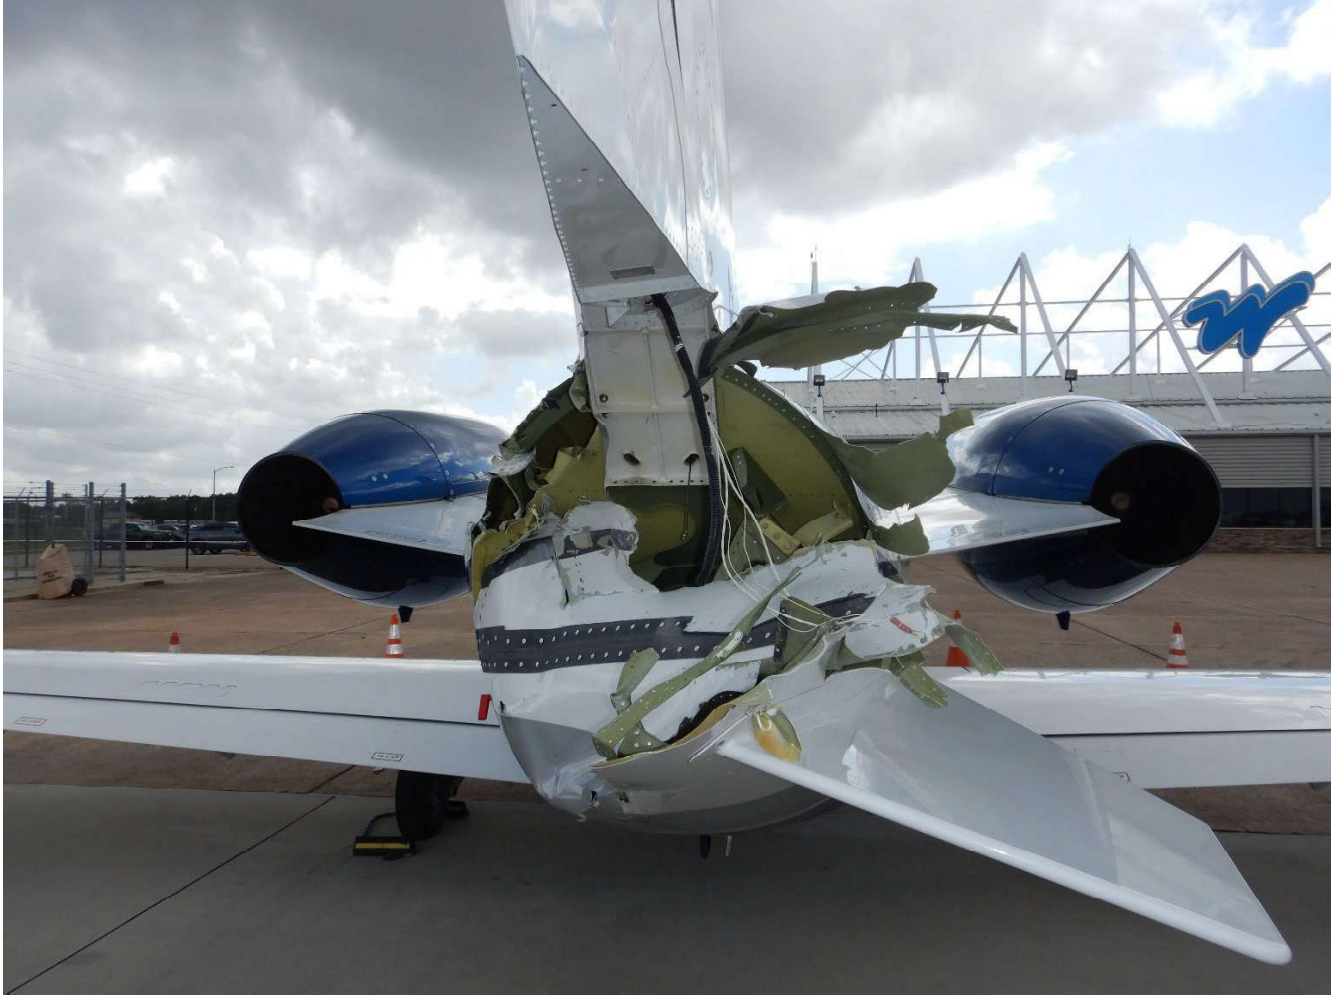
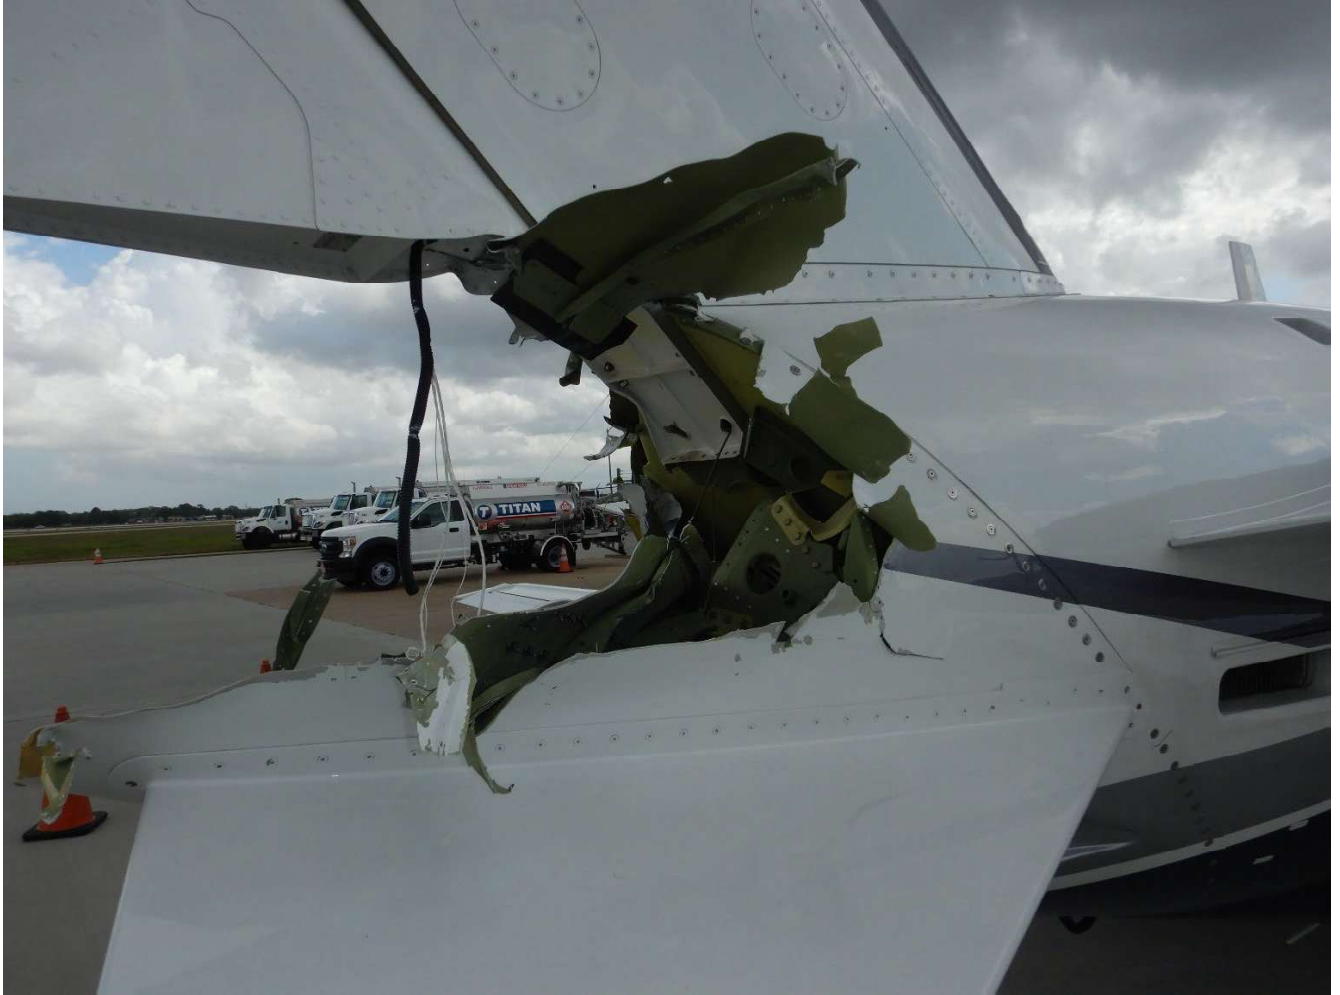
The Cessna 510 was impacted on the left side of the tail section by the left wing of a Hawker 850XP. The skin tears were consistent with the wing penetrating the left side of the tail stinger and exiting the right side, severing a portion of the stinger (Reference Figure 1). The impact damage was isolated to the area of the empennage. The impact damage began at approximate fuselage station 465.00 near the upper left tailcone skin and aft canted bulkhead intersection and extended aft to the tip of the stinger. The impact damage extended from approximate water line 108.00, near the top of the strake attach point, upward to the top of the stinger at water line 116.00. (Reference photographs 1-3)

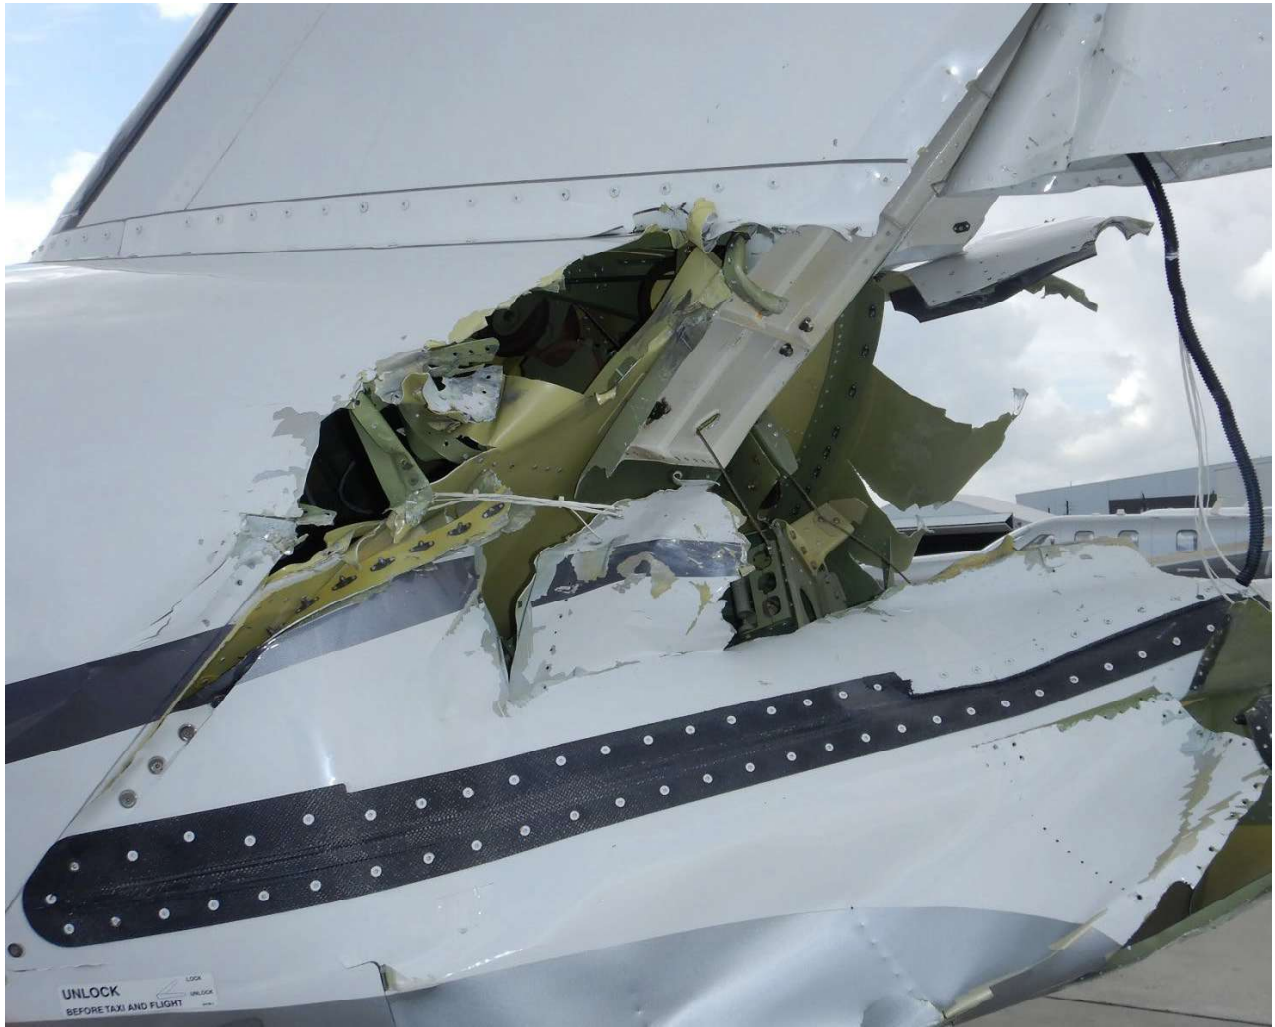
Textron Aviation Examination ASI-23-CR-022 (Cropped) (Photograph 4)

The impact separated a section of the aft canted bulkhead approximately four inches wide by sixteen inches long (Reference photograph 4). A portion of the upper aft tailcone skin similar in length was fractured along with the bulkhead. A section of the aft horizontal stabilizer spar approximately ten inches in length; common to the rudder sector attach point was torn and bent consistent with the wing impact (Reference photograph 5). The rudder sector mount was torn from the structure at the fastener locations.

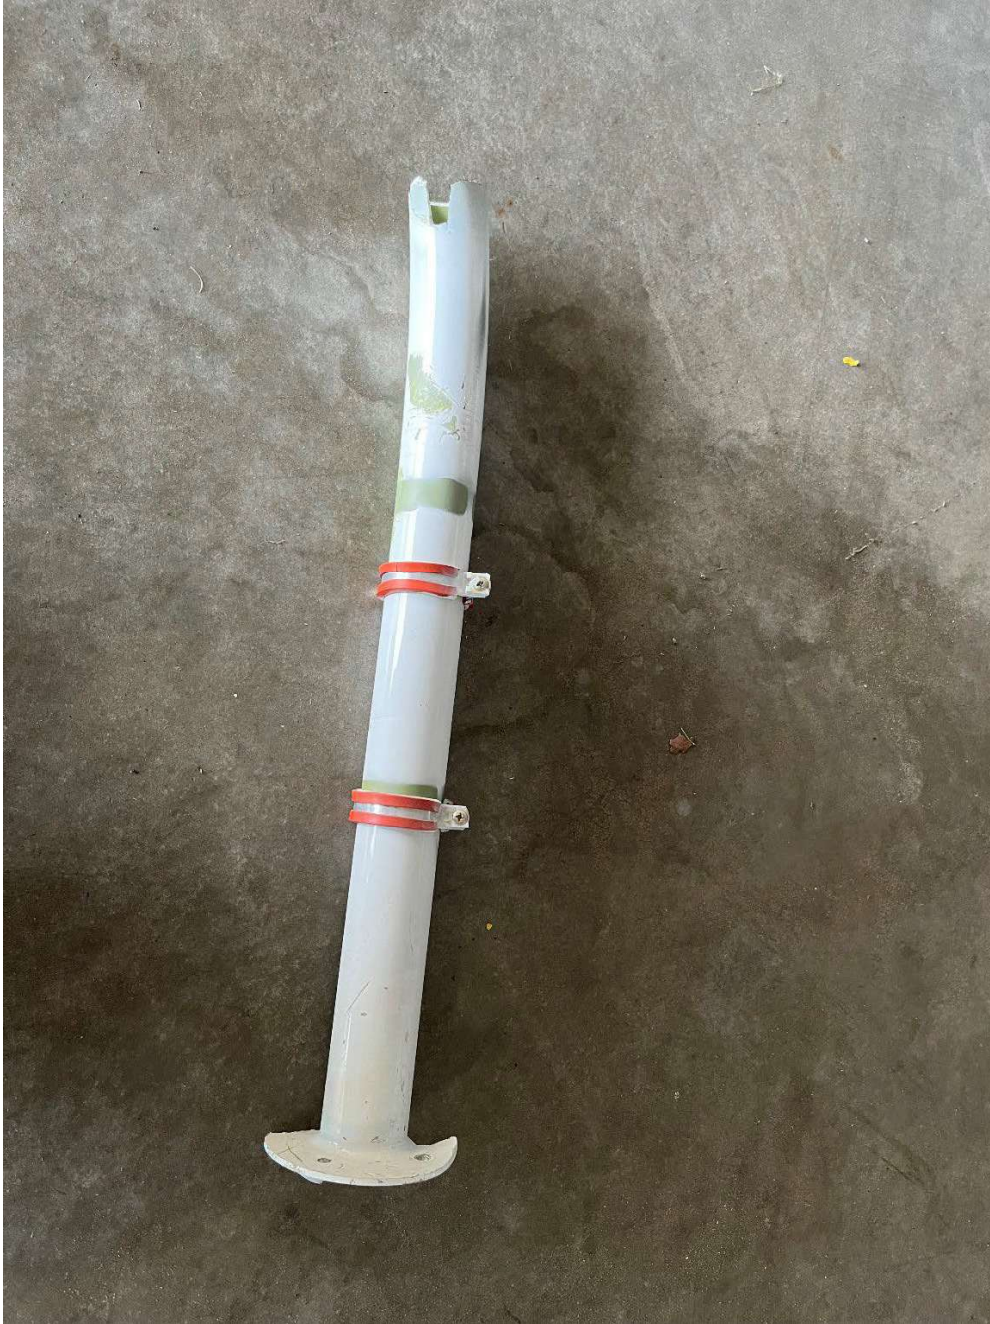
Textron Aviation Examination ASI-23-CR-048 (Photograph 6)

The rudder torque tube was fracture separated from the rudder control sector and the rudder (Reference photograph 6). The upper and lower left and lower right rudder control cables were broken in a manner consistent with tensile overload. The upper right rudder control cable remained intact, but the ball end was pulled from the rudder sector. The autopilot rudder servo control cable was fracture separated consistent with tensile overload. The left autopilot cable pulley bracket, with pulley attached, was liberated from the canted bulkhead. The skin on the right side of the rudder approximately eight inches up from the lower rib exhibited wrinkles and deformation. The left lower forward corner of the rudder exhibited a vertical impact signature approximately six inches in length and two inches deep. The left strake was impact fractured from the tailcone stinger and was recovered from the runway along with various sheet metal fragments from the stinger.
