# National Transportation Safety Board

DCA24FA017

## **AIR TRAFFIC CONTROL**

Group Chairman's Factual Report

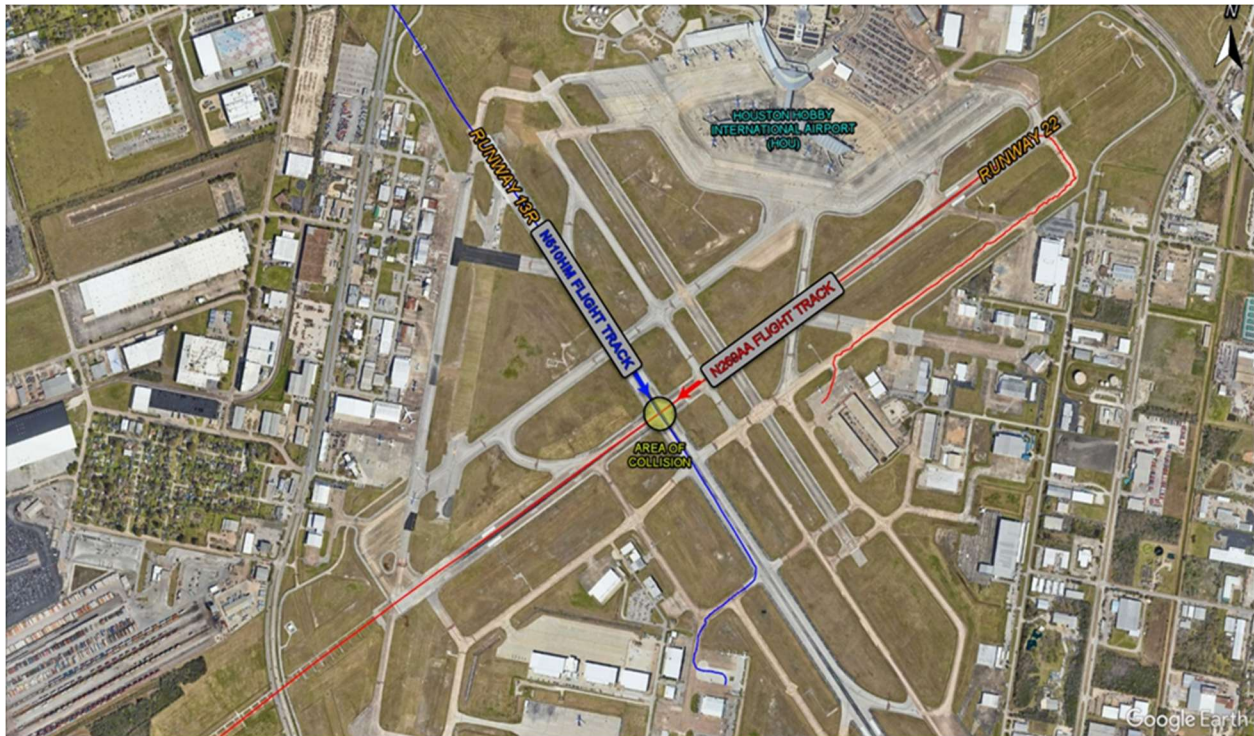
**Figure 1.** Overhead view of both flight tracks with the ground collision included.

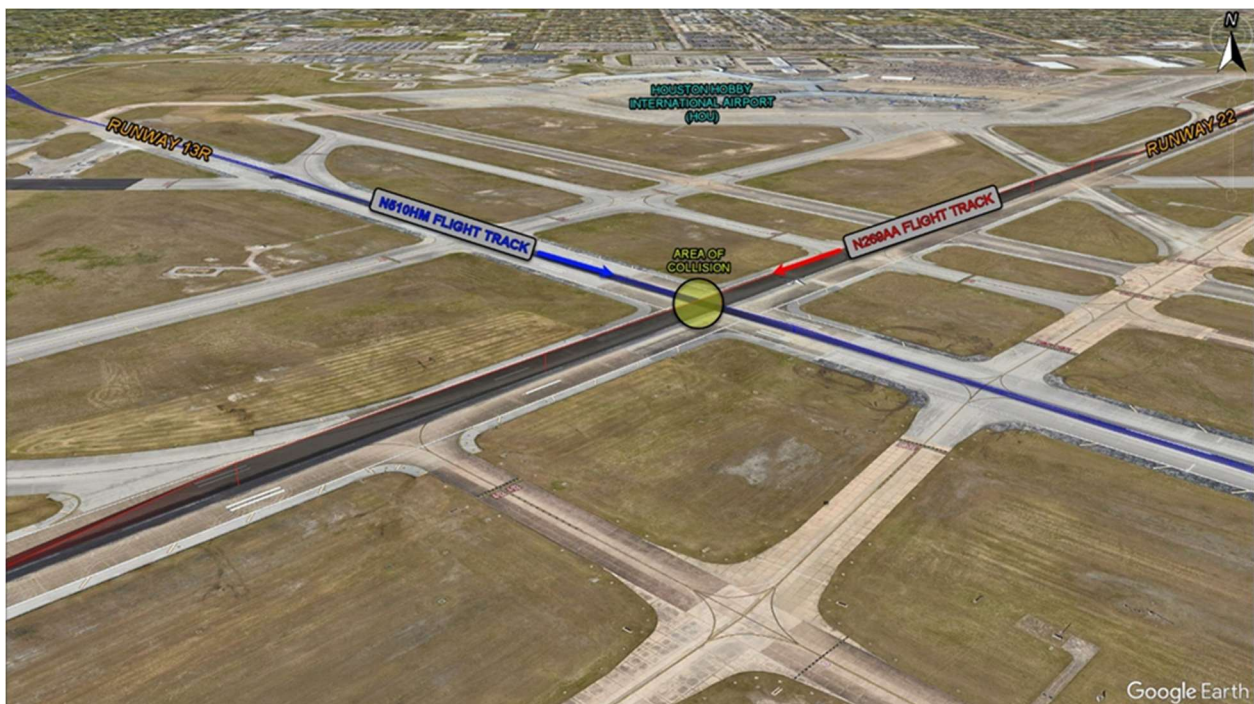
**Figure 2.** Profile view of both flight tracks with the area of the ground collision included.

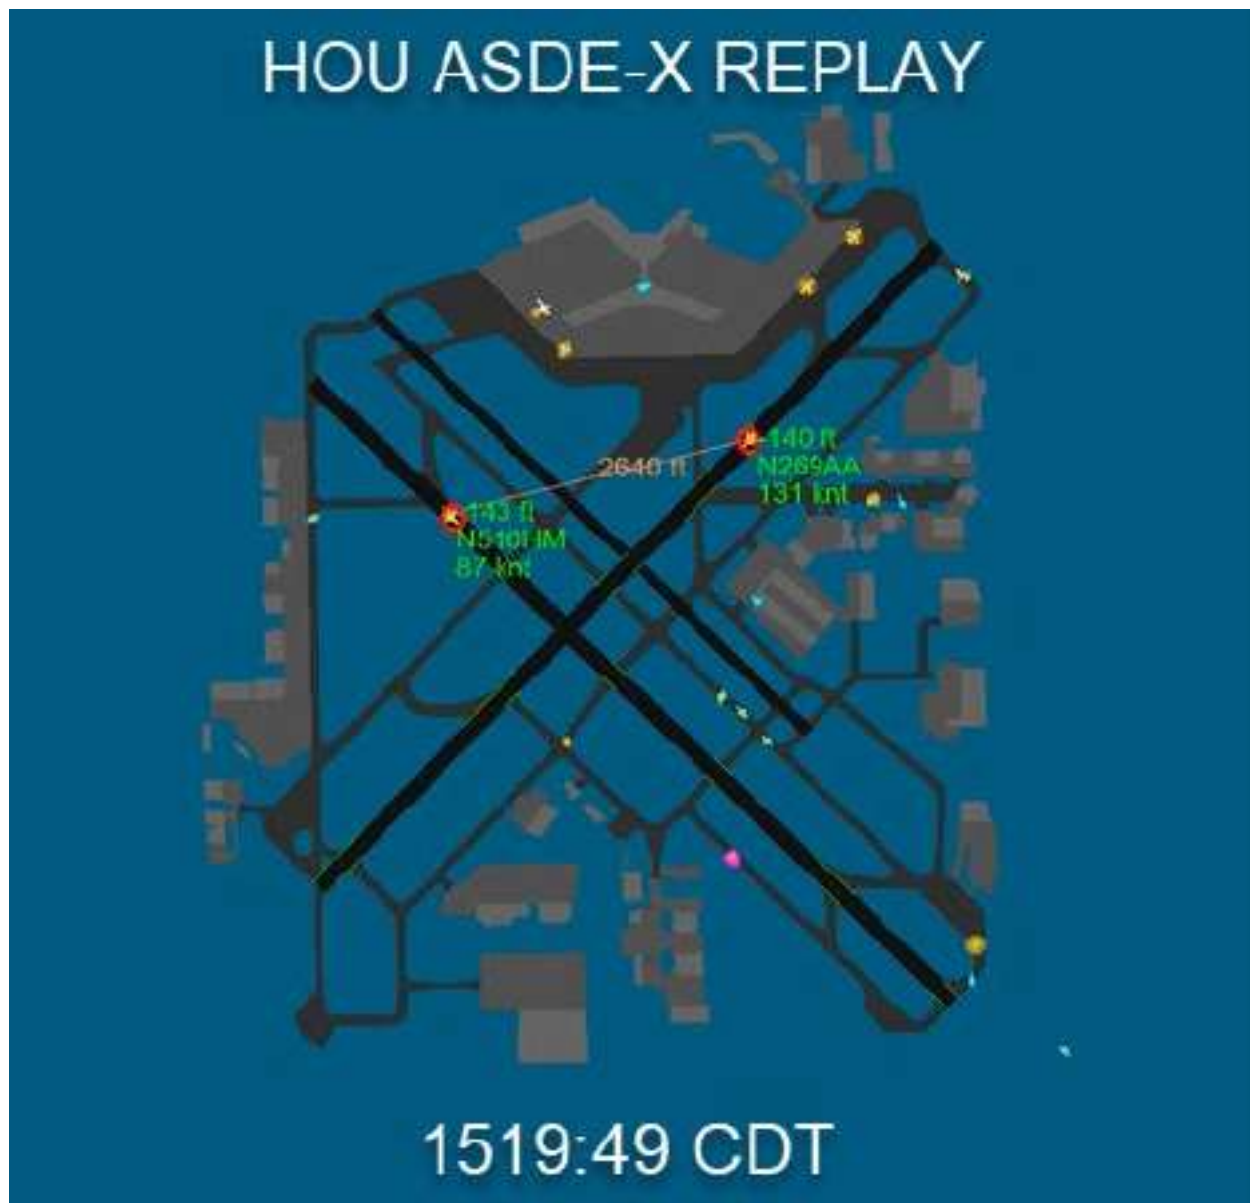
The tower was equipped with an Automatic Surface Detection Equipment - Model X (ASDE-X)<sup>9</sup> system that included displays located at the LC, GC, OS, and Helicopter Control (HC) position workstations. A post event ASDE-X replay analysis was provided by the FAA Technical Center. Figure 7 below is a screen capture from the analysis showing the time the ASDE-X first alerted, and figure 8 is a screen capture closeup of the displayed information at the time of the collision.

**Figure 7.** ASDE-X Screen capture taken at the time of the first alert.

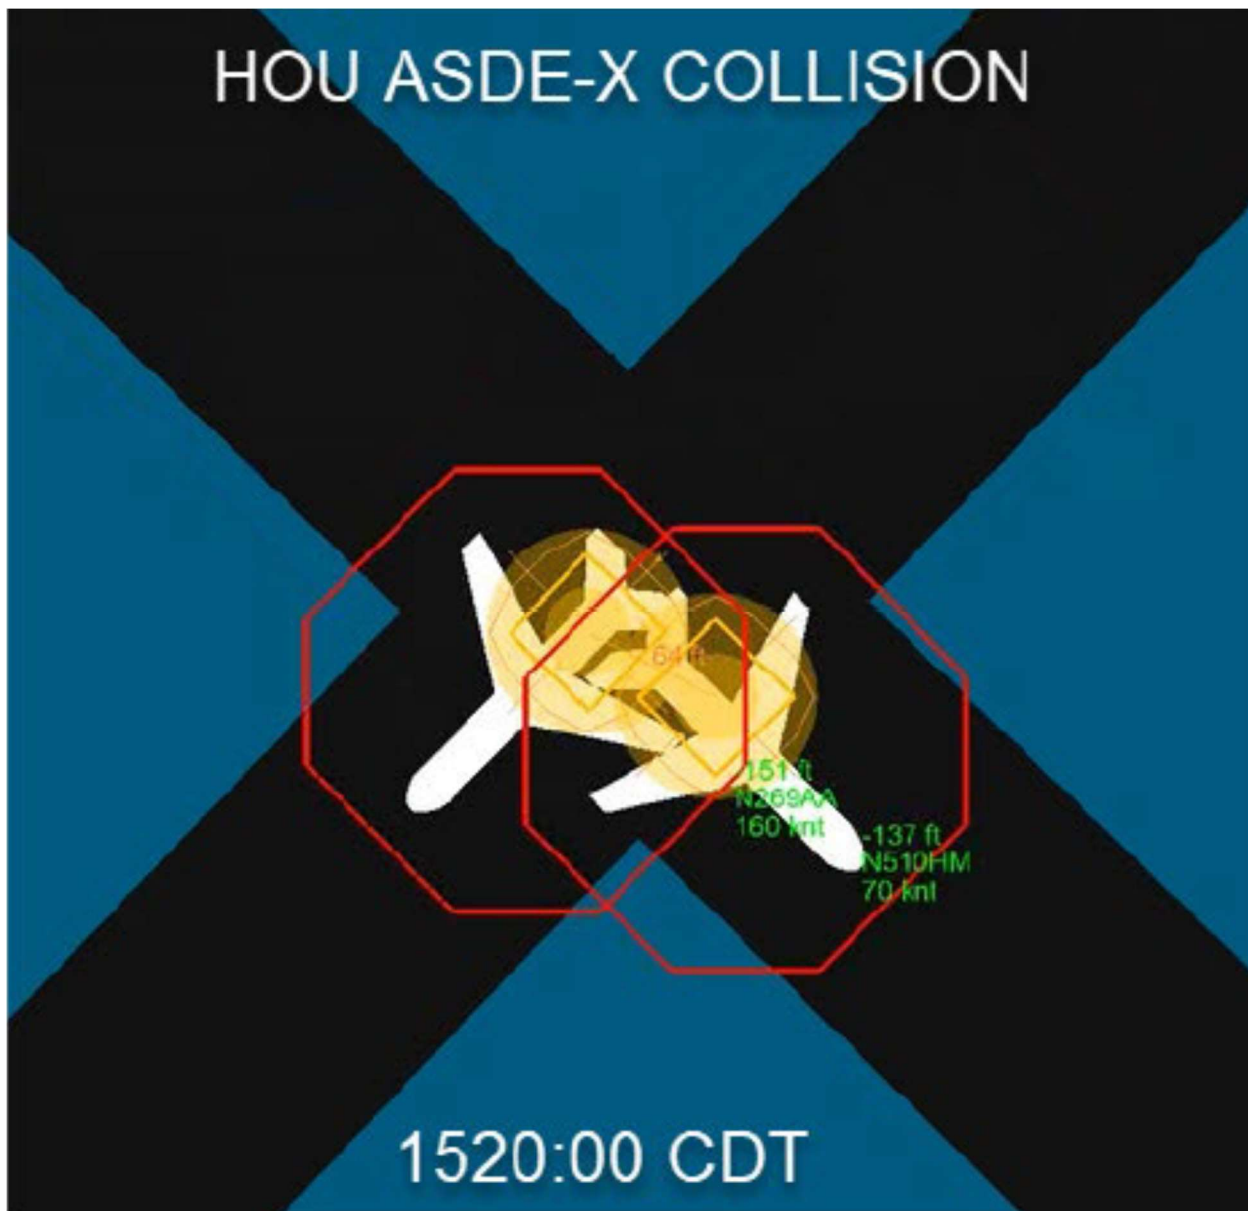
**Figure 8.** ASDE-X Screen capture taken at the time of the collision.
